# BUREAU OF SHIPS GROUP

## TECHNICAL INSPECTION REPORT

6 OPERATION CROSSROADS.  
U.S.S. CRITTENDEN (APA77)

TEST ABLE.

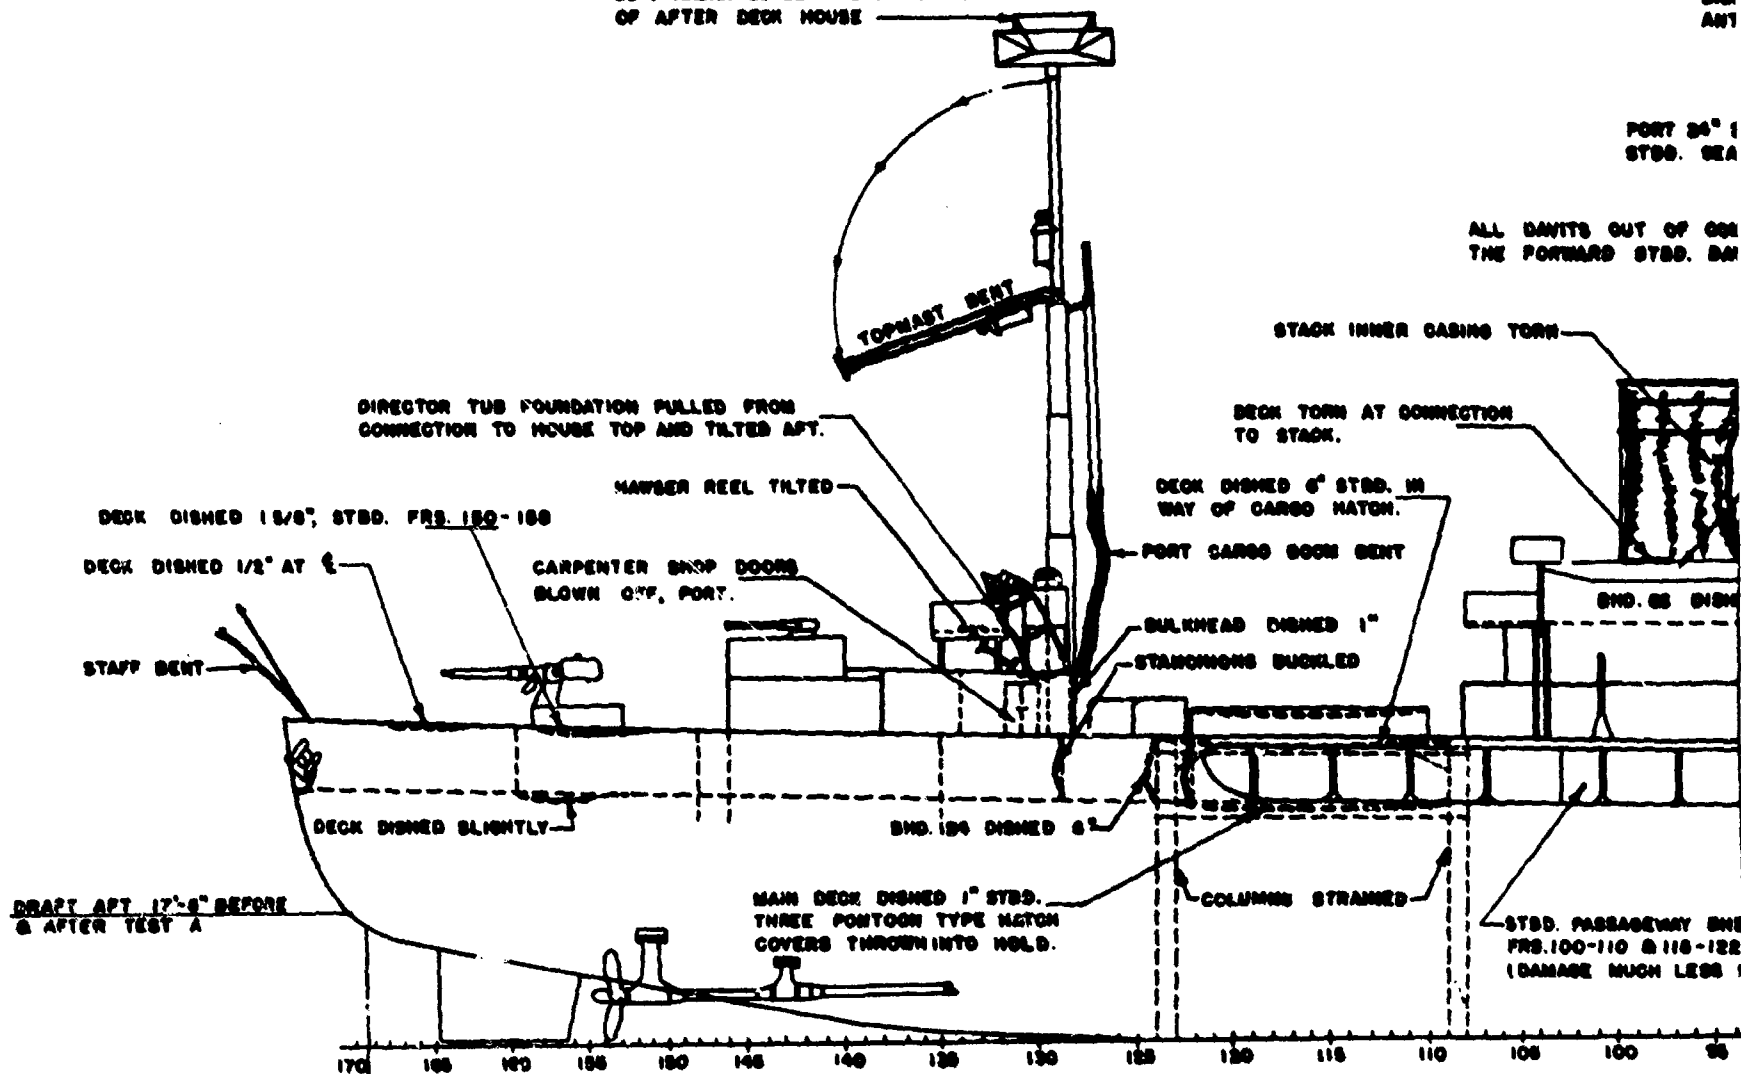
ALL DANTS OUT OF OR  
THE FORWARD STBD. BN

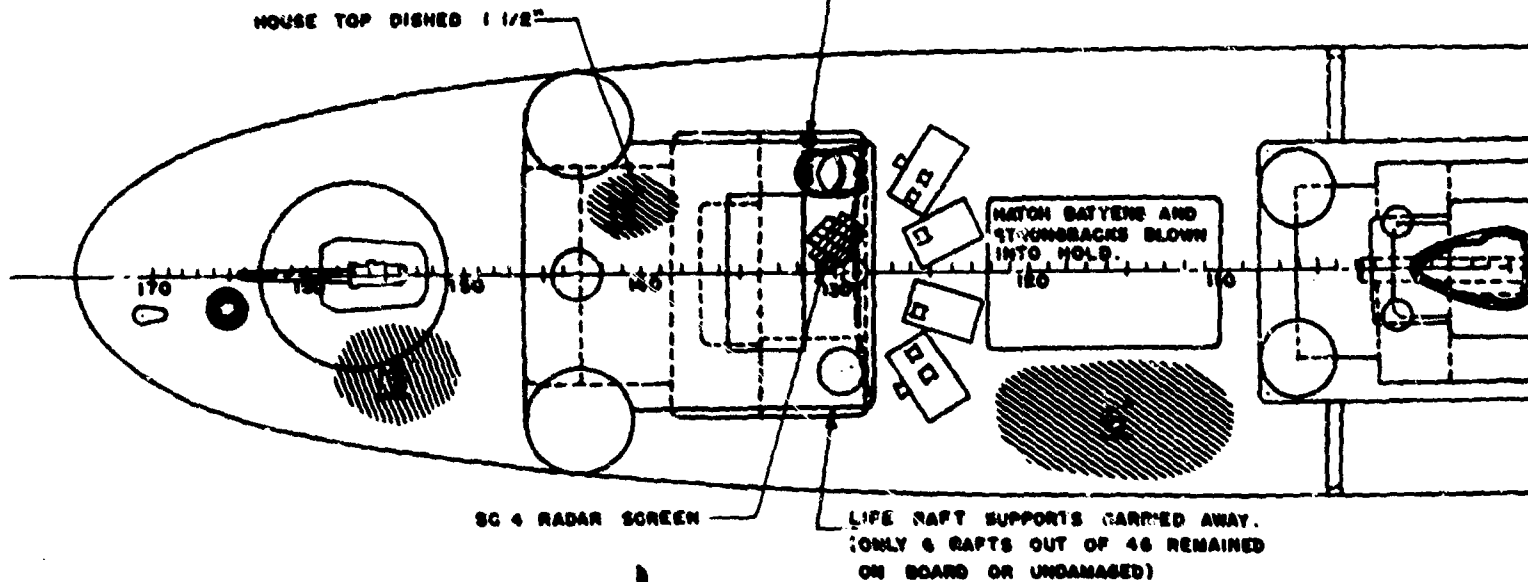
HOUSE TOP BUCKLED DOWN 6" FROM PRESSURE  
EXERTED BY DIRECTOR TUB FOUNDATION

NO 4 RADAR SCREEN FELL TO TOP  
OF AFTER DECK HOUSE

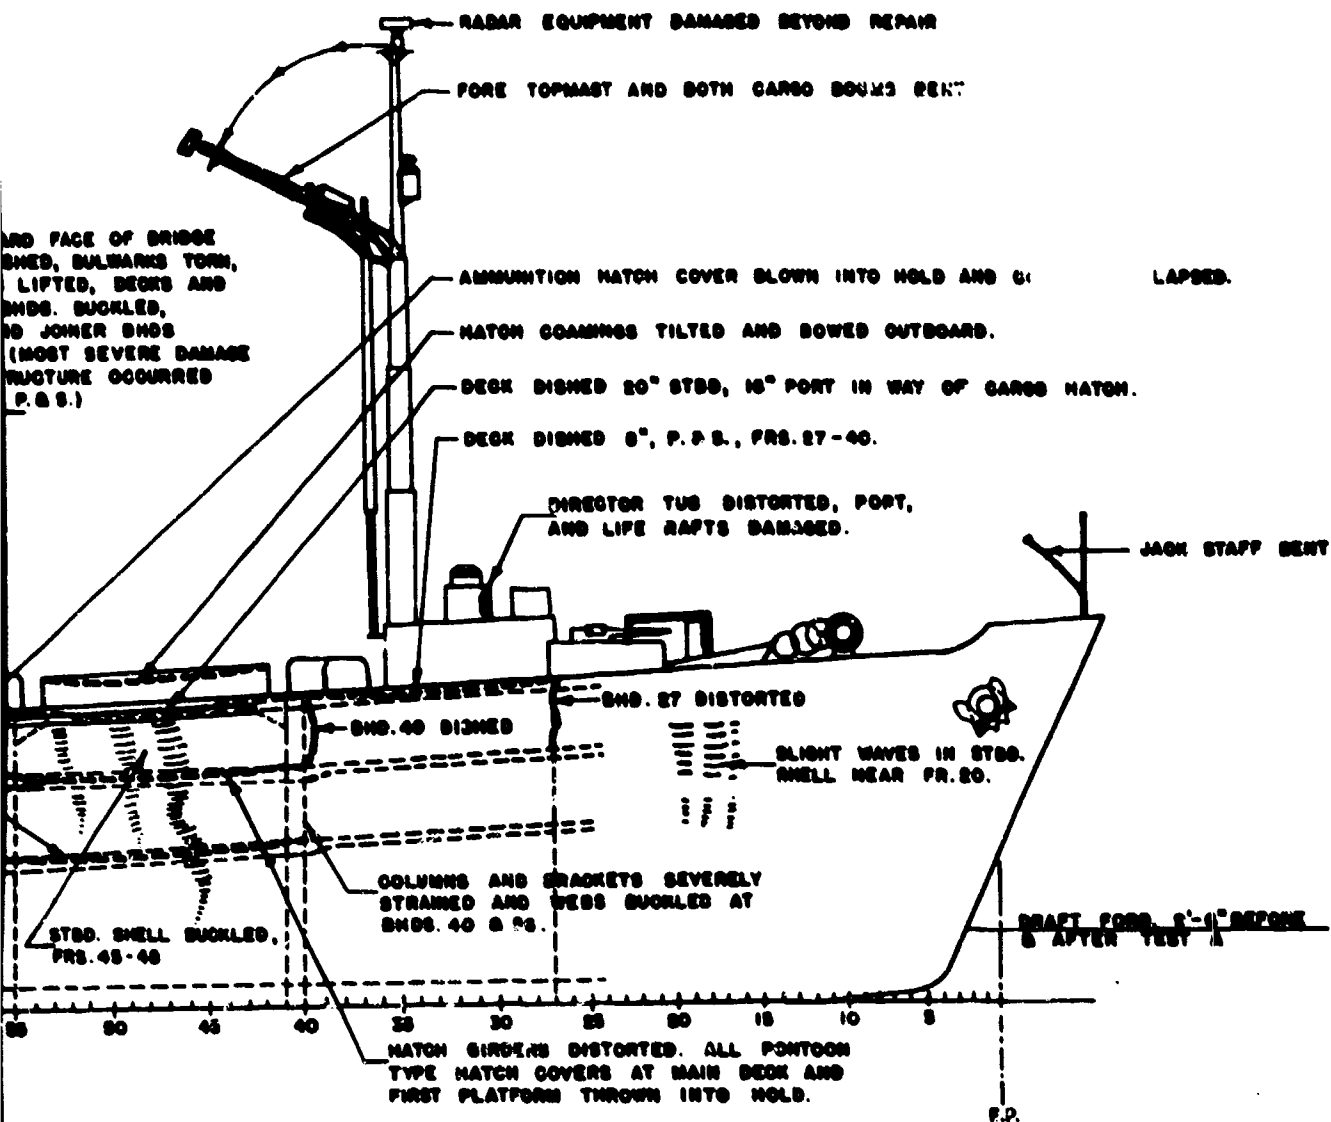
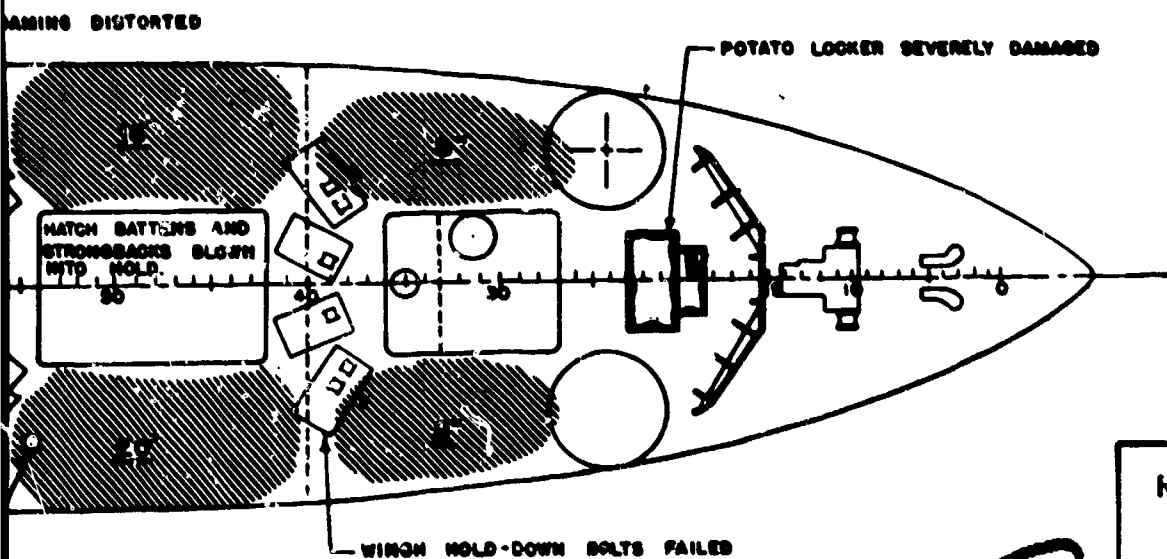
WING HOLD-DOWN BOLTS FAILED

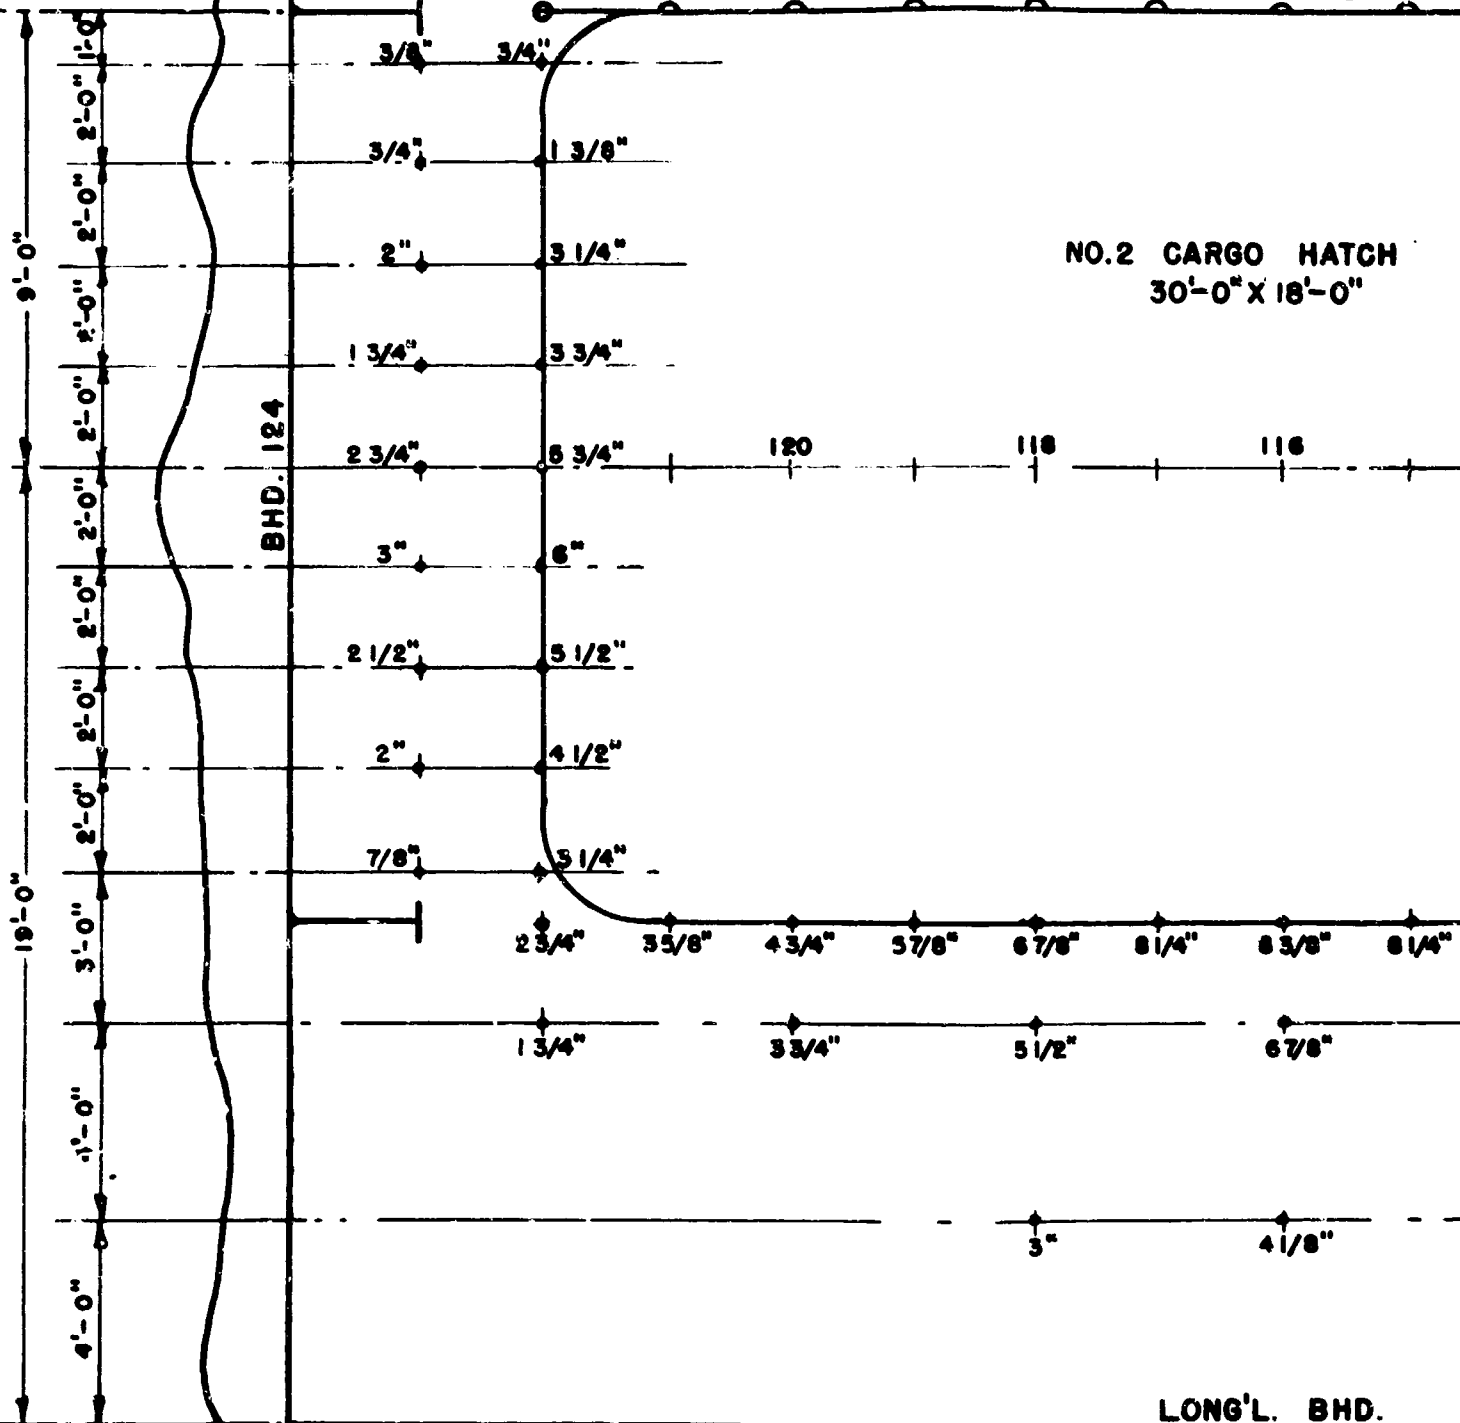
MAIN DECK  
PLAN VIEW

NO.2 CARGO HATCH  
30'-0" X 18'-0"

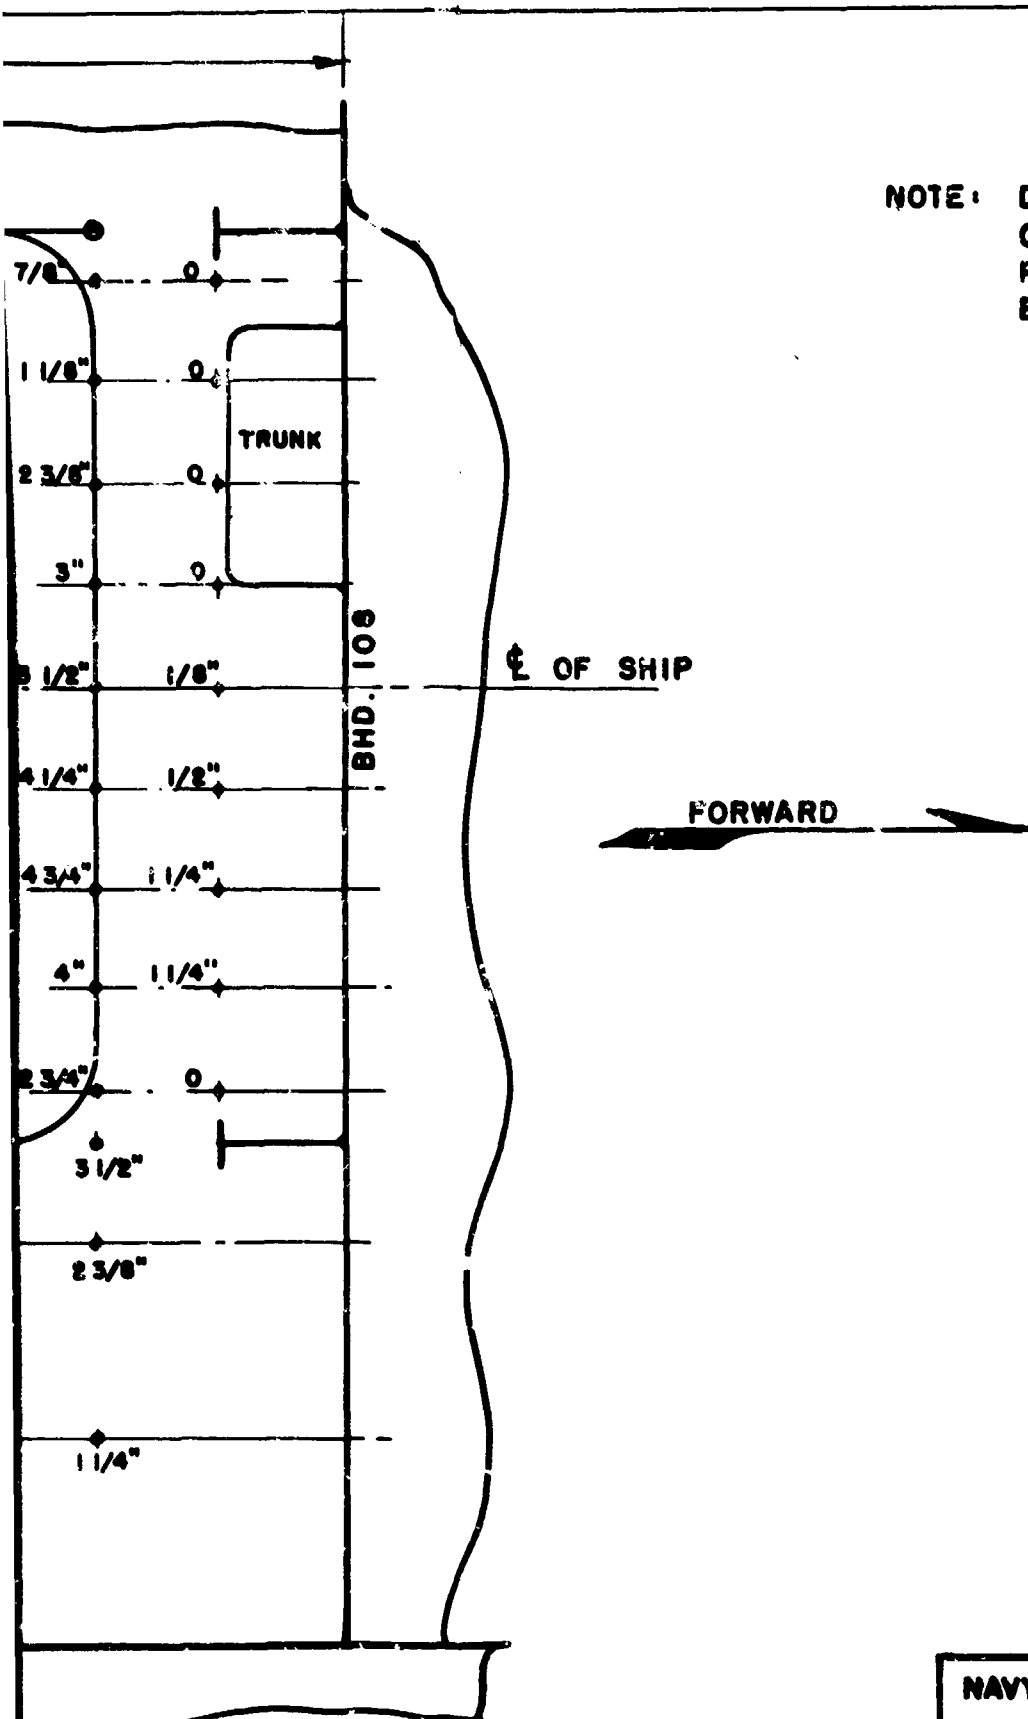
NOTE: DECK DEFLECTION MEASUREMENTS  
OBTAINED BY MEASURING TO DECK  
PLATE FROM CHALK LINE STRETCHED  
BETWEEN BHDS. 108 AND 124.

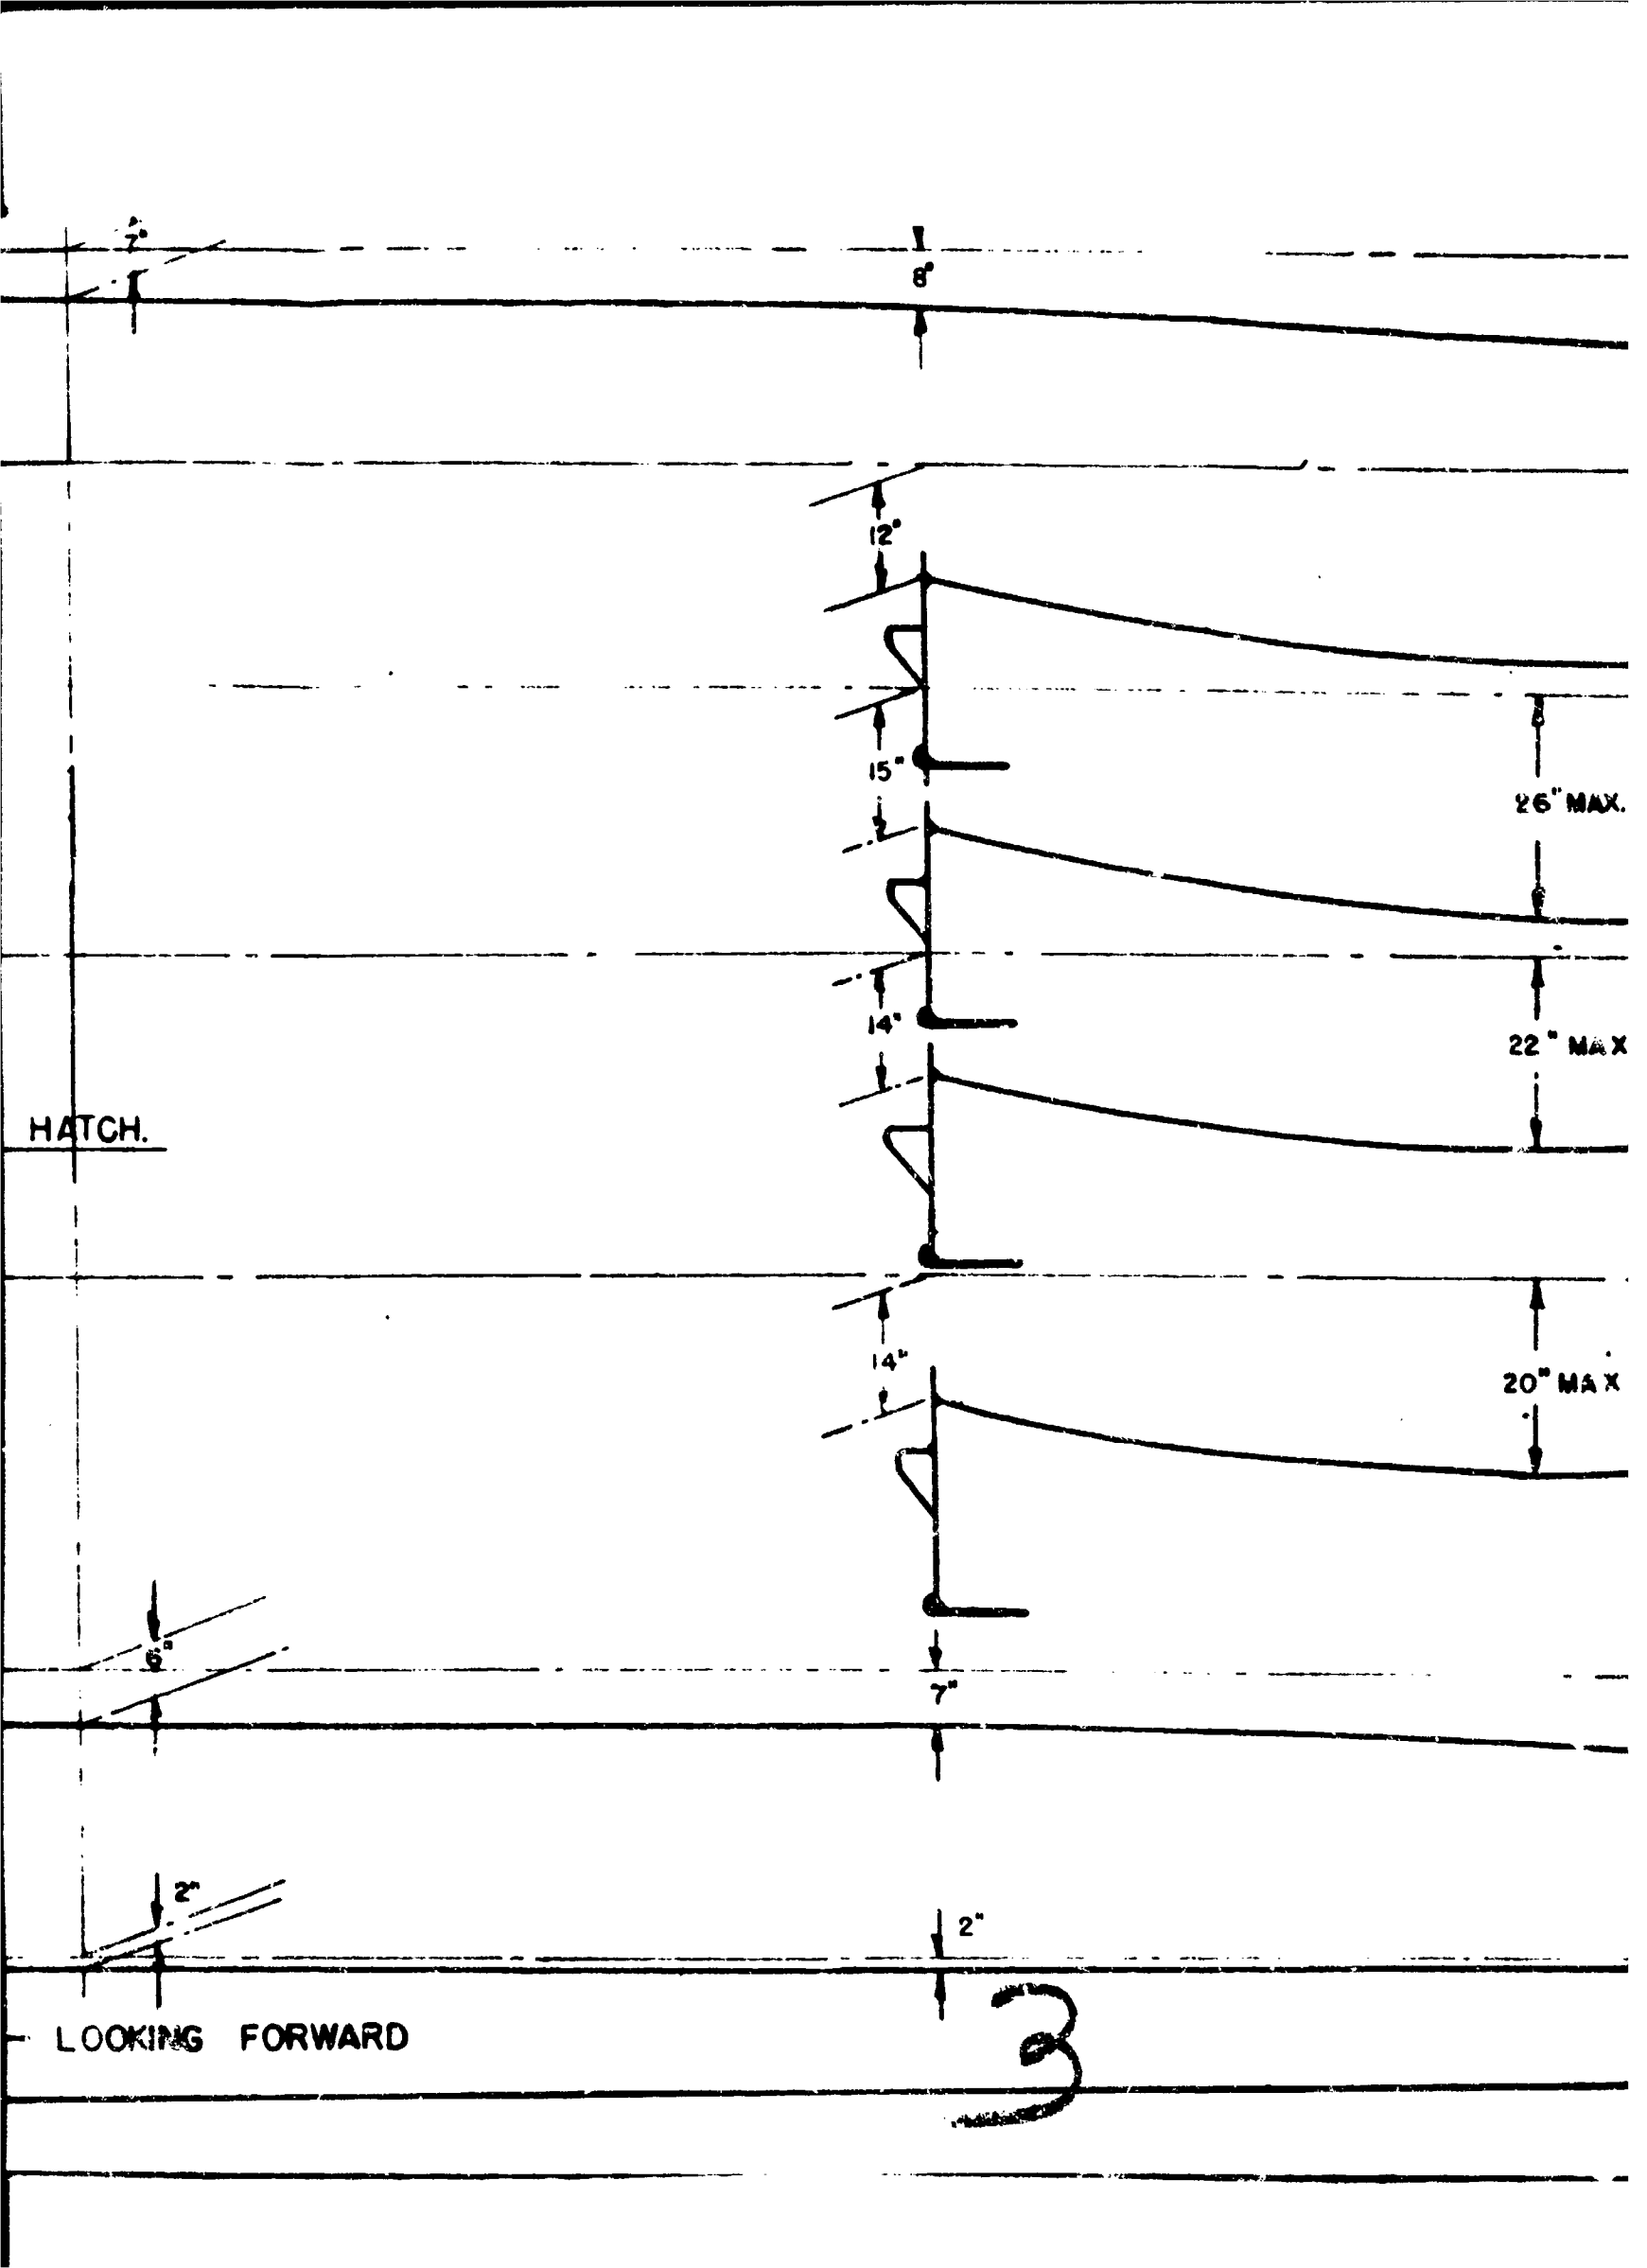
MAIN DECK — LOOKING FOR

22° MAX.
