TECHNICAL INSPECTION REPORT

OPERATION CROSSROADS.
U.S.S. CRITTENDEN (APA 77)
U.S. NAVY
U.S. BUREAU OF SHIPS
U.S. NAVY REPORT DIRECTLY FROM THE FIELD
TEST ABLE.
U.S. NAVY Support Agency
Washington, D. C. 20301
VOLUME 2 [U].

OPERATION CROSSROADS

BUREAU OF SHIPS GROUP
TECHNICAL INSPECTION REPORT

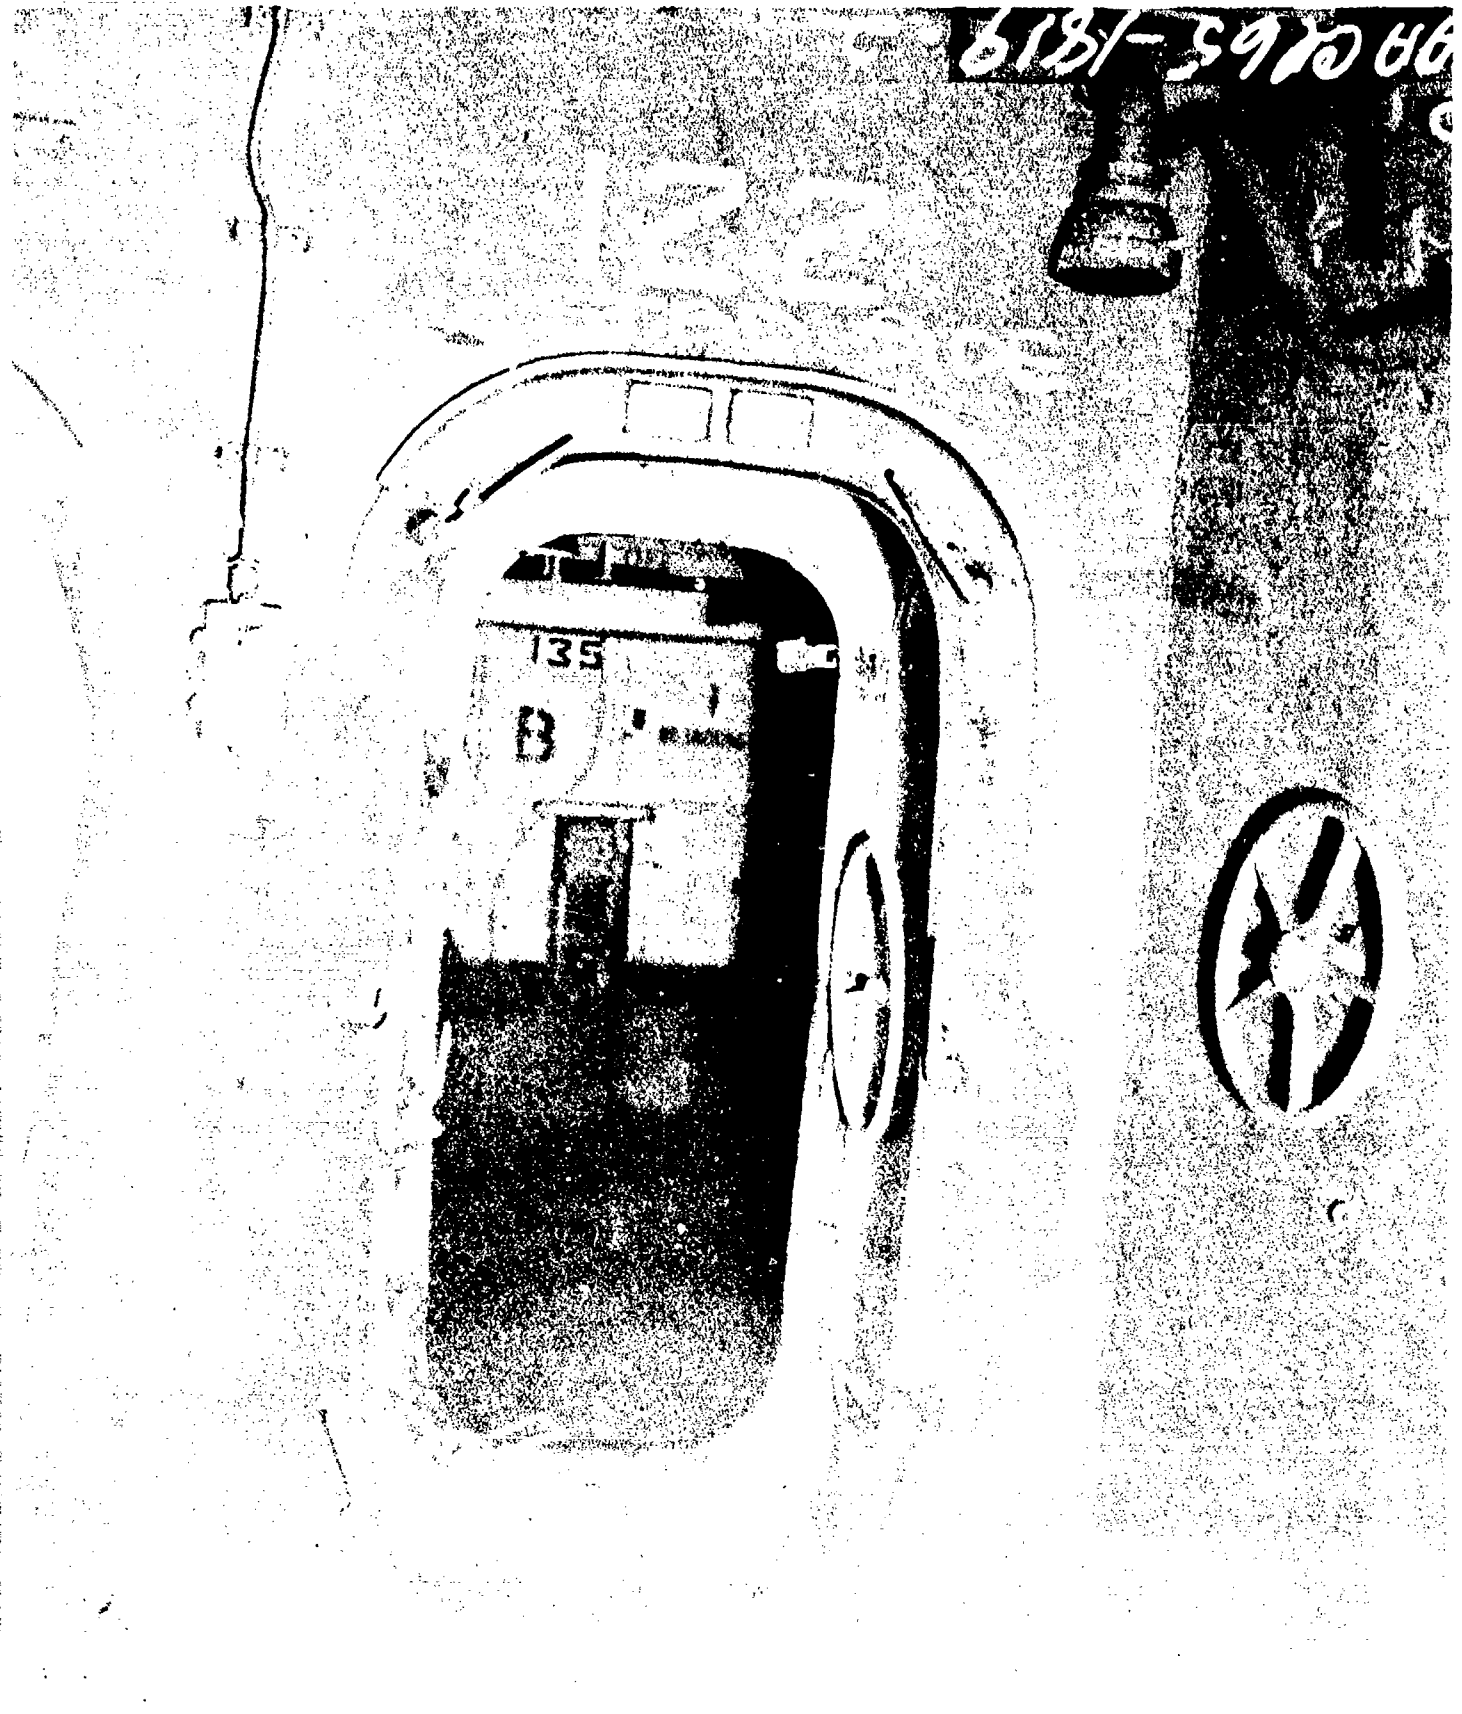
AA-CR-65-1819-2. Lookingaft in main deck, well, starboard, showing damage after bulkhead 122.

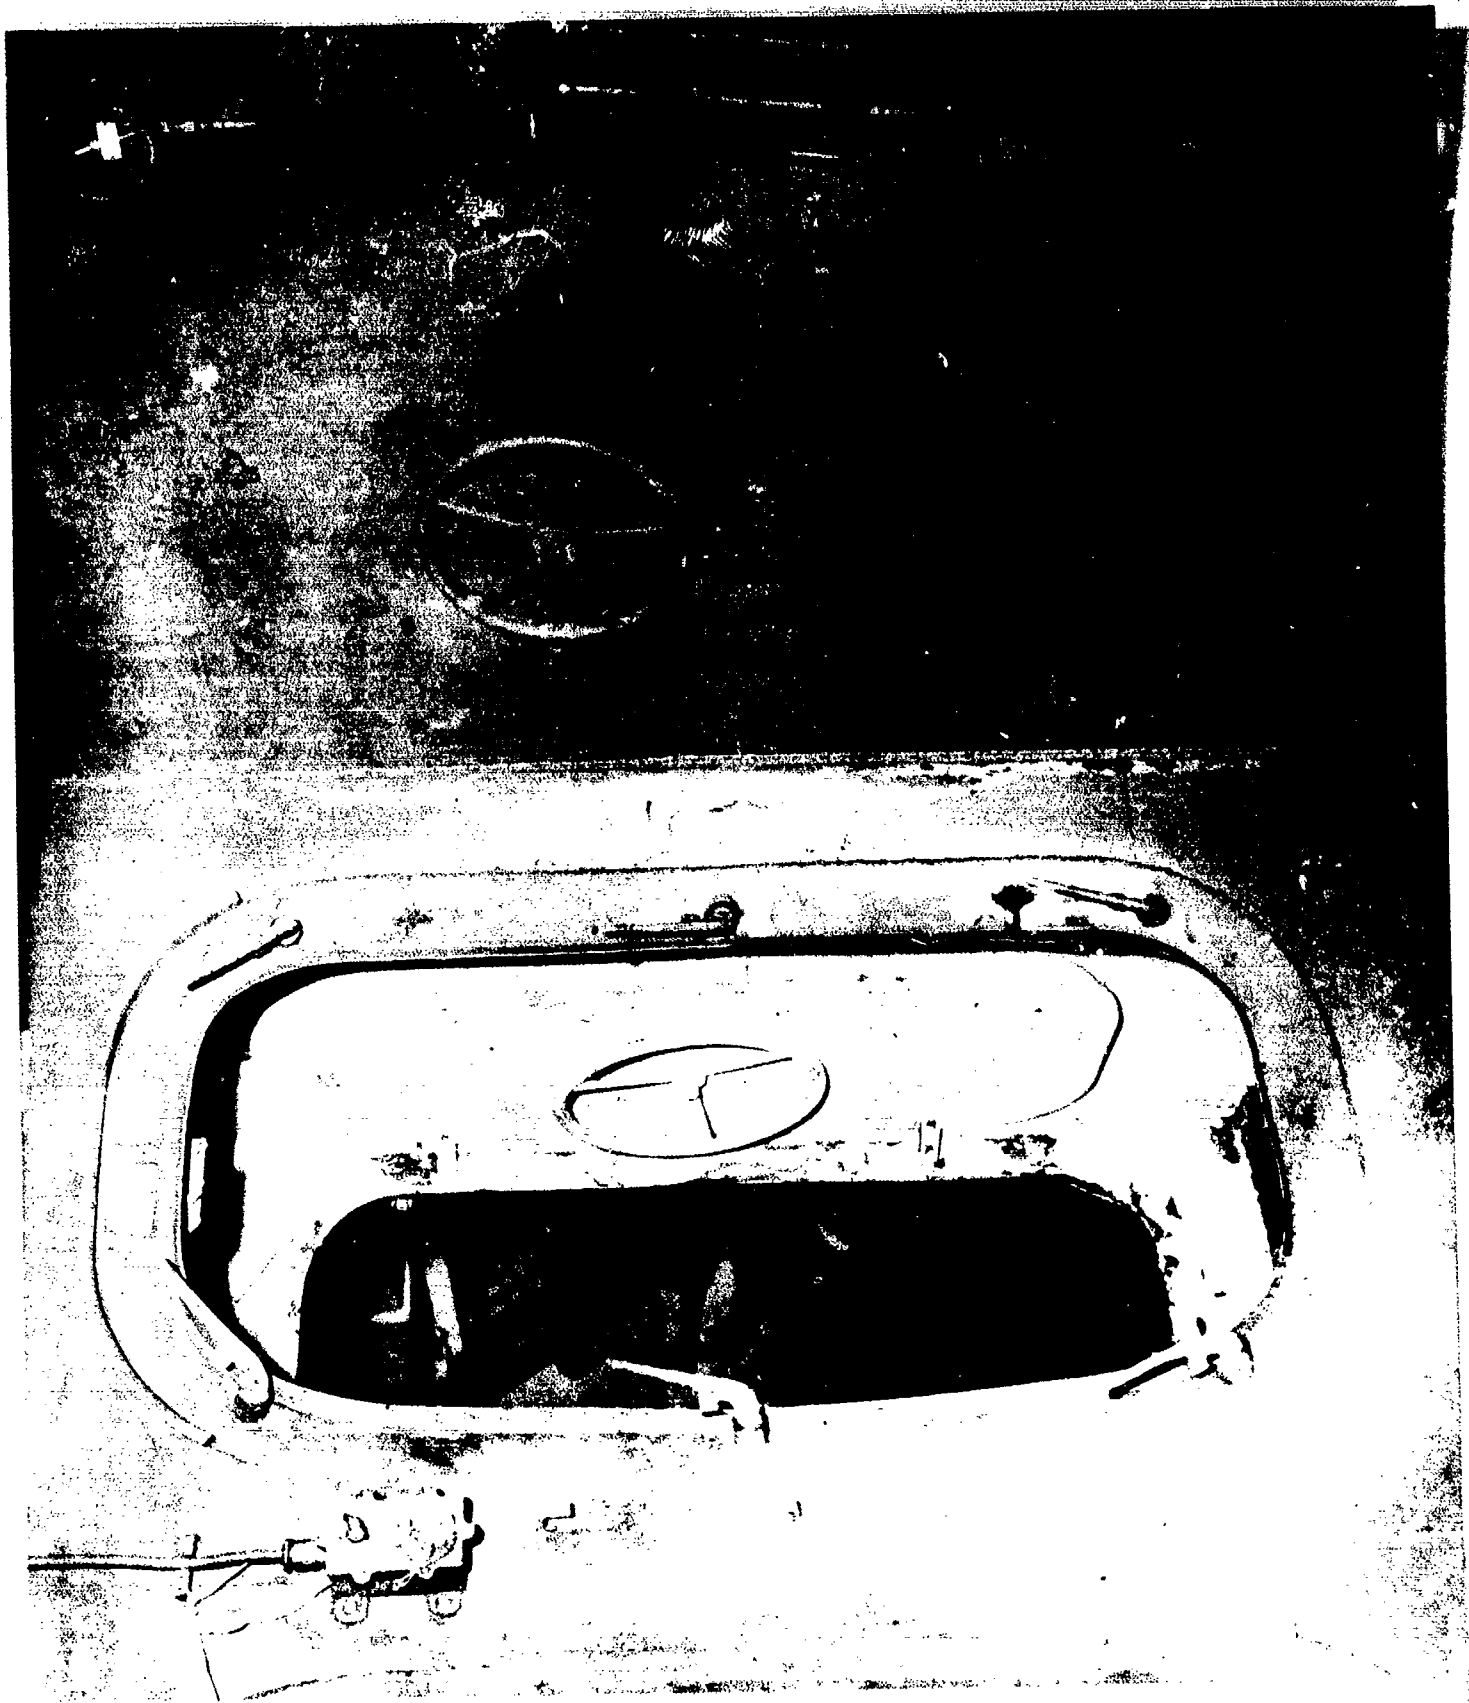
AA-CR-80-1908-8. Looking aft in main deck well, starboard, showing damage to after bulkhead.

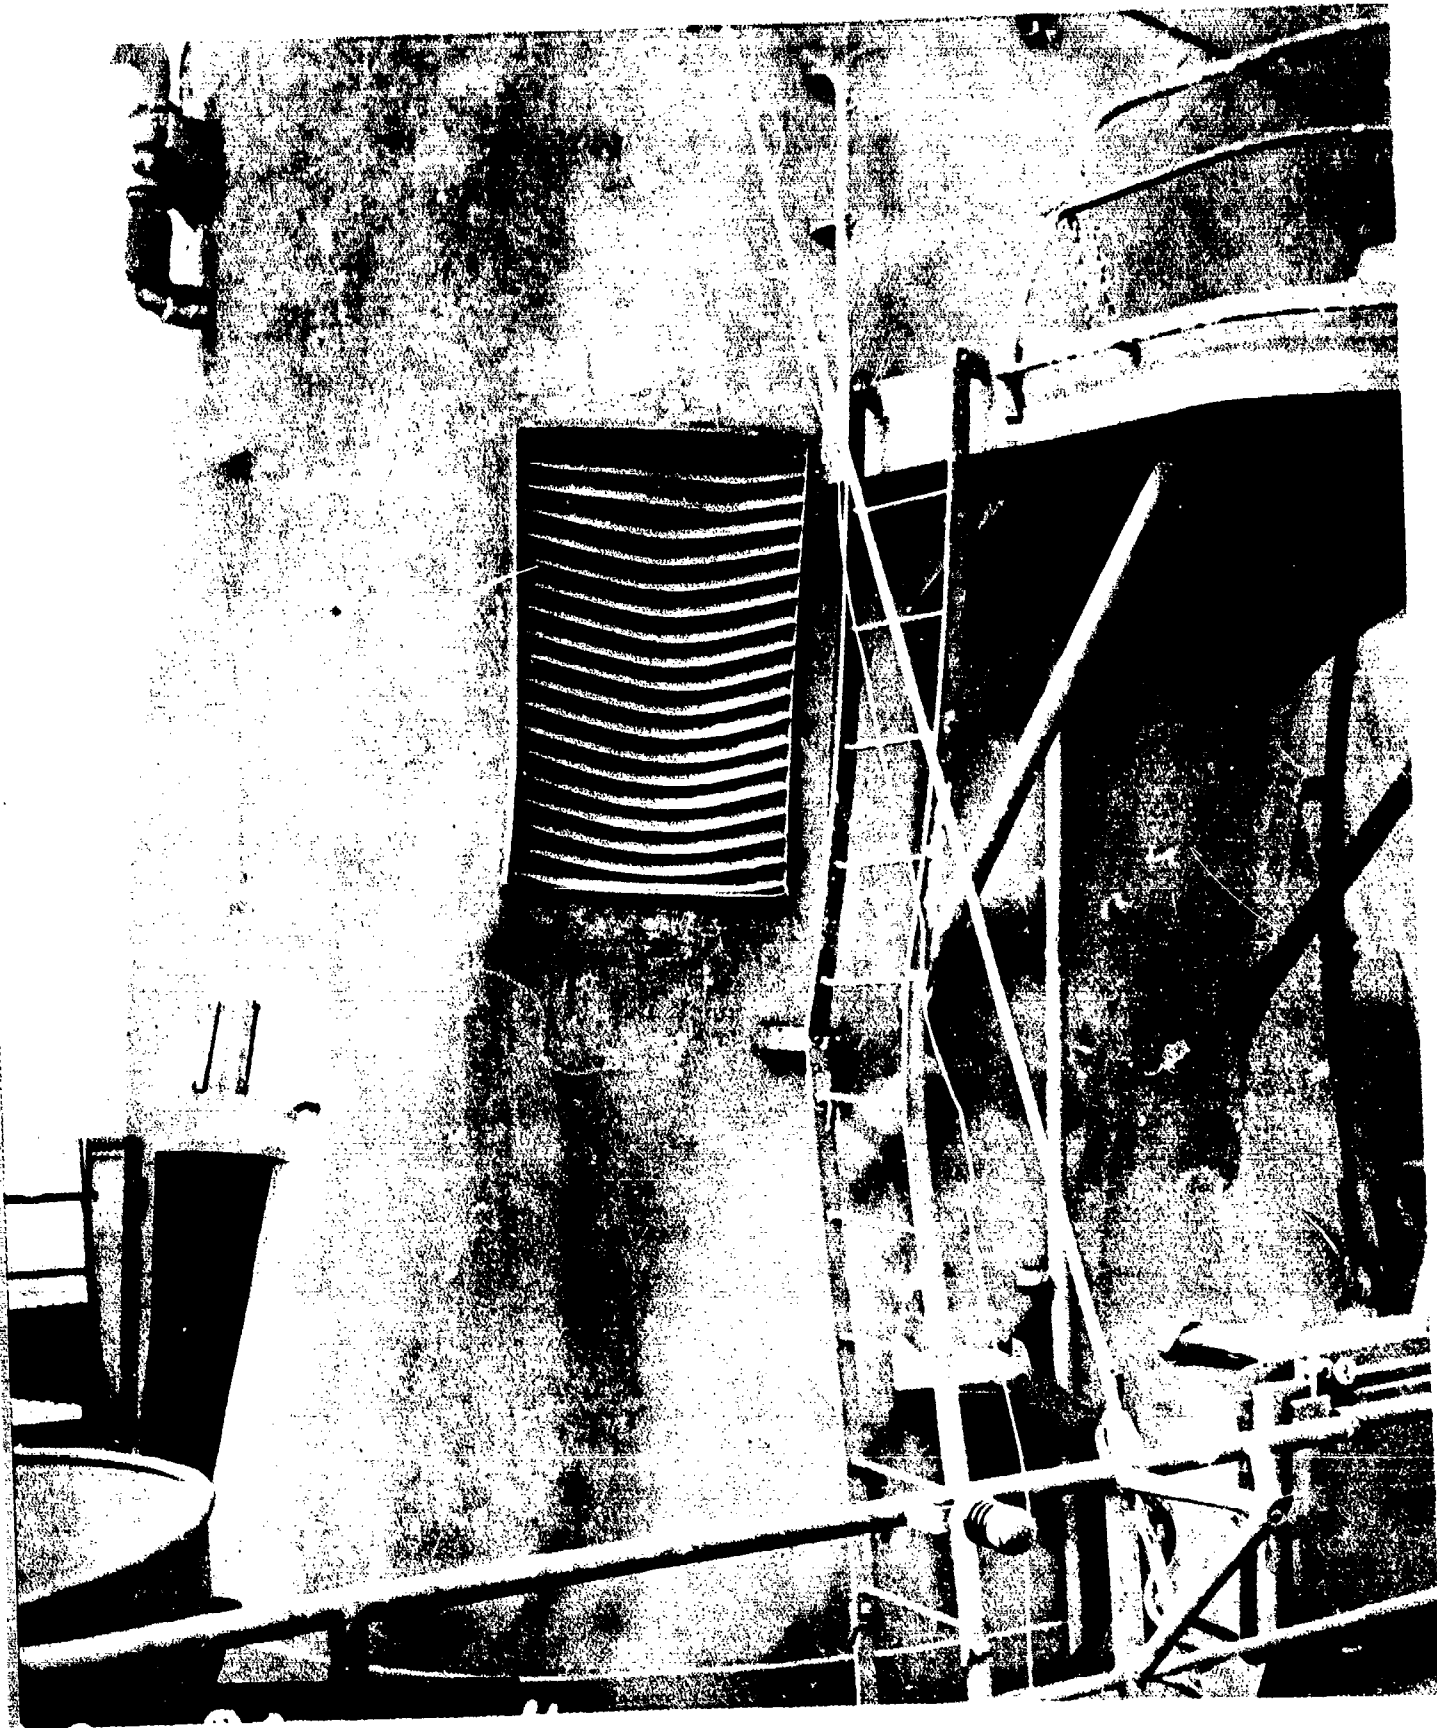
AA-CR-80-1904-4. Looking to starboard and aft on signal bridge level showing damage to starboard side of forward stack.

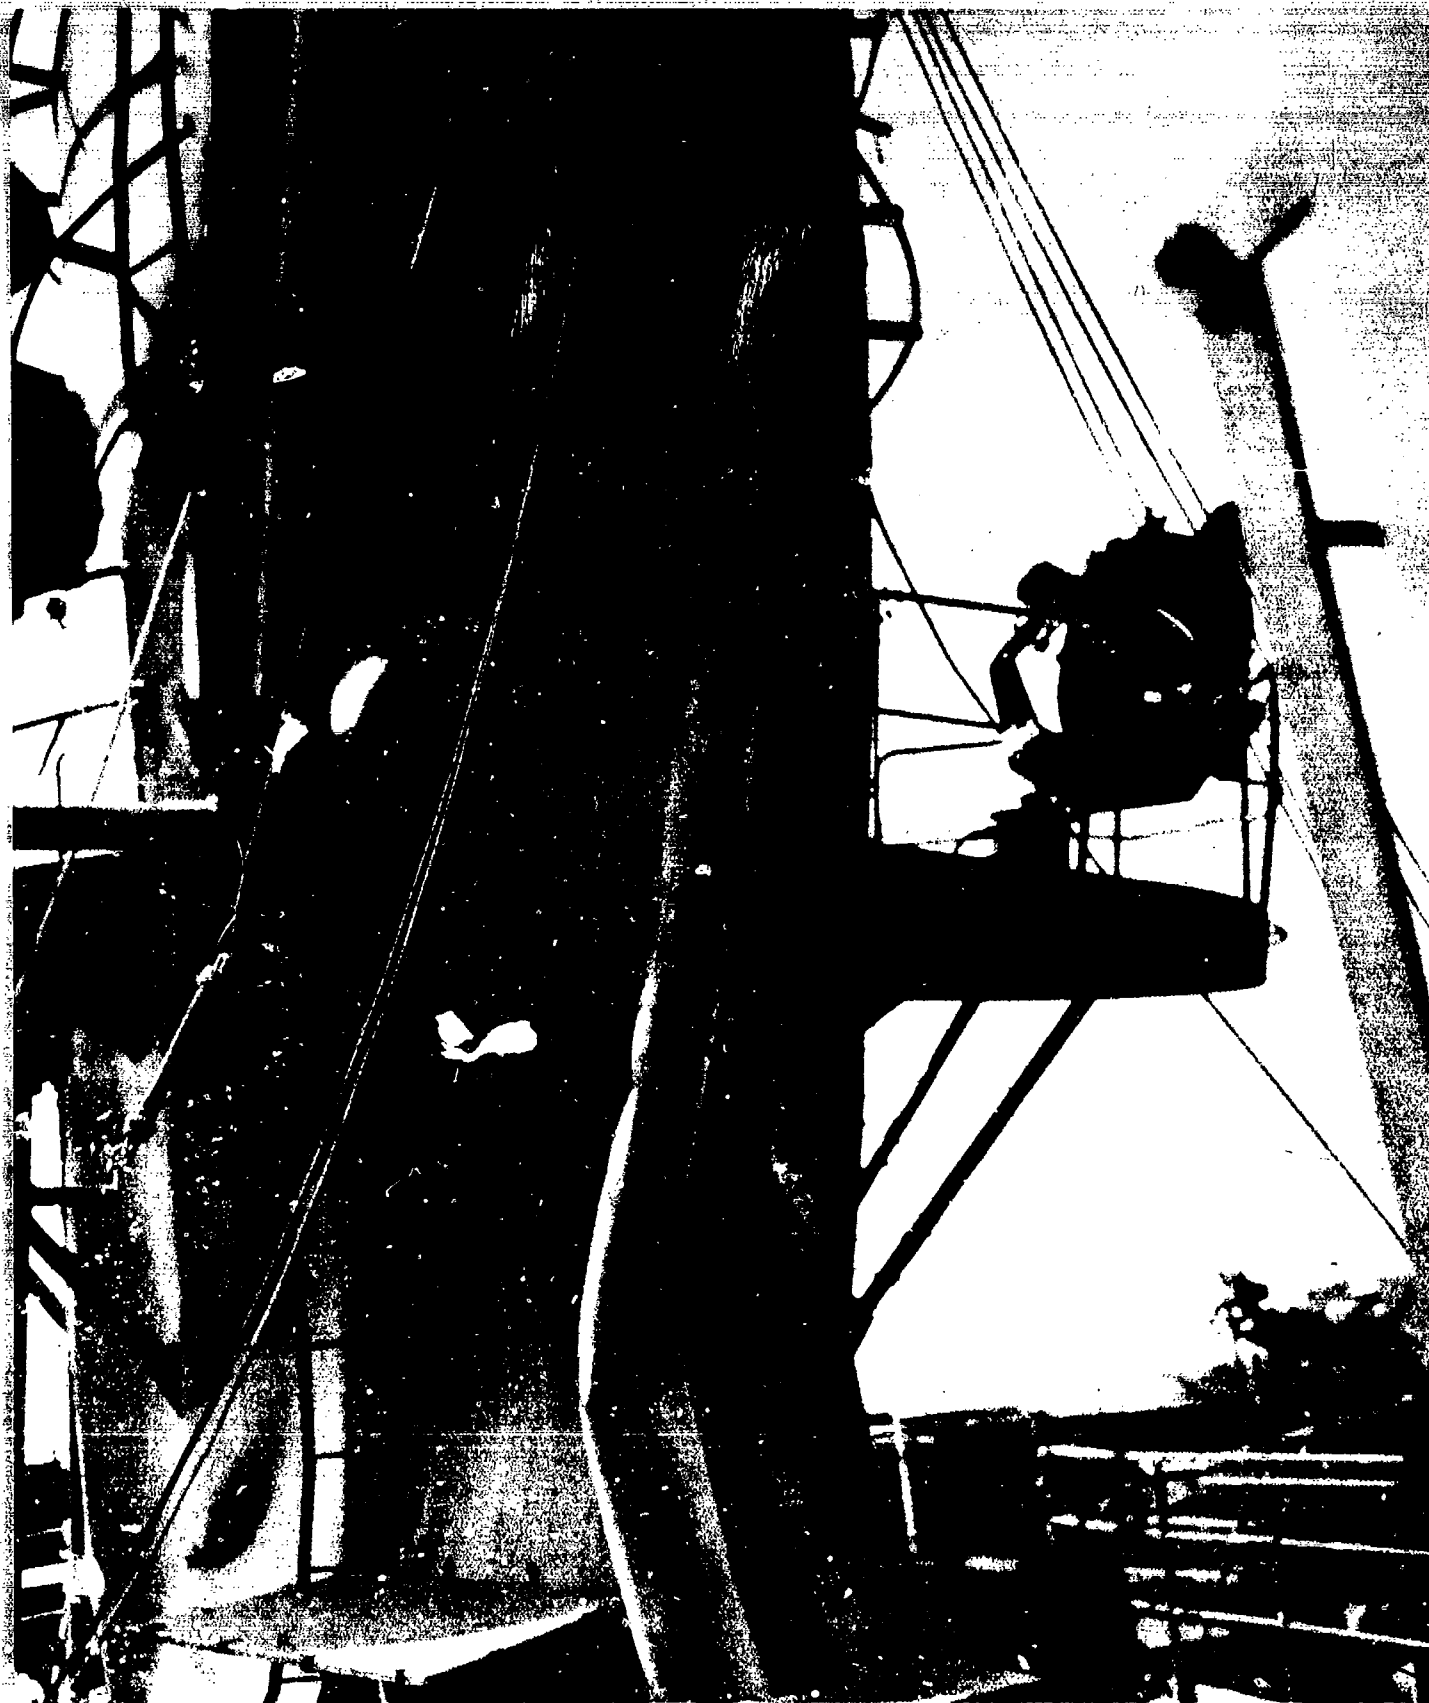
AA-CR-59-2058-10. Looking forward and to starboard on signal bridge level showing damage to after side of forward stack and starboard 24-inch searchlight.

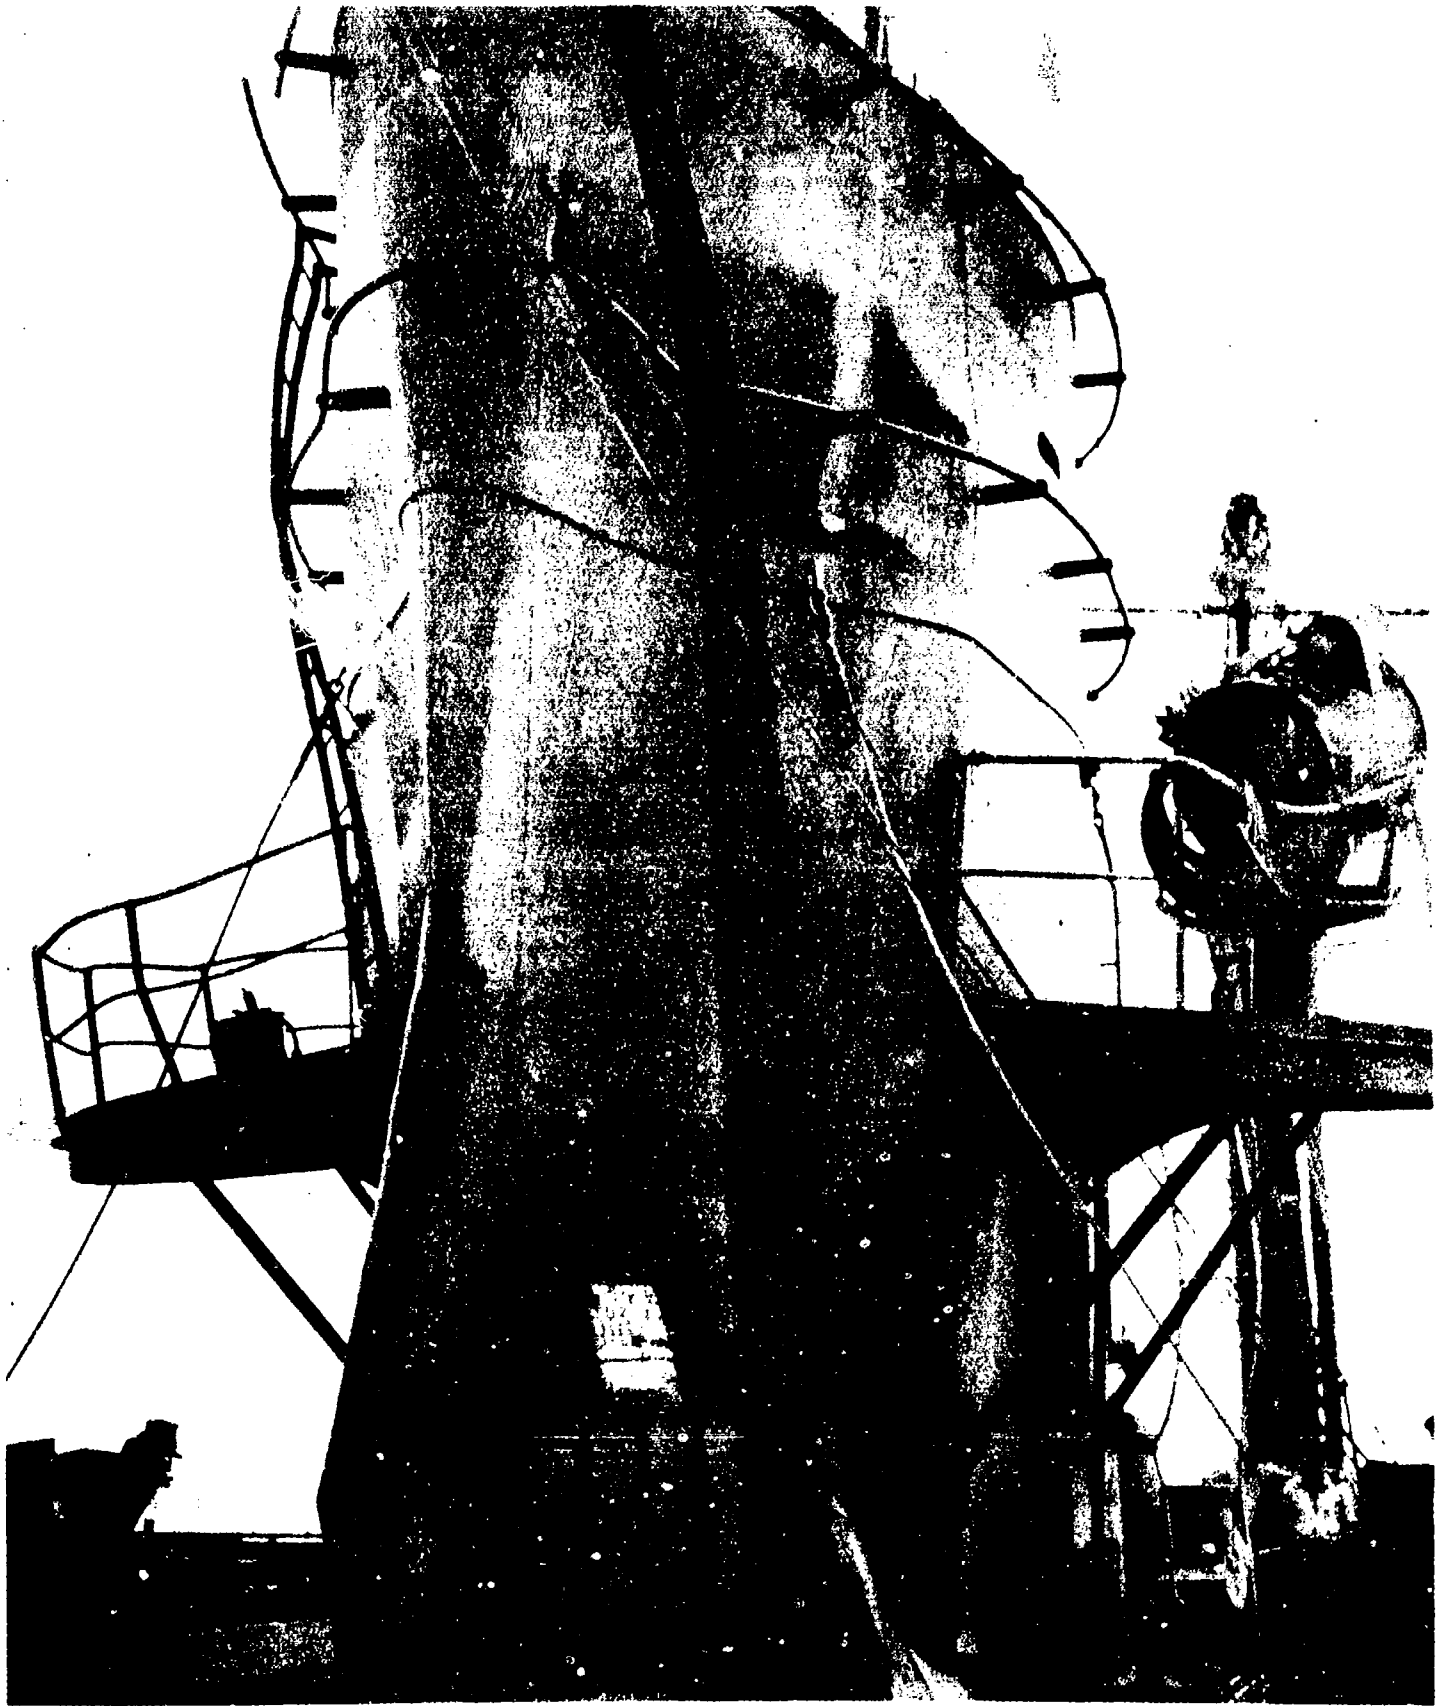
AA-CR-62-1878-6. Looking forward and to port at damage to forward stack. -

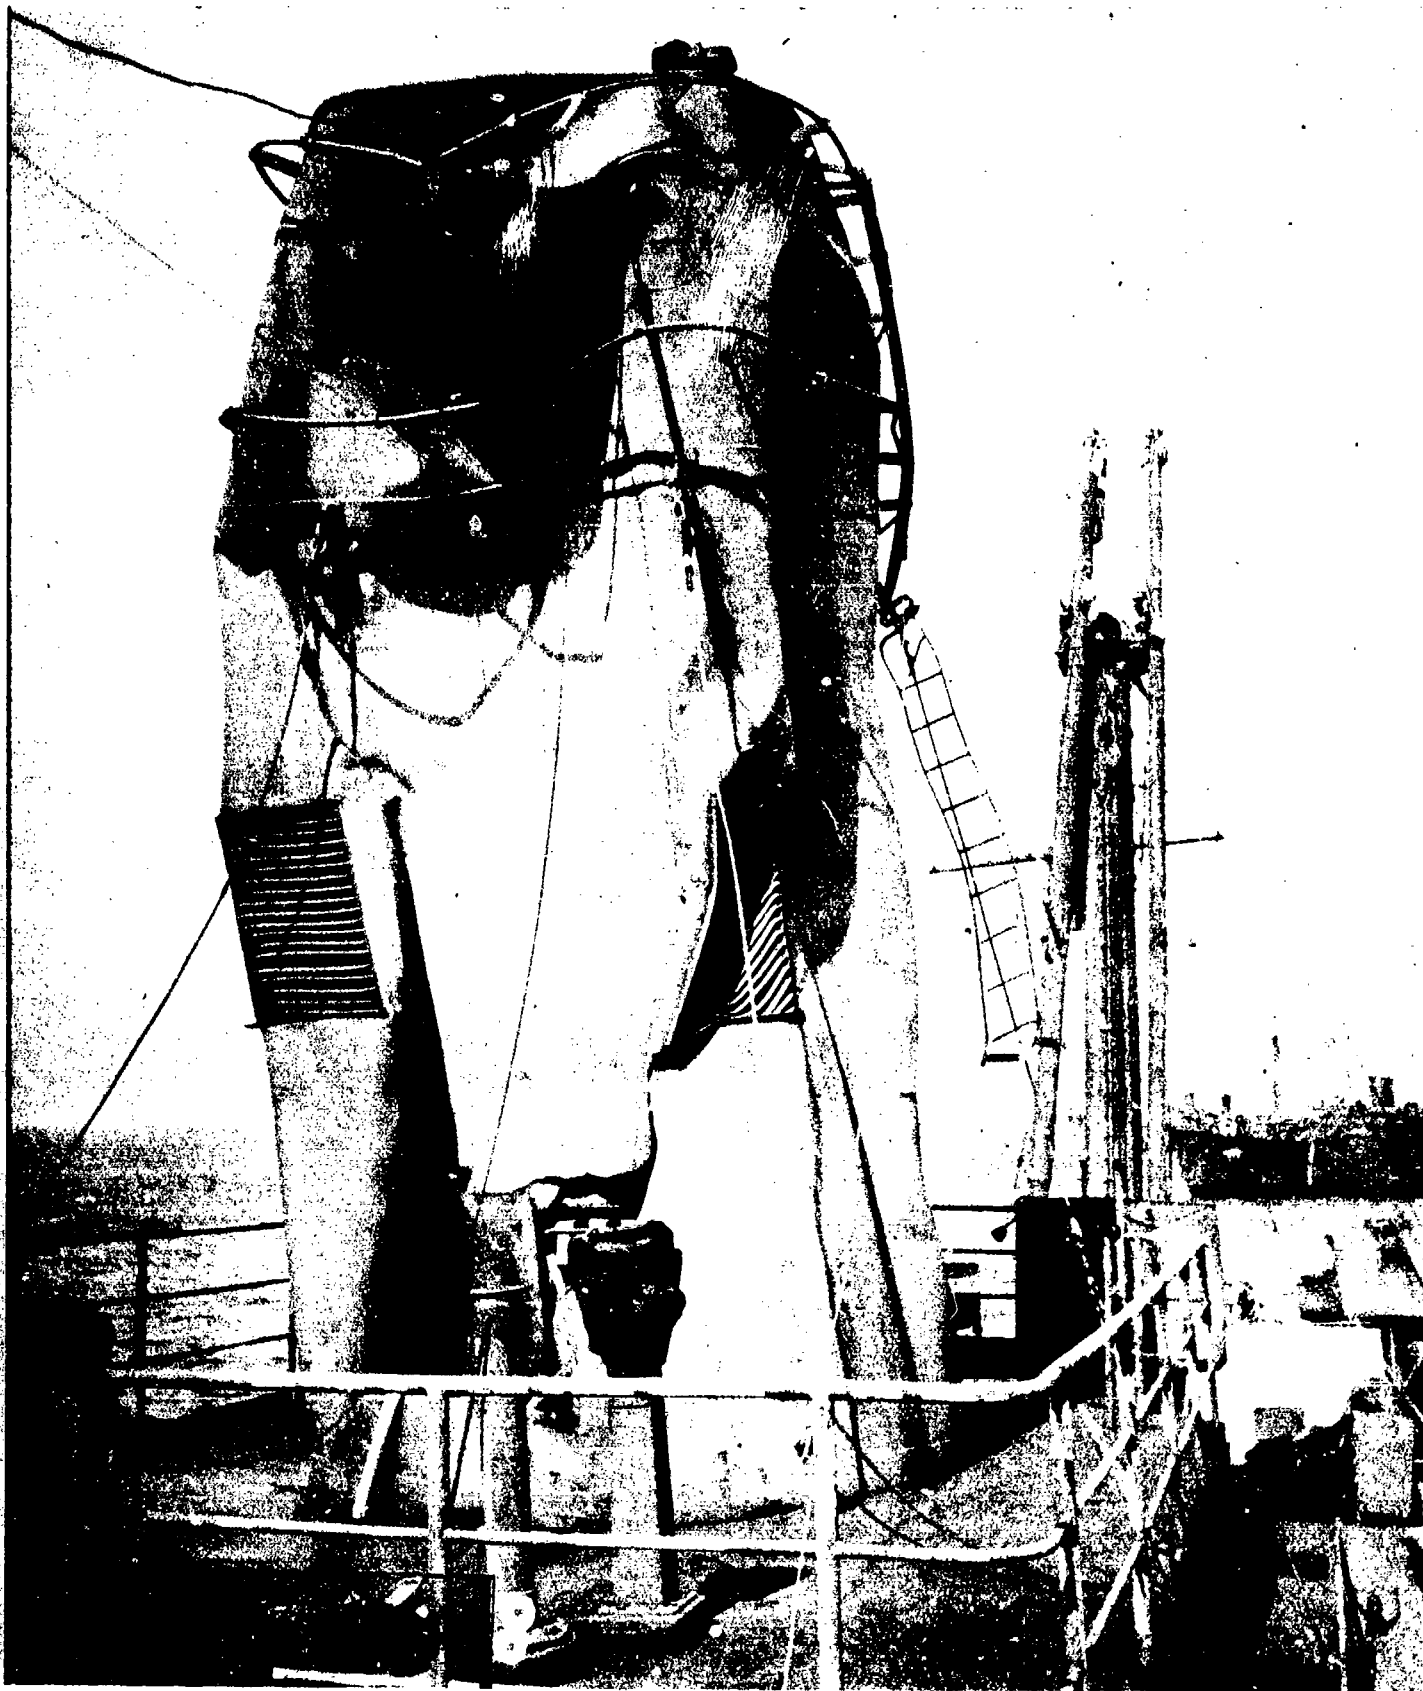
AA-CR-80-1904-8. Looking aft on signal bridge level showing damage to after stack and sky lookout tub. -

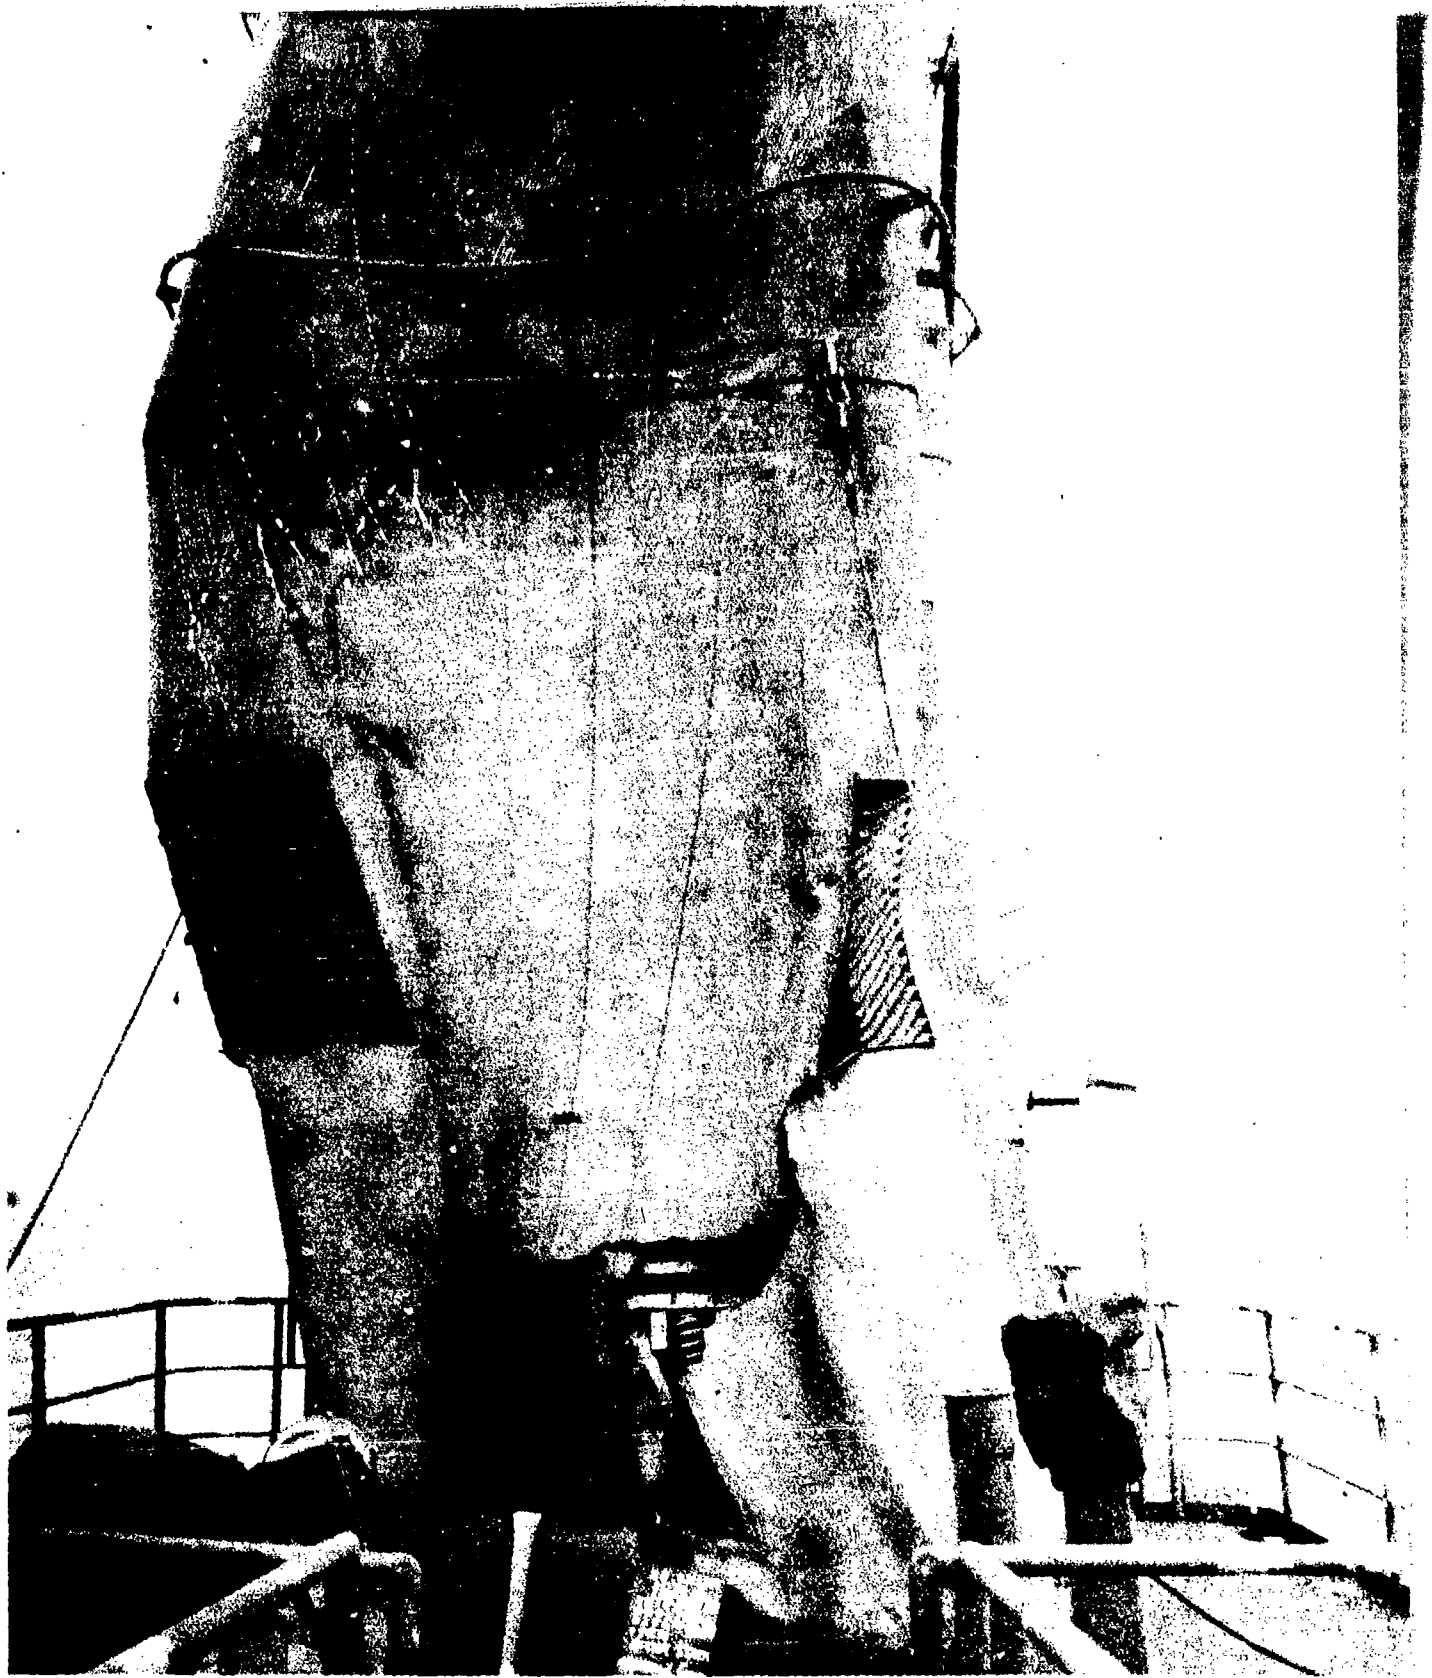
AA-CR-62-1878-4. Looking aft at damage to after stack.

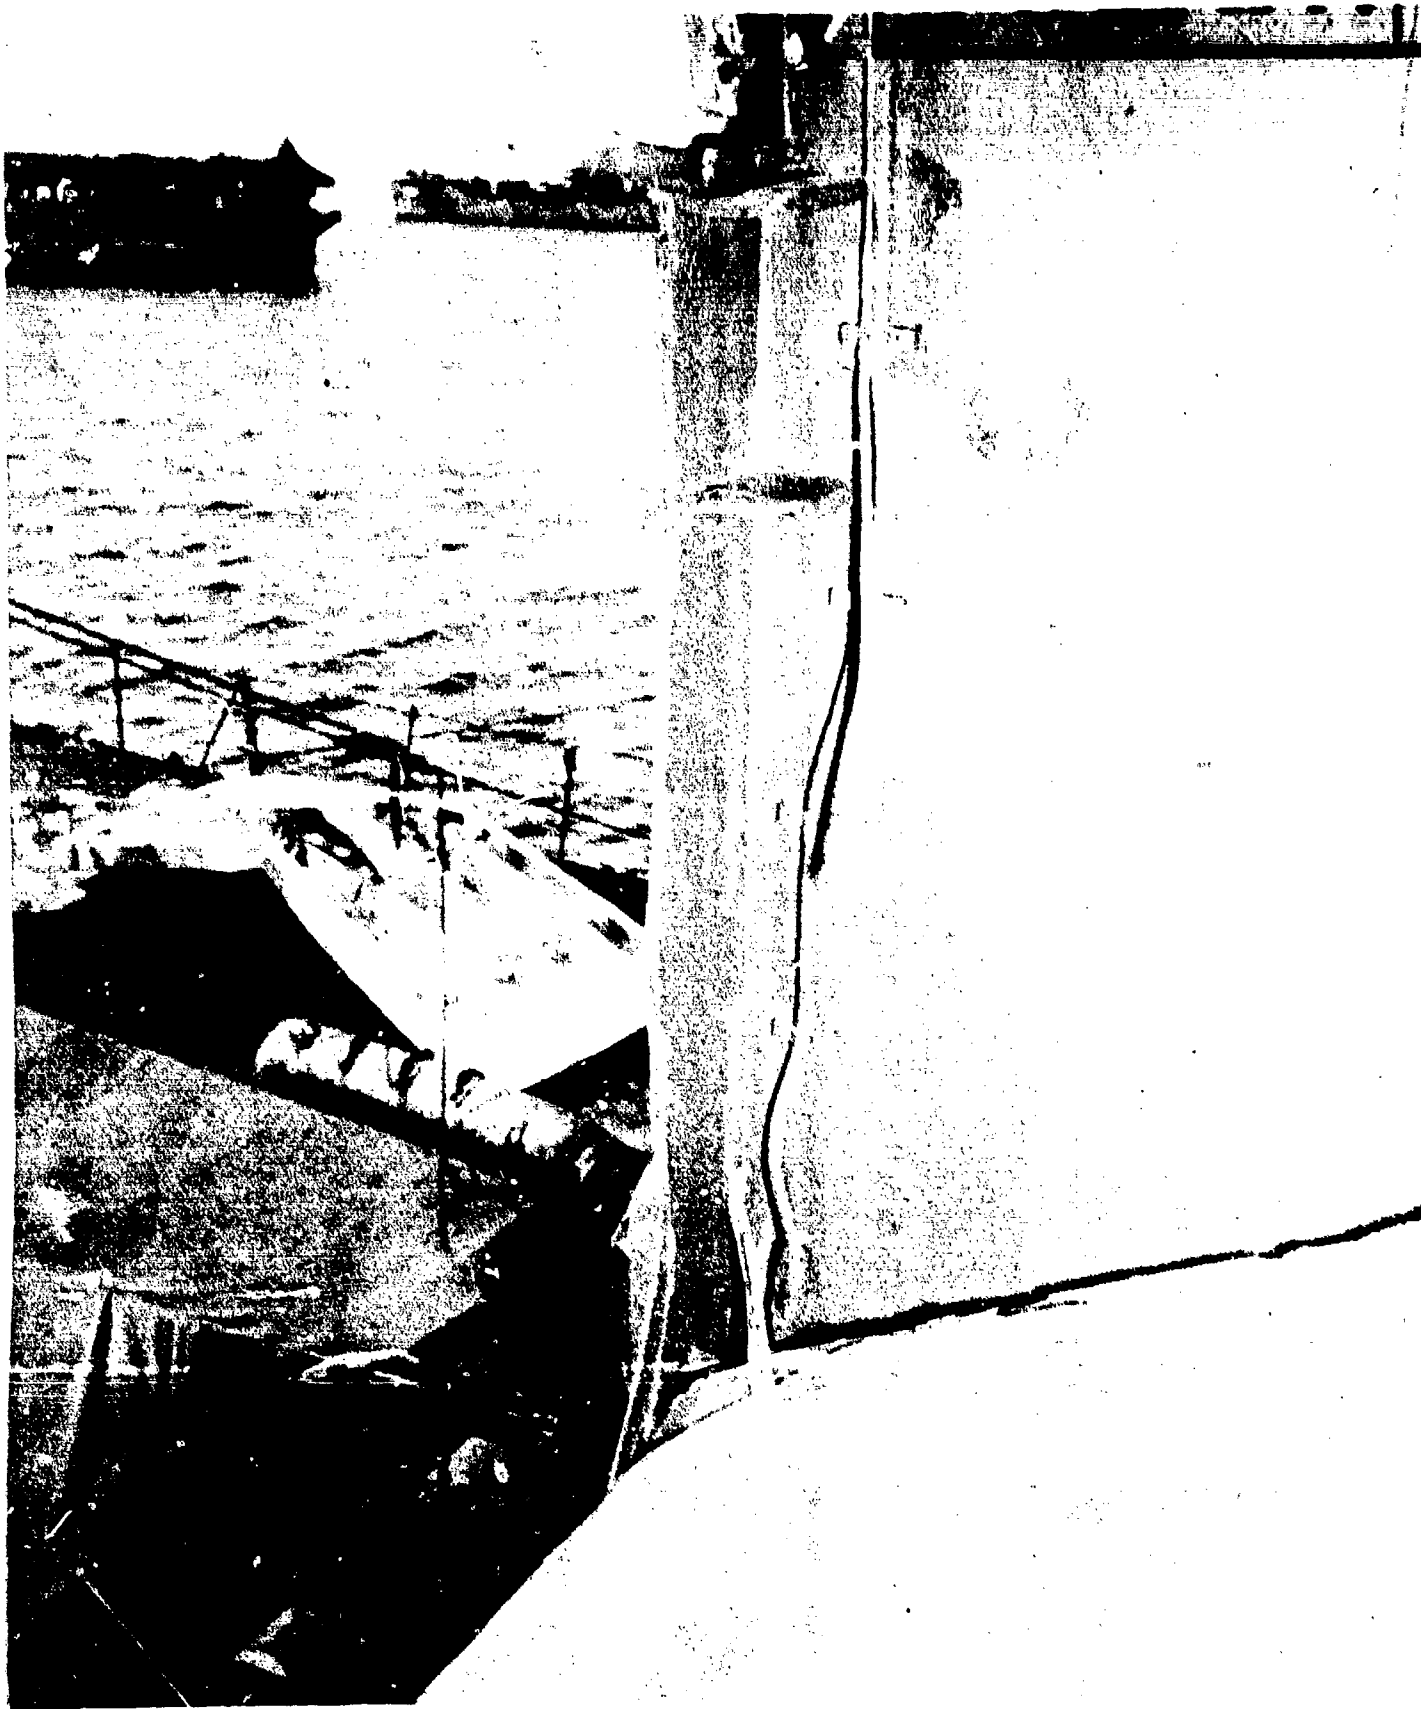
AA-CR-59-2058-6. Looking forward and to starboard from port wing of navigating bridge showing damage to bulwark. Refer to 1960-4.

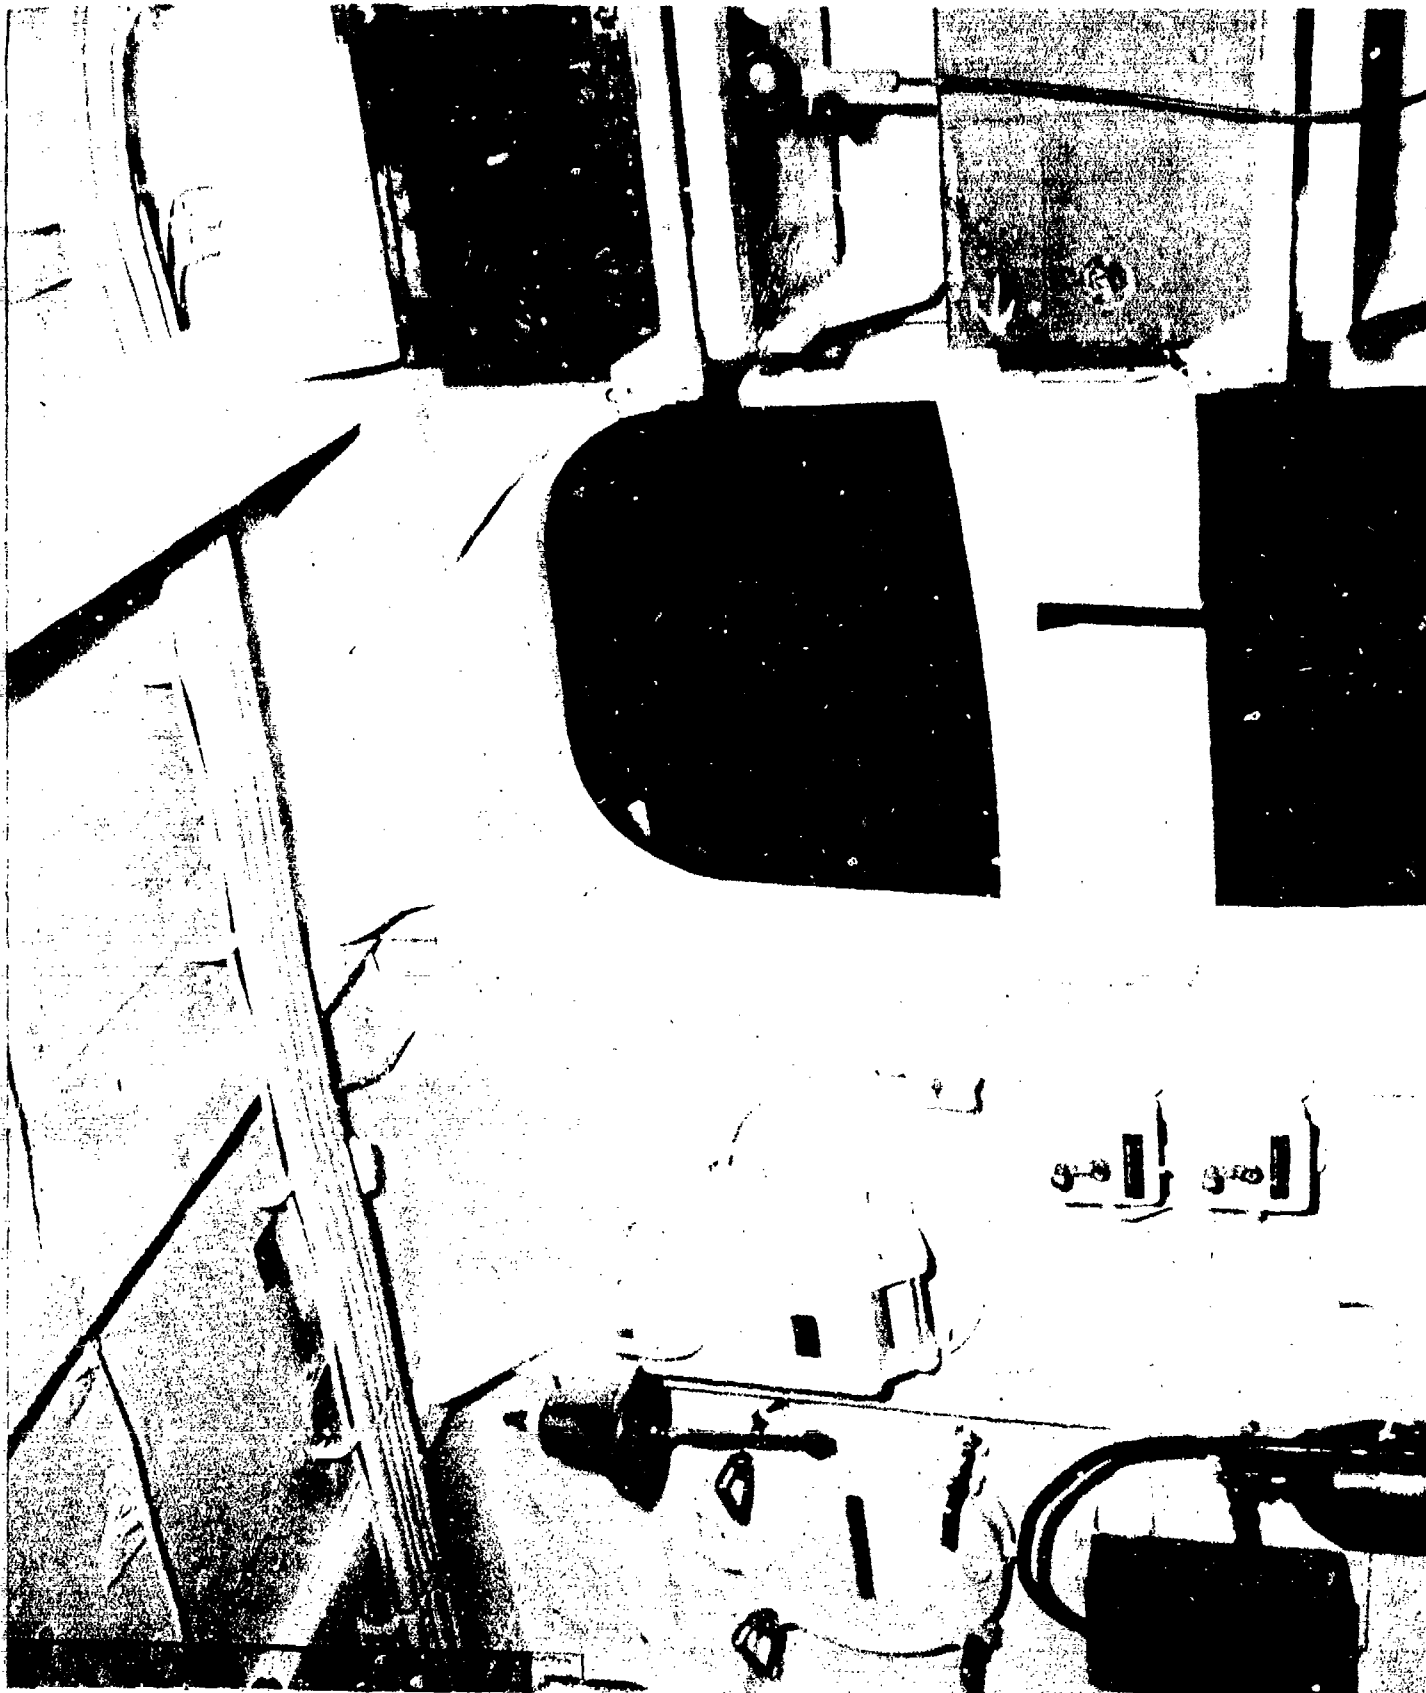
AA-CR-80-1905-10. Looking to port in wheel house showing dishing of port longitudinal bulkhead and door frame but equipment attached to bulkhead has only slight damage.
