TECHNICAL INSPECTION REPORT

OPERATION CROSSROADS.
U.S.S. CRITTENDEN (APA 77)
U.S. NAVY
U.S. BUREAU OF SHIPS
U.S. NAVY REPORT DIRECTLY FROM THE FIELD
TEST ABLE.
U.S. NAVY Support Agency
Washington, D. C. 20301
VOLUME 2 [U].

OPERATION CROSSROADS

BUREAU OF SHIPS GROUP
TECHNICAL INSPECTION REPORT

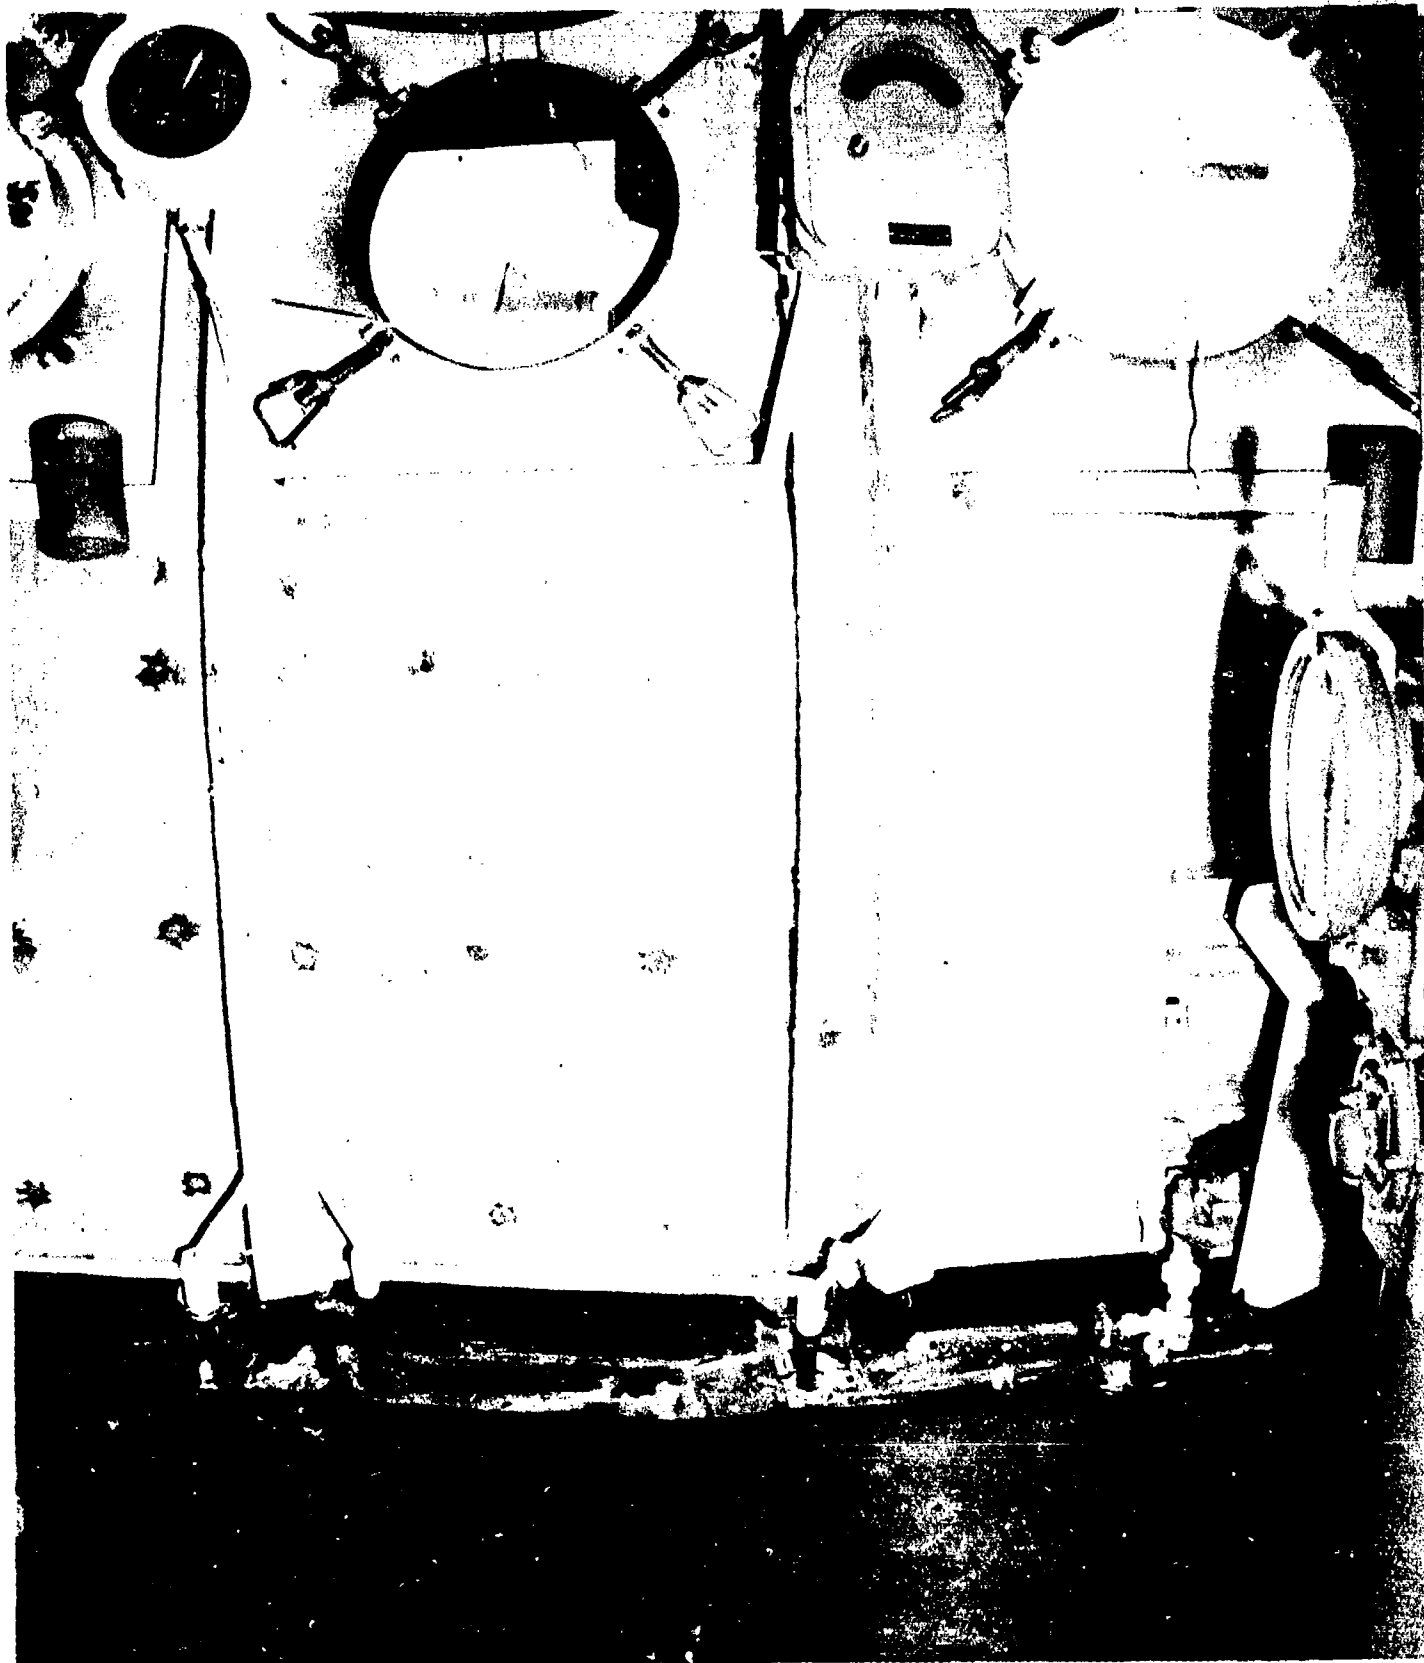
AA-CR-59-2058-4. Looking forward in pilot house showing damage to forward bulkhead and only slight damage to instruments.

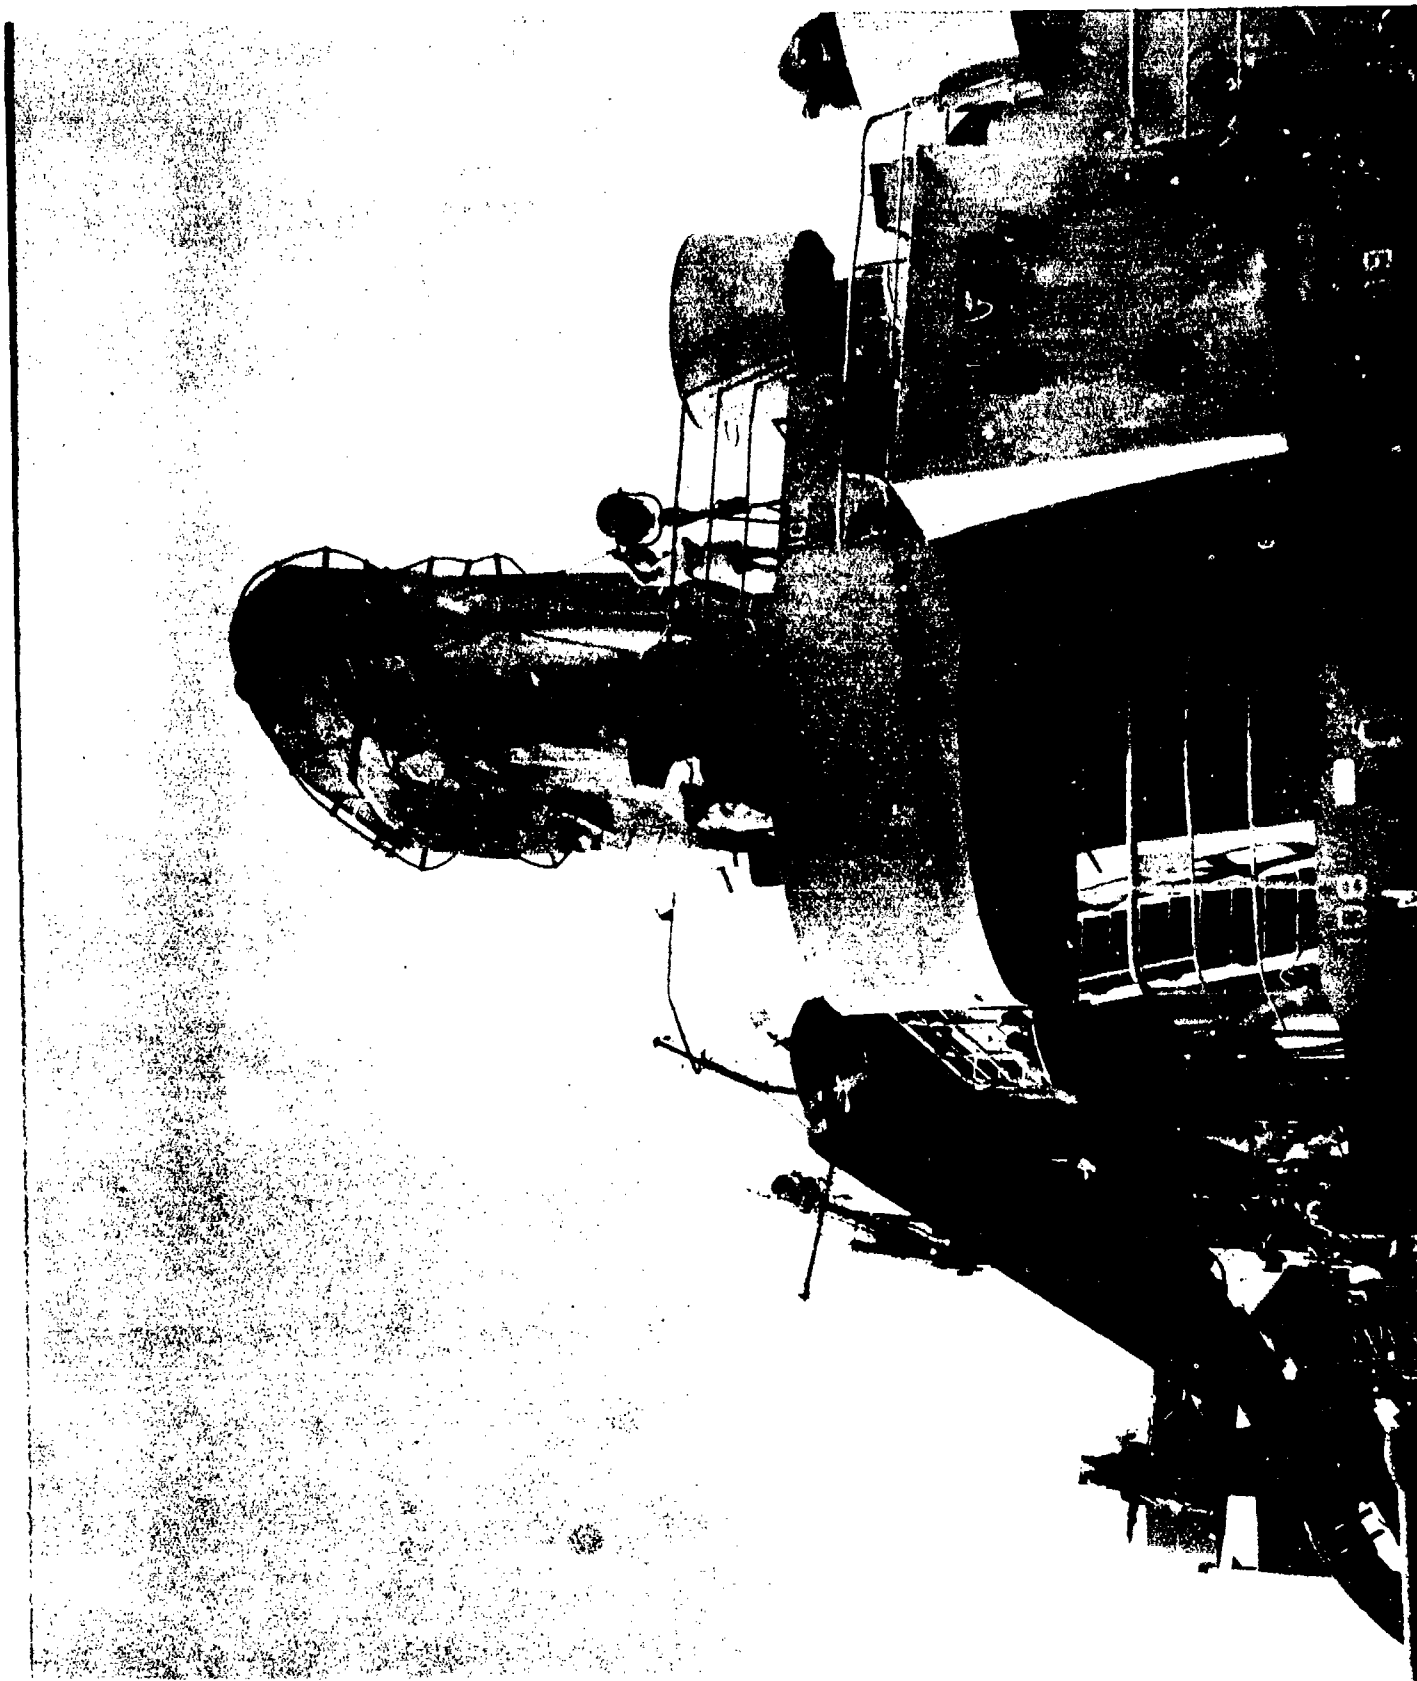
AA-CR-80-1906-11. Looking forward and to starboard from upper deck showing damage to port davits, moving picture projection house, and after stack.

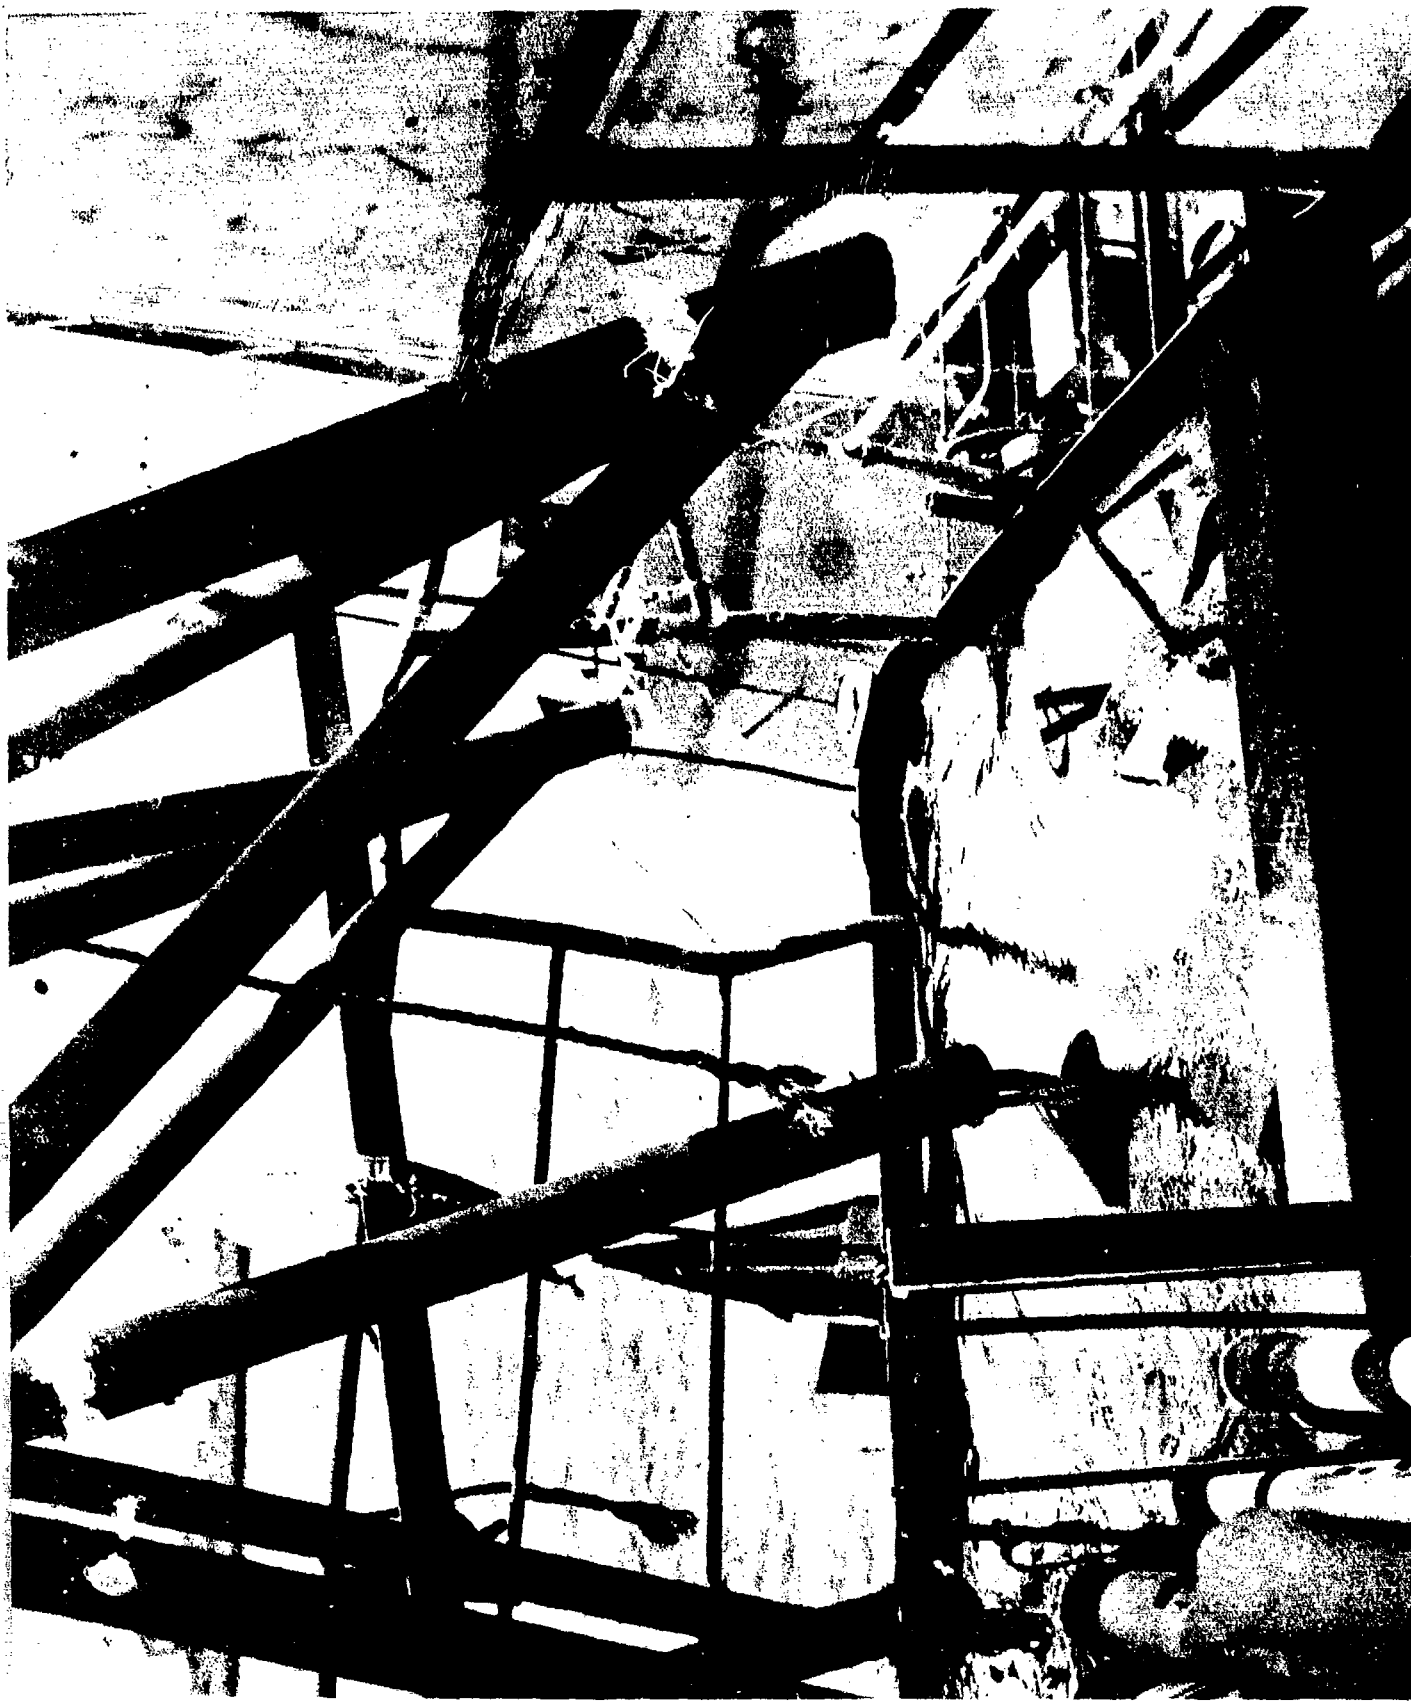
AA-CR-80-1907-1. Looking to port on top of after deck house showing damage to port director foundation.

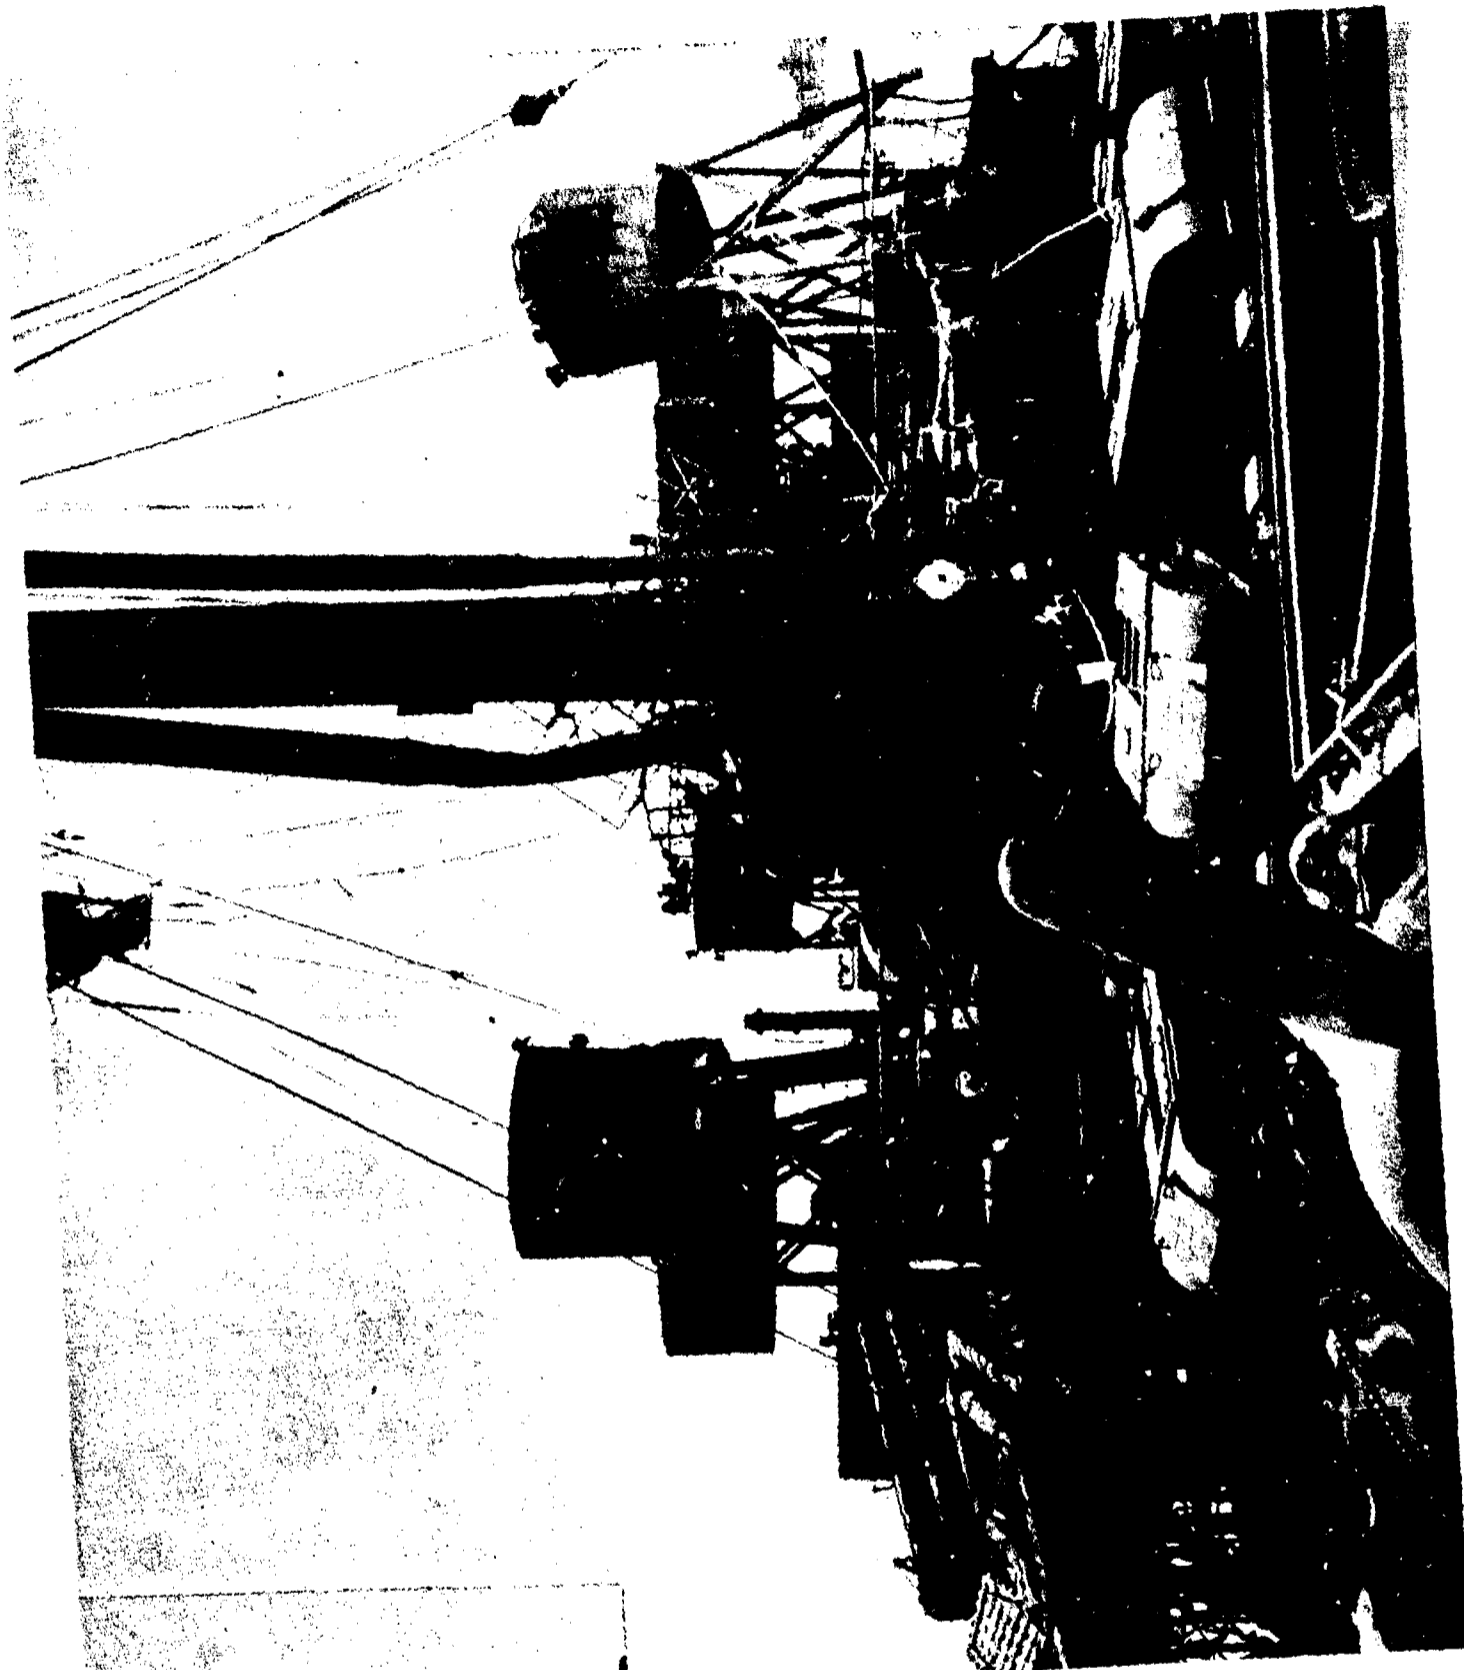
1051
AA-CR-98-1961-10. View looking aft and to port showing bent boom on mainmast and damage on top of after deck house.

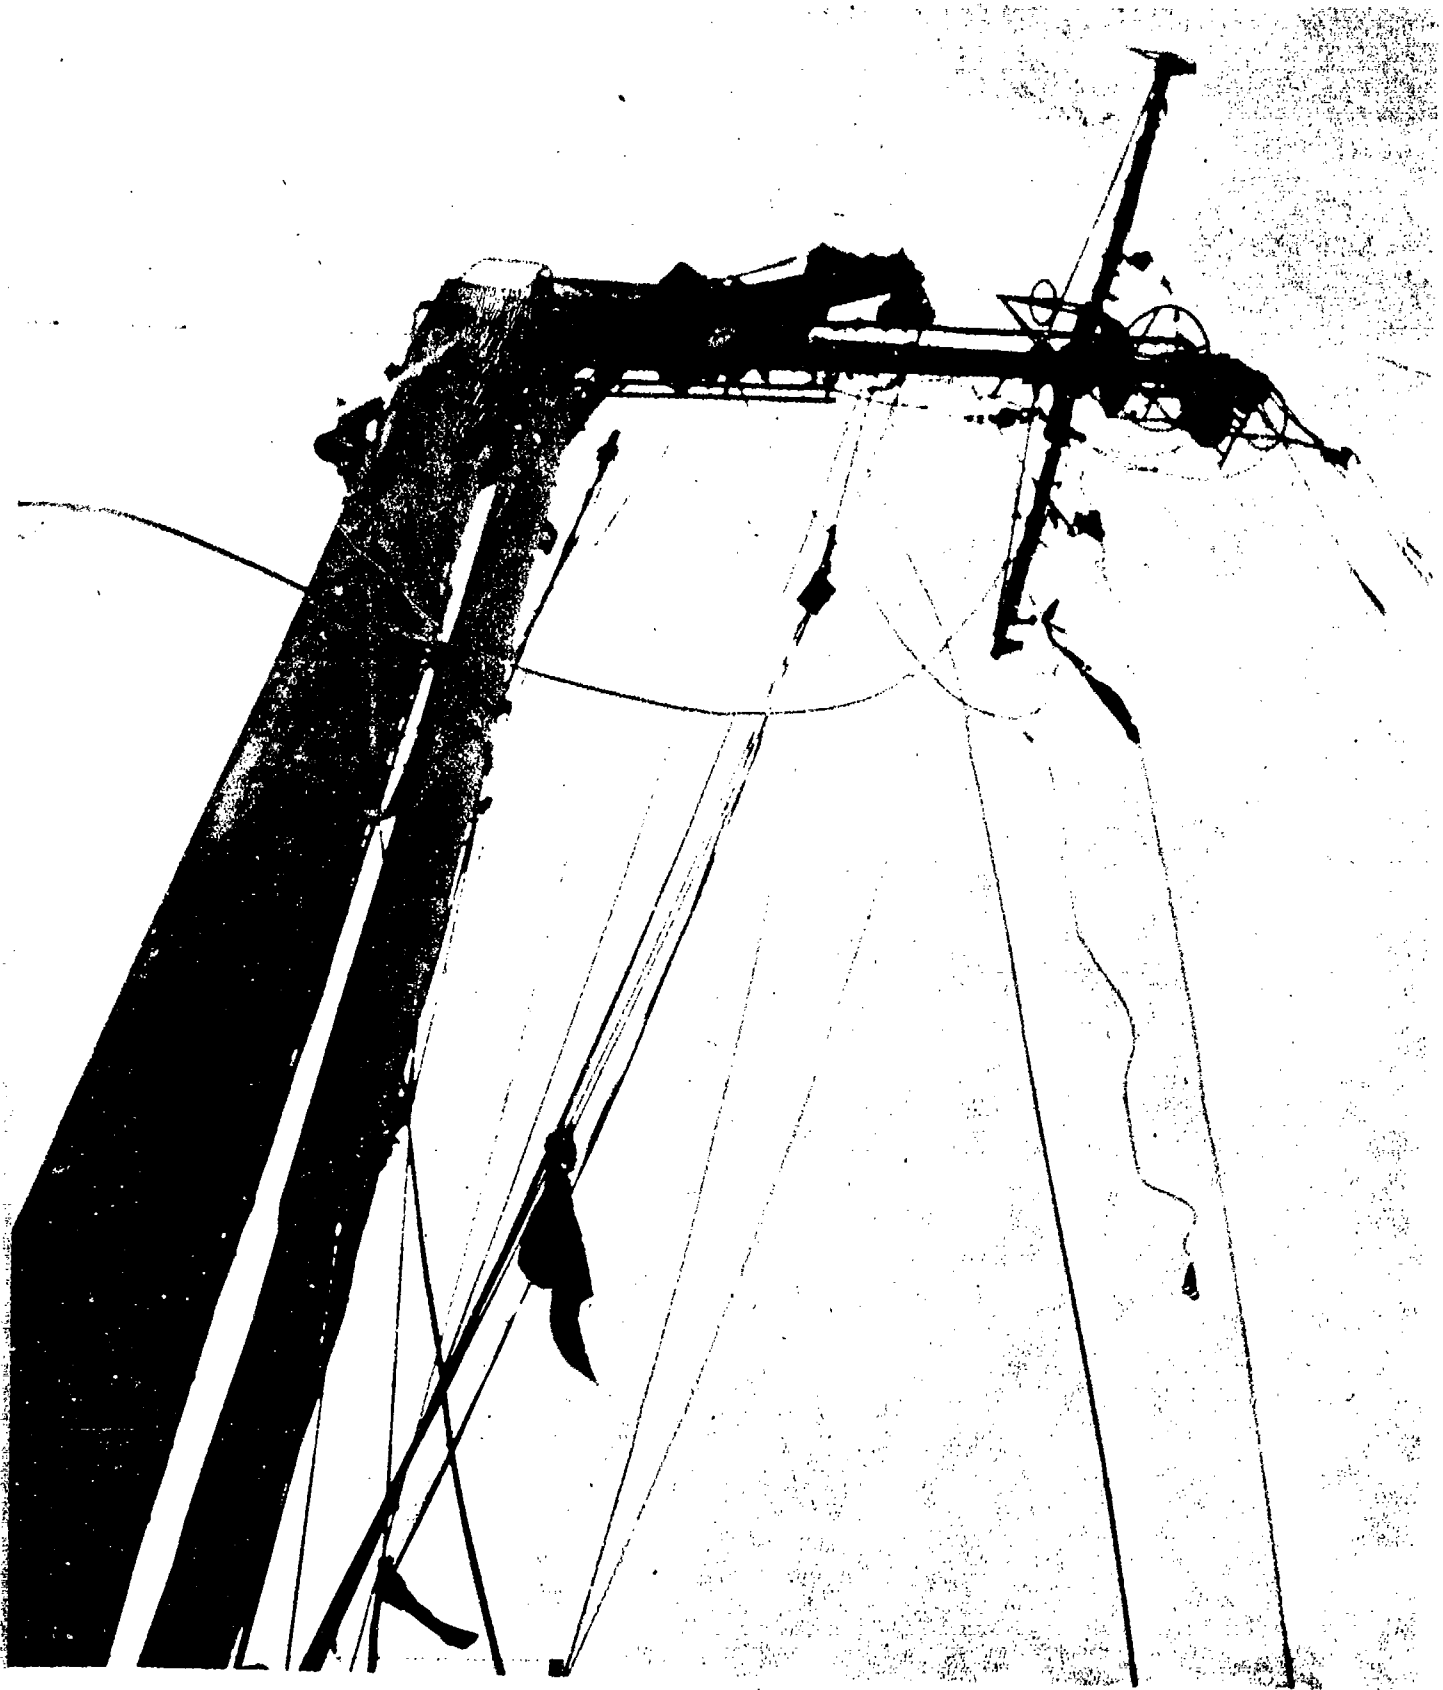
AA-CR-82-1921-10. Looking up and to starboard showing damage at top of foremast and to cargo booms.

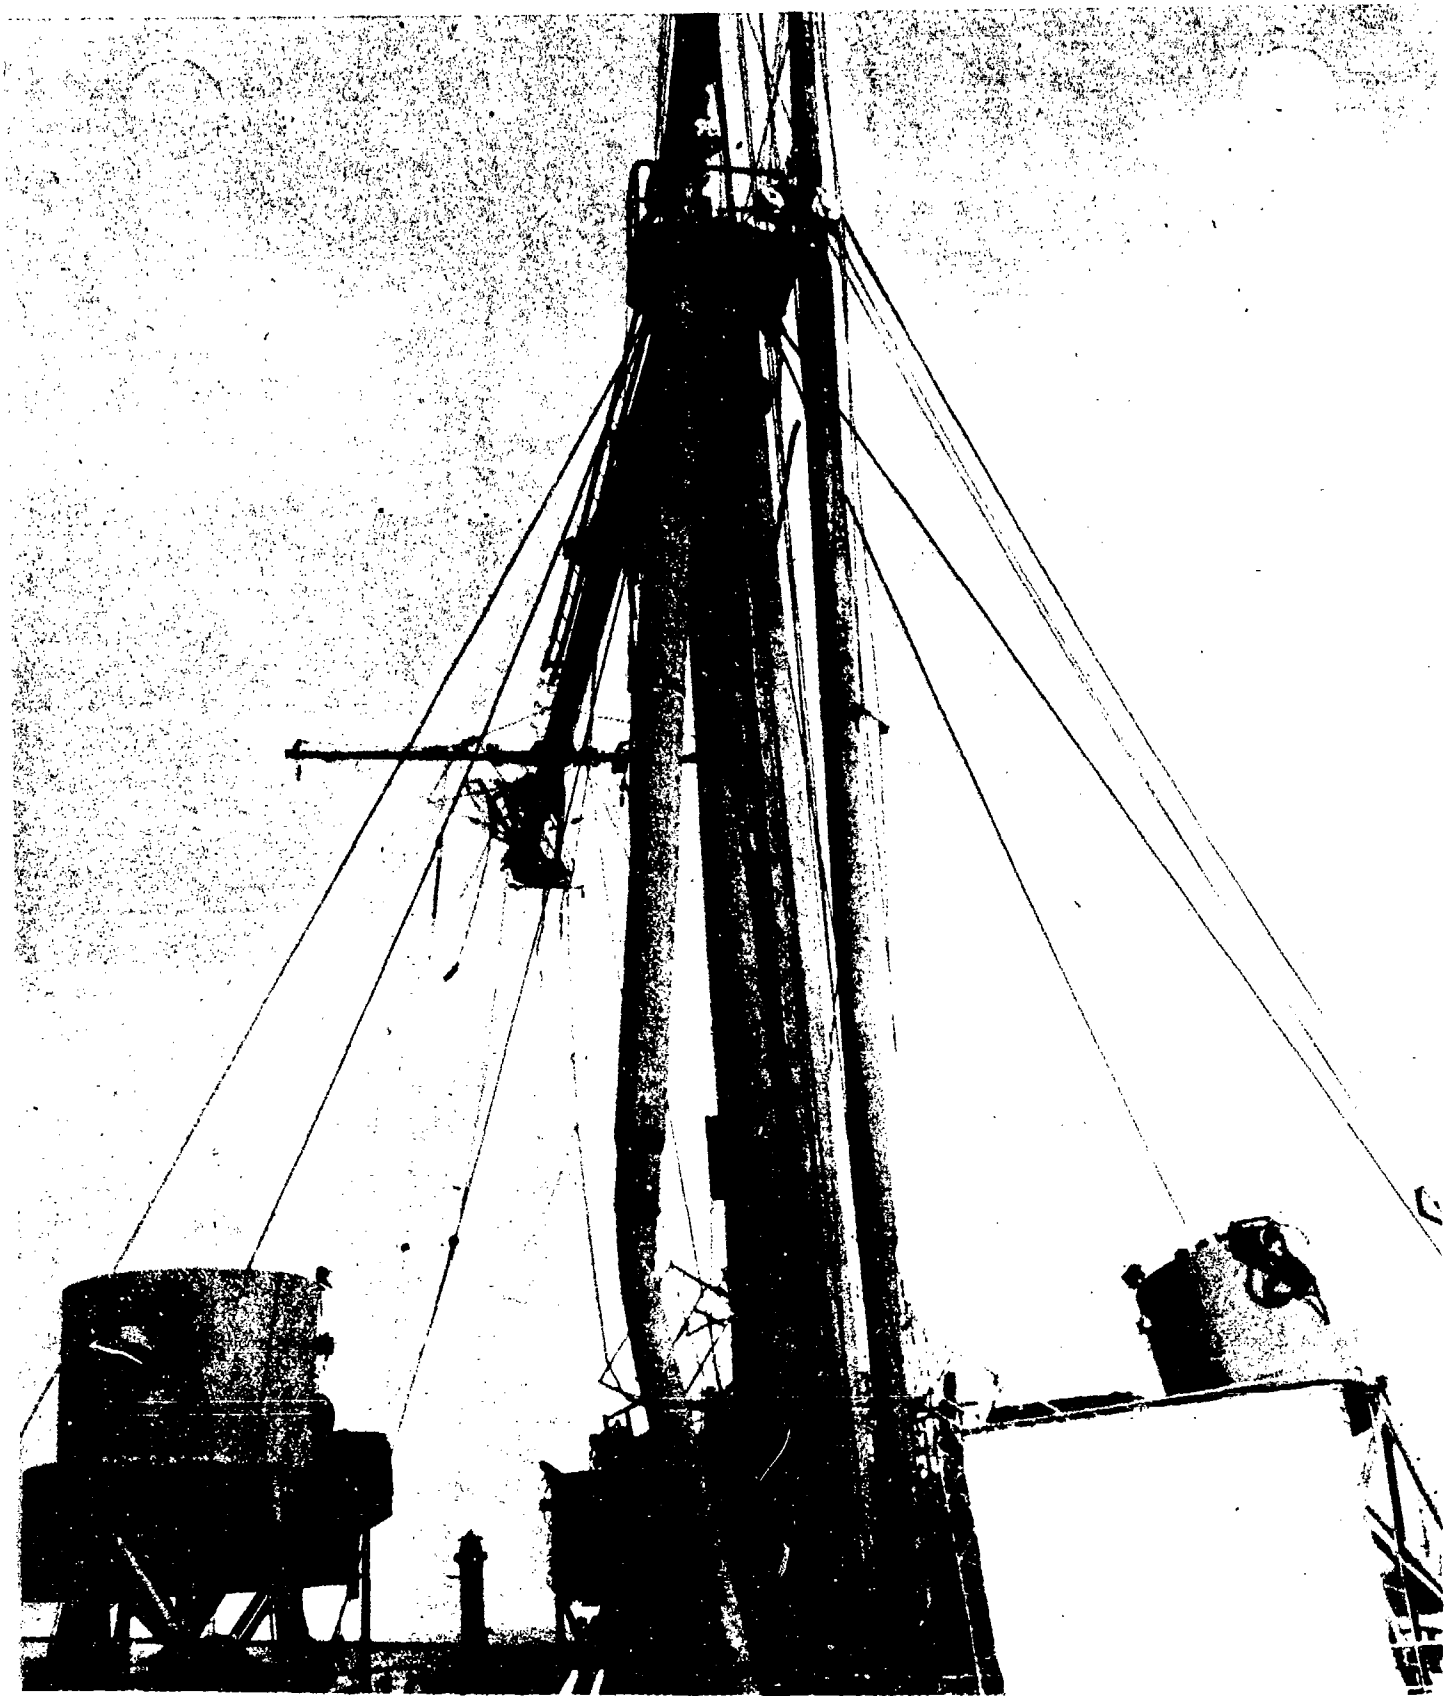
AA-CR-80-1905-11. Looking aft on upper deck showing damage on mainmast and top of after deck house.

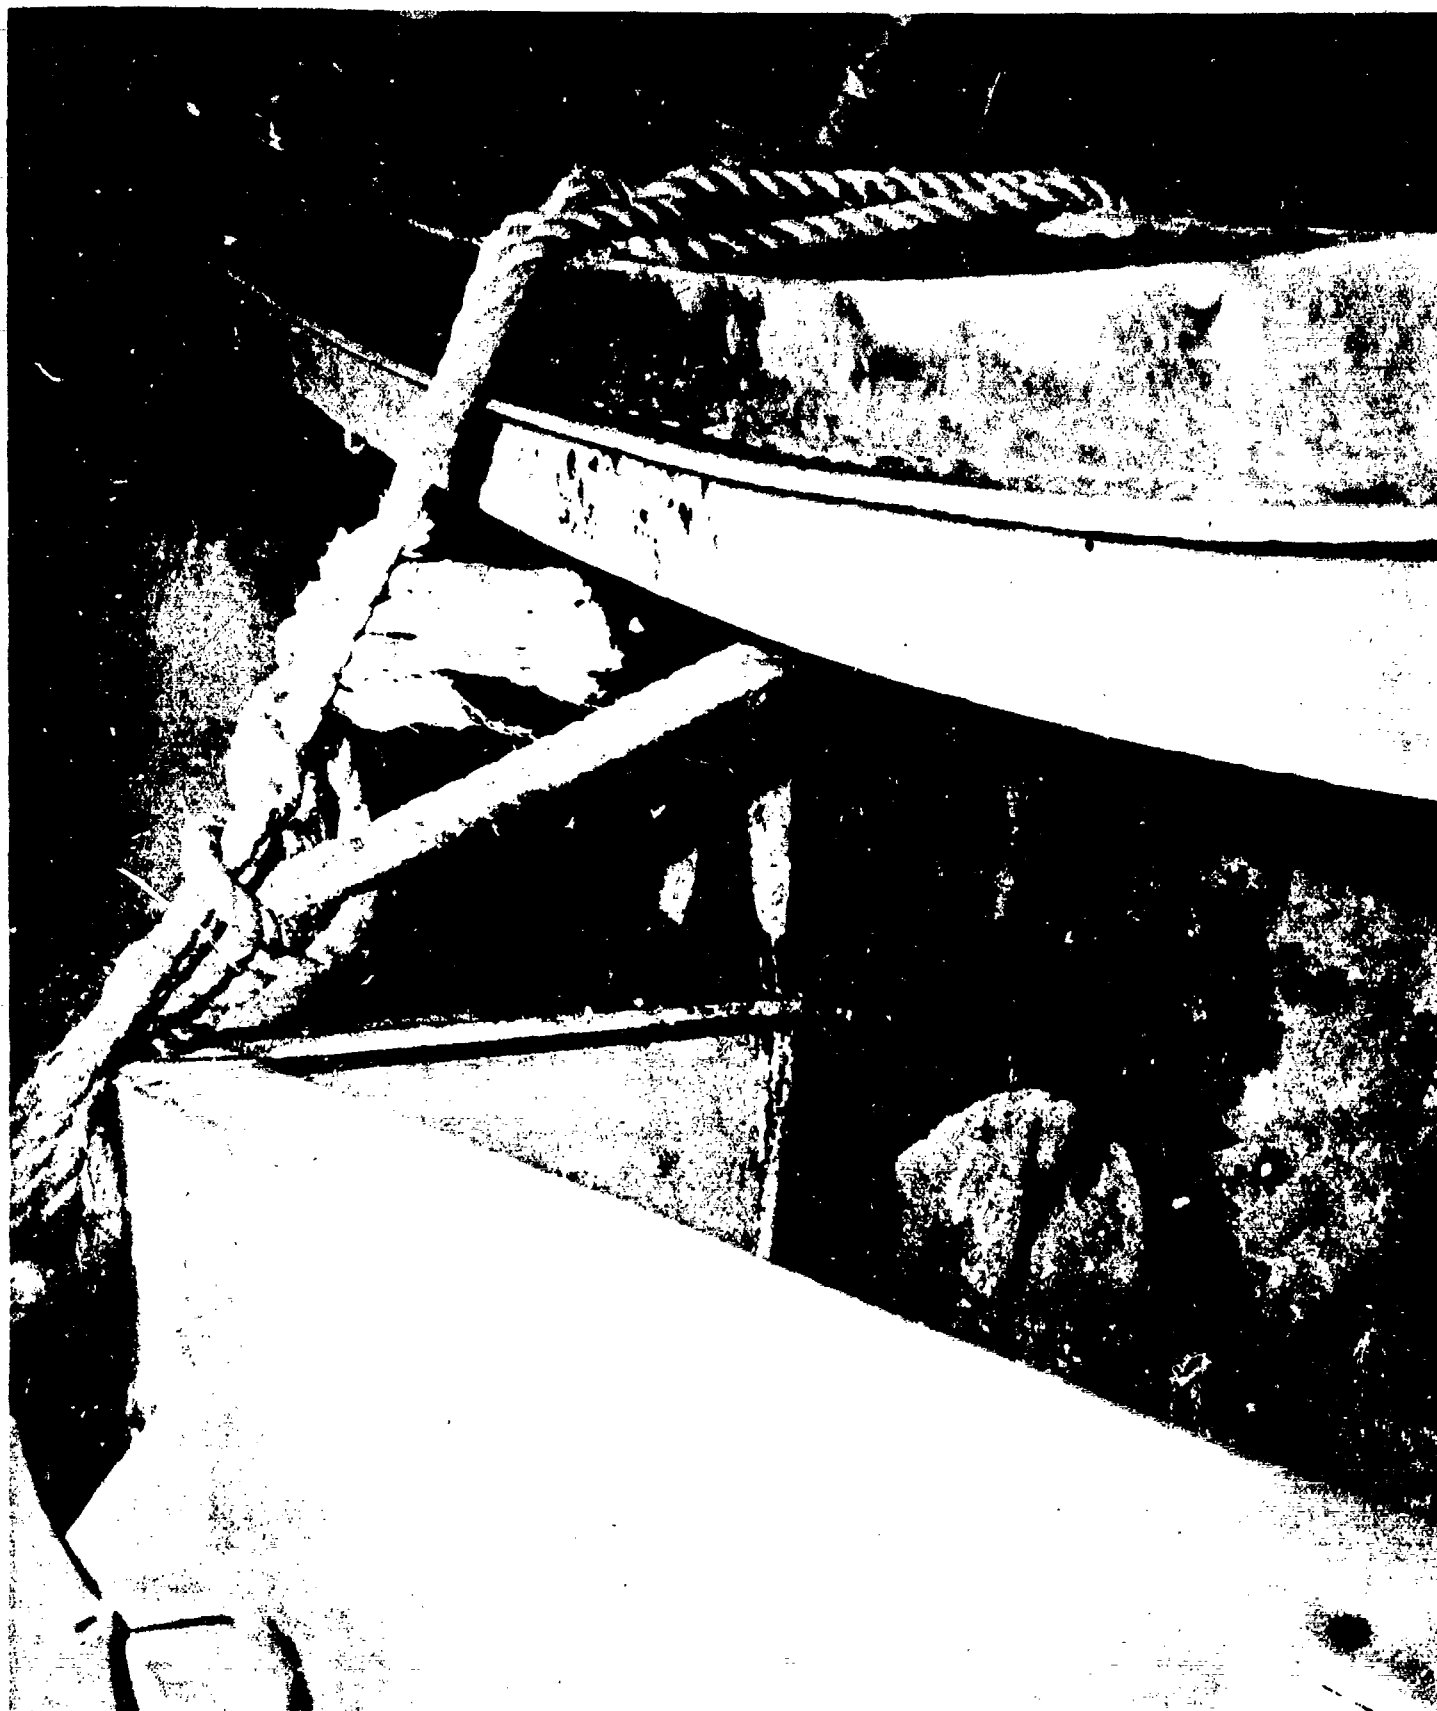
AA-CR-59-2112-12. Looking aft on upper deck showing weld failure at toe of bracket at port after corner of forward cargo hatch. (Note distorted strong-back.)

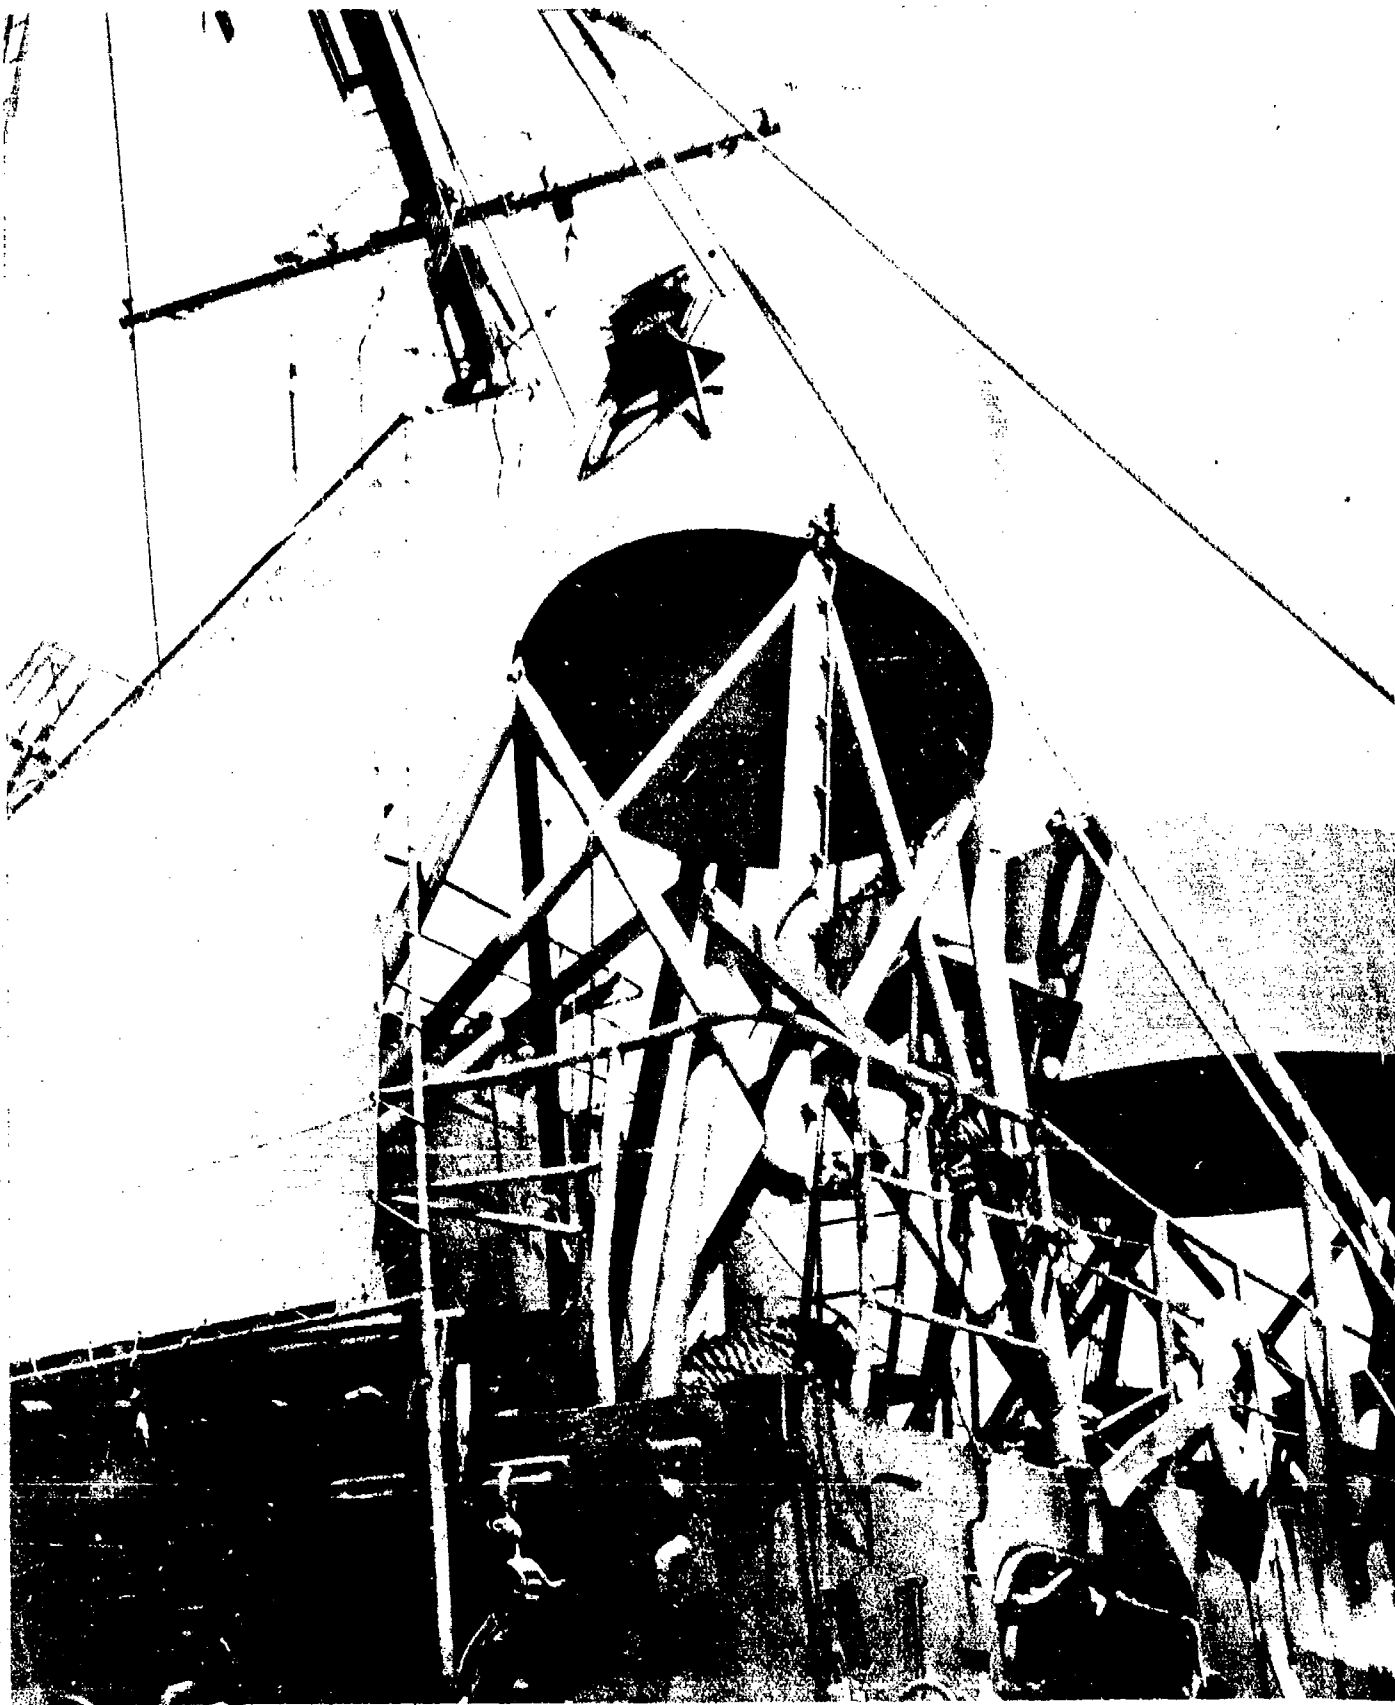
AA-CR-80-1906-10. Looking aft and to starboard from upper deck, port, showing damage to director foundations and doors missing to carpenter shop, dishing of deck house bulkheads.

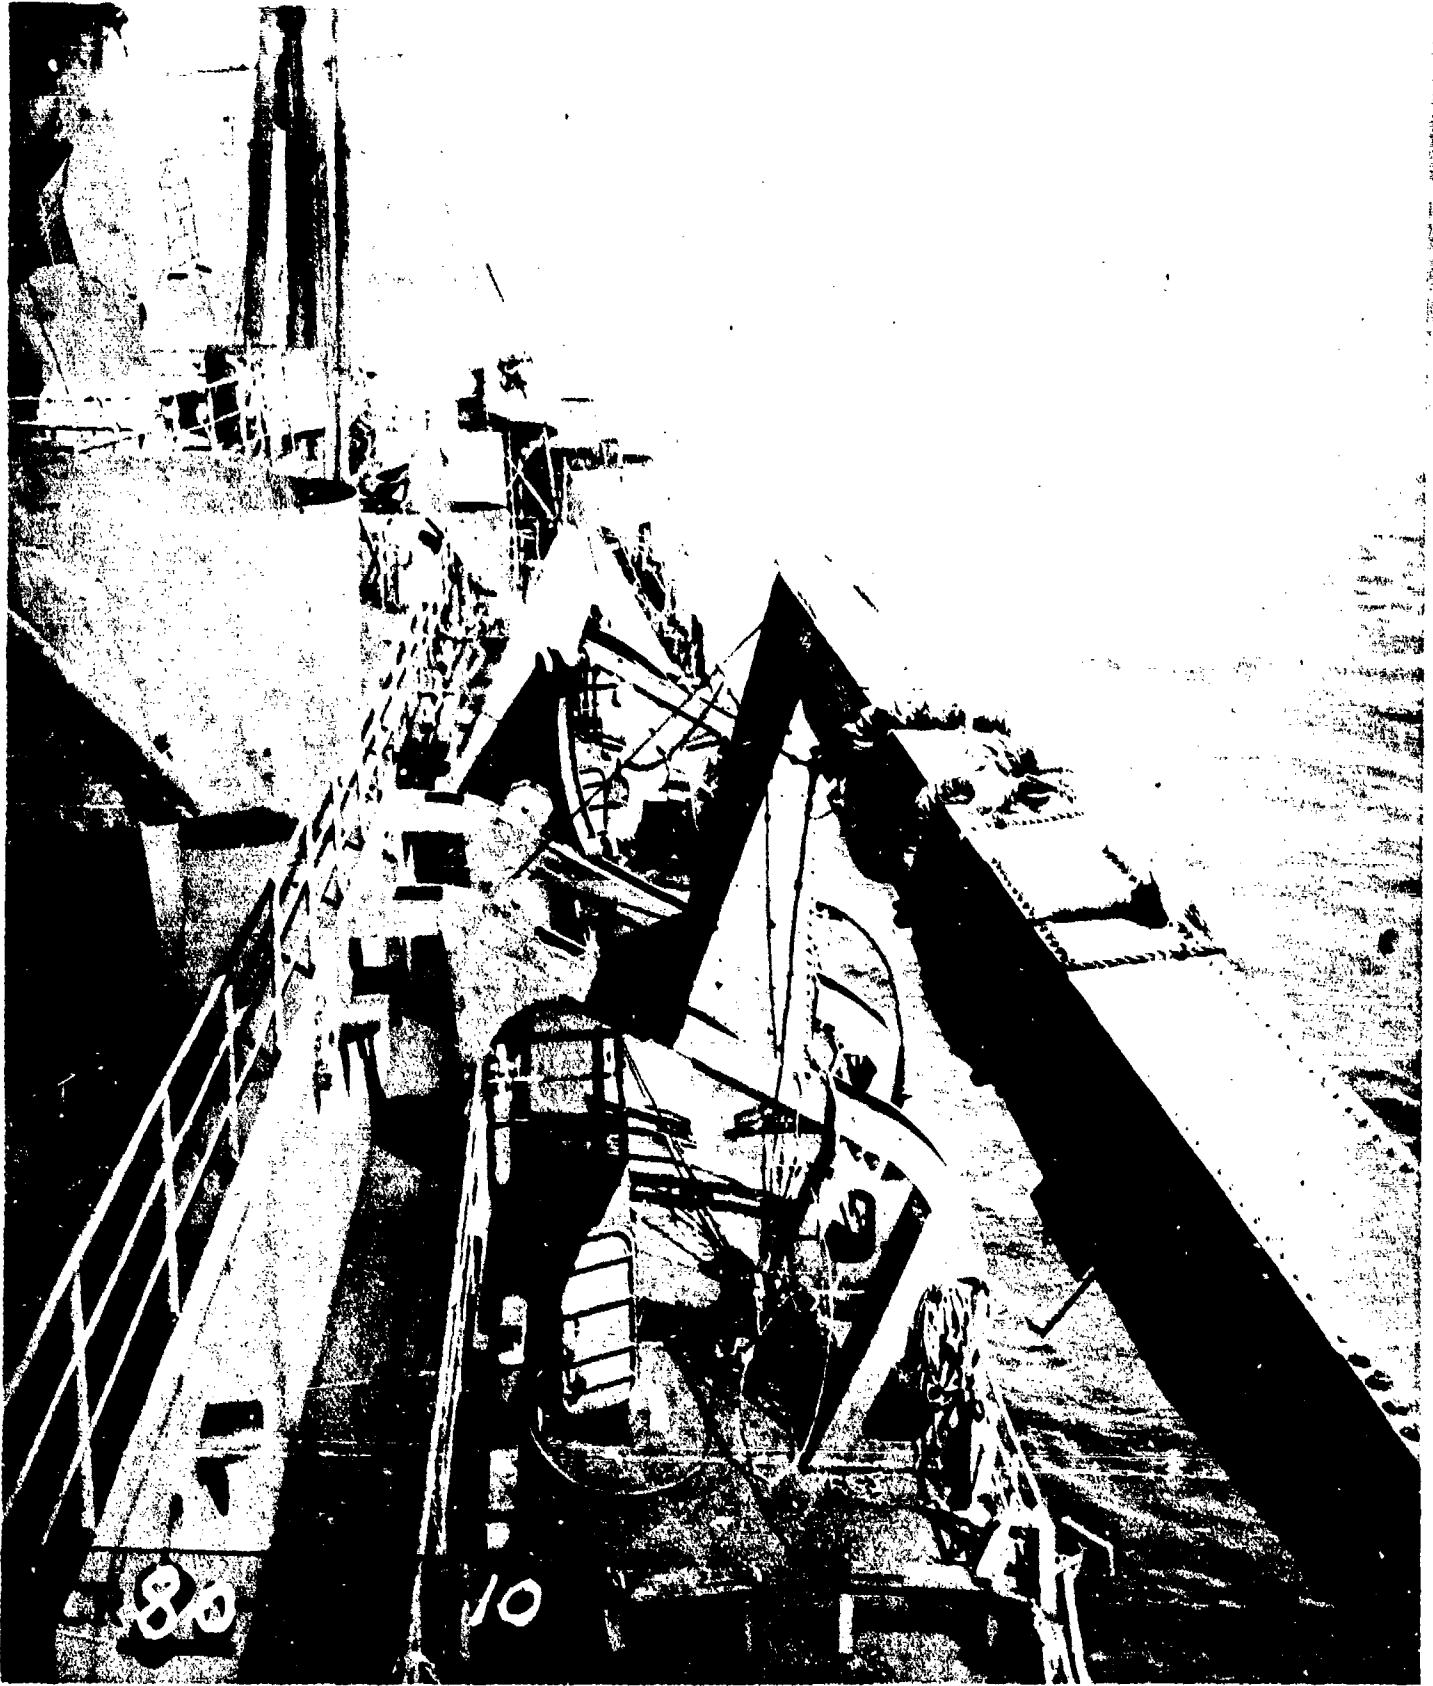
AA-CR-80-1904-10. Looking aft along port side of deck house showing damage to port davits.
