TECHNICAL INSPECTION REPORT

OPERATION CROSSROADS.
U.S.S. CRITTENDEN (APA 77)
U.S. NAVY
U.S. BUREAU OF SHIPS
U.S. NAVY REPORT DIRECTLY FROM THE FIELD
TEST ABLE.
U.S. NAVY Support Agency
Washington, D. C. 20301
VOLUME 2 [U].

OPERATION CROSSROADS

BUREAU OF SHIPS GROUP
TECHNICAL INSPECTION REPORT

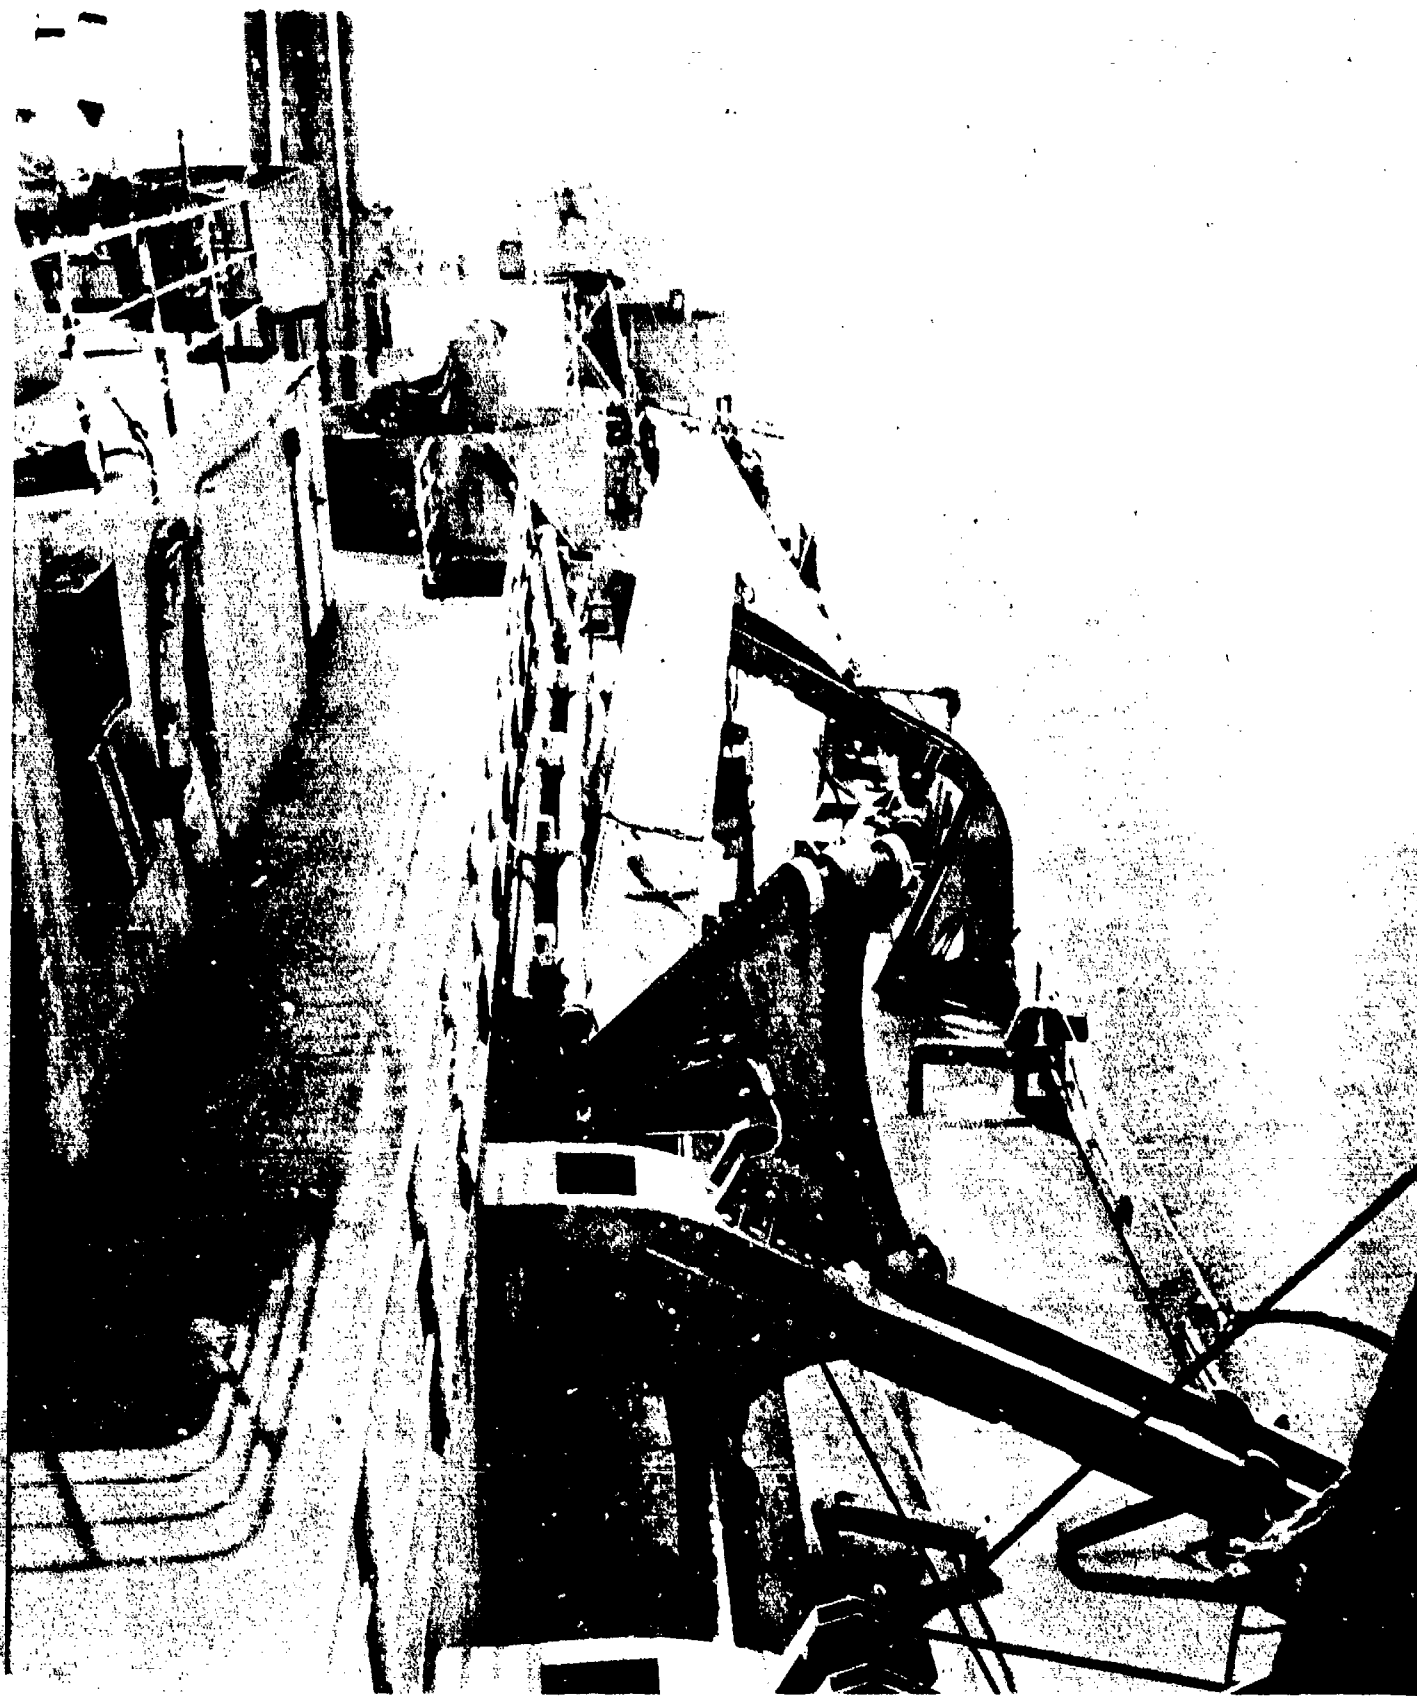
AA-CR-82-1922-3. Looking aft along port side of deck house showing damage to davit at frame 89 and sky lookout tub at frame 100.

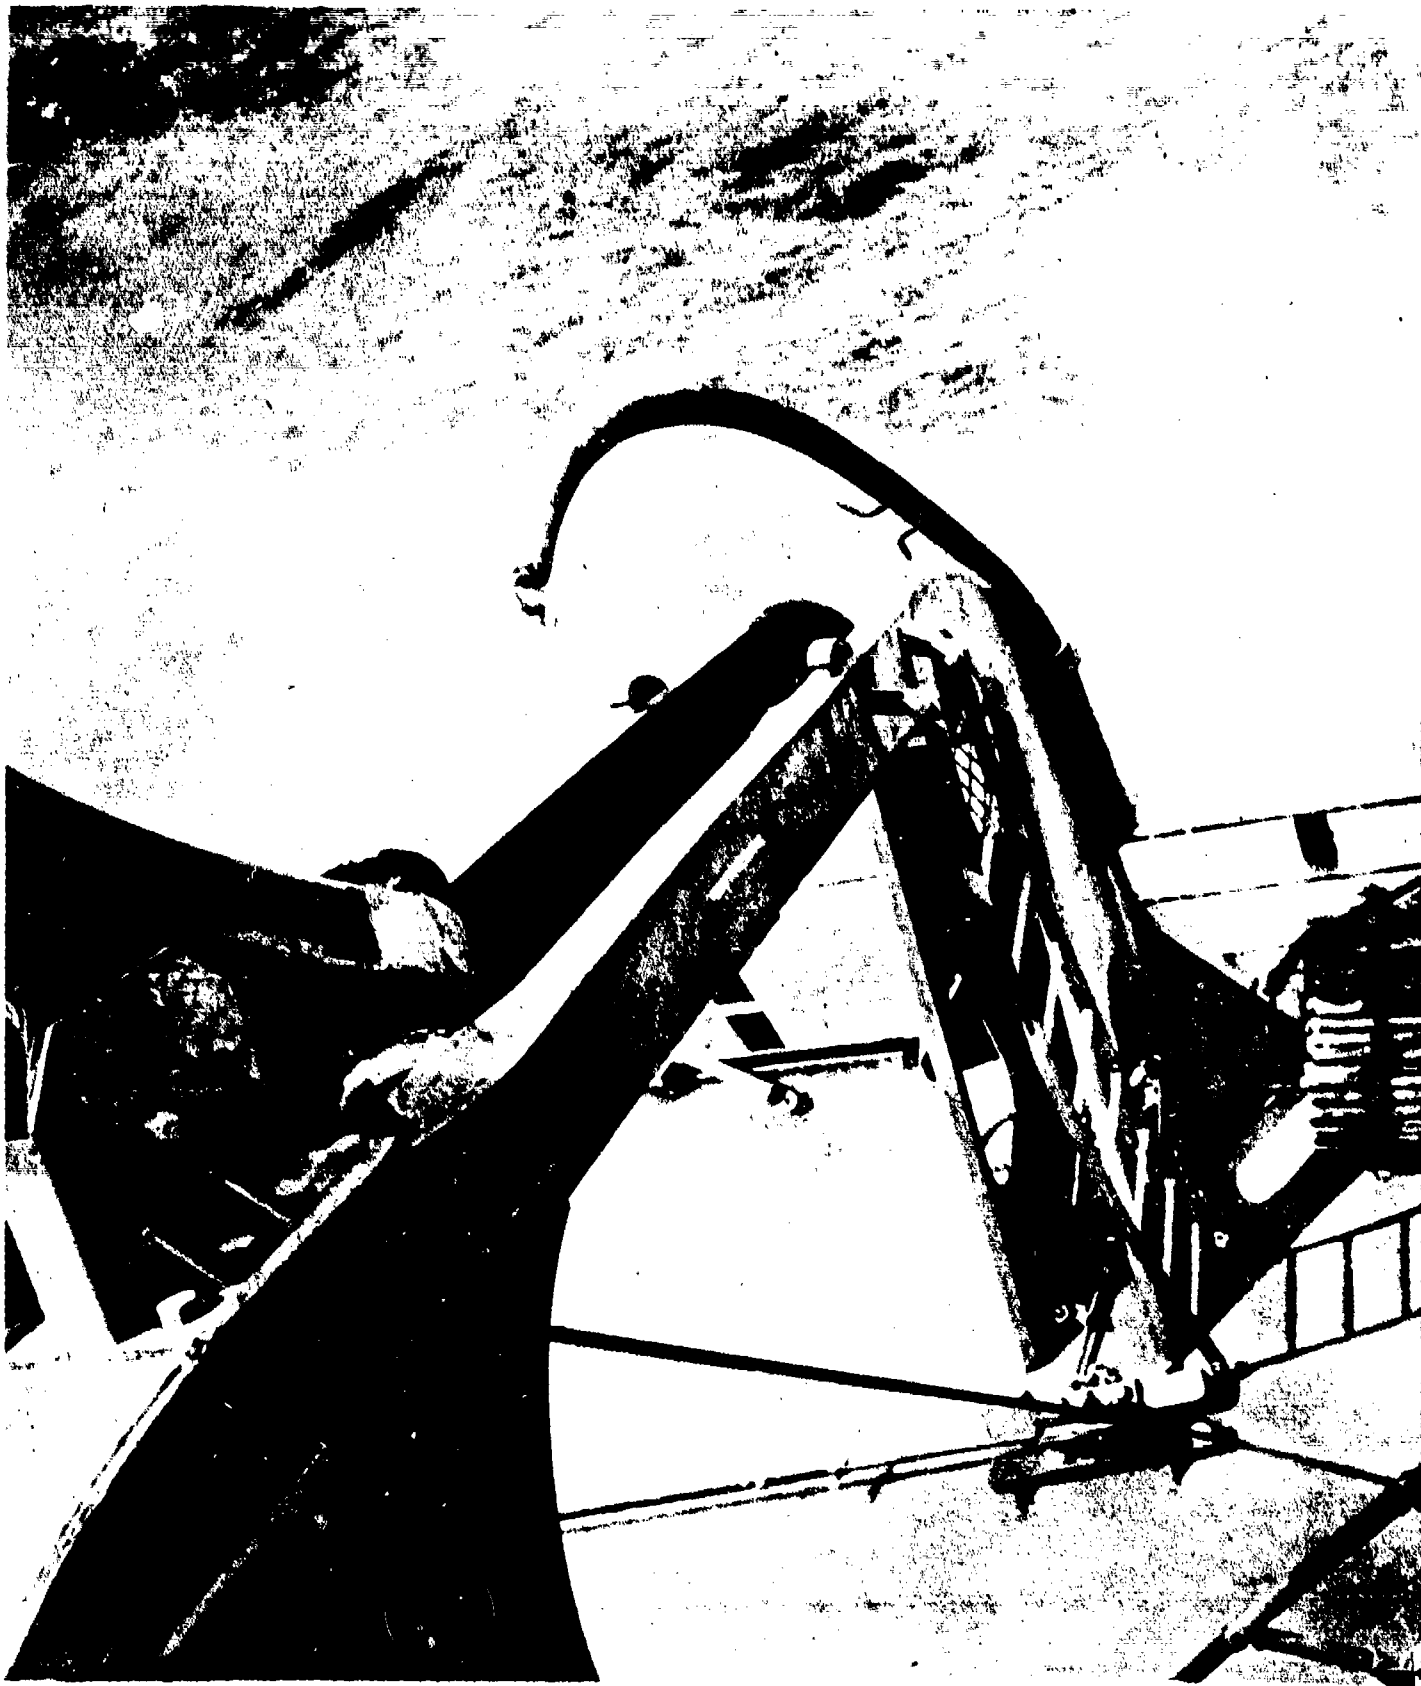
AA-CR-82-1922-4. Looking to port in way of damage to davit at frame 89 port.

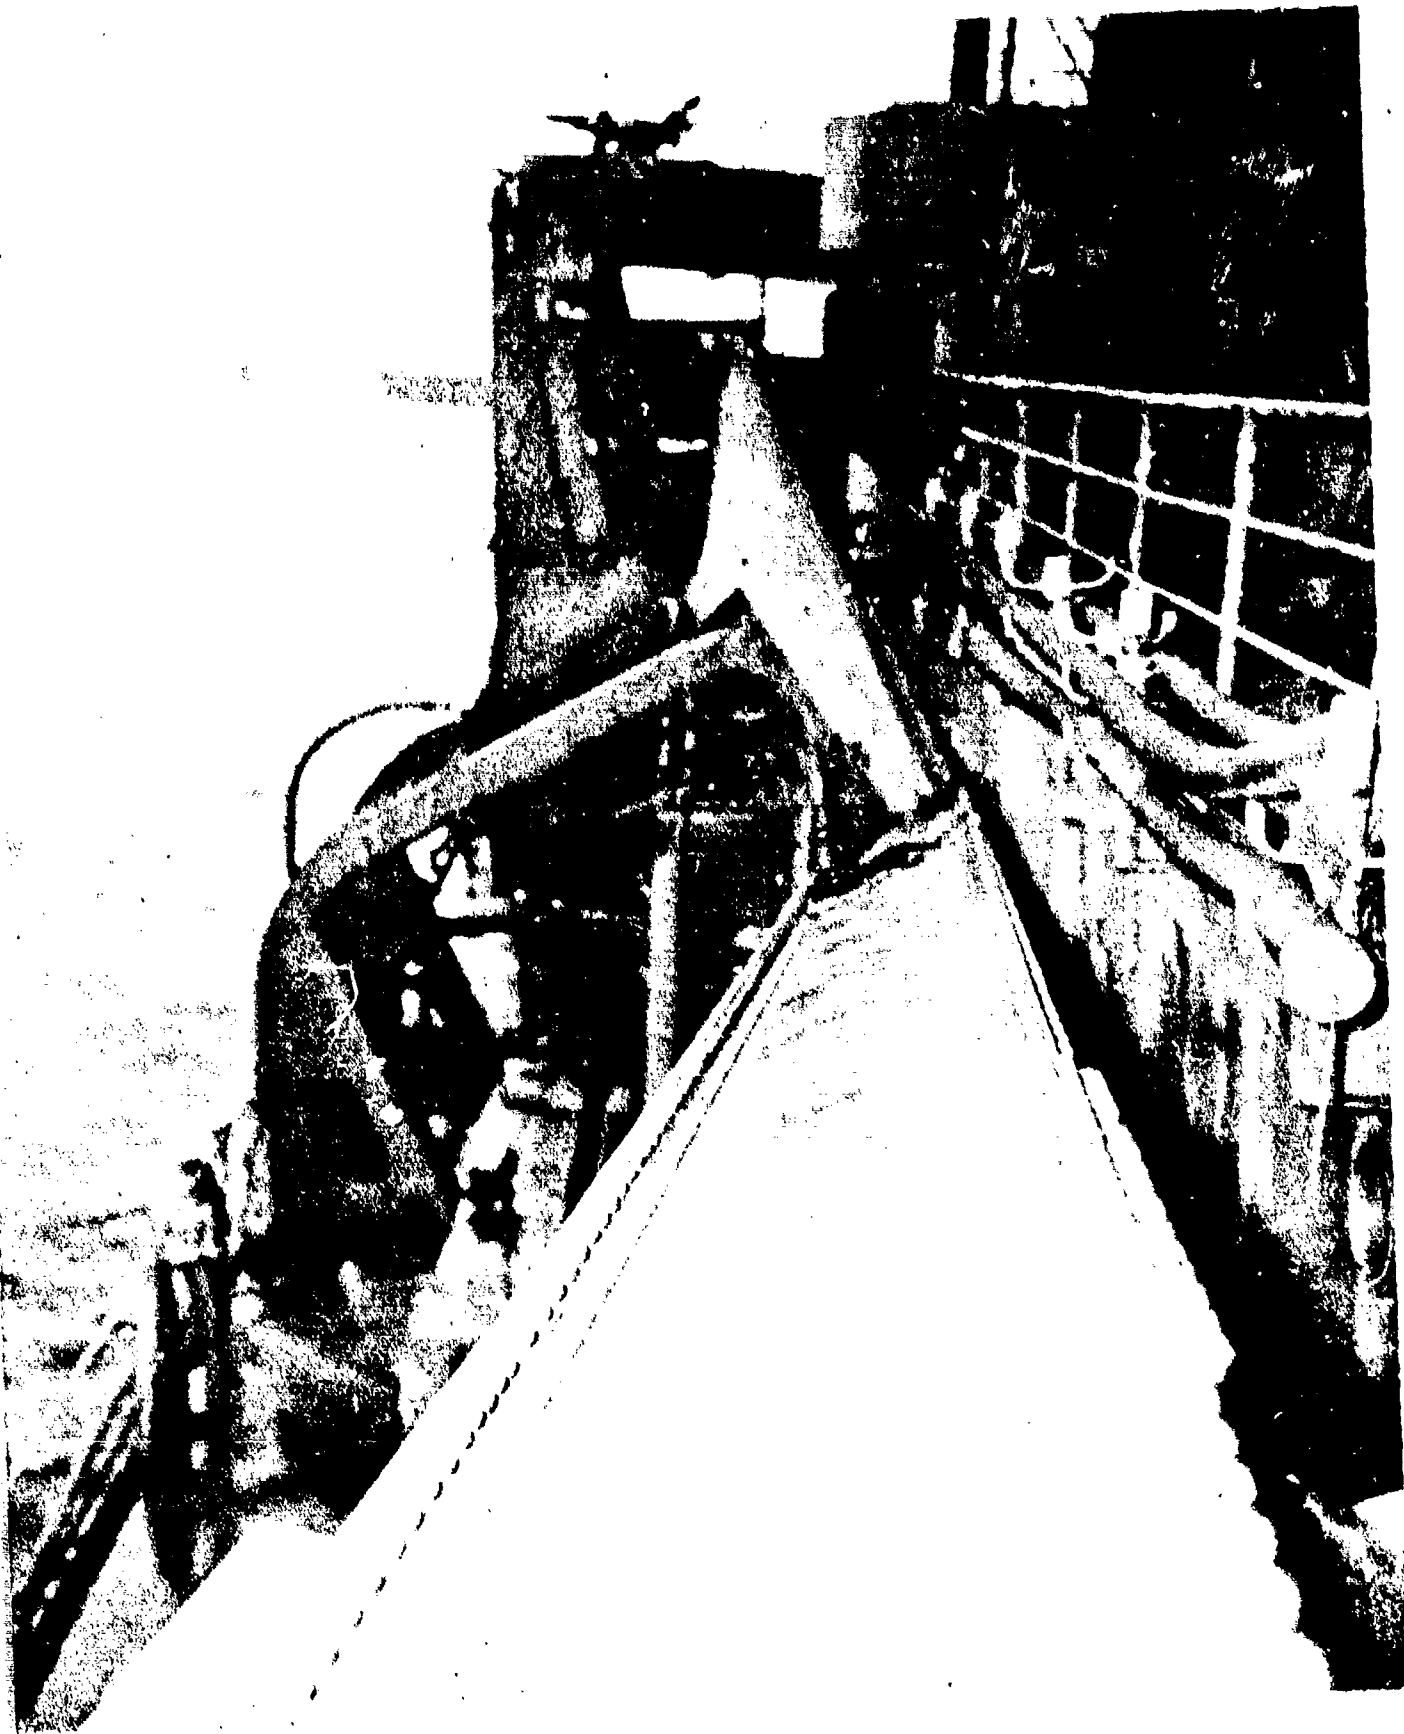
AA-CR-62-1882-6. Looking forward along port side of deck house showing damage to number 4 davit.

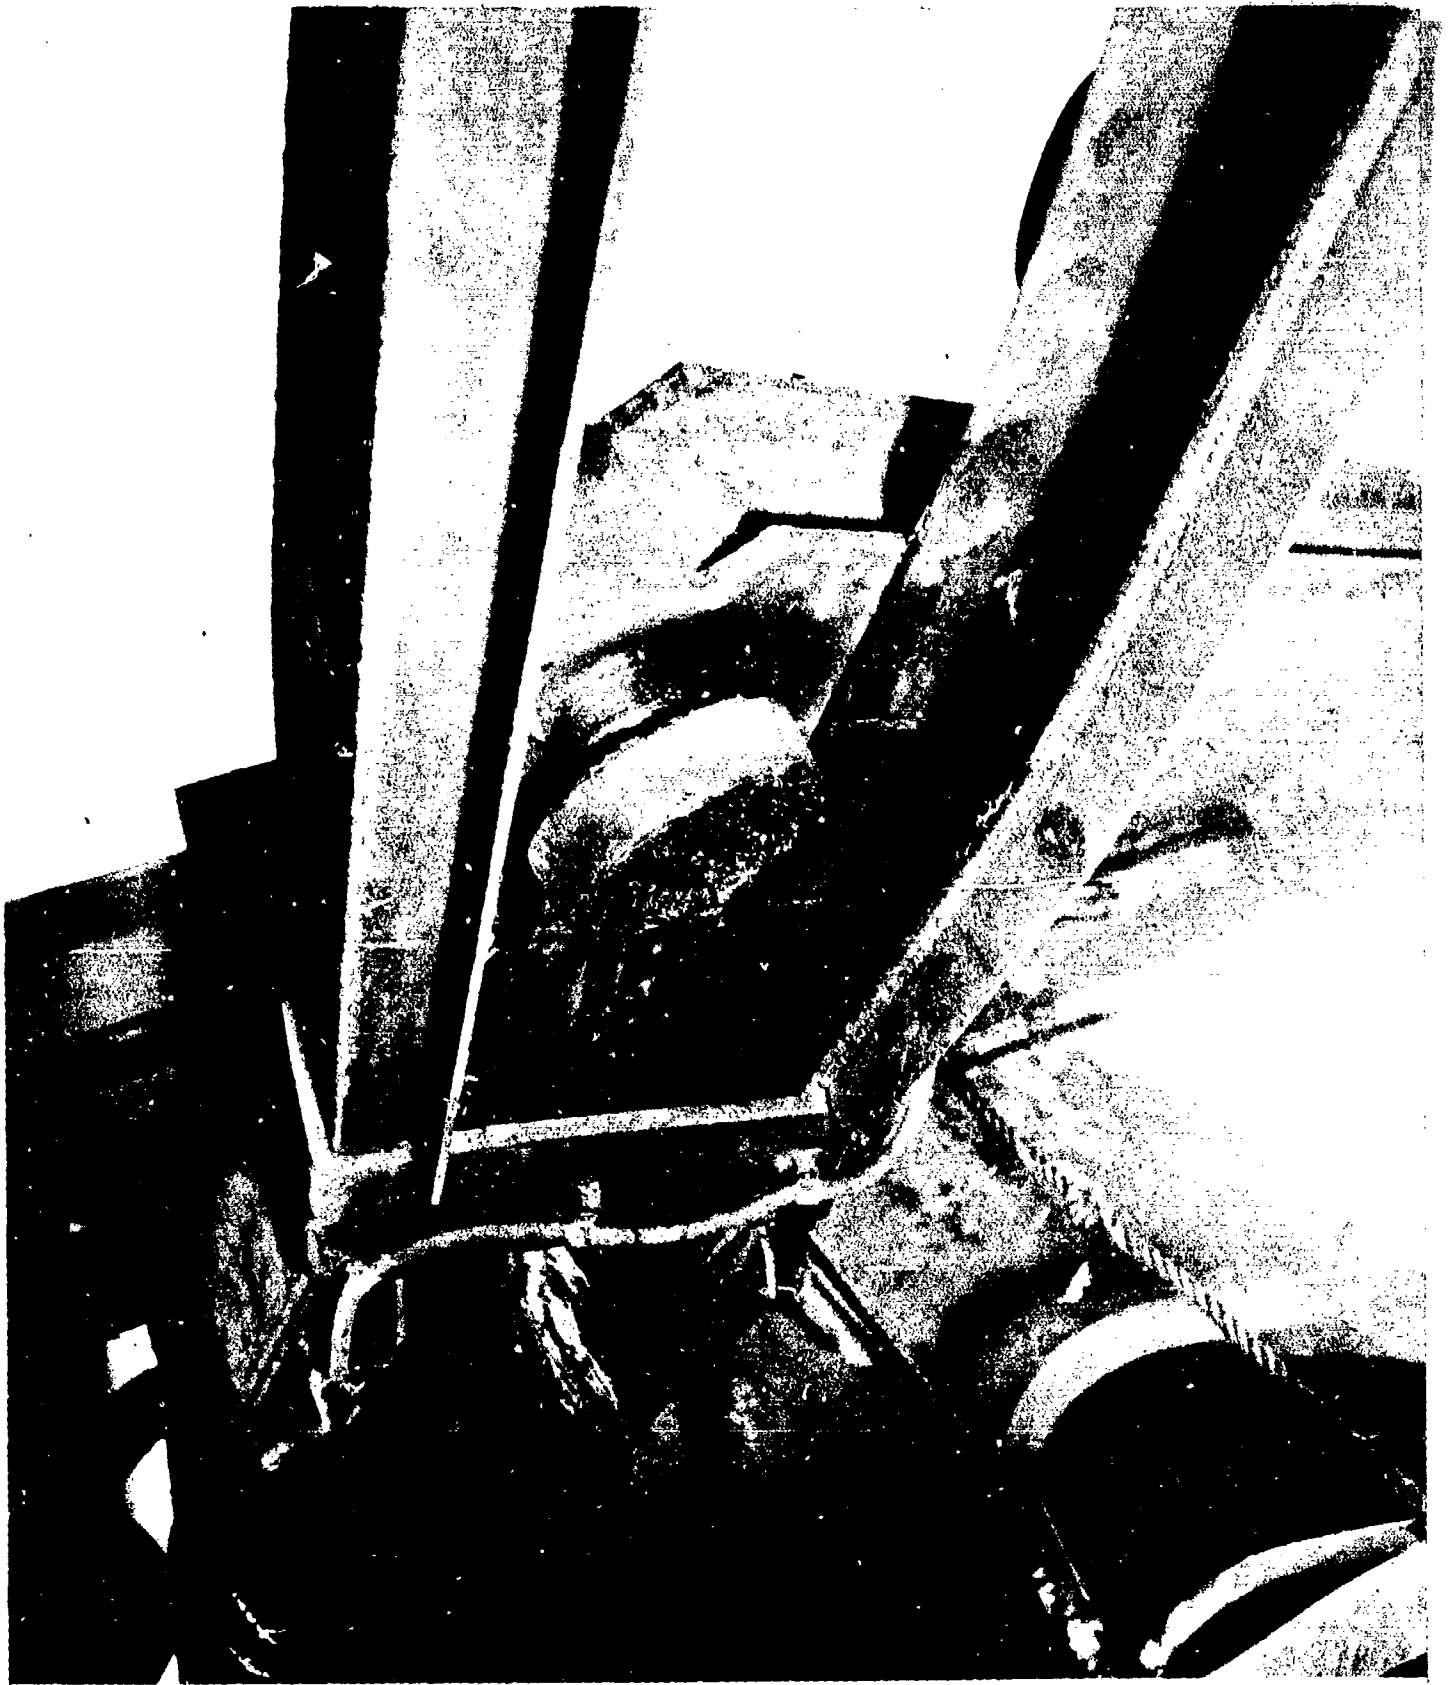
AA-CR-82-1922-6. Close-up of damage to port after boat davit, frame 104, showing dislodged member lying aft.

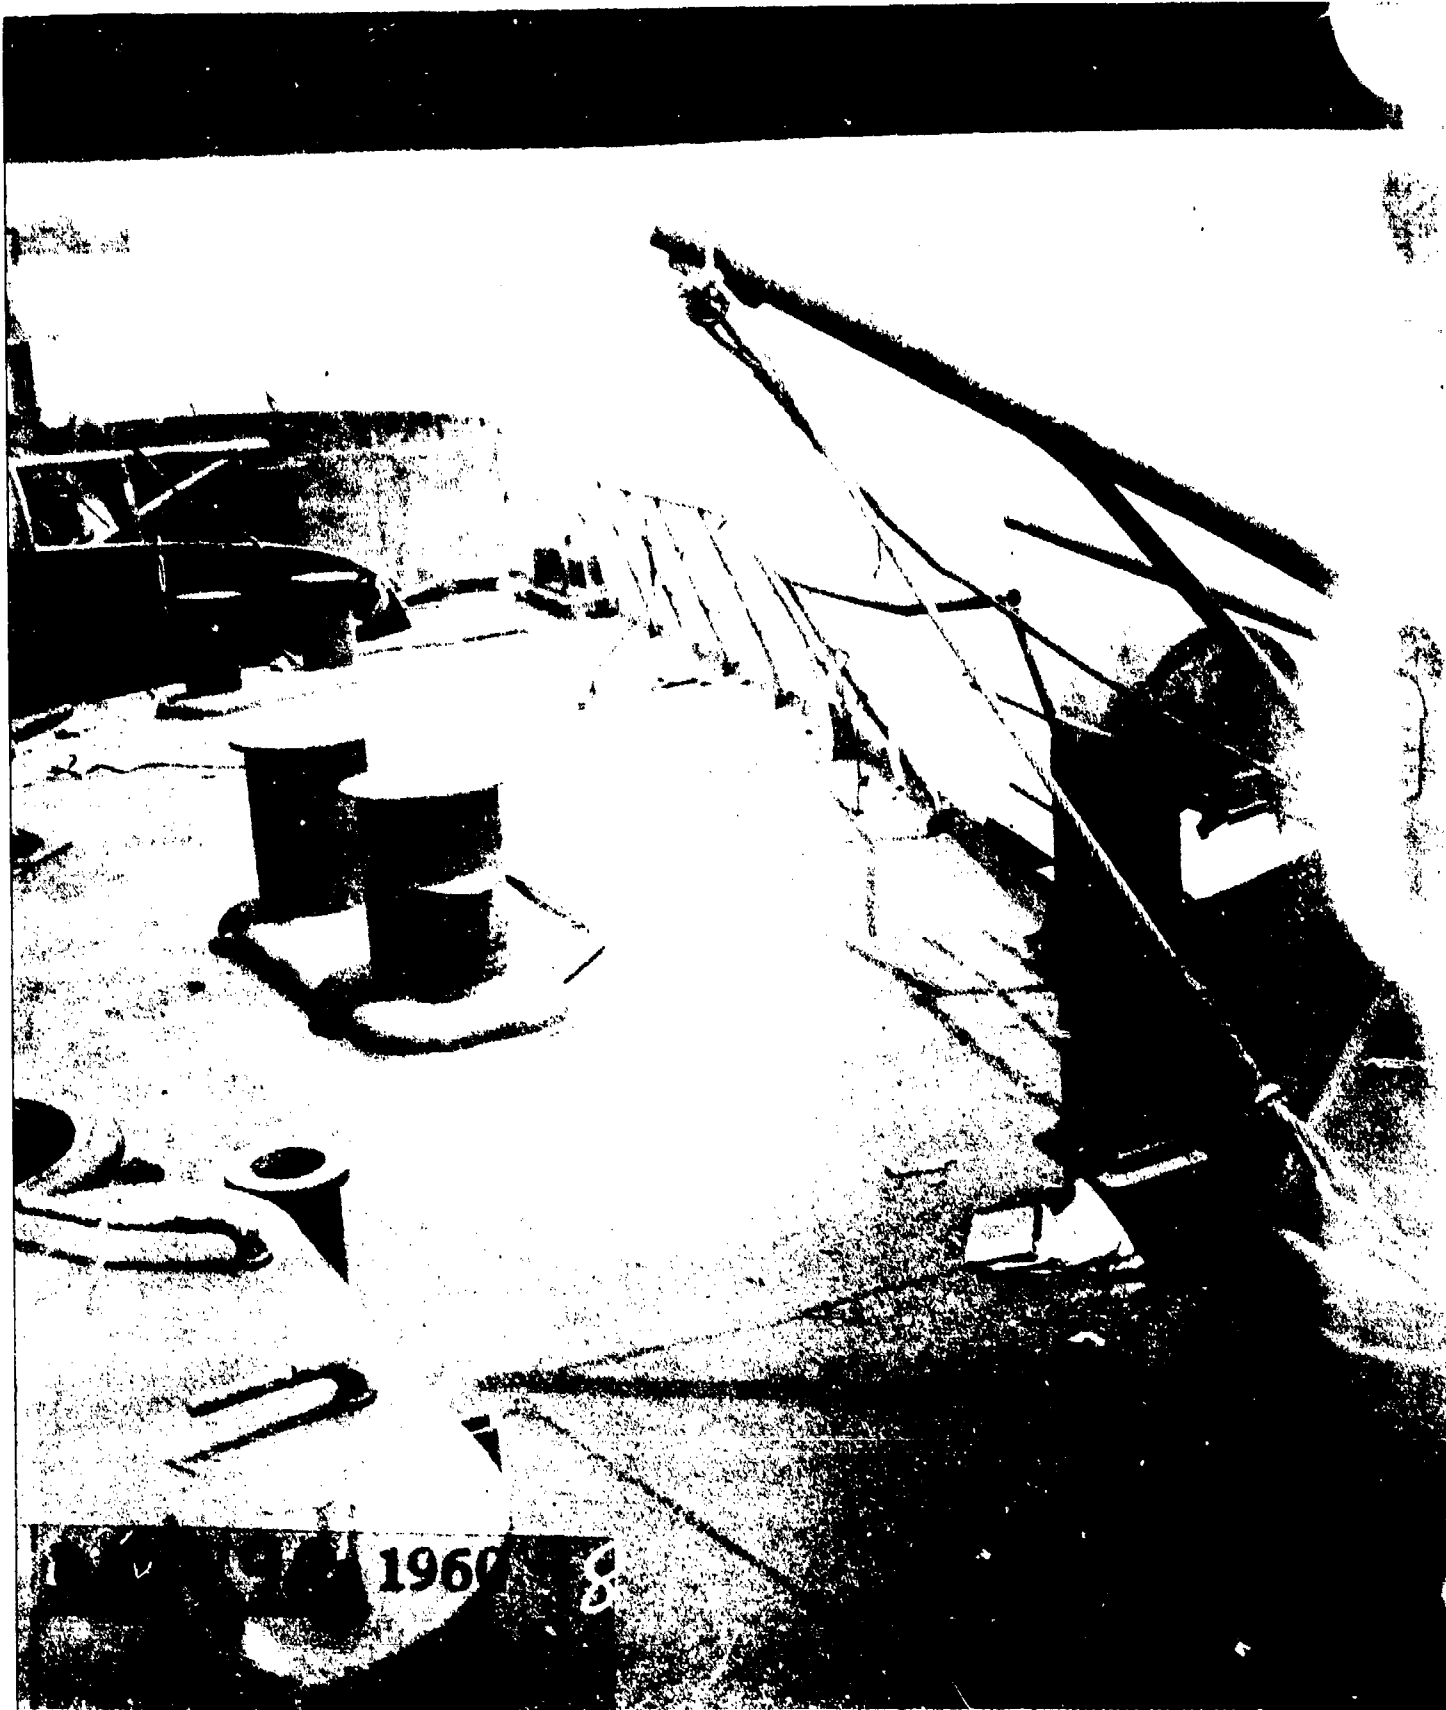
AA-CR-98-1960-8. Looking aft on upper deck, port, from bow, showing damaged railing.

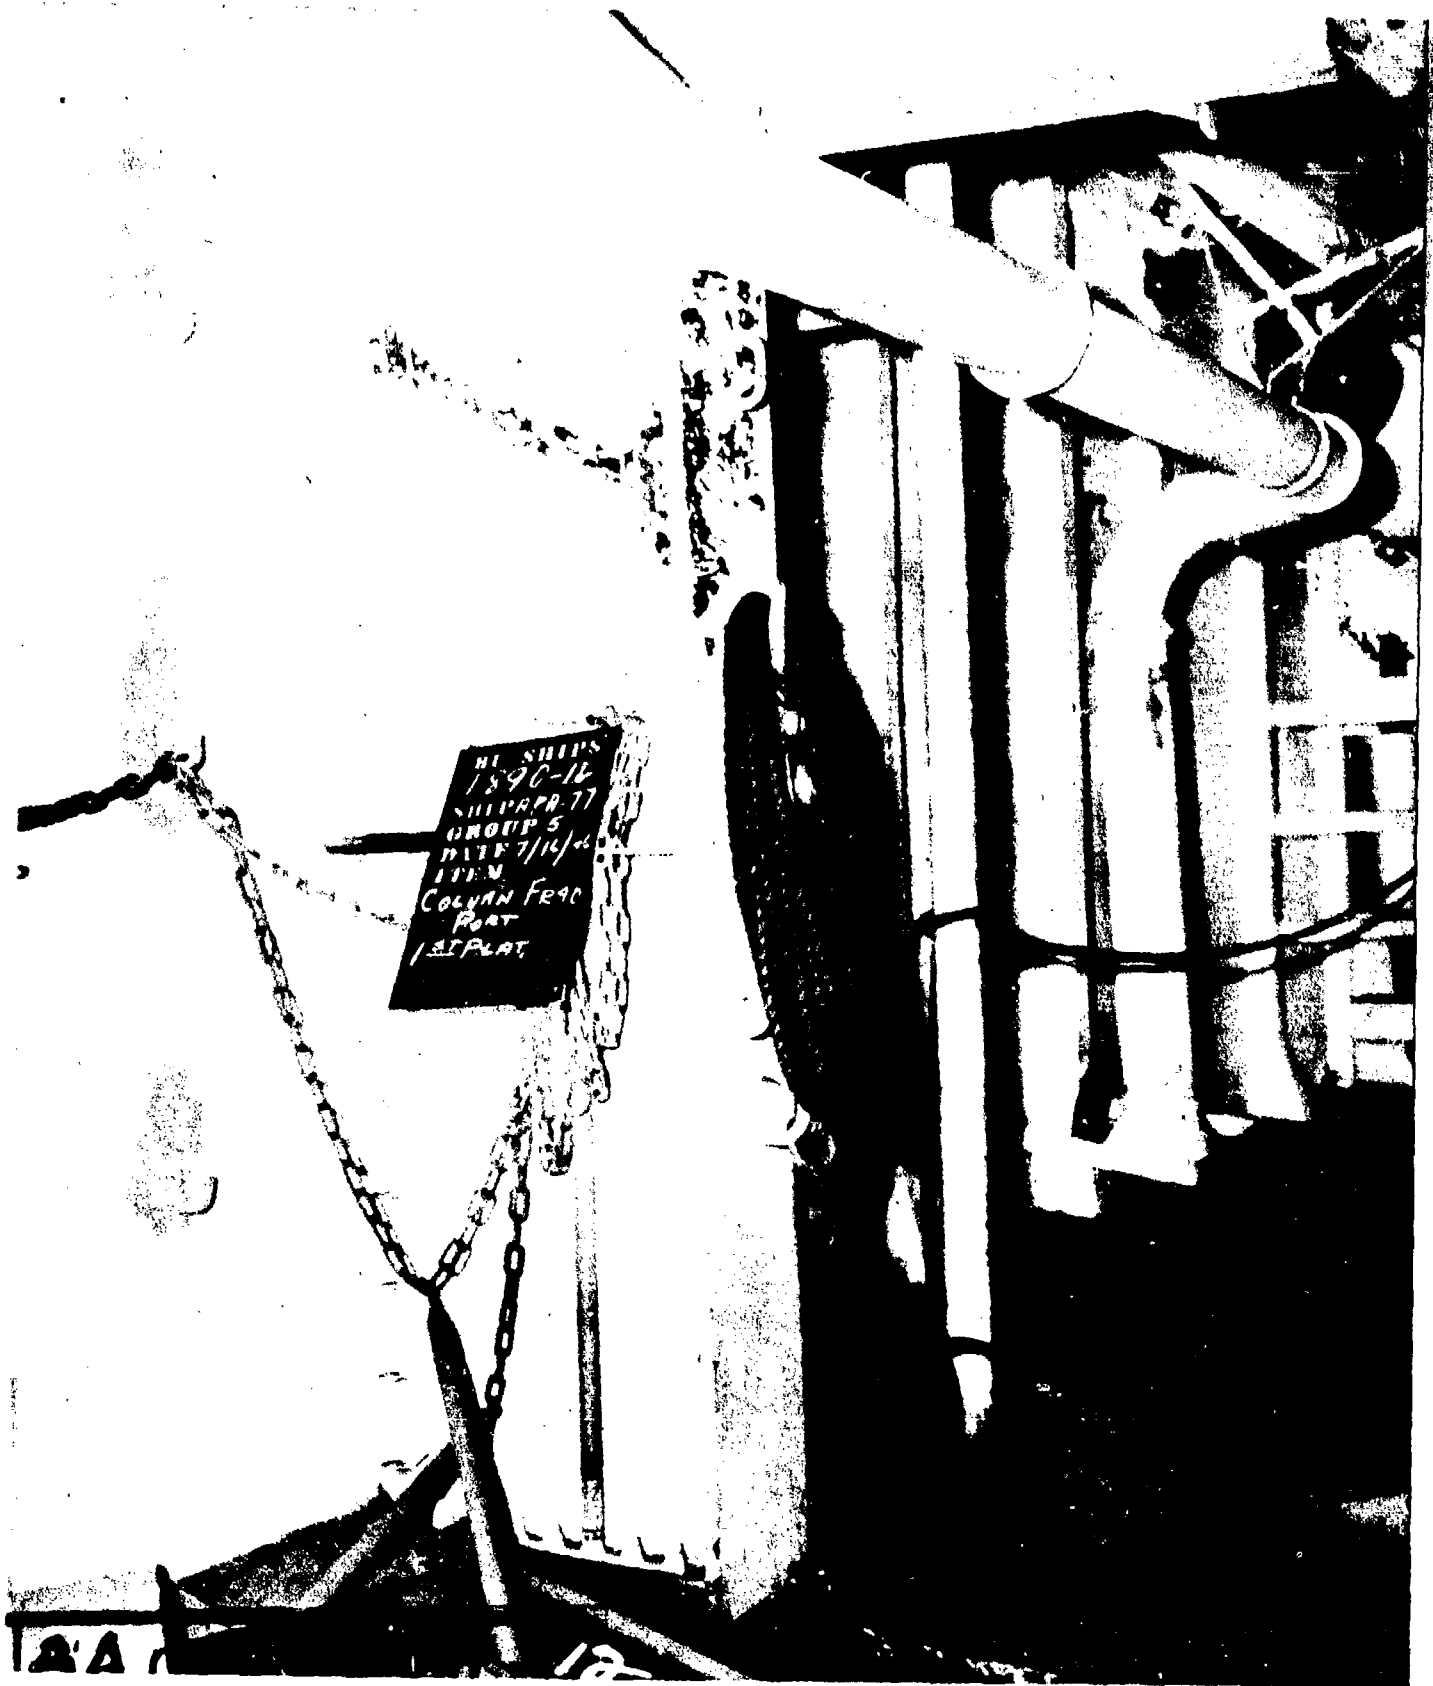
AA-CR-100-1890-12. Looking forward and to starboard along bulkhead 40 on first platform in forward cargo hatch area showing damage to column in way of port edge of hatch.

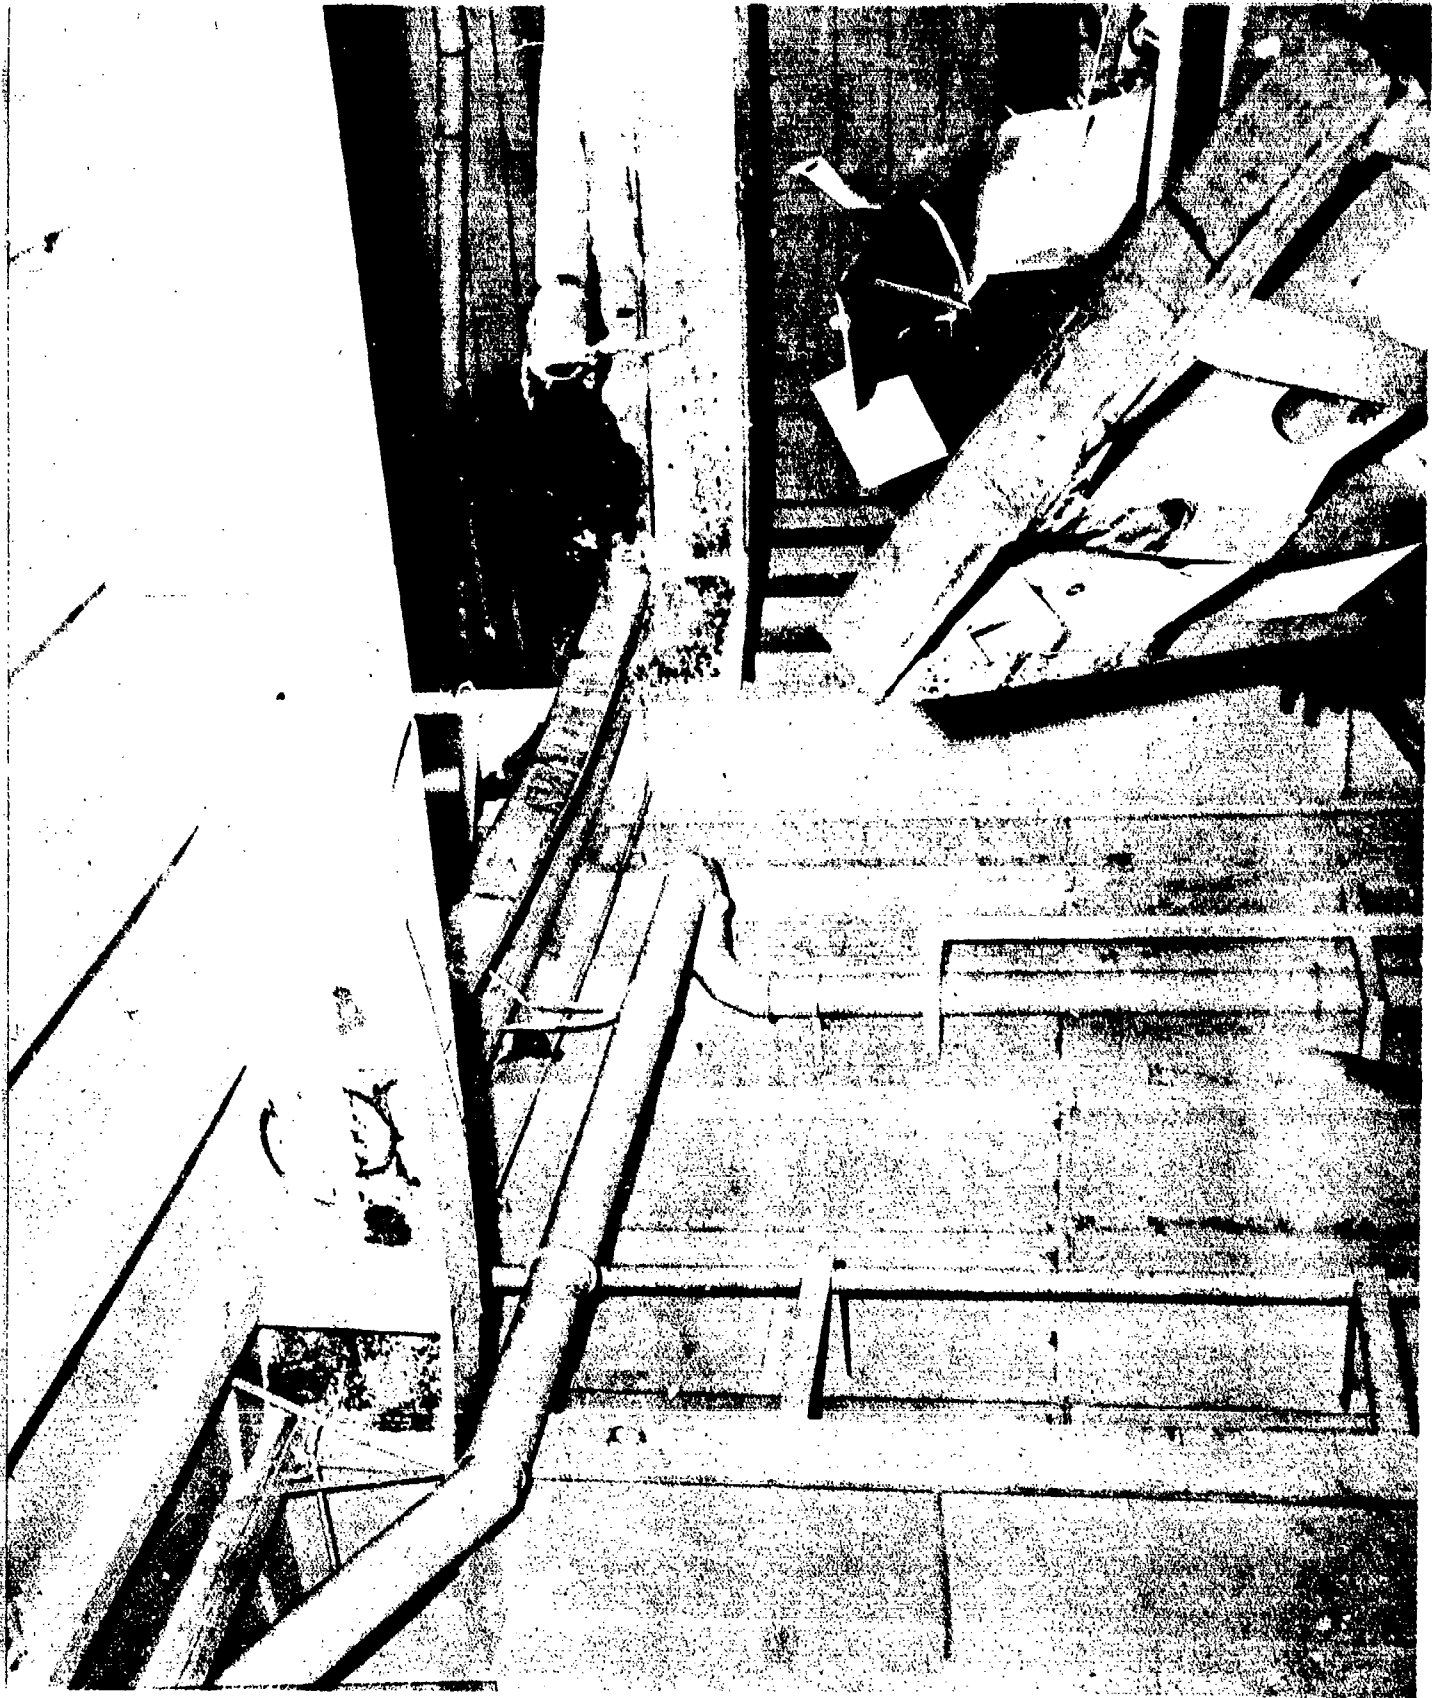
AA-CR-80-1907-10. Looking forward and to starboard in forward cargo hold showing damage to hatch girders near bulkhead 40.

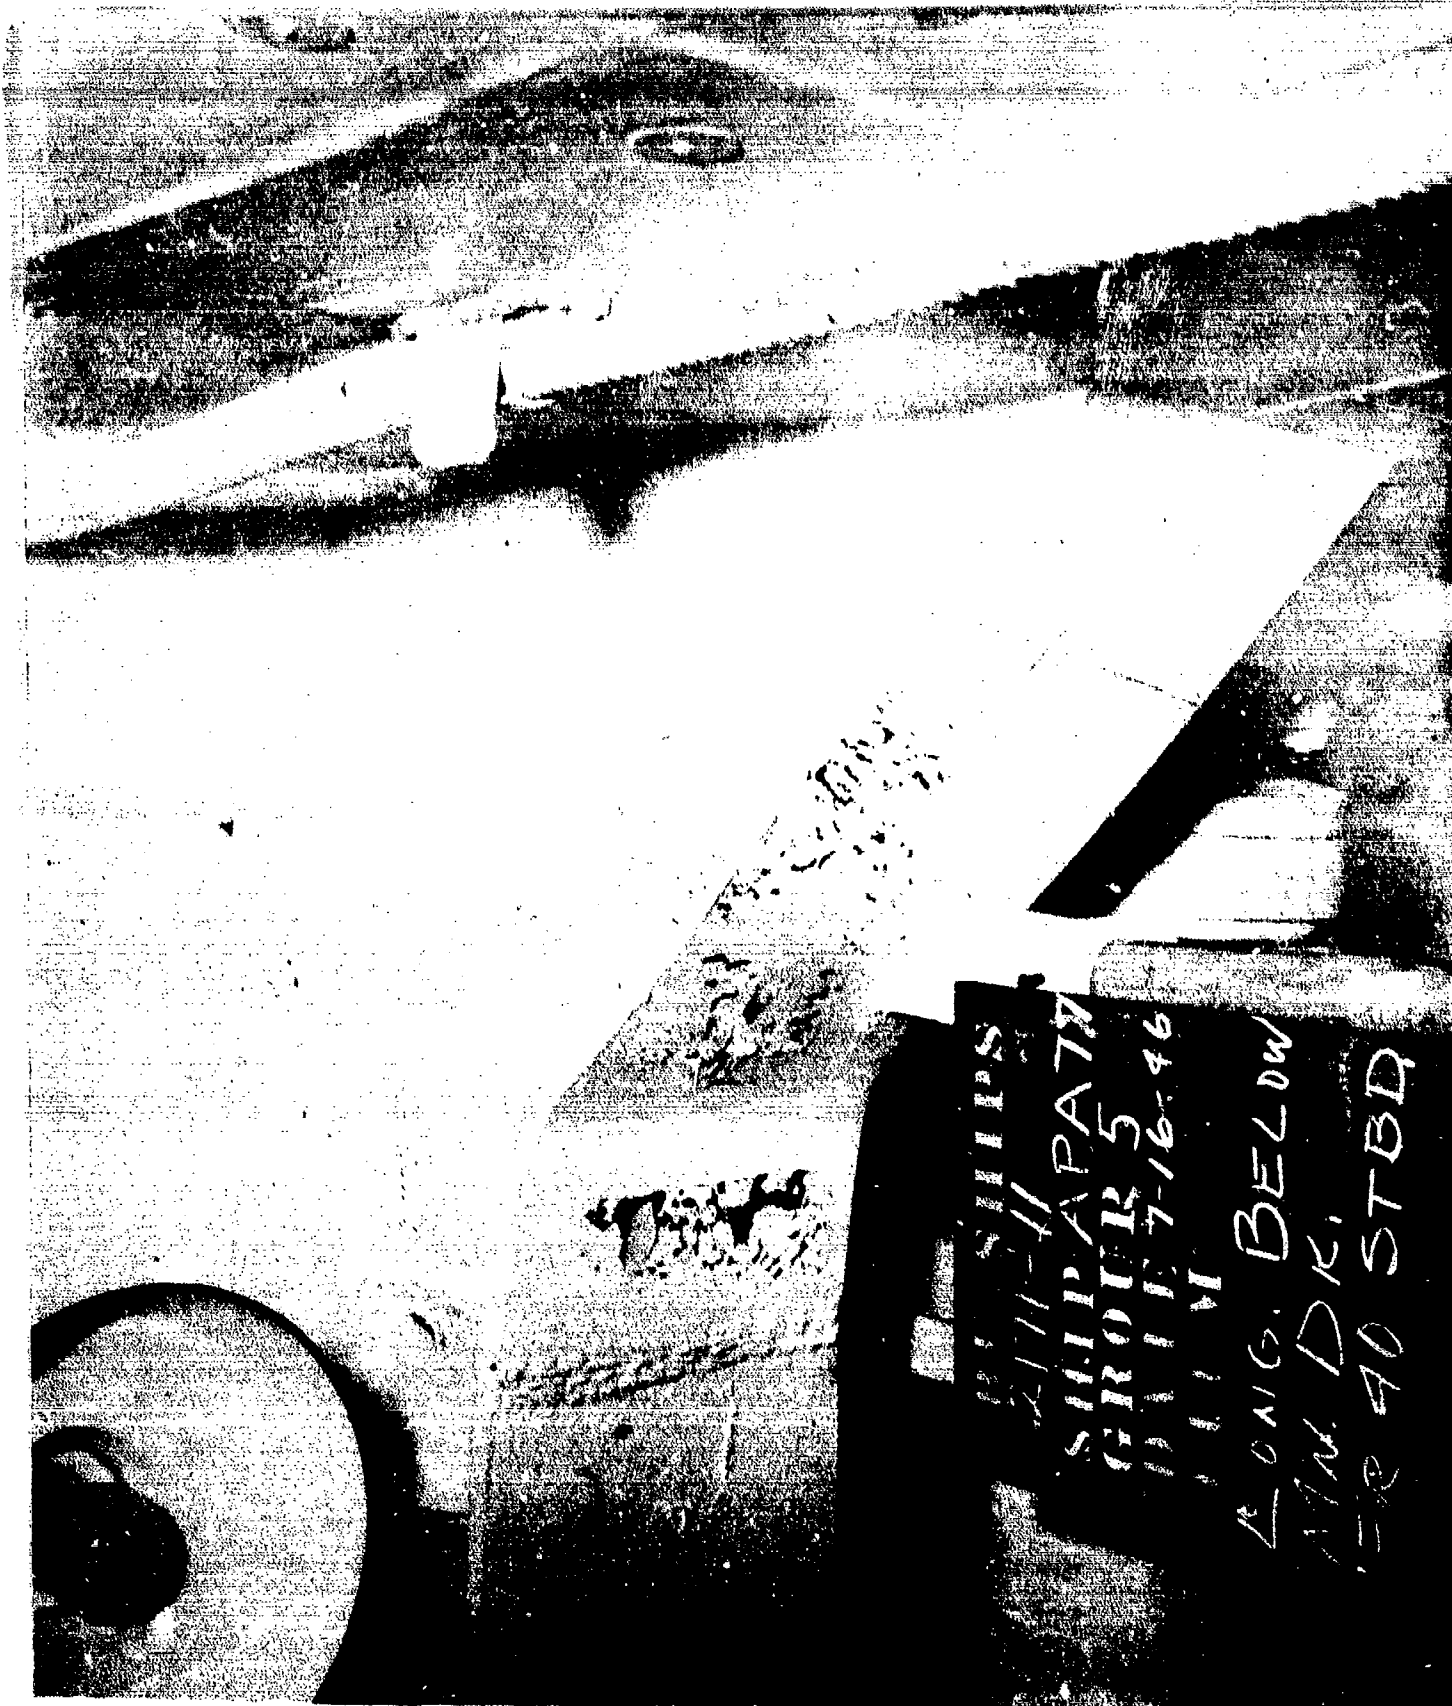
AA-CR-62-2171-11. Looking to starboard on first platform showing damage to longitudinal under main deck adjacent to forward side of bulkhead 40.

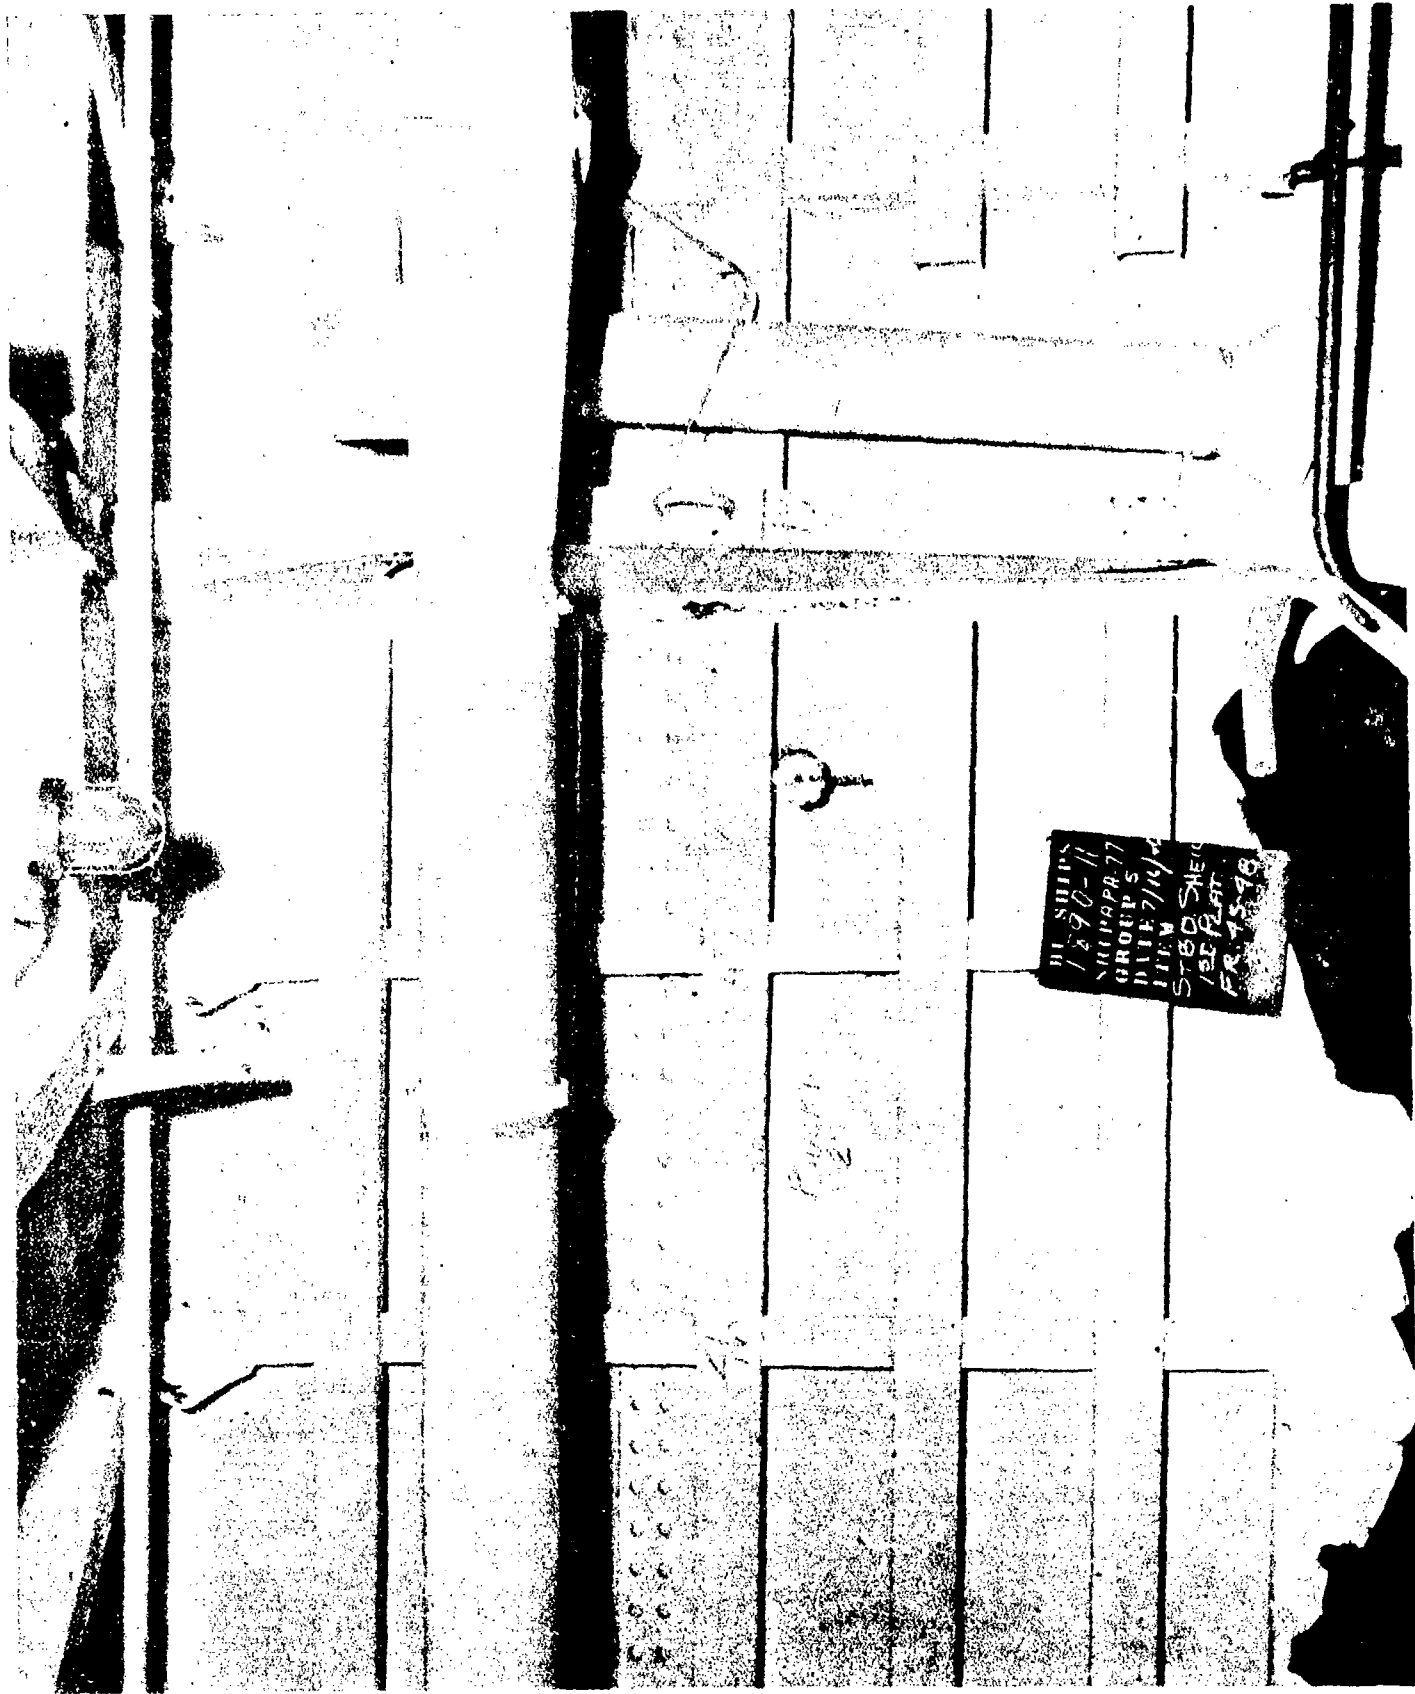
AA-CR-100-1890-11. Looking to starboard on first platform in forward cargo hatch area showing damage to web frame 48 and to brackets under main deck at starboard shell. Refer to 2086-7.
