TECHNICAL INSPECTION REPORT

OPERATION CROSSROADS.
U.S.S. CRITTENDEN (APA 77)
U.S. NAVY
U.S. BUREAU OF SHIPS
U.S. NAVY REPORT DIRECTLY FROM THE FIELD
TEST ABLE.
U.S. NAVY Support Agency
Washington, D. C. 20301
VOLUME 2 [U].

OPERATION CROSSROADS

BUREAU OF SHIPS GROUP
TECHNICAL INSPECTION REPORT

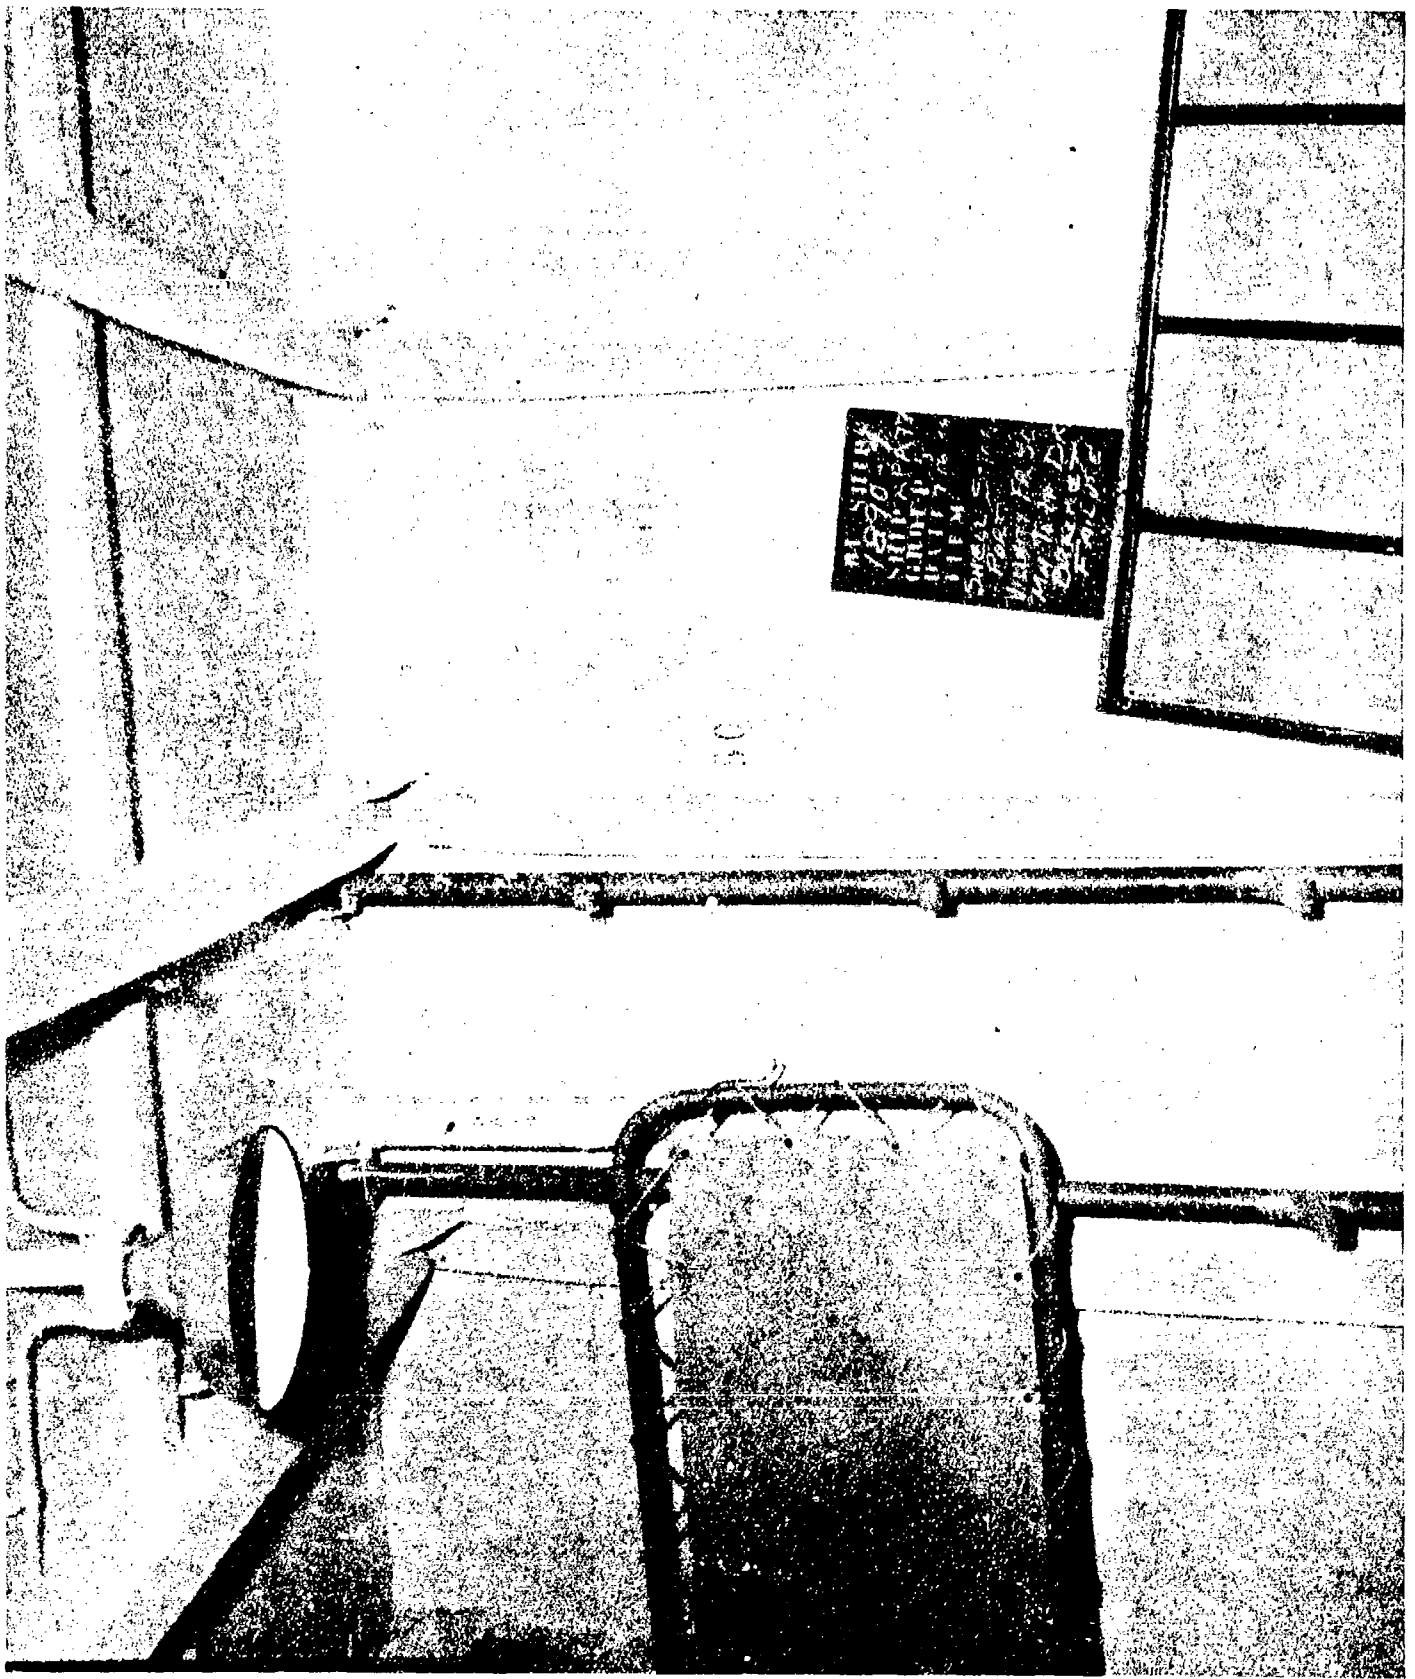
AA-CR-100-1890-7. Looking to port on main deck in crews berthing A-104L showing damage to brackets and stiffeners under upper deck, frame 49 to 52.

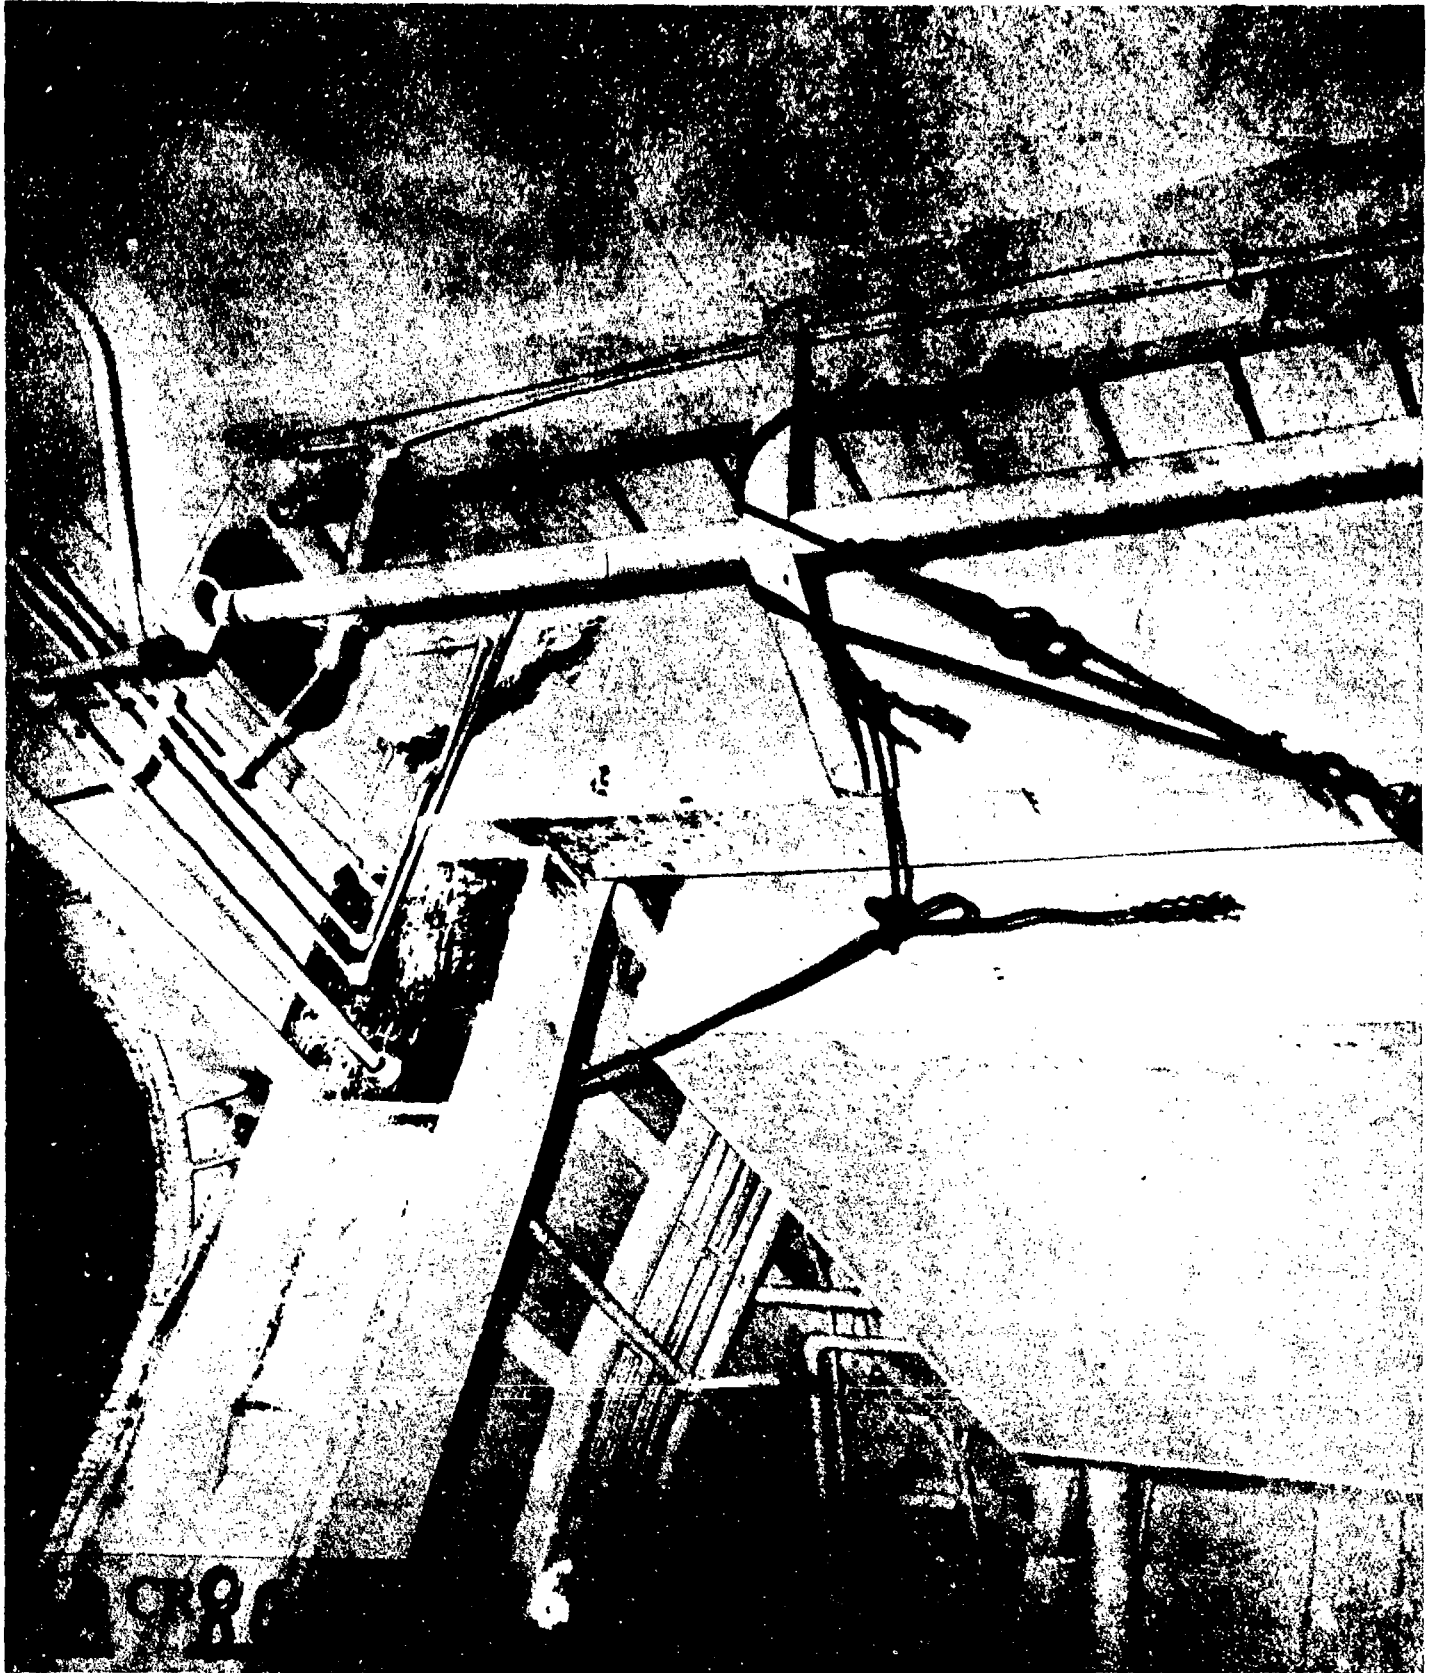
AA-CR-80-1908-6. Looking up, aft, and to starboard in after cargo hold showing damage to web column and main deck girder at starboard edge of hatch.

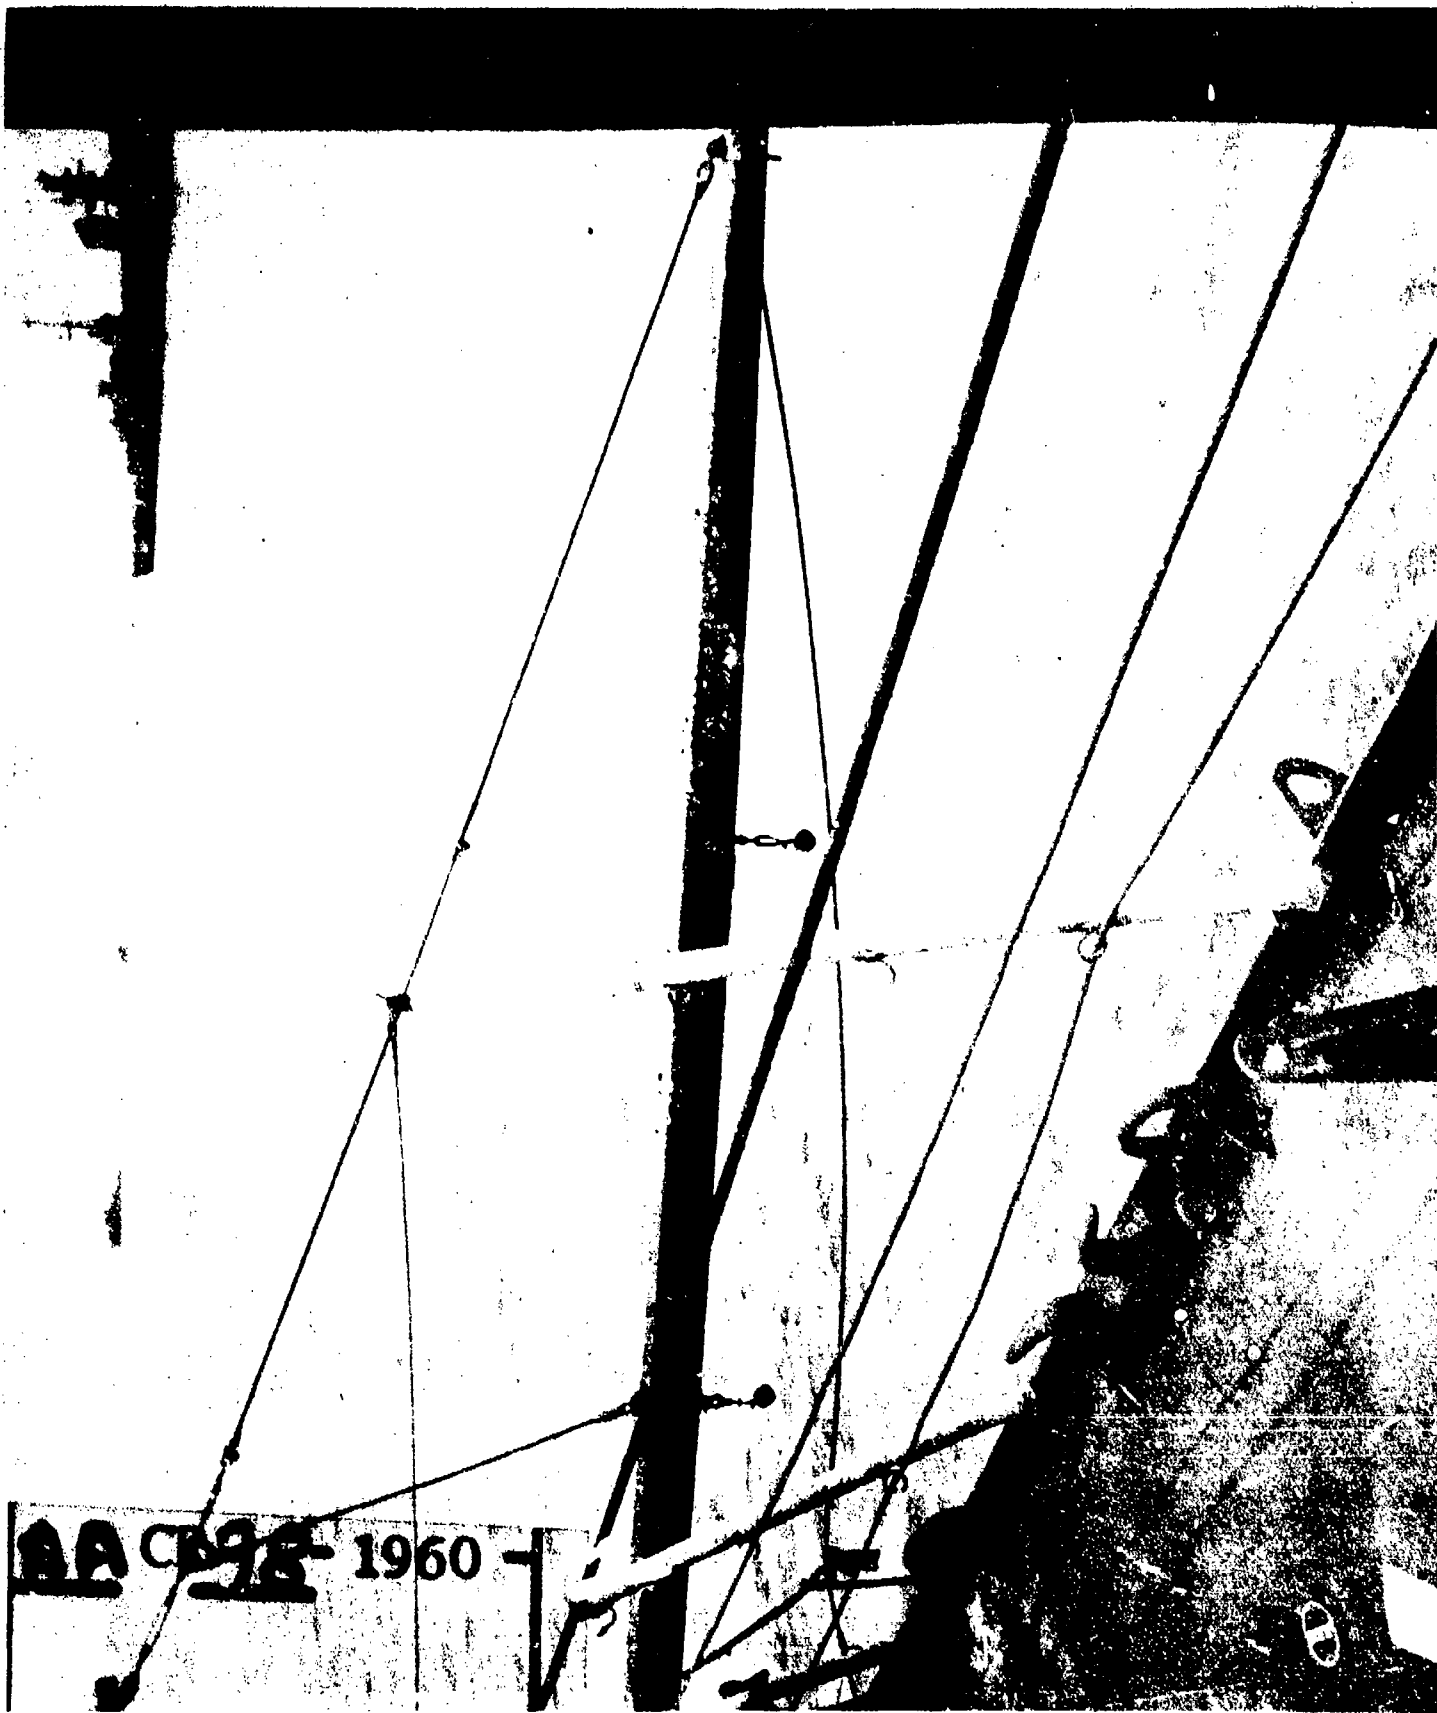
AA-CR-98-1960-12. Looking aft and to port showing burned paint on boat boom.
