# BUREAU OF SHIPS GROUP TECHNICAL INSPECTION REPORT

⑥ OPERATION CROSSROADS.  
U.S.S. DAWSON (APA79)

TEST ABLE CU

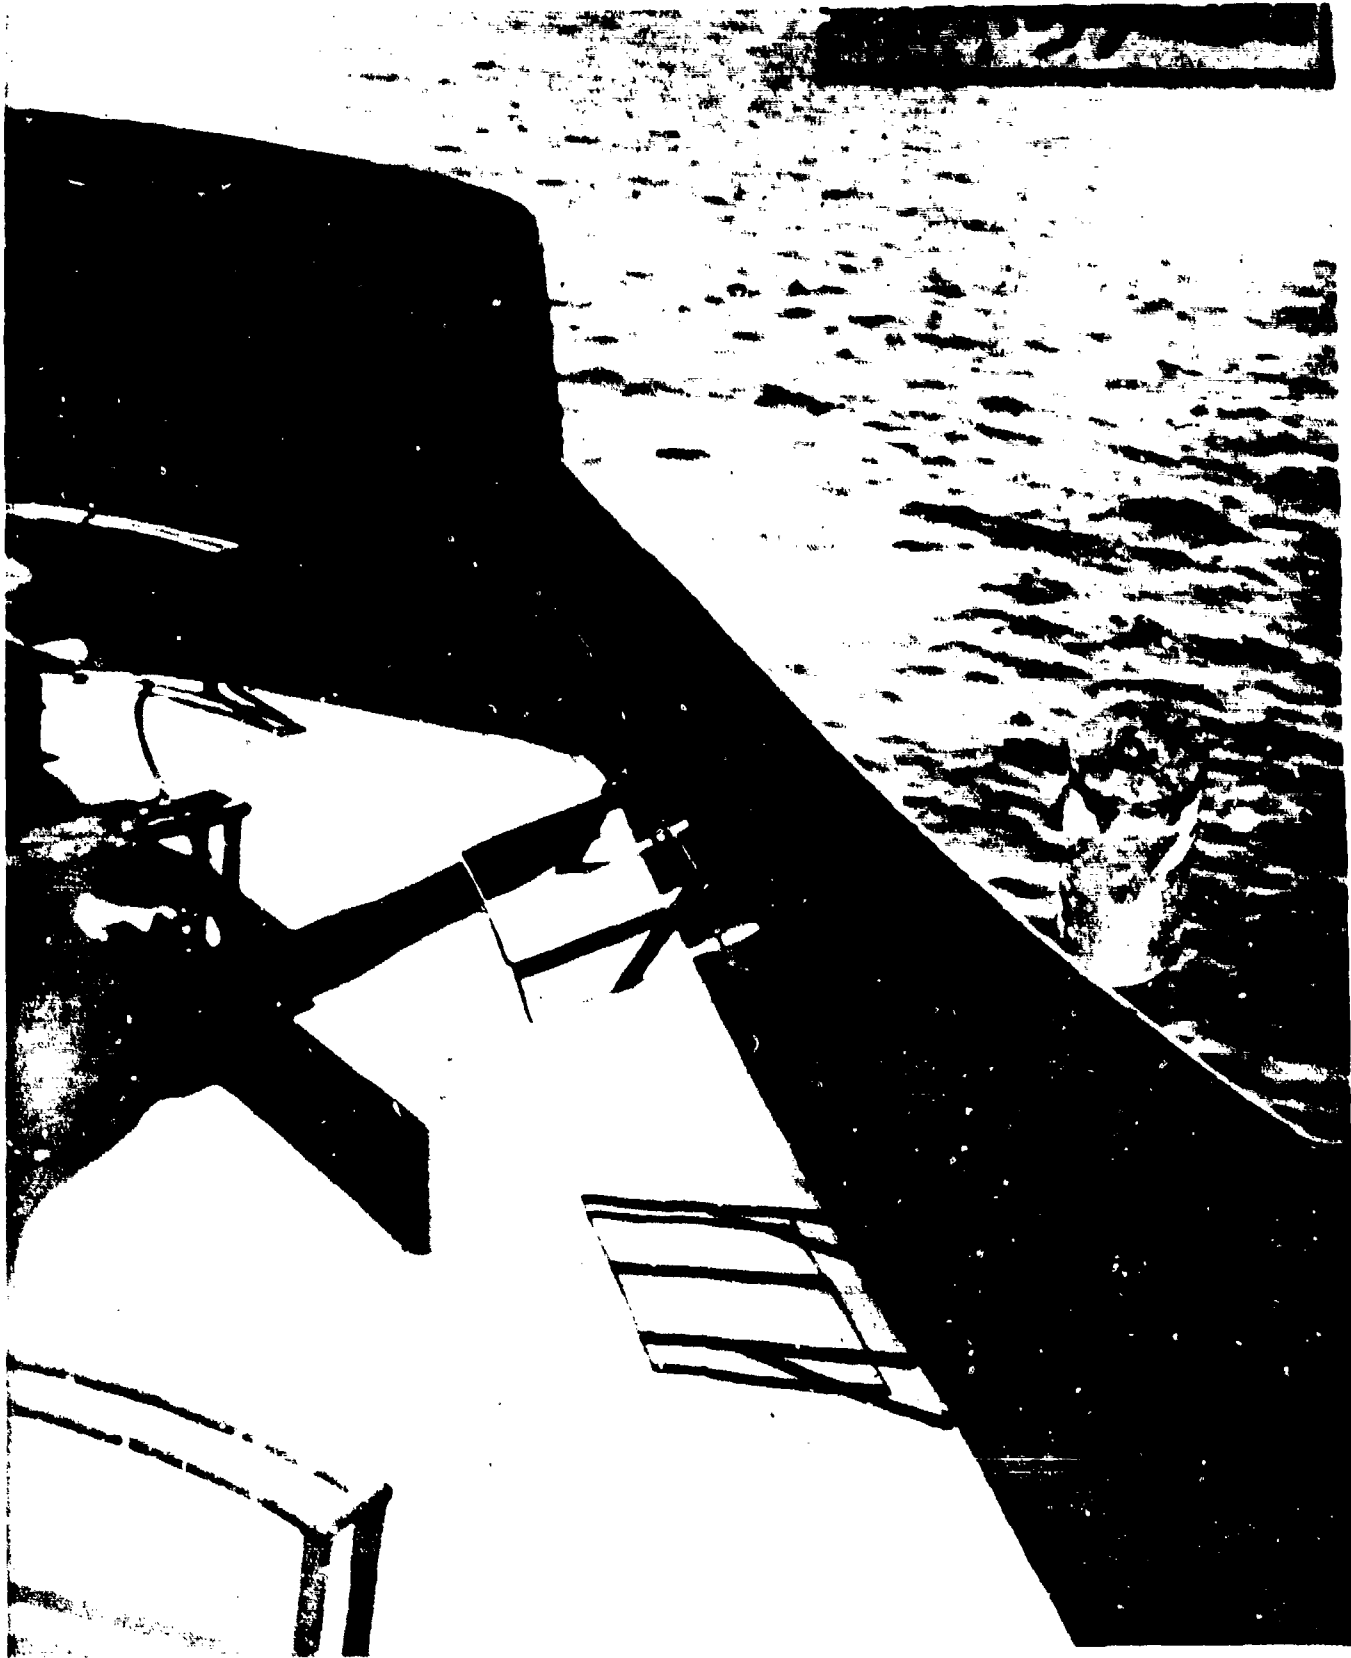
failure in the bulwark capping at the centerline. (Photo. 1741-7; page 78 ). The forward port bulwark of the port 20 MM gun enclosure is deflected approximately 14 inches (Photo. 1741-5; page 75 ).

AA-CR-65-1741-5. Looking to port, along forward bulwark of signal bridge and 20MM gun enclosure.

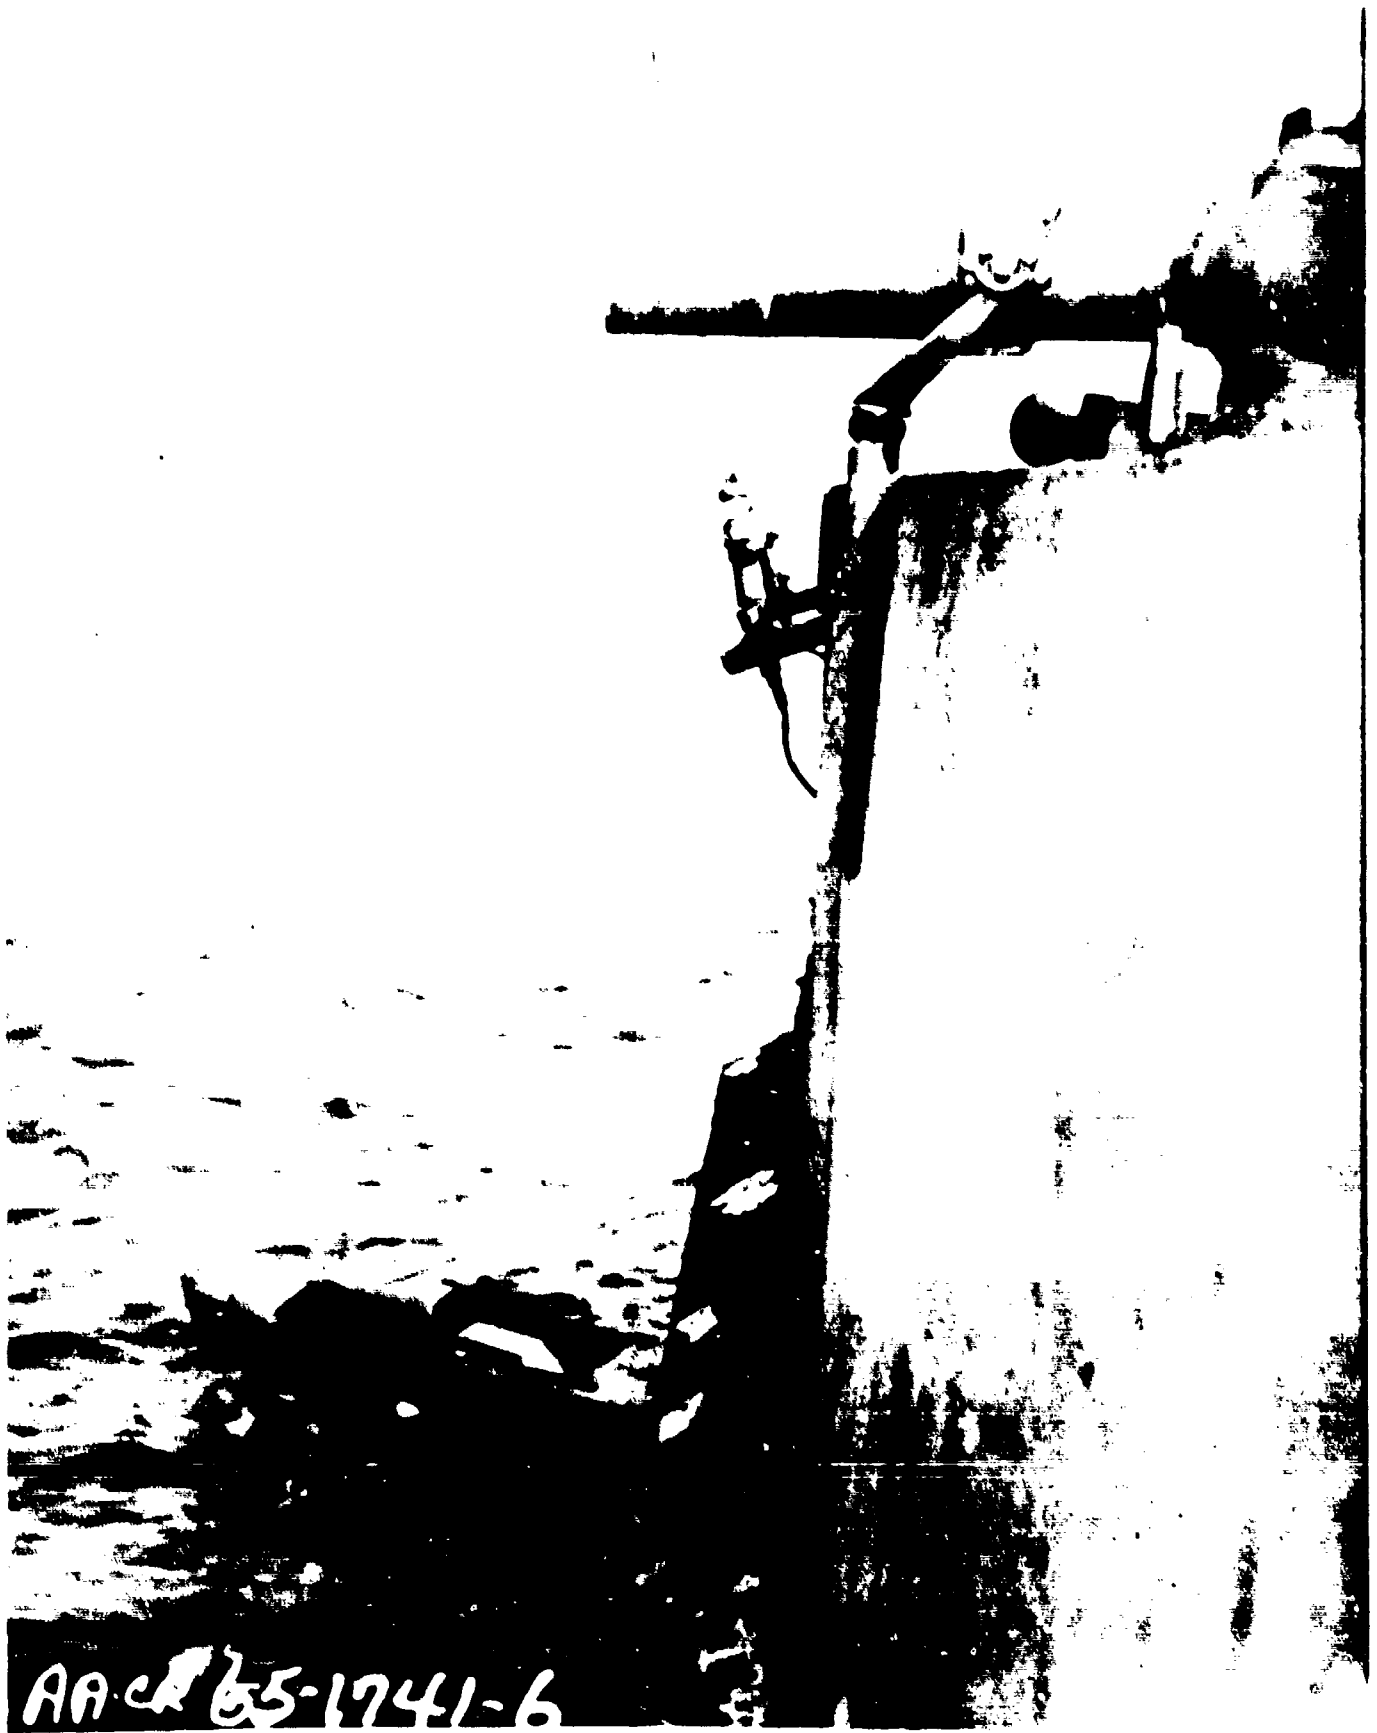
AA-CR-65-1741-6. Looking to starboard along forward bulwark of signal bridge.

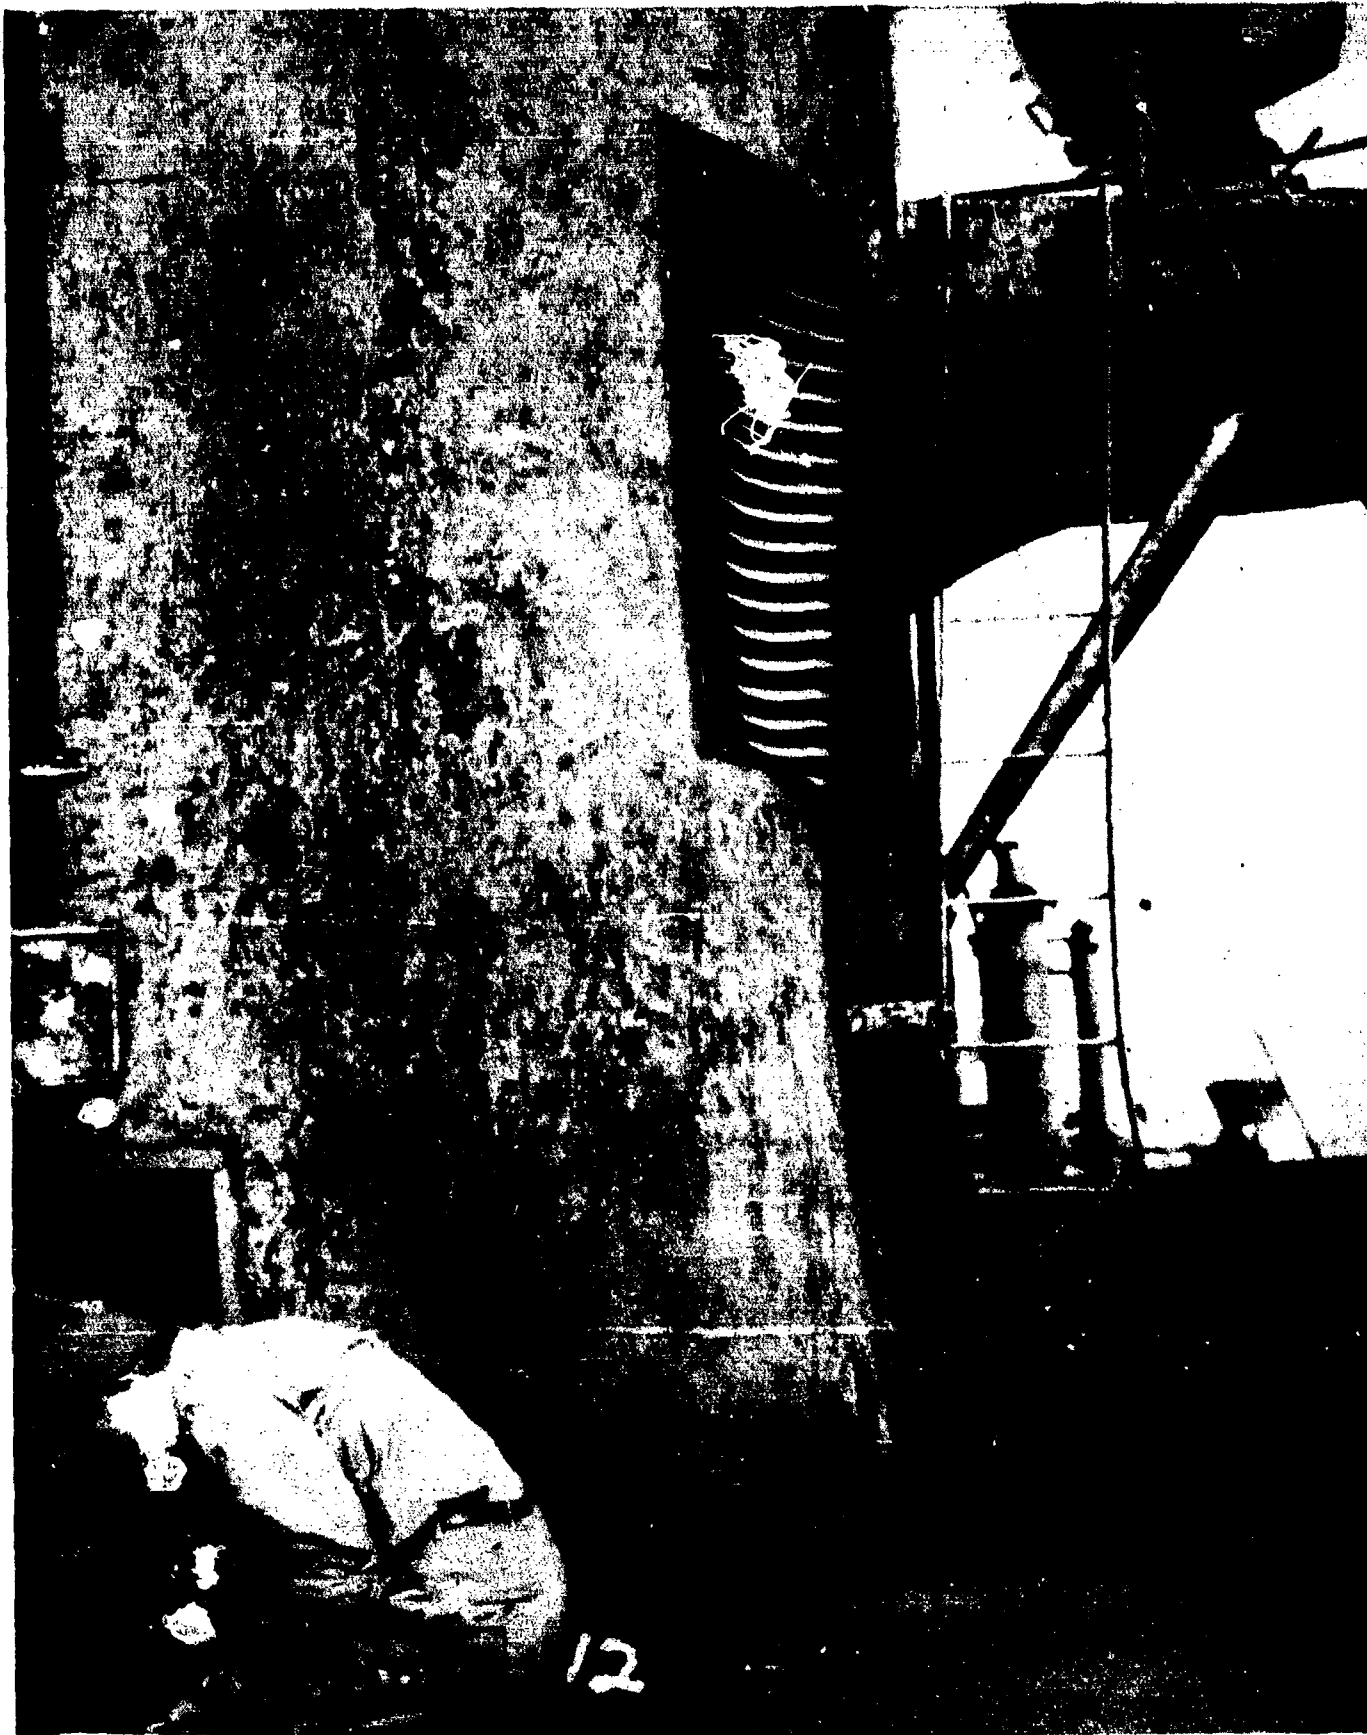
AA-CR-62-2168-12. Forward stack, port side, looking aft, note bowed ladder.

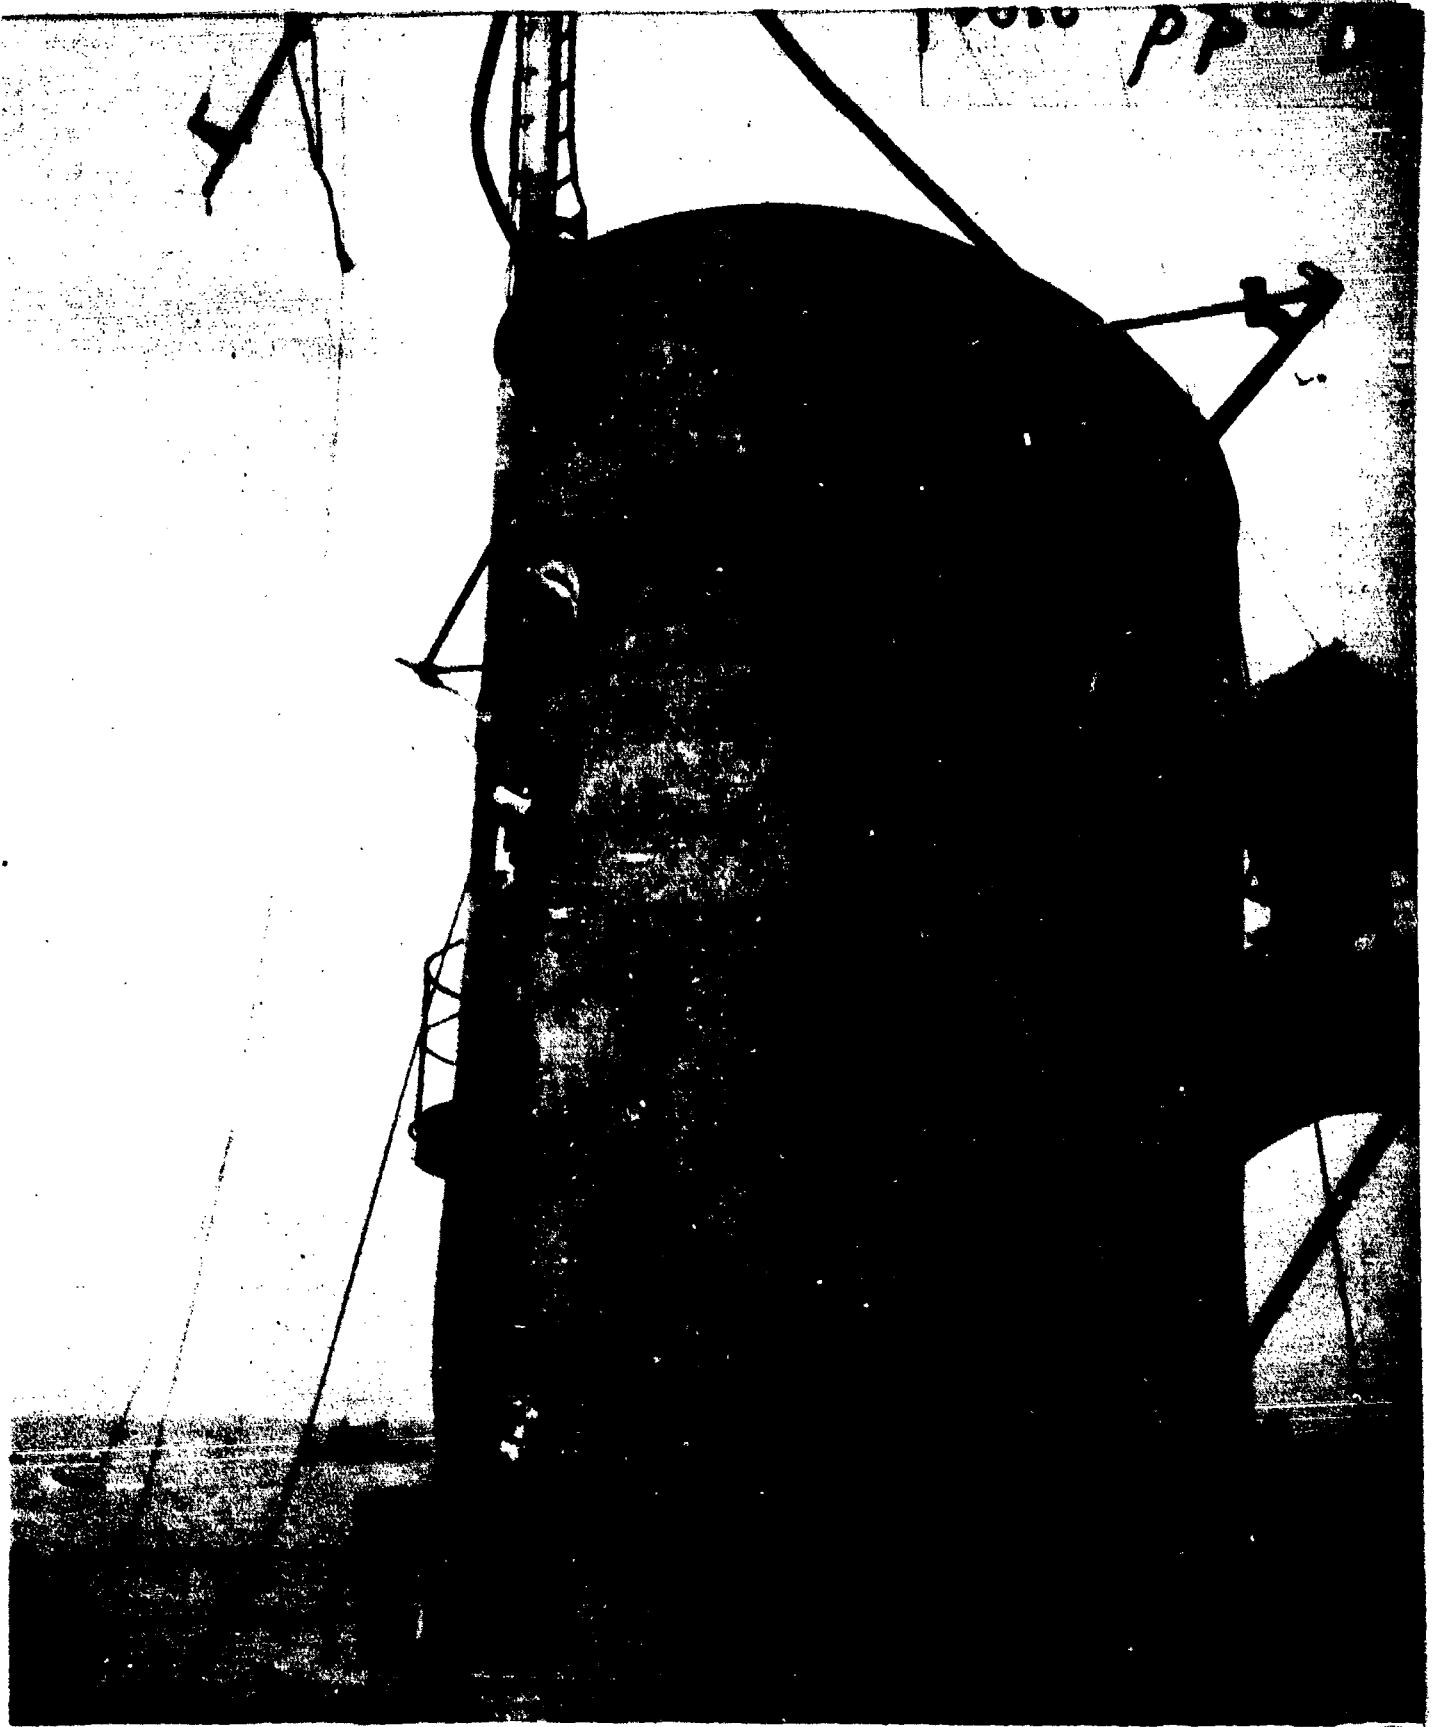
AA-CR-88-2104-8. Looking aft and to starboard, showing damage to forward stack, ladder and sun shields on ready service ammunition lockers.

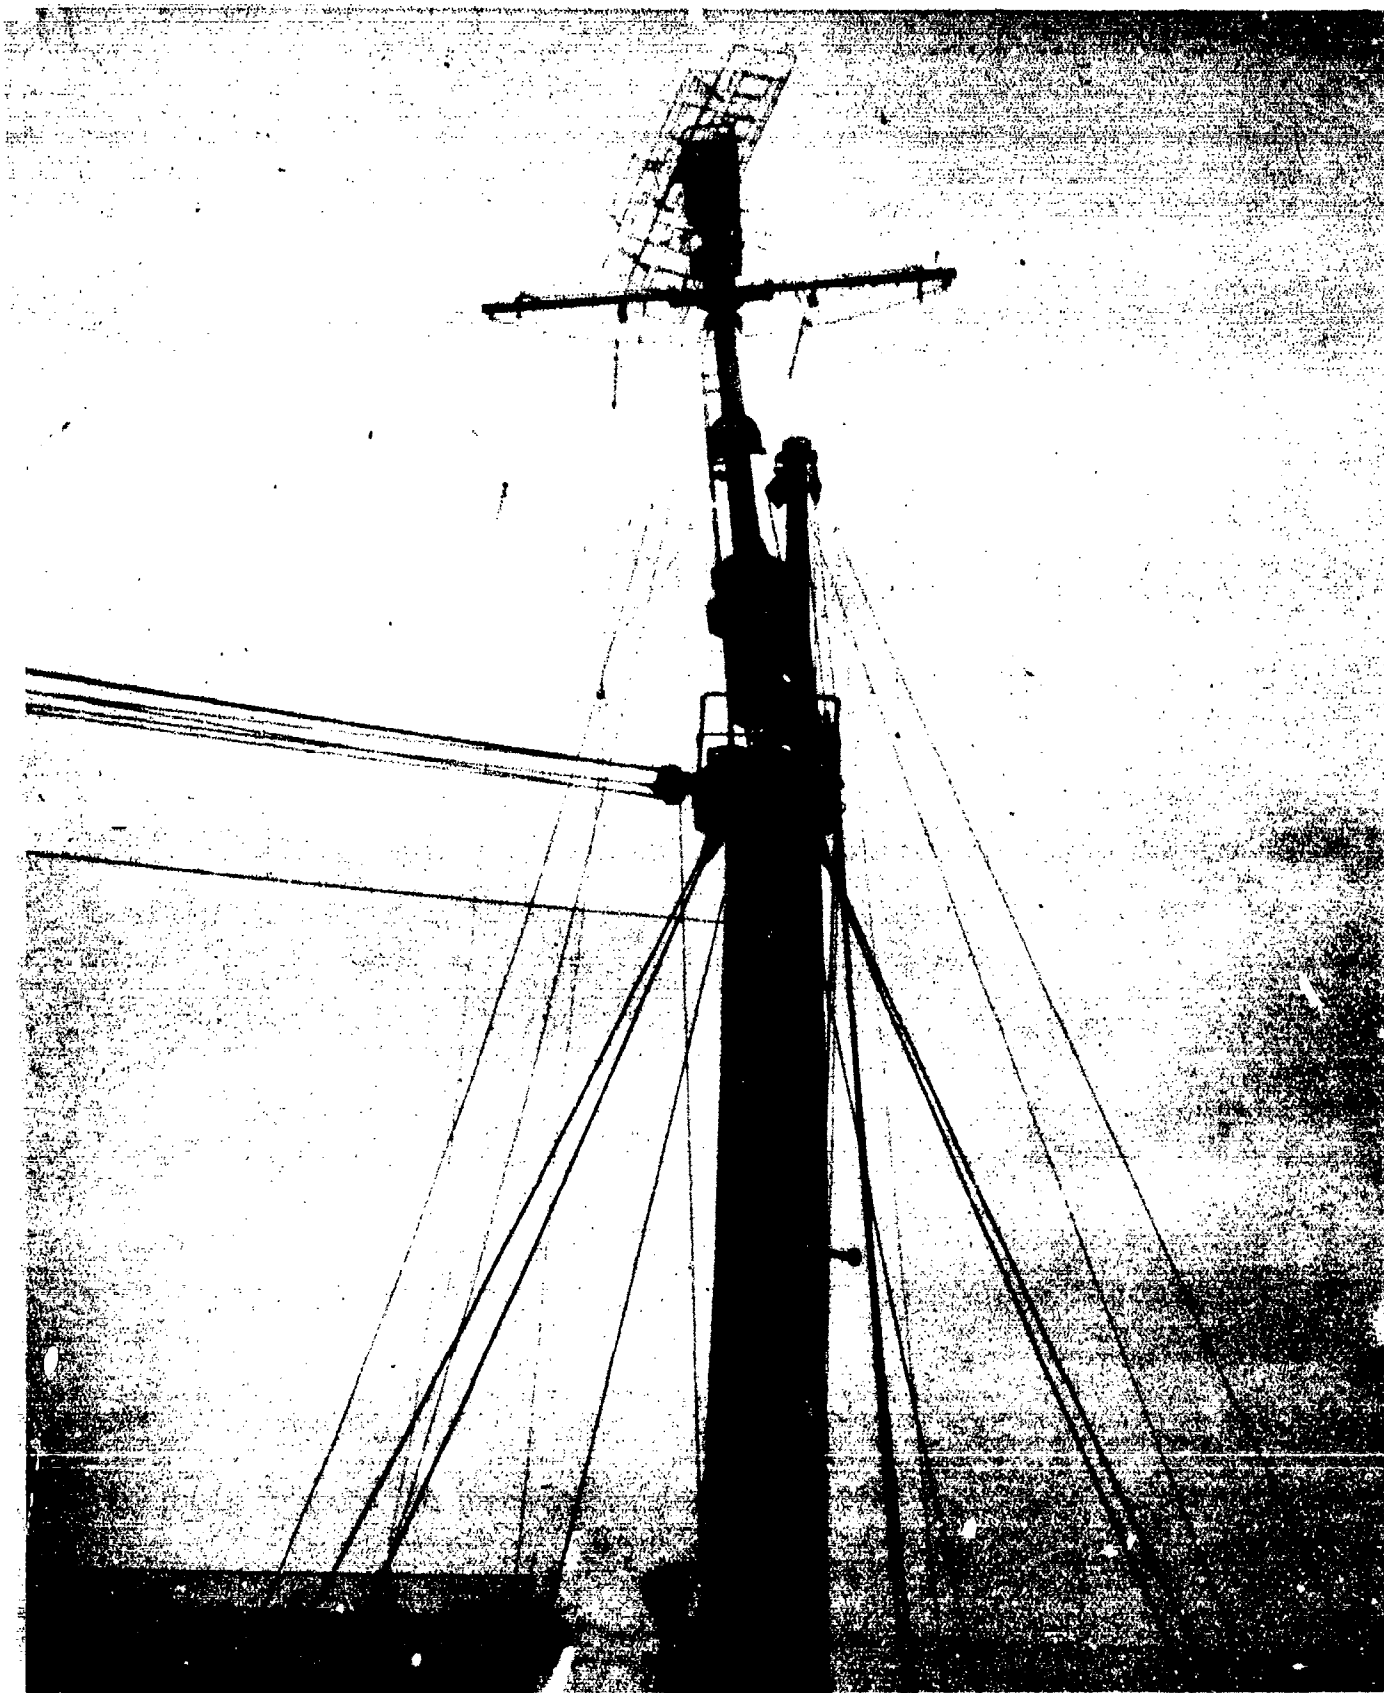
AA-CR-88-2103-1. Looking up and aft, showing bent main topmast and damaged radar screen.

Topmasts should be eliminated and radar screens should be made retractible or readily replaceable by spares.

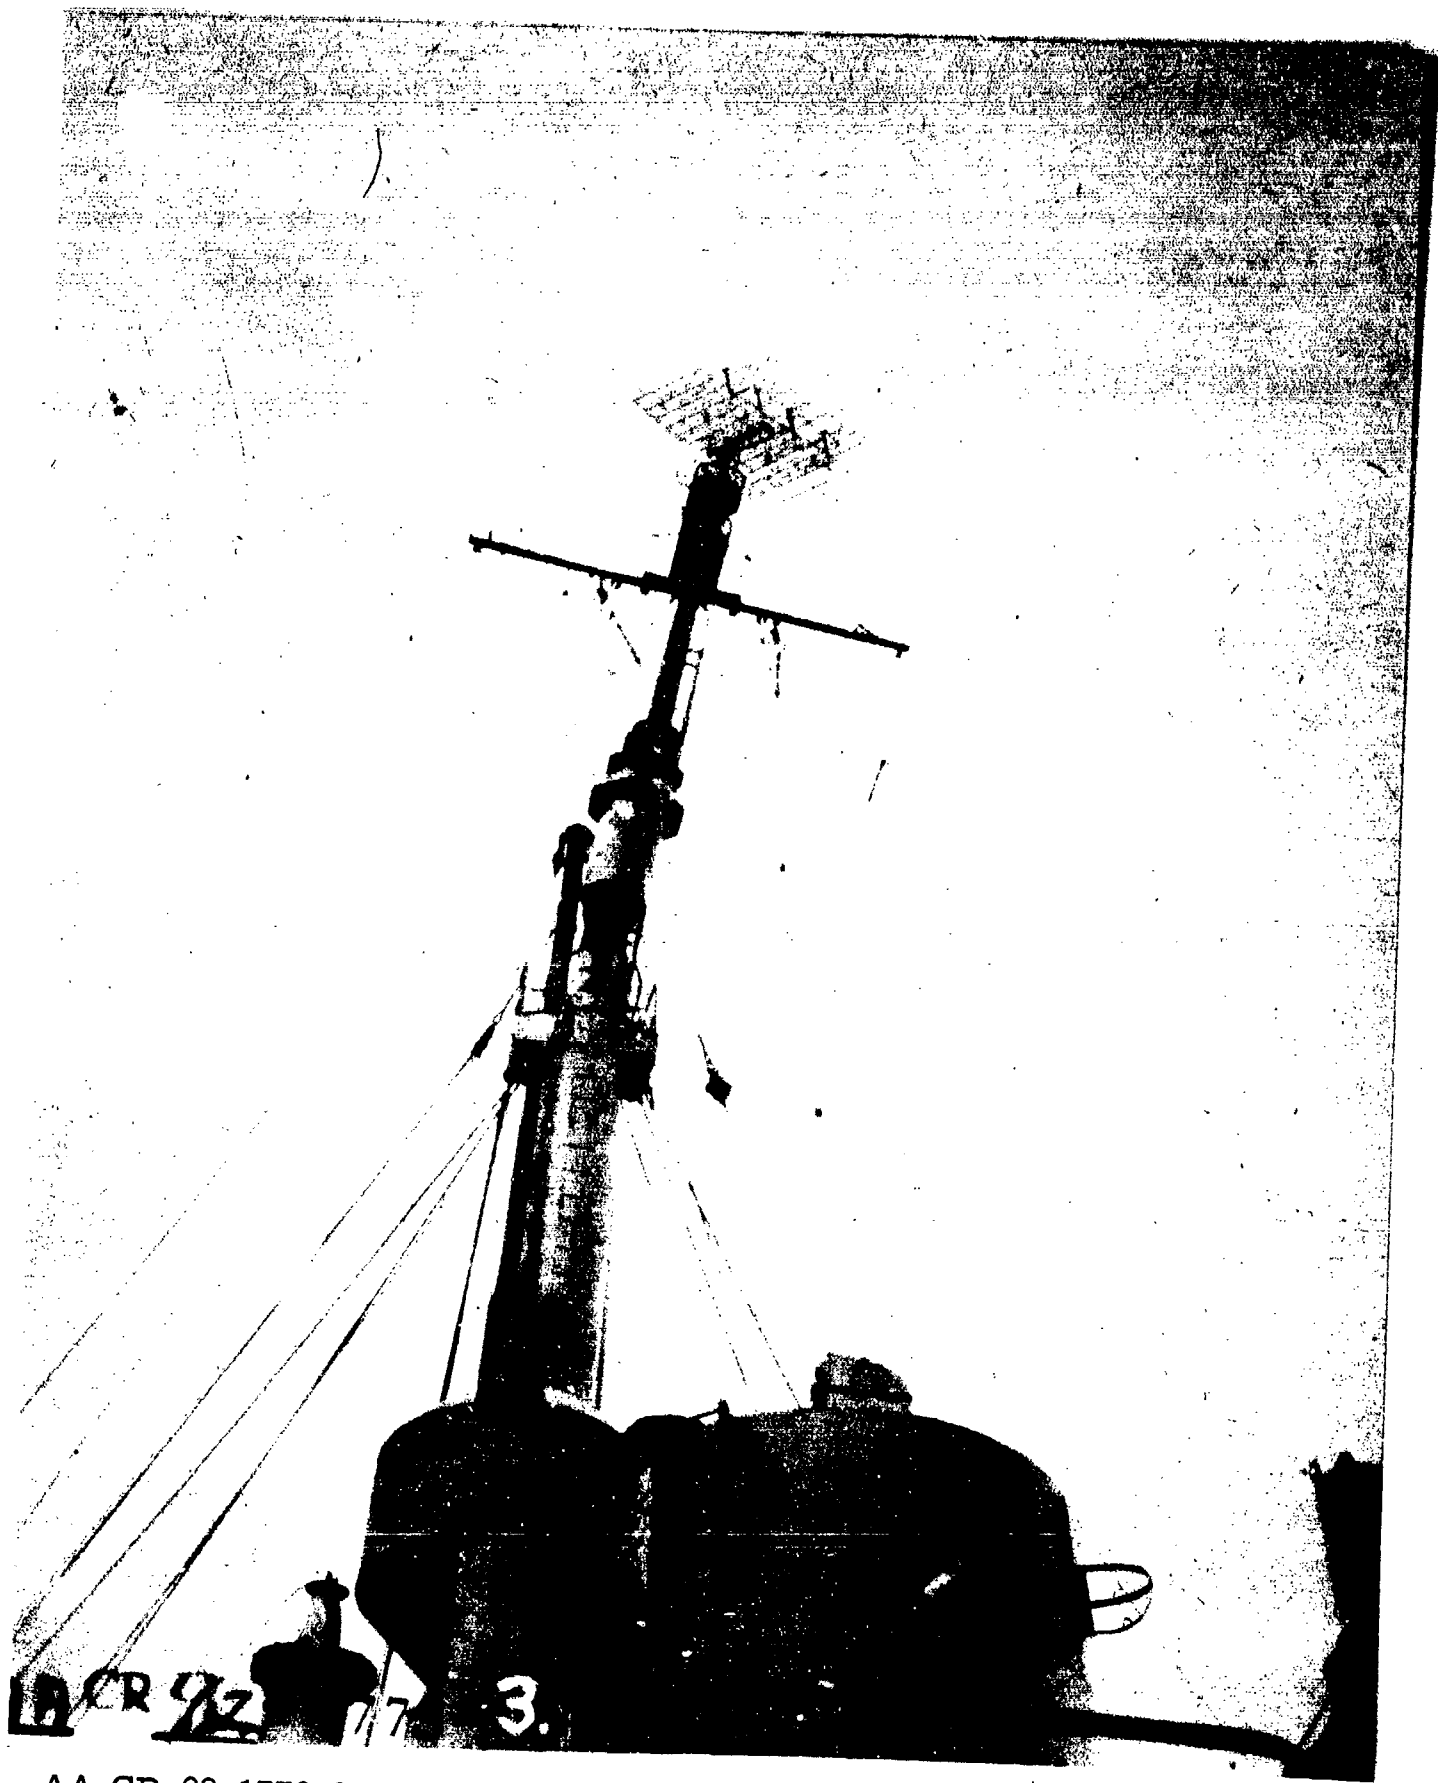
AA-CR-92-1773-3. Looking up and forward, showing bent main topmast and damaged radar screen.

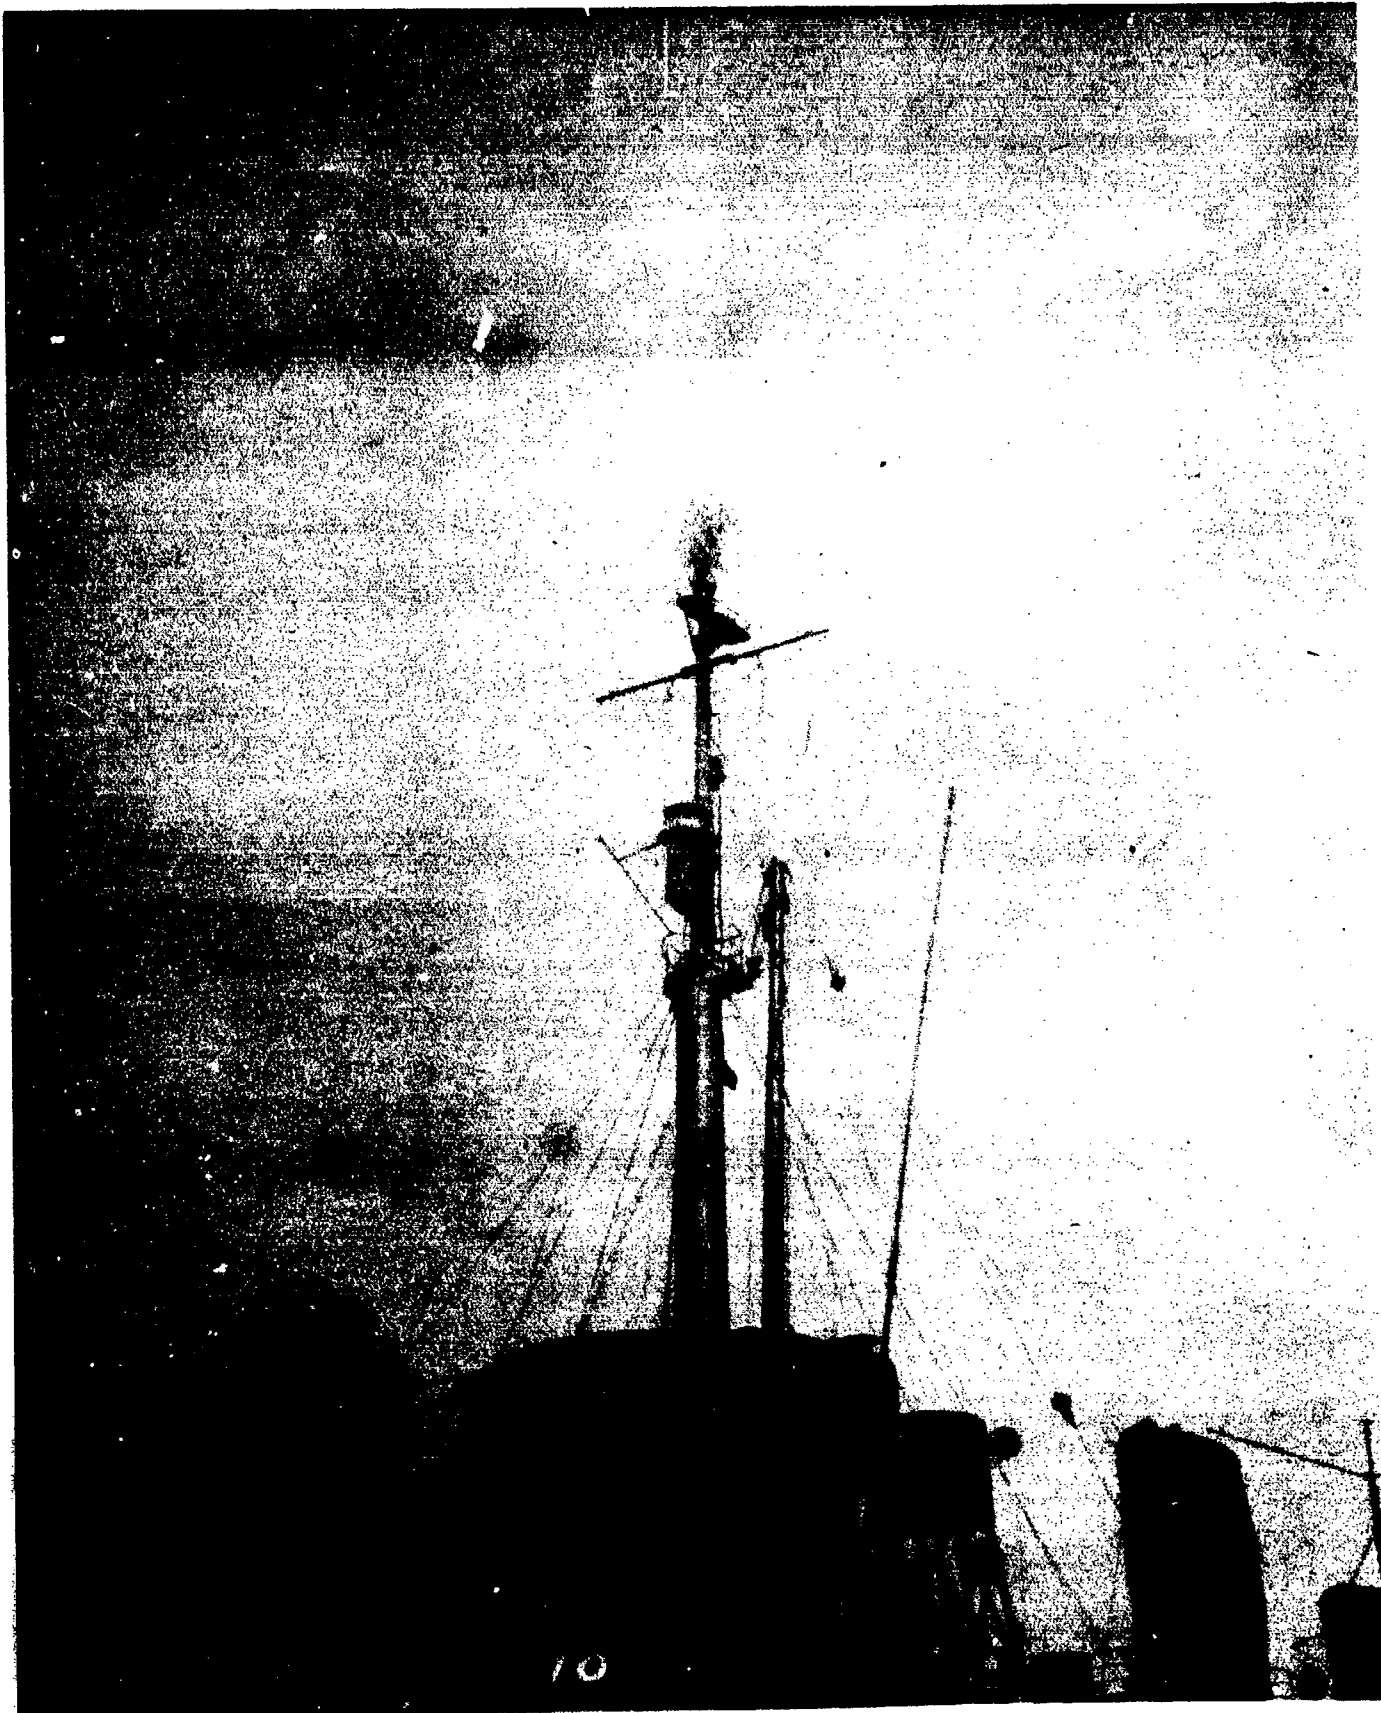
AA-CR-82-1922-10. Looking forward and to port showing damaged radar screen on main mast.

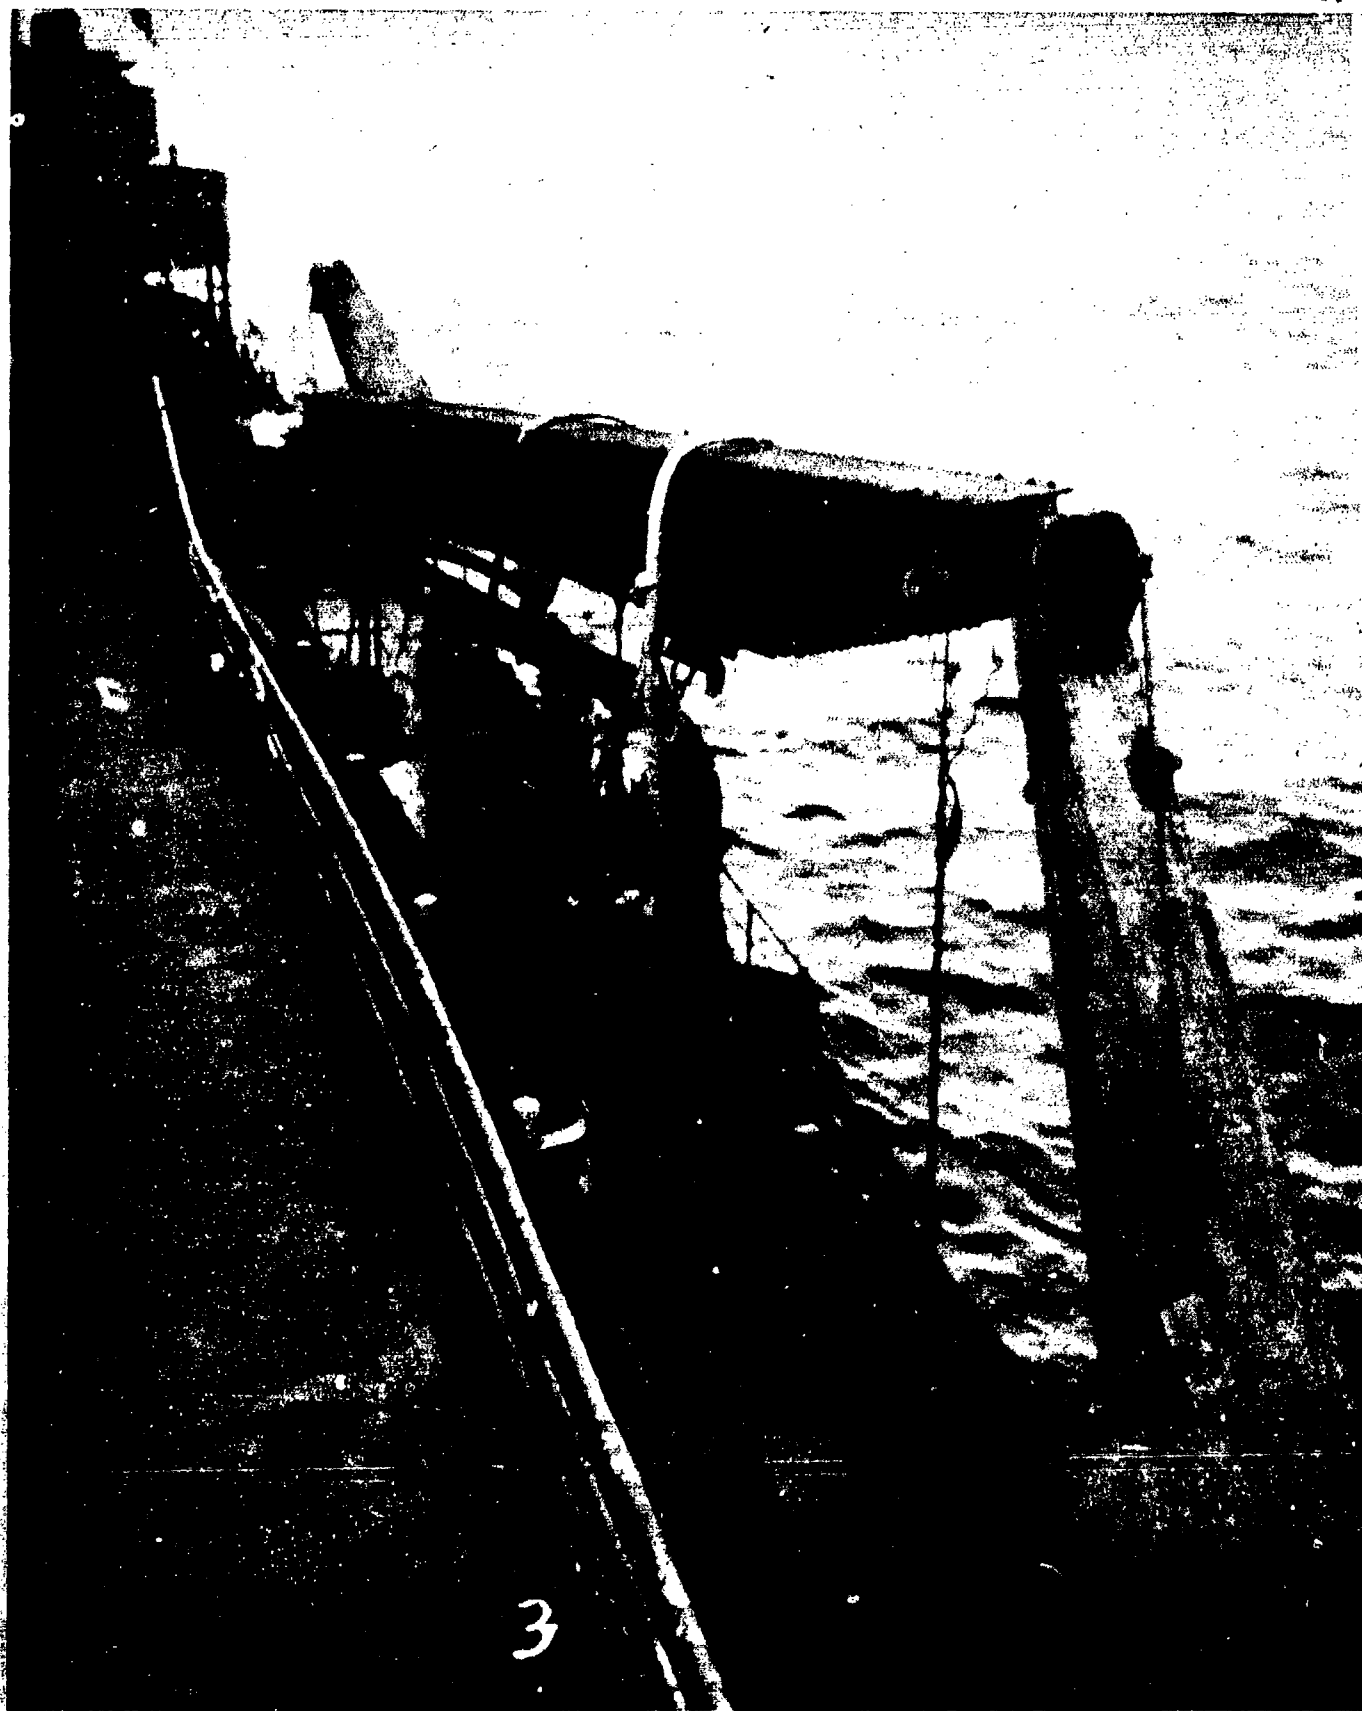
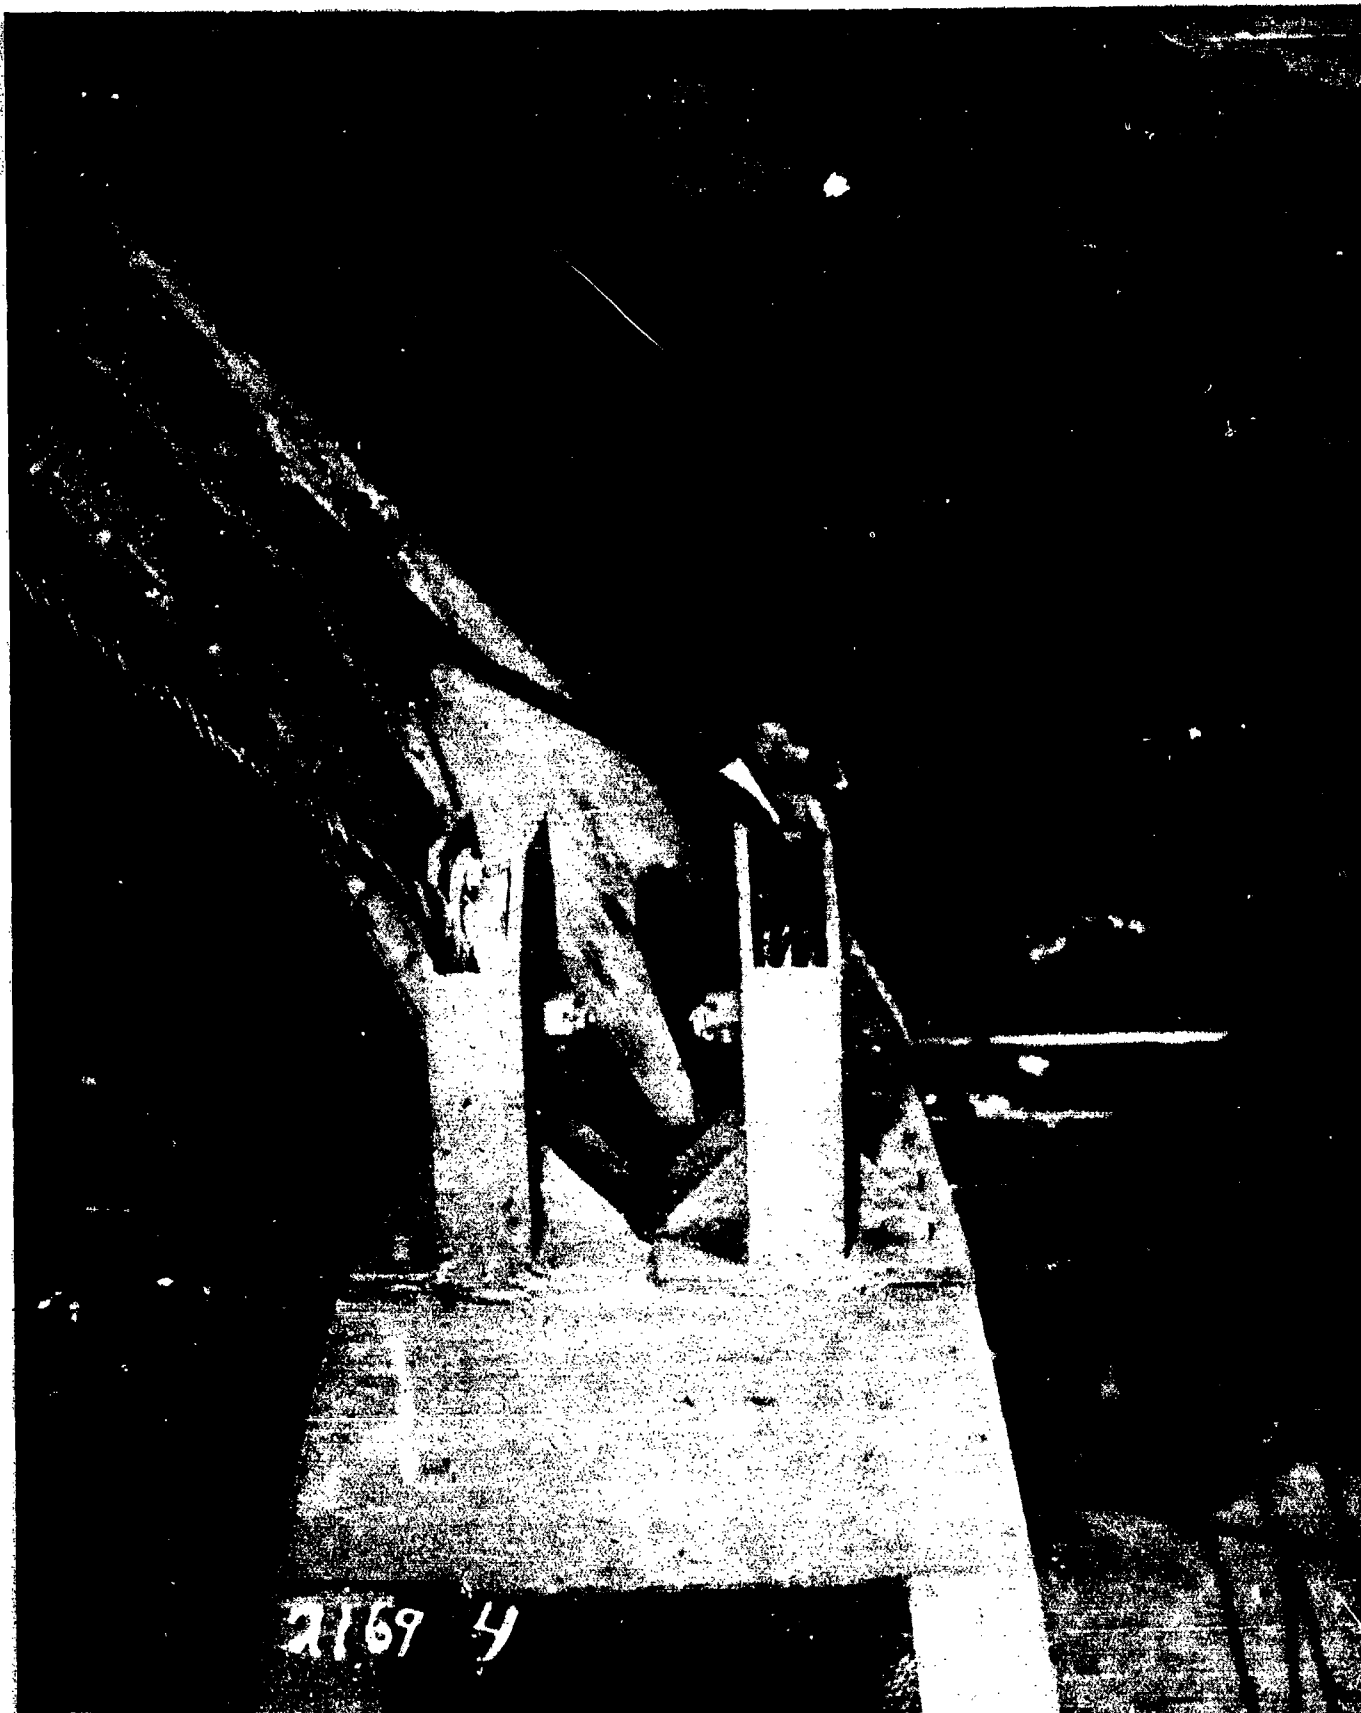
The outer casings of both stacks were considerably pushed in by blast pressure and the galley smokestack was flattened between the casings of the after stack. Both Welin davits on the port side were severely damaged structurally. No. 4 davit (after port) is considered to be beyond repair.

Both port Welin davits are inoperable because of structural damage. Neither can be repaired by the ship's force.

AA-CR-62-2169-3. Looking aft at No. 4 davit.

It is recommended that a study be made to determine whether Welin davits can be made more resistant to blast pressure.
