# BUREAU OF SHIPS GROUP TECHNICAL INSPECTION REPORT

⑥ OPERATION CROSSROADS.  
U.S.S. DAWSON (APA79)

TEST ABLE CU

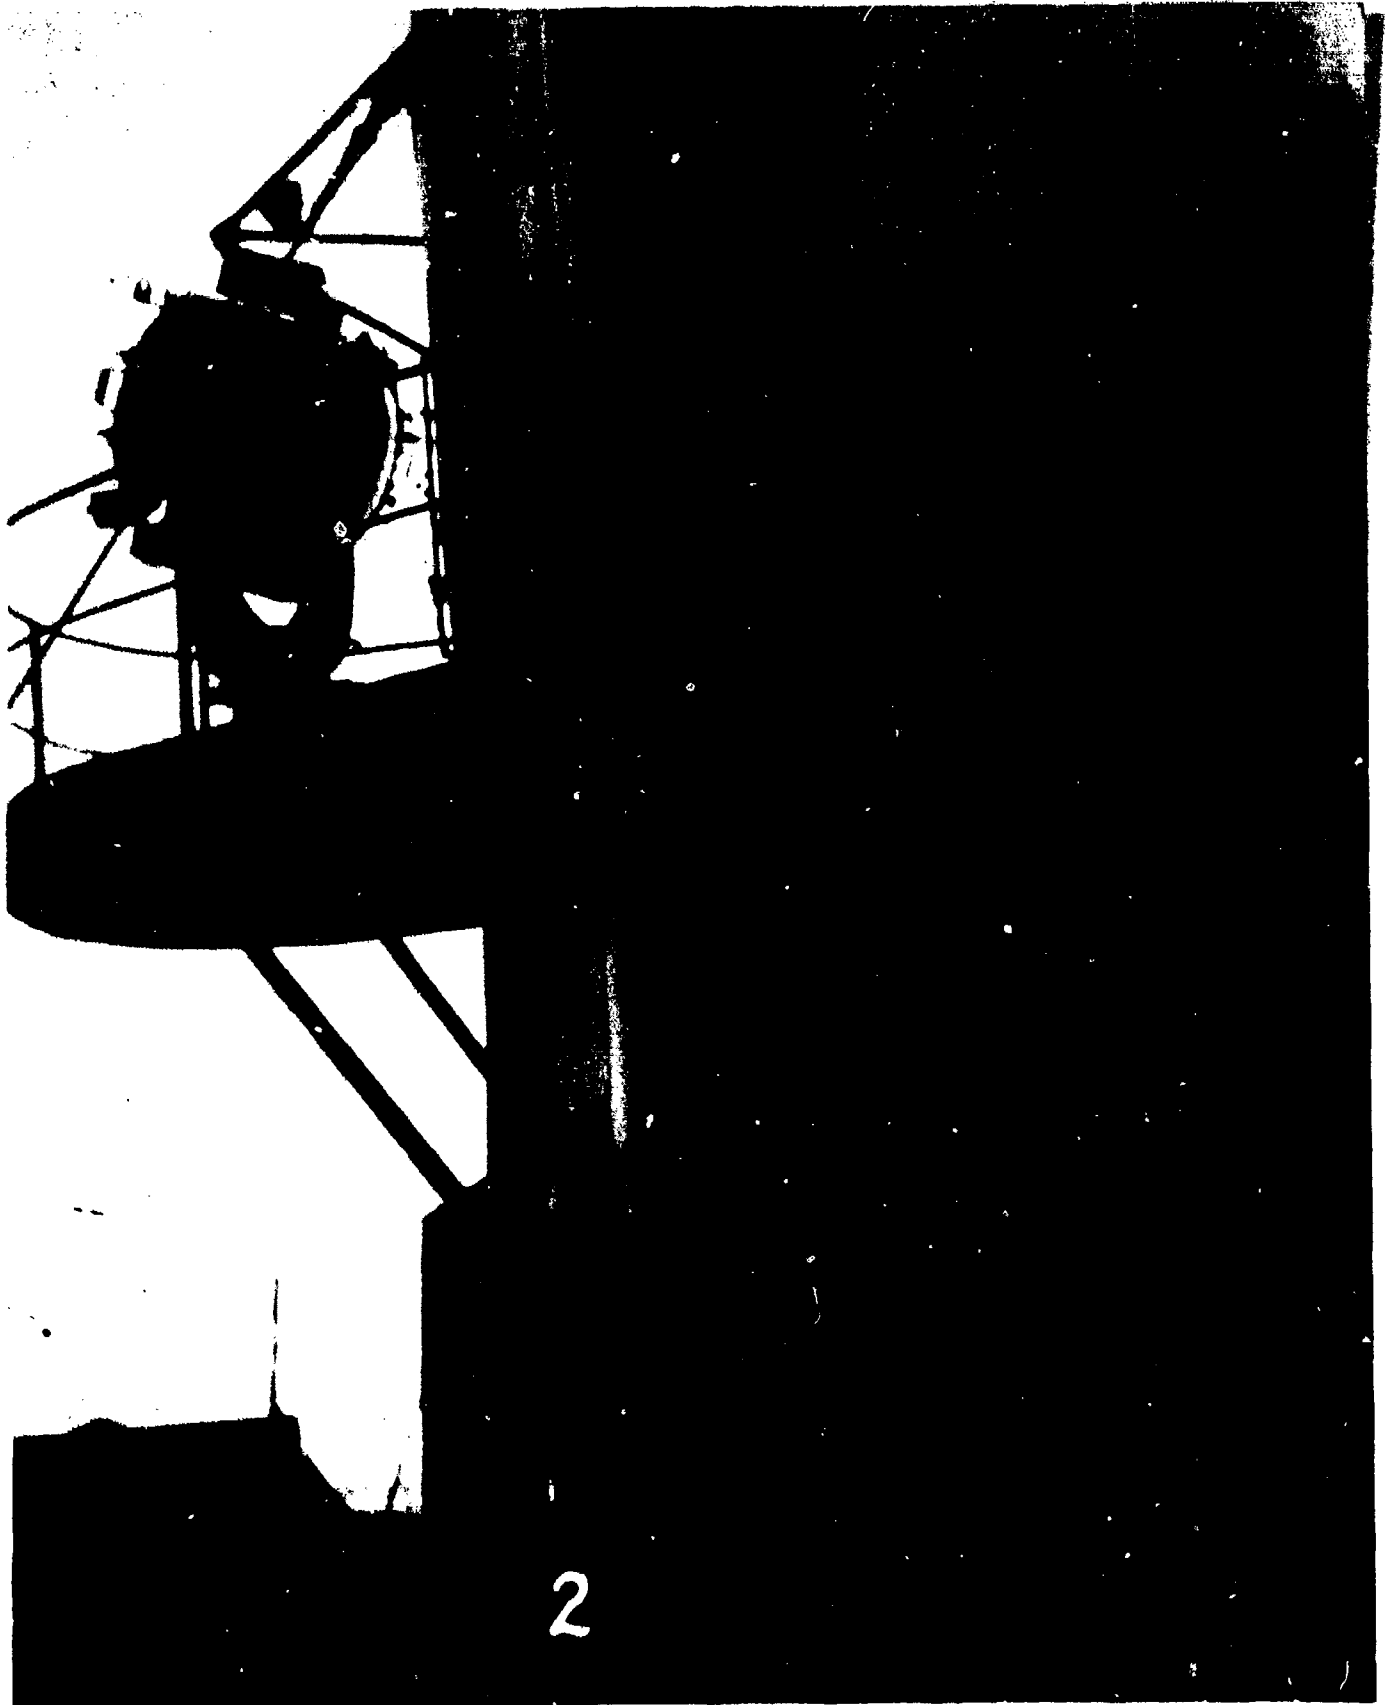
AA-CR-62-2169-2. Forward stack, showing dish on port quarter.

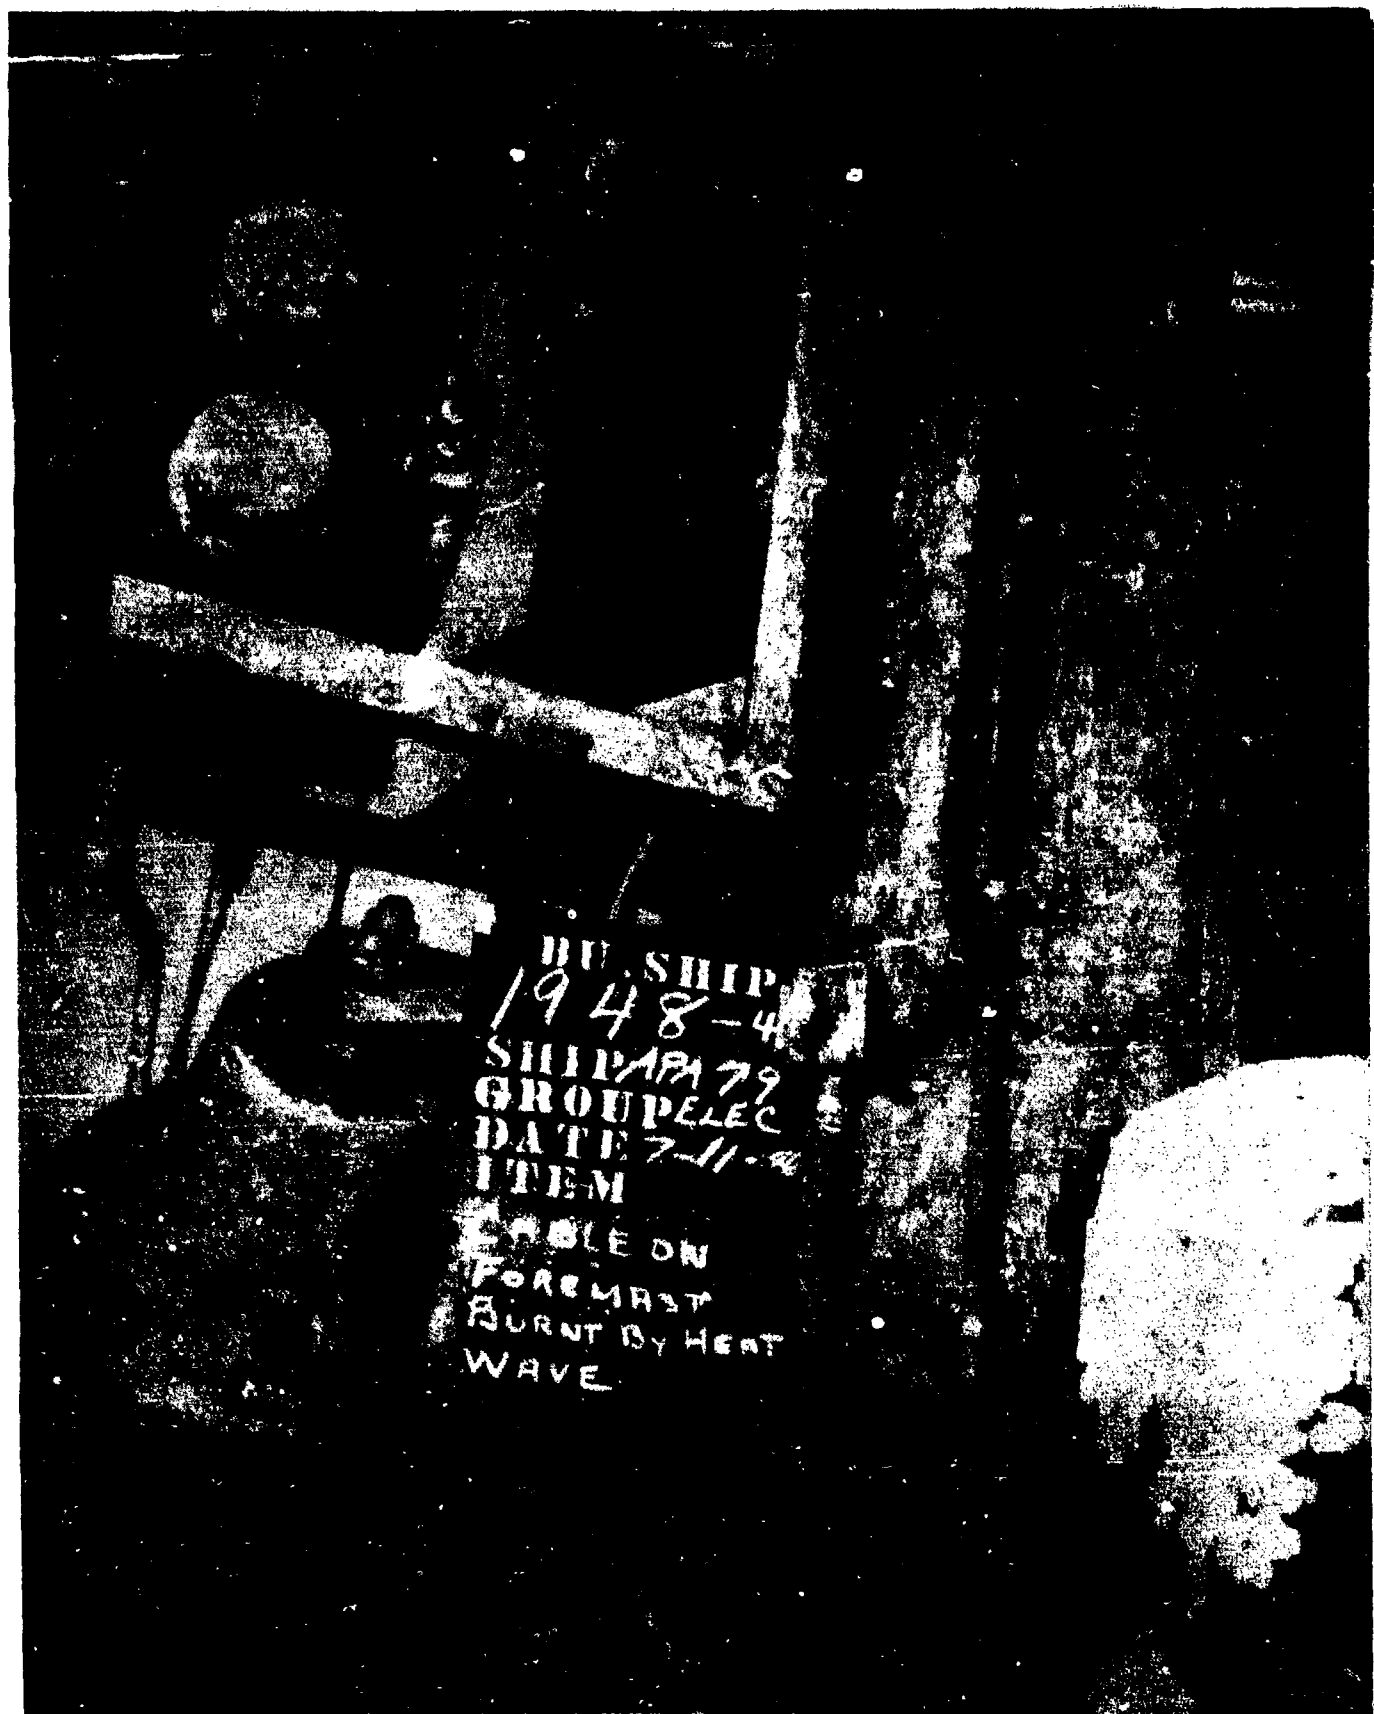
A small fire on the starboard side of the forward deck house at frame 27, destroyed the insulation on a sound powered telephone cable and a call bell cable. It is also believed that this fire contributed to the damage to cables on the lower part of the foremast.

AA-CR-78-1948-4. Showing the effects of radiant heat on the cables installed on the foremast. Note insulation seeping through armor.

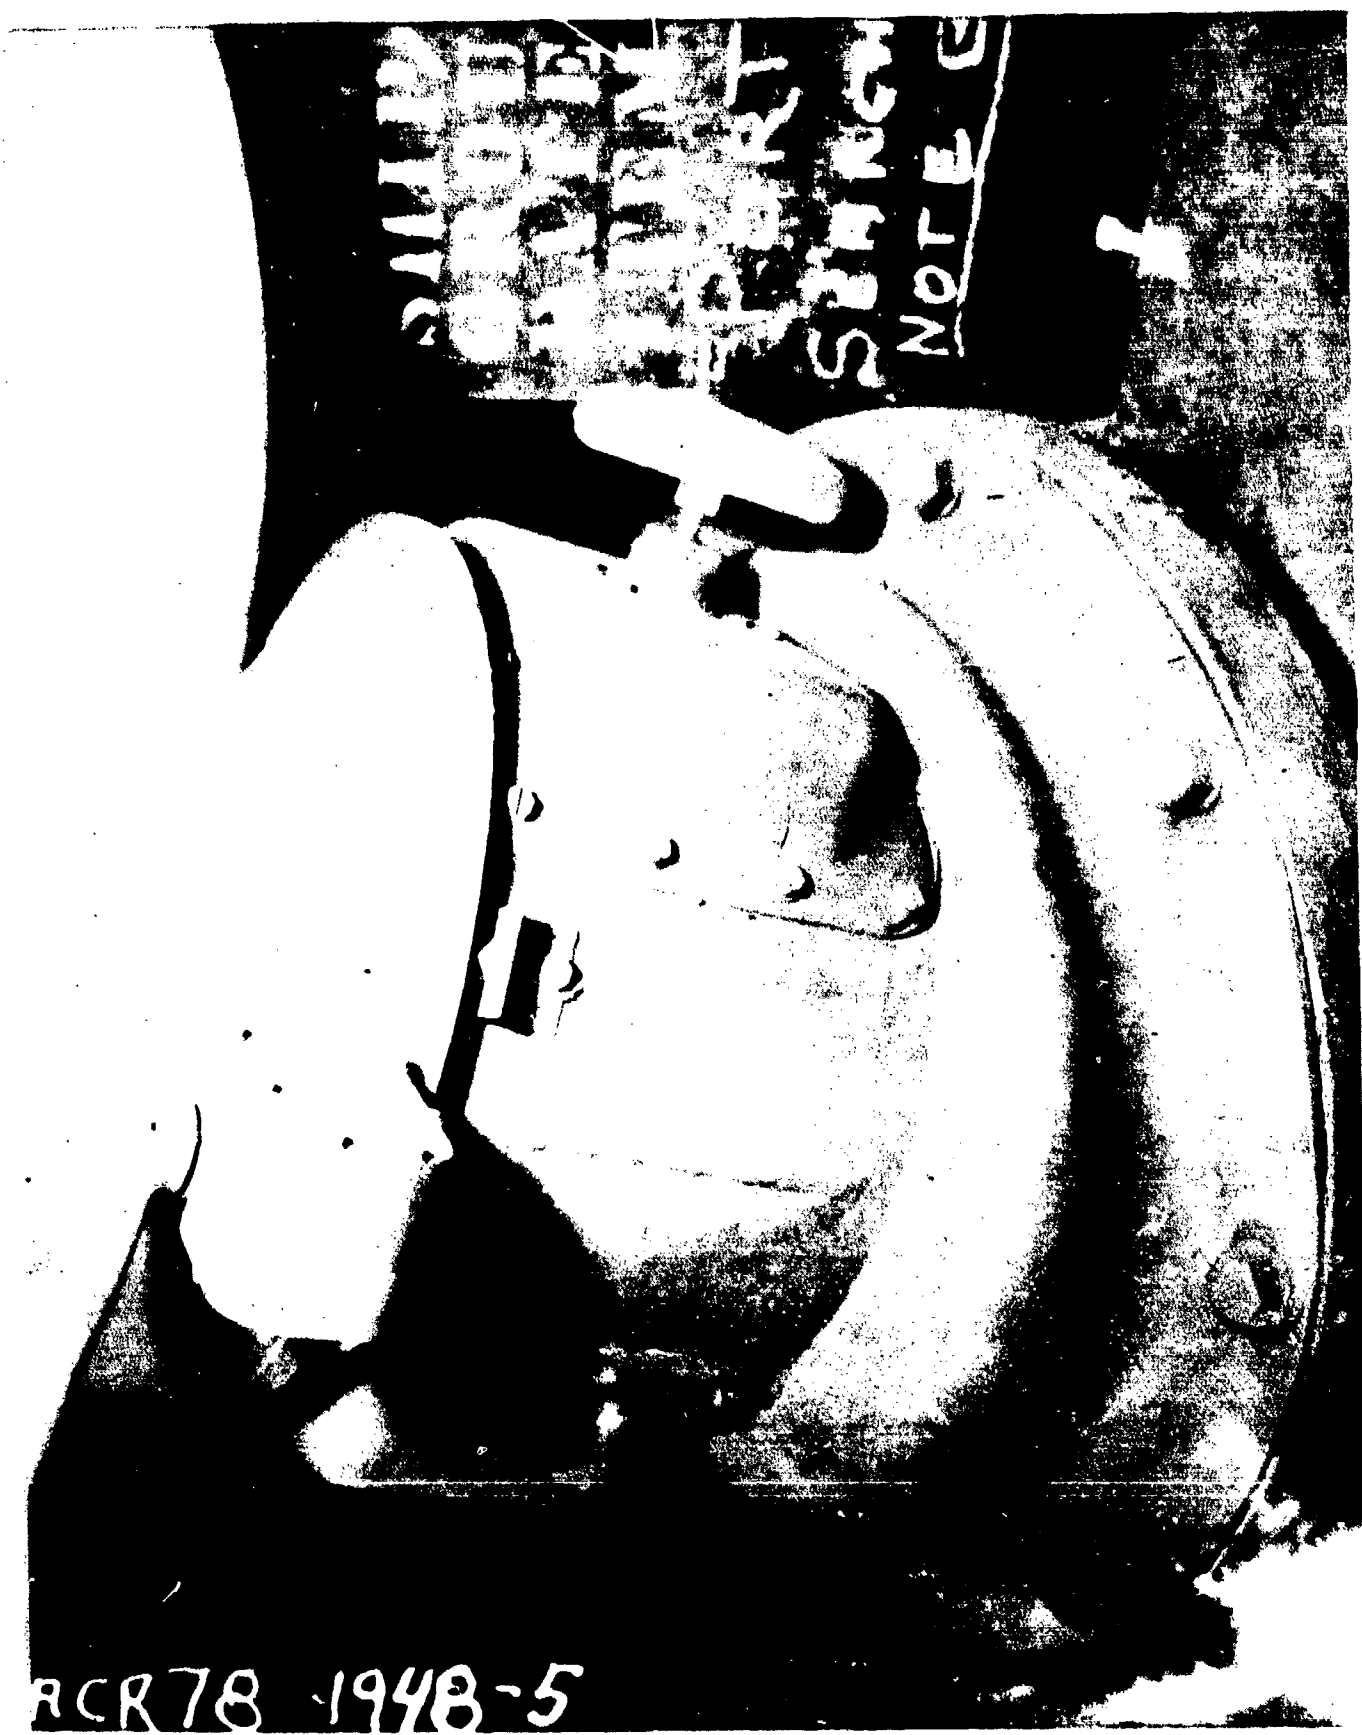
RCR78-1948-5

1. The bases were distorted on both 24 inch searchlights. The port searchlight was rendered inoperable.
2. Three gyro repeaters were dislodged from their gimbals rings. However, no material damage resulted to these repeaters and when they were replaced, they were all operable.
3. The port 12 inch signal searchlight was blown over the side.
4. Number 2 fuel oil service pump was rendered inoperable due to a severed cable in its control circuit.
5. The fire alarm circuit for the after cargo hold was rendered inoperable due to a severed cable.
6. The Anemometer cups were carried away by the air blast.
7. Some lamps were broken, mainly on the port side above the main deck.

AA-CR-78-1948-5. Port 24" searchlight, showing the effects of the air blast on its base.

(a) It is recommended that the 24 inch searchlights be redesigned to have resistance to air blast comparable with that of other electrical equipment.

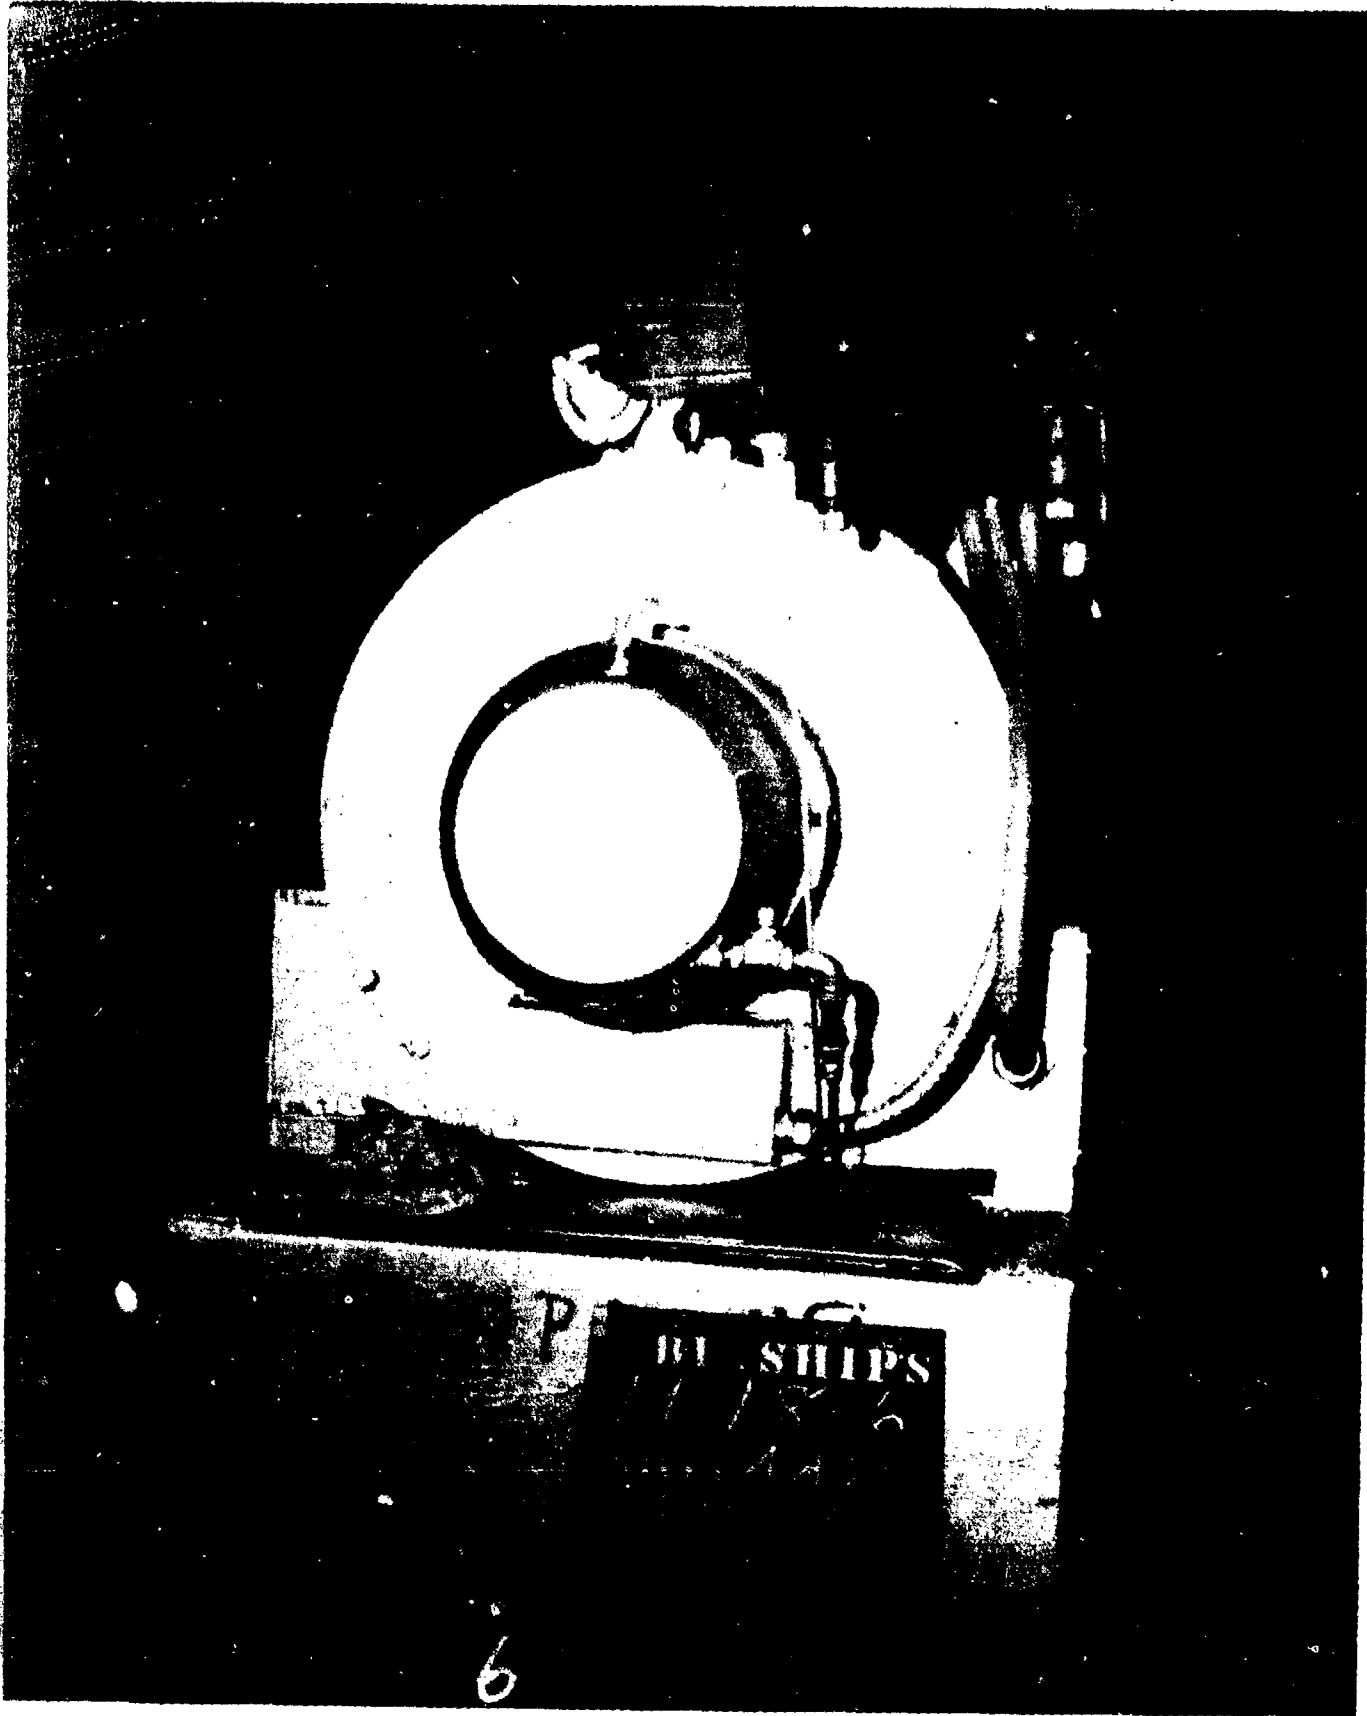
AA-CR-78-1948-6. Showing the damage to the controller for the 60 K.W. diesel generator set. Code 660. 13E1. Forward cargo hold.

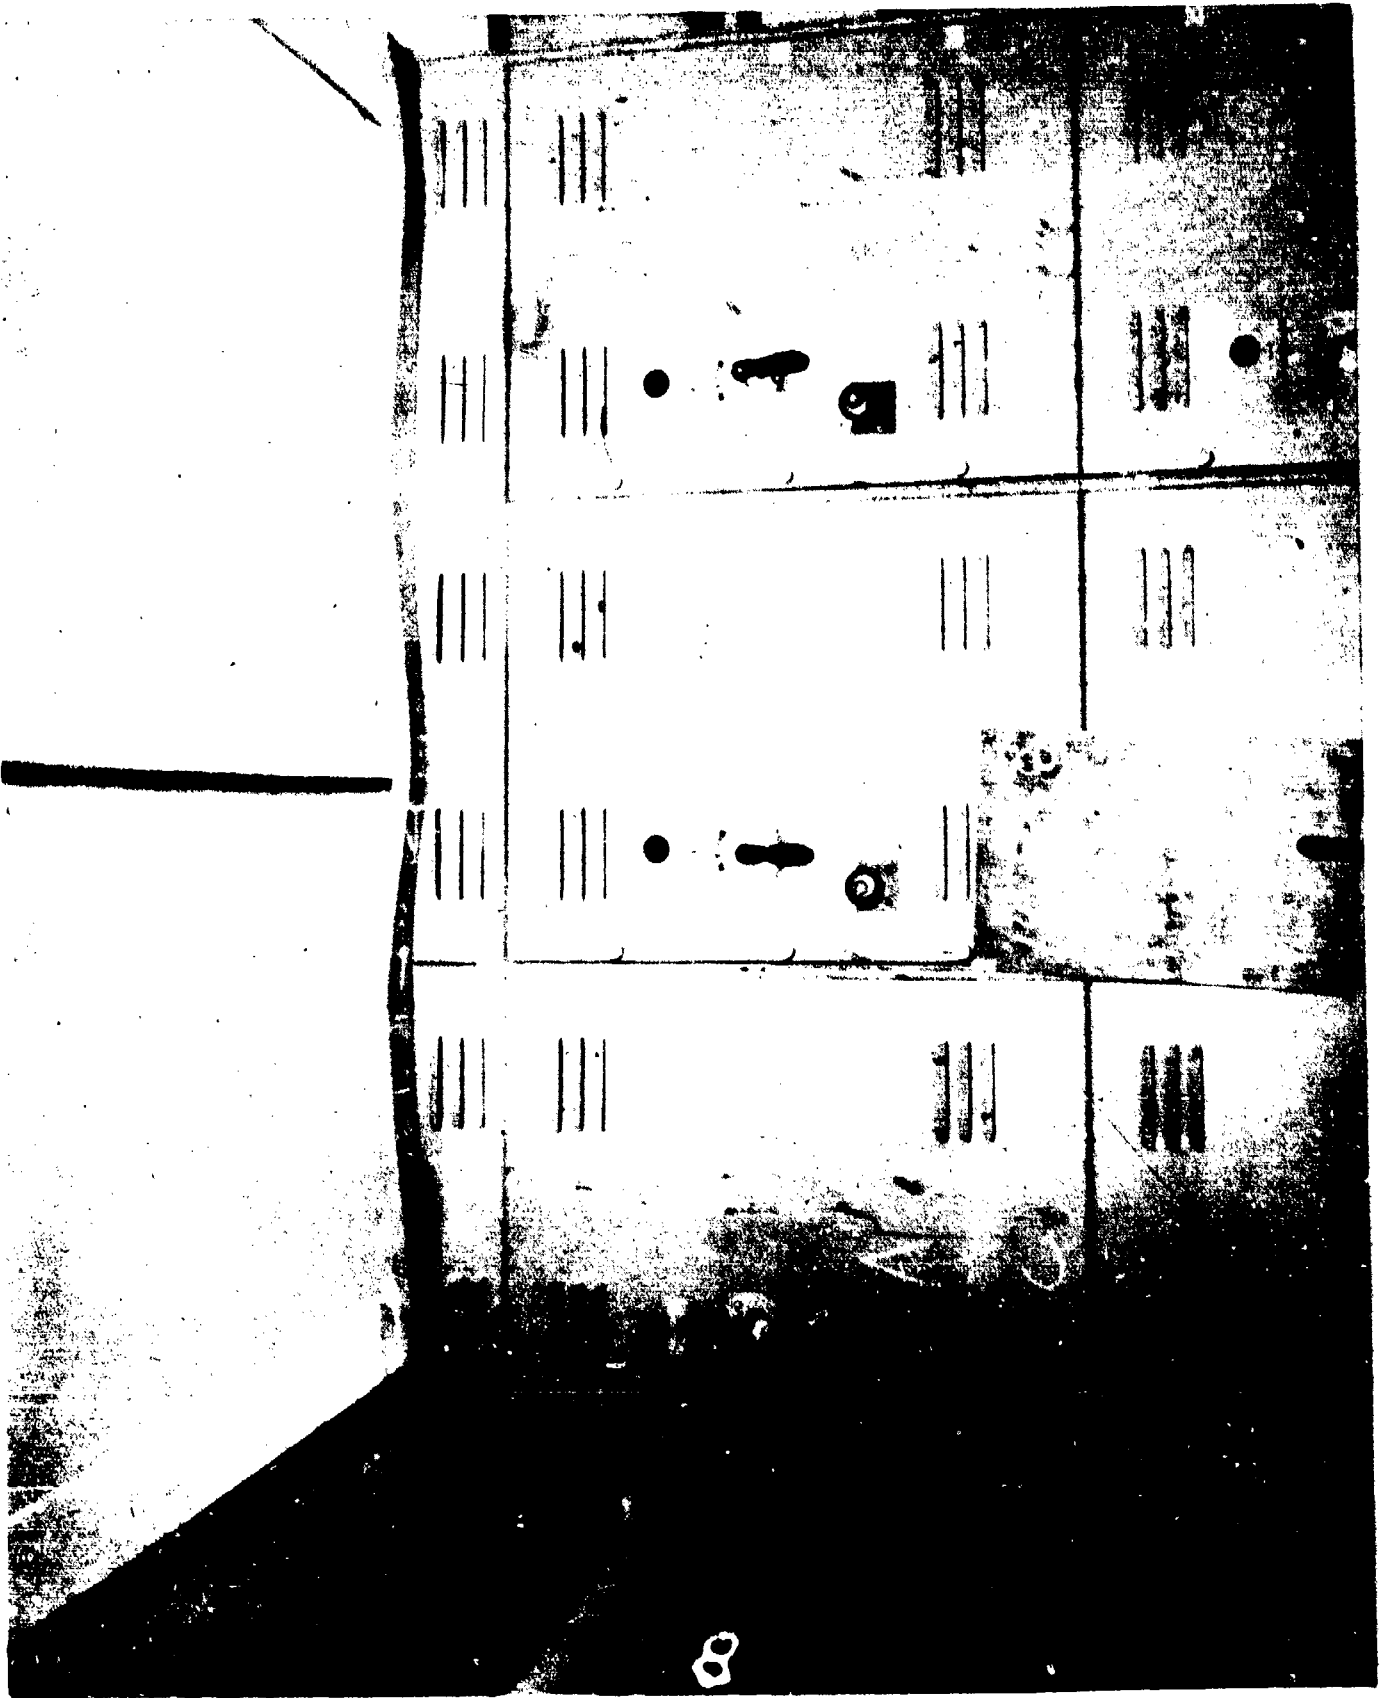
AA-CR-78-1948-8. Showing the damage to the special 660 switchboard, installed for the test, when the overhead came down on it. Code 660, item 13E4. Located in the forward cargo hold.
