# BUREAU OF SHIPS GROUP TECHNICAL INSPECTION REPORT

OPERATION CROSSROADS.  
U.S.S. FILLMORE (APA83).

TEST ABLE

OPERATION CROSSROADS

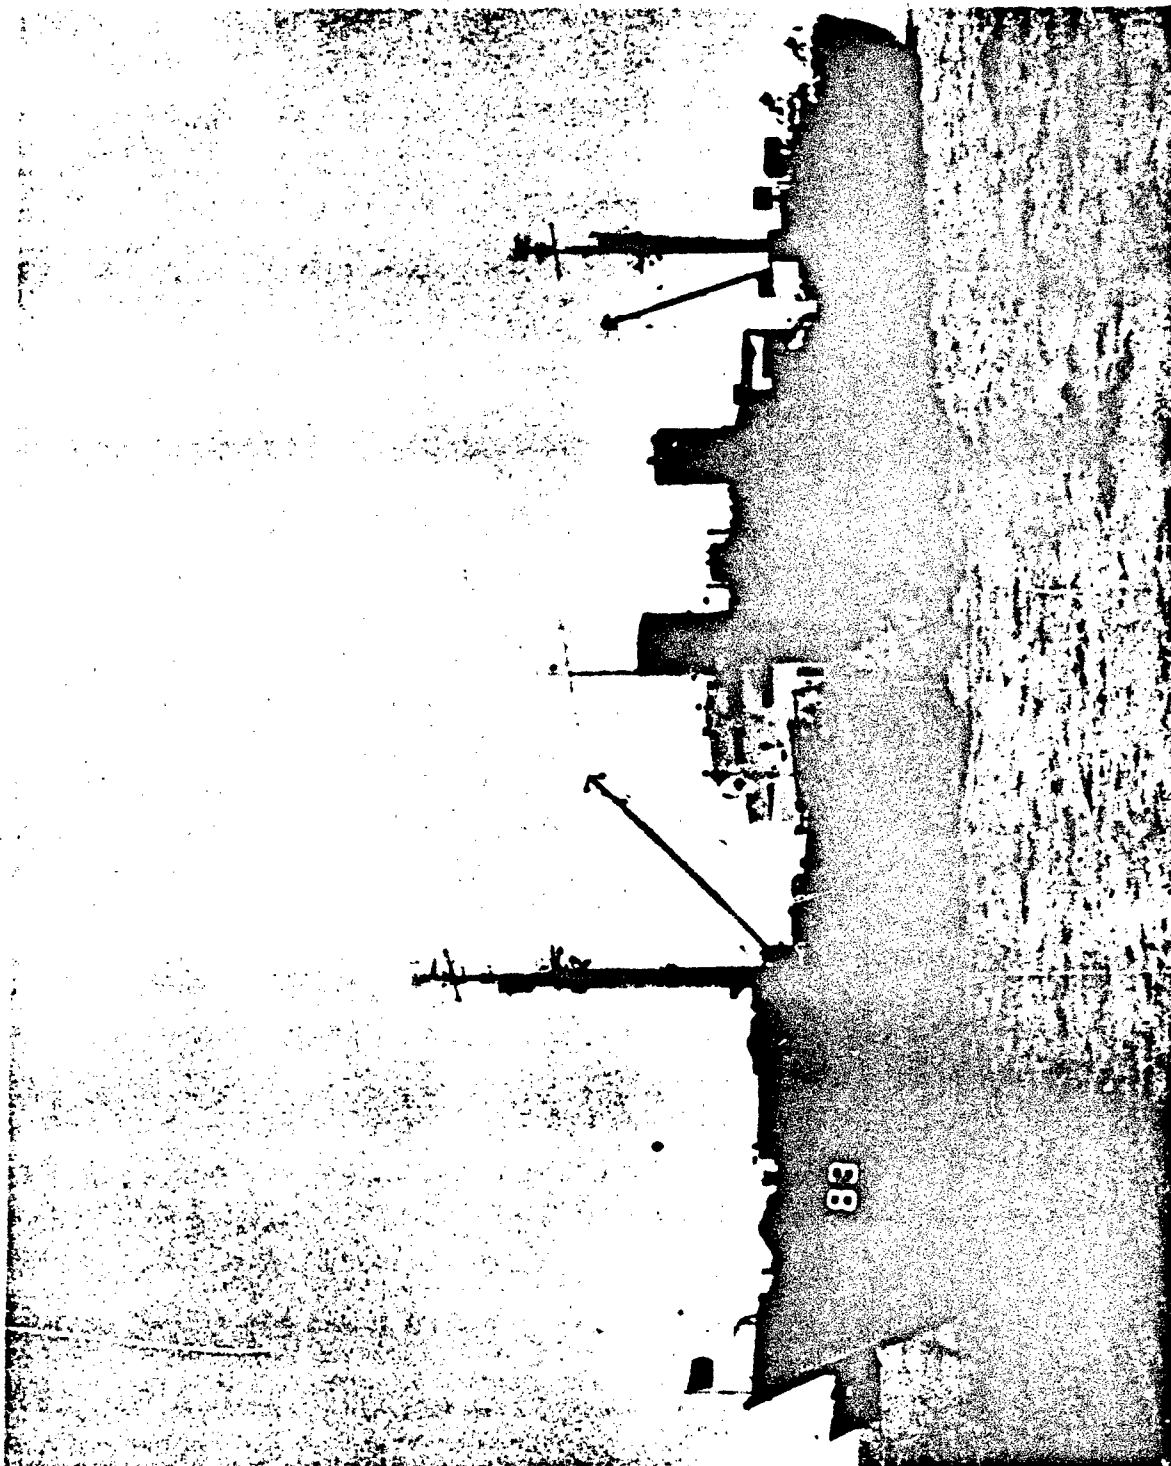
AA-CR-227-49-25. Port bow after Test A.

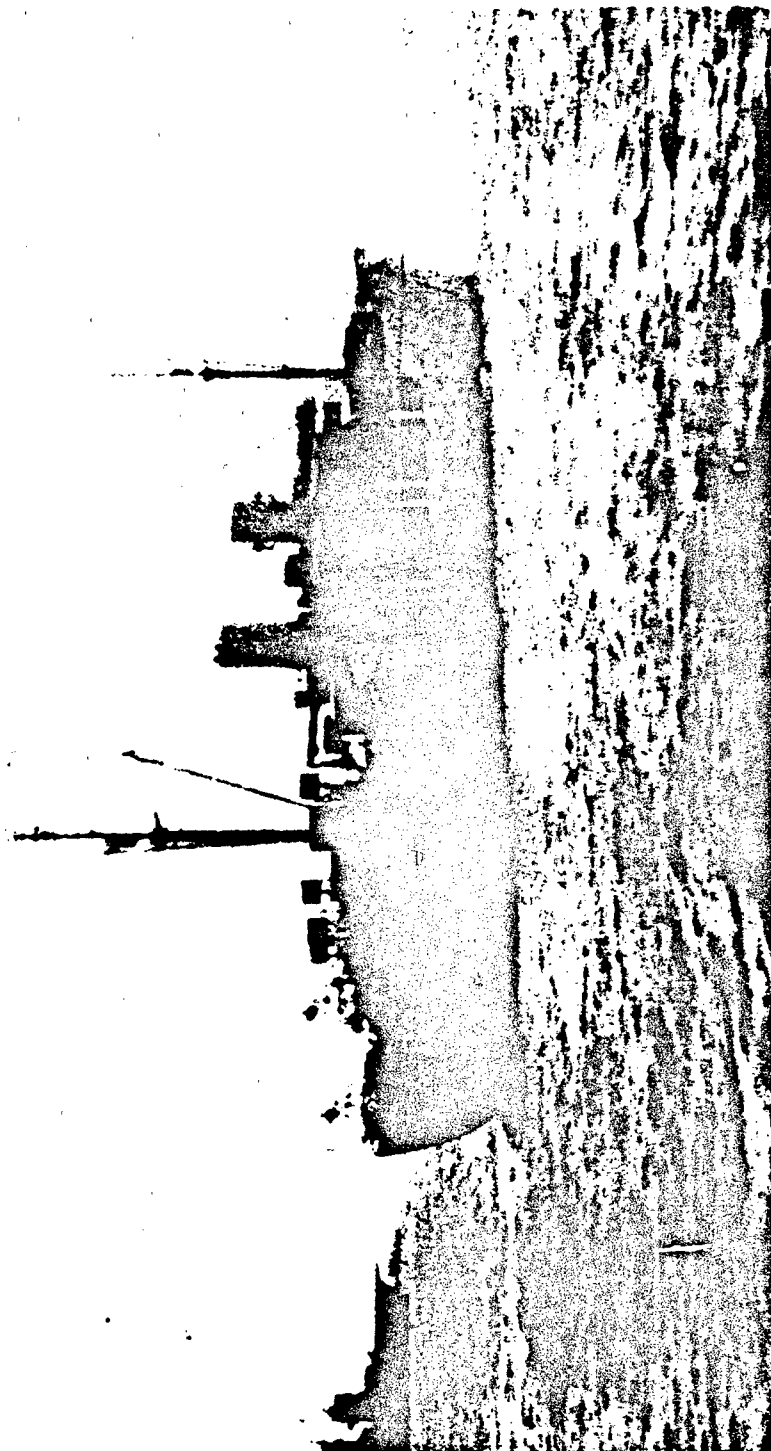
AA-CR-227-49-21. Starboard quarter after Test A.

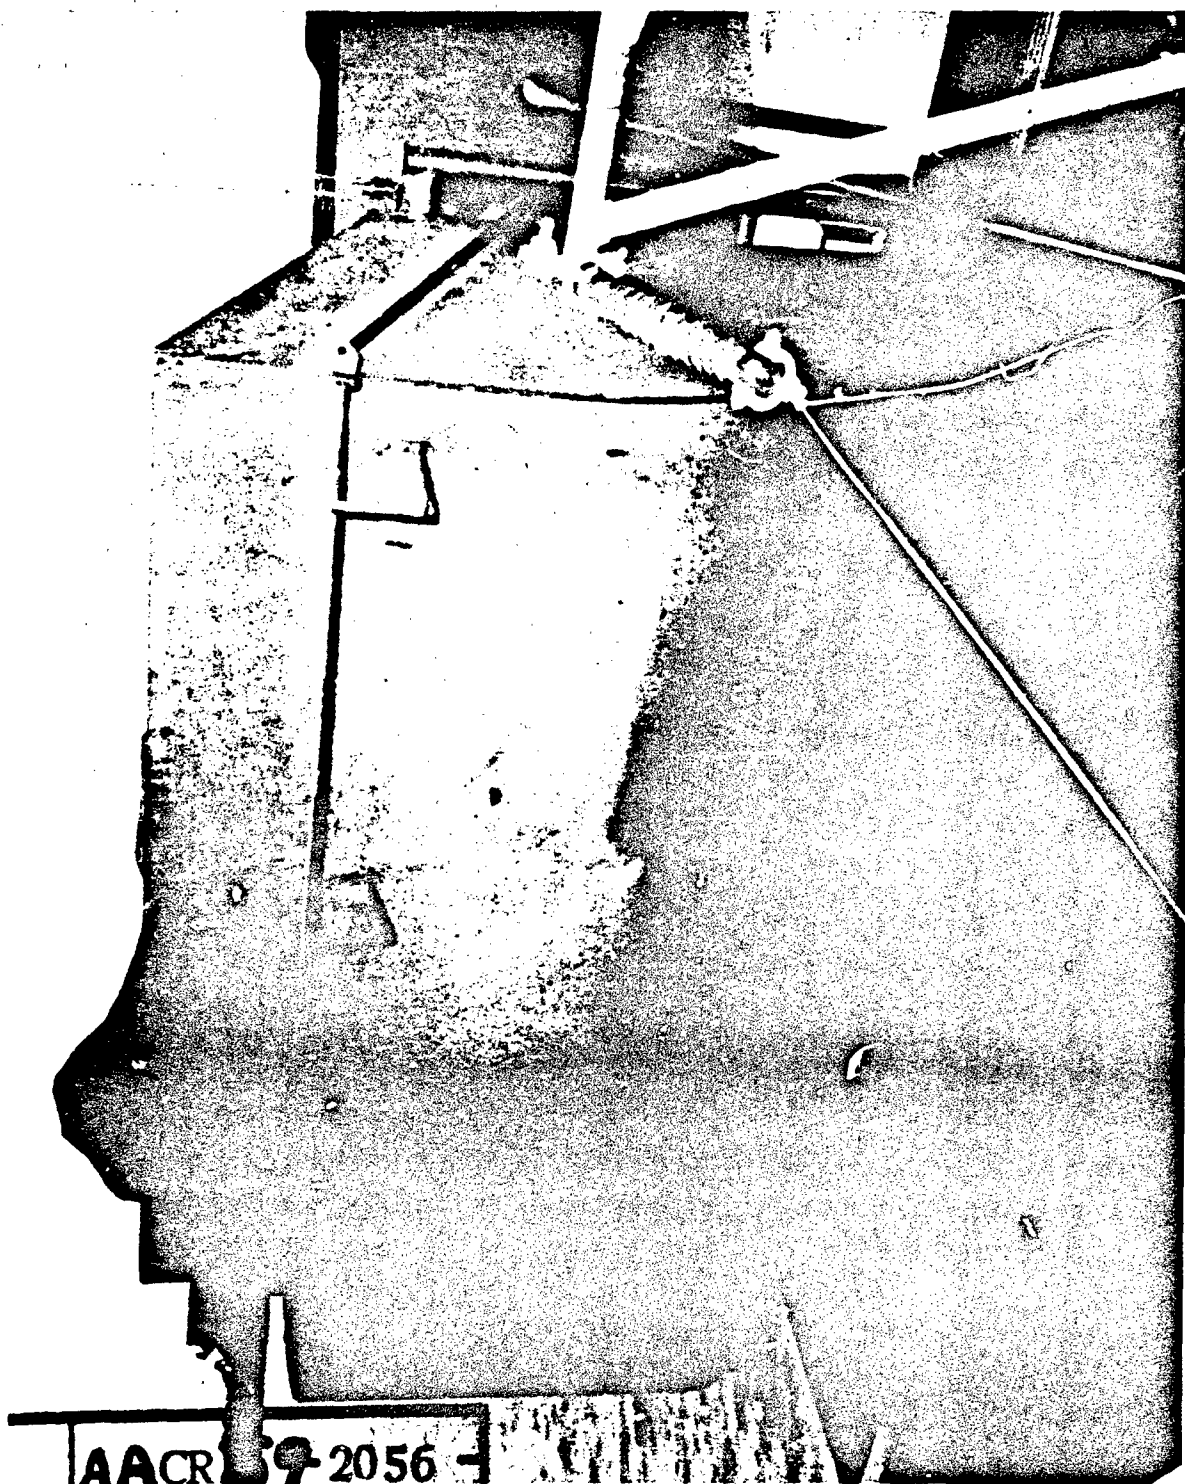
The port flag bag is dished a maximum of 6'' from blast. (photo 2058-3, page 35 ). The sheet metal signal shack (6' x 6' x 4') is dished about 6'' around the door in the after bulkhead.

AA-CR-59-2056-3. After side of port flag bag.

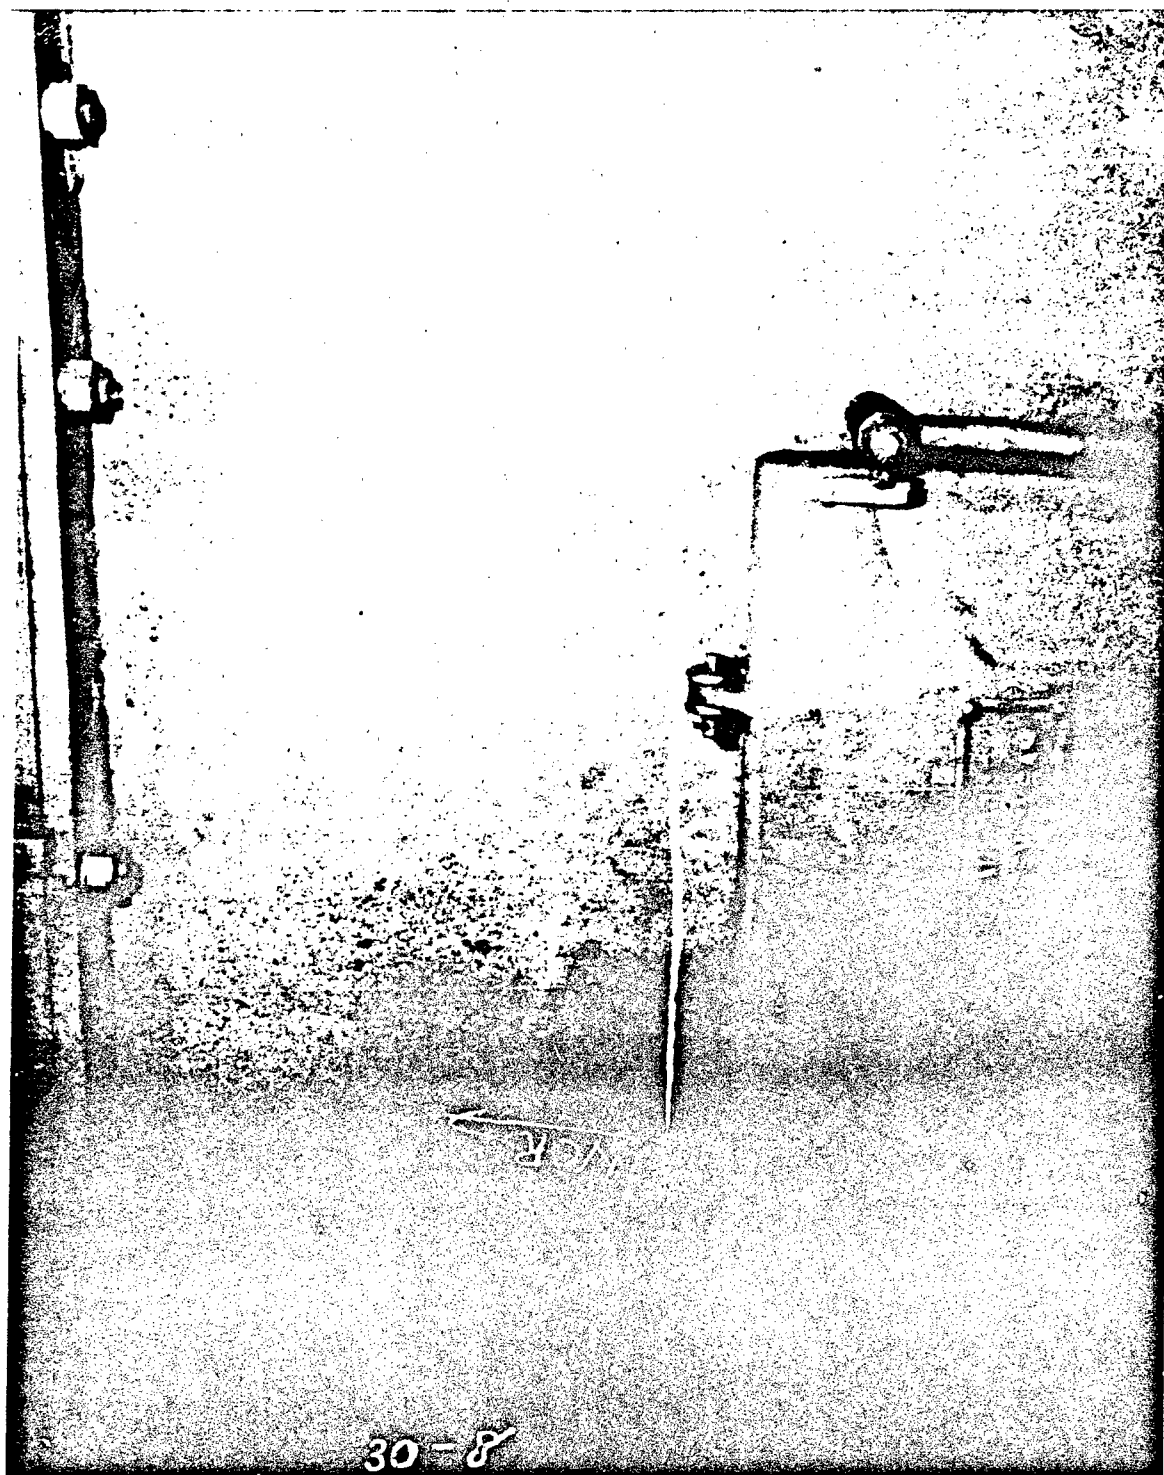
AA-CR-65-1730-8. Scorched paint on cargo winch upper deck, frame 127, port.
