TECHNICAL INSPECTION REPORT

(6) OPERATION CROSSROADS.
U.S.S. GASCONADE (APA85).

TEST ABLE [U].

U.S.S. GASCONADE (APA 85)

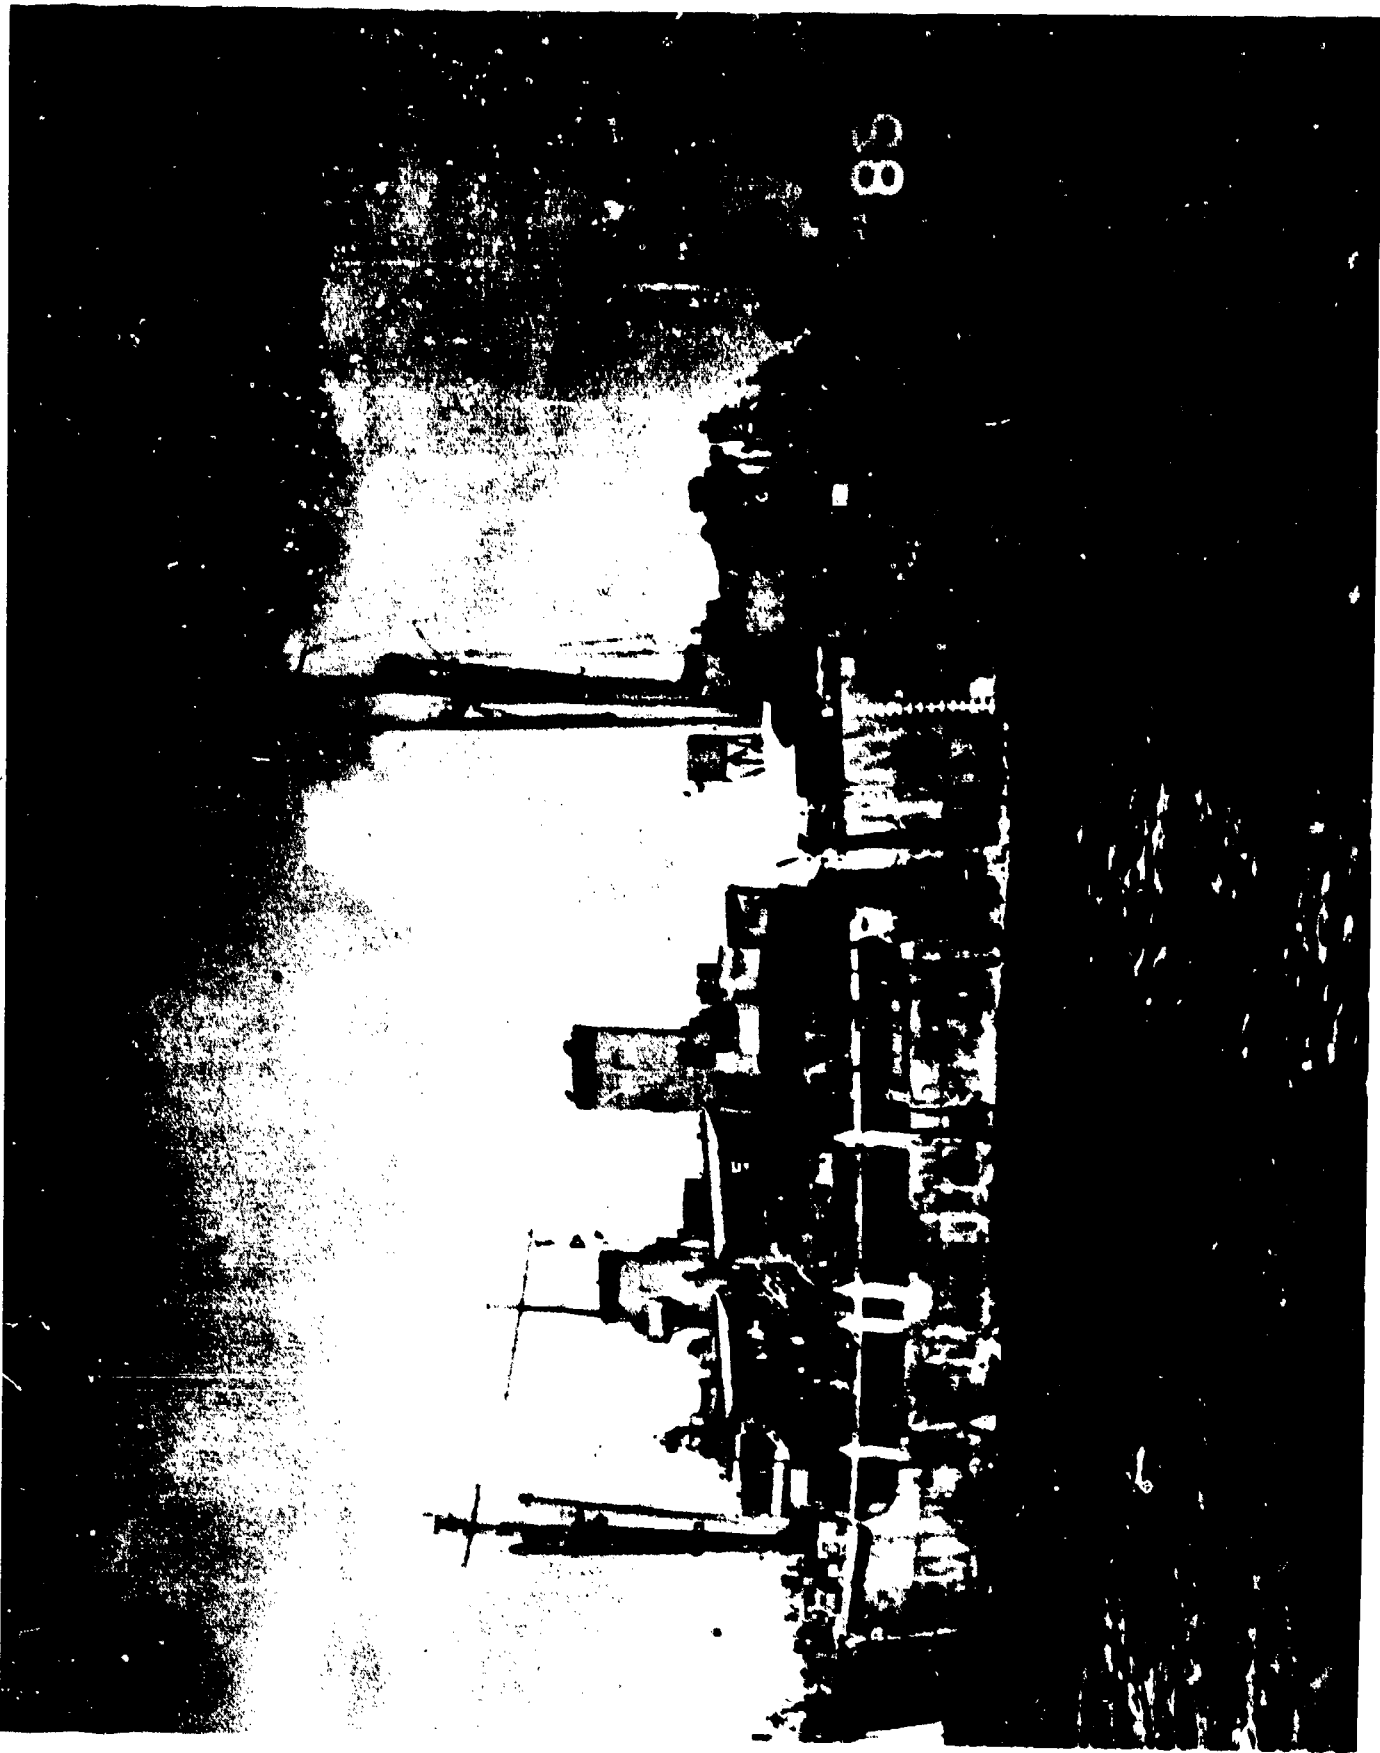
AA-CR-227-50-64. View from off port quarter after Test A.

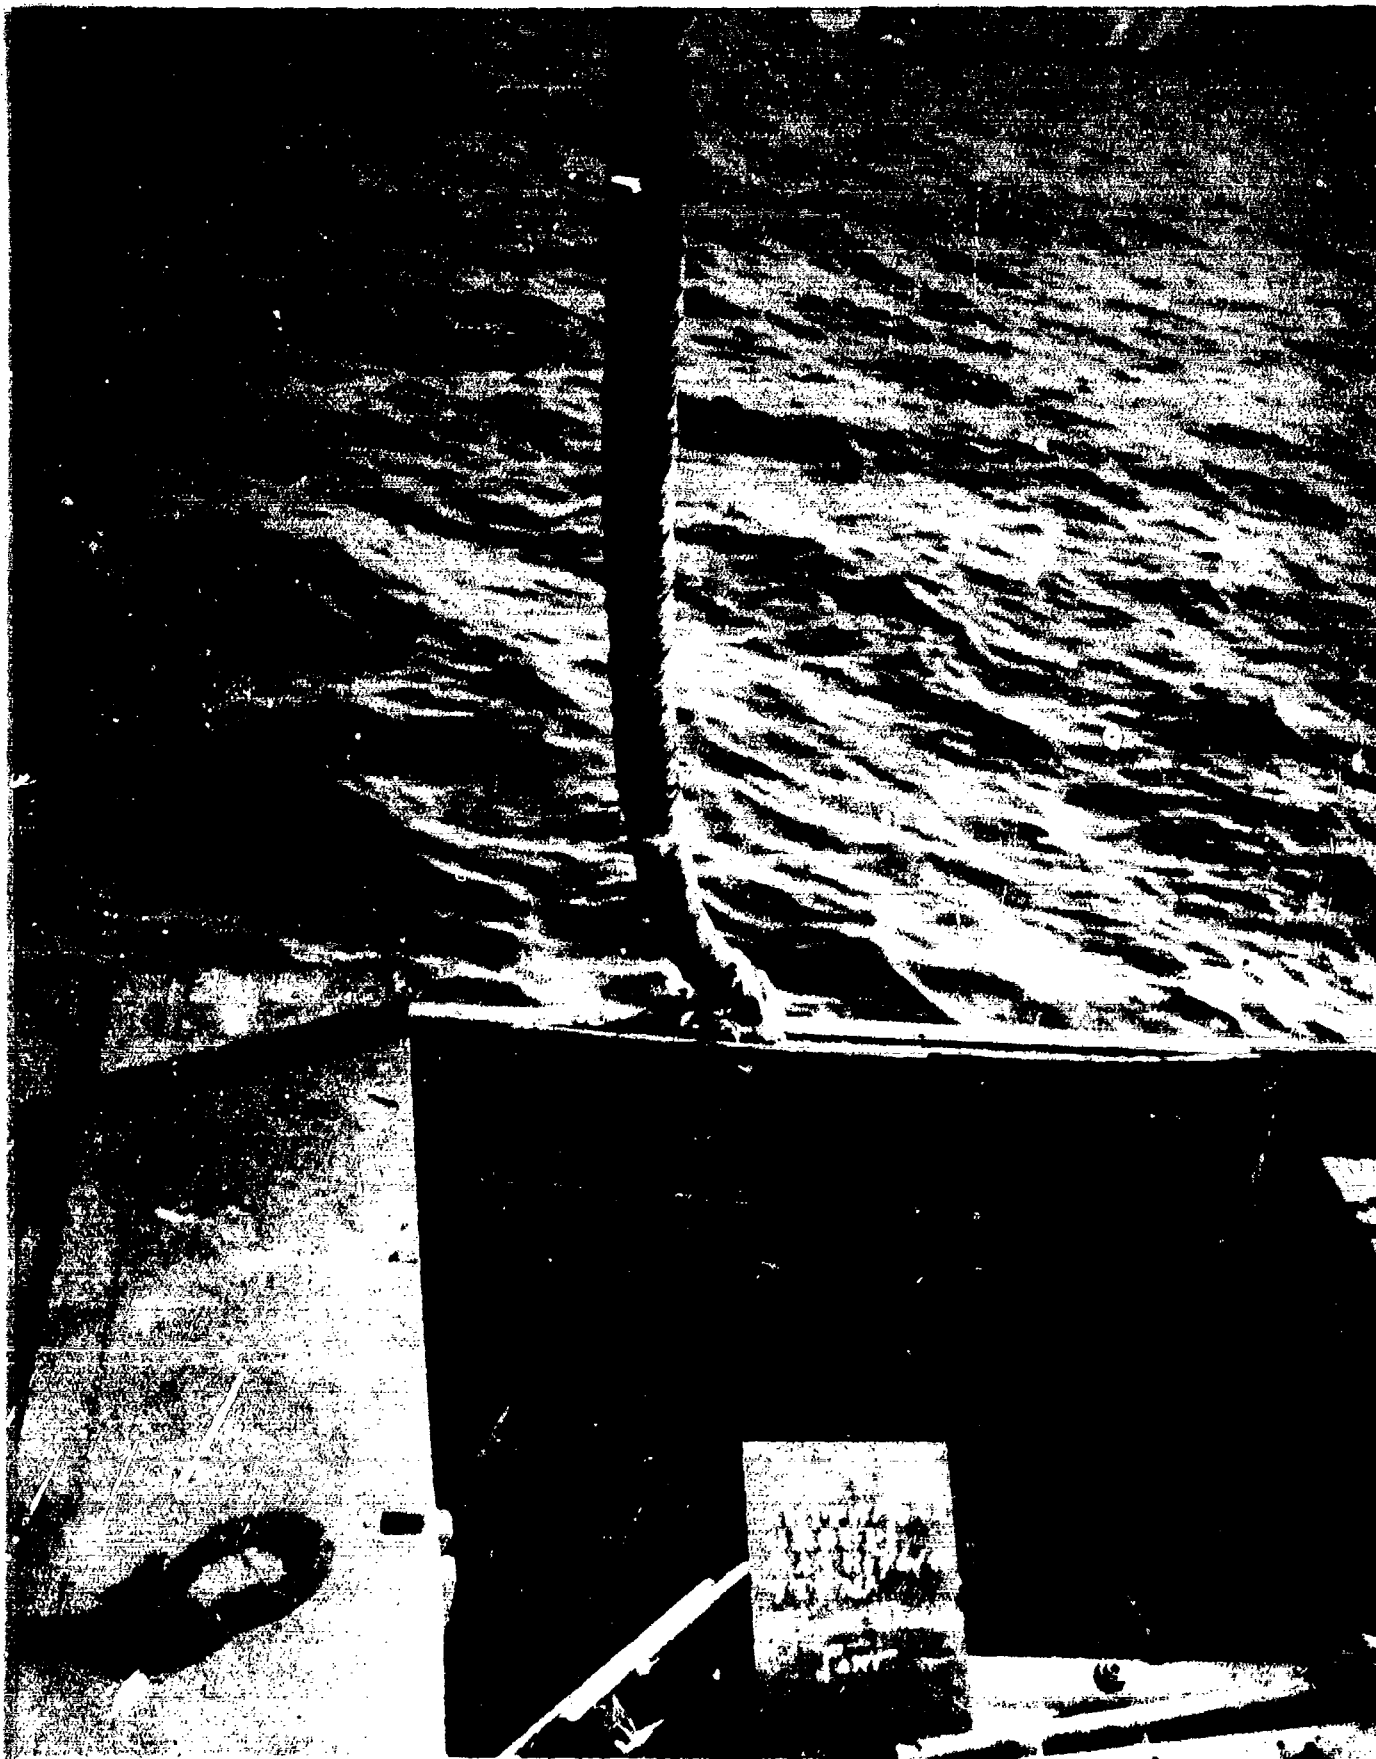
AA-CR-65-1737-8. Detail of scorched gripe on No. 2 Welin davit.

1. Graphite grease on running rigging dried to caked carbon, reducing flexibility.
2. Boat gripe davit 4, burned down to bare wire; gripe on davit 2, scorched.
