BUREAU OF SHIPS
TECHNICAL INSPECTION REPORT

BEACHED LANDING CRAFT
TEST ABLE [U].8

⑥ OPERATION CROSSROADS

BEACHED LANDING CRAFT

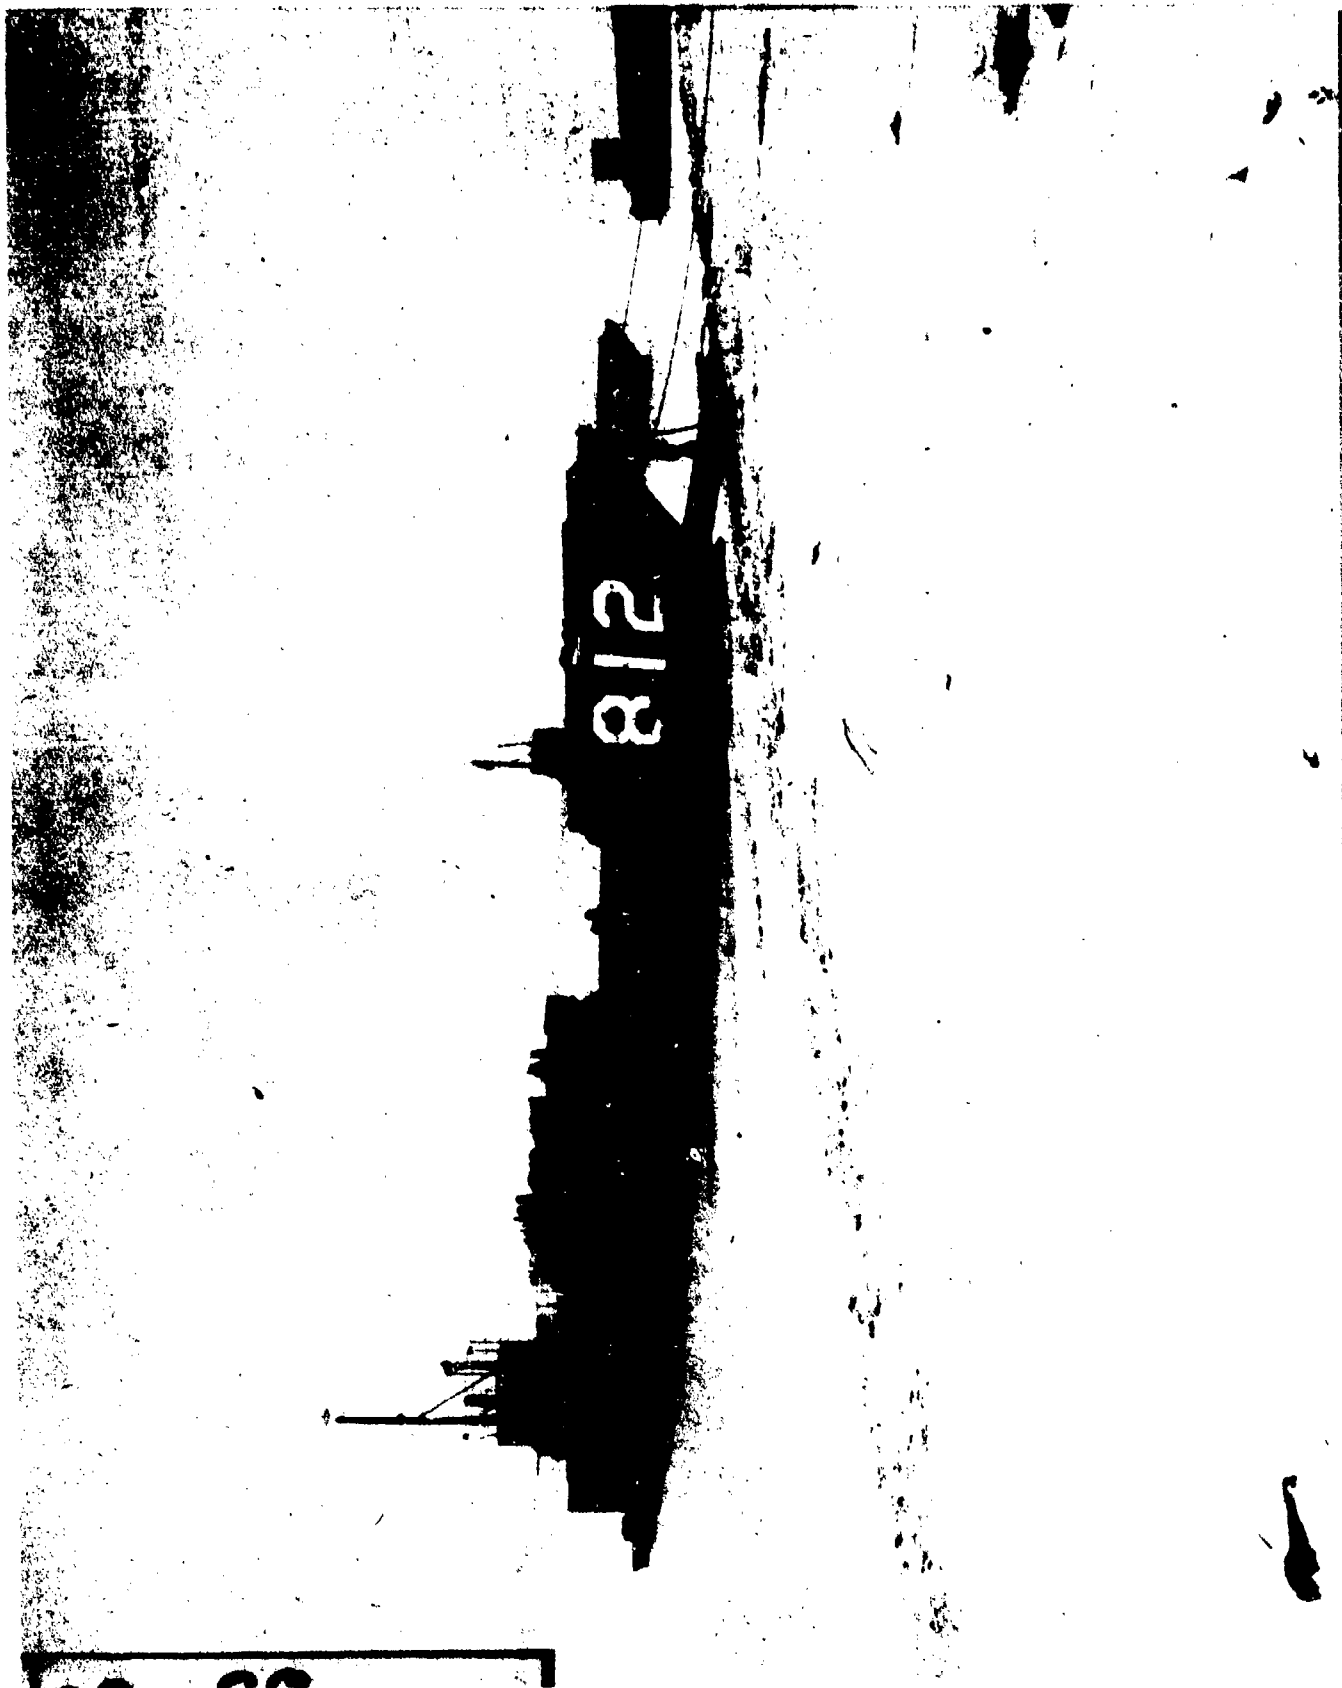
At the time of inspection, this craft was striking heavily forward on coral ledges. The engine room flooded to within 2 feet of the overhead from a 10 inch split in the bottom plating. The ramp was down on the beach, probably left in this position for the test. The damage is considered to be the result of wave action during the unattended period. (Photograph 1958-3, page 16).

AA-CR-98-1958-3. LCT-812 after Test A.
