TECHNICAL INSPECTION REPORT

(6) **OPERATION CROSSROADS,
U.S.S. YOG 83.
TEST ABLE [U].**

OPERATION CROSSROADS

USS YOG 83

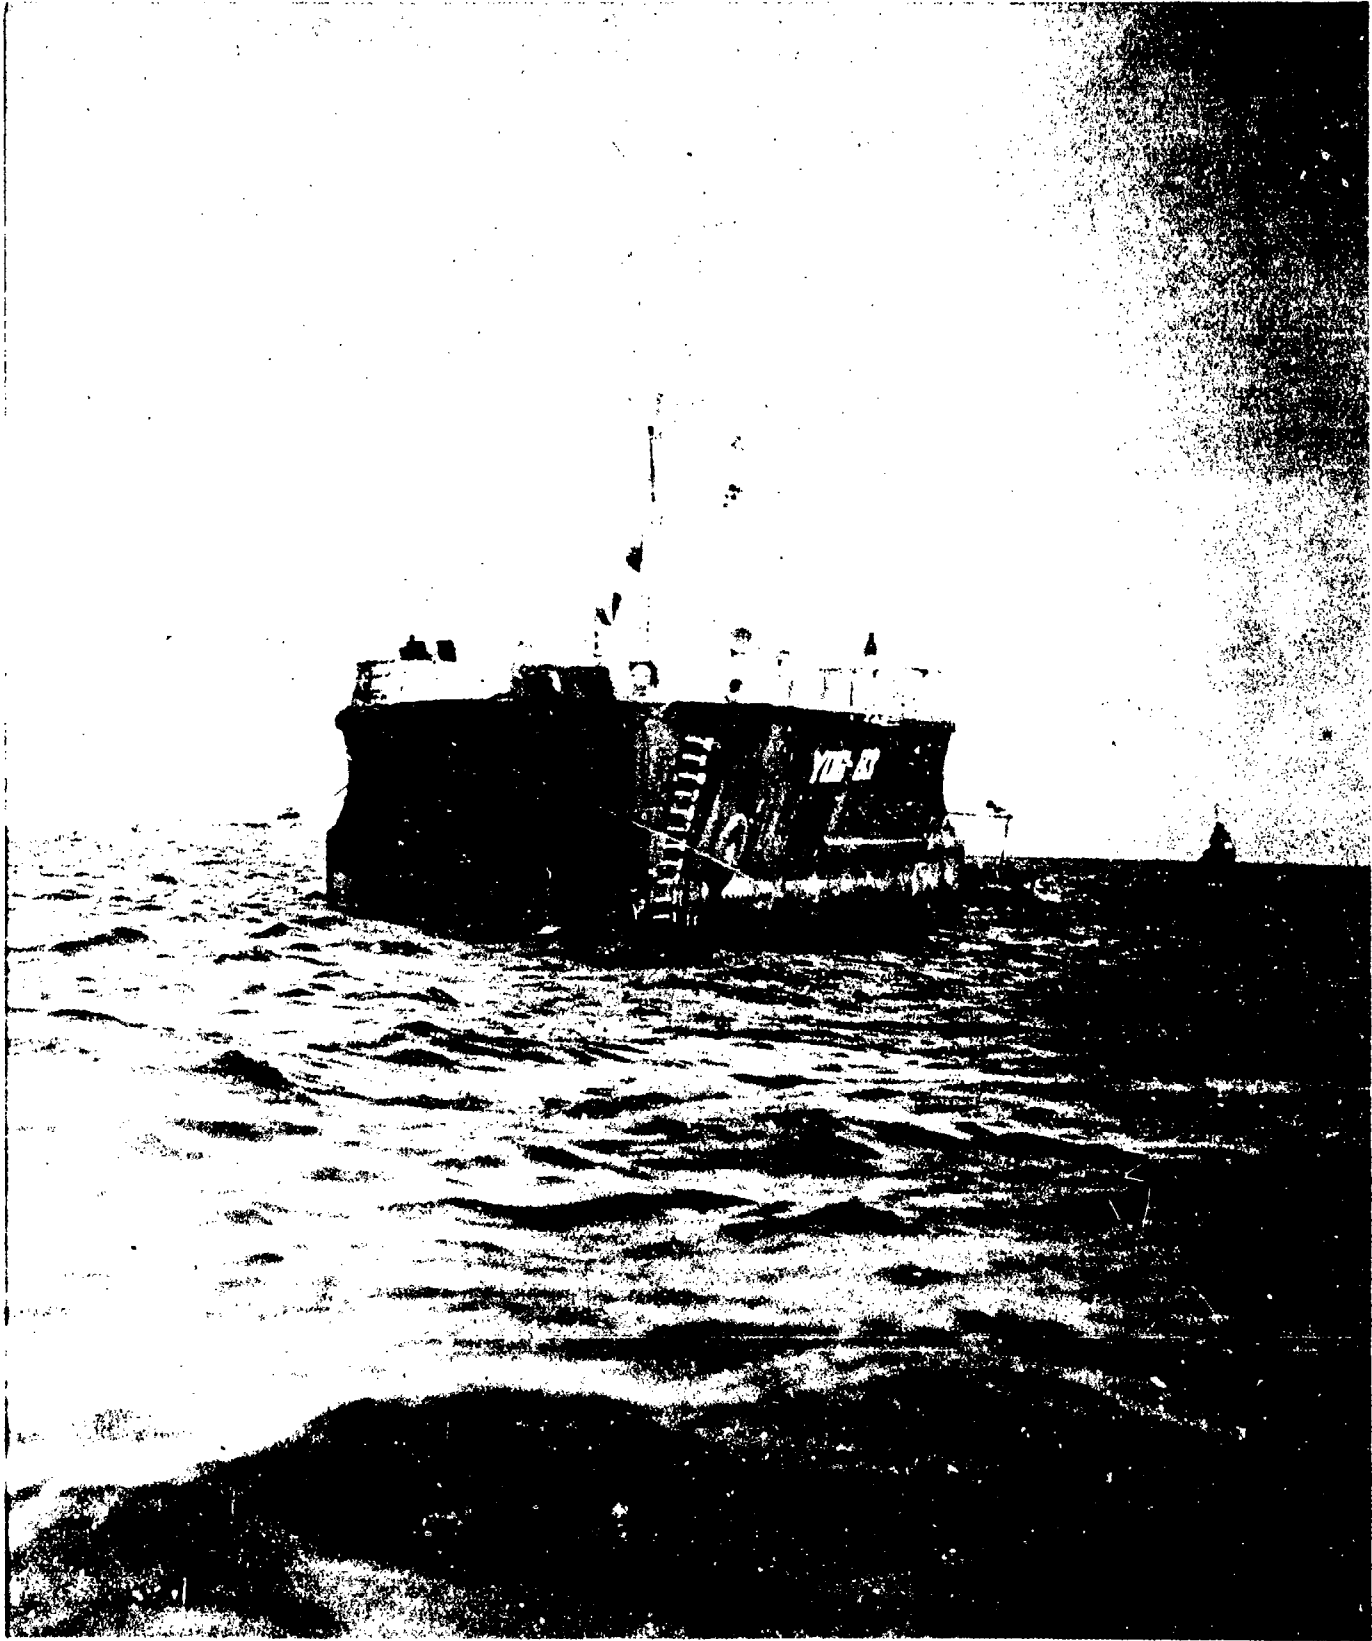
AA-CR-227-91-28. View from port quarter after Test A.

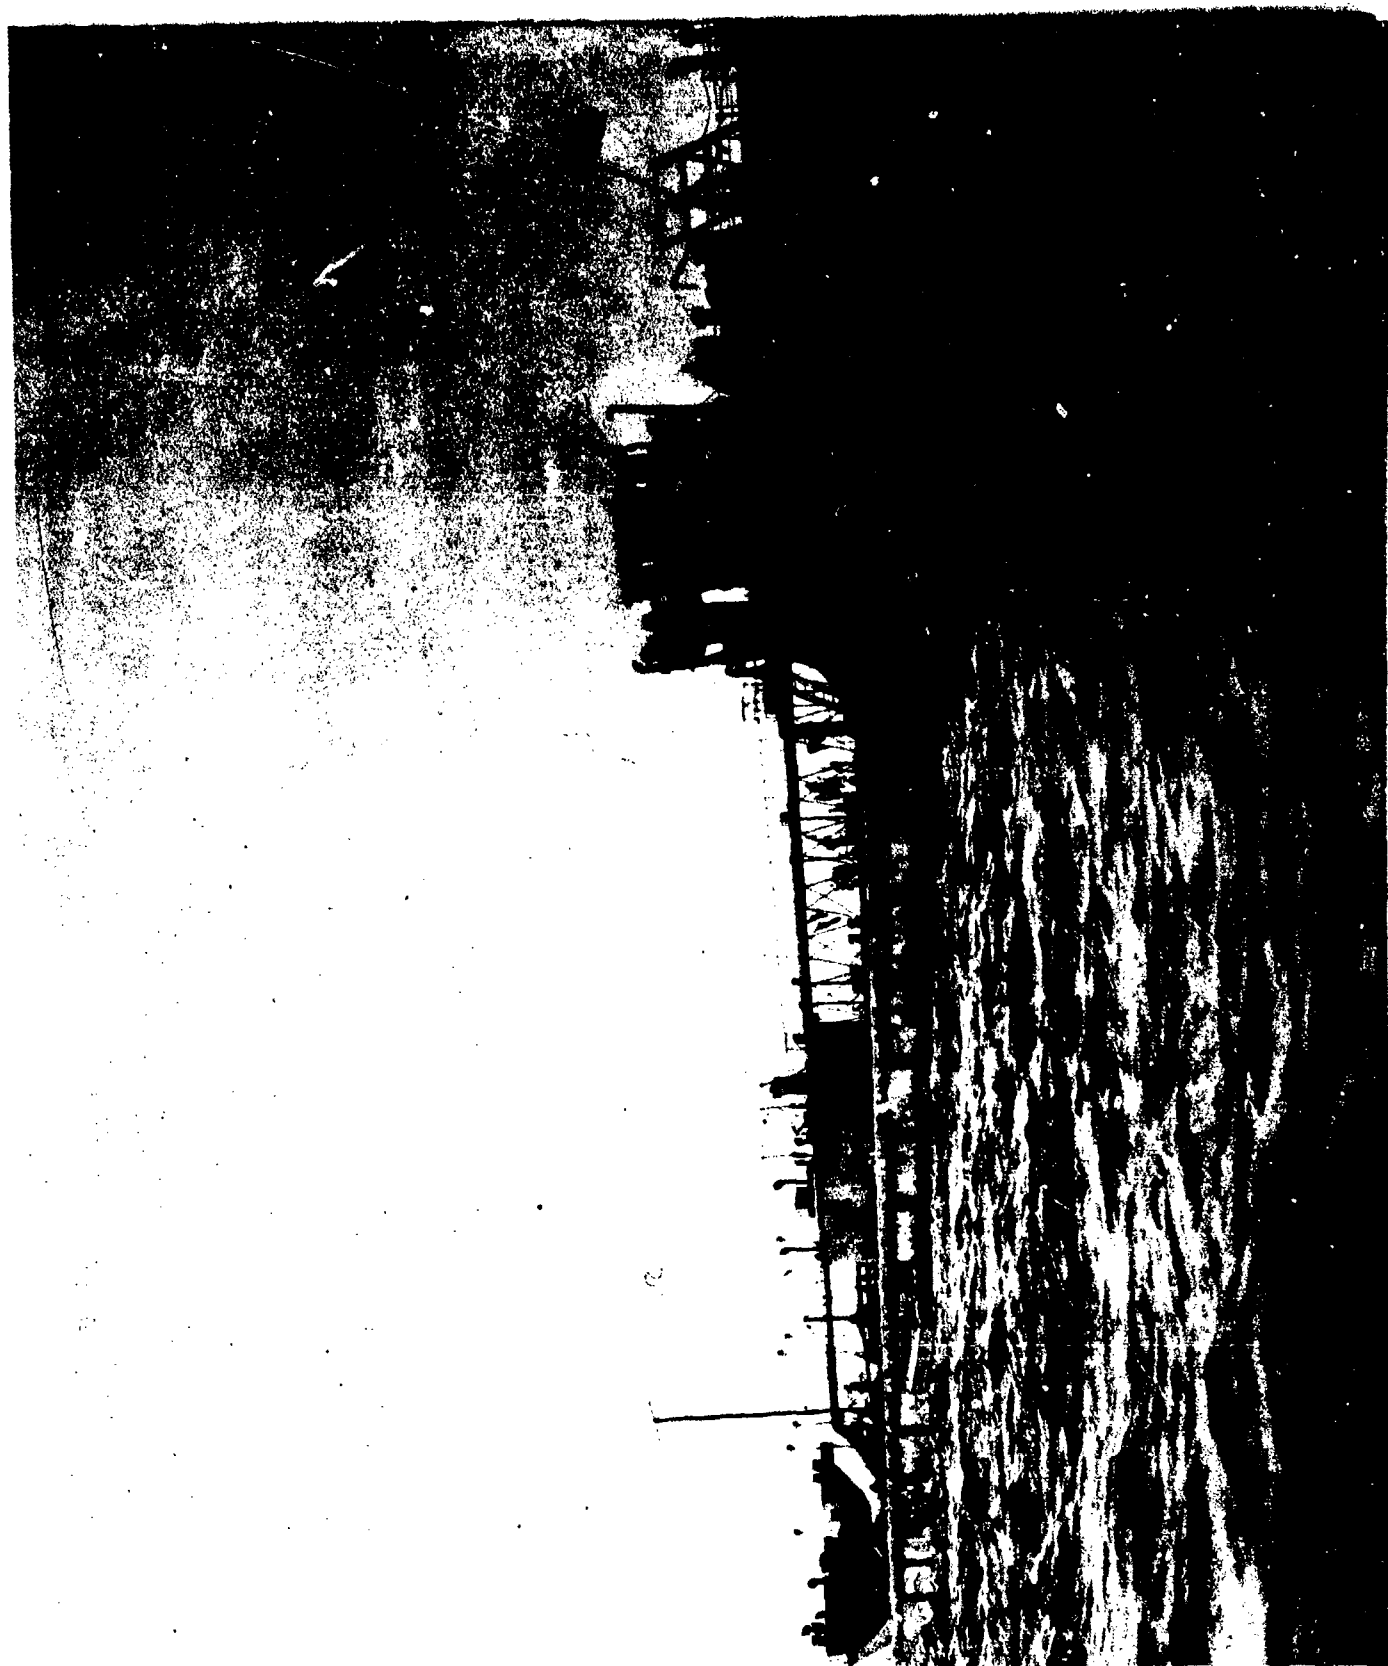
AA-CR-227-91-23. View from bow after Test A.

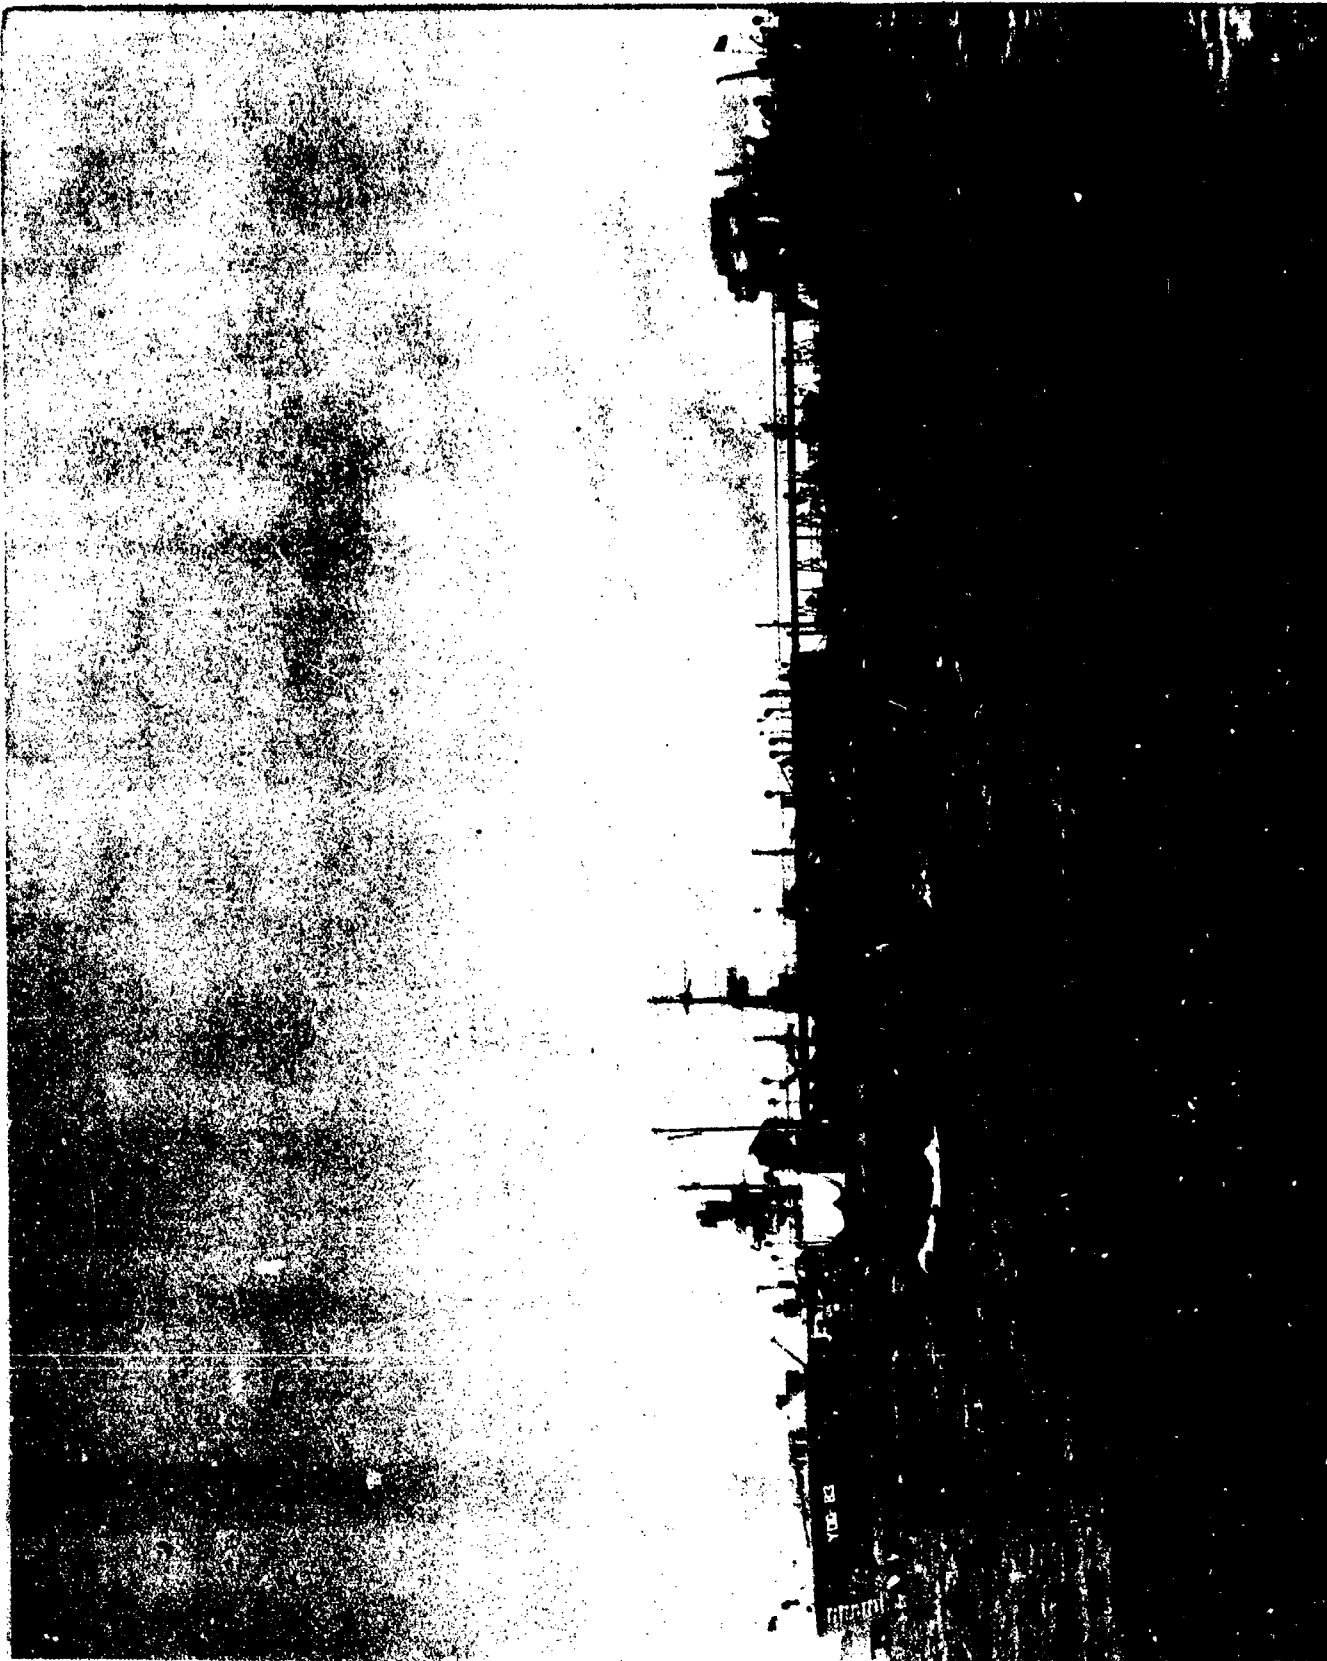
AA-CR-227-91-22. View from off port beam after Test A.

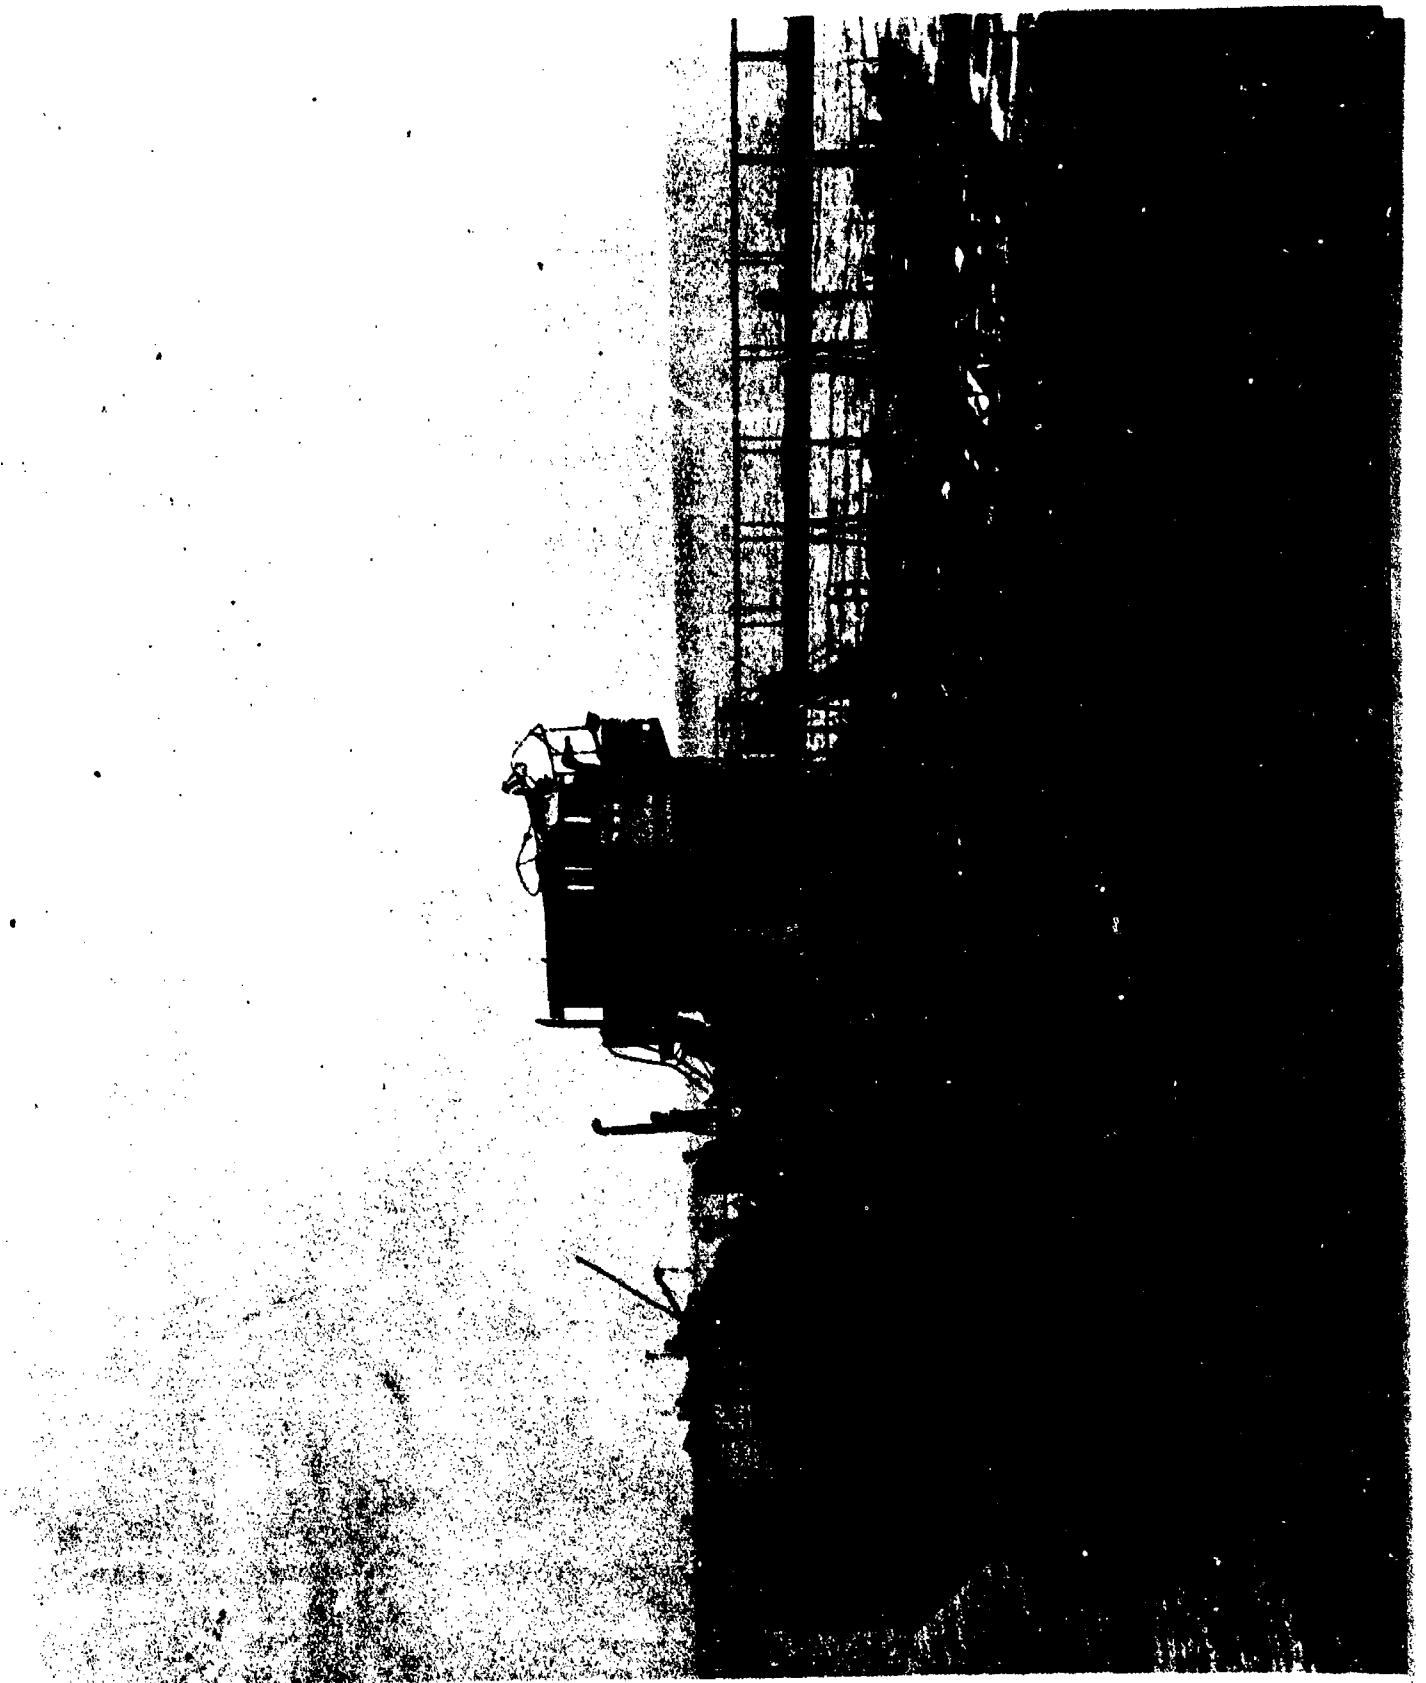
AA-CR-68-1744-4. After deck house from starboard.

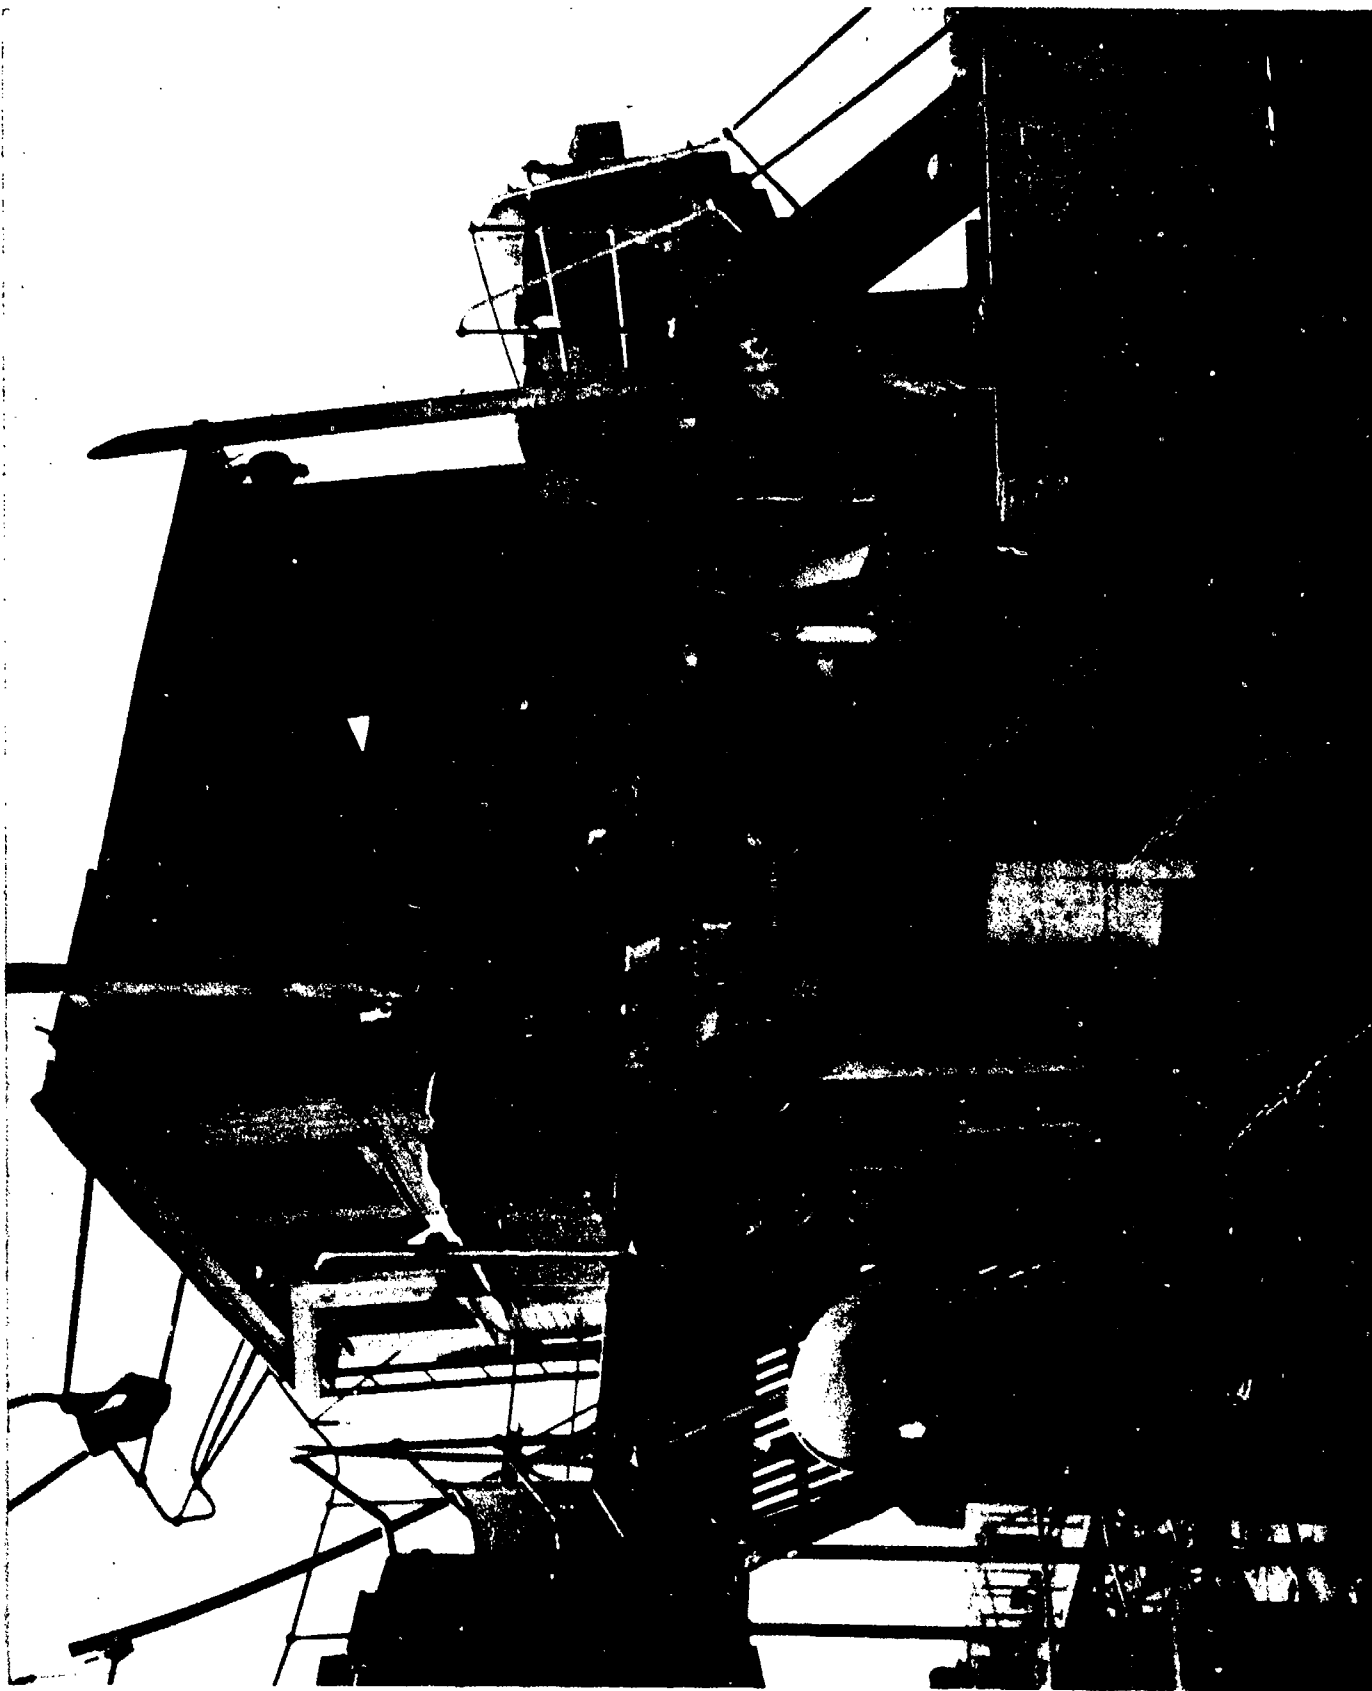
The wooden enclosure around the tank house is blown down (Photos 1829-7, 8, pages 41 and 42). The wheel house is intact but is twisted to port and forward. The pipe railing on top of the wheel house is blown down. The life raft frame on the starboard side of the poop deck is blown inboard and is pulled completely out of the foundation anchorages. (Photos 1744-10, 1829-9, pages 44 and 43). Cinch bolts and shear plates on this foundation pulled out of the concrete. The supports for the control box for the steering motor splintered the poop deck locally exposing the anchorage bolts and the reinforcing bars (photo 1744-8, page 45).

AA-CR-82-1829-7. Wooden bridge house, showing port and after sides.

The flimsy wooden pilot house is inconsistent with the construction of the remainder of the vessel, and should be replaced by a stronger one.
