BUREAU OF SHIPS GROUP TECHNICAL INSPECTION REPORT

U.S.S. ARDC 13

TEST ABLE [unclear] 8

6 OPERATION CROSSROADS. Defense Atomic Support Agency, Washington, D. C. 20301

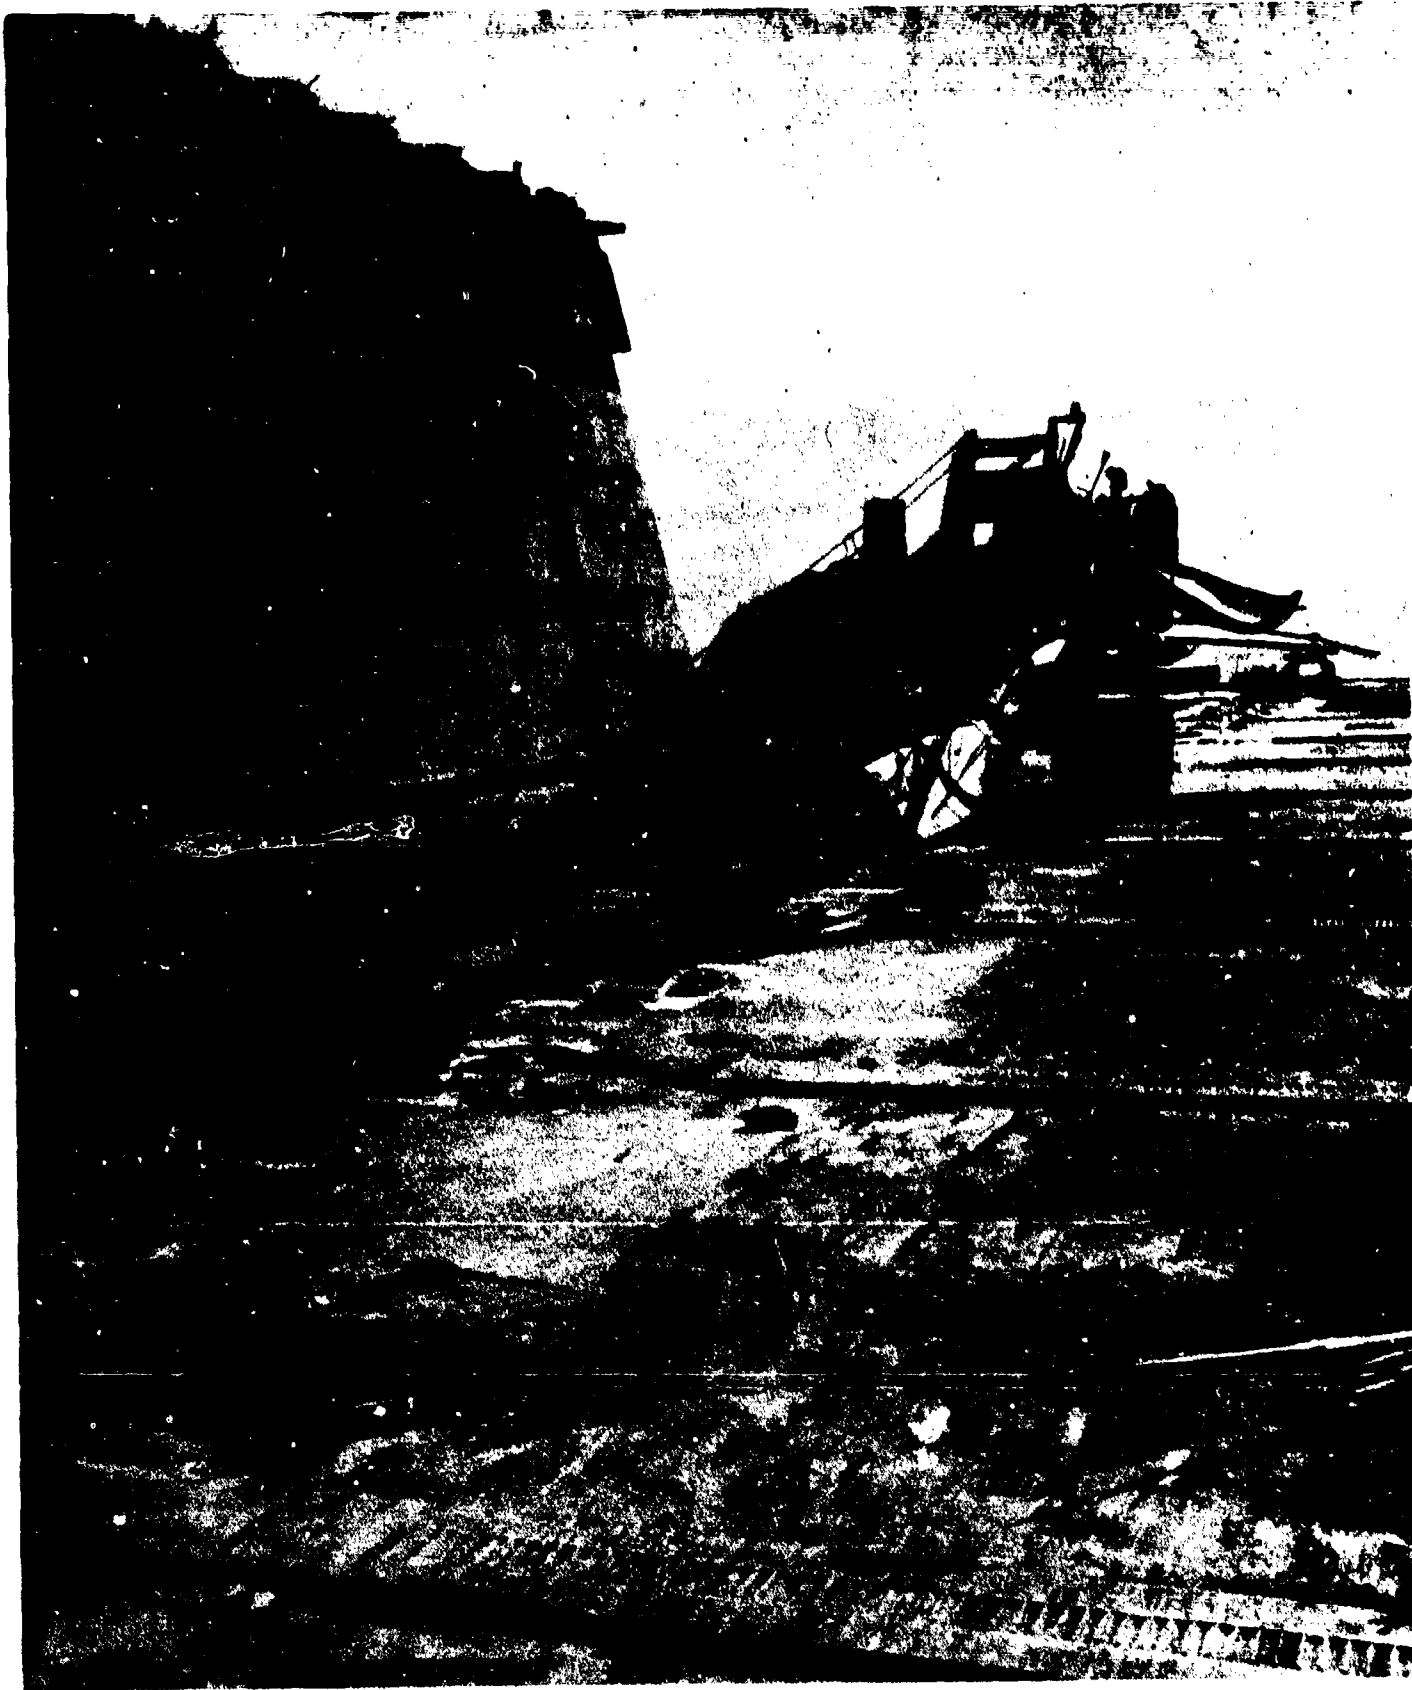
AA-CR-98-1963-9. View looking aft from starboard side of deck floor showing damage to caterpillar crane.

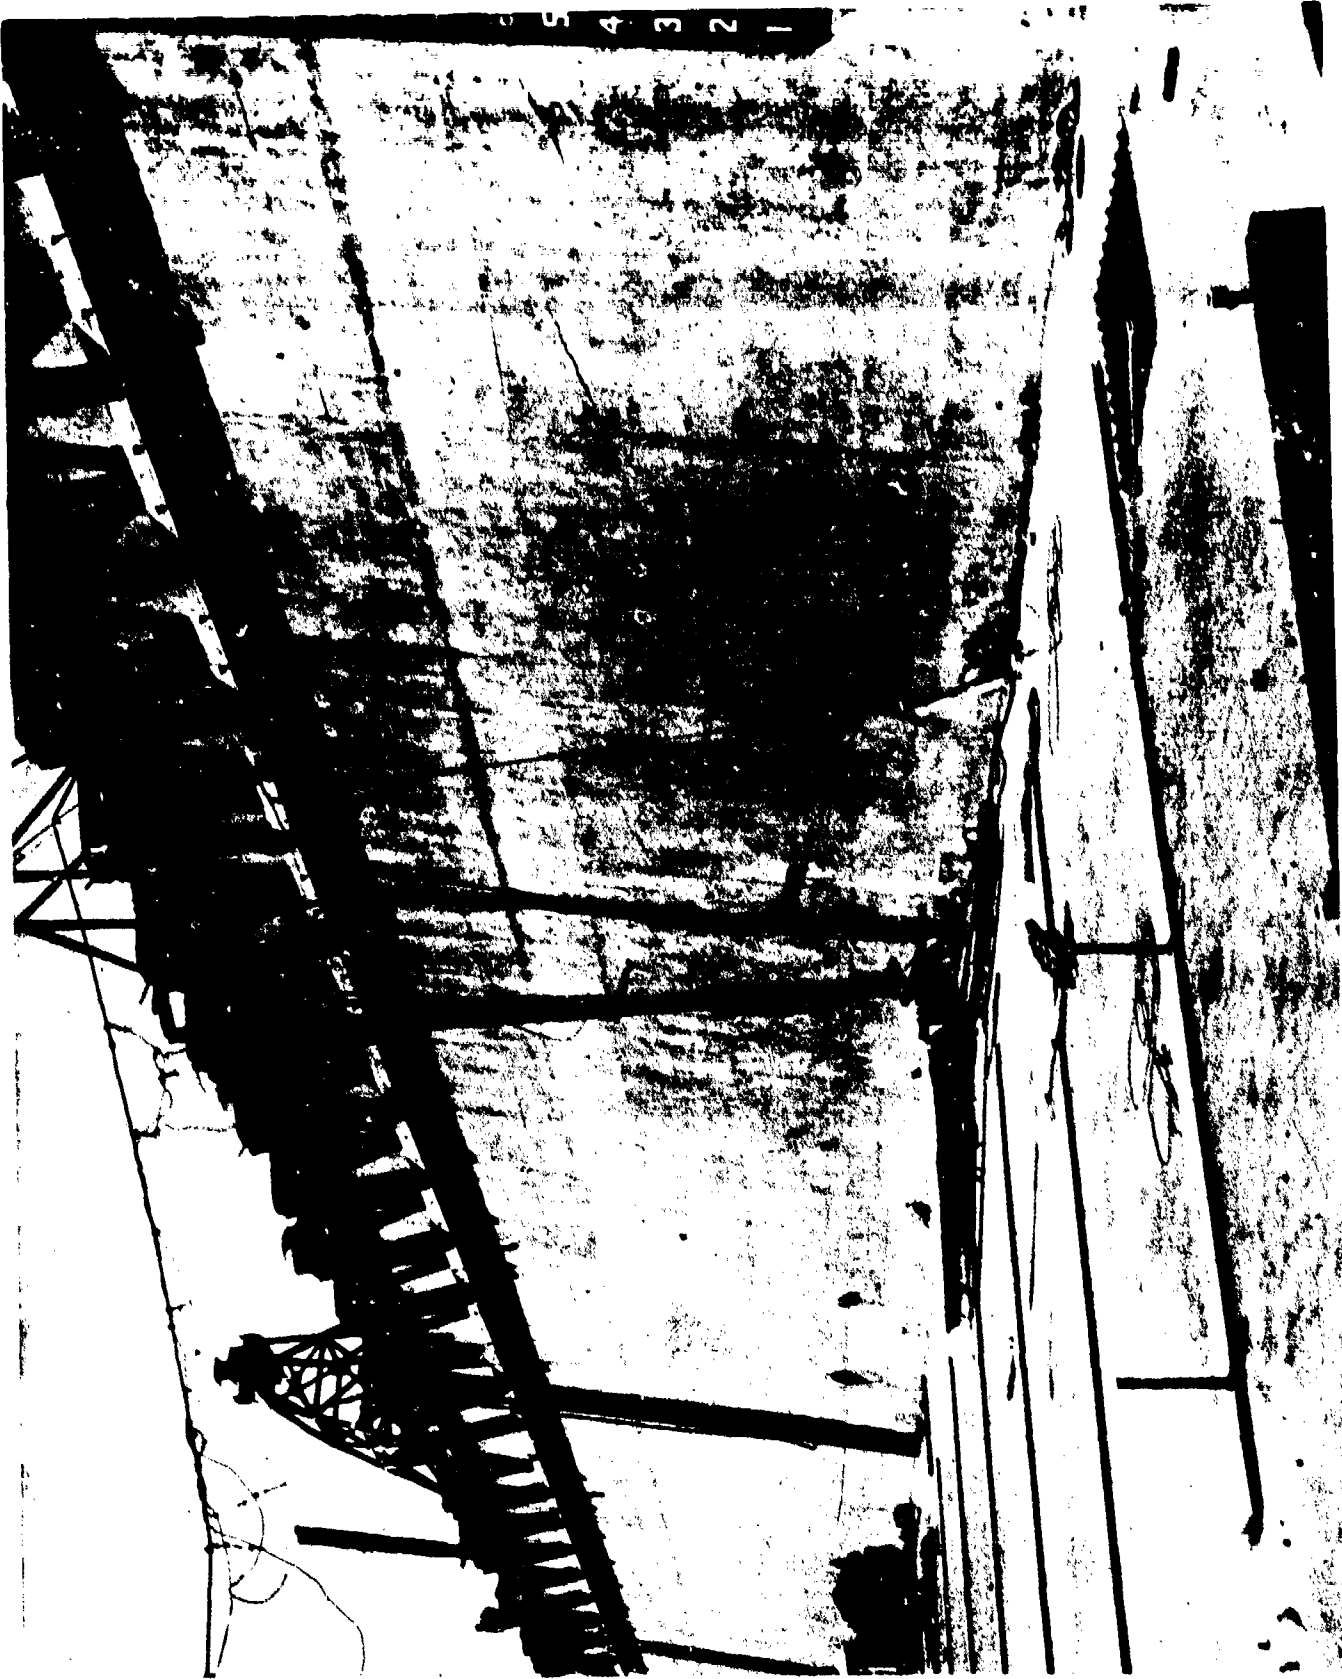
This damage is not considered to have impaired the usefulness of the vessel, or significantly affected its strength, inasmuch as the majority of the damage consists of clean tensile cracks in the concrete ranging in width from hairline to approximately 1/4 inch. (Photos 1916-2, 1914-11, 1914-4, 1916-1, 1963-5, pages 61 , 62 , 63 , 64 , and 65).

The inboard face of the port wall amidships contains longitudinal cracks running four to five feet from the top of the wall, and at about midheight (Photo 1914-11, page 62). There is a continuous set of cracks running about five feet above the floor on the starboard wall (Photos 1916-2, 1963-5, pages 61 , and 65).

AA-CR-82-1914-11. View looking aft along port wing wall showing longitudinal cracks at about mid-height of wall.

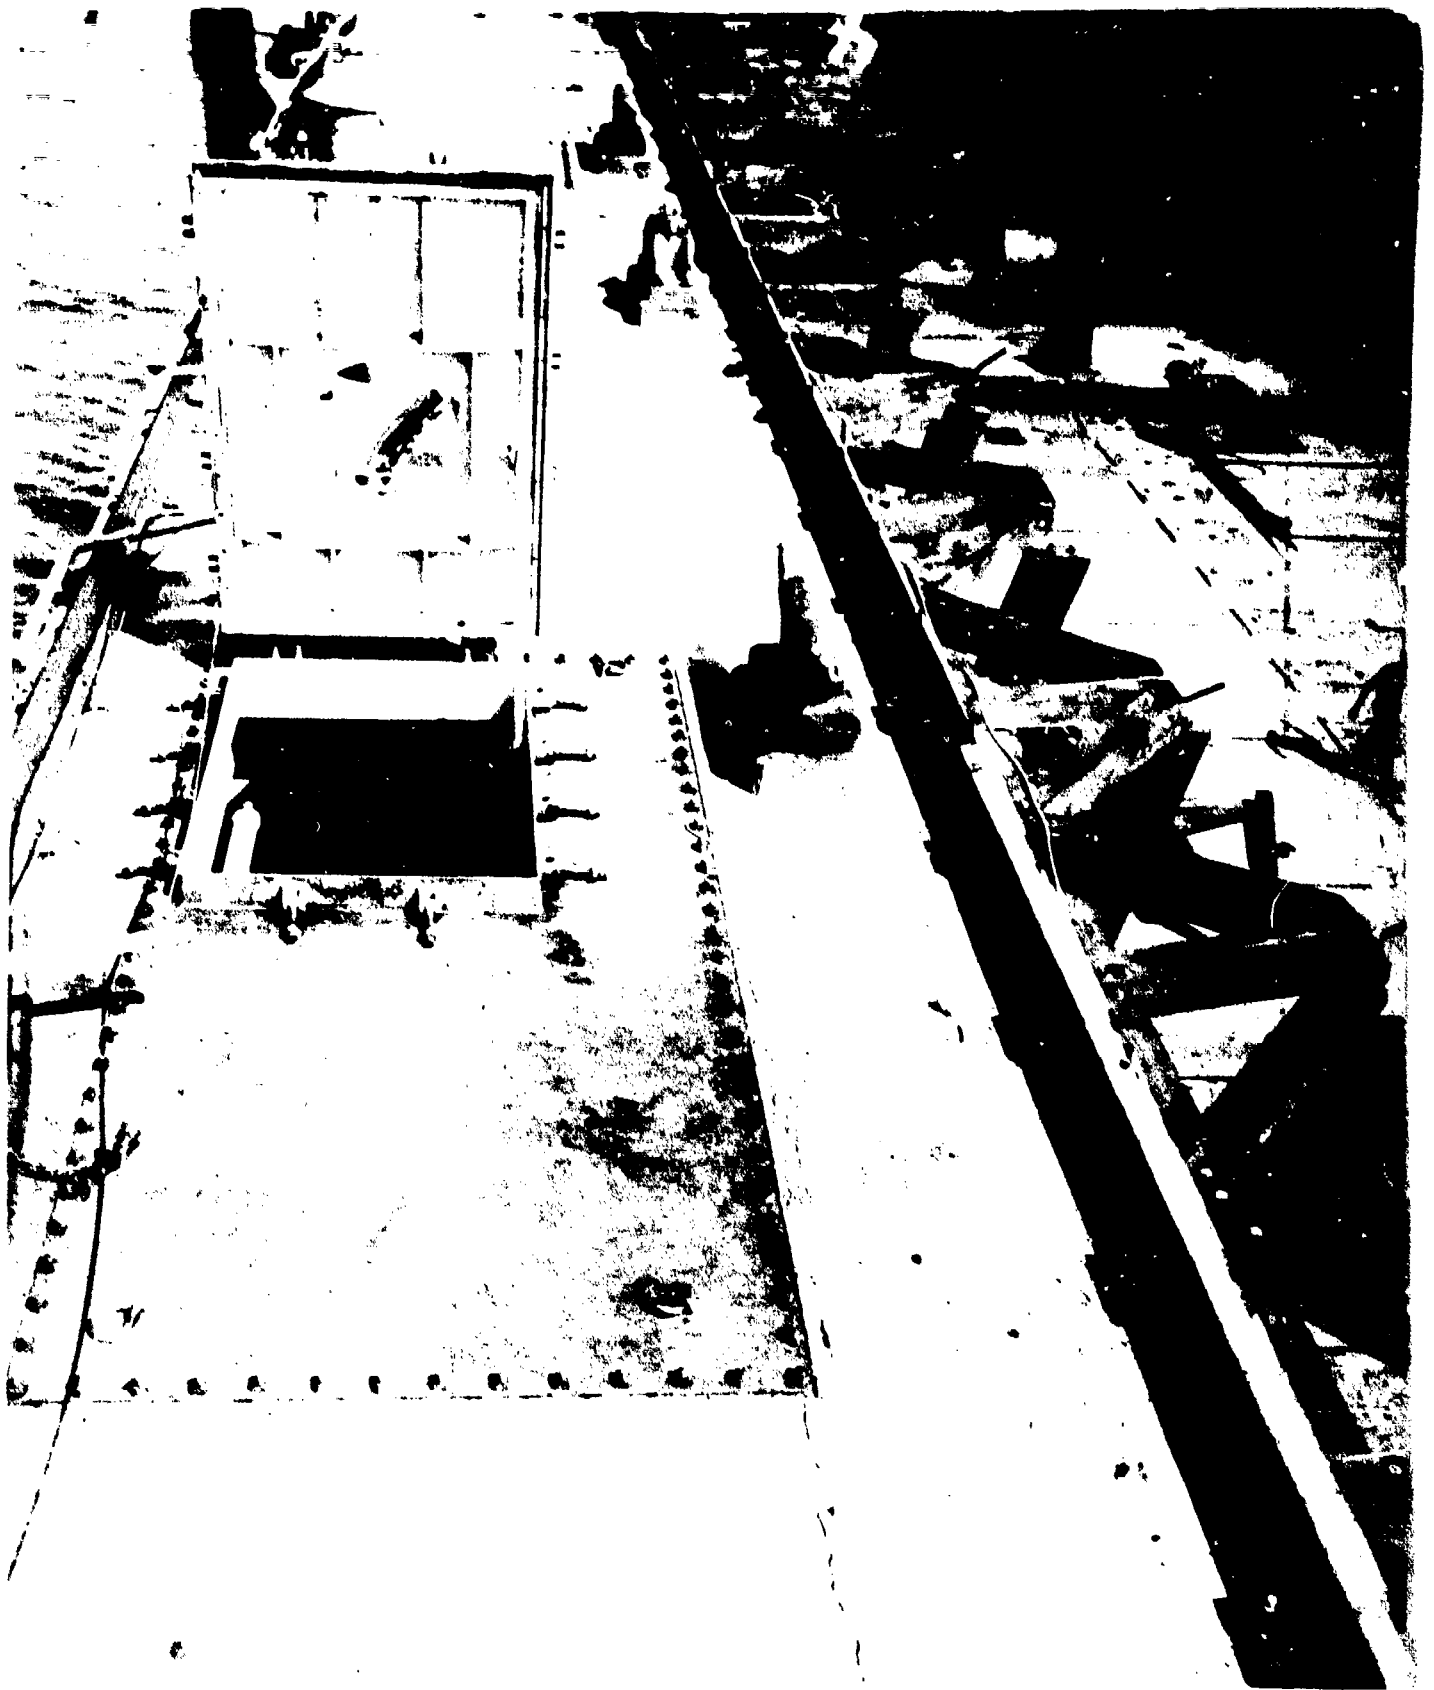
AA-CR-82-1914-4. View looking forward, port side, showing crack in "A" deck.

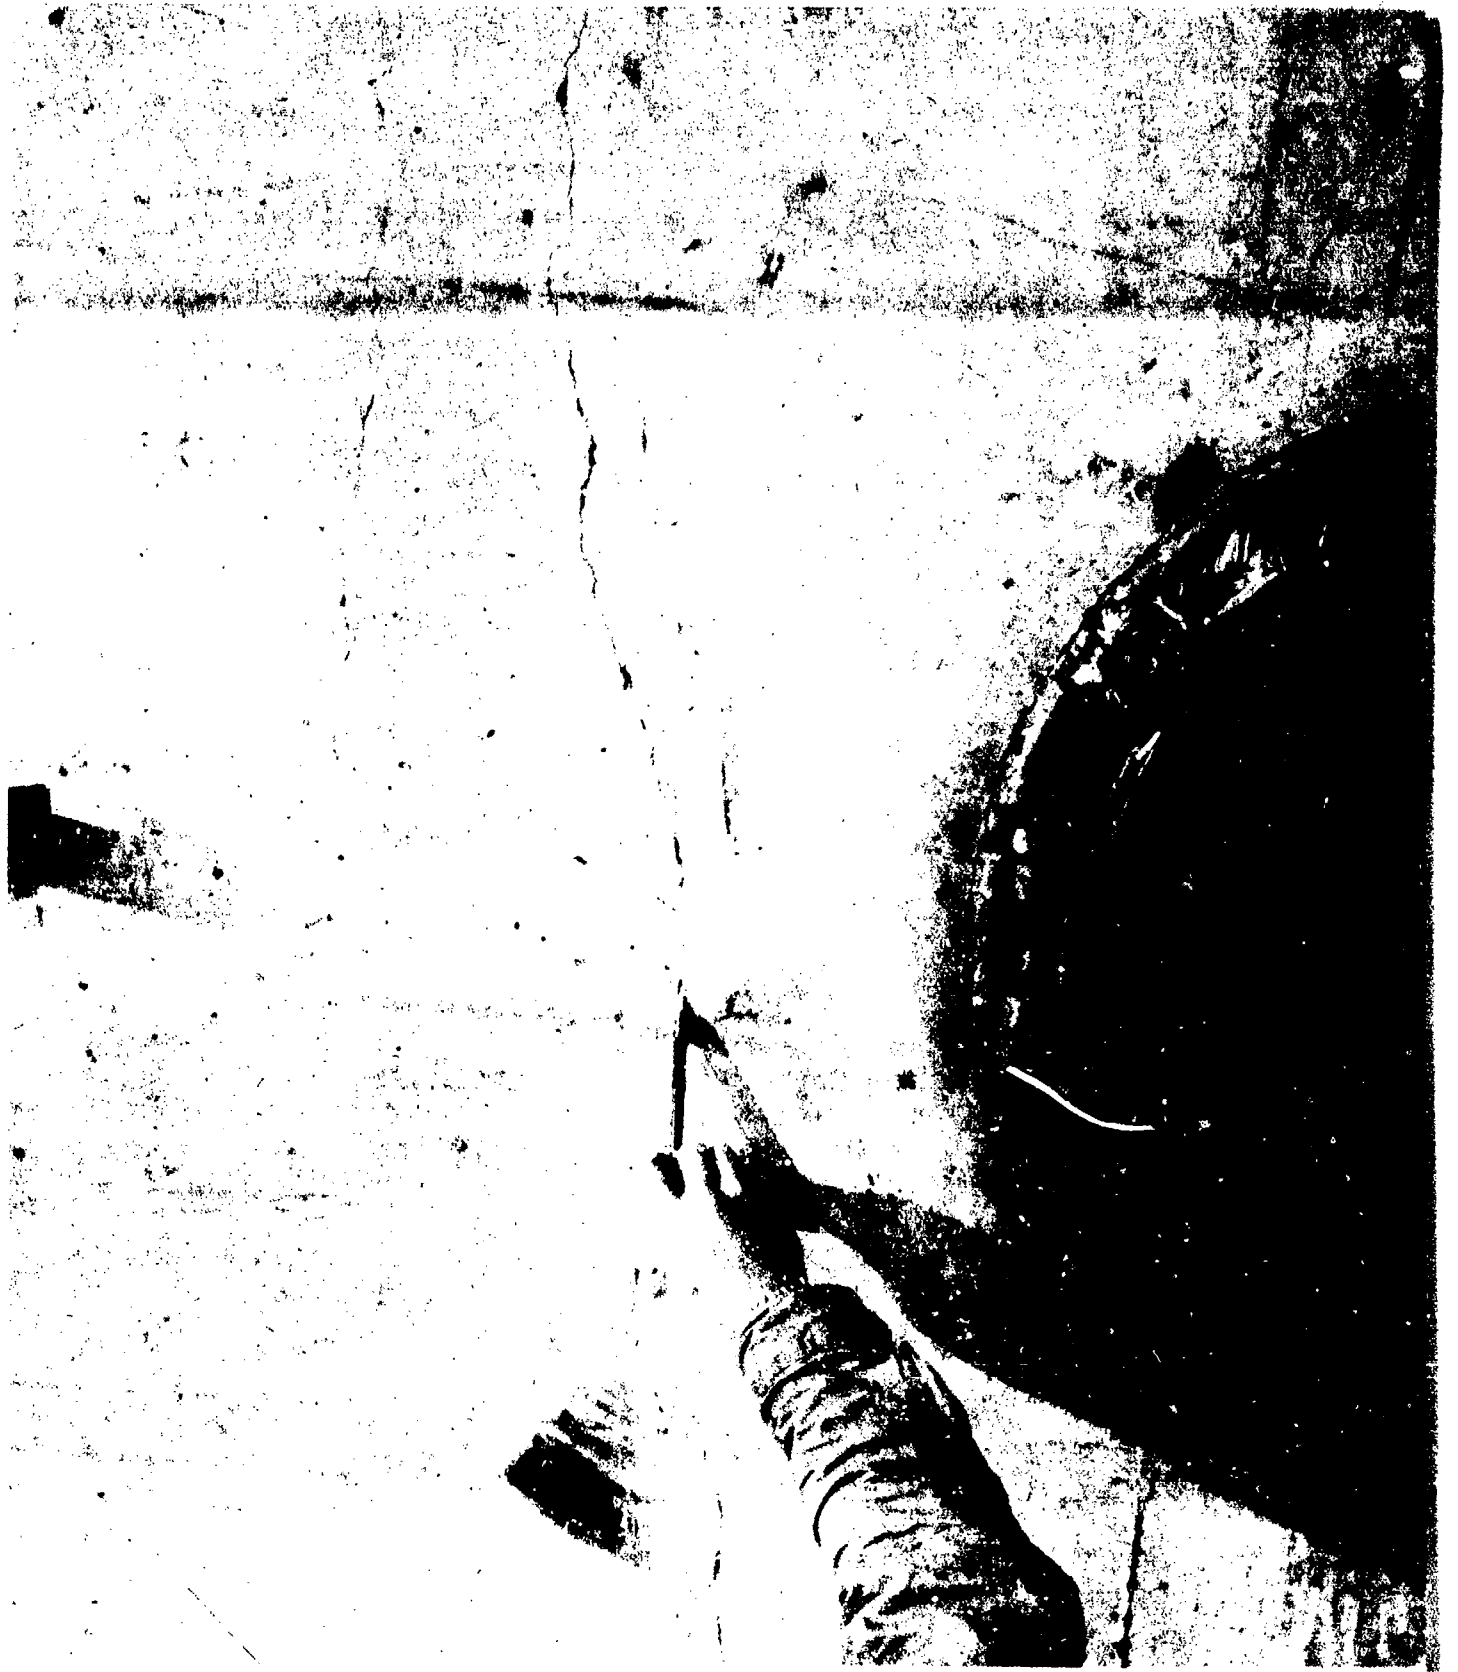
AA-CR-98-1963-5. View of crack in after inside face of starboard wing wall.

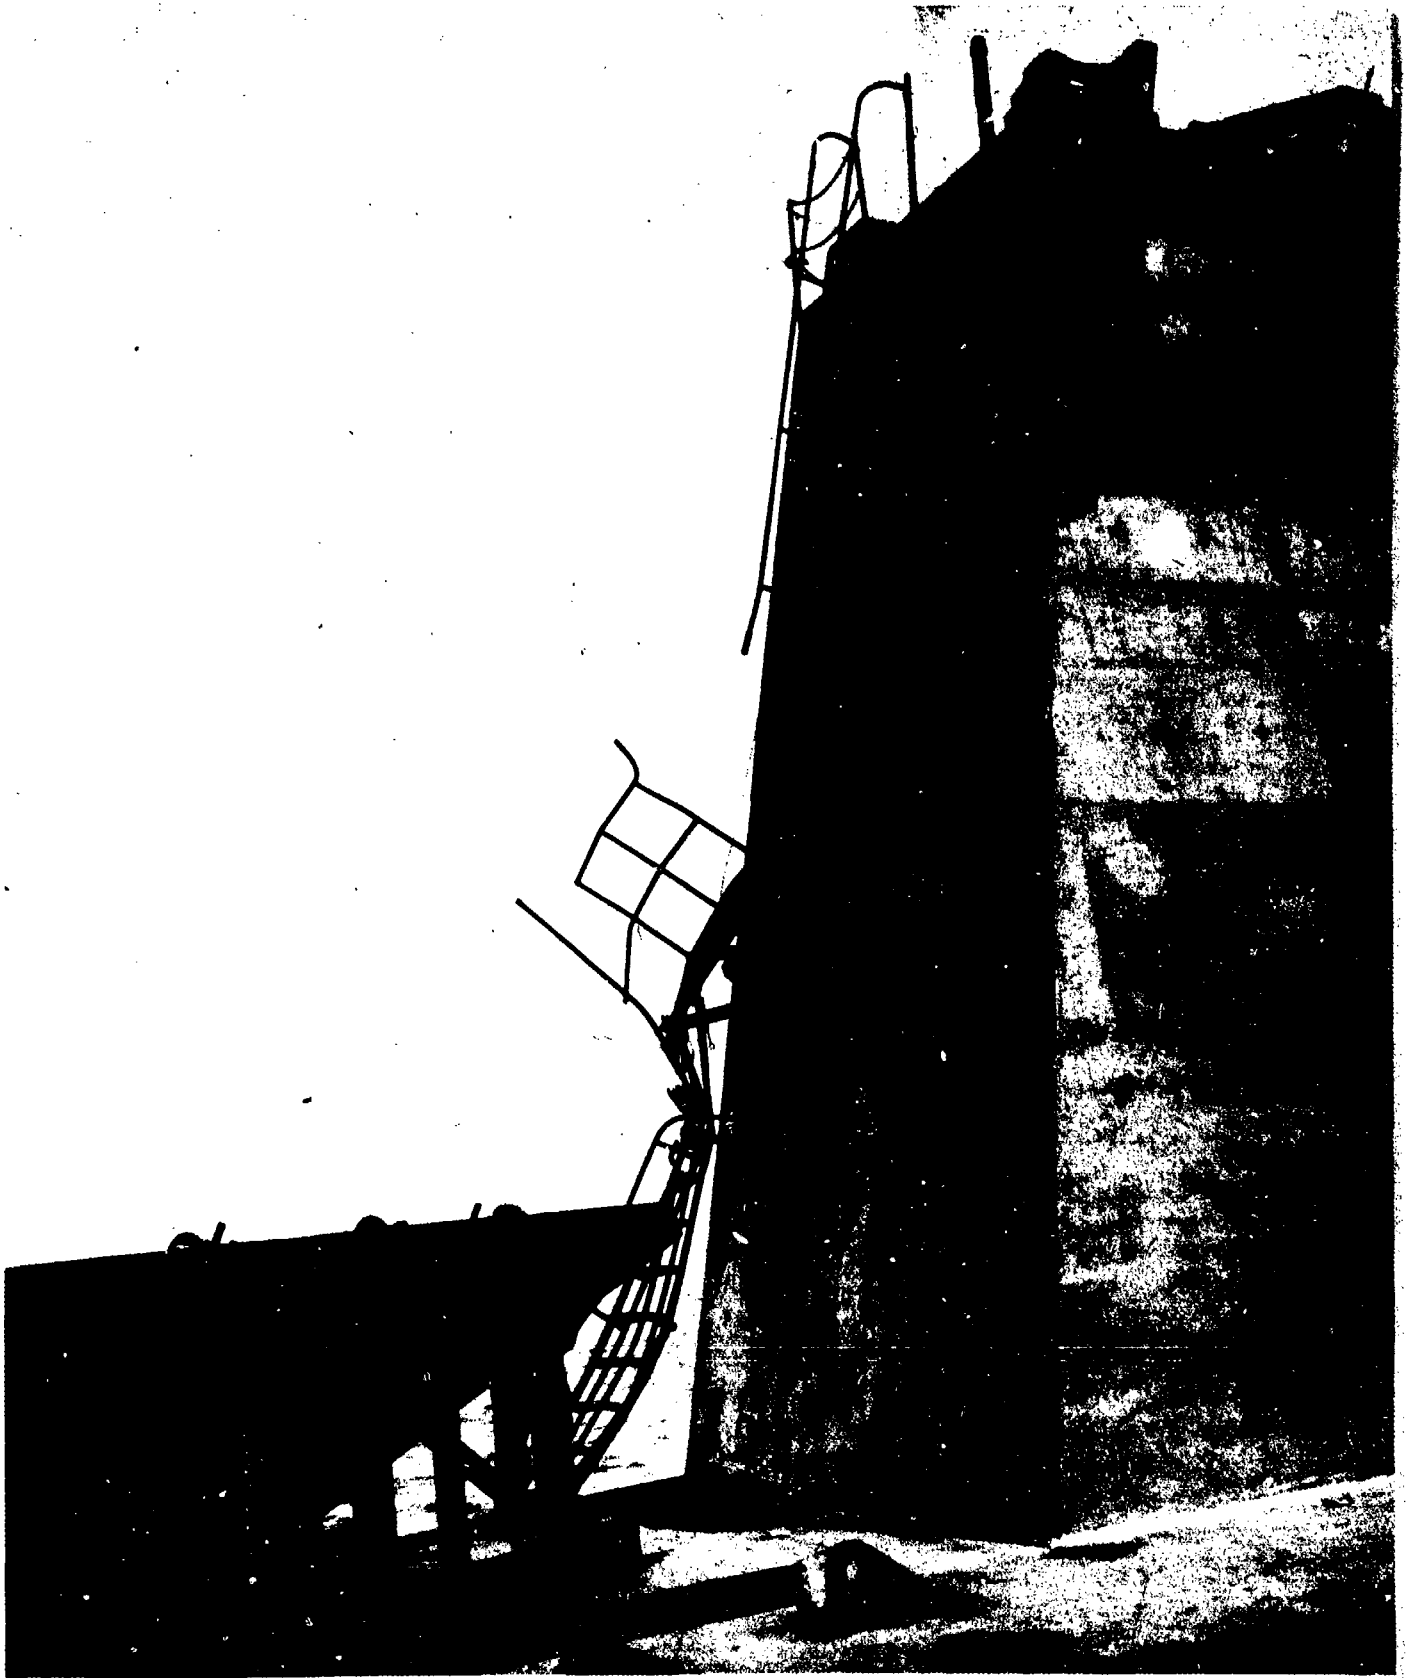
AA-CR-98-1963-11. View of damage to ladder on forward face of starboard wing wall.

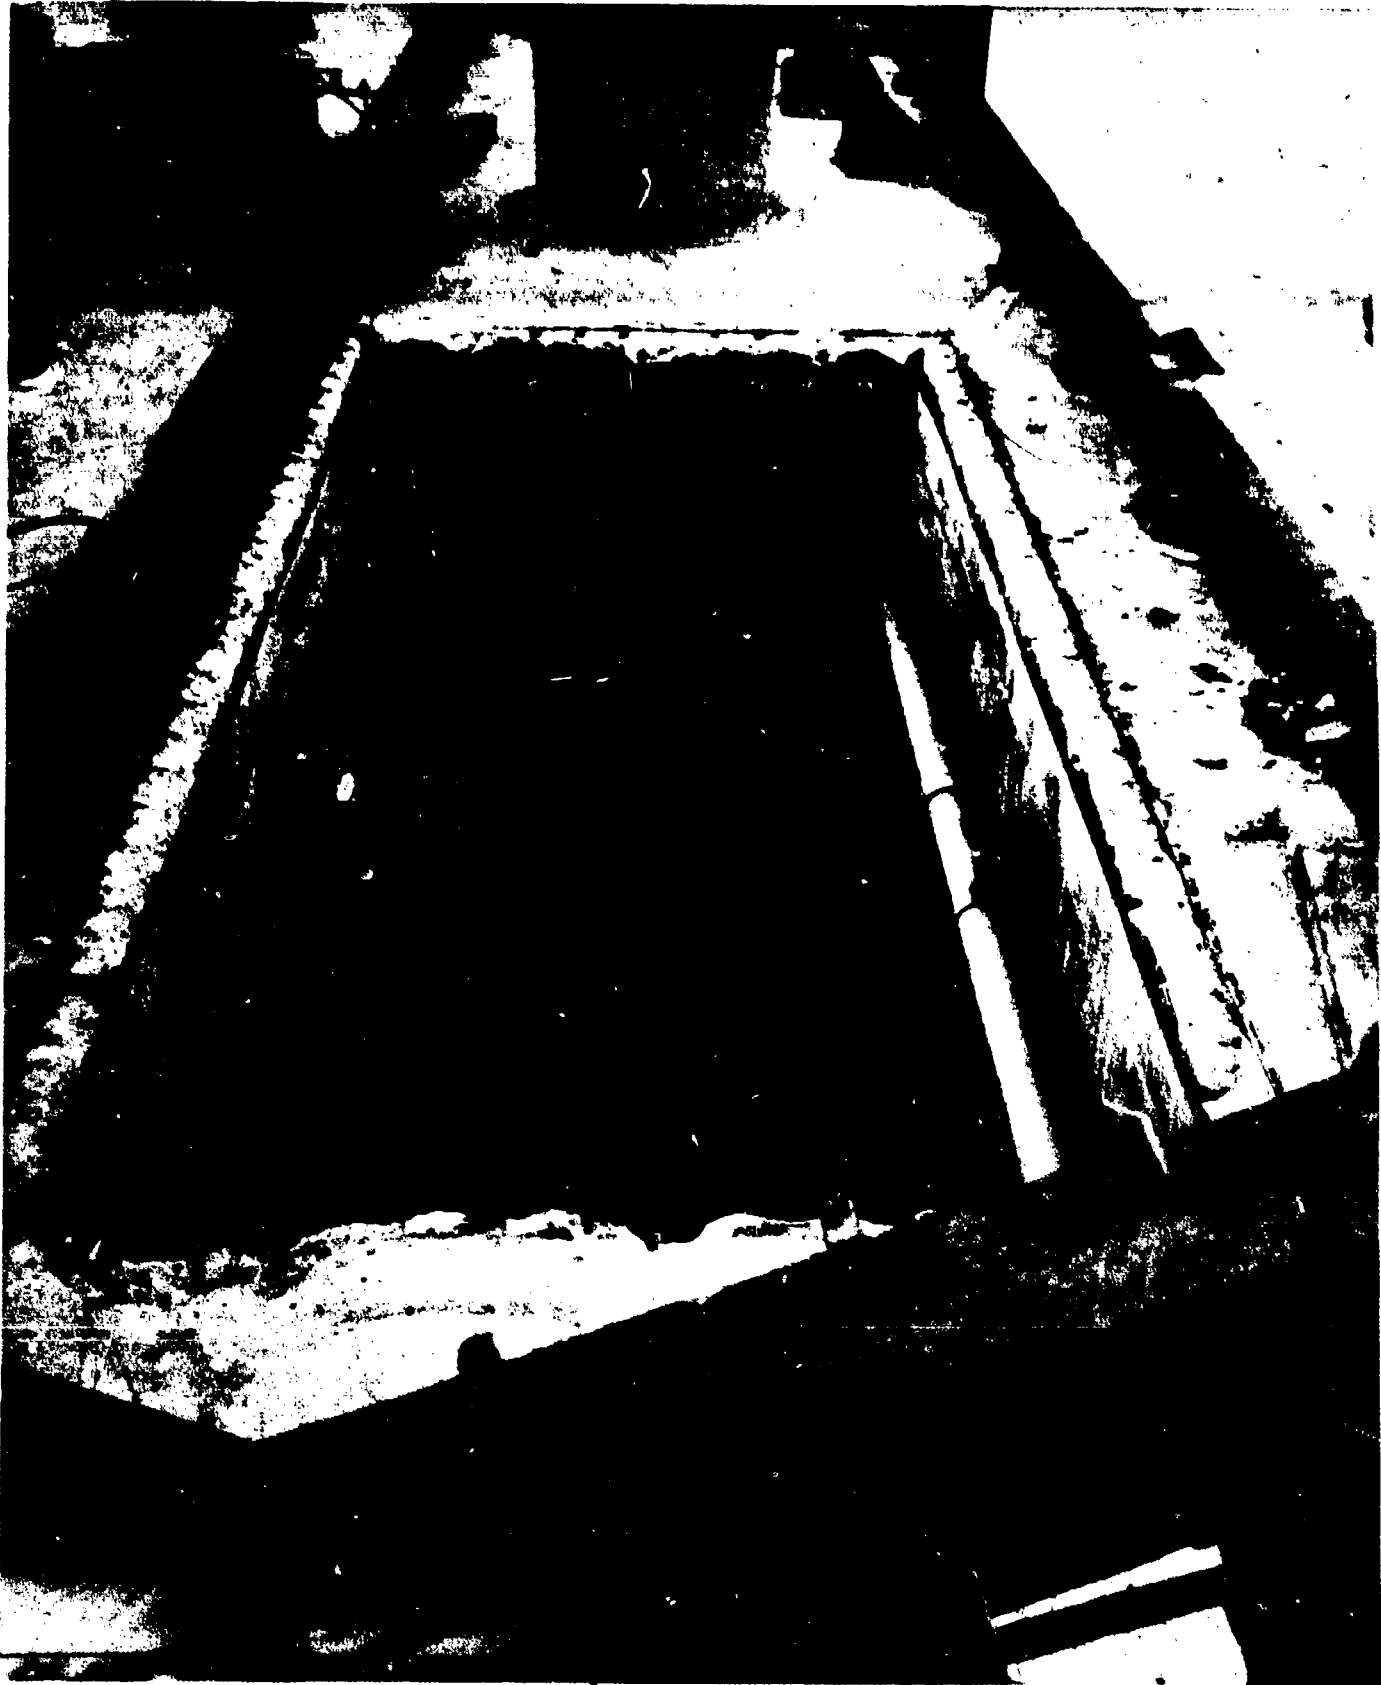
AA-CR-98-1964-2. View looking aft at engine room hatch opening in port "A" deck. The cover plate and hatch are missing - see 1914-4 for typical installation.

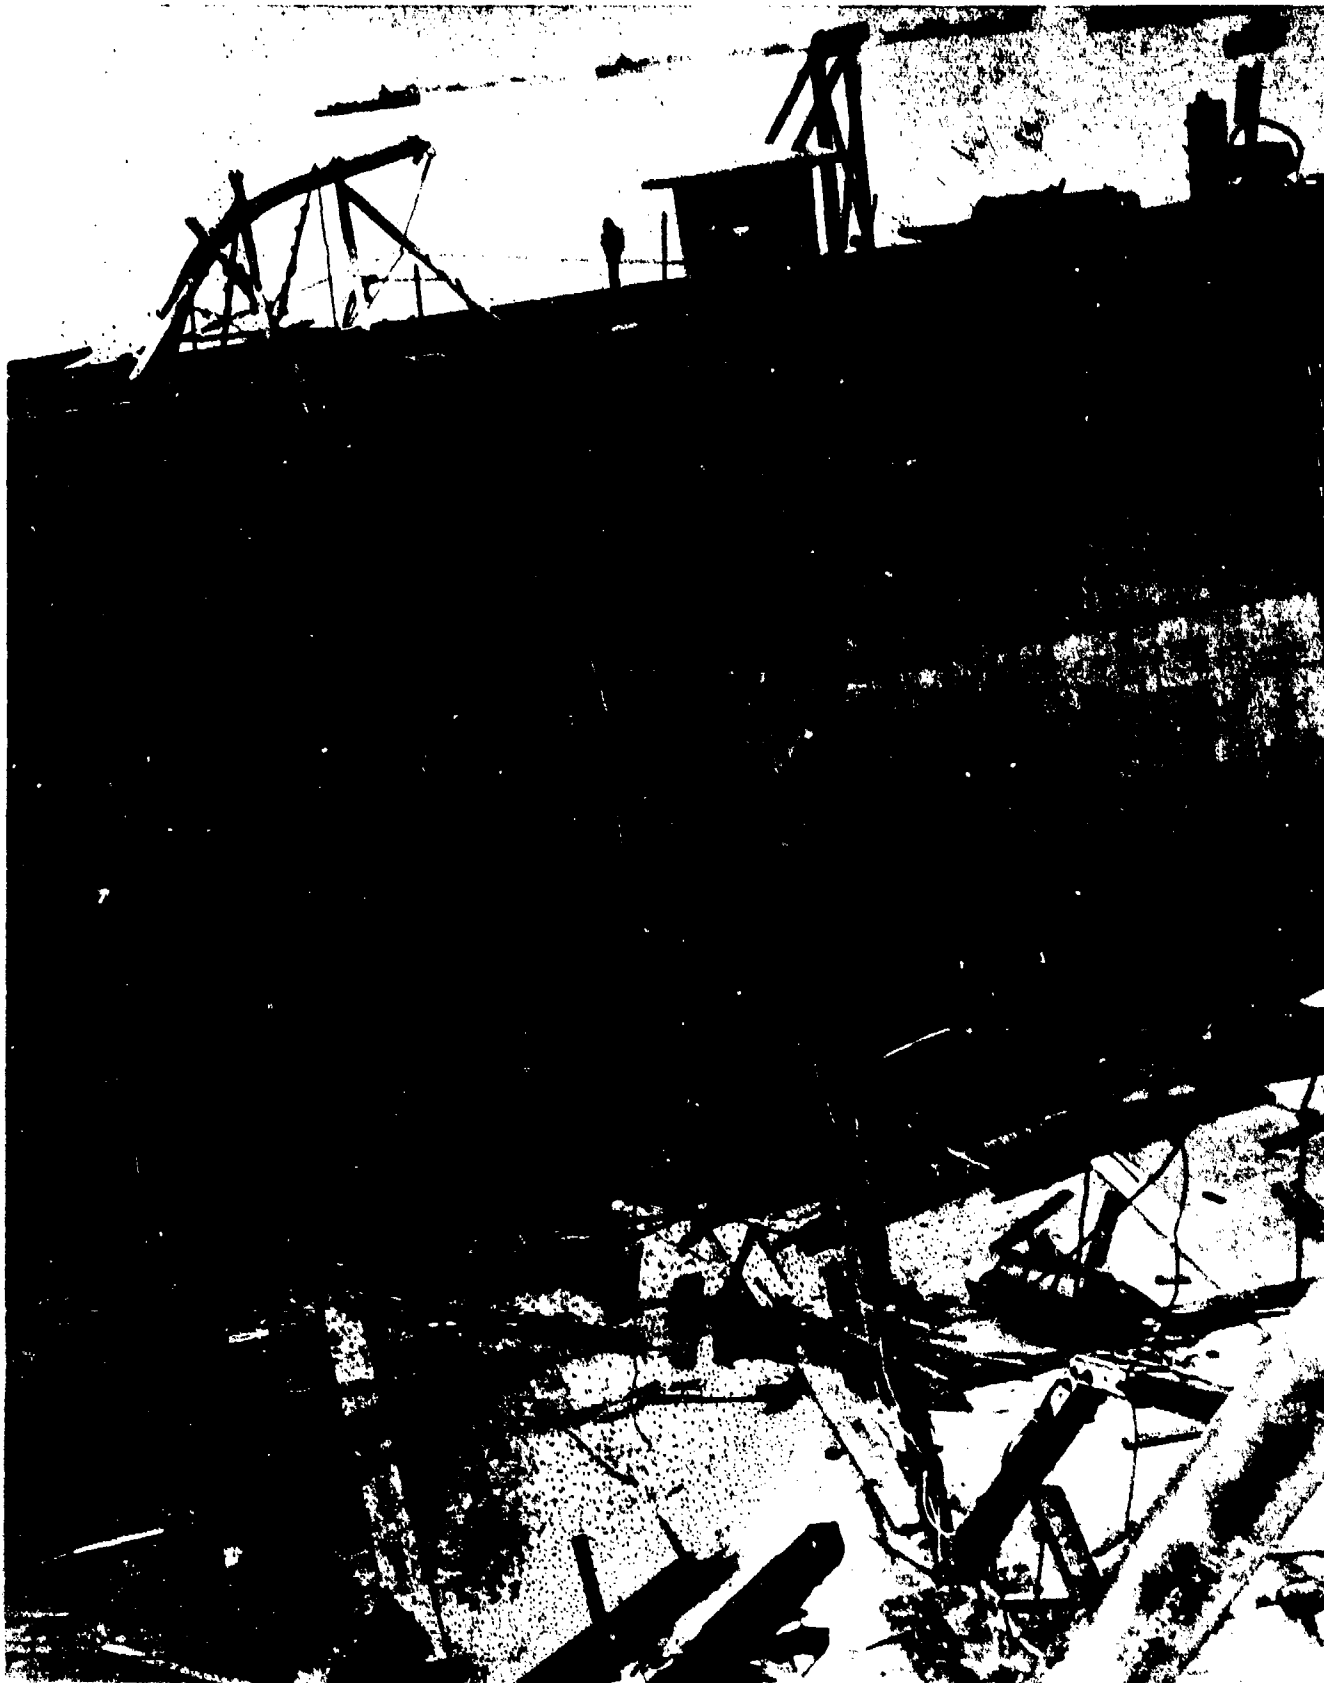
68 , and 39). Ventilators remained intact; life lines are broken, bent, or blown away. Light standards are broken and bent and wiring is stripped in many places. One main engine room hatch is missing from the port wingwall, apparently blown over the side. (Photo 1964-2, page 70). The athwartships catwalk amidships, is demolished. (Photos 1962-7 and 9, pages 71 , and 72).

AA-CR-98-1962-9. View looking athwartship and damage to catwalk and starboard wing wall amidships.

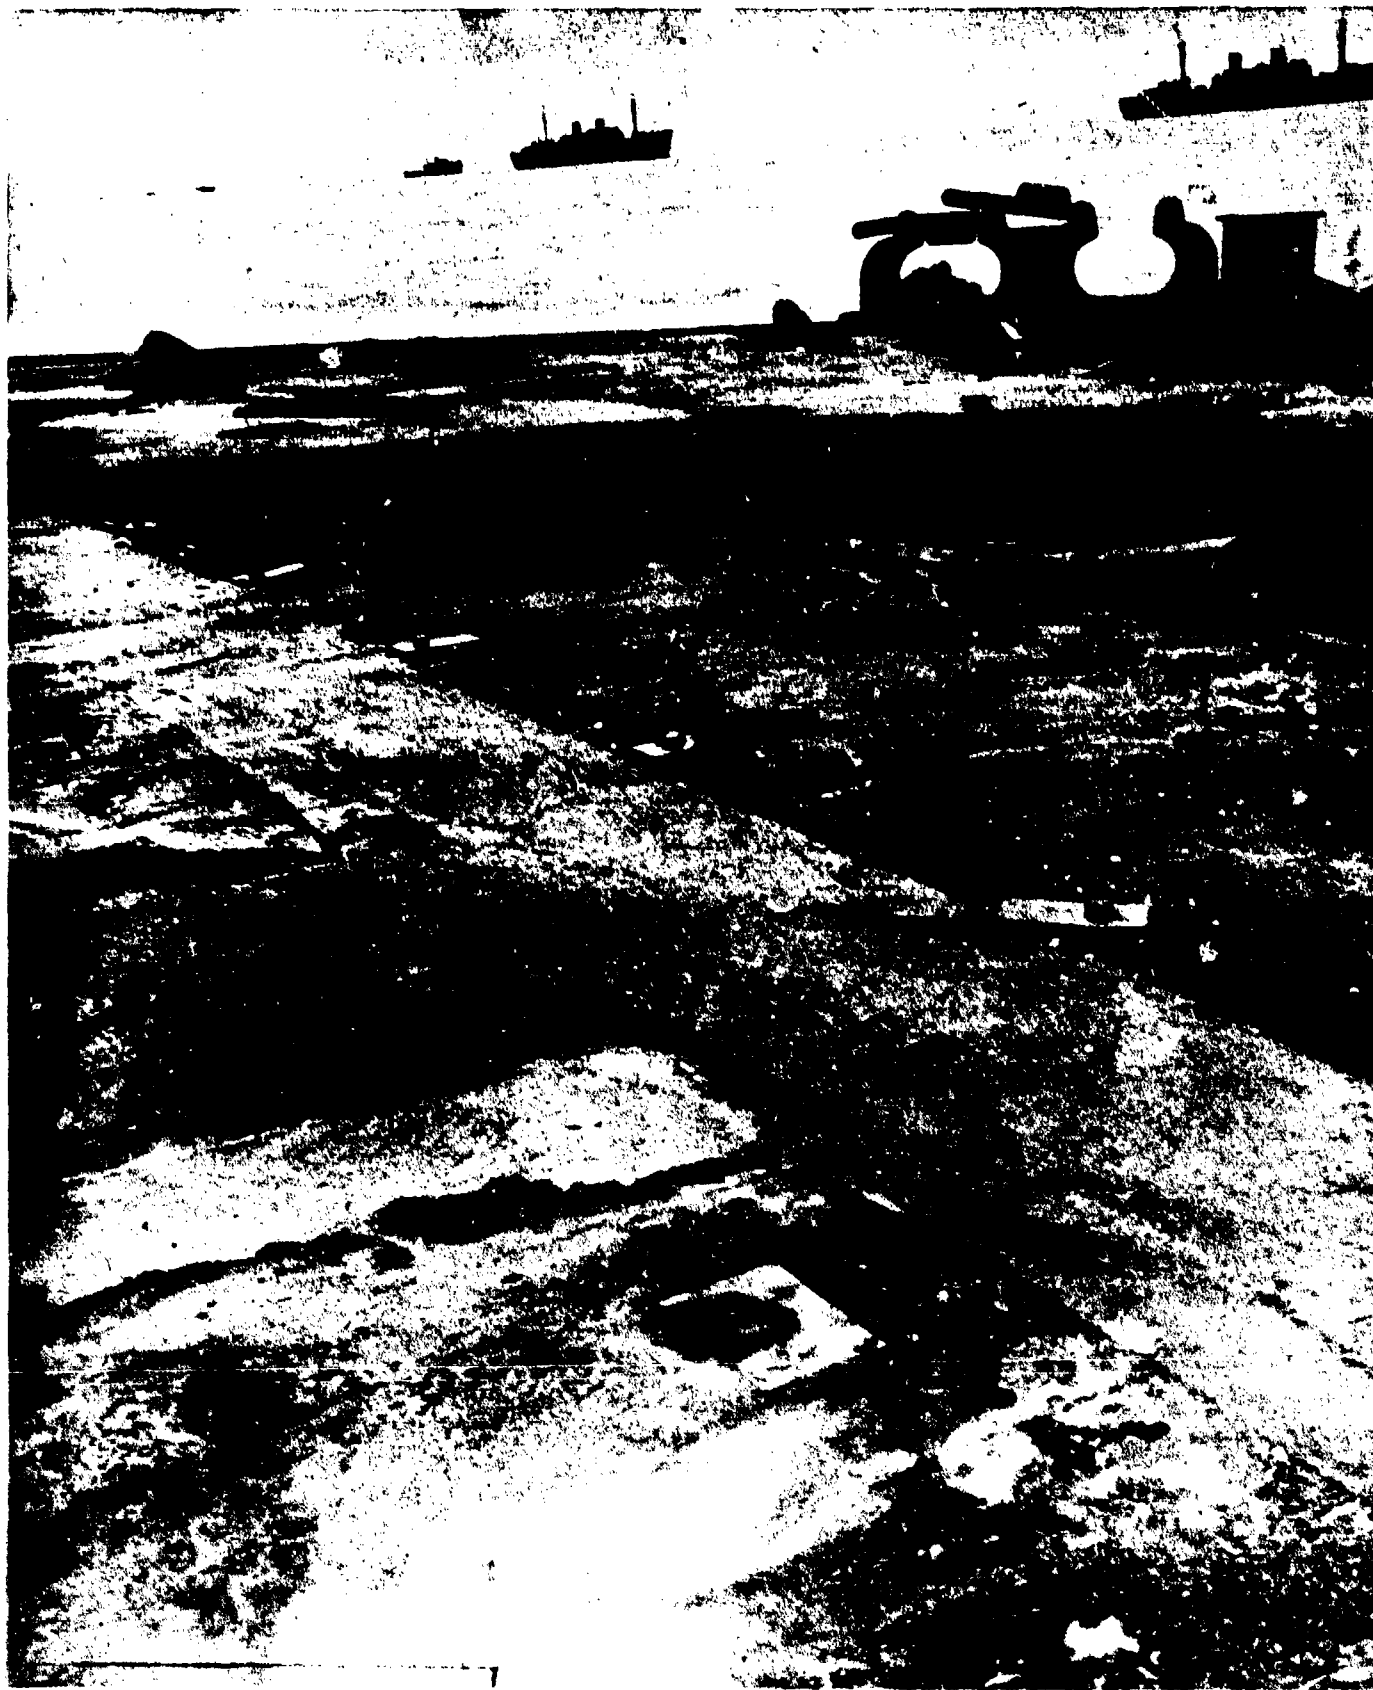
The A deck slab which is the top cover for the wingwalls, contains longitudinal cracks over its entire length. The principal crack in the port wall, A deck, is the most severe and has caused spalling of the concrete in some areas. (Photos 1914-4, 1916-1, 1964-1 and 1914-12, pages 63 , 64 , 73 , and 74). The dock floor slab, on C deck, suffered damage throughout its length. This damage is in the form of longitudinal tensile cracks 1/16 to 1/8 inch in width running about three feet on each side of the centerline. There is also a crack about three feet inboard of the starboard wall extending from frame 10 to 25 and from 39 to 57. Plank flooring covering the propellor pits at the stern has been blown away (Photos 1962-11, 1964-3, pages 75 , and 76).

AA-CR-98-1964-3. Looking aft along dock floor at starboard propeller pit, the wooden cover is missing.

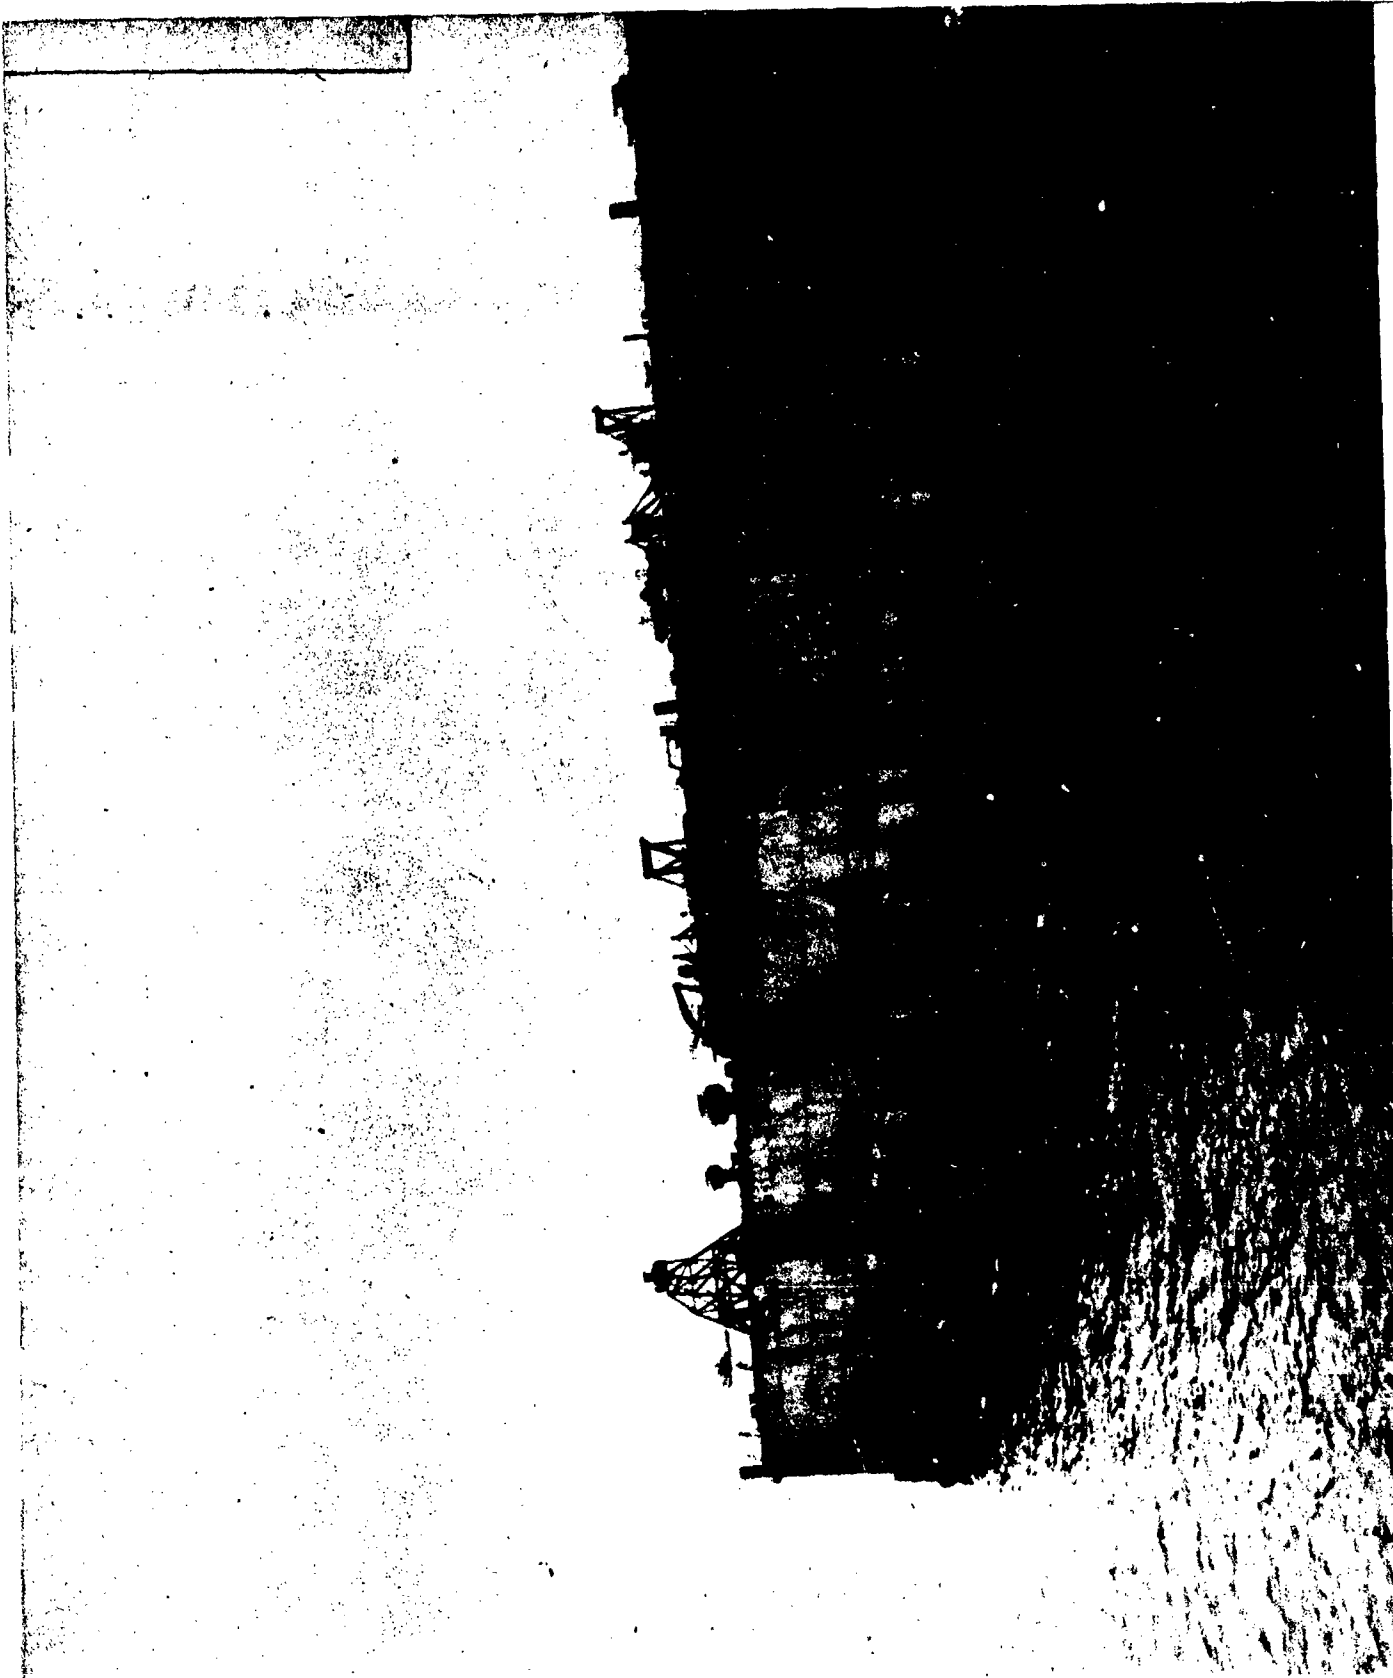
The exterior face of the port wall was darkened by radiated heat and the extensive timber fender system is charred to a depth of about 1/16 inch. (Photo 1964-10, page 78). There is a well defined crack running almost the length of the deck in line with the connection of the wall to B deck. There is a small crack extending through the port shell slab about six inches below the waterline running between frames 18 and 55. The crack was reported leaking over about one fourth of its total length. Outside of this one crack, the underwater damage is considered to be relatively minor.

AA-CR-98-1964-10. View of exterior face of port wing wall looking
aft from off port bow.
