BUREAU OF SHIPS GROUP TECHNICAL INSPECTION REPORT

U.S.S. ARDC 13

TEST ABLE [unclear] 8

6 OPERATION CROSSROADS. Defense Atomic Support Agency, Washington, D. C. 20301

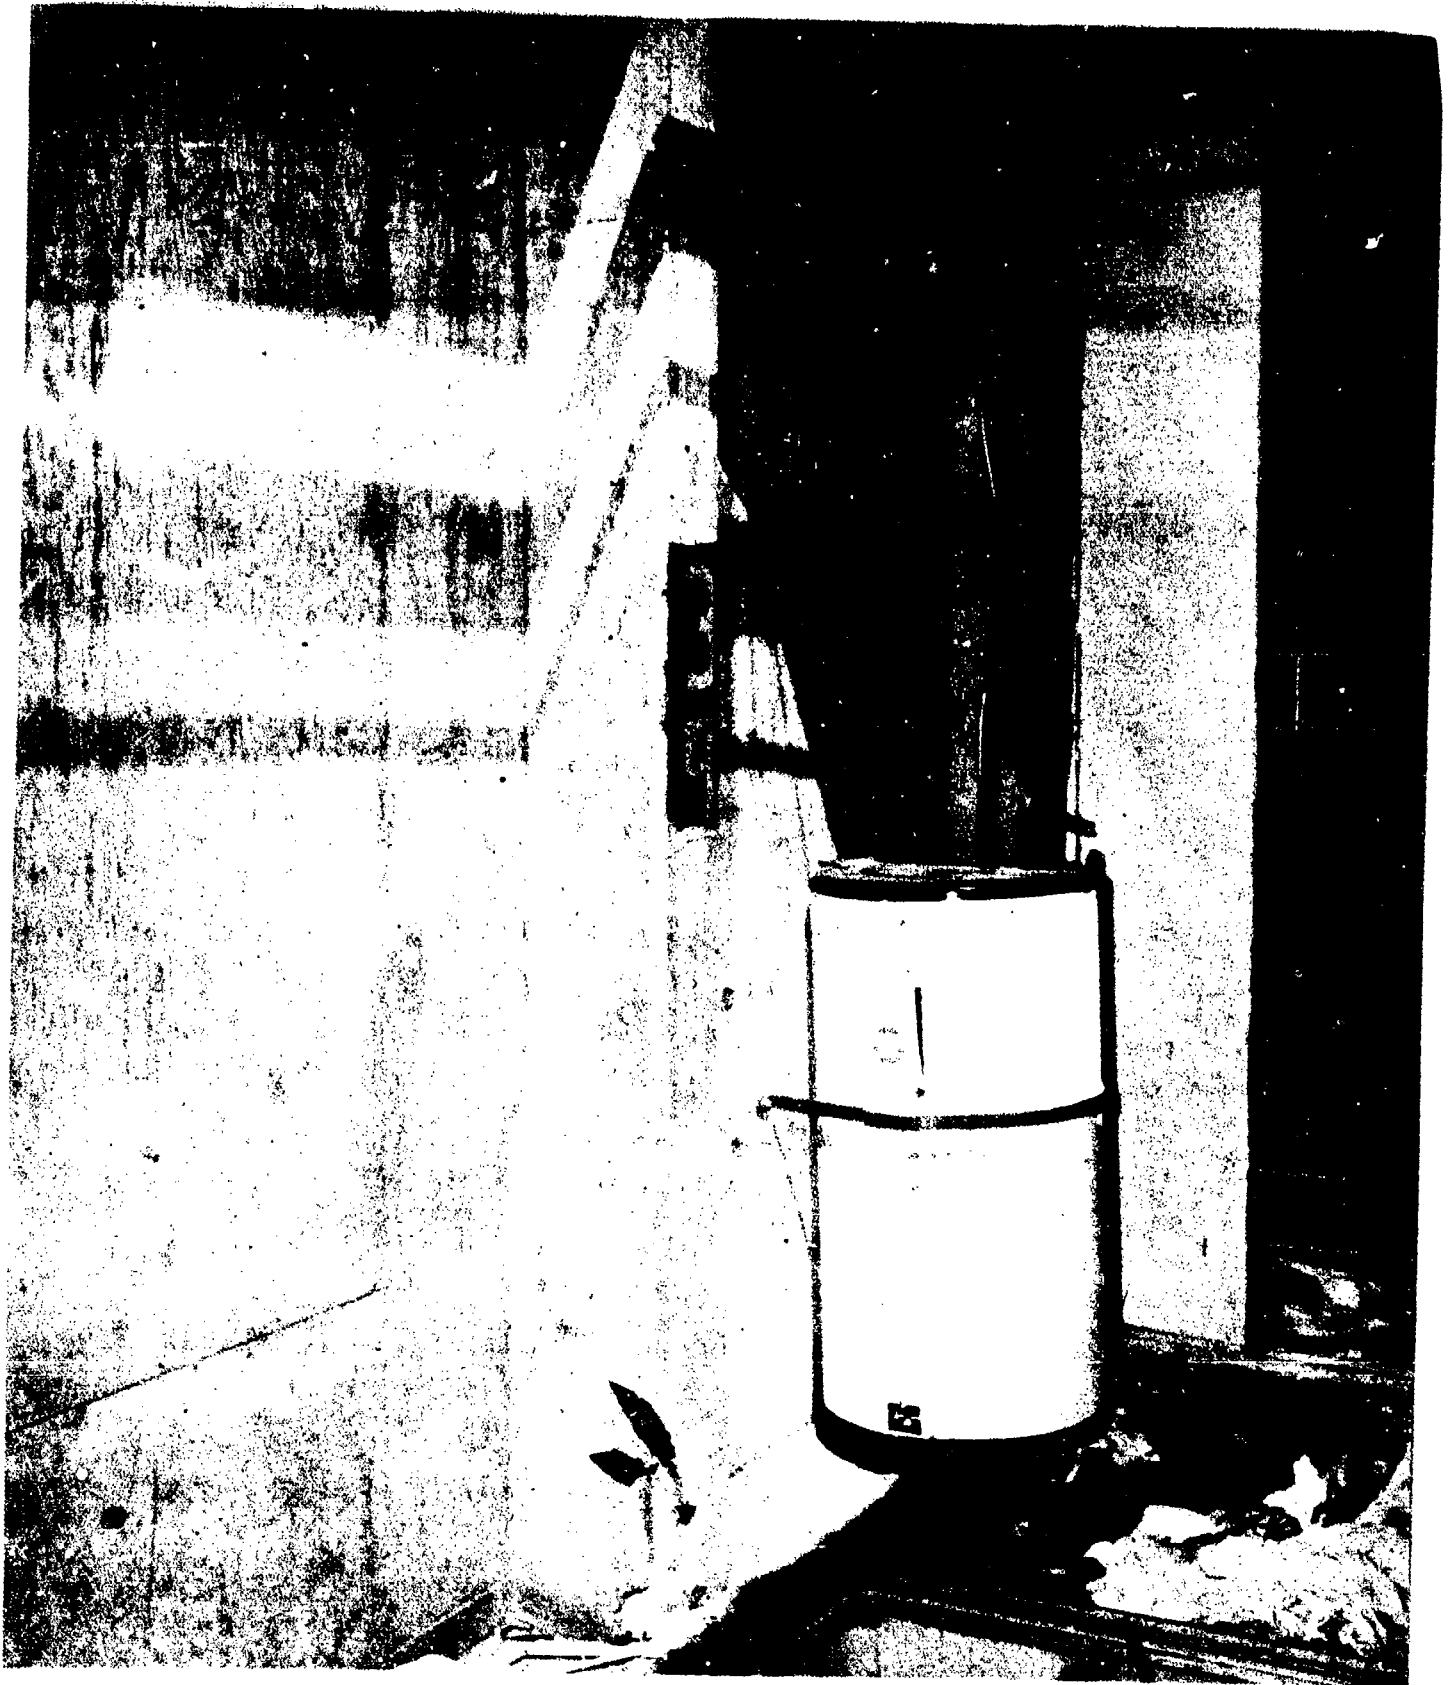
deck levels (Photos 1914-6, 1914-7, 1914-10, pages 79 , 80 , and 81). On the starboard side, only the wing frames were affected. These have fine structural cracks about four feet above the B deck level. The port wing wall has two large areas that are over stressed. Structural, longitudinal cracks run between frames 25 and 40 at about B deck level, and about three feet below A deck. Structural bulkheads between frames 19 to 44, port, on B deck, are badly damaged. Concrete here has spalled, exposing the reinforcing bars. The watertight integrity of these bulkheads is impaired. (Photos 1914-8, 1914-5, pages 82 , and 83).

AA-CR-32-1914-6. Typical damage is shown at the base of frame 39, port side, looking forward.
