TECHNICAL INSPECTION REPORT

OPERATION CROSSROADS
U.S.S NEVADA (BB36).

TEST ABLE.

VOLUME I [u] (8)

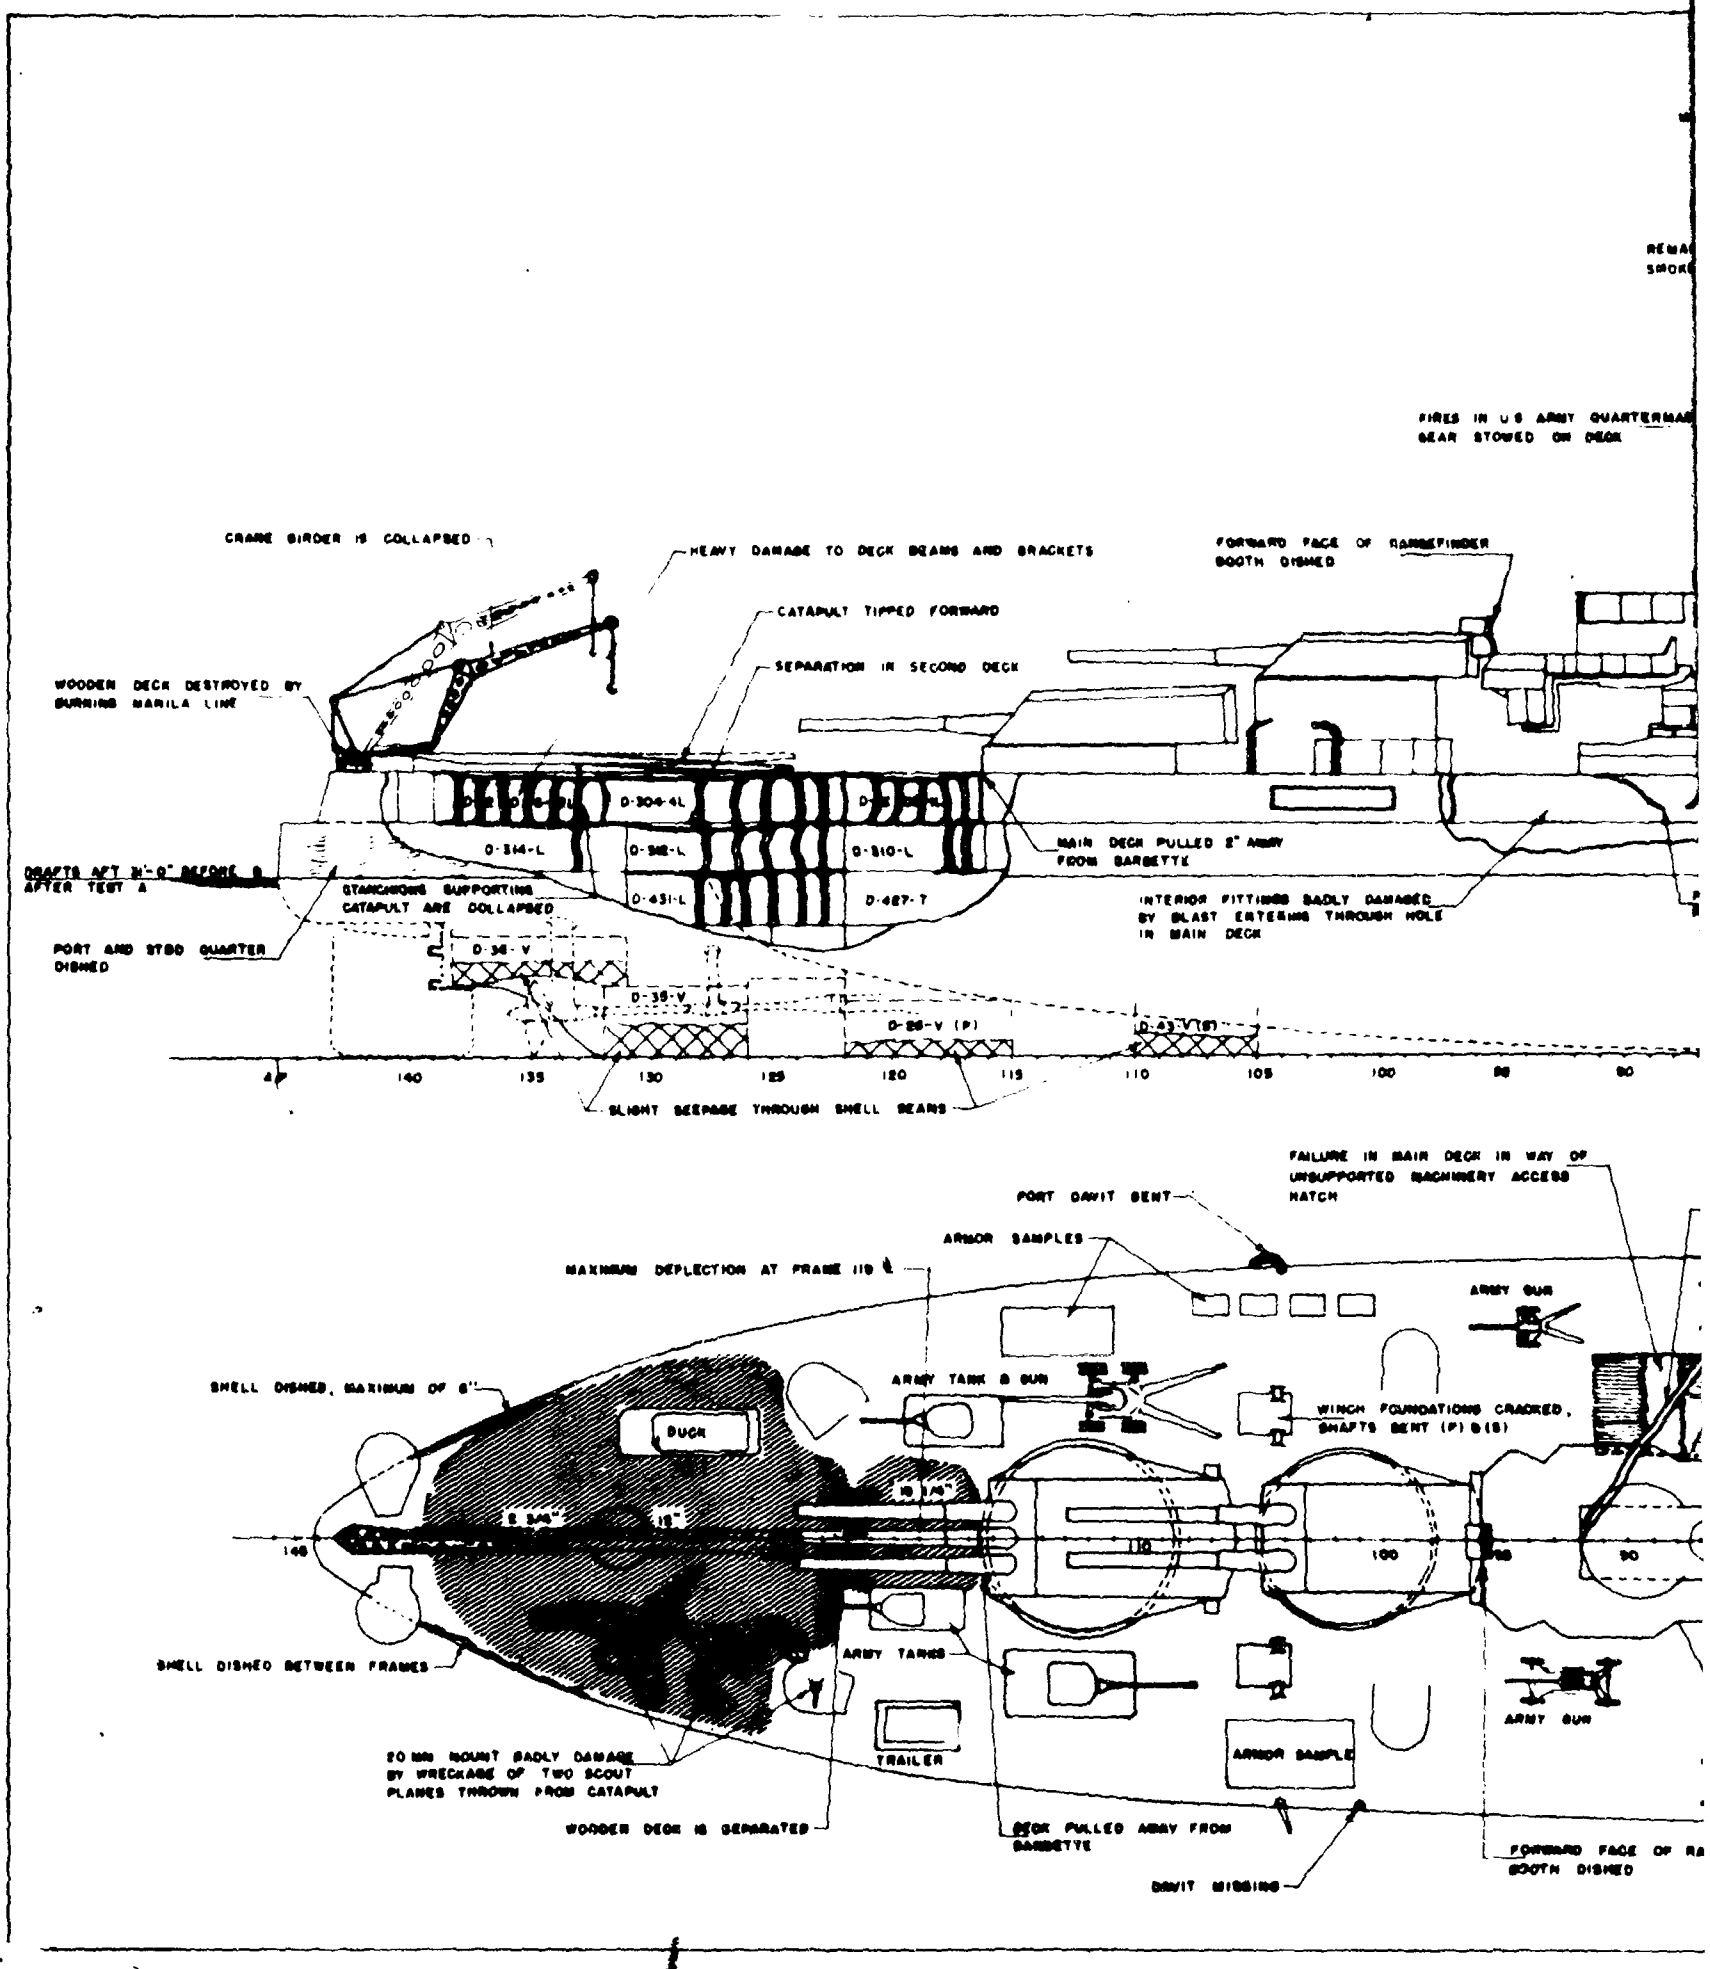
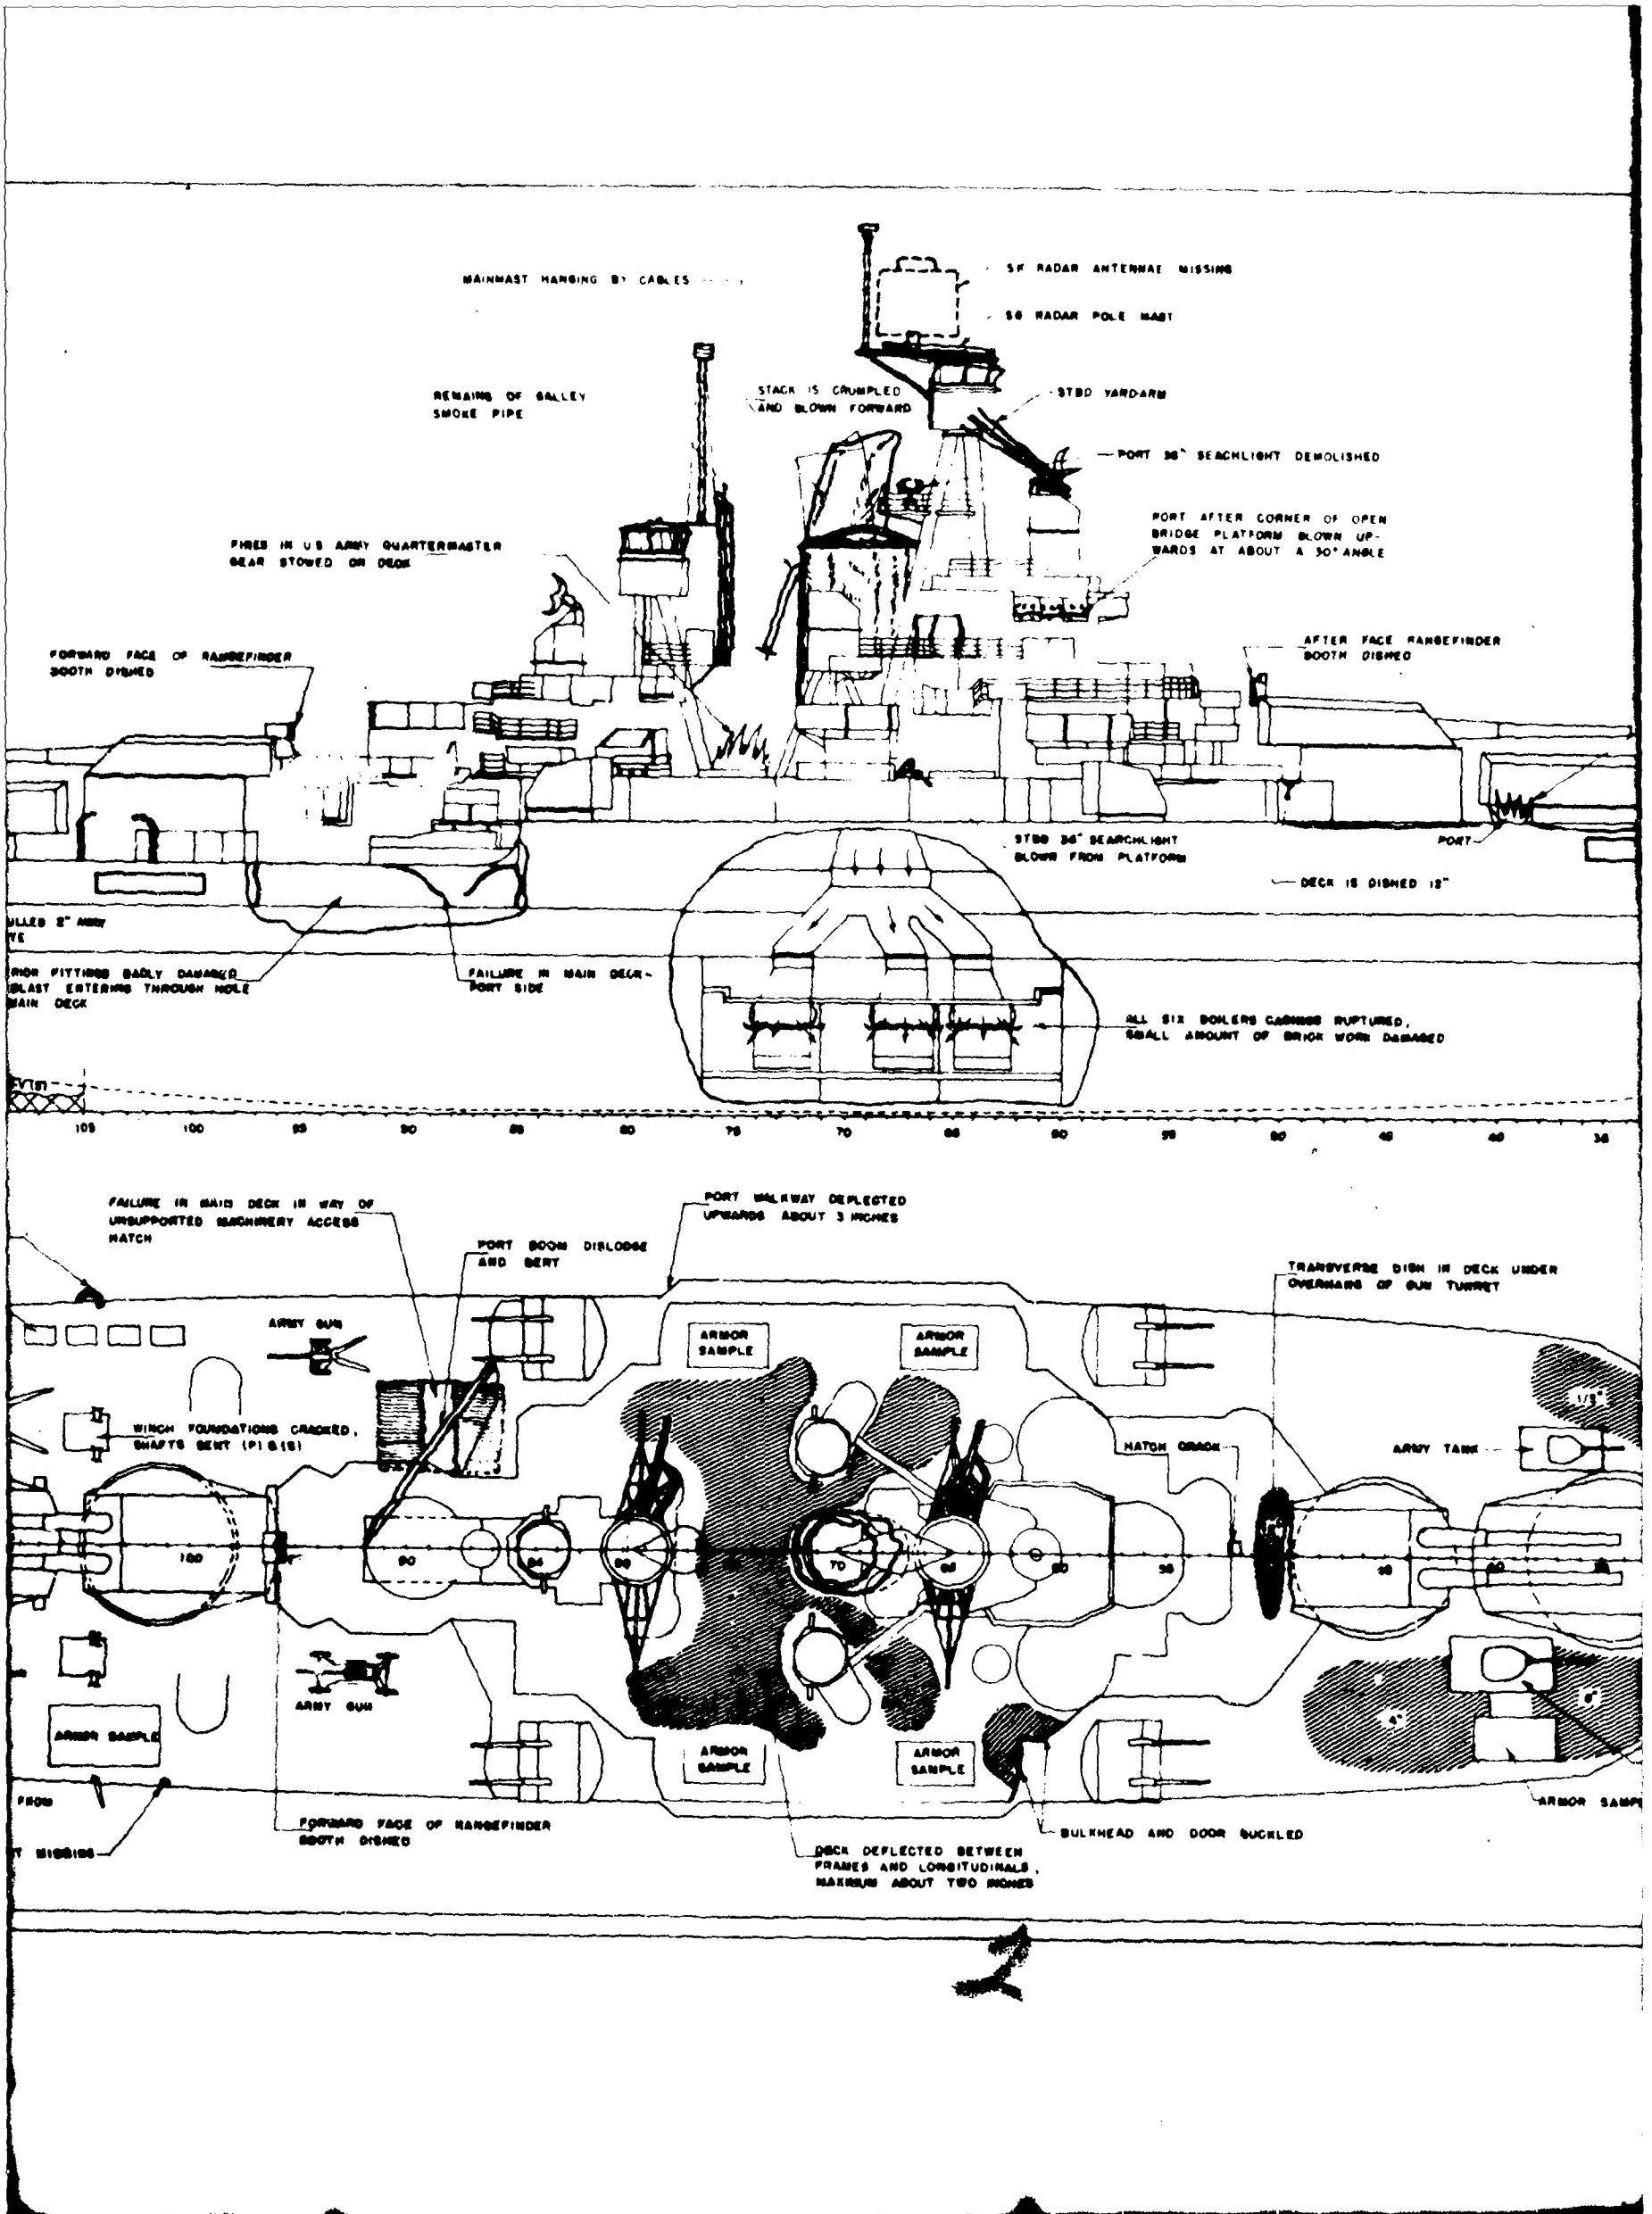
The weather deck aft of No. 4 turret and the port side from frame 86 to 91, is badly damaged. Forward of frame 60, the deck is lightly damaged. All exposed portions of the superstructure have suffered varying degrees of damage (see figure 1, page 91).

FIRES IN U.S. ARMY QUARTERMA
GEAR STOWED ON DECK

DAVIT MISSING

FORWARD FACE OF RA
BOOTH DISHED

5" BEACHLIGHT DEMOLISHED

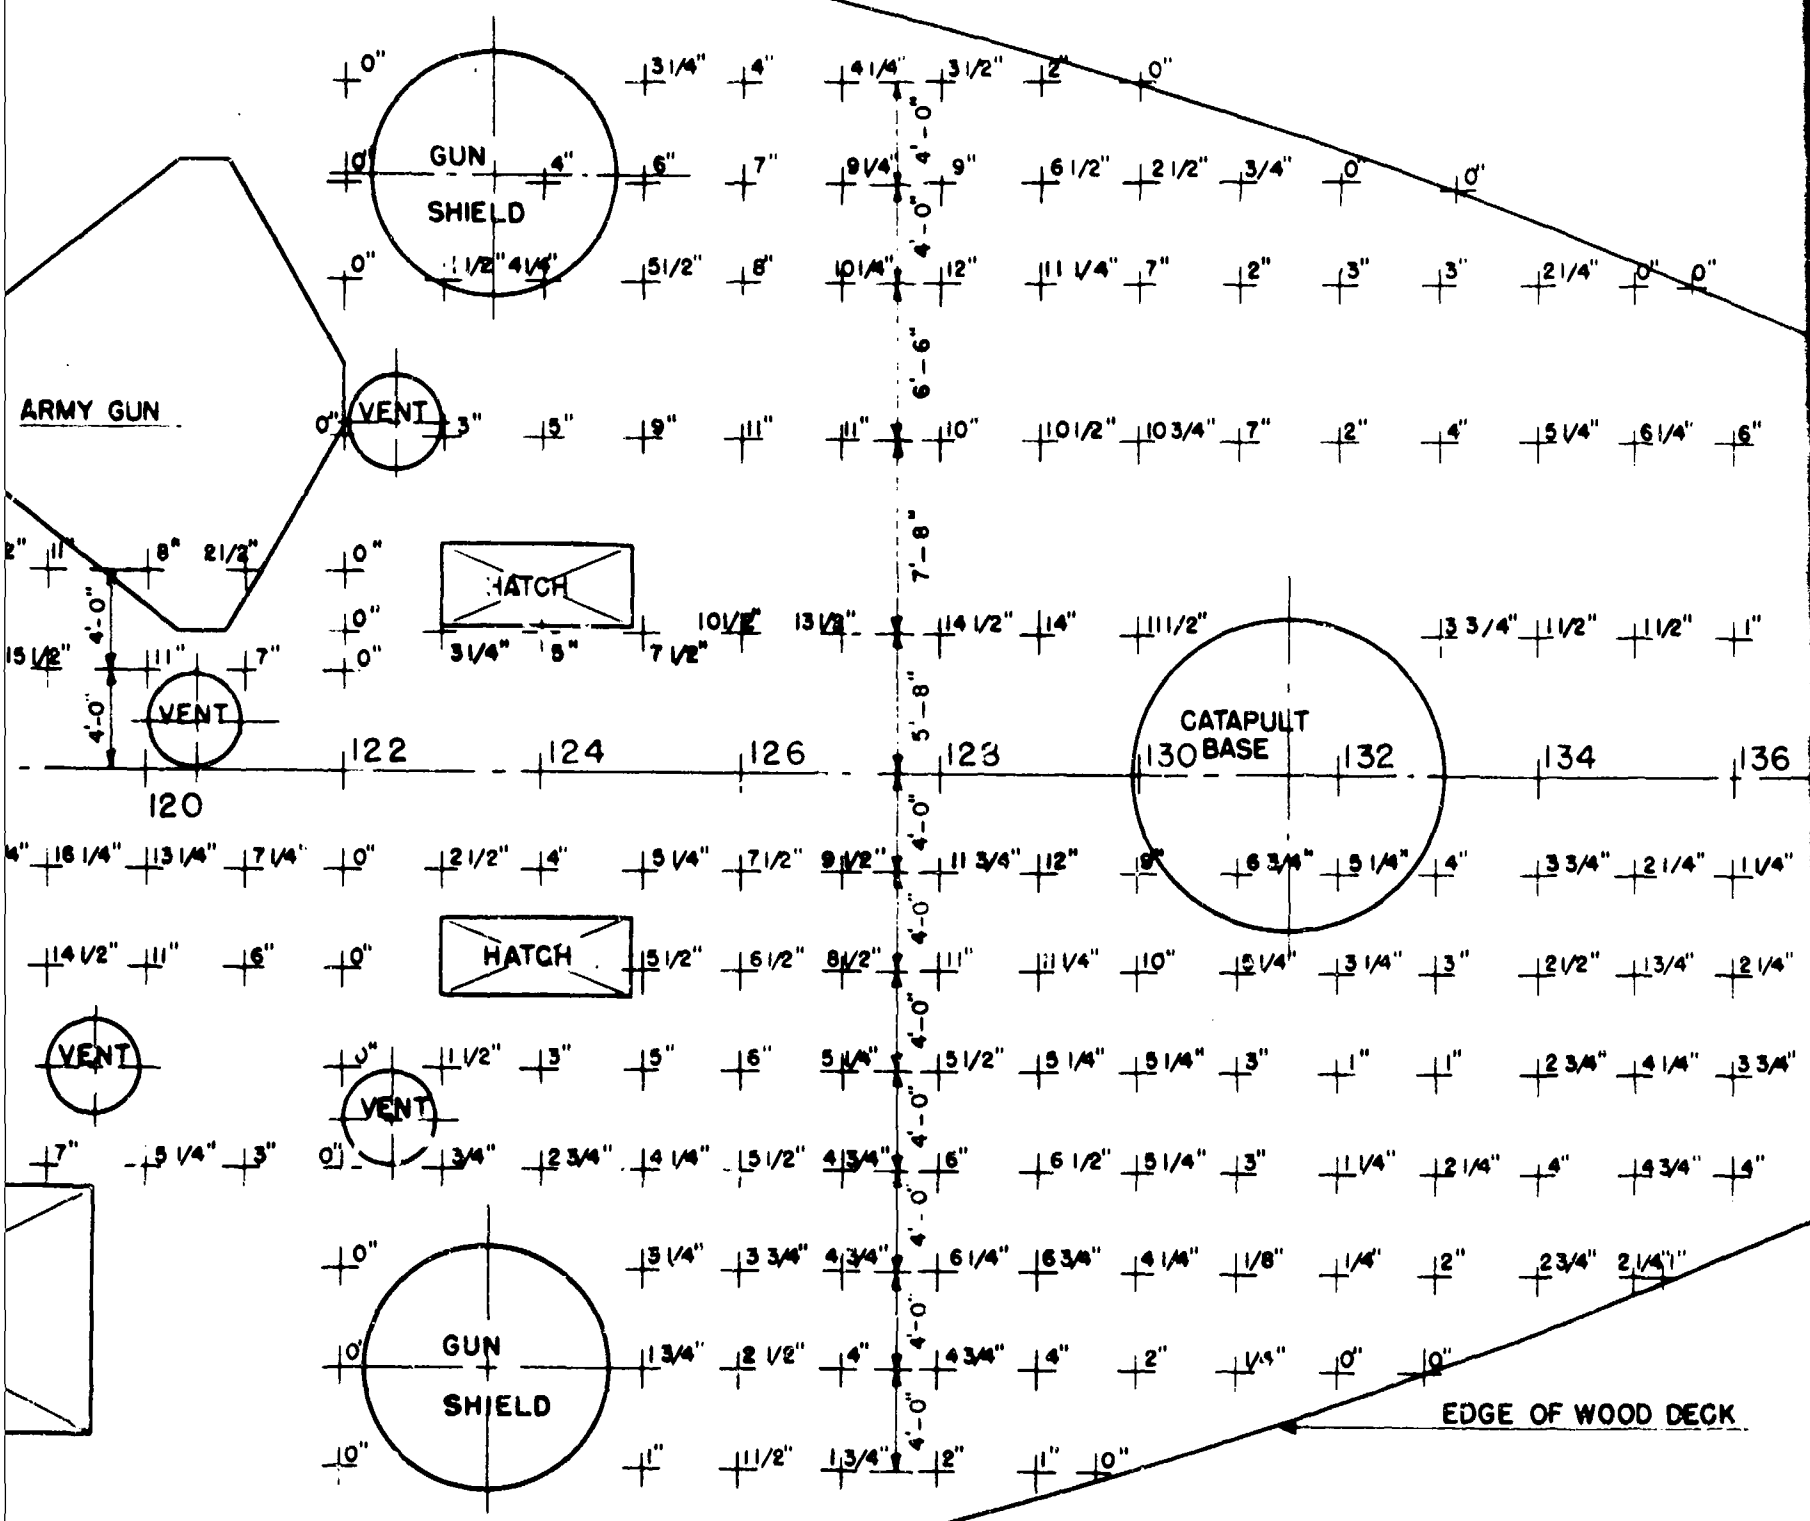
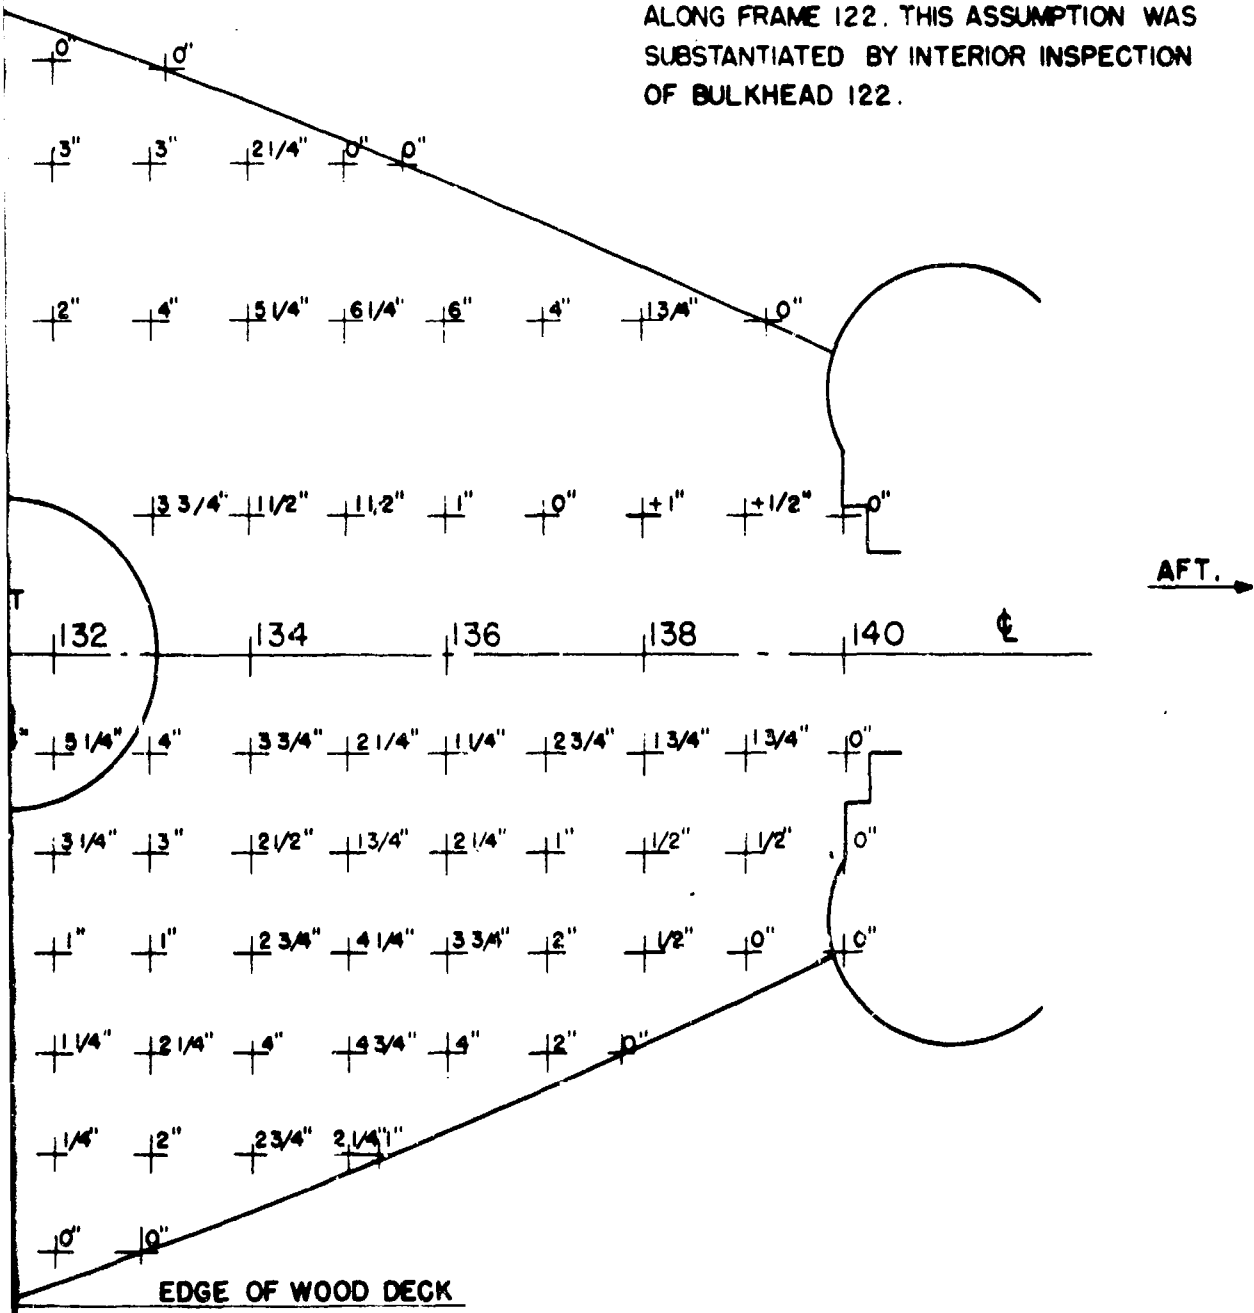
SECRET
 NAVY DEPT. BUREAU OF SHIPS
DECK DEFLECTIONS
 U.S.S NEVADA BB 36
 FIGURE NO. 2 PAGE 99 OF 153 9795

There is heavy deflection of the main deck aft as a result of blast. The most severe depression is slightly aft of No. 4 turret (figures 1 and 2, pages 94 and 99). This depression pulled the deck away from the after face of No. 4 barrette. The maximum deflection in this area is about 16 1/2 inches. Between frames 122 and 132 the maximum deflection is about 14 inches. The deflections of the main deck are accompanied by failure of supporting stanchions and distortion of connections of the deck beams to the shell stiffeners. The second deck is deflected aft of the armor from bulkhead 122 to about frame 134, the maximum being about 12 inches. The damage diminishes as it goes deeper into the ship.

FOR THE PURPOSE OF OBTAINING THESE MEASUREMENT IT WAS NECESSARY TO ASSUME THAT THE DECK DID NOT DEFLECT ALONG FRAME 122. THIS ASSUMPTION WAS SUBSTANTIATED BY INTERIOR INSPECTION OF BULKHEAD 122.

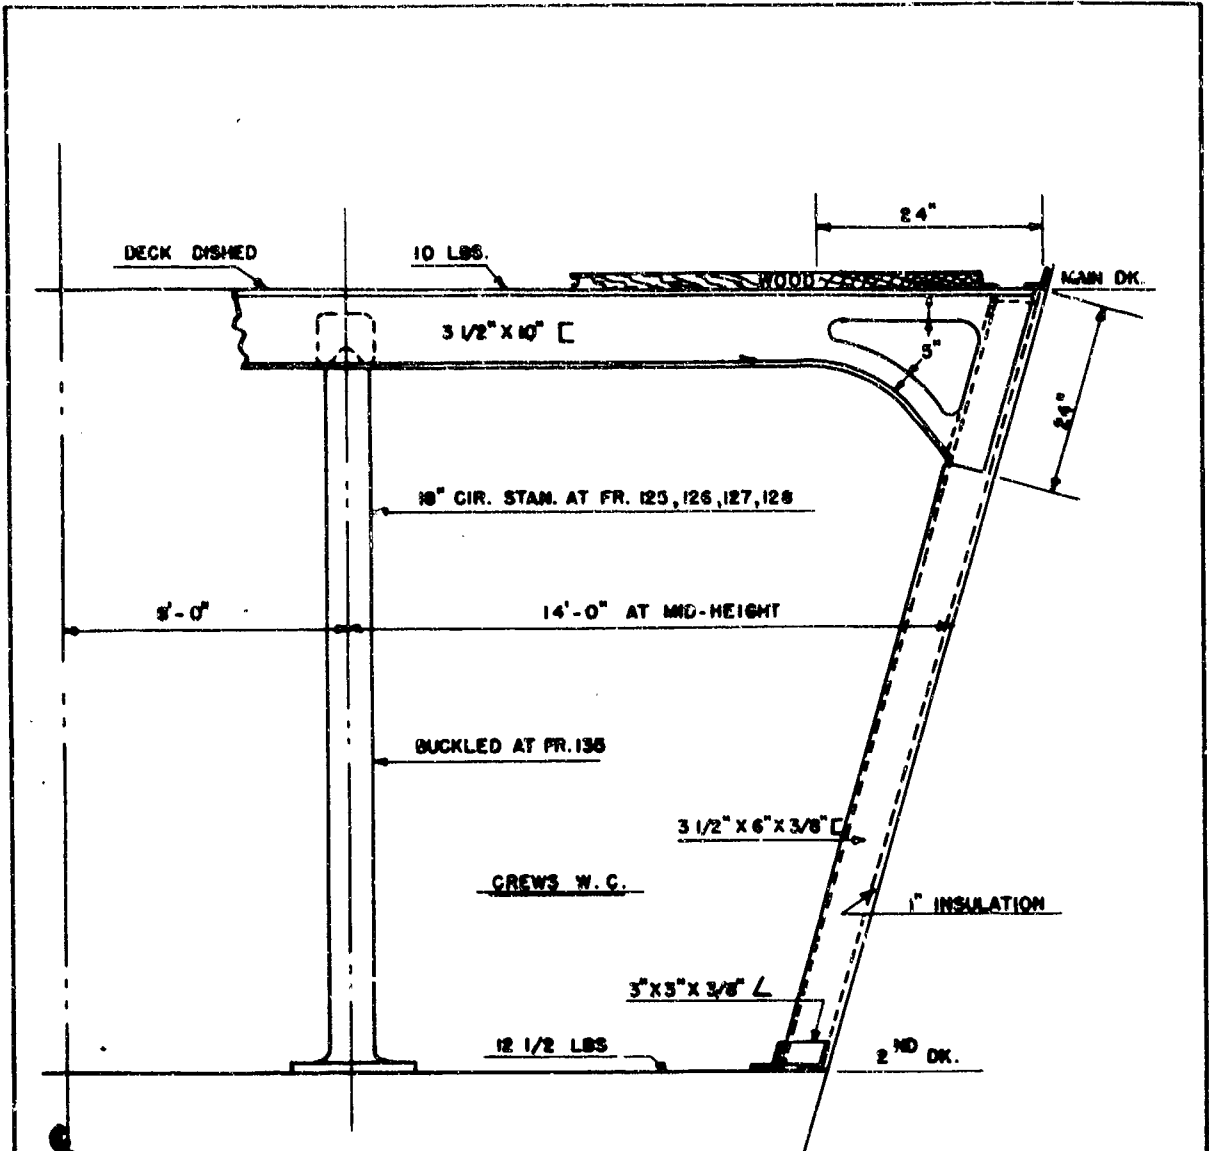
**SECTION AT FRAME 135
 STB'D SIDE LOOKING FWD.**

NOTE:
 PRINCIPAL DISHING IS IN MAIN DECK
 CENTERING APPROX. AT FR. 135
