TECHNICAL INSPECTION REPORT

(6) OPERATION CROSSROADS,  
U.S.S. NEW YORK (BB34).

TEST BAKER *[initials]*

OPERATION CROSSROADS

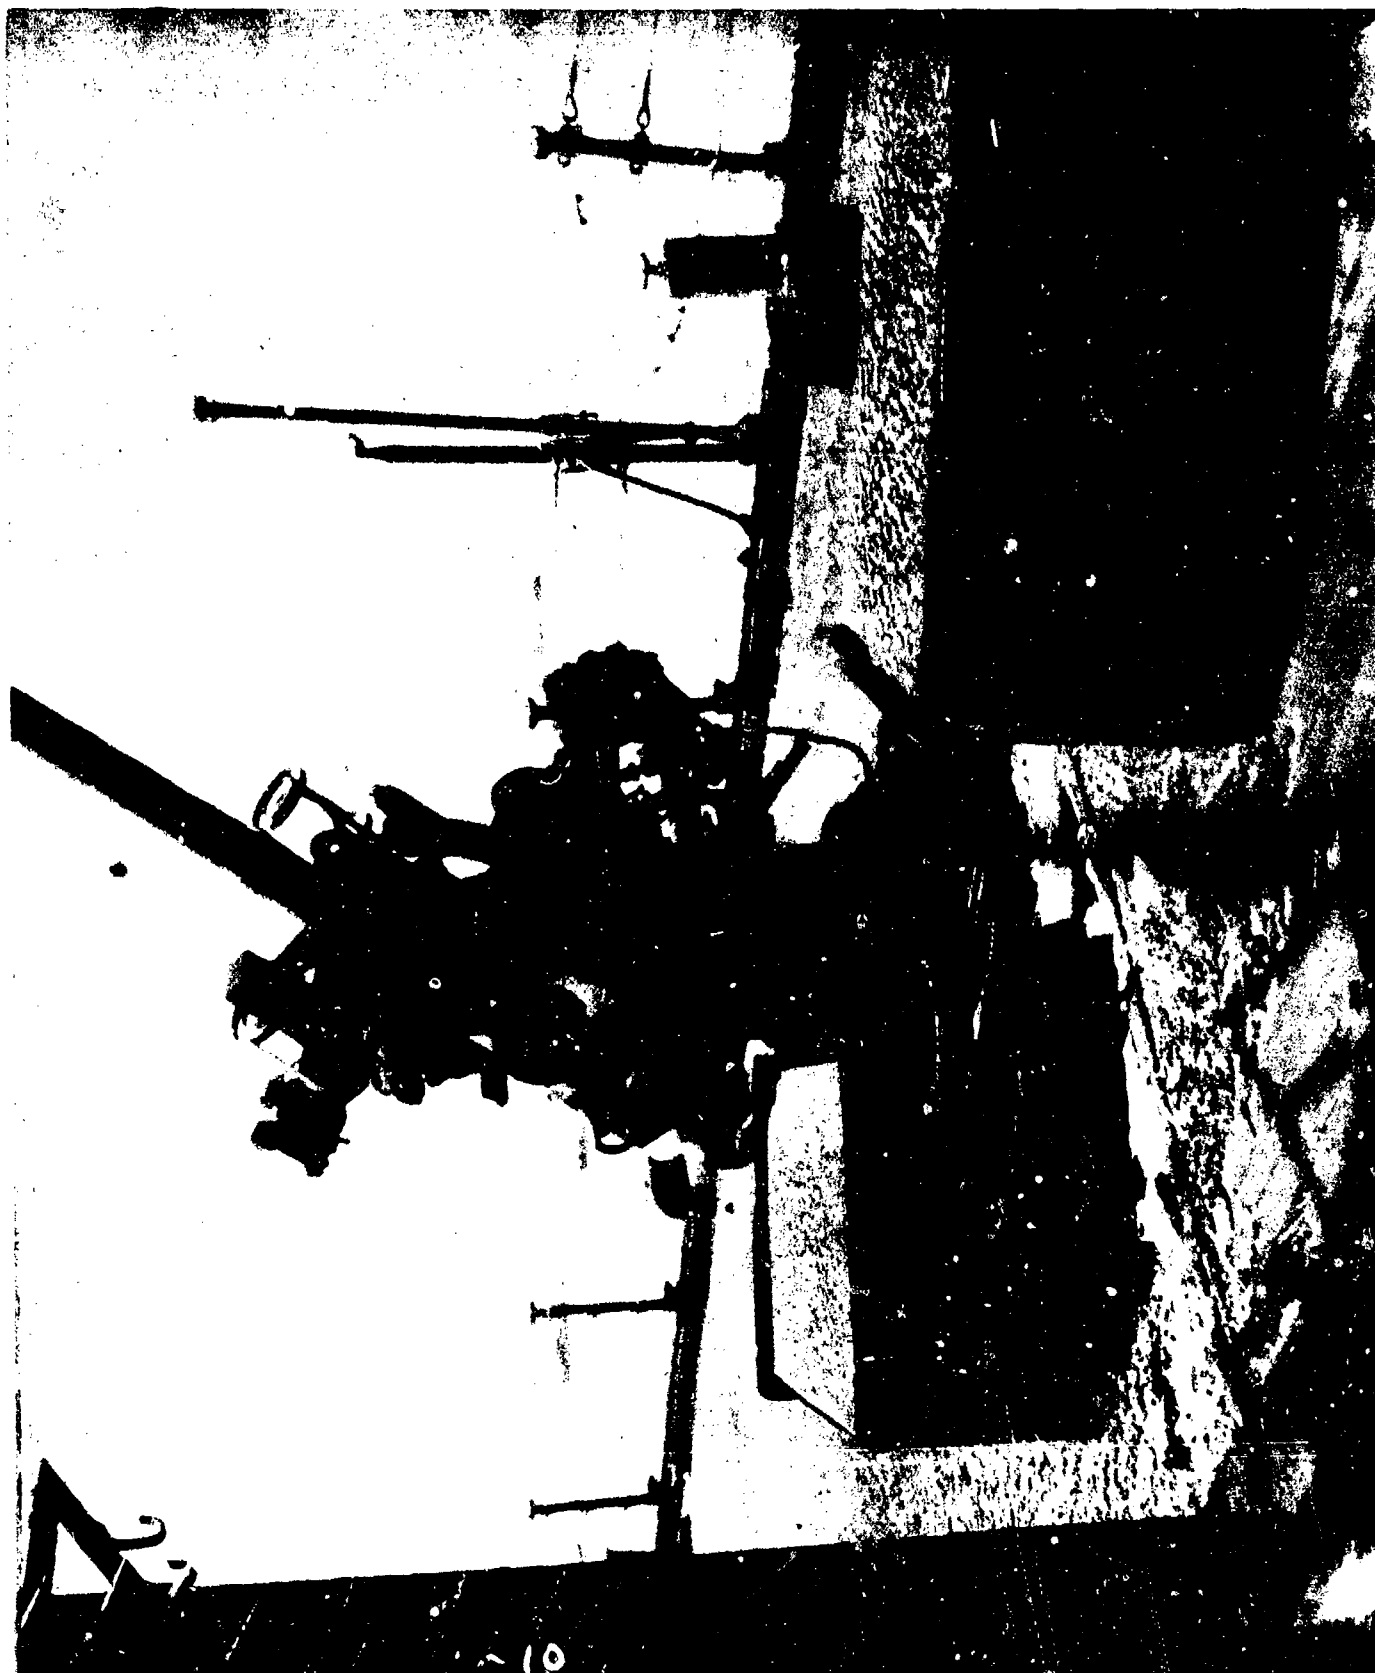
The principal cause of damage is underwater shock. The airplanes, ready service boxes and air intake louvres may have suffered damage from solid water taken aboard.

AB-CR-87-2544-10. Dislodged ready service boxes, main deck,  
starboard side about frame 100.

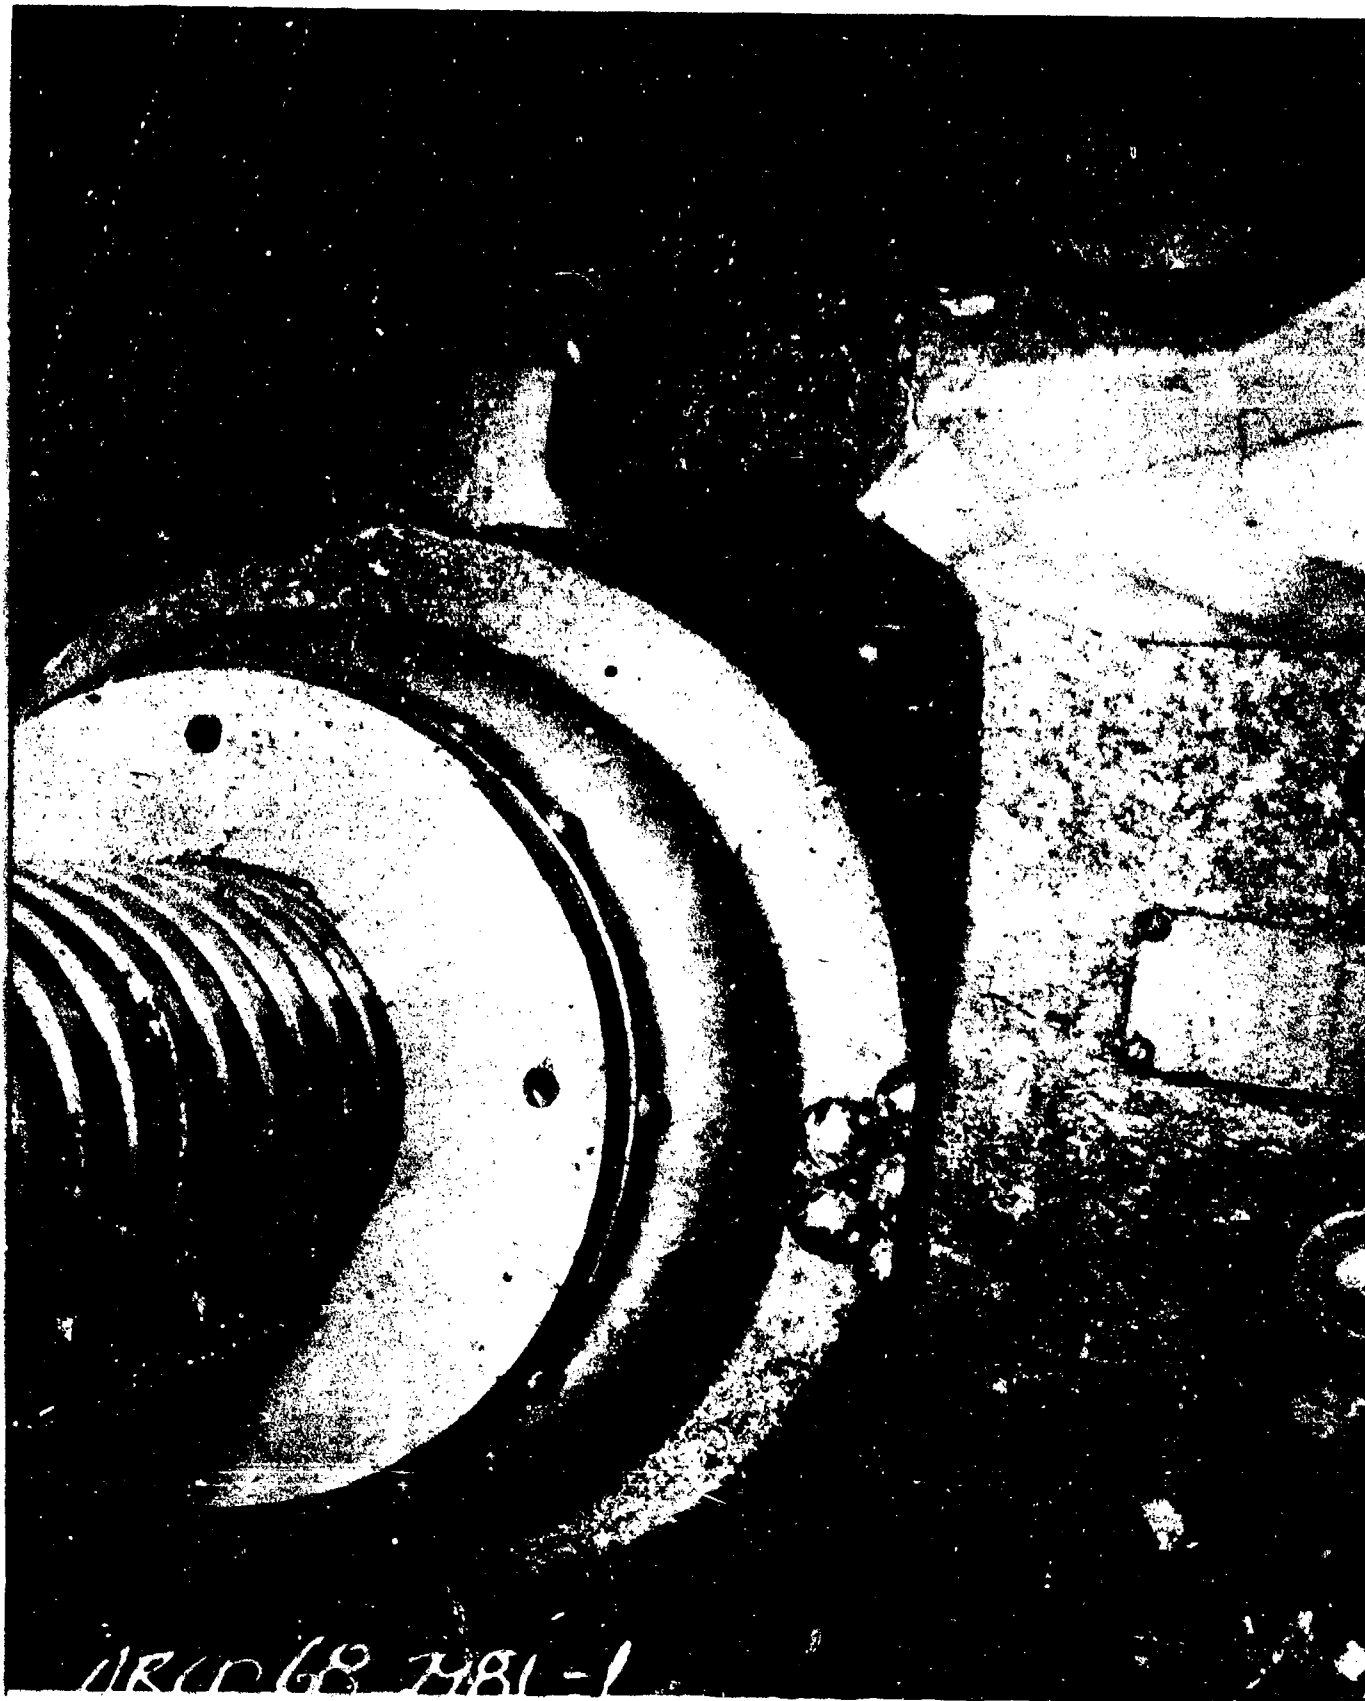
The 14" turrets were damaged by shock. The left gun of turret 2 and the right guns of turrets 3 and 4 are inoperable due to the failure of the elevating screw oscillating bearings. (Photo 2981-1, 2, 4222-6, 7, 8, 9, 10; pages 106 to 112). Since the guns are muzzle heavy the failure permitted them to depress. (Photos 2152-1, 2, 6; pages 78, 71, and 74). The guns affected are all on the port side of the ship which was the side nearest the bomb.

AB-CR-68-2981-1. Right gun of Turret 3, elevating screw oscillating bearing, looking down and to front showing top assembly pulled out of position and ball bearings scattered.

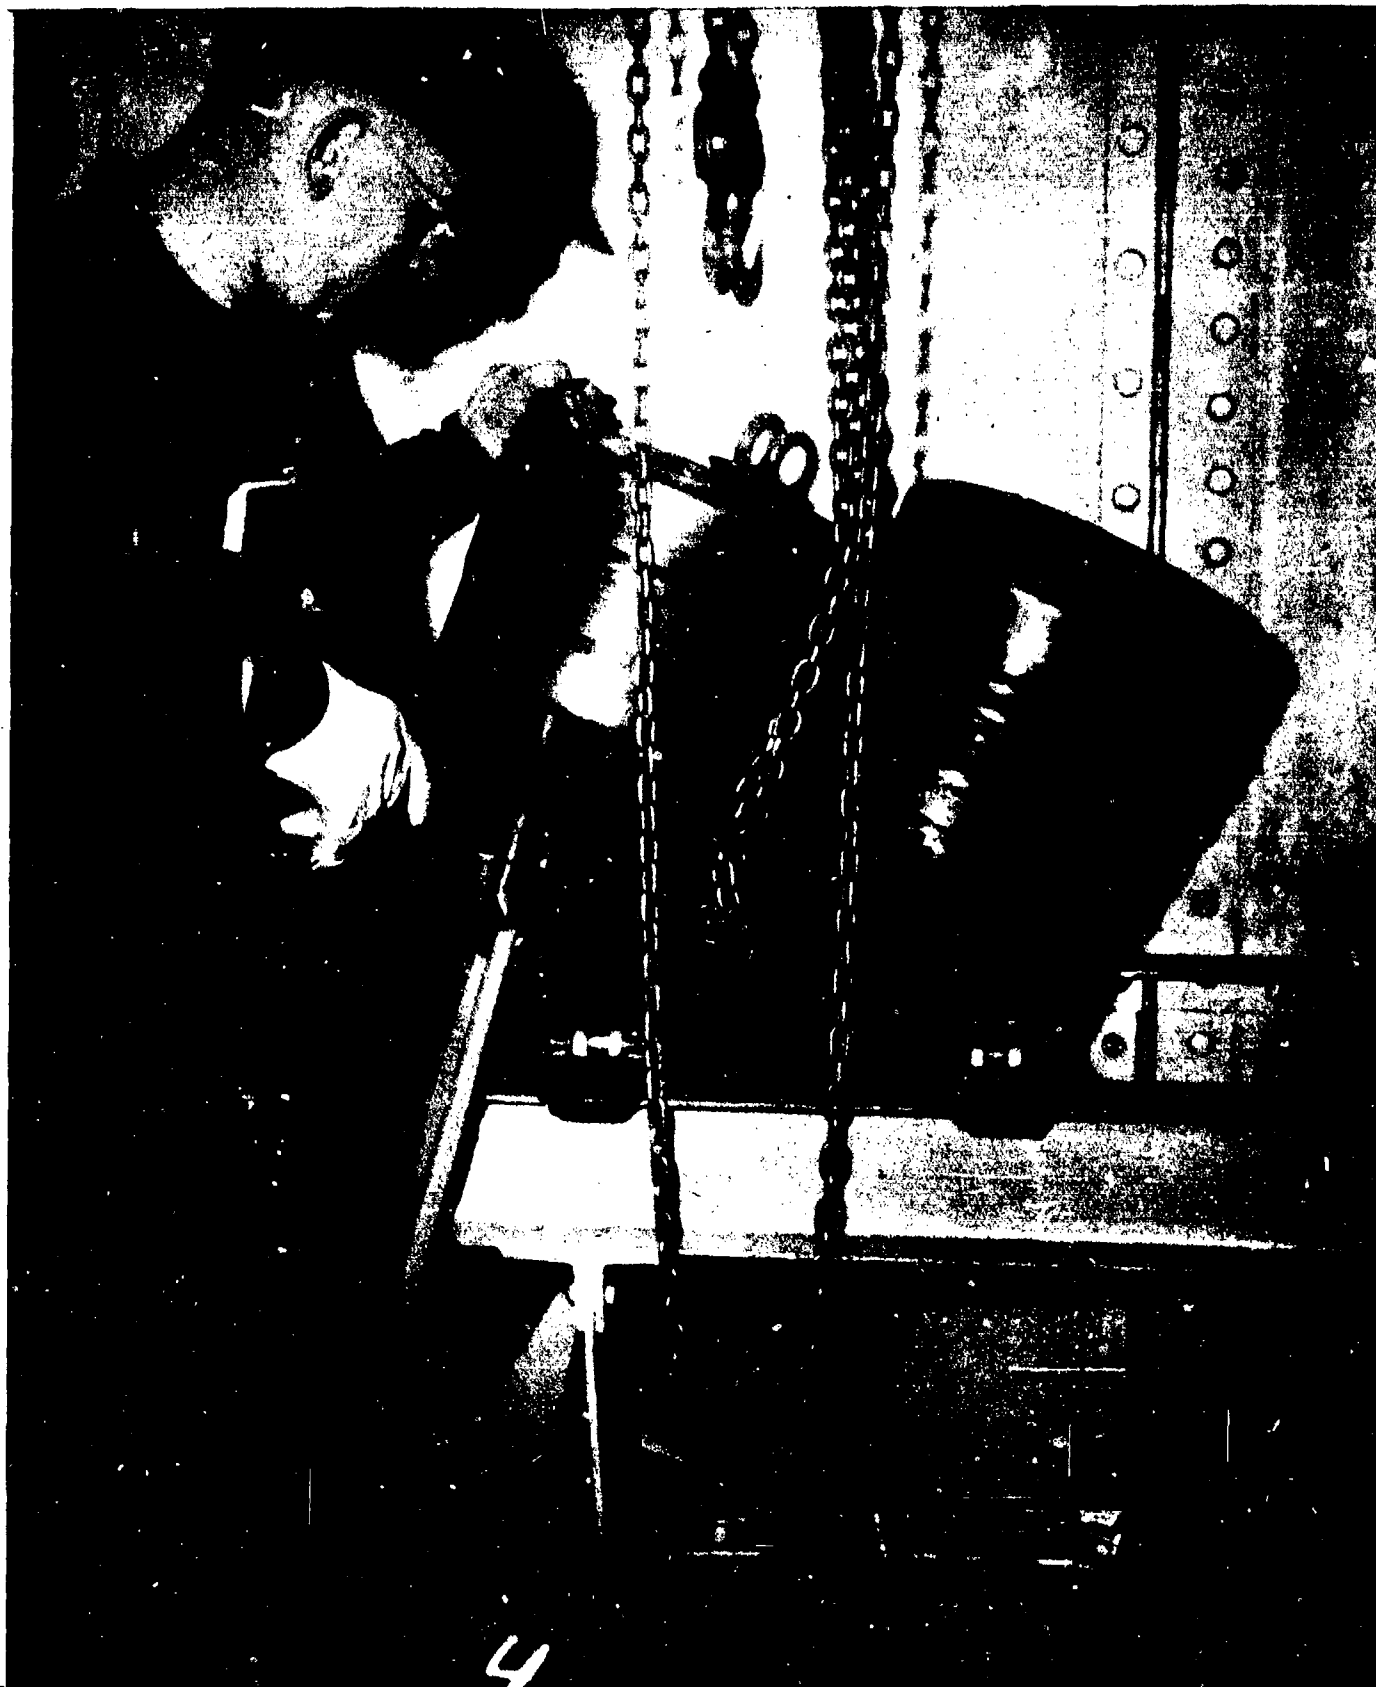
Underwater shock was sufficient to lift 14-inch shells out of stowage, fracture cast-iron foundations, damage holding-down clips and turret machinery and upset directors.

AB-CR-62-4164-4. Turret 5, projectile transfer level, left side, showing disarrangement of projectiles.

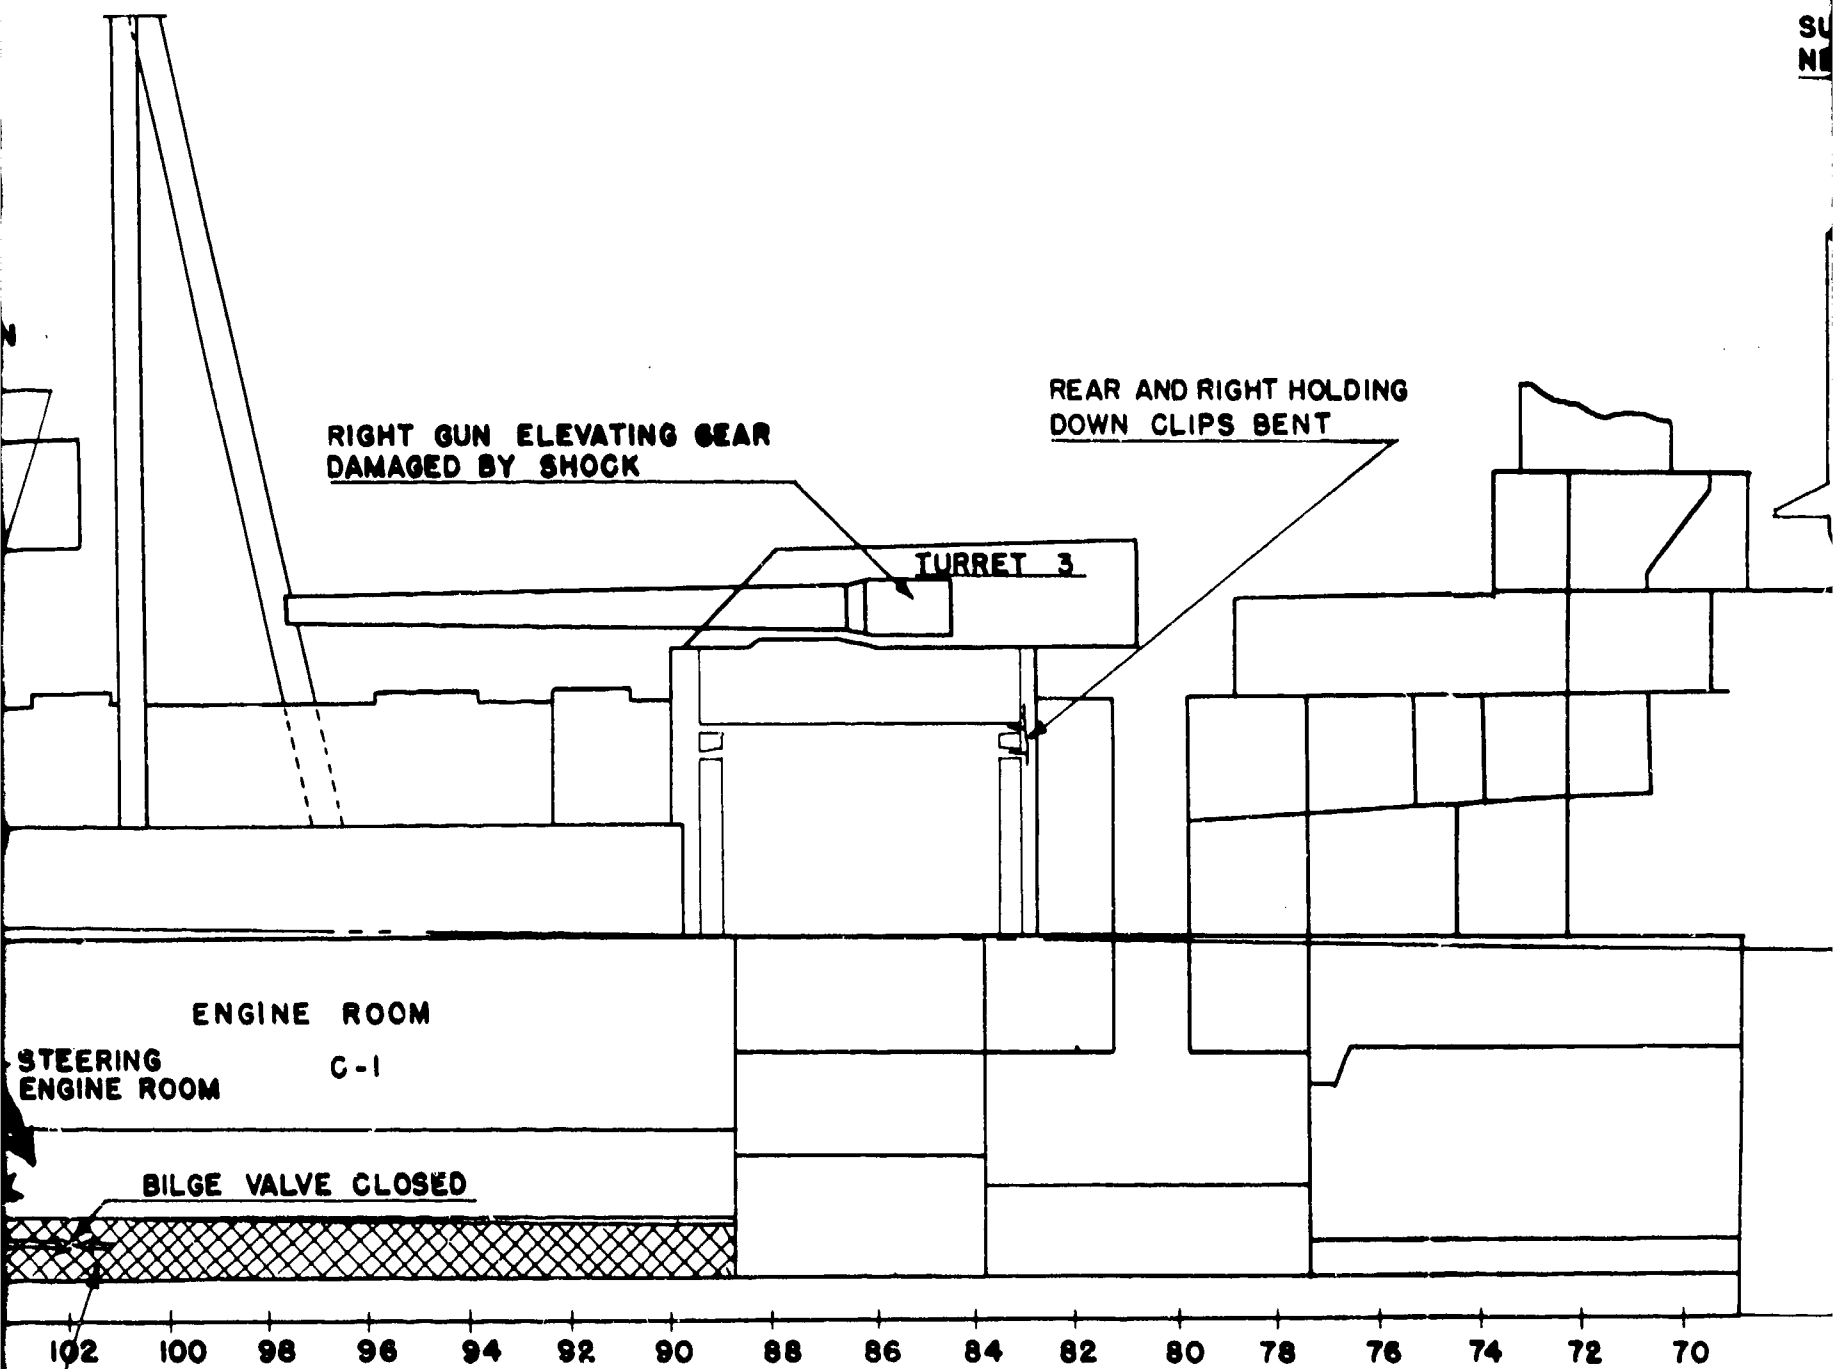
RIGHT GUN ELEVATING GEAR  
DAMAGED BY SHOCK

REAR AND RIGHT HOLDING  
DOWN CLIPS BENT

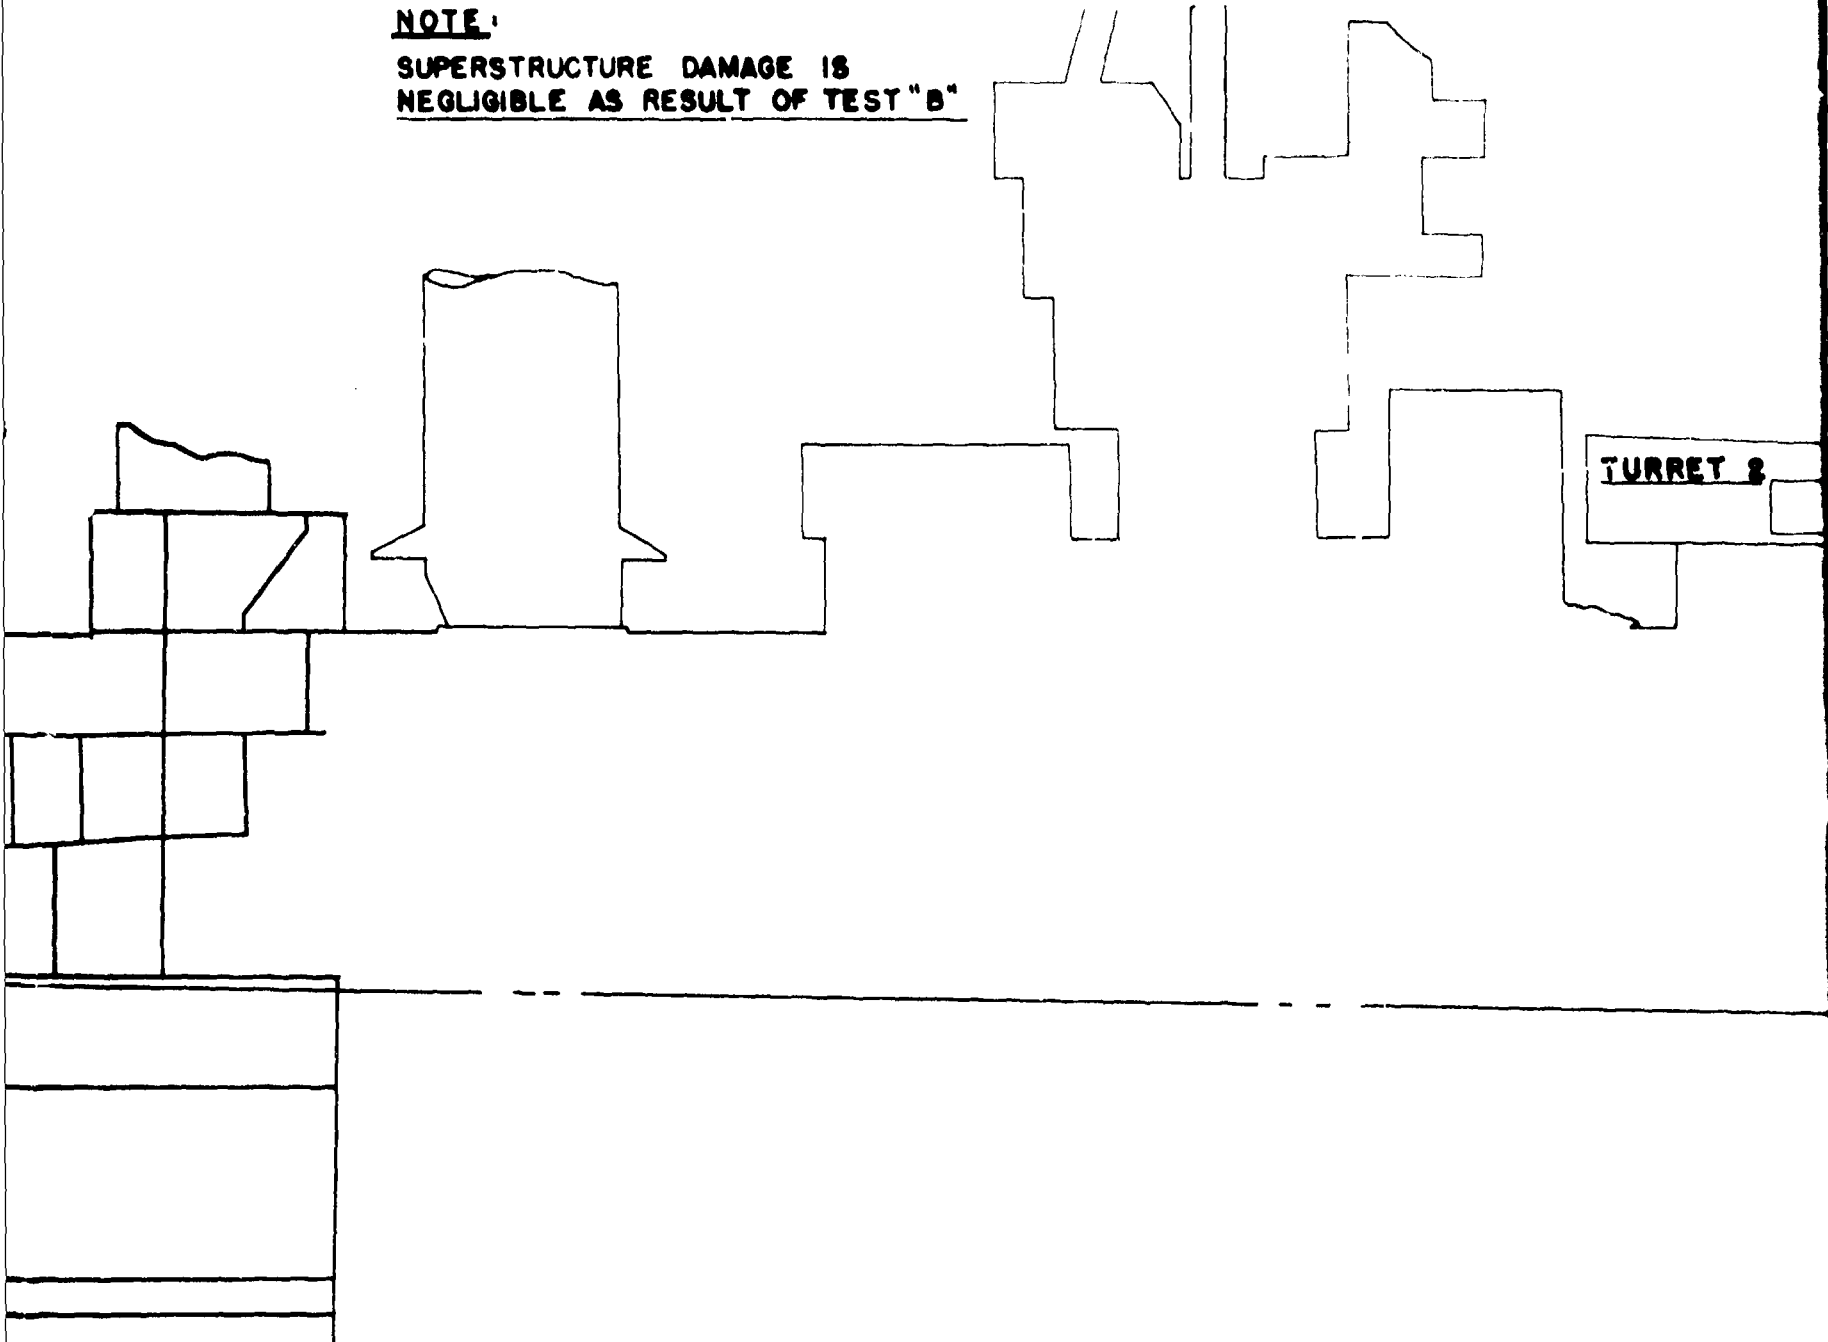
TURRET 2

LEFT GUN ELEVATING GEAR  
DAMAGED BY SHOCK
