TECHNICAL INSPECTION REPORT

(6) OPERATION CROSSROADS.  
U.S.S. NEVADA (BB36).

TEST BAKER [u] (8)

OPERATION CROSSROADS

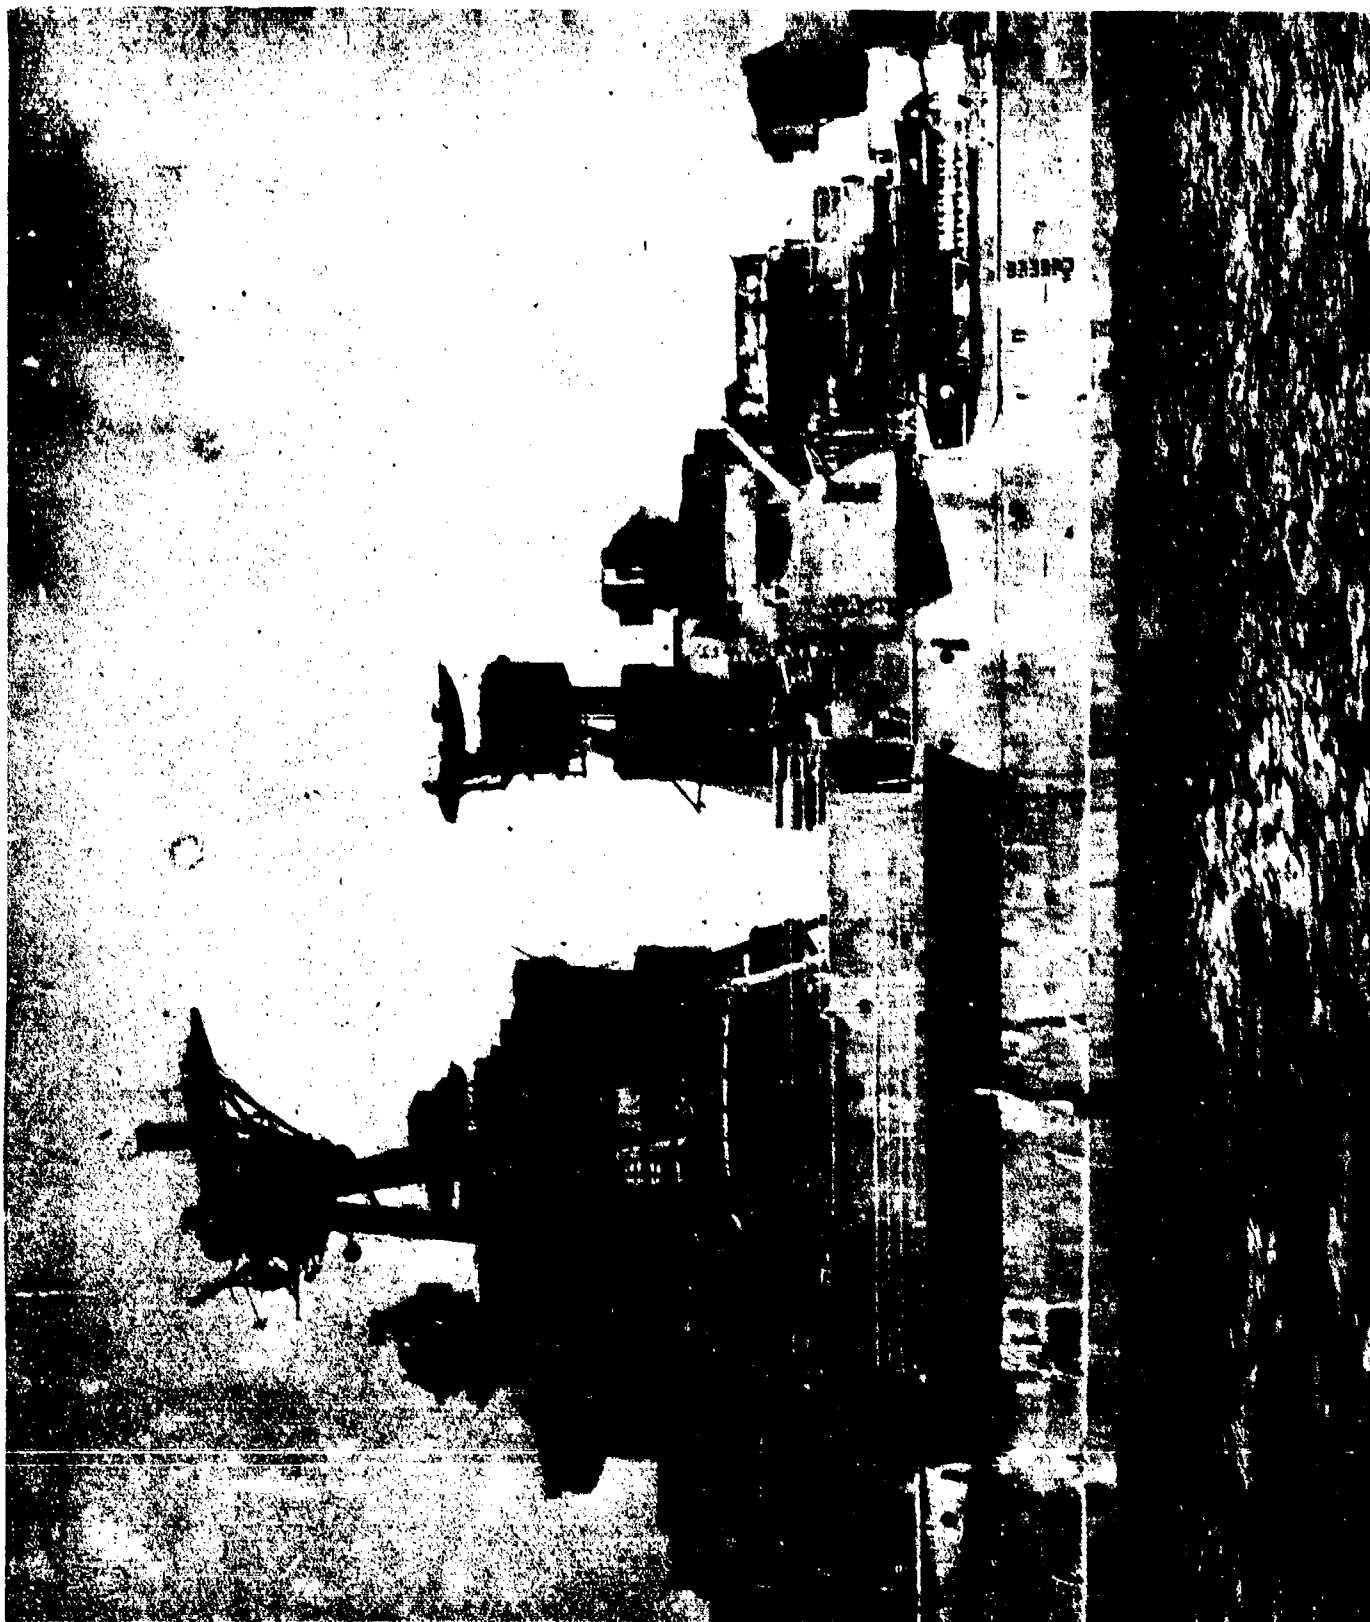
There is no significant additional damage to the superstructure. Topside structure weakened during Test A shows a slight increase in damage in a few places; the stack is further distorted, for instance, and equipment is displaced.

AB-CR-68-2150-7. Close-up of superstructure from off port beam after Test B.

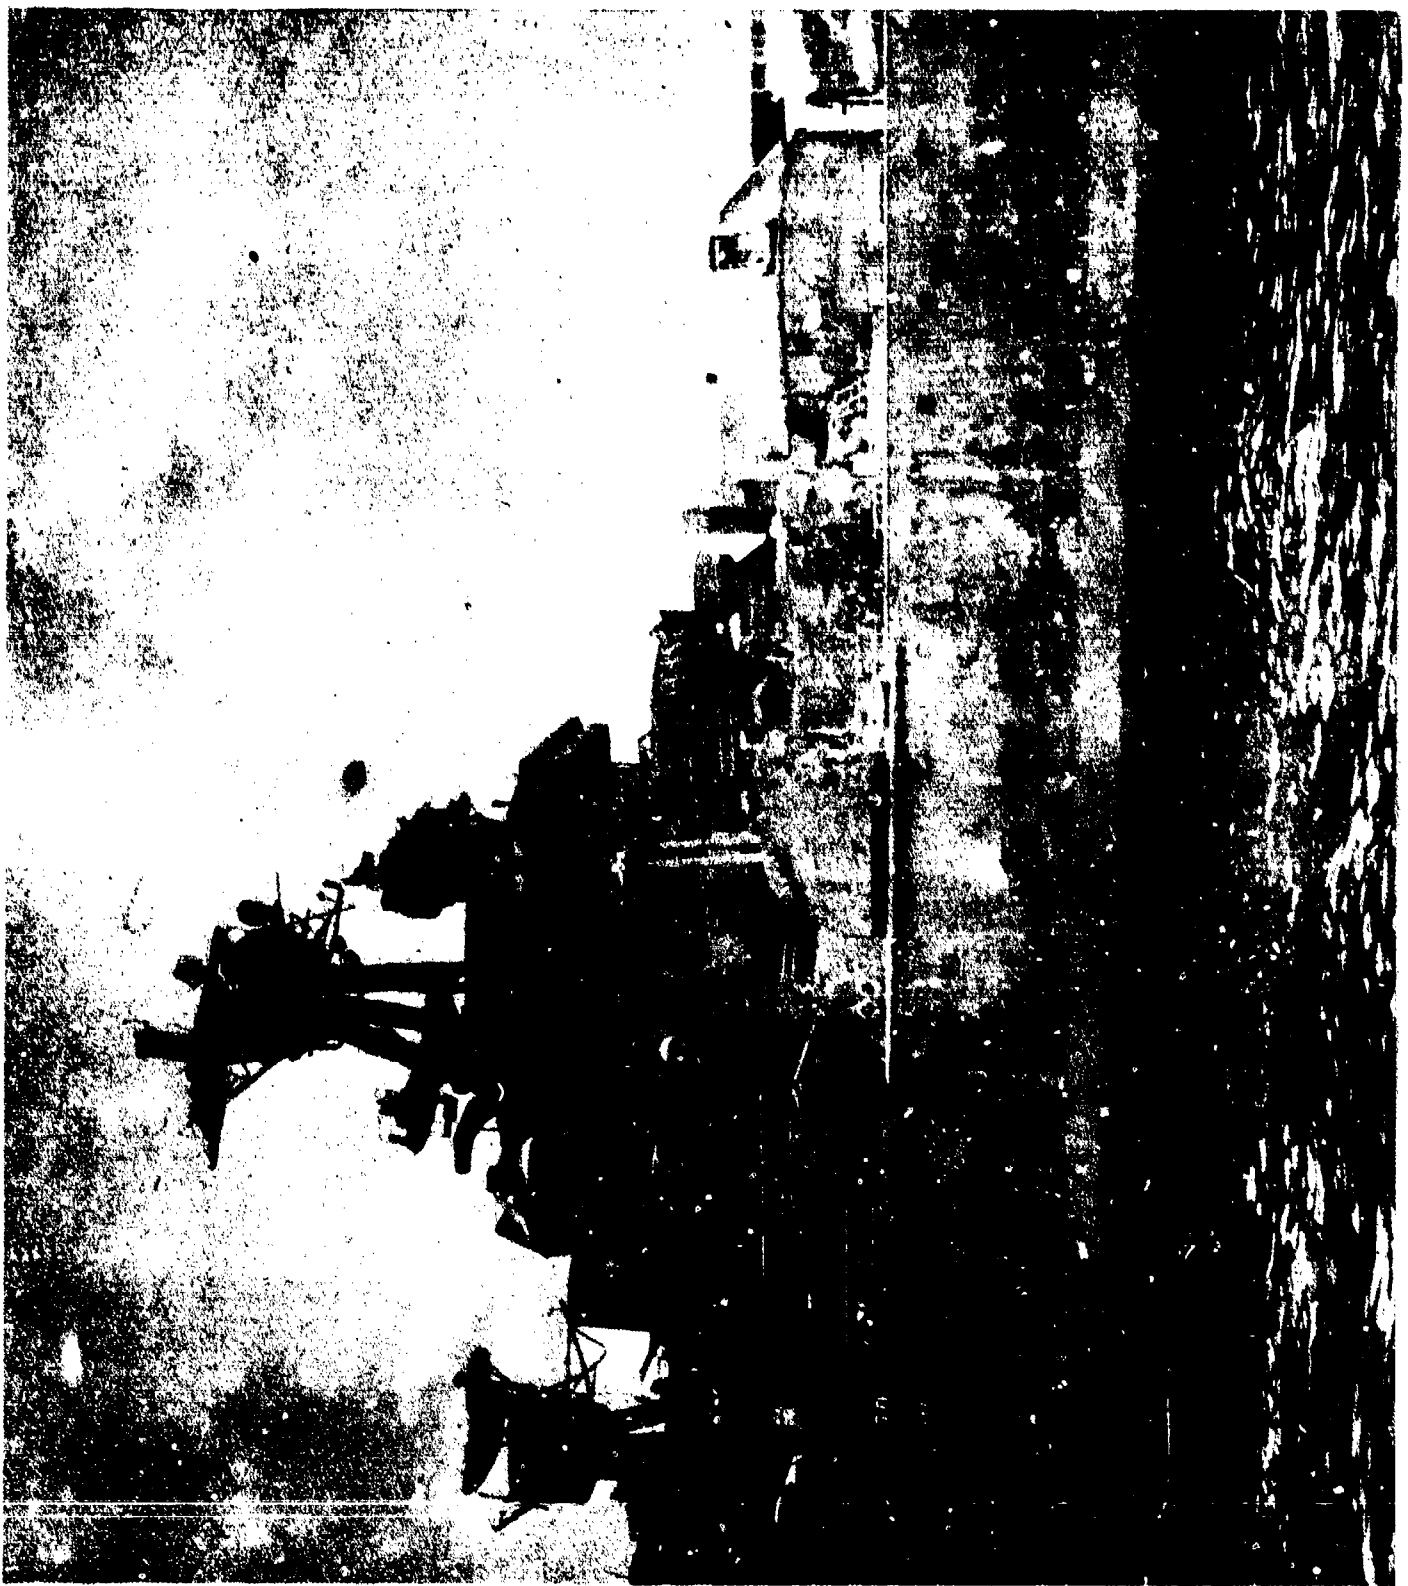
AB-CR-68-2150-1. Close-up view of starboard superstructure and shell after Test B.

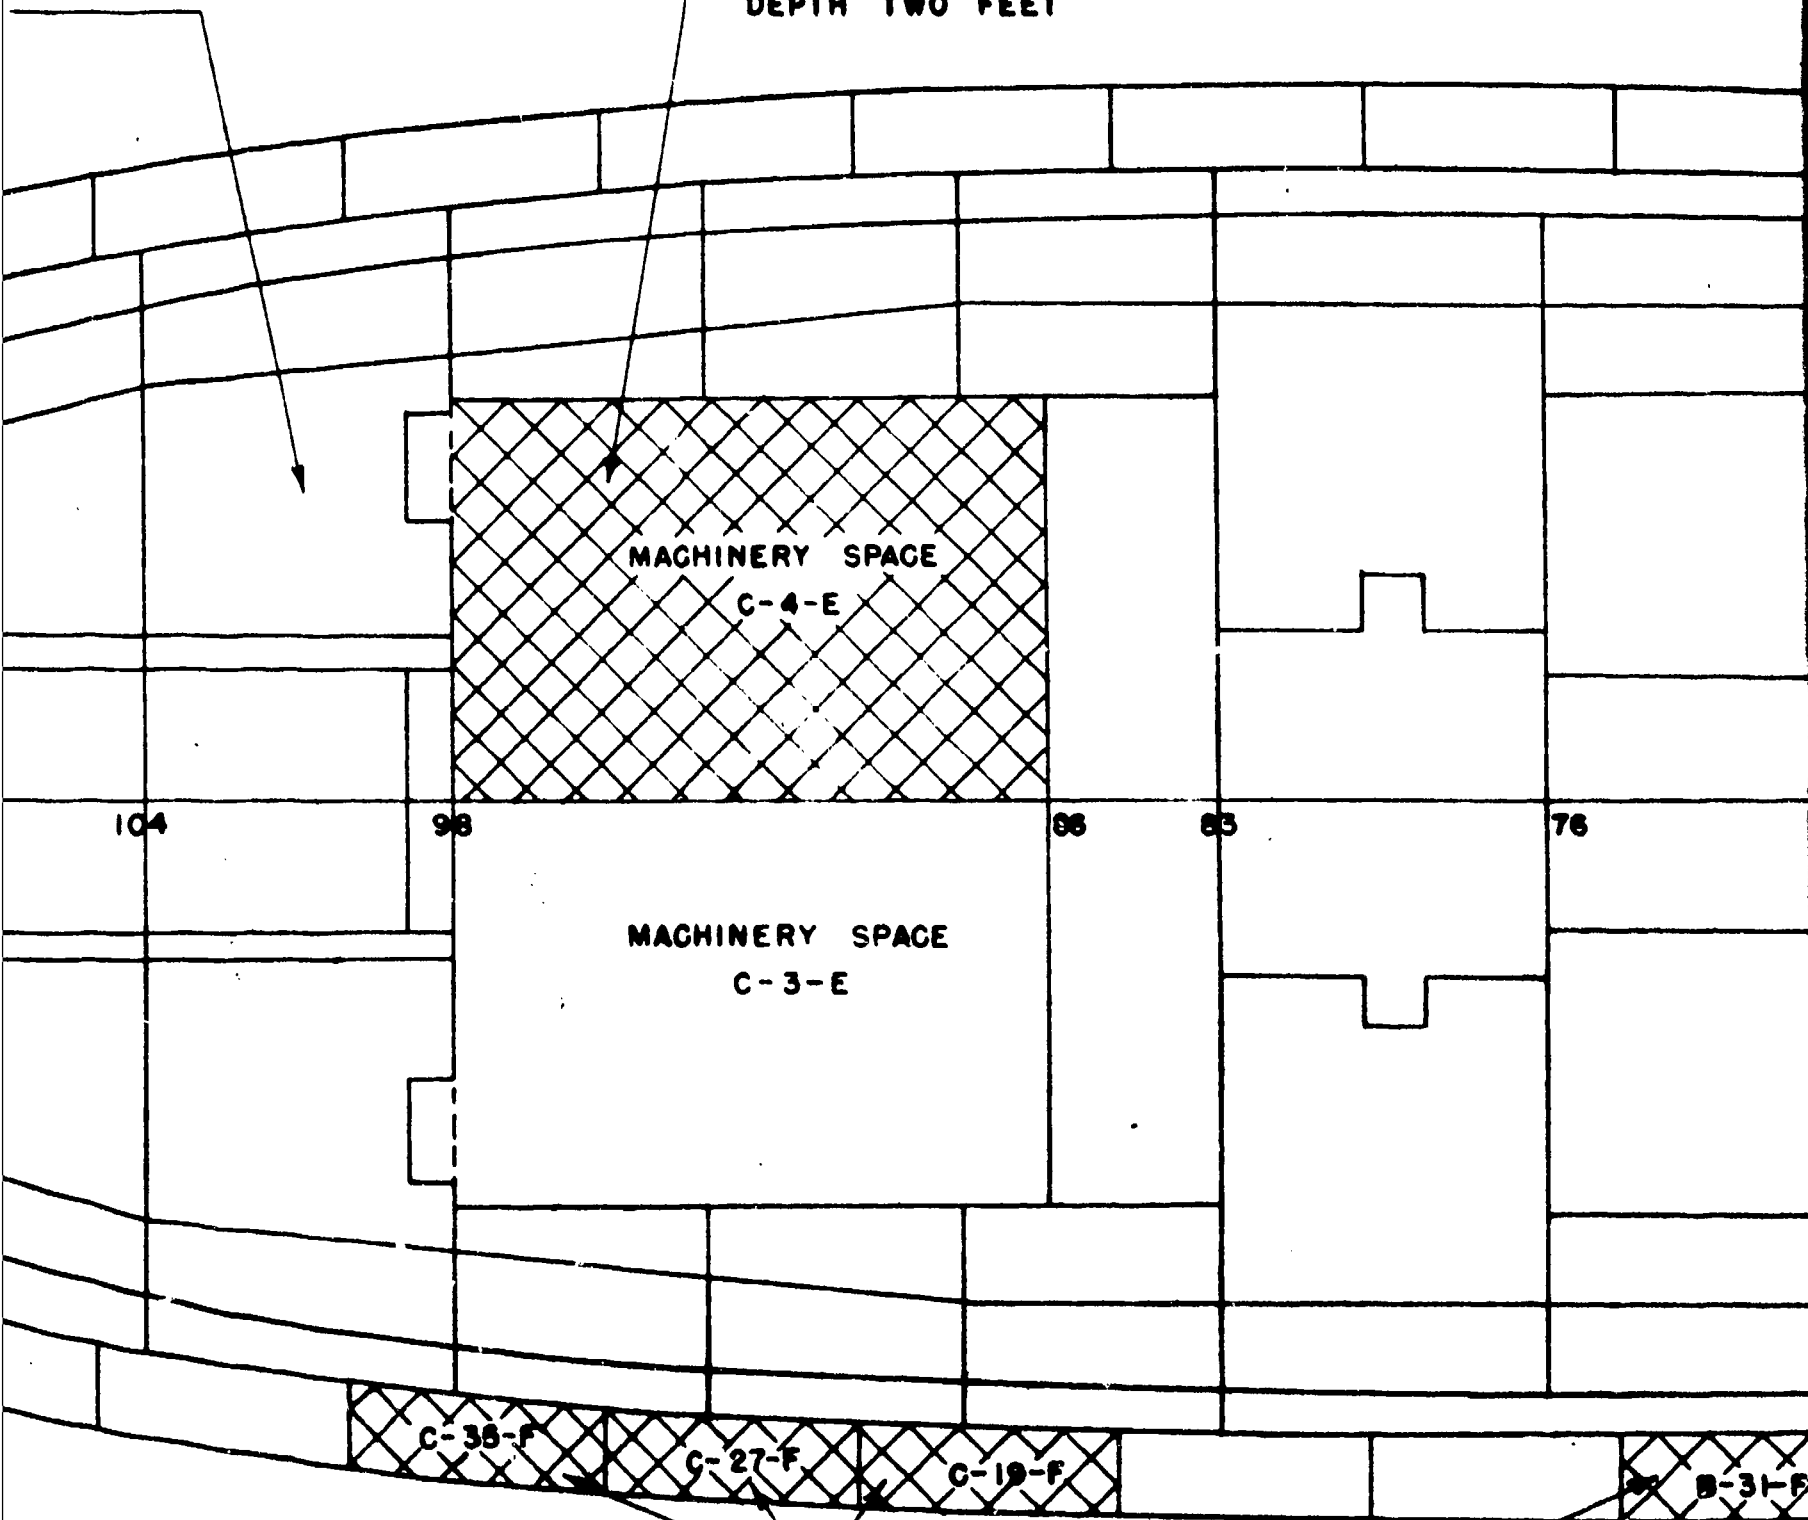
The starboard inboard longitudinal bulkhead between the first and second platform, frames 23 to 30, is bulged about two inches inboard. Soundings of inner bottom tanks in way of the keel, frames 82 to 98, indicate that some damage to the shell plating has occurred, allowing seepage of sea water into these tanks.

APPARENTLY DOUBLE BOTTOM TANKS  
FLOODED THROUGH SEAMS IN SHELL

DOUBLE BOTTOM TANKS  
ROUGH SEAMS IN SHELL.

FLOODED THROUGH CRACK IN  
OVERBOARD DISCHARGE LINE.  
DEPTH TWO FEET

APPARENTLY TANKS FLOODED  
THROUGH SEAMS IN SHELL.
