TECHNICAL INSPECTION REPORT

U.S.S. SALT LAKE CITY (CA 25)

TEST BAKER

OPERATION CROSSROADS

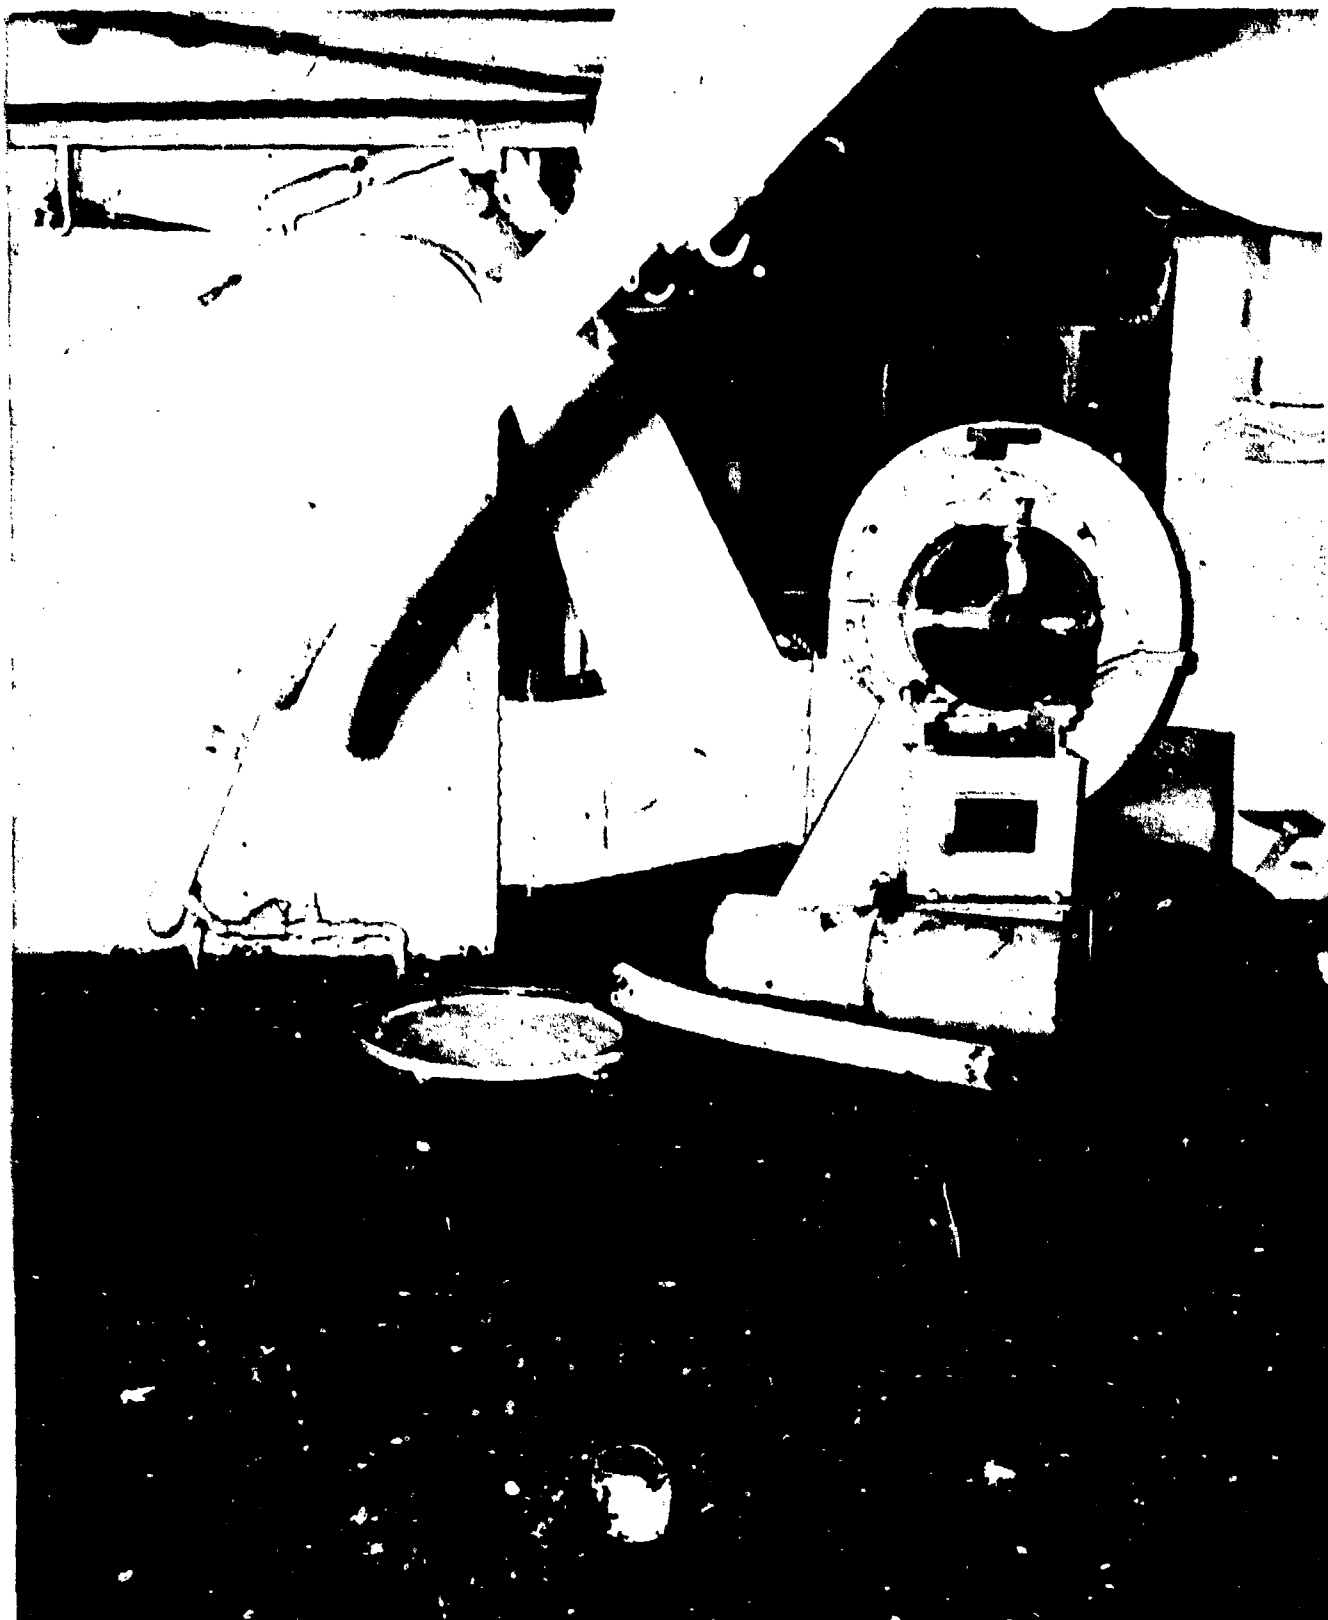
The only visible structural damage above the second (armor) deck is the fractured stanchions at frames 65, 68, and 97. (Photos 1718-8, 9, 10, 11, 12, 1710-1; pages 84 , 85 , 86 , 87 , 88 , and 89).

AB-CR-65-1718-10. C-201L. Fracture of centerline stanchion under main deck transverse girder at frame 68. Compare with 1894-8, 2102-10, and 2102-12 showing condition after Test A.

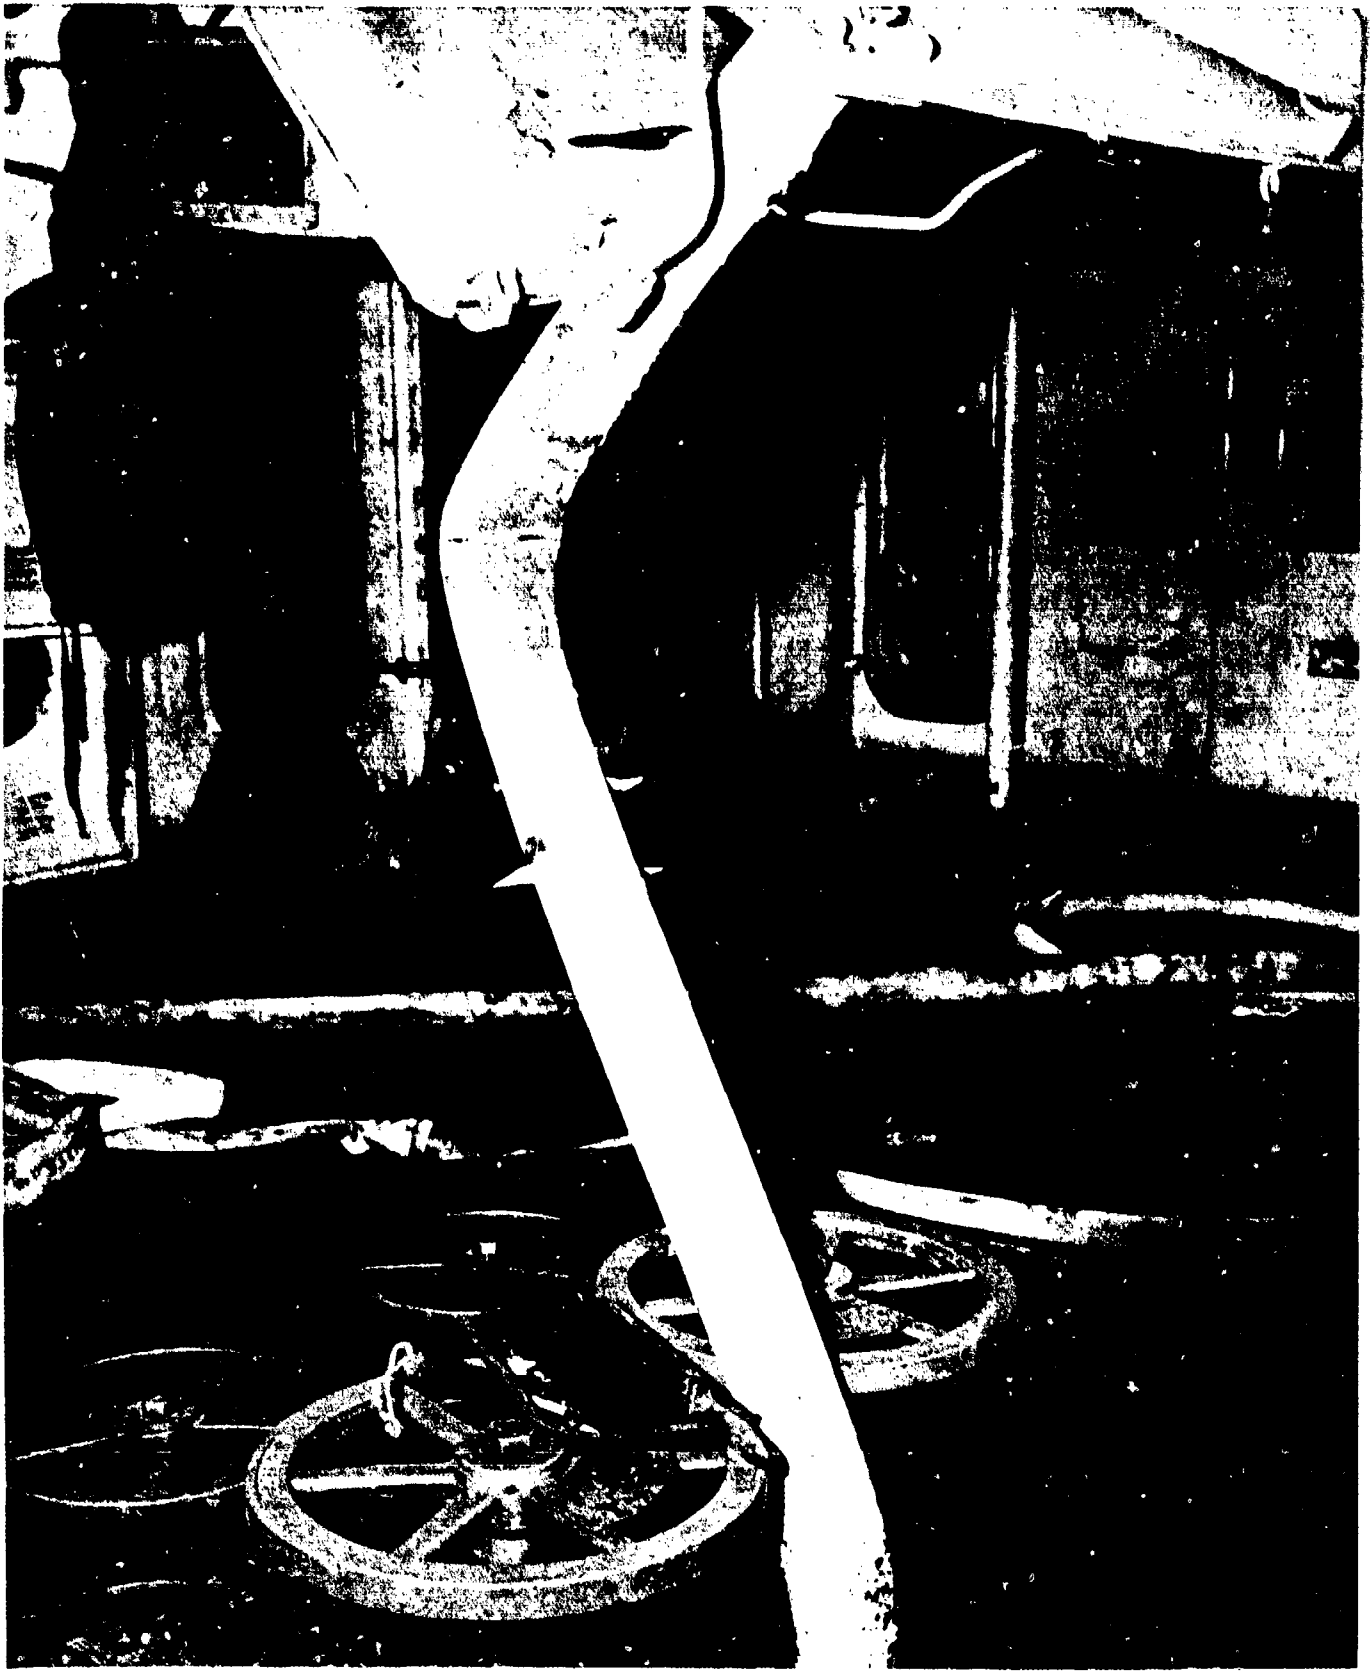
AB-CR-65-1718-11. C-201L. Fracture of centerline stanchion under main deck transverse girder at frame 65. Compare with 2102-3, 2102-4, 2102-5, and 1894-7. Showing condition after Test A.

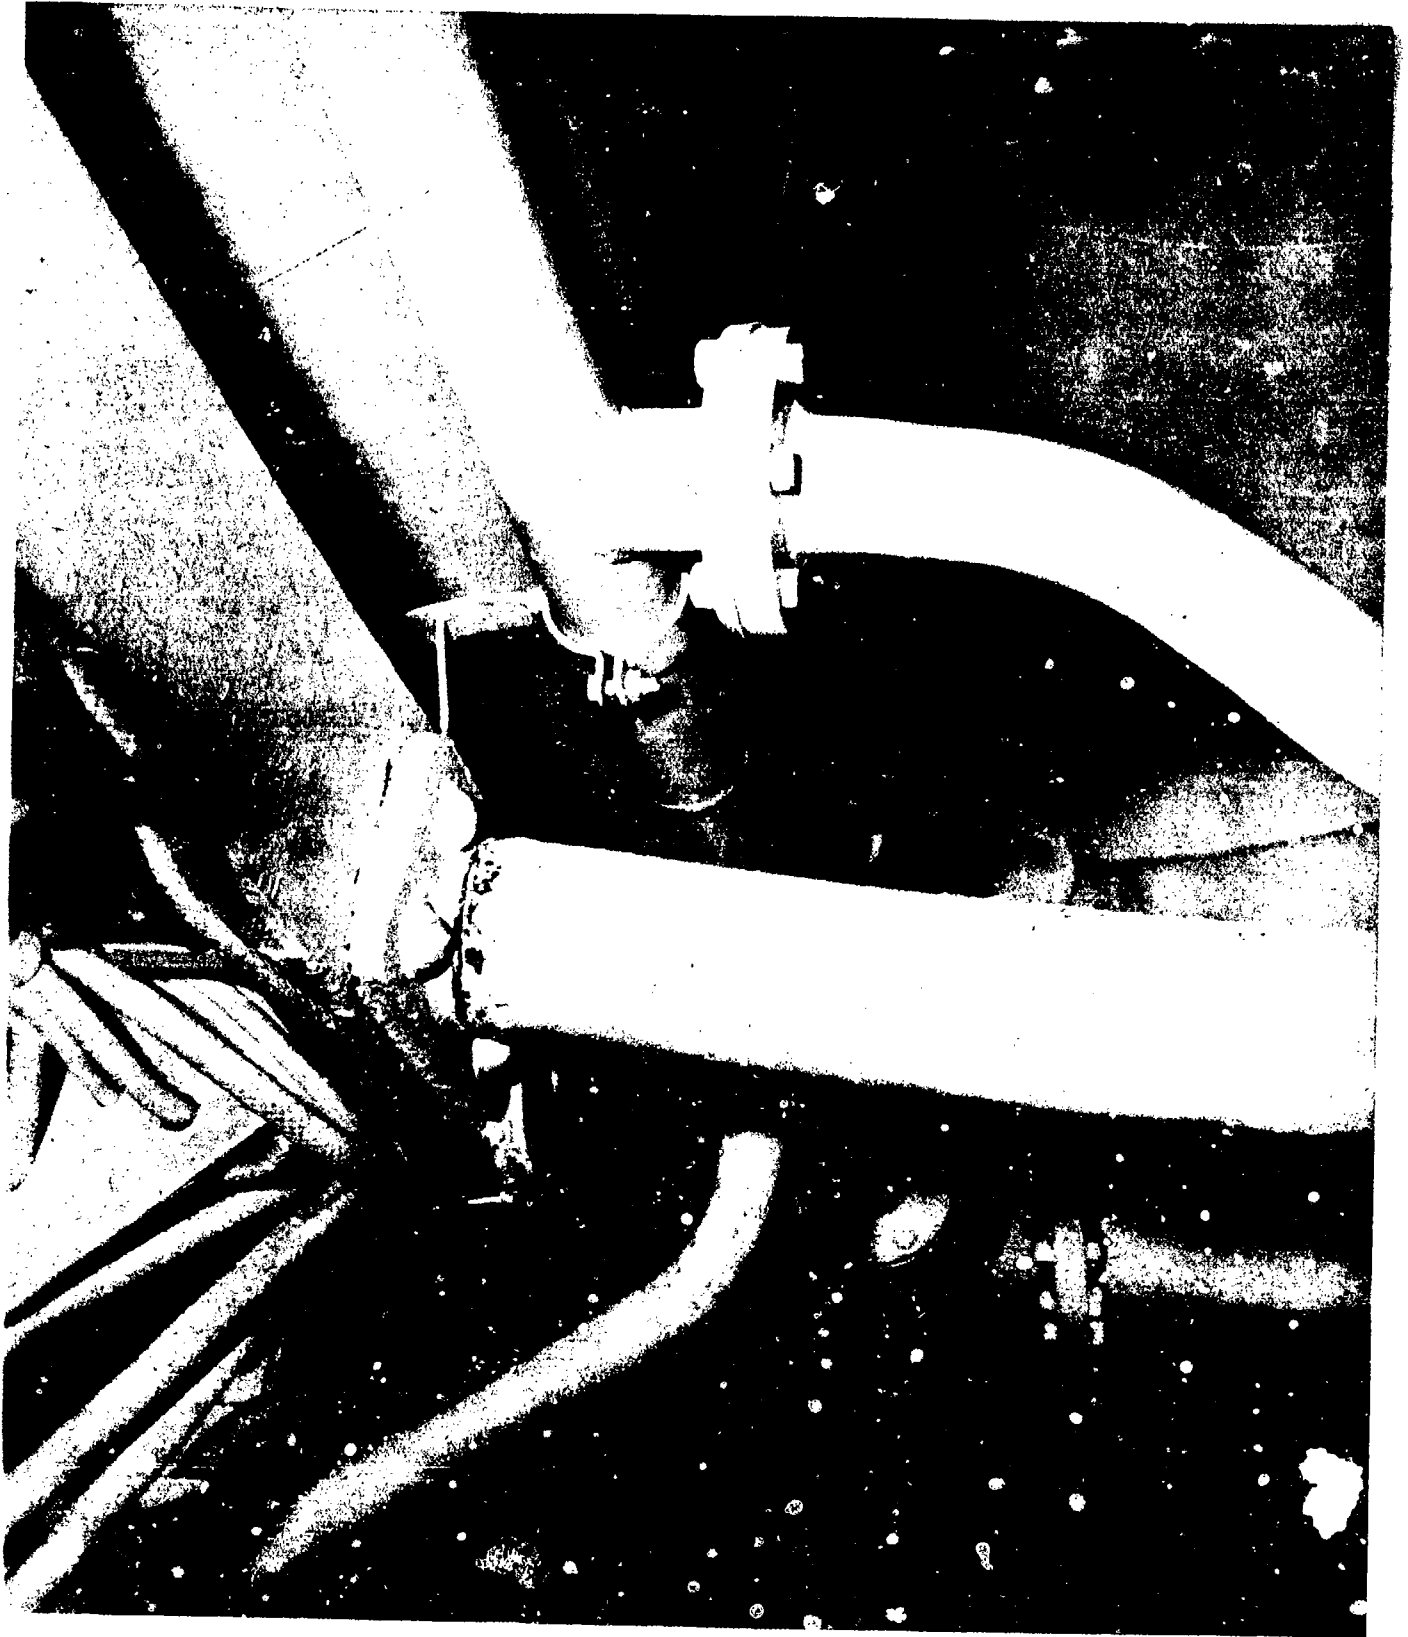
AB-CR-60-1710-1. Centerline stanchion at frame 97, second deck compressed and buckled during Test A, snapped during Test B.

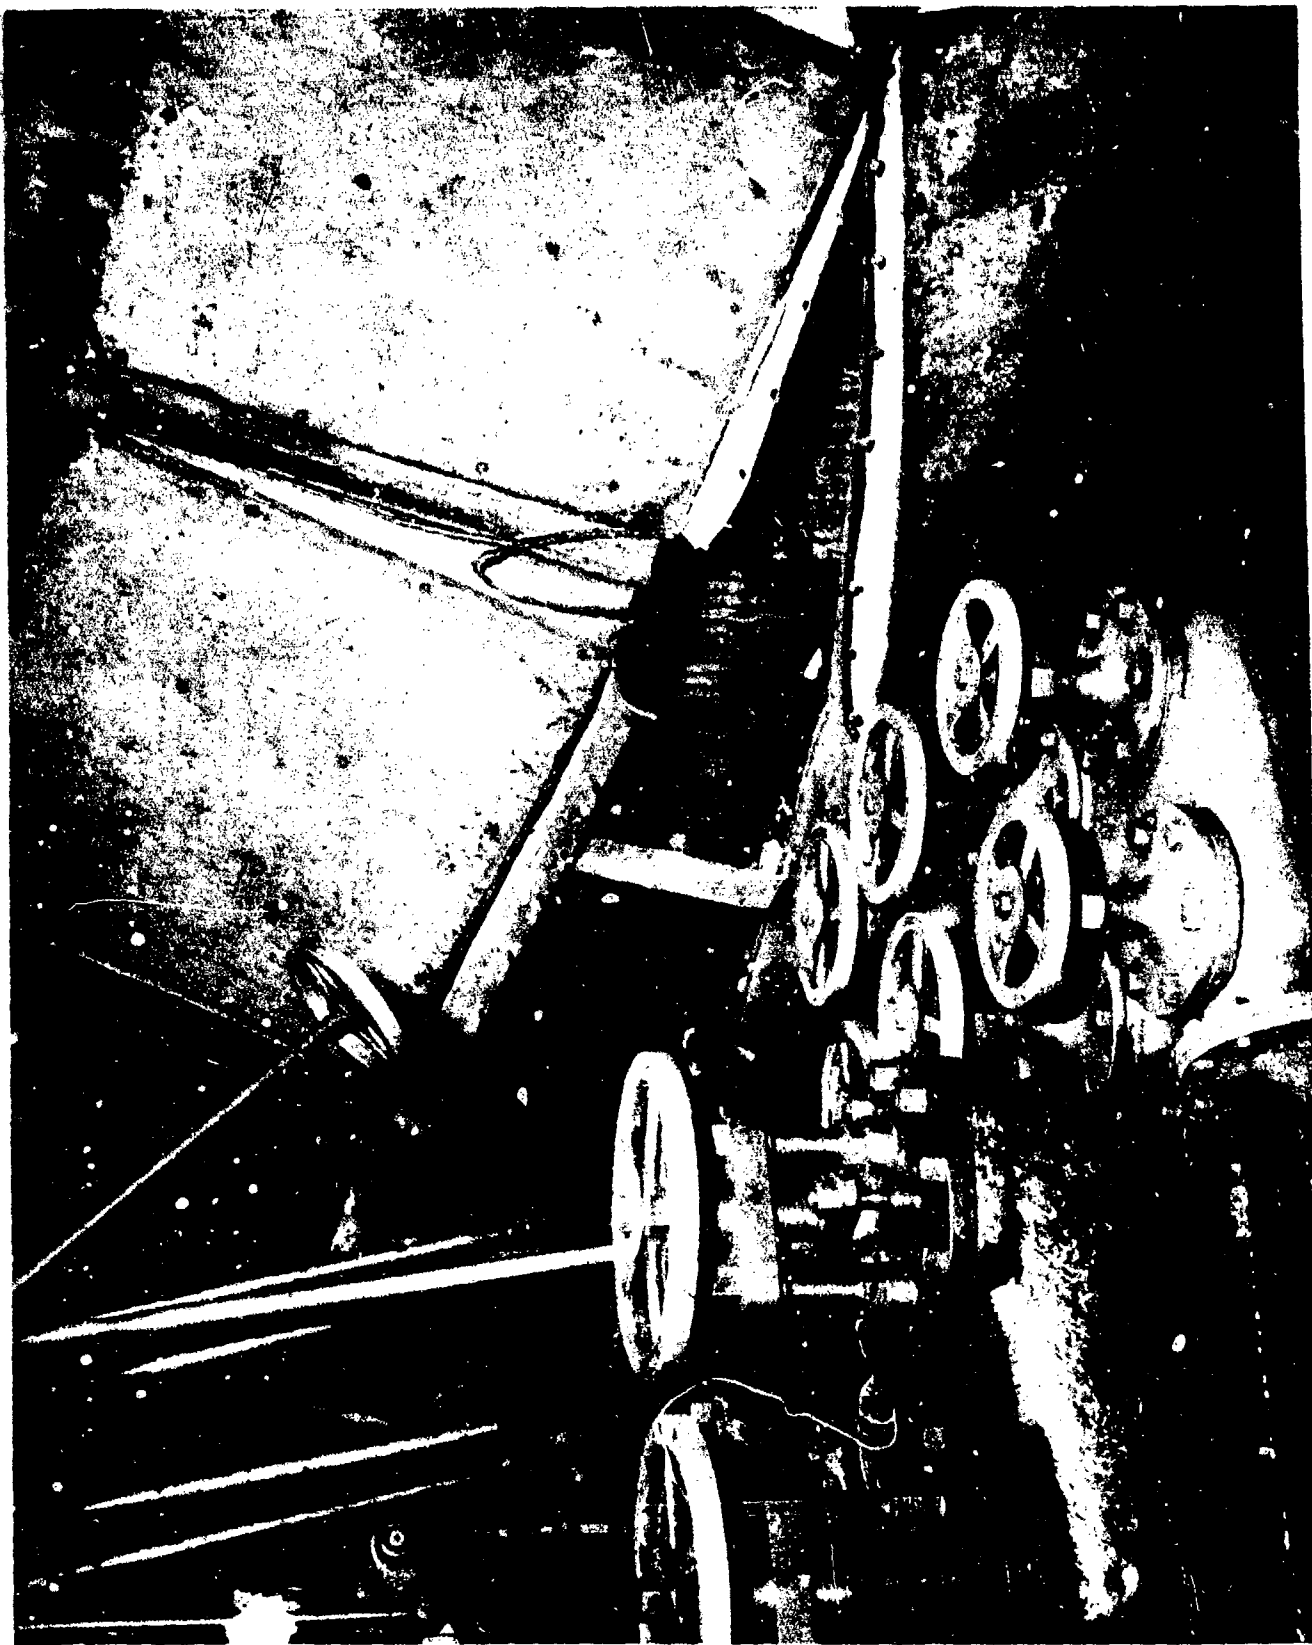
AB-CR-24-4060-2. No. 3 boiler casing.

Boiler casings ruptured in Test A are more severely buckled than before. The casings of boilers numbers 5 and 6, previously repaired, have again been ruptured. There is minor damage to brick and plastic in all boilers. The only other damage to equipment is from flooding. This would not have occurred had the ship been manned.
