TECHNICAL INSPECTION REPORT

U.S.S. MAYRANT (DD 402)

TEST BAKER

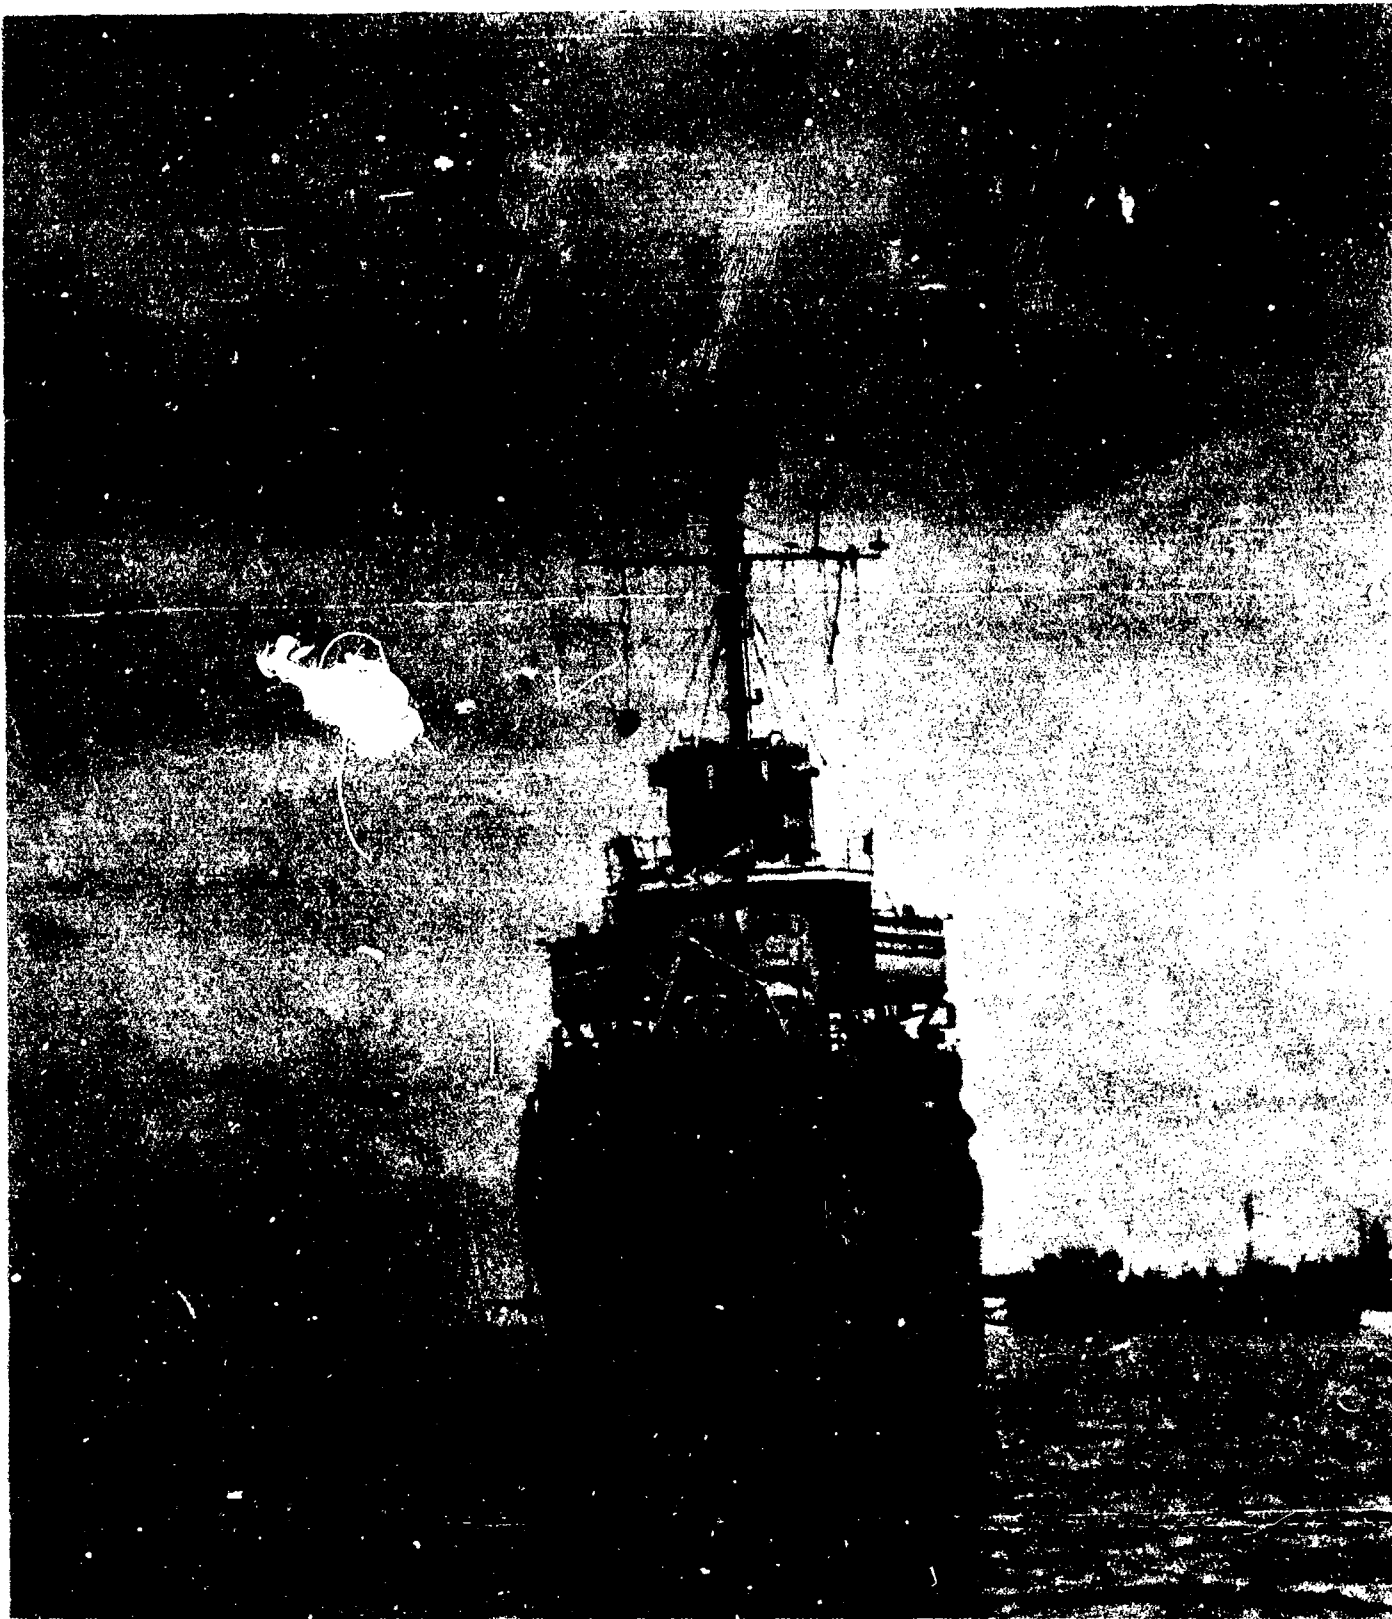
AA-CR-227-283-35. View from dead ahead after Test B.

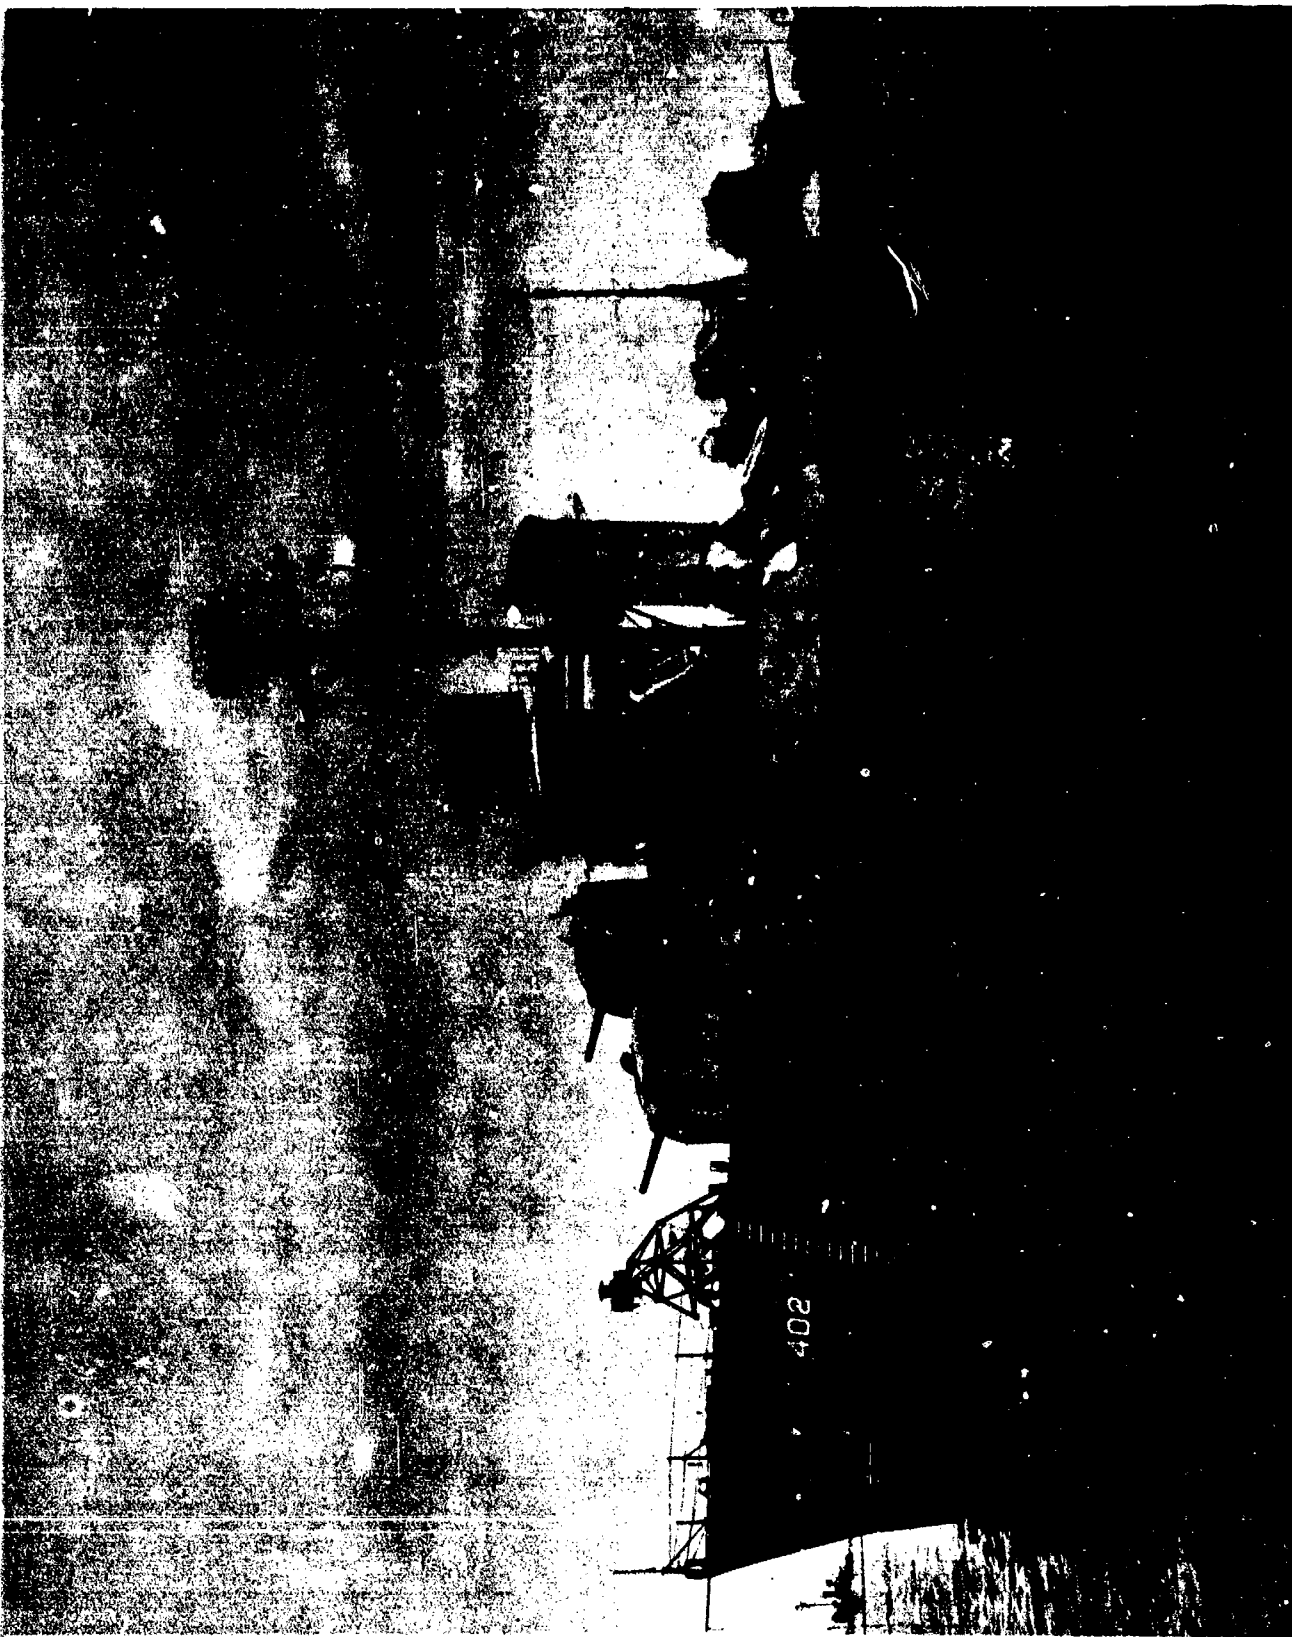
AB-CR-227-283-36. View from off port bow after Test B.

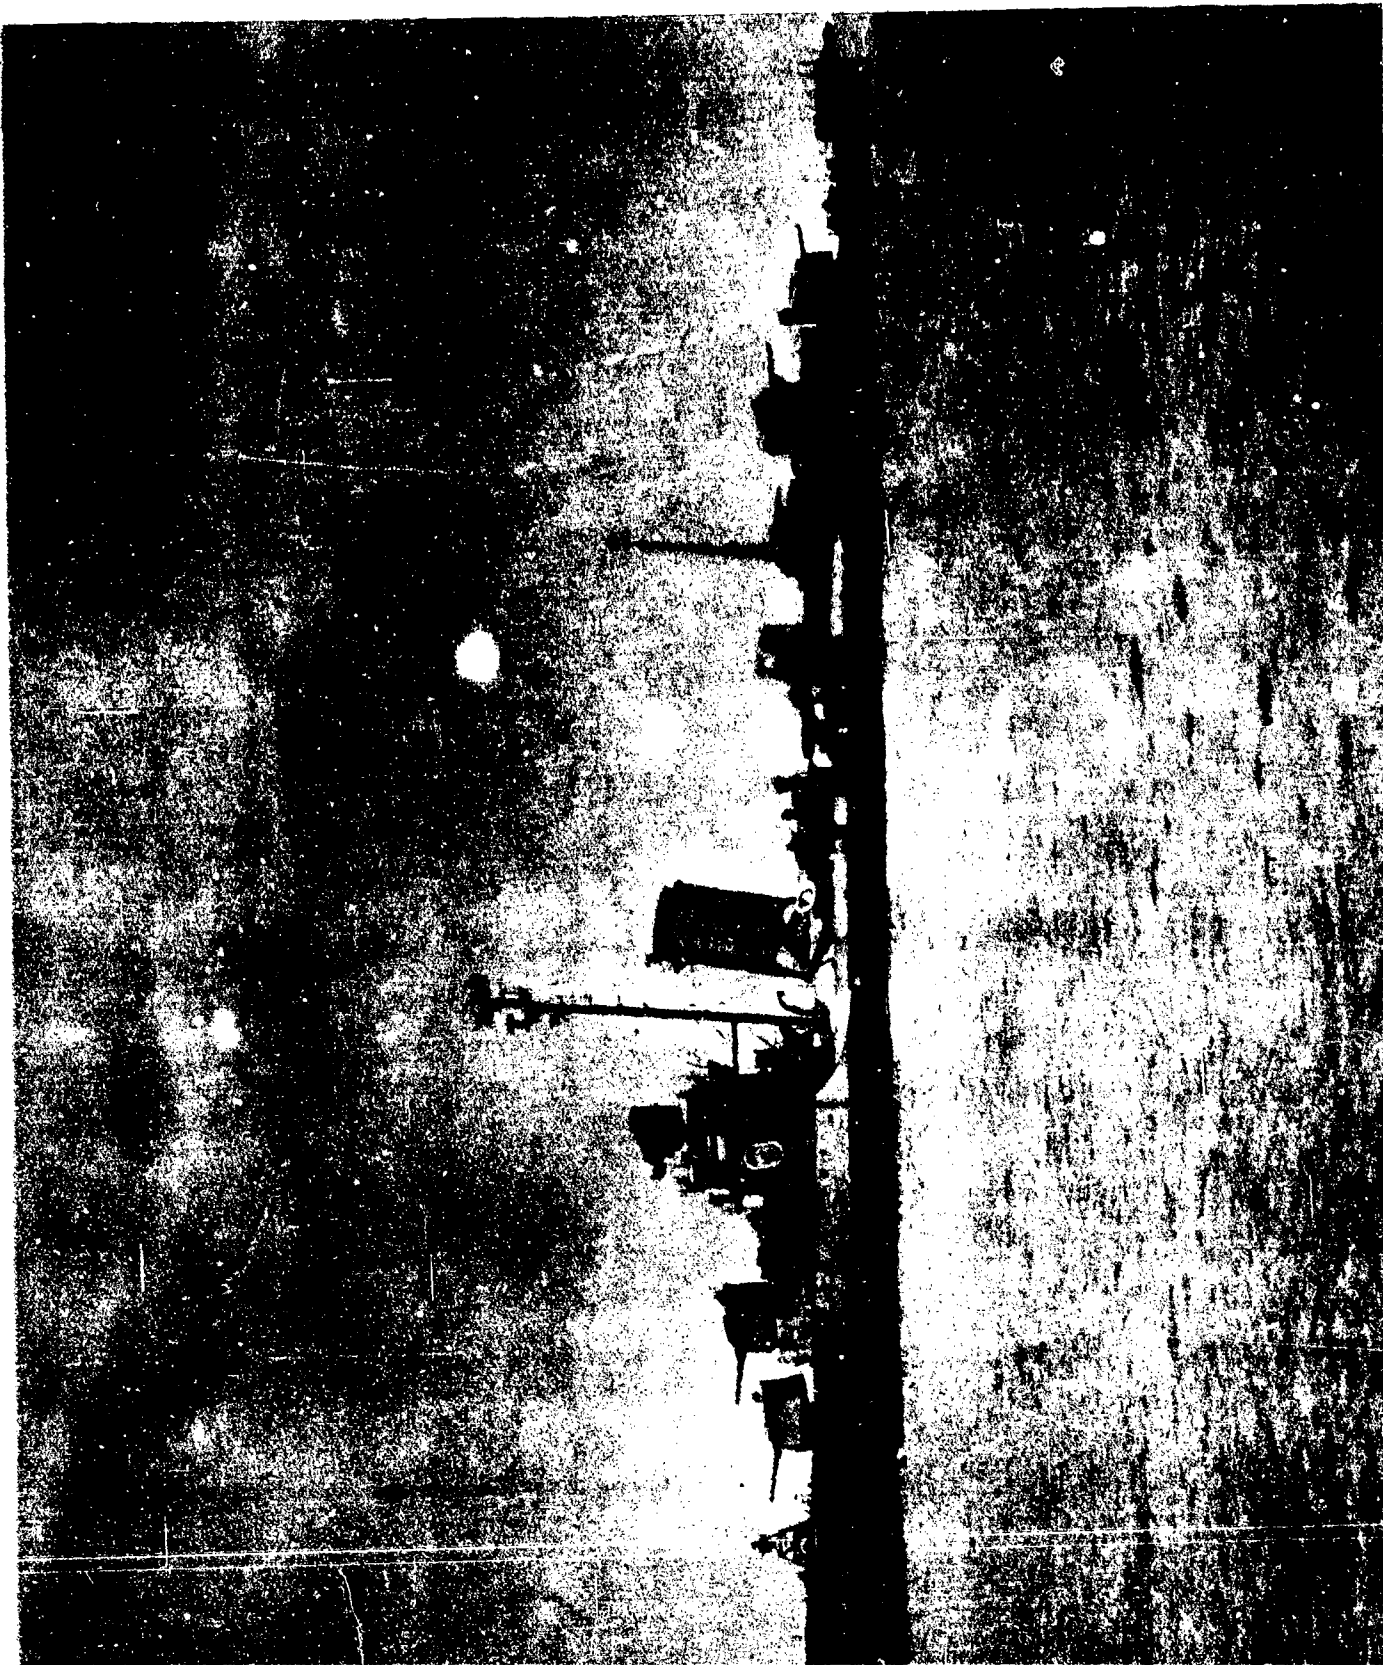
AB-CR-227-283-37. View from off port beam after Test B.

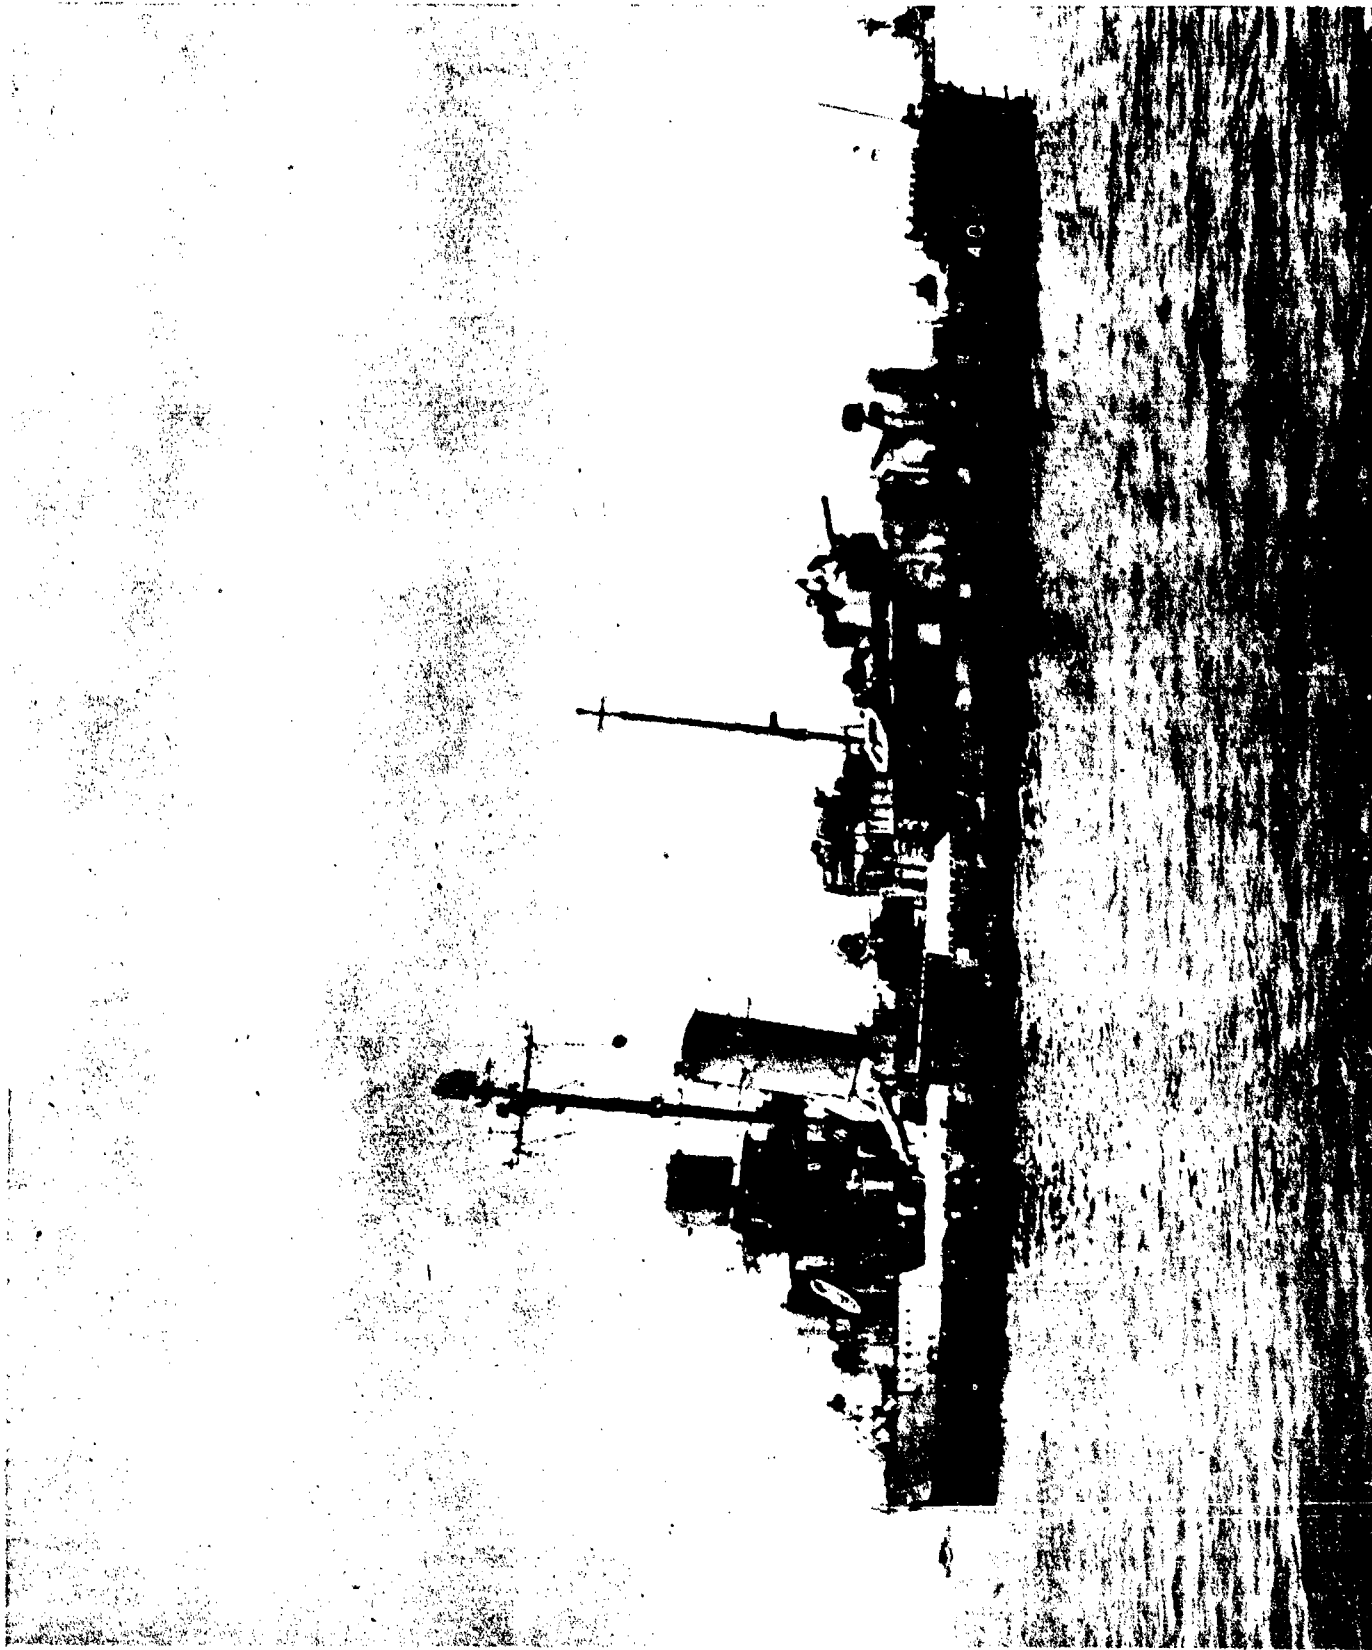
AB-CR-227-283-38. View from off port quarter after Test B.

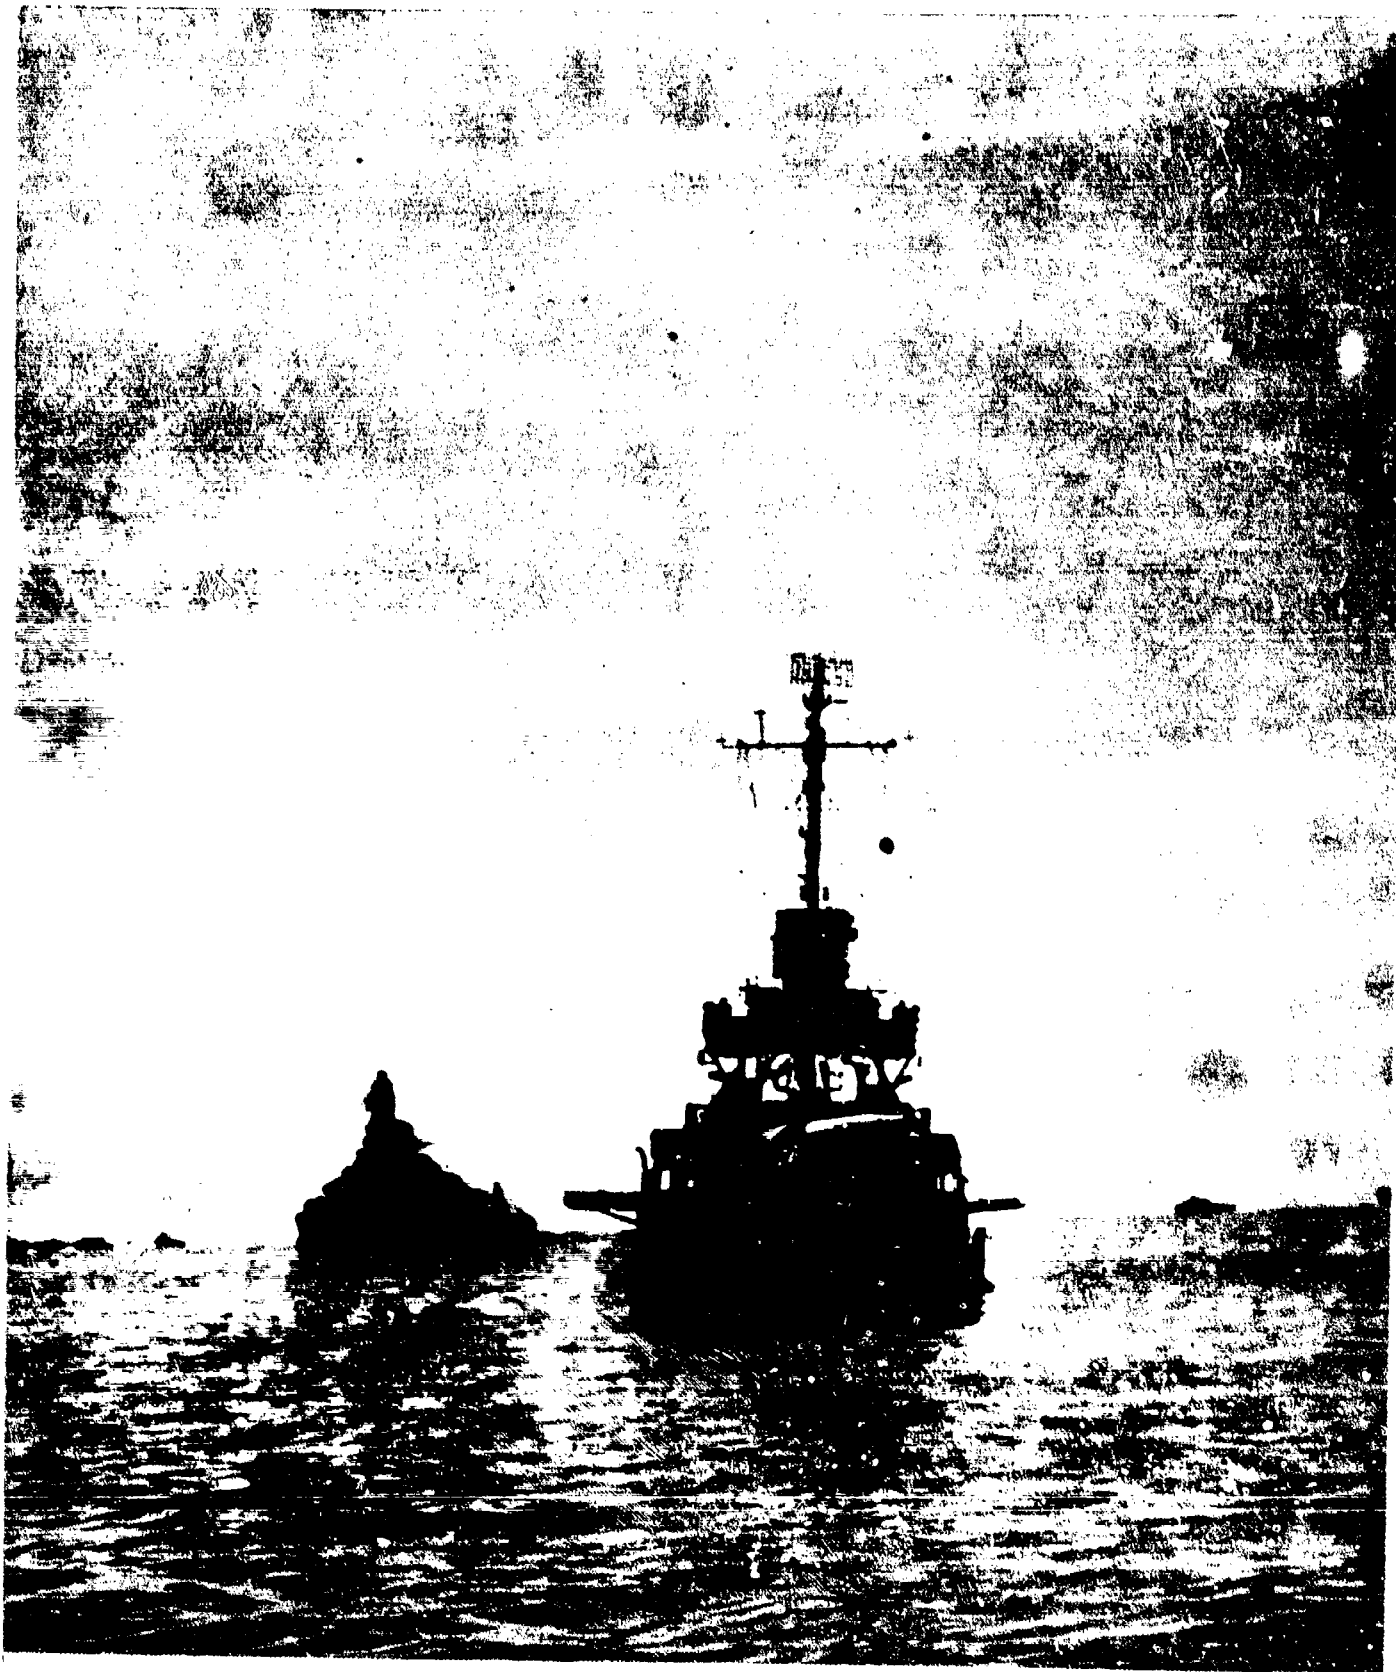
AB-CR-227-283-39. View from dead astern after Test B.

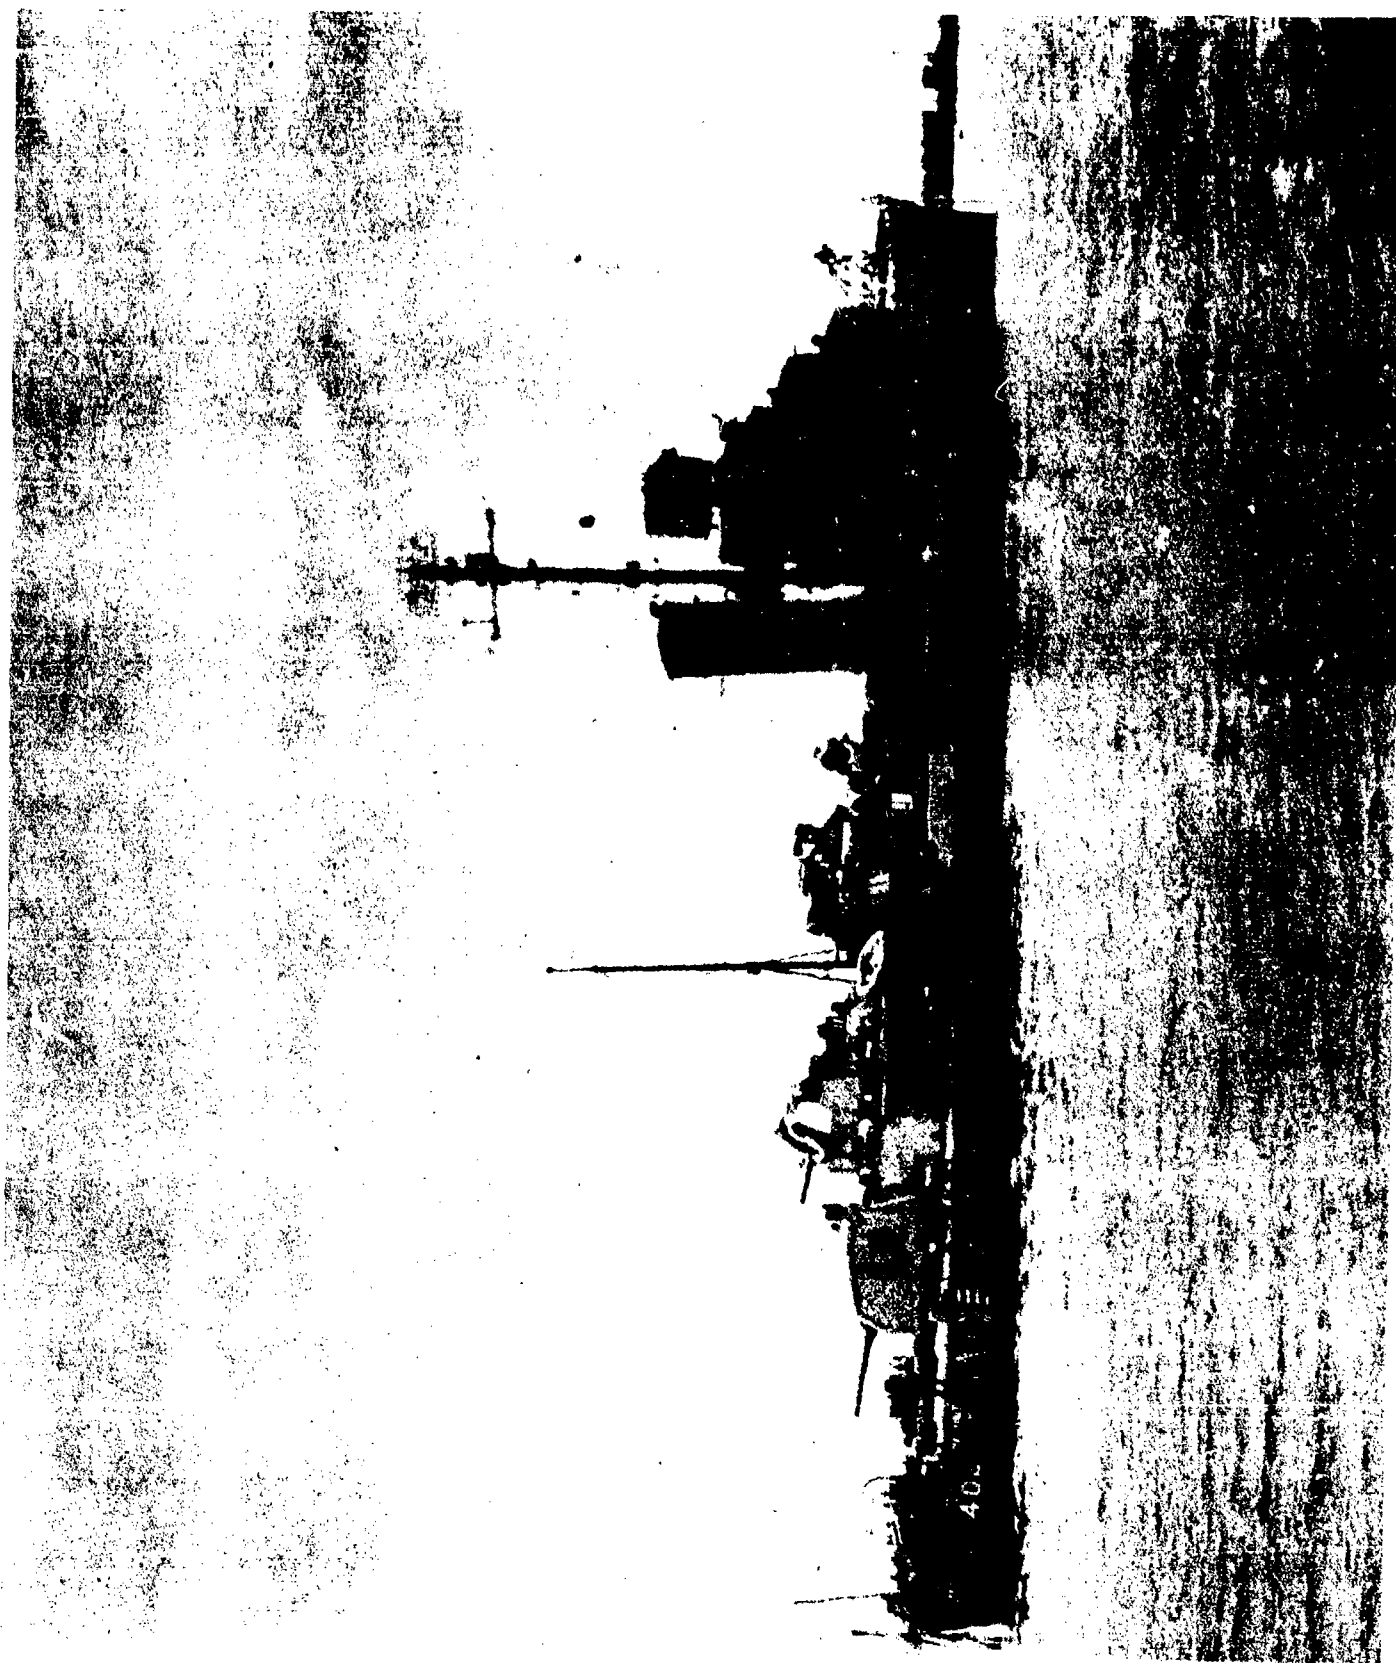
AB-CR-227-283-40. View from off starboard quarter after Test B.

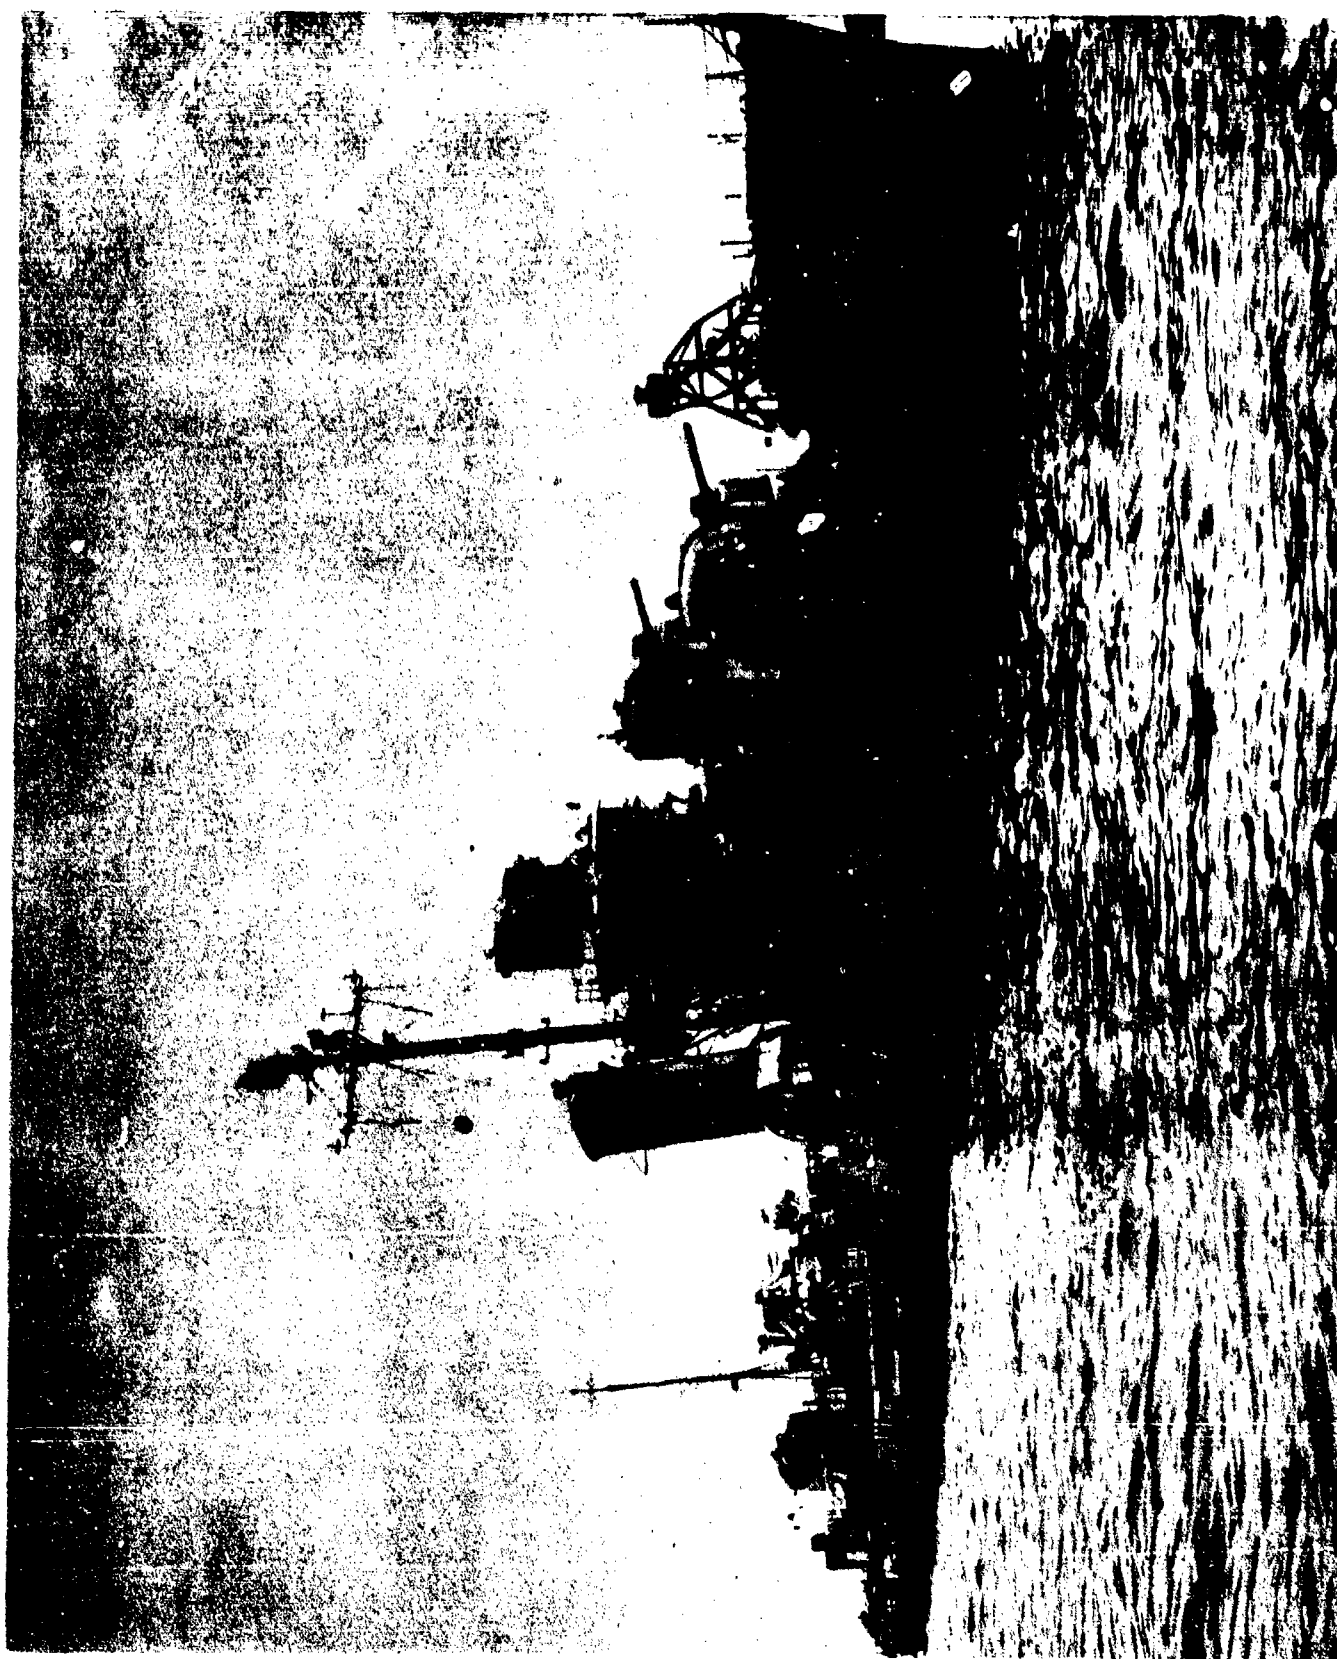
AB-CR-227-283-34. View from off starboard bow after Test B.

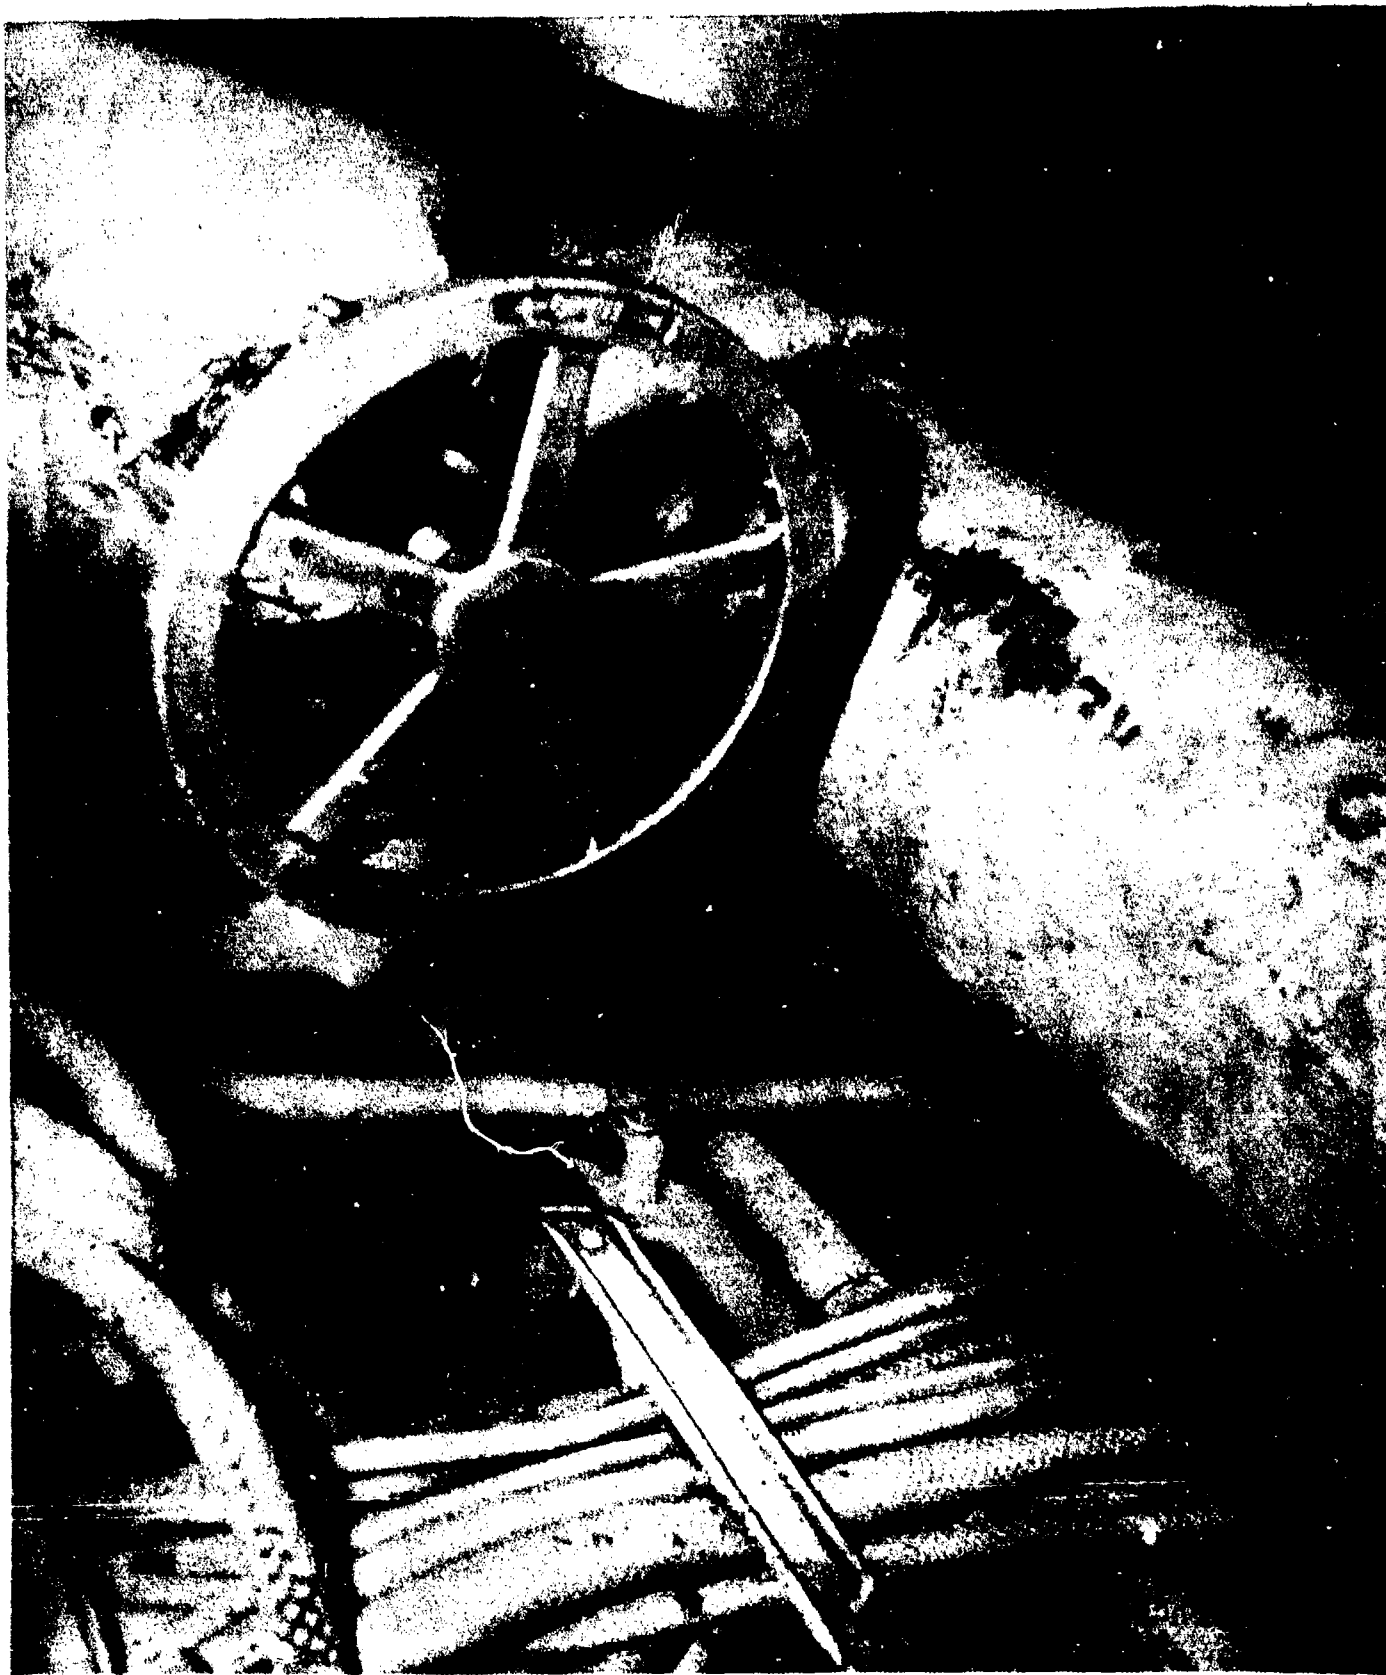
AB-CR-62-2177-2. Frame 108, starboard, looking aft at buckle in way of un-reinforced lightning hole.

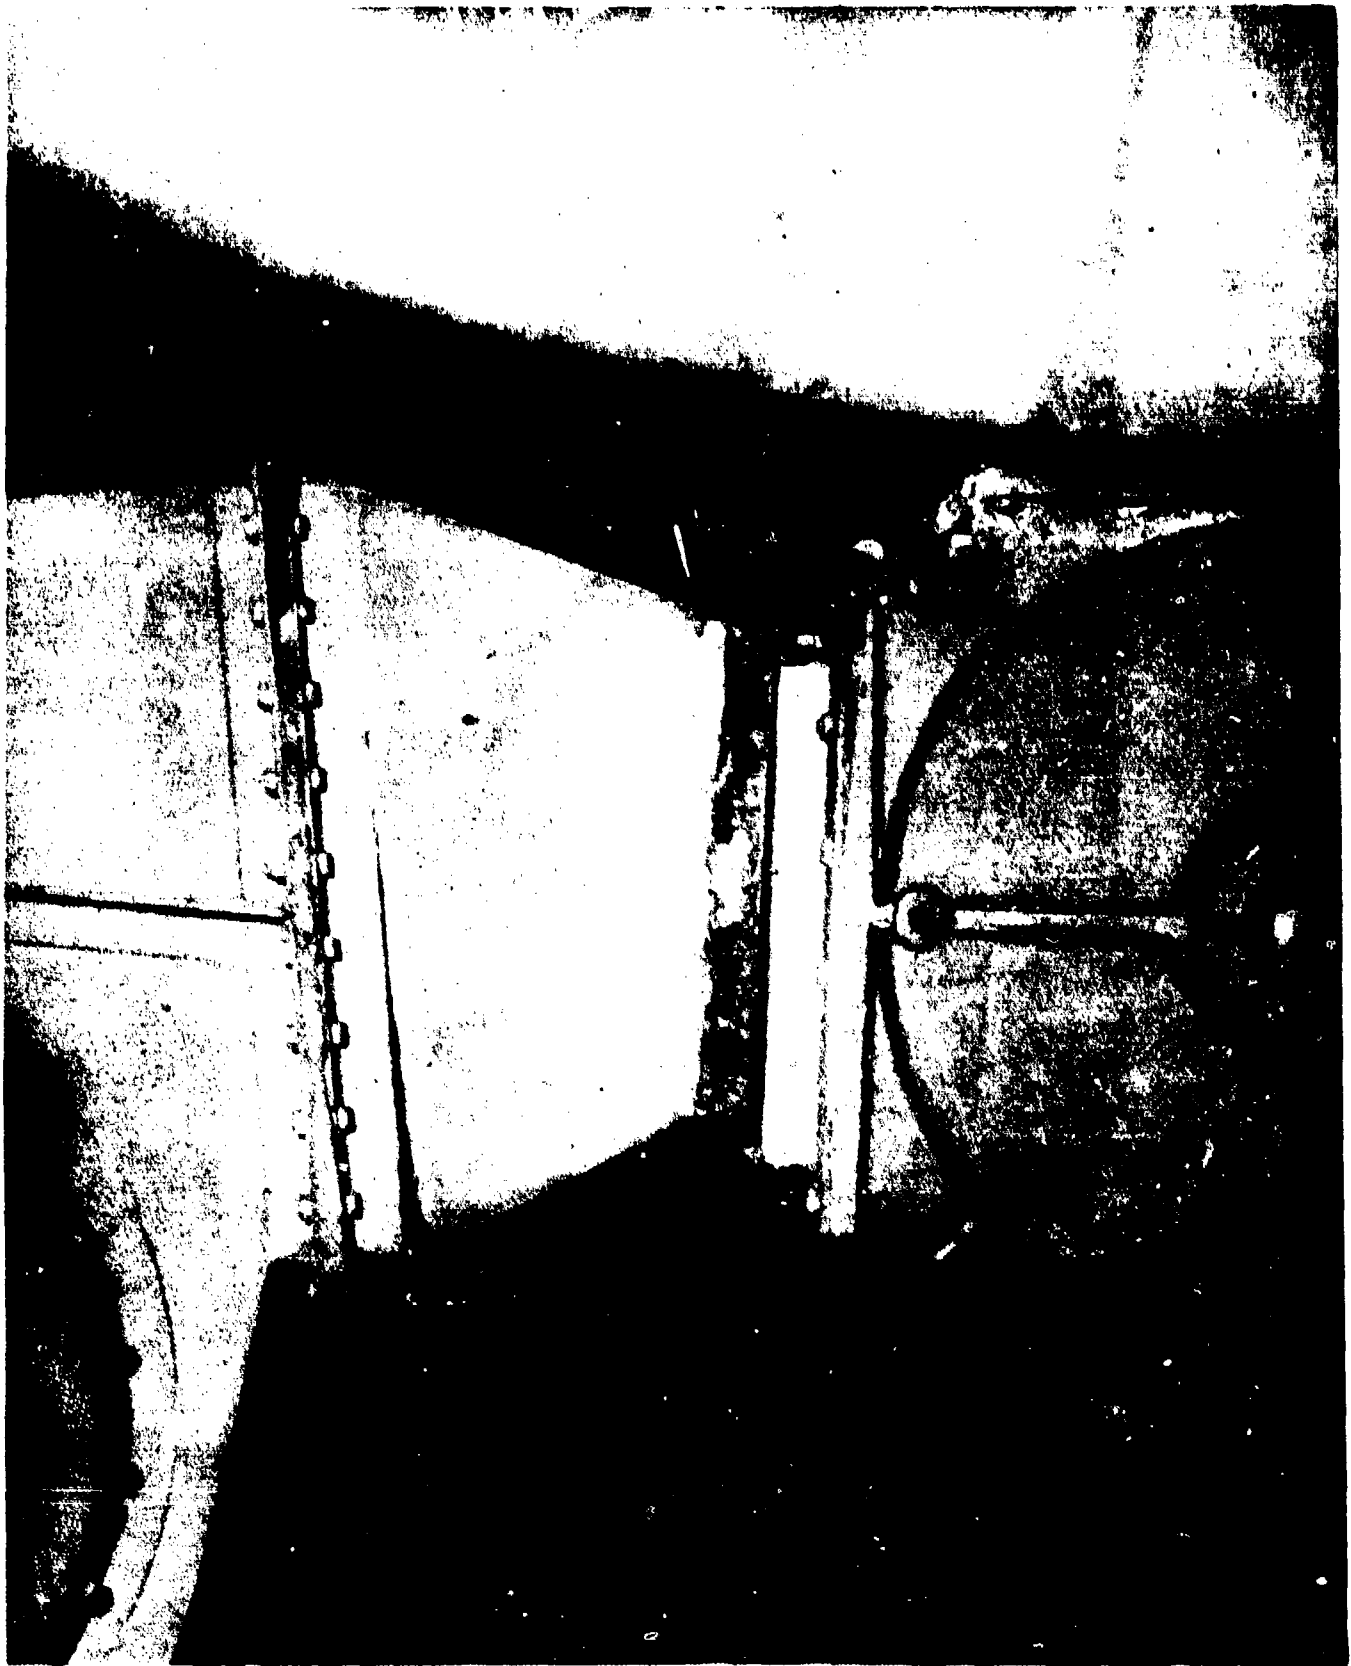
Structural damage generally was confined to the superstructure side plating, dishing of doors and starboard shell. The duct to the No. 3 port use forced draft blower in after fire room was ruptured at the section immediately below the fan outlet, however, there was no adverse effects to the motor or impeller and from visual inspection appears to be operable.

AB-CR-82-4221-4. Port use blower of No. 3 boiler.
