6 OPERATION CROSSROADS,  
U.S.S. RHIND (DD404).

TEST BAKER [U]

BUREAU OF SHIPS GROUP  
TECHNICAL INSPECTION REPORT

USS RHIND (DD404)

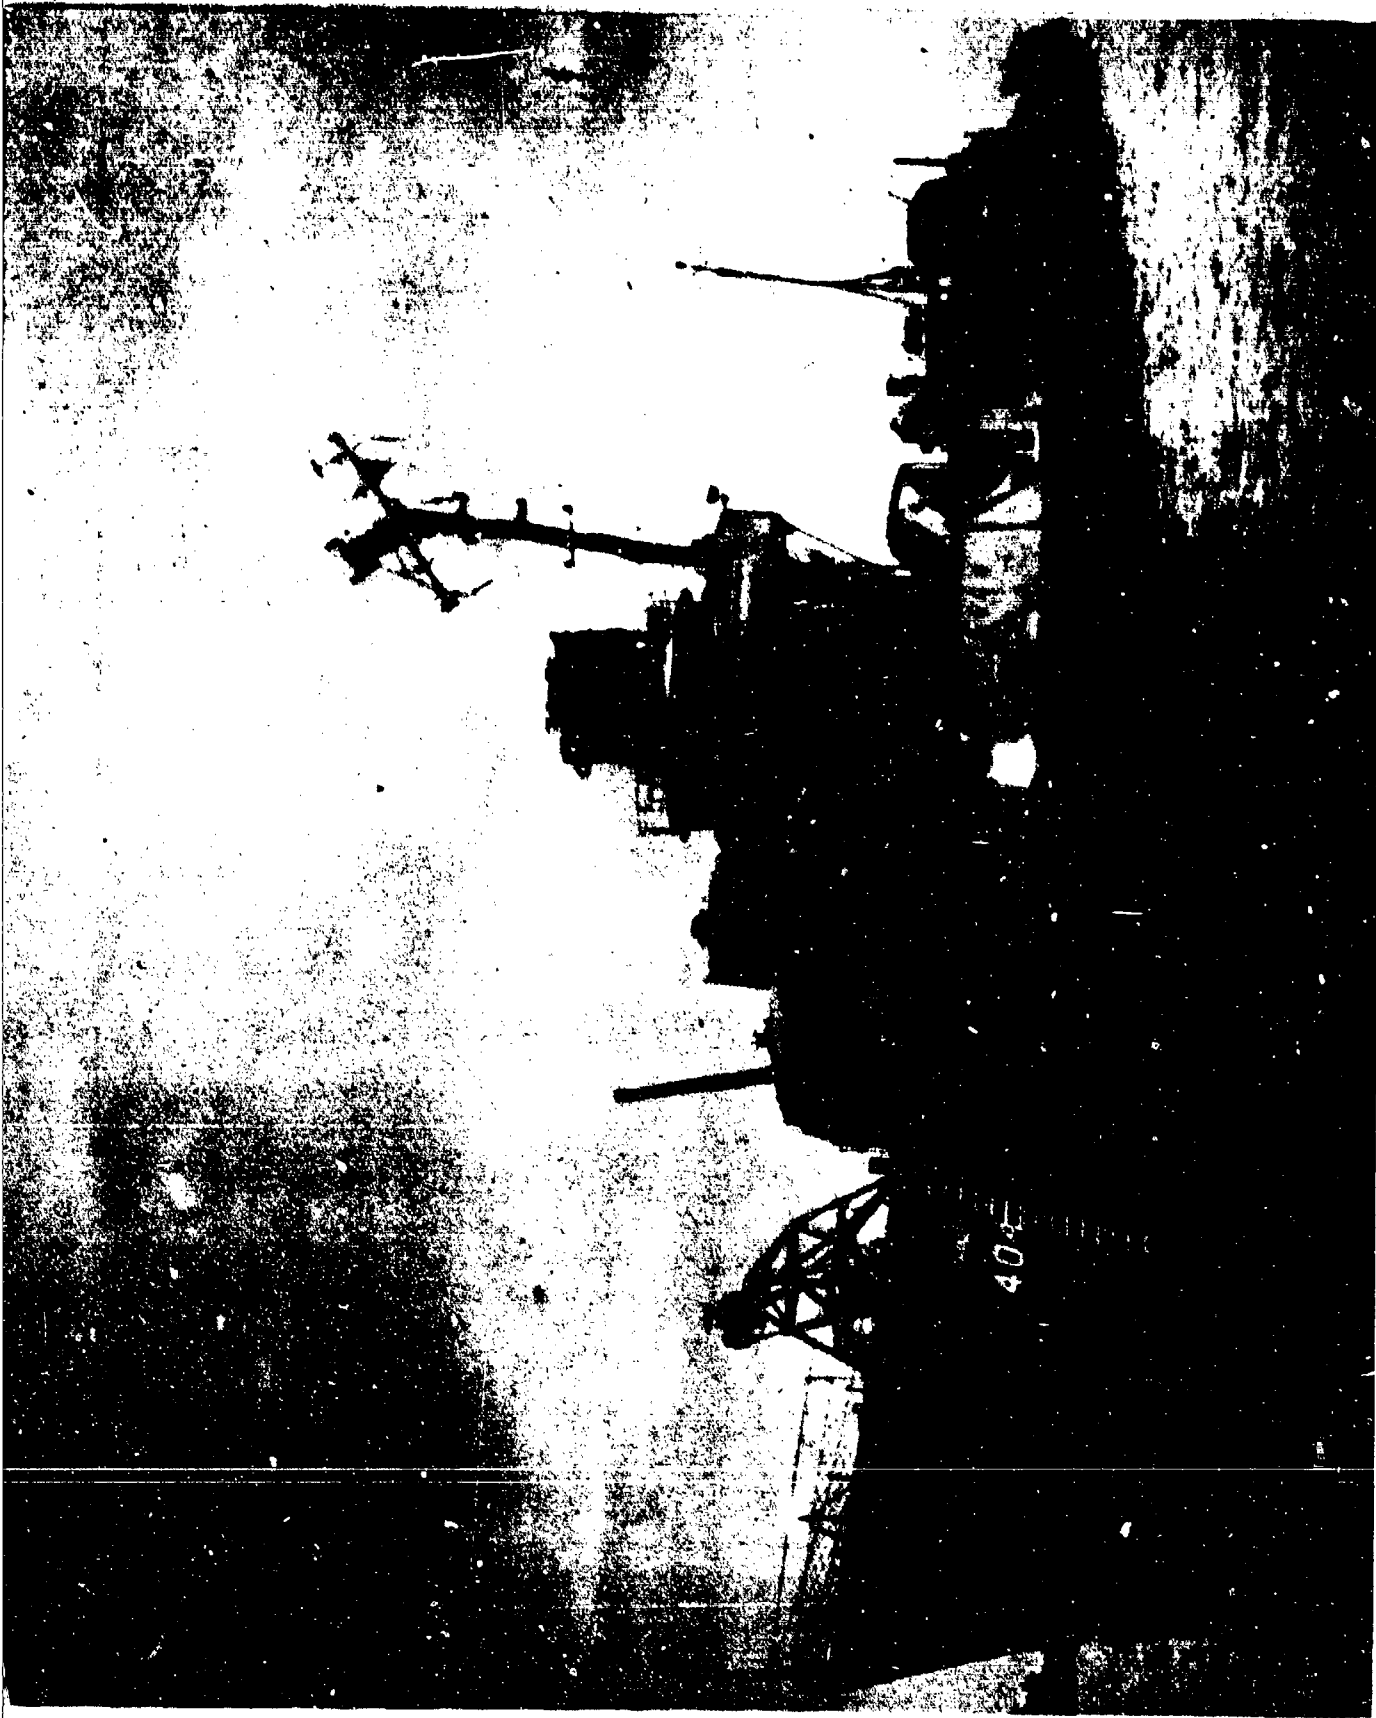
There is no apparent hull damage. Normal leakage into the engine rooms occurred. Draft and list readings prior to and following the test were identical. Photos pages 20 to 21 show the ship before and after Test B.

AB-CR-227-283-58. Port bow after Test B.

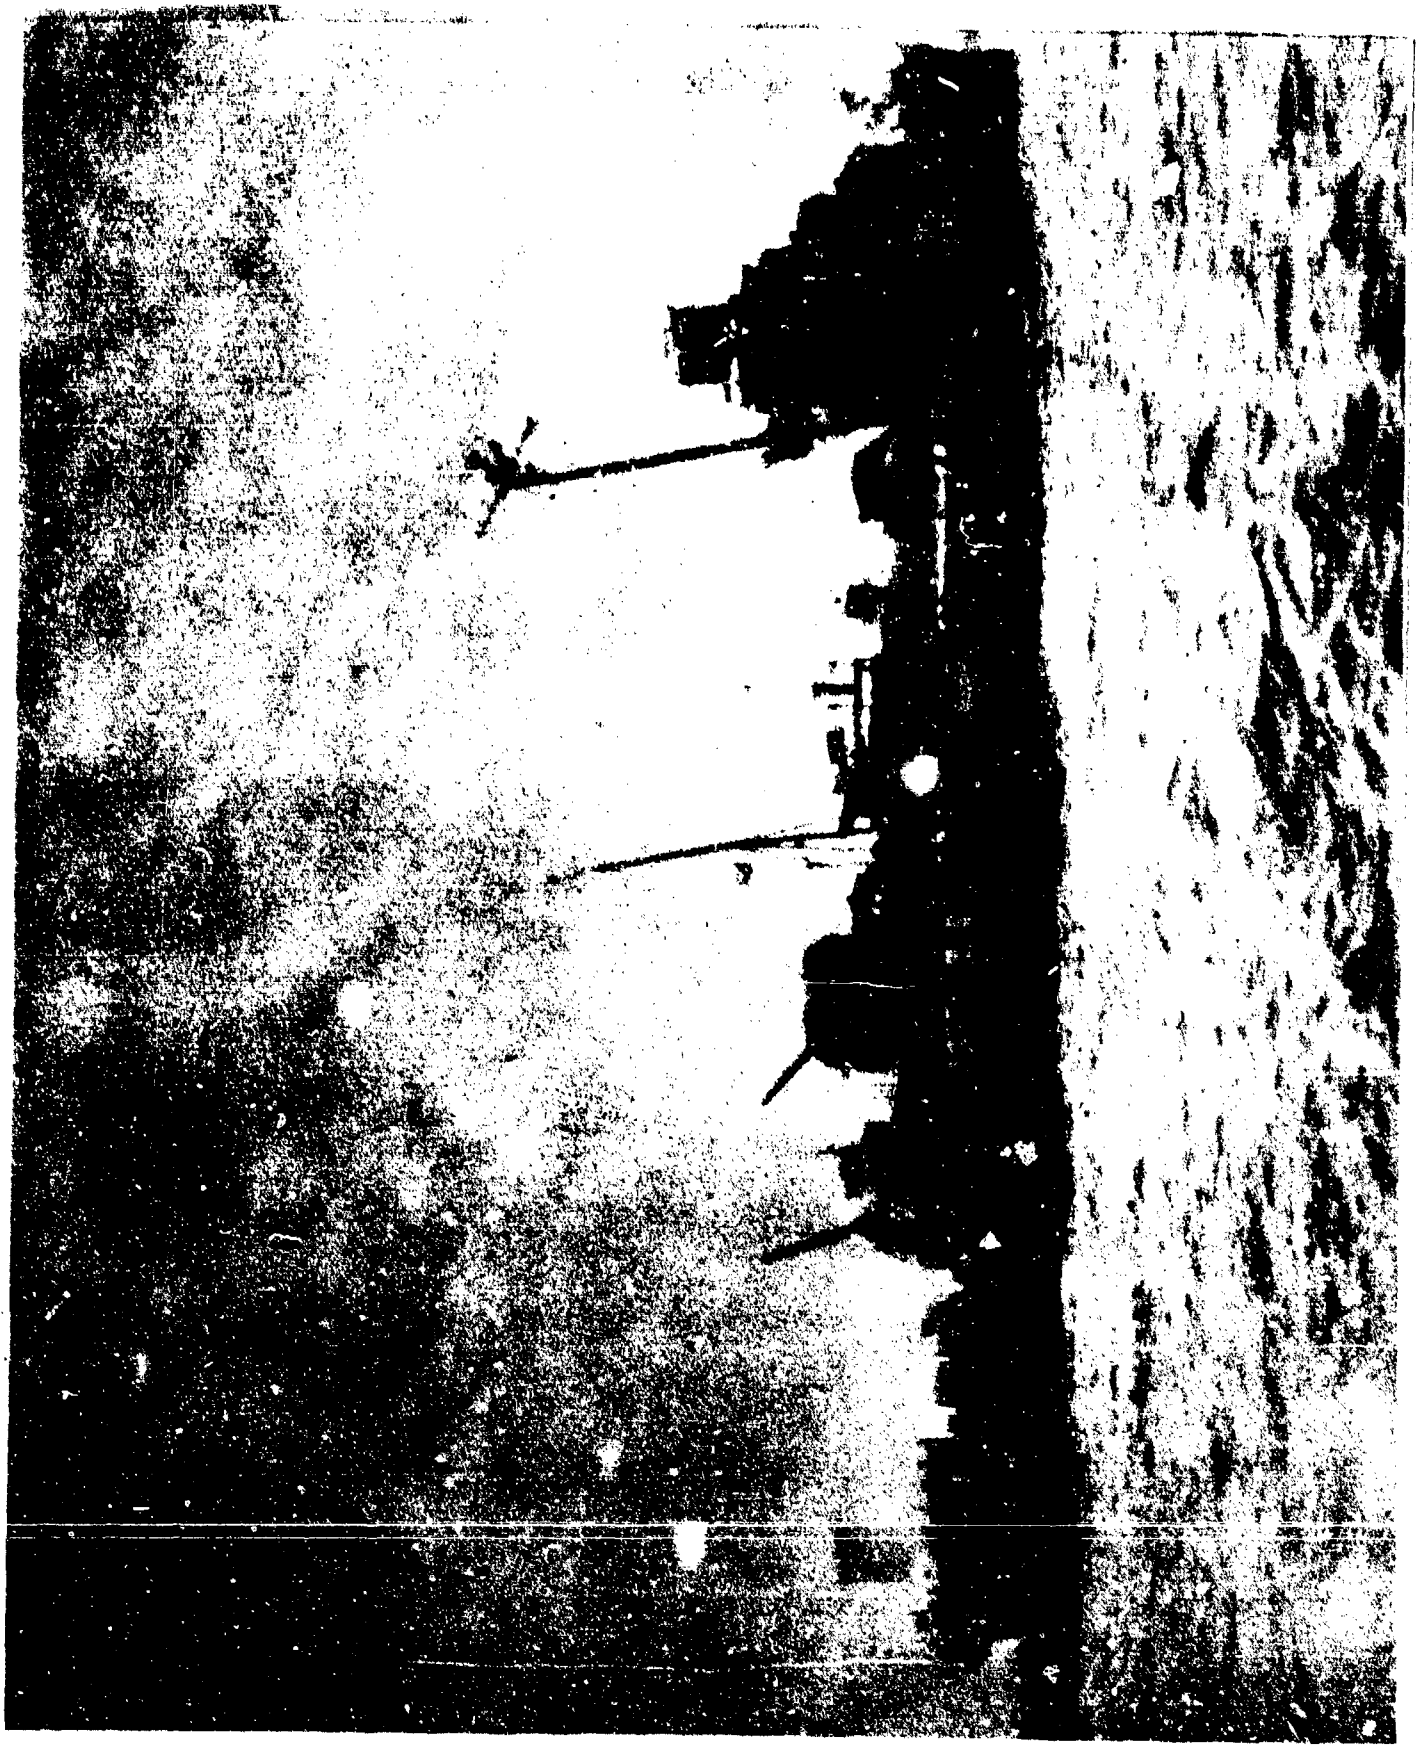
BB-CR-520-520-42. Starboard quarter before Test B.
