BUREAU OF SHIPS GROUP
TECHNICAL INSPECTION REPORT

⑥ OPERATION CROSSROADS.
U.S.S HUGHES (DD410).
TEST BAKER.

VOLUME II [u] ⑧

USS HUGHES (DD410)

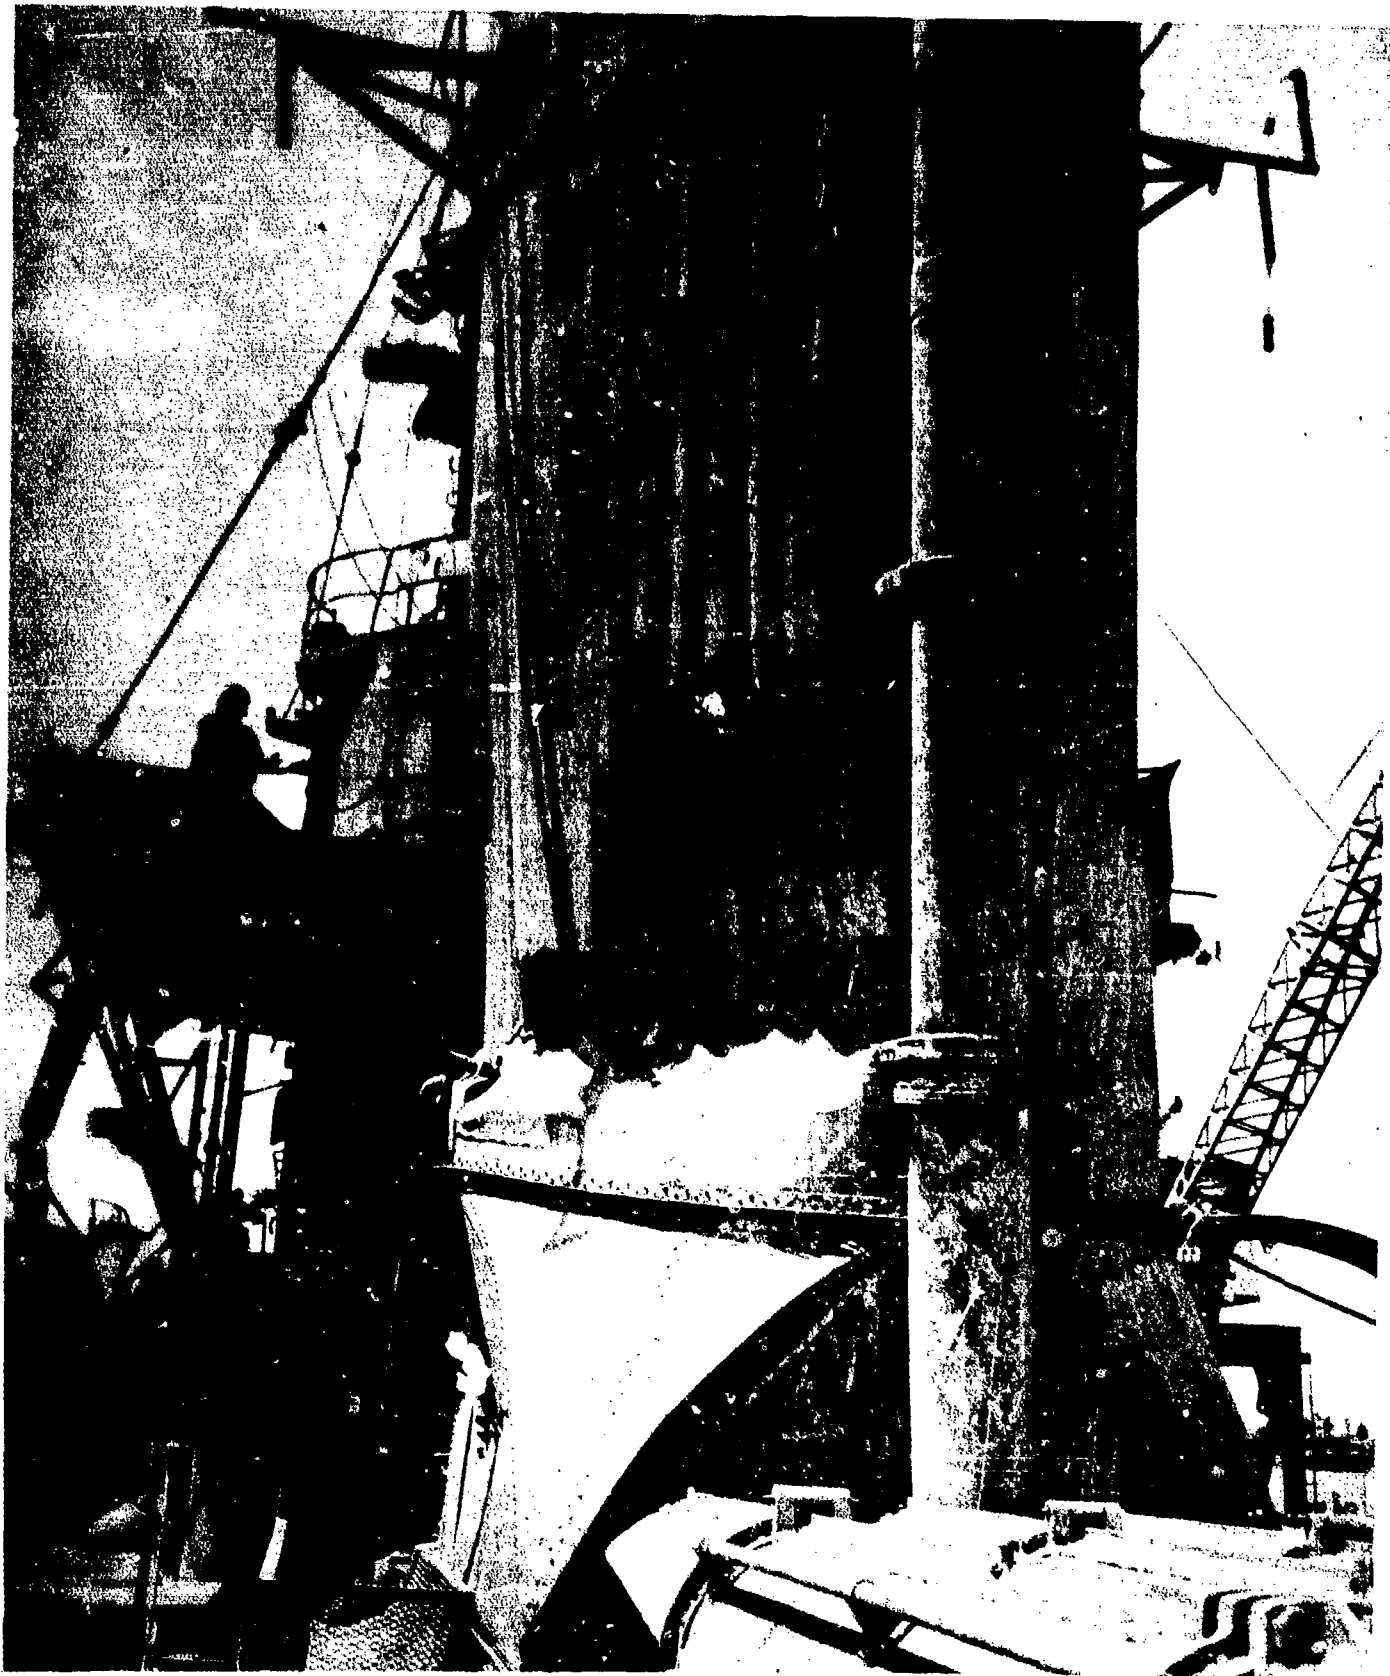
AB-CR-76-2077-9. Looking forward from port side of midship deck house at damage to port side of stack.

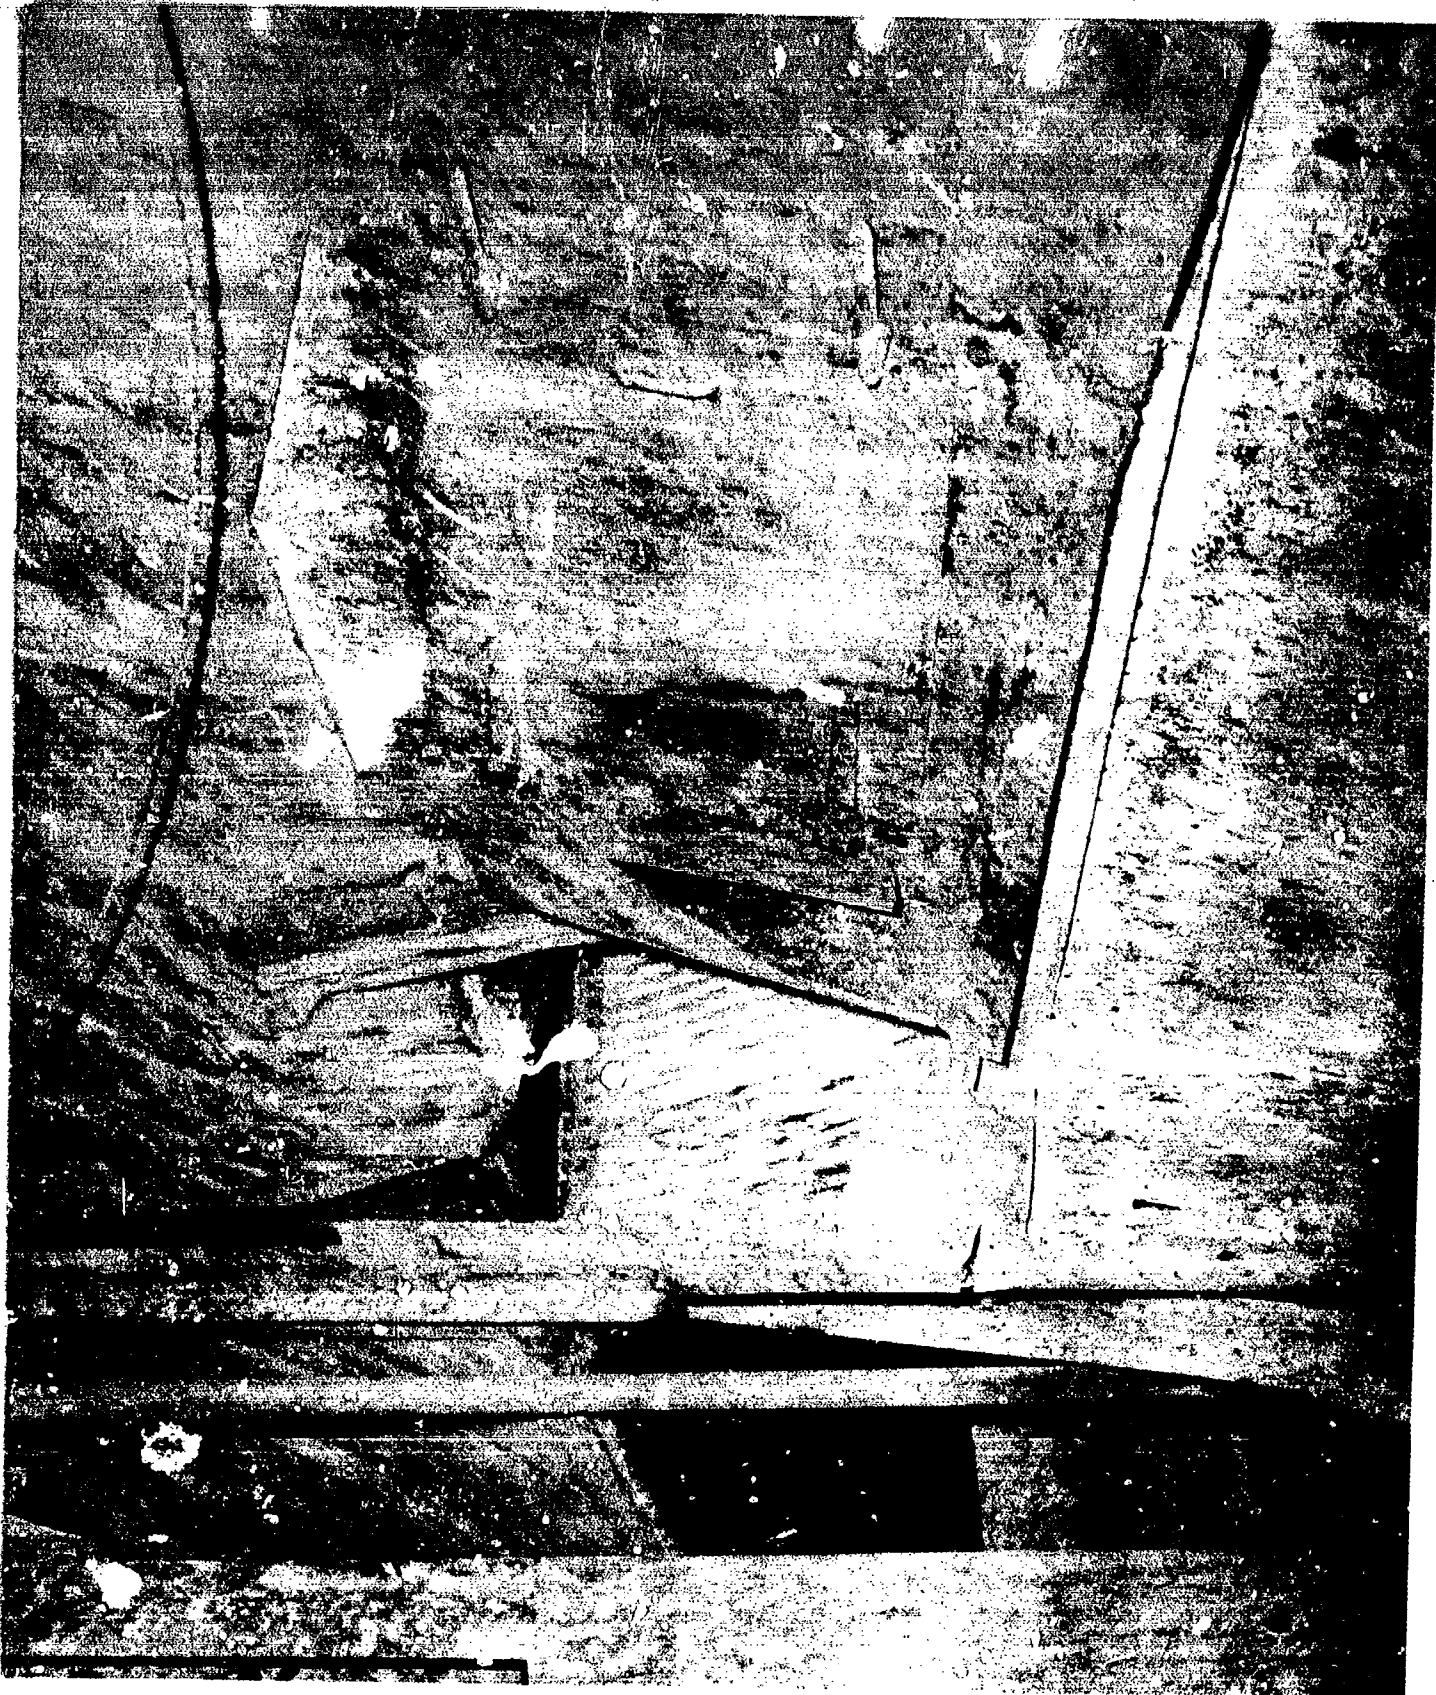
AB-CR-76-2077-3. Looking aft and to port at damage to starboard side of No. 2 boiler uptake.

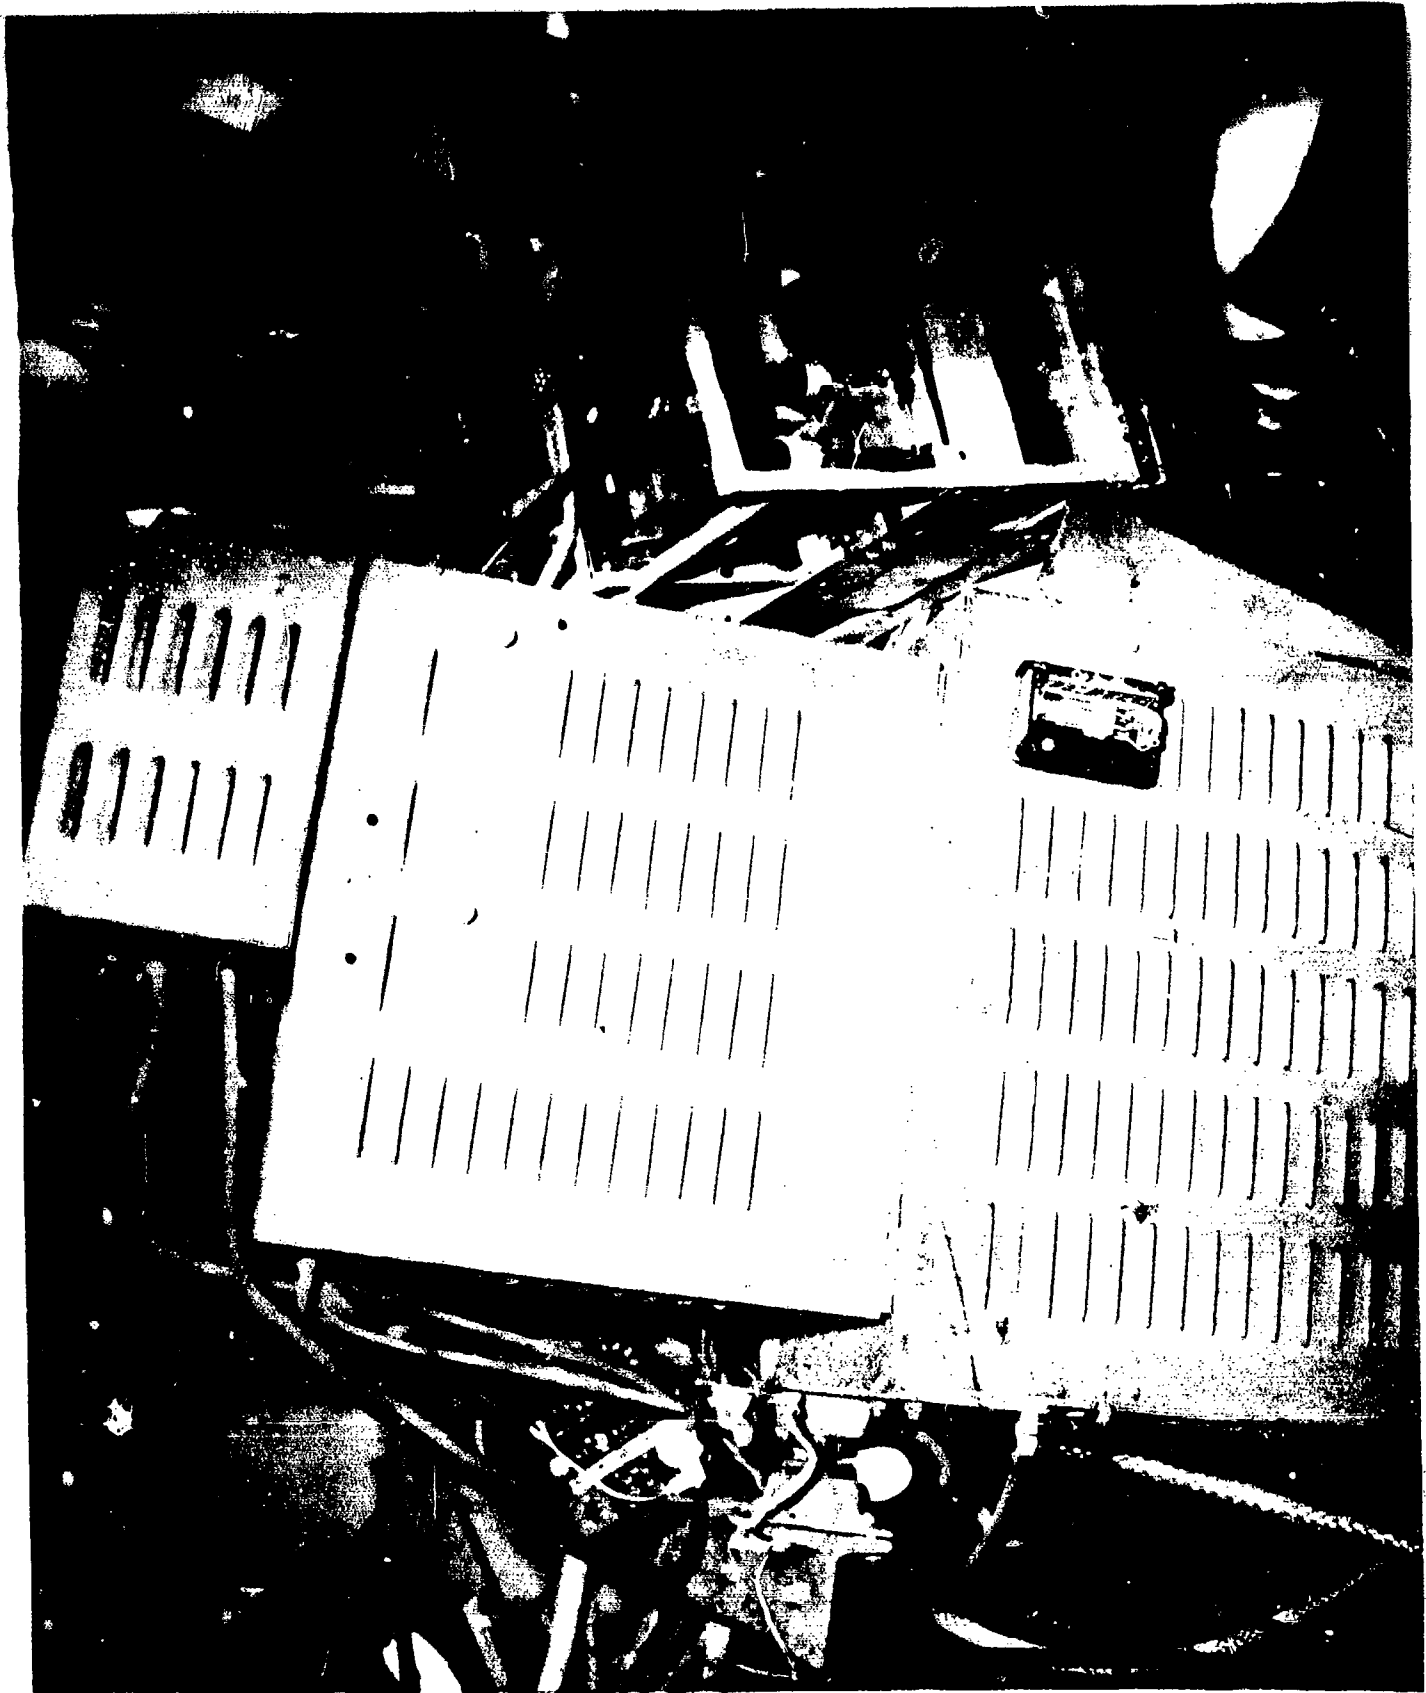
AB-CR-78-1951-8. Equipment damage in deck house on superstructure deck.

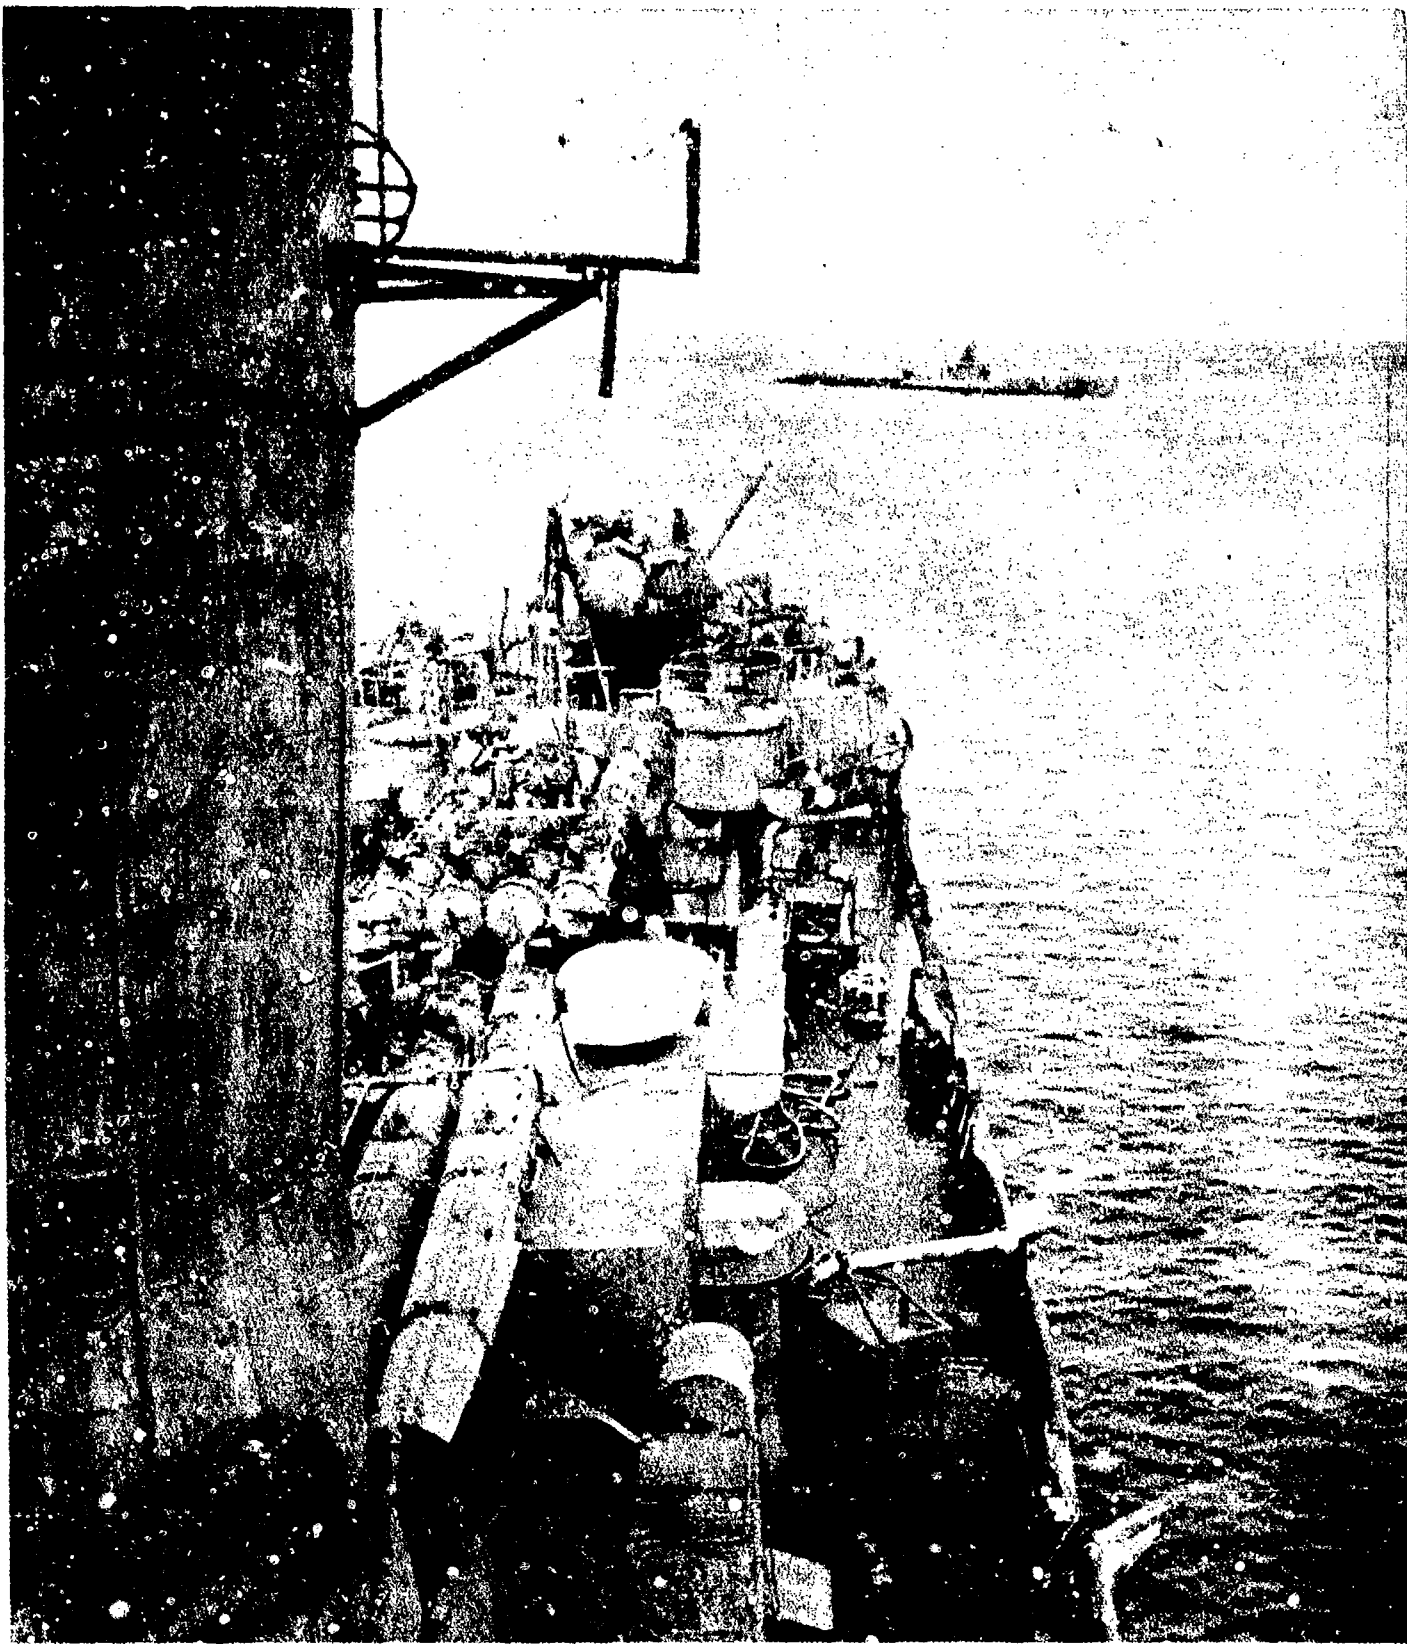
AB-CR-100-4204-5. Looking down and aft to main deck showing port side of stack and damage to port.

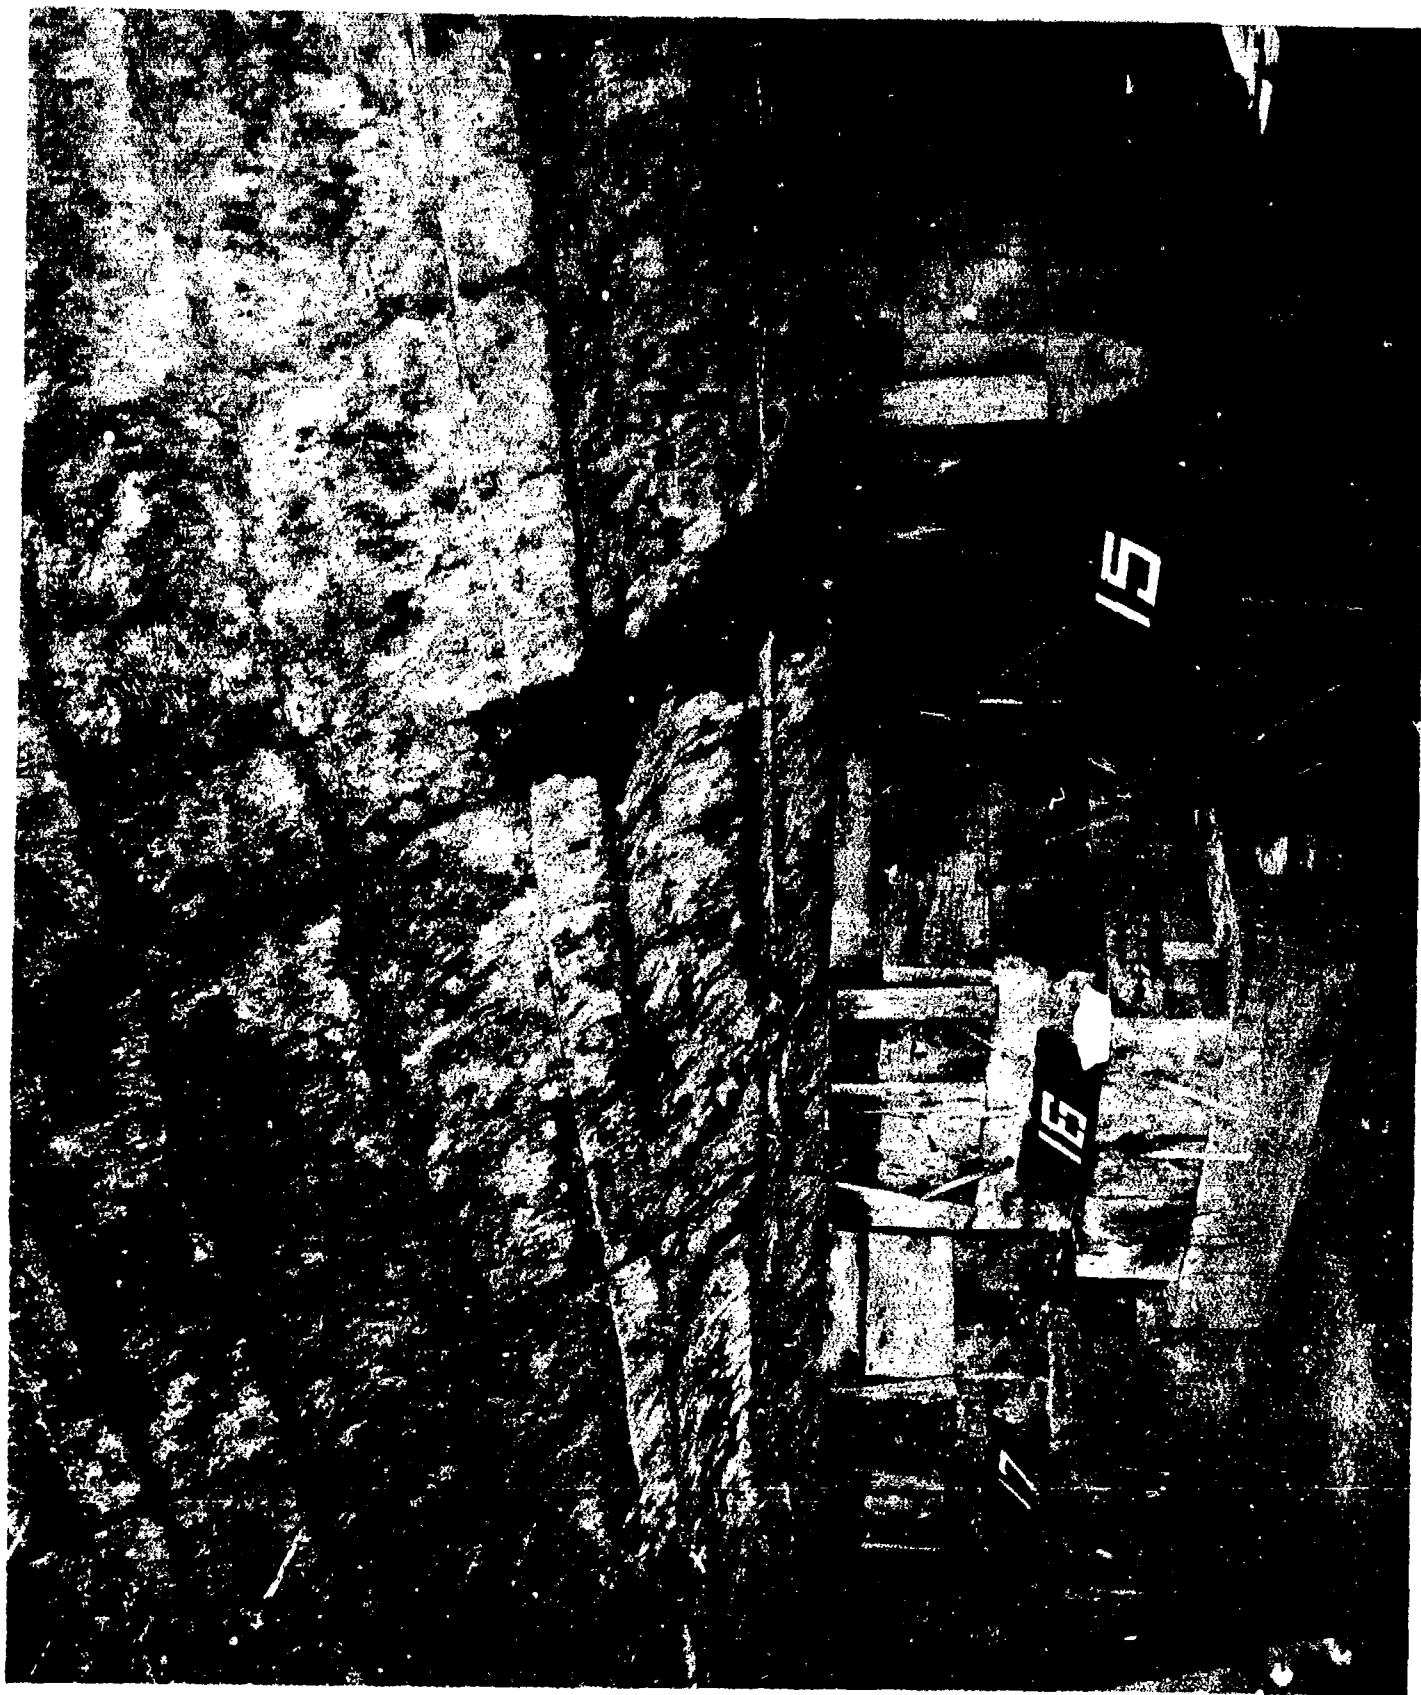
AB-CR-97-4050-3. Starboard bottom shell looking inboard and aft, frames 36 to 40, in way of severe grounding damage superimposed upon washboarding due to underwater shock wave.

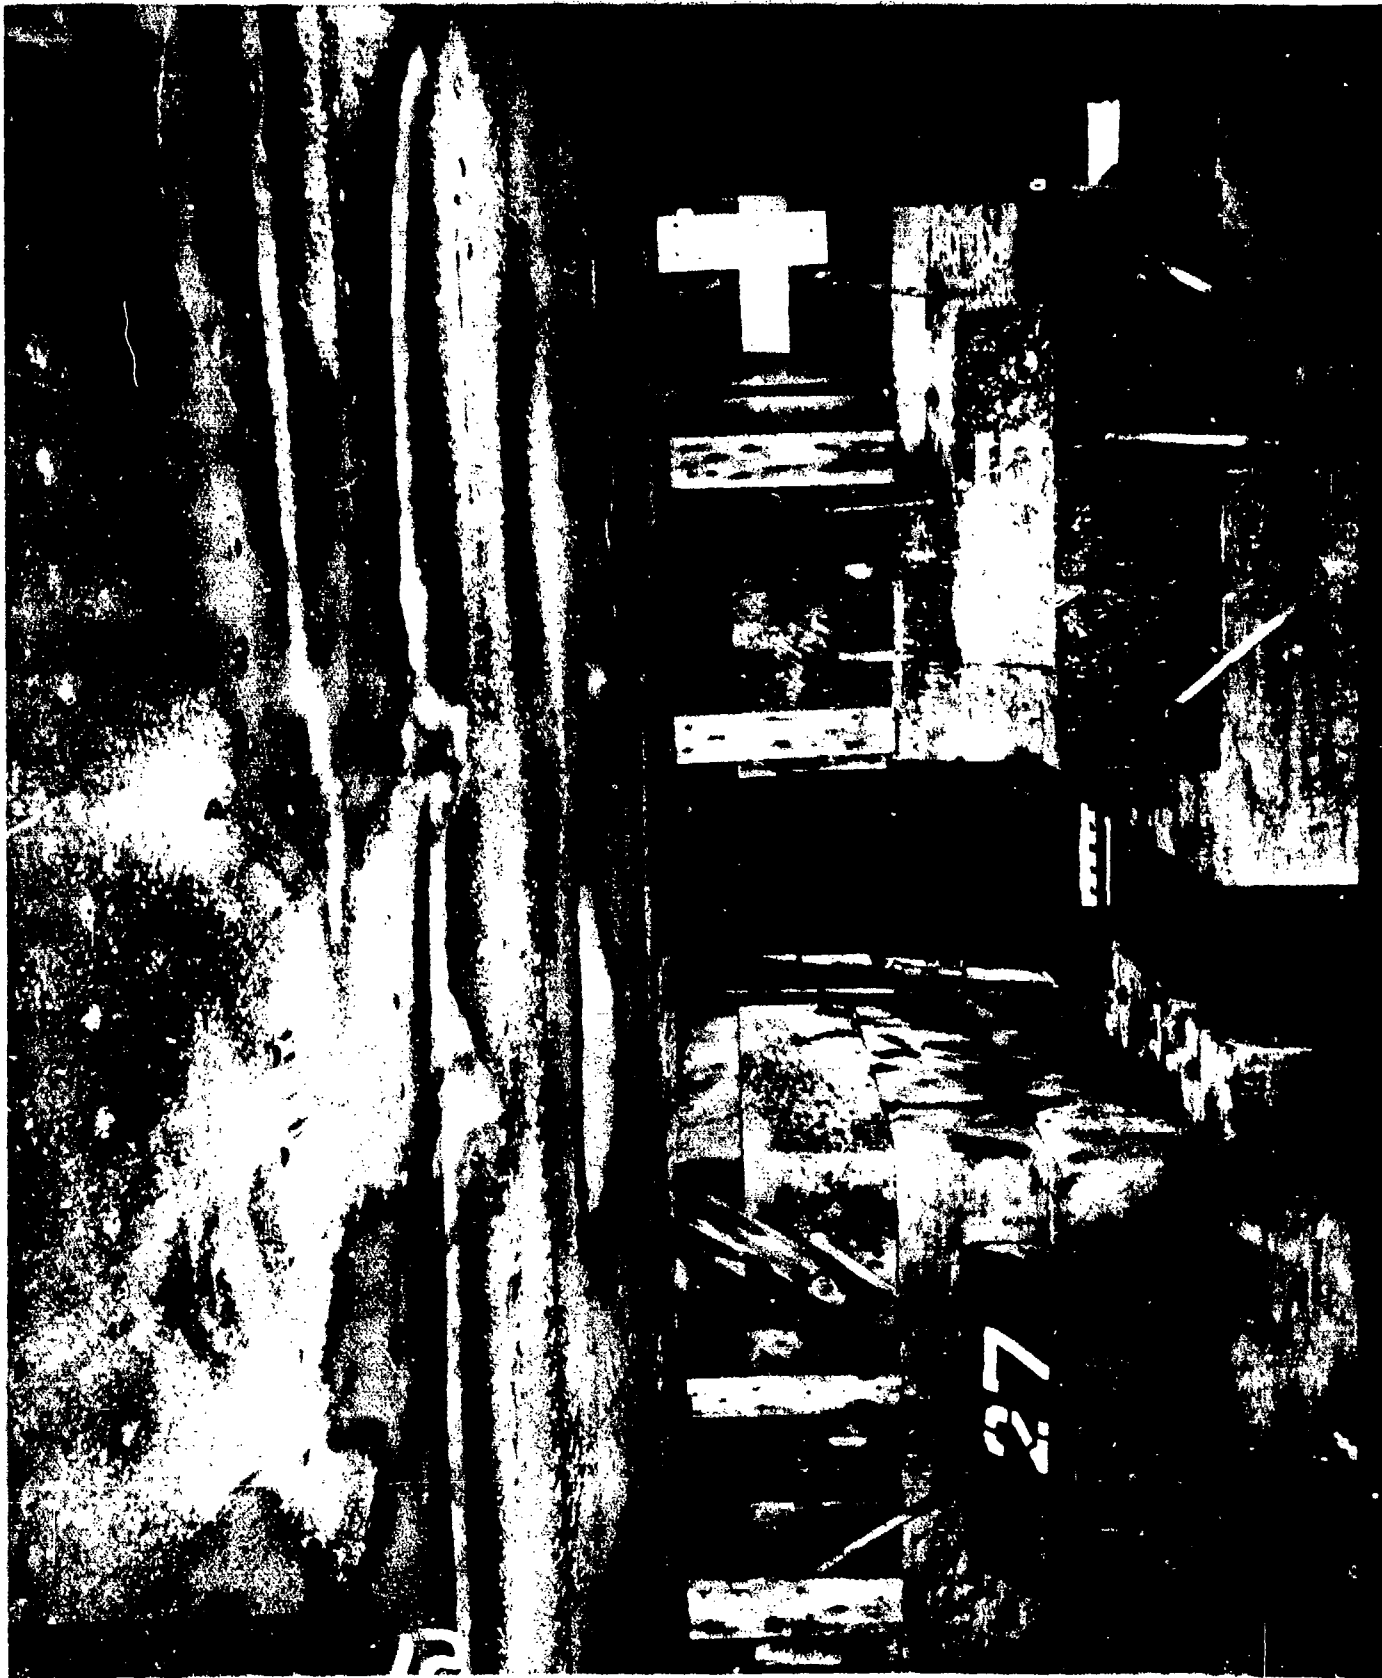
AB-CR-97-4049-12. Starboard bottom shell, looking inboard at frame 78. Note longitudinal dishing, probably due to grounding damage.

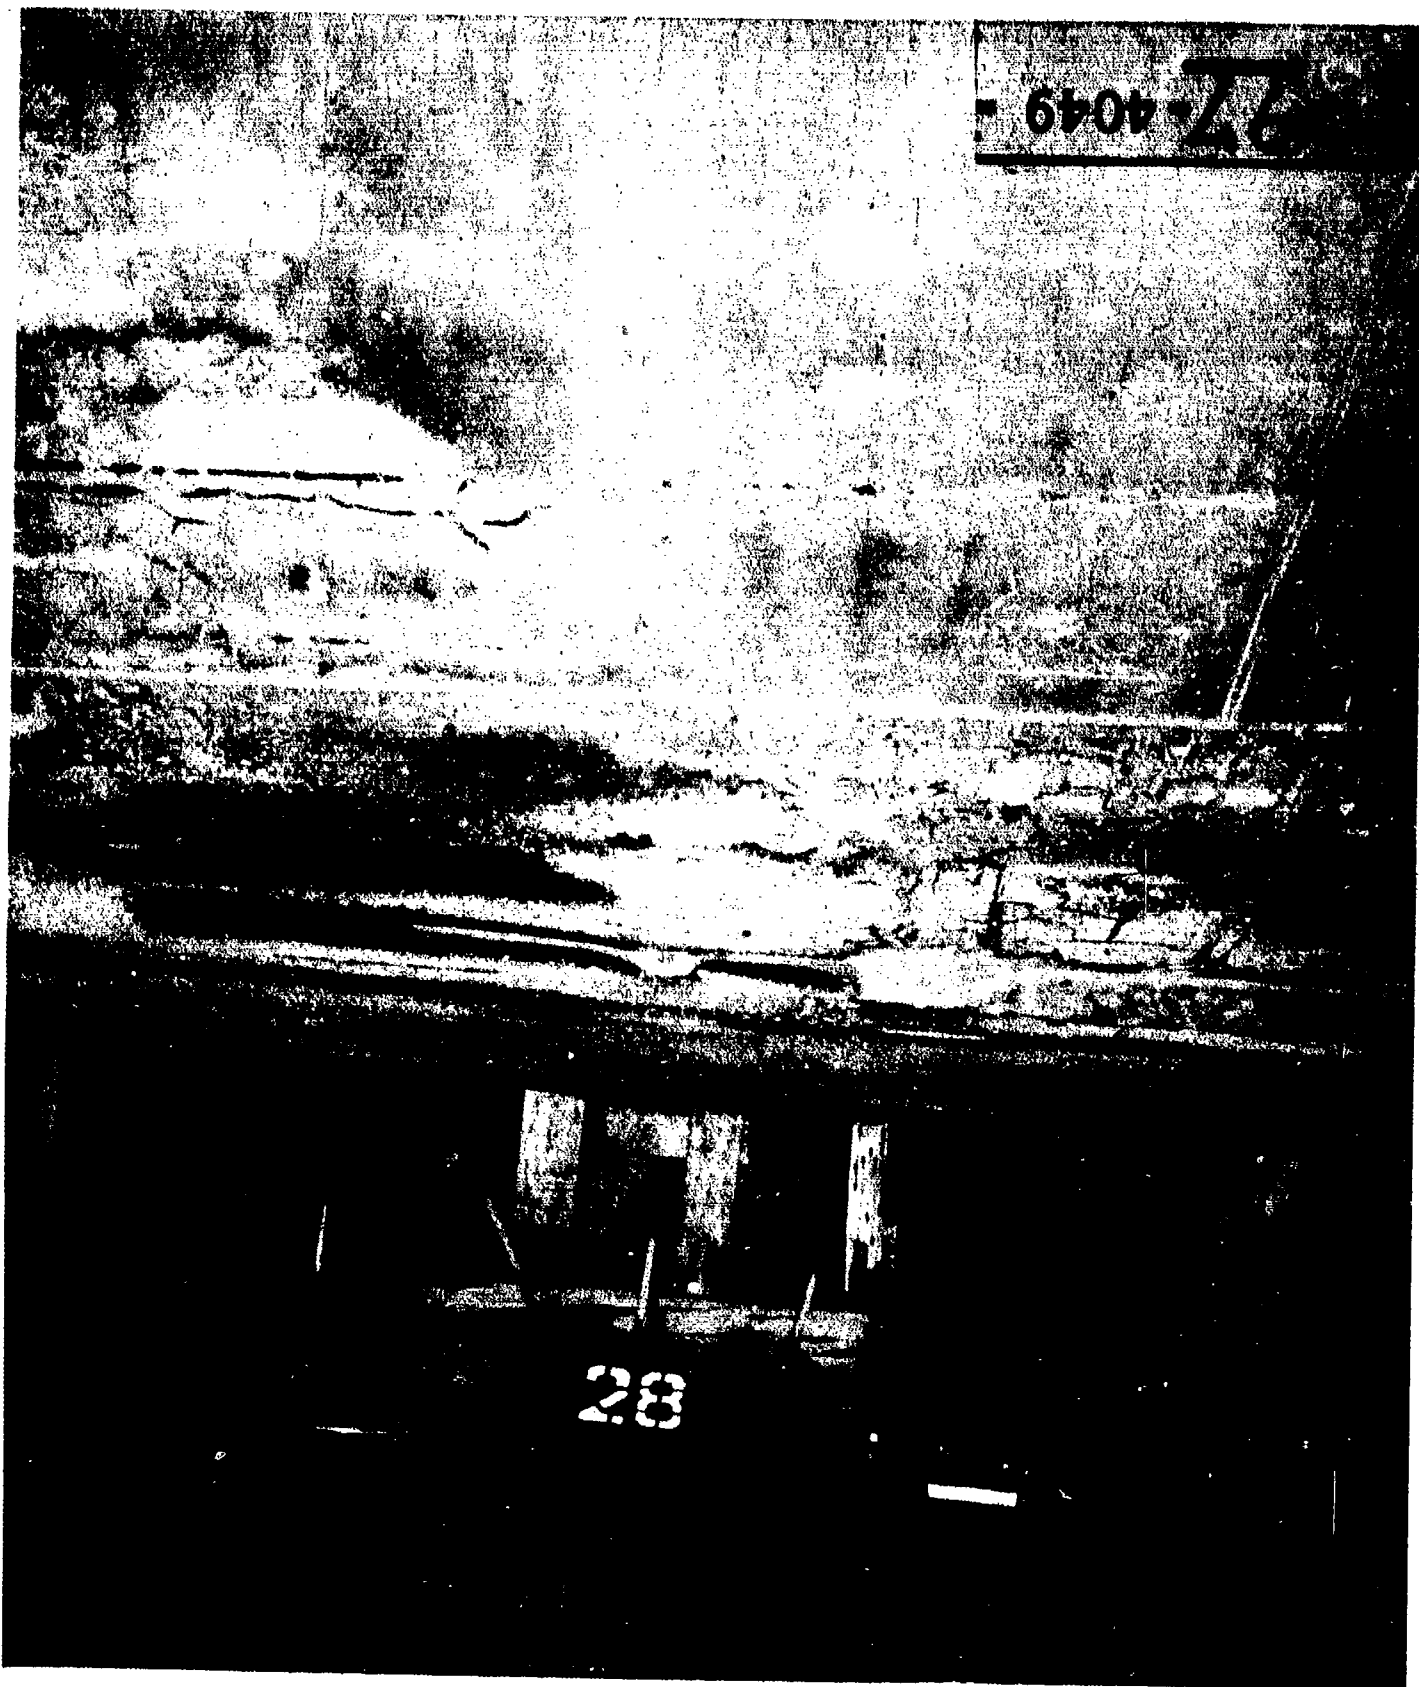
AB-CR-97-4049-11. Starboard bottom shell, looking inboard at frame 82 grounding damage.

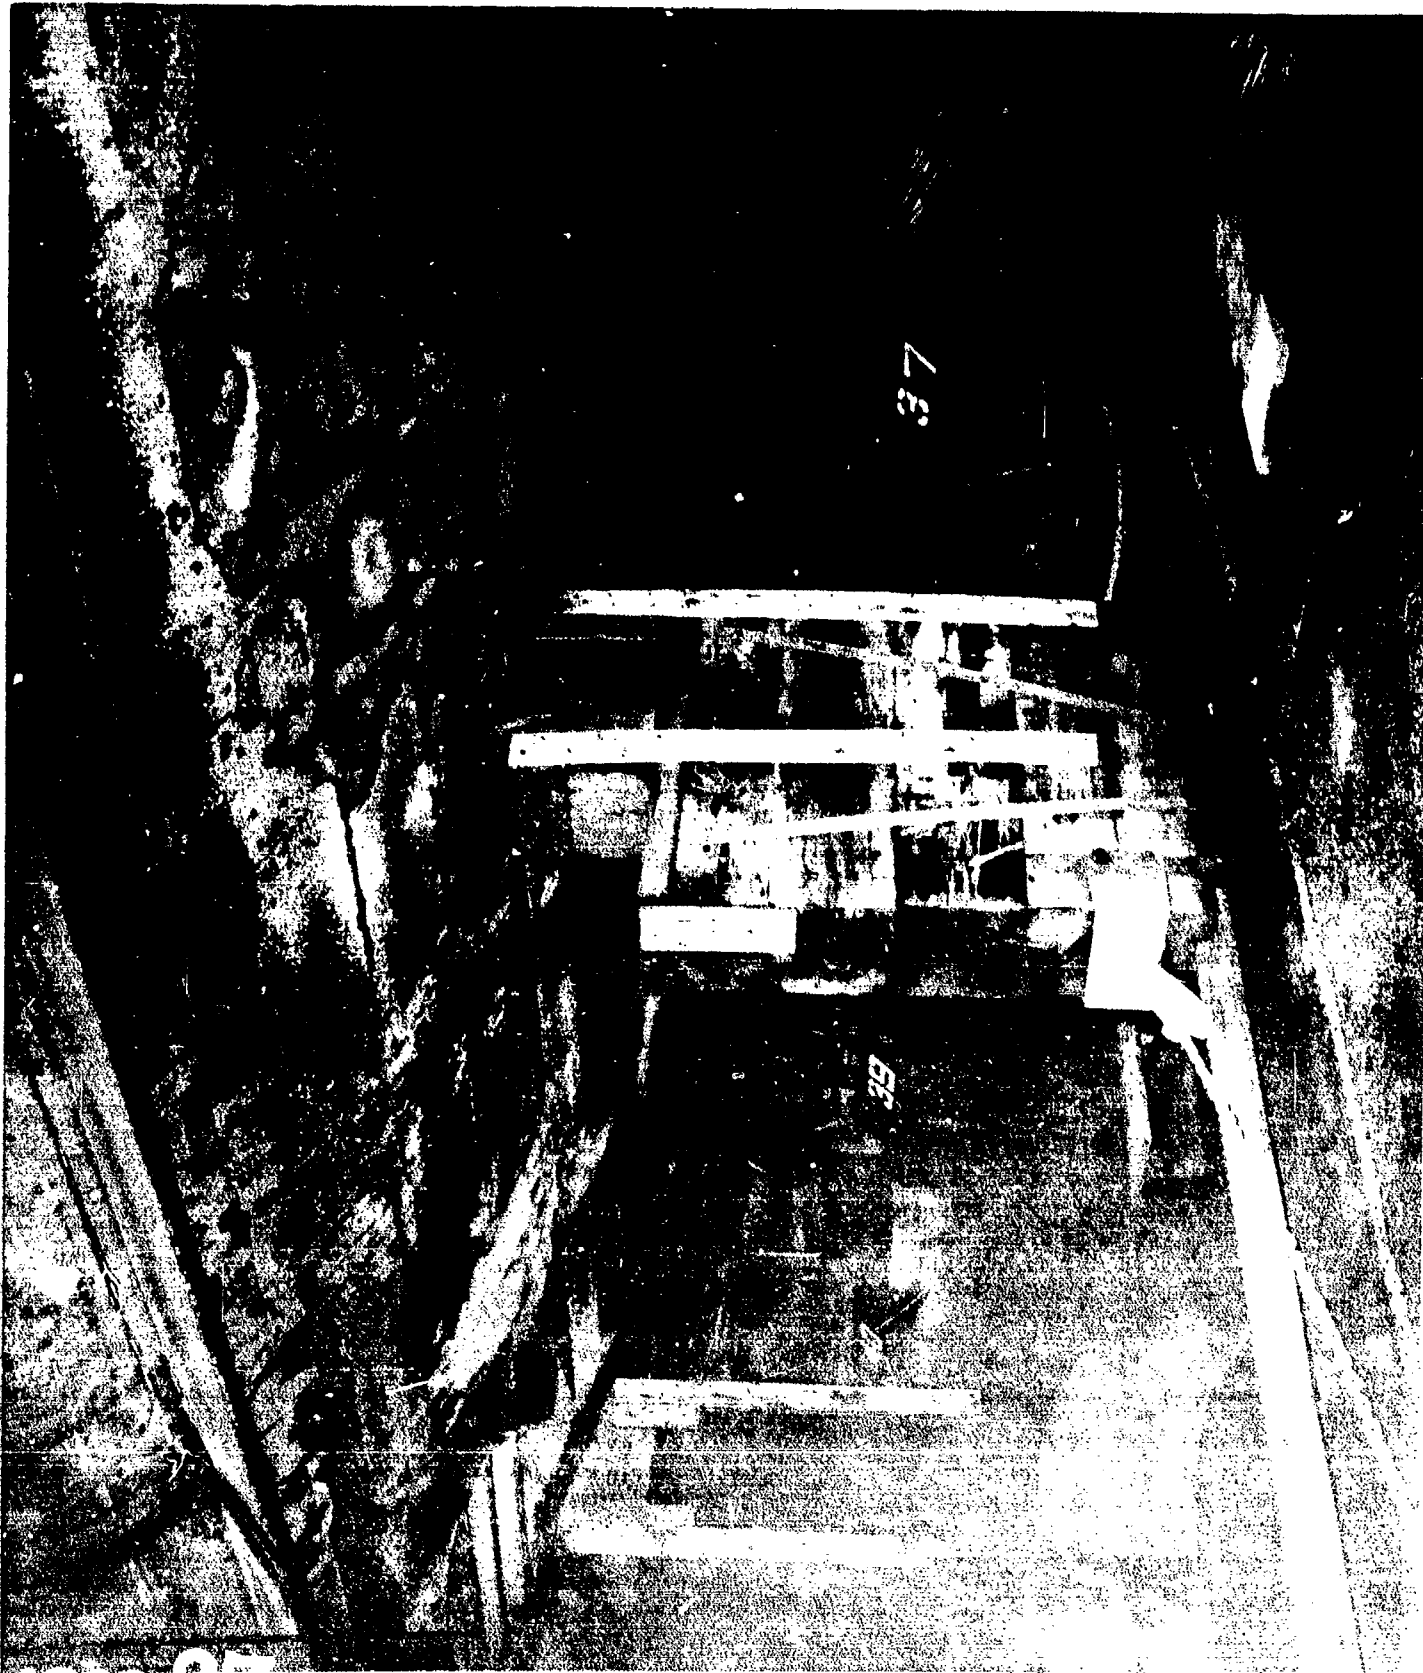
AB-CR-97-4049-9. Starboard bottom shell, looking inboard and aft, frames 108-120. The right half of B strake is dimpled and the plastic coating has been worn off in contact with the coral during grounding.

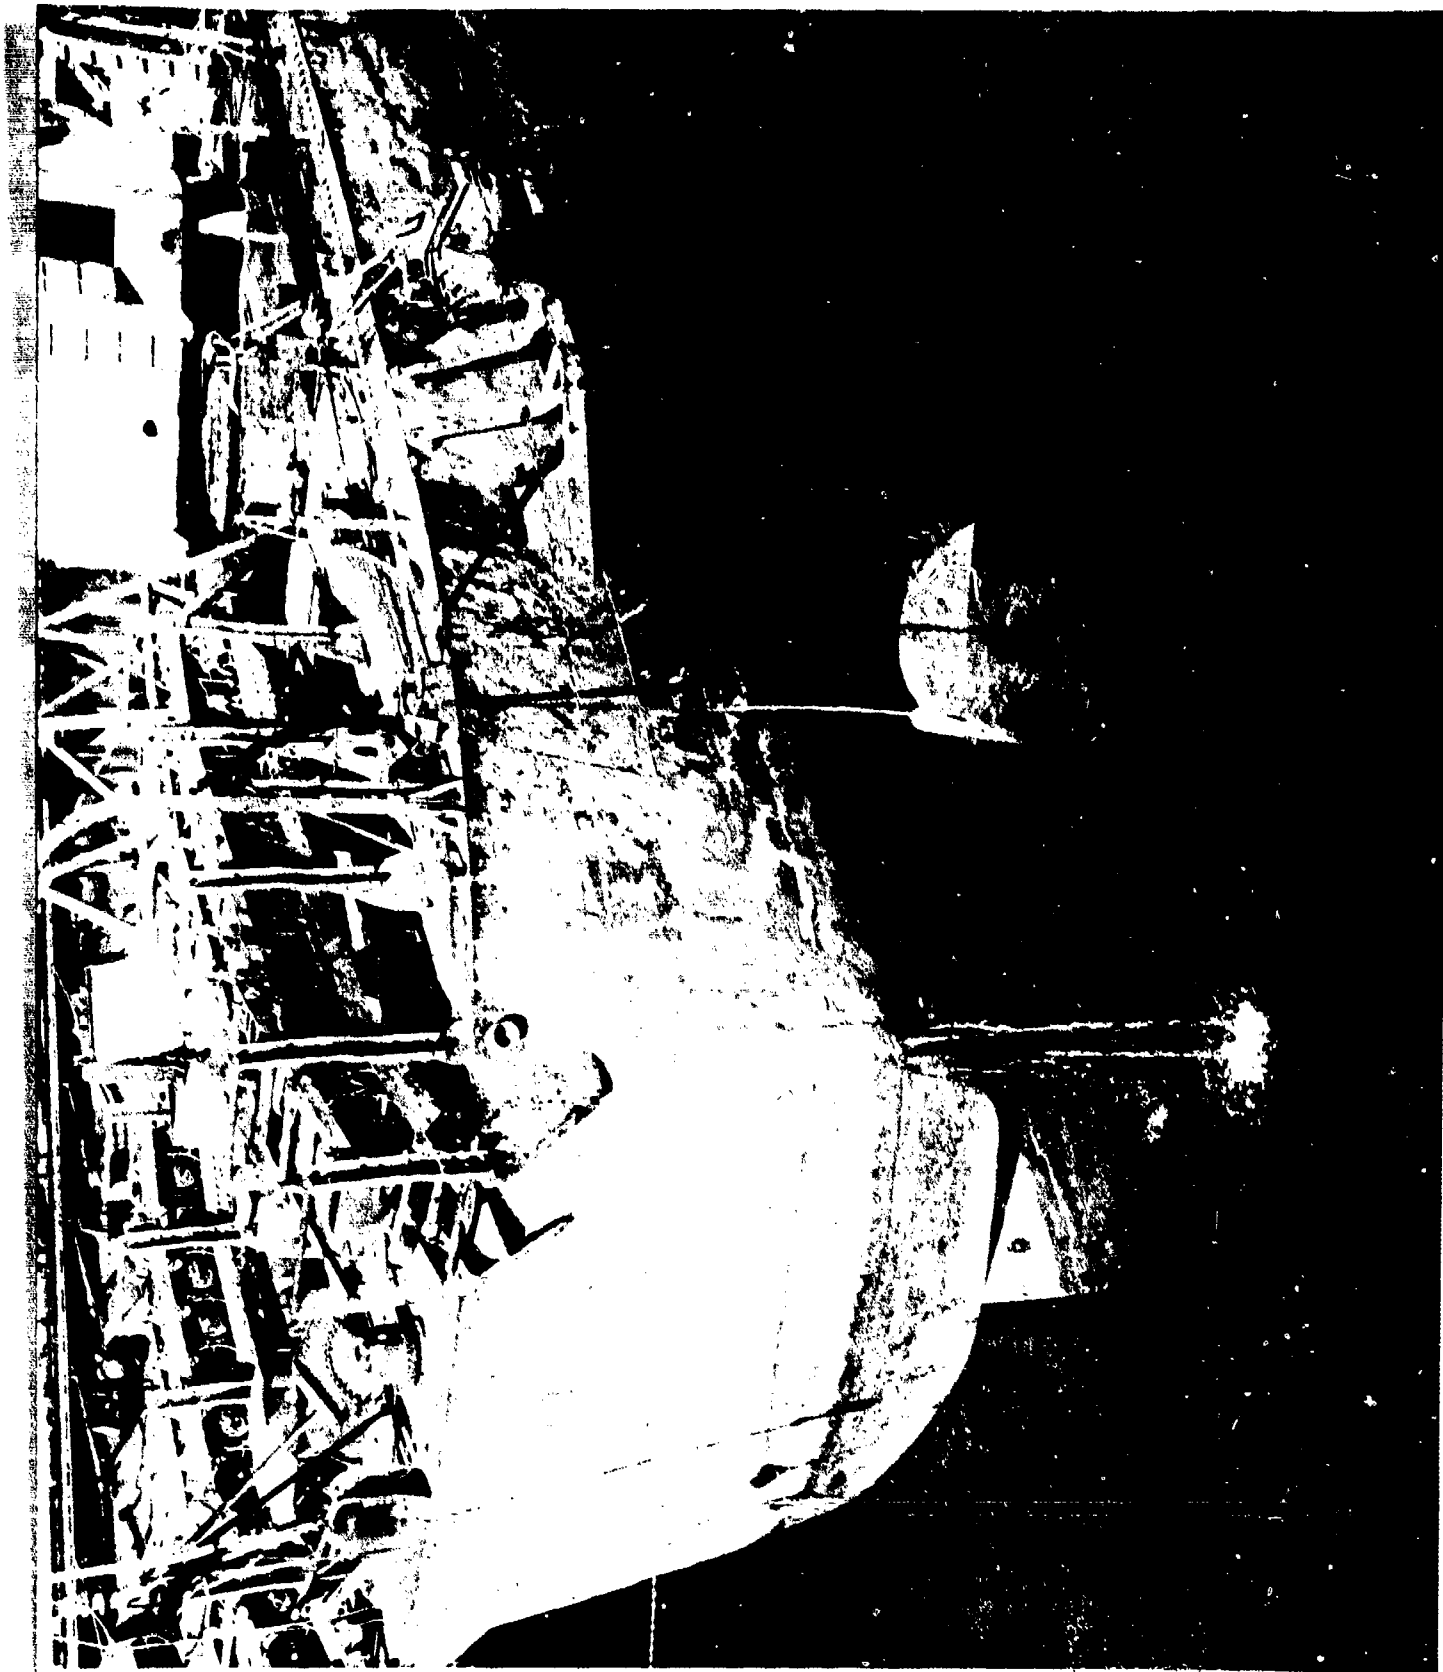
AB-CR-82-4223-11. Close-up showing depth charge racks and leakage in way of shell plating seam at starboard corner of transom.
