BUREAU OF SHIPS GROUP
TECHNICAL INSPECTION REPORT

⑥ OPERATION CROSSROADS.
U.S.S HUGHES (DD410).
TEST BAKER.

VOLUME II [u] ⑧

USS HUGHES (DD410)

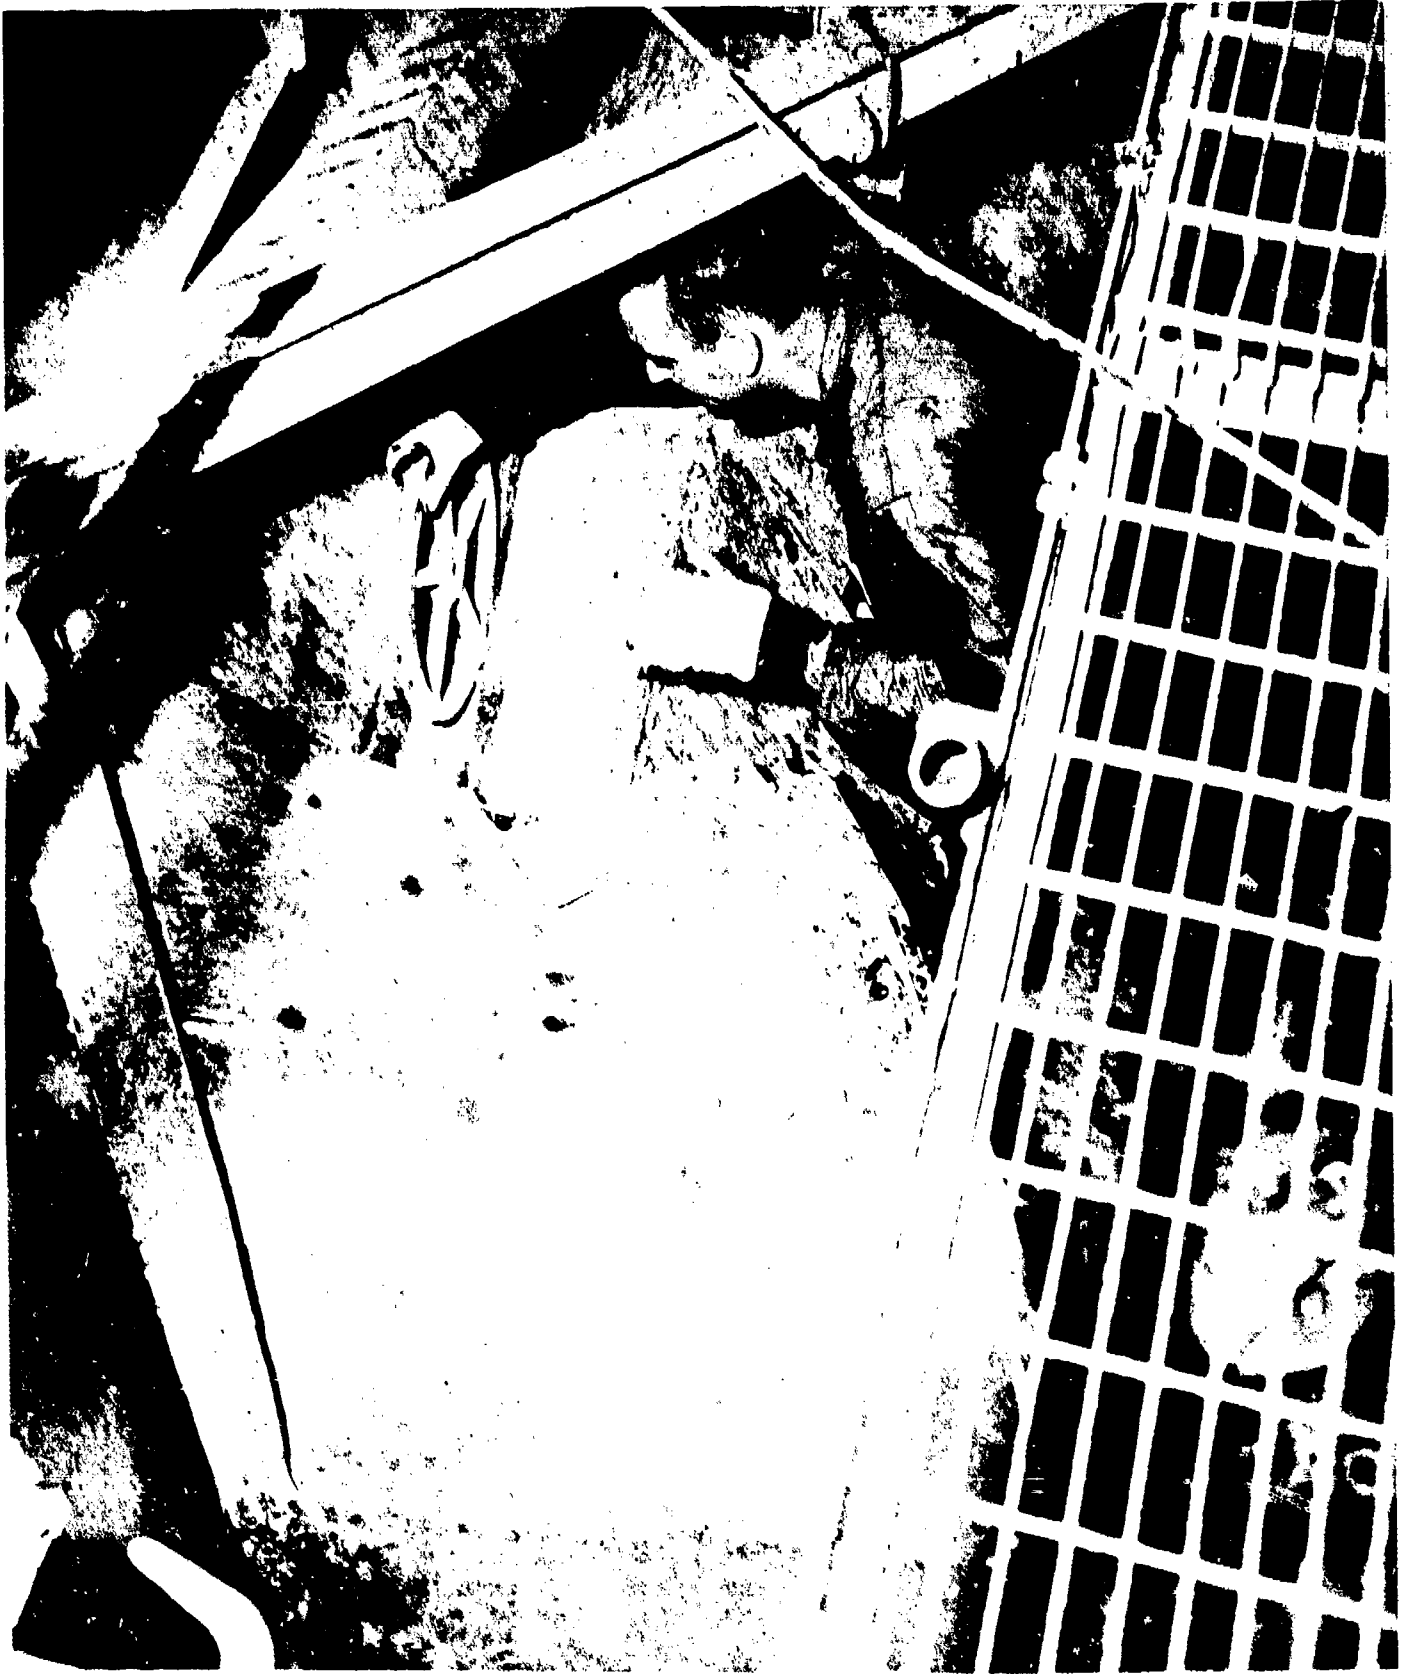
AB-CR-76-2077-7. No. 3 uptake, rupture of sheet and main frame.

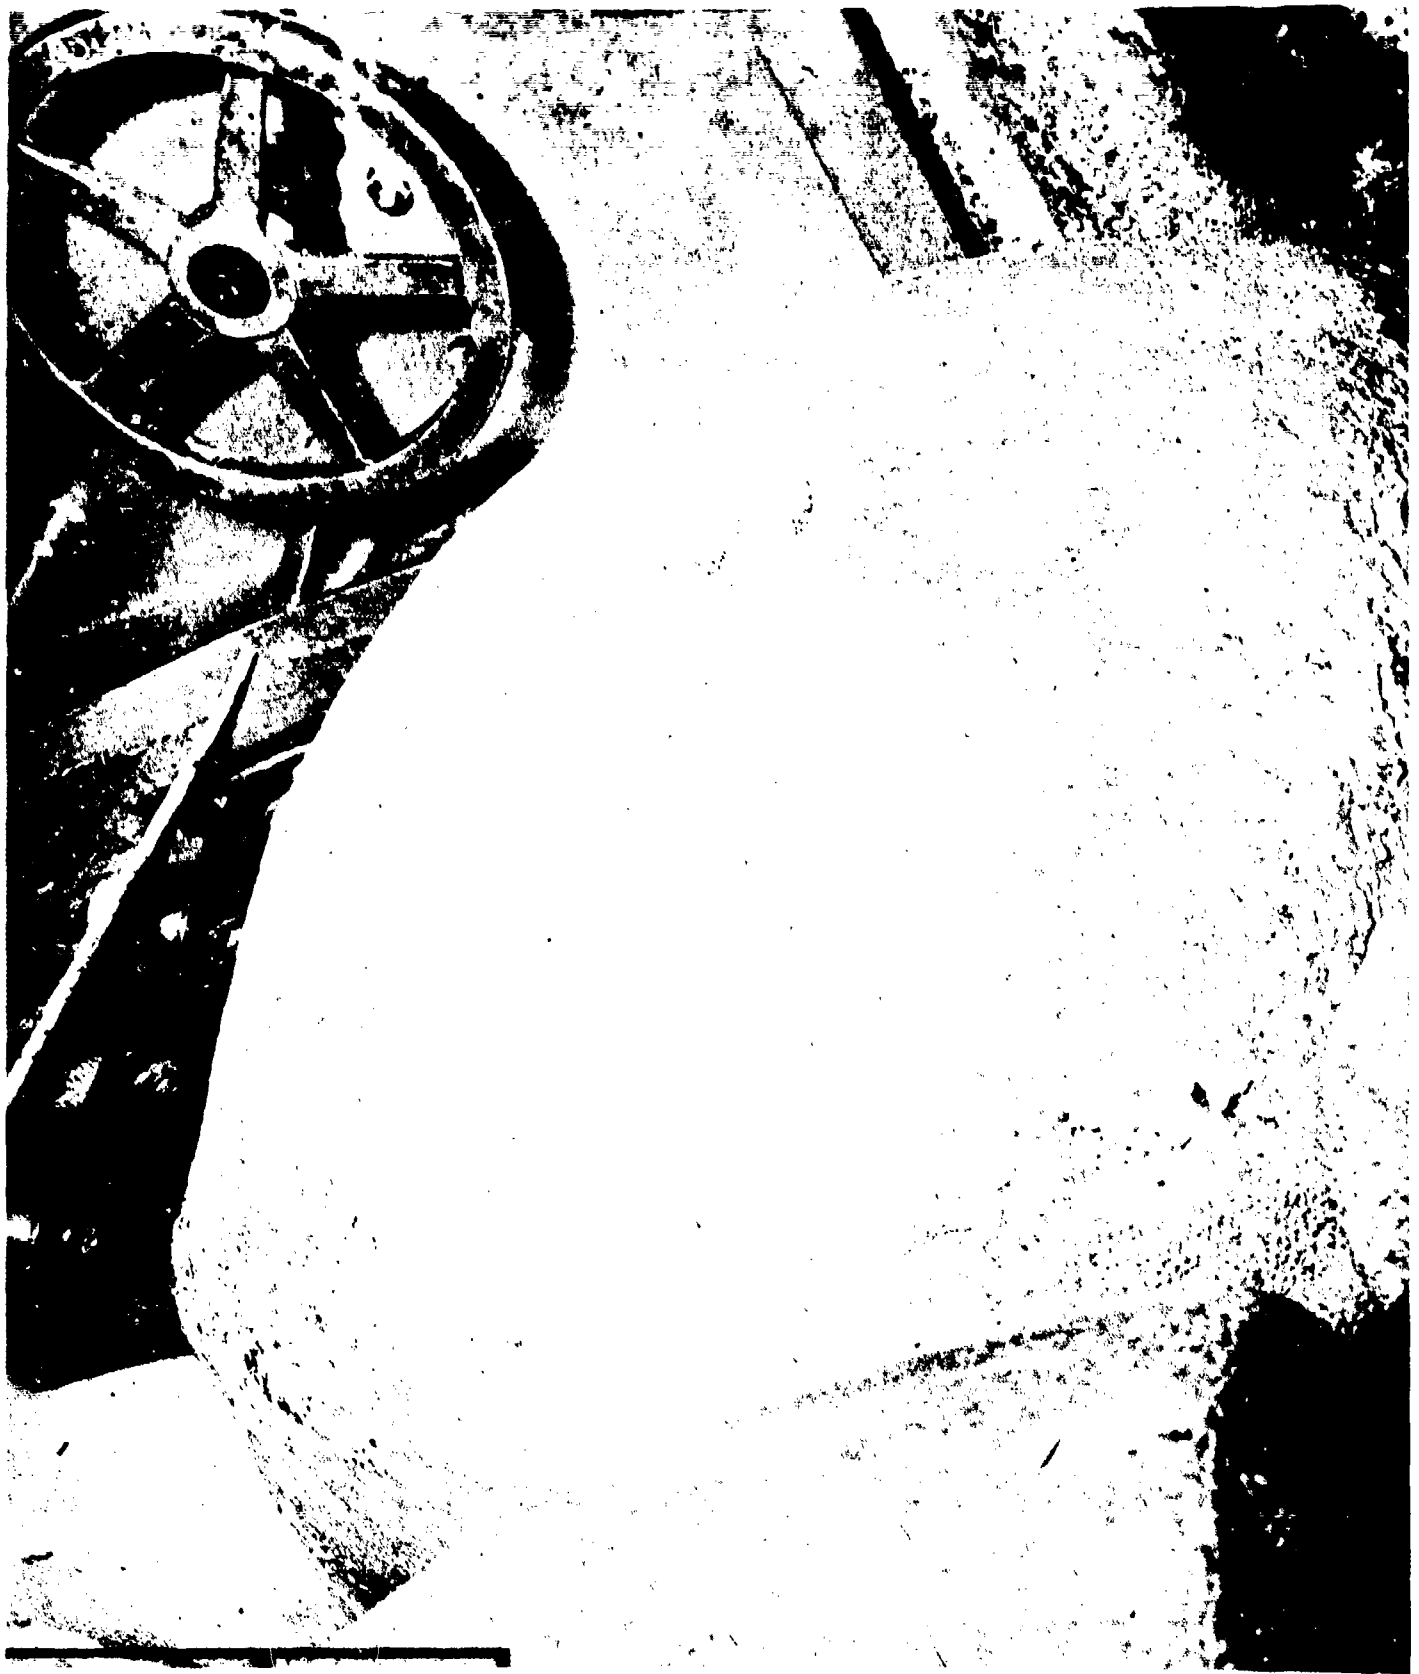
AB-CR-97-4059-9. No. 2 engine room, main steam manifold support bracket failure.

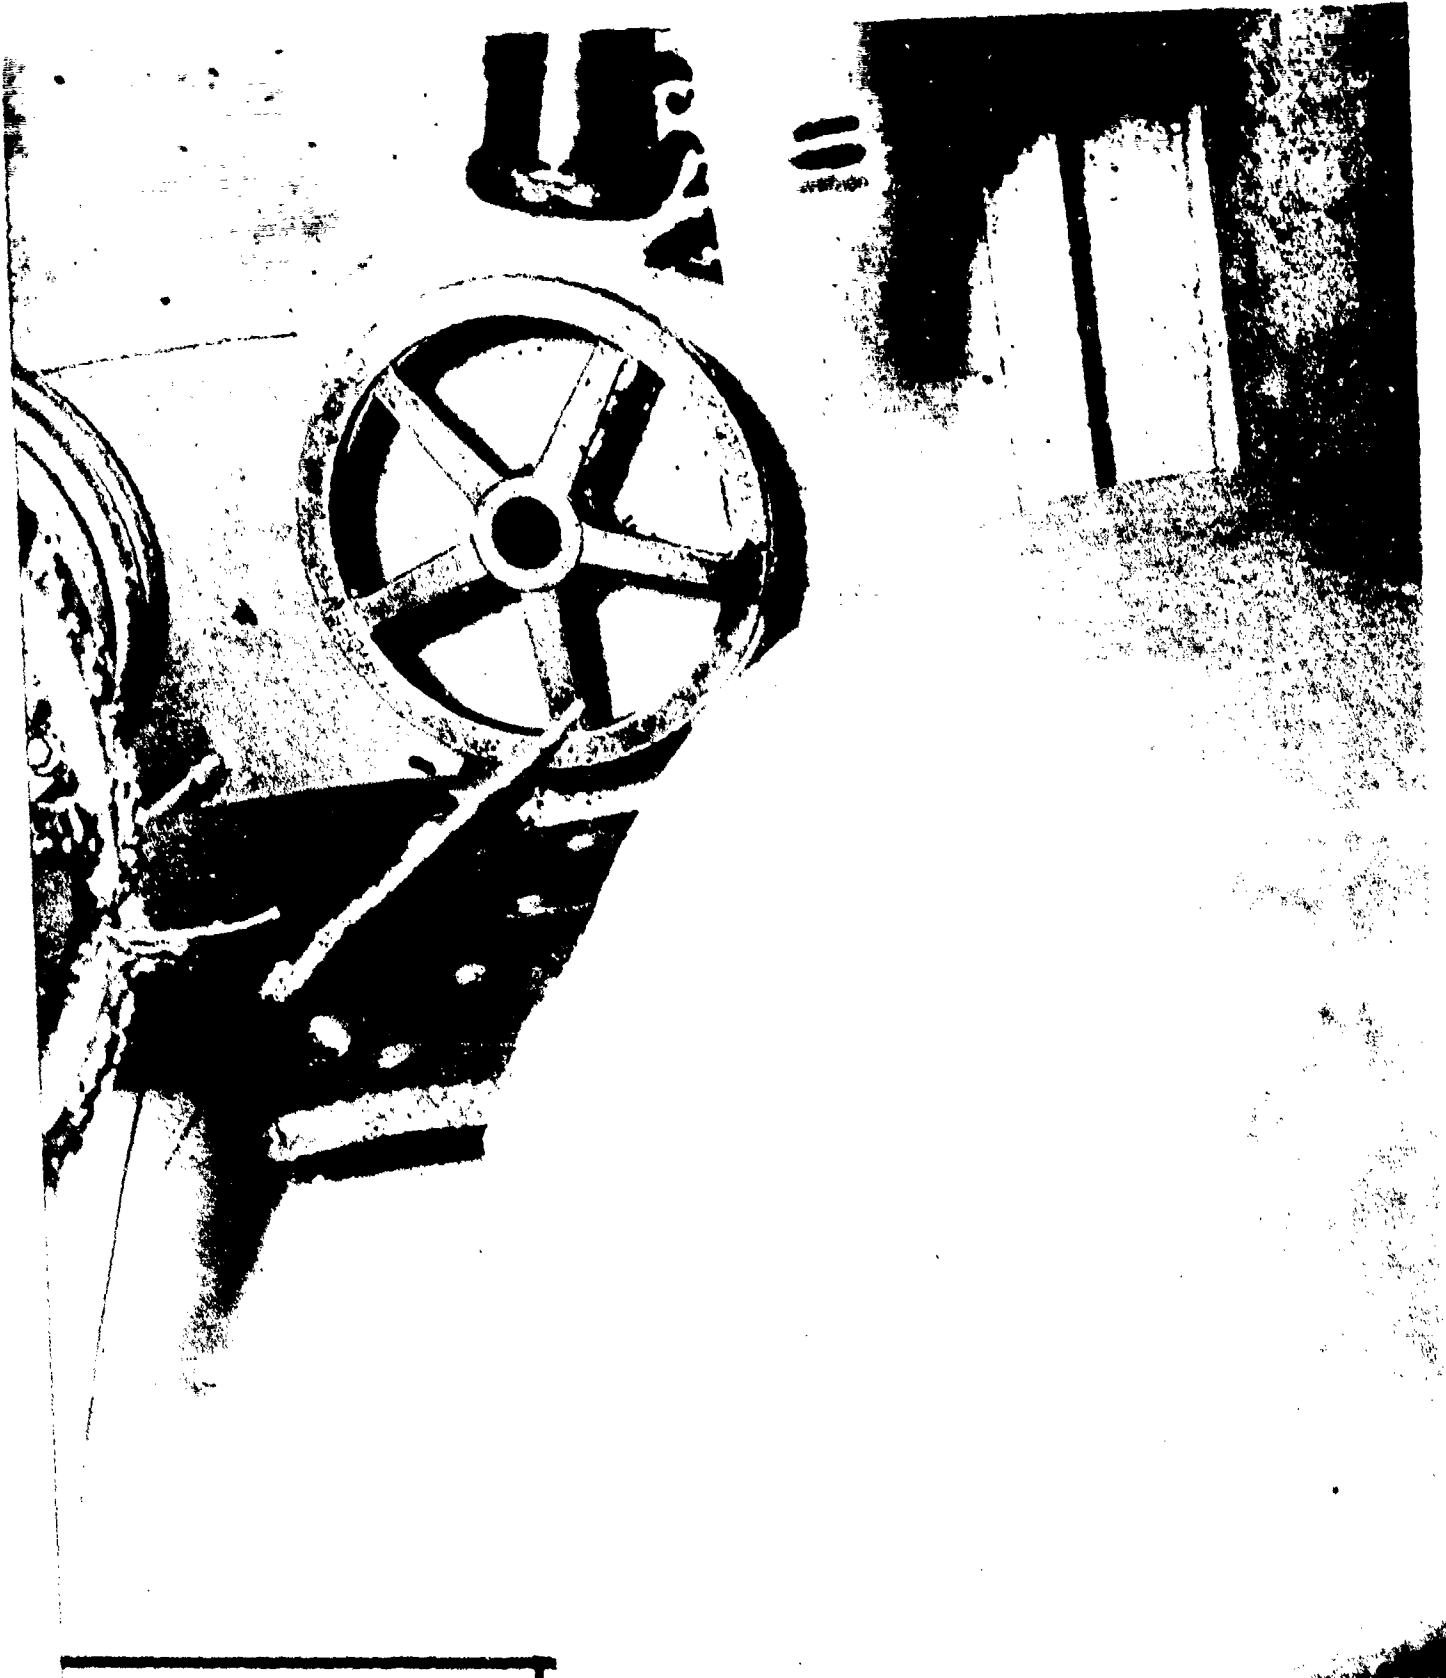
AB-CR-66-153-3. Showing No. 2 throttle valve outboard hanger failure.

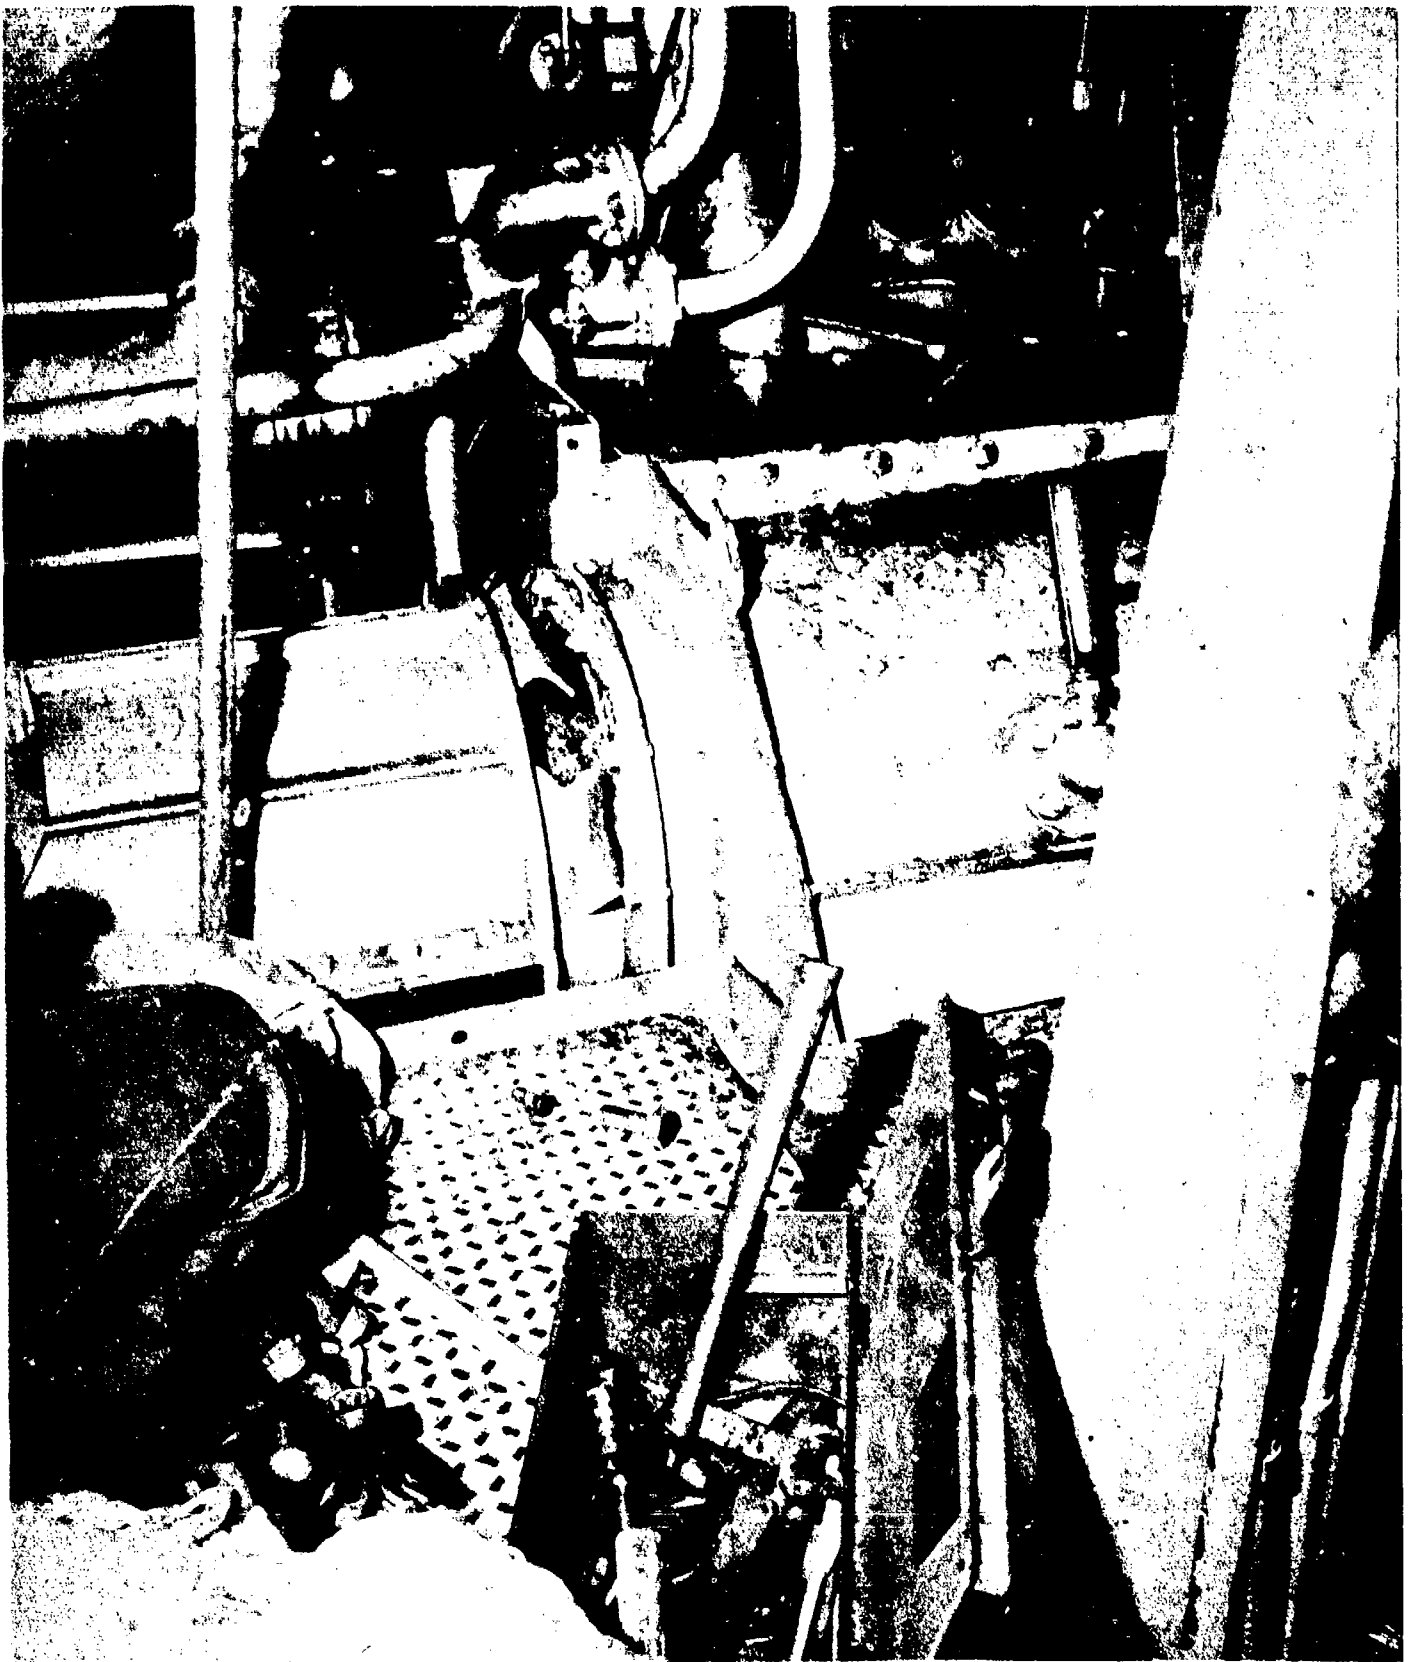
AB-CR-68-2950-10. Showing broken low pressure coupling cover at reduction gear end No. 1 engine room.

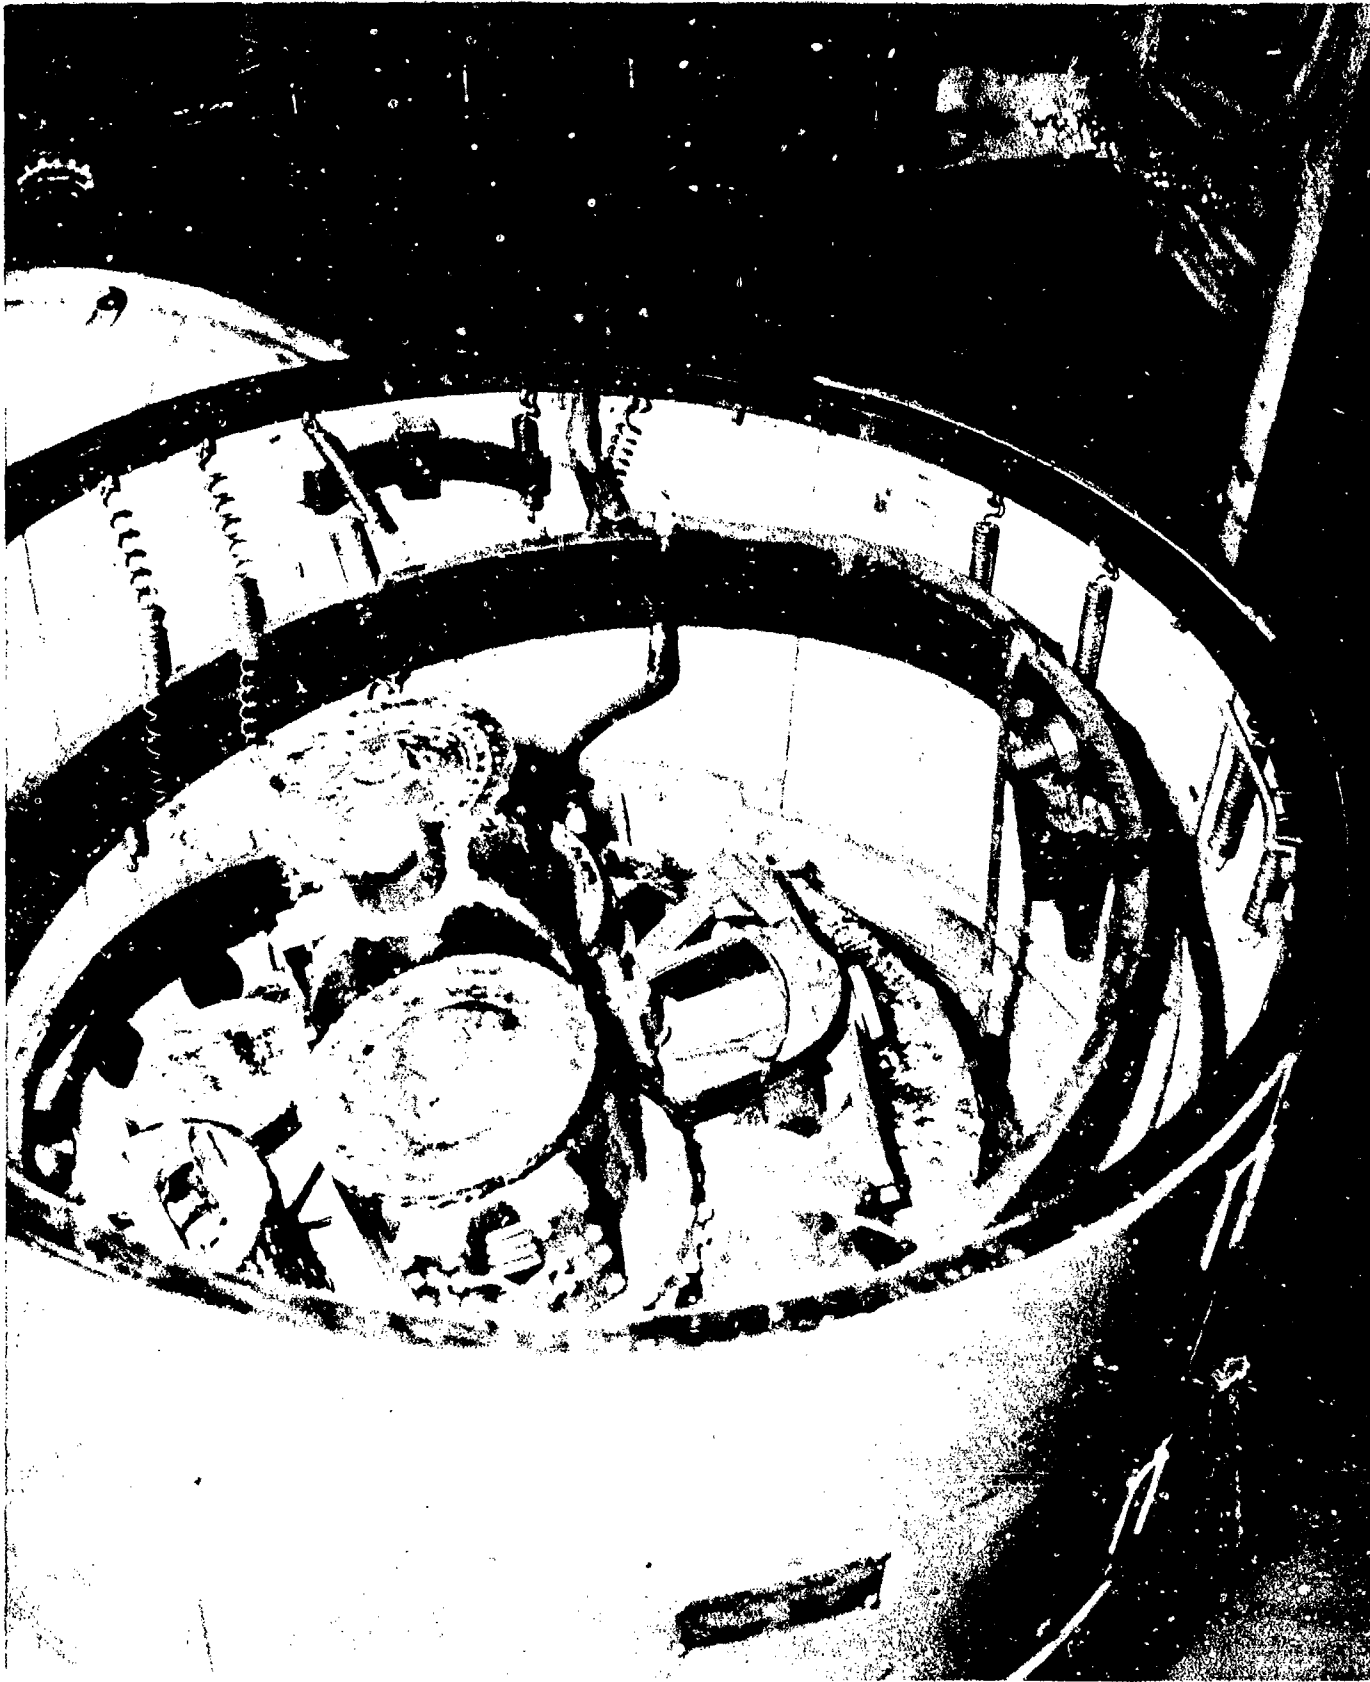
AB-CR-76-1934-1. Gyro compass mounted in the I.C. room. Shows damage to the gimbal mount, and gyro element dropped to the bottom of the binnacle. Dirt and silt were caused by flooding of the space.

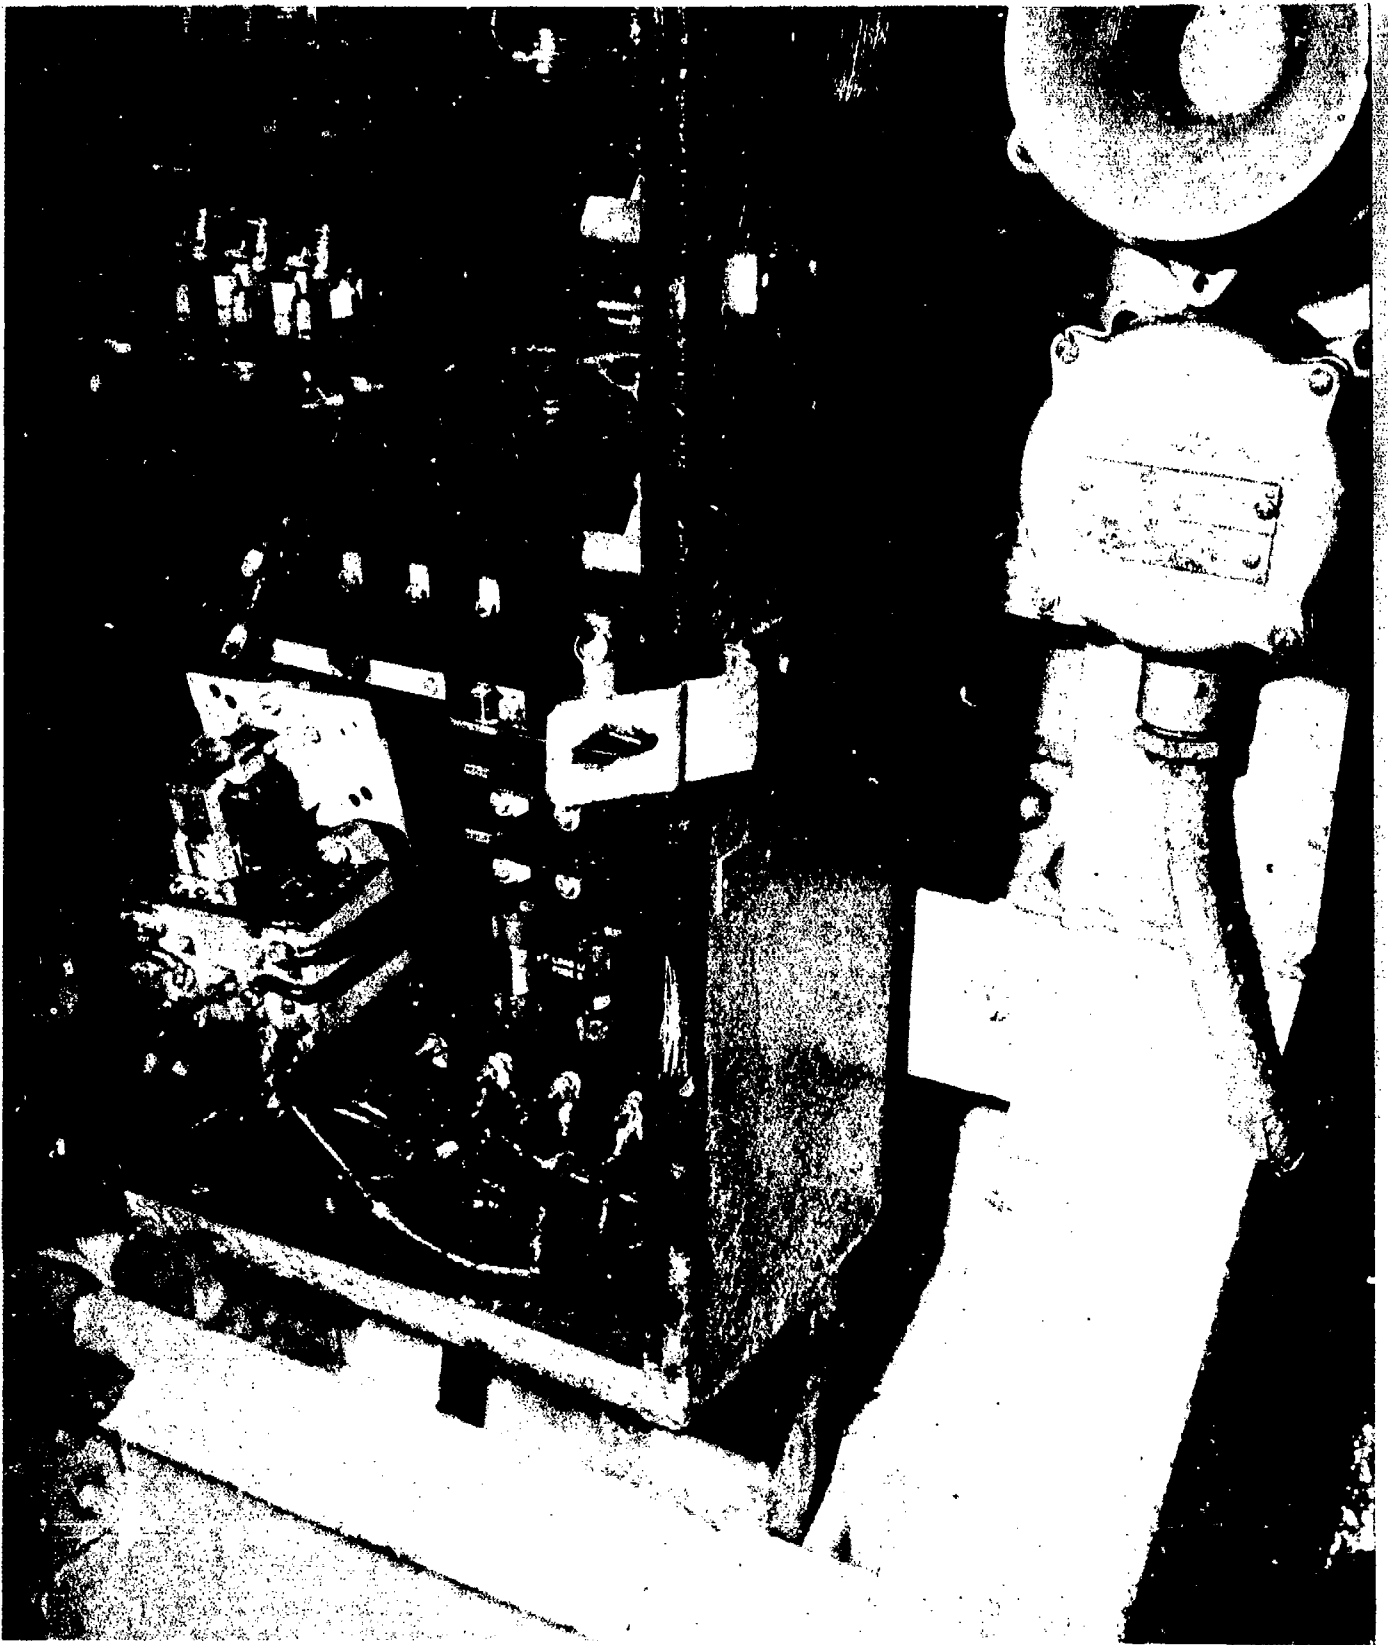
AB-CR-68-2950-3. Diesel fuel oil supply pump motor mounted in the after engine room. Shows contactor broken away from the phenolic base. Picture taken looking to starboard.
