TECHNICAL INSPECTION REPORT

OPERATION CROSSROADS.

U.S.S. WAINWRIGHT (DD419).

TEST BAKER [U].

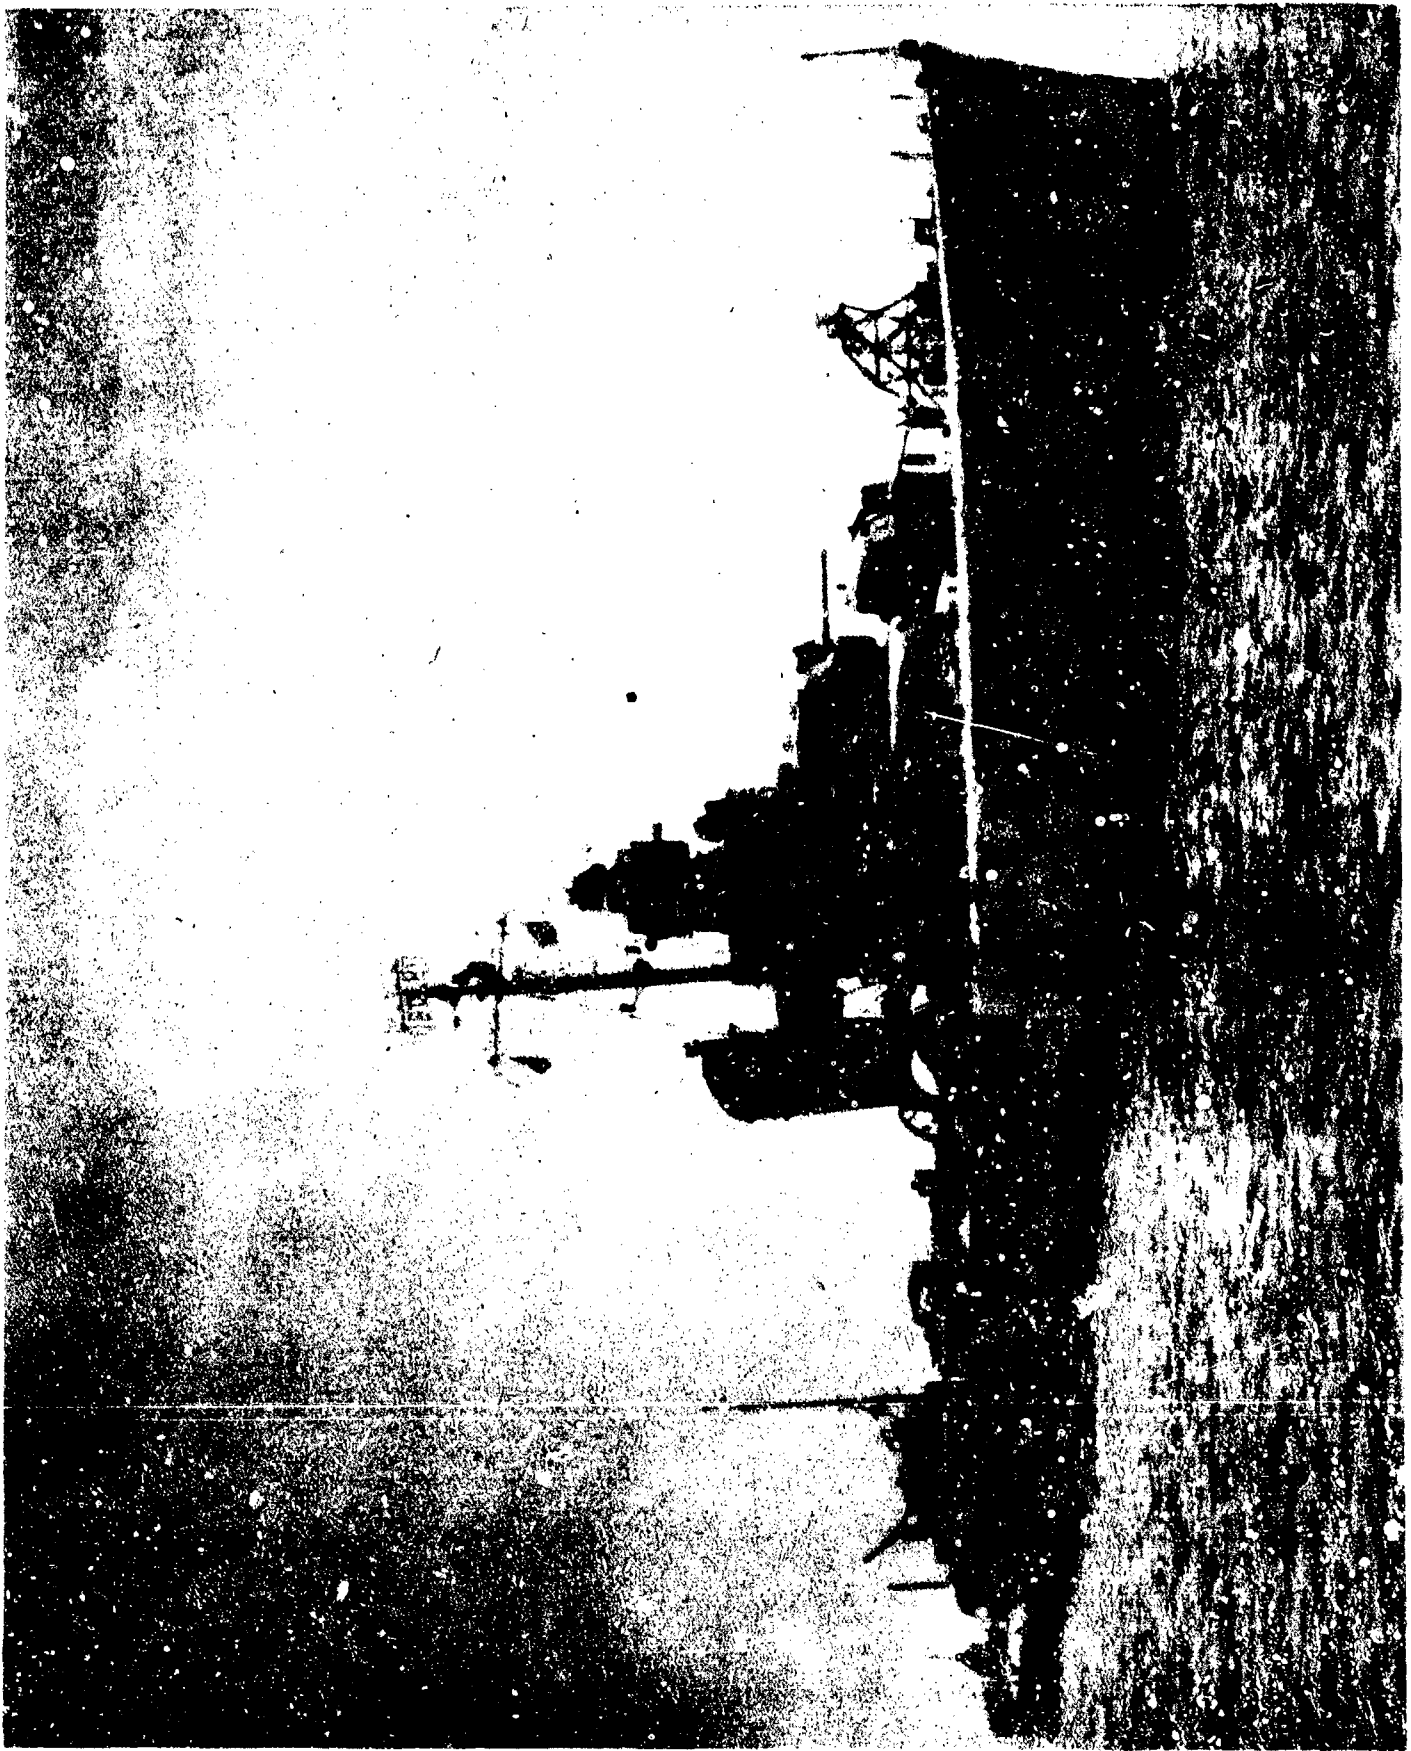
No Hull damage resulted from Test B. The after engine room flooded to a depth of two feet above the lower level floor plates as the result of normal stern tube leakage. Photos pages 33 and 34 are general views of the ship after Test B.

AB-CR-227-283-72. Starboard bow after Test B.

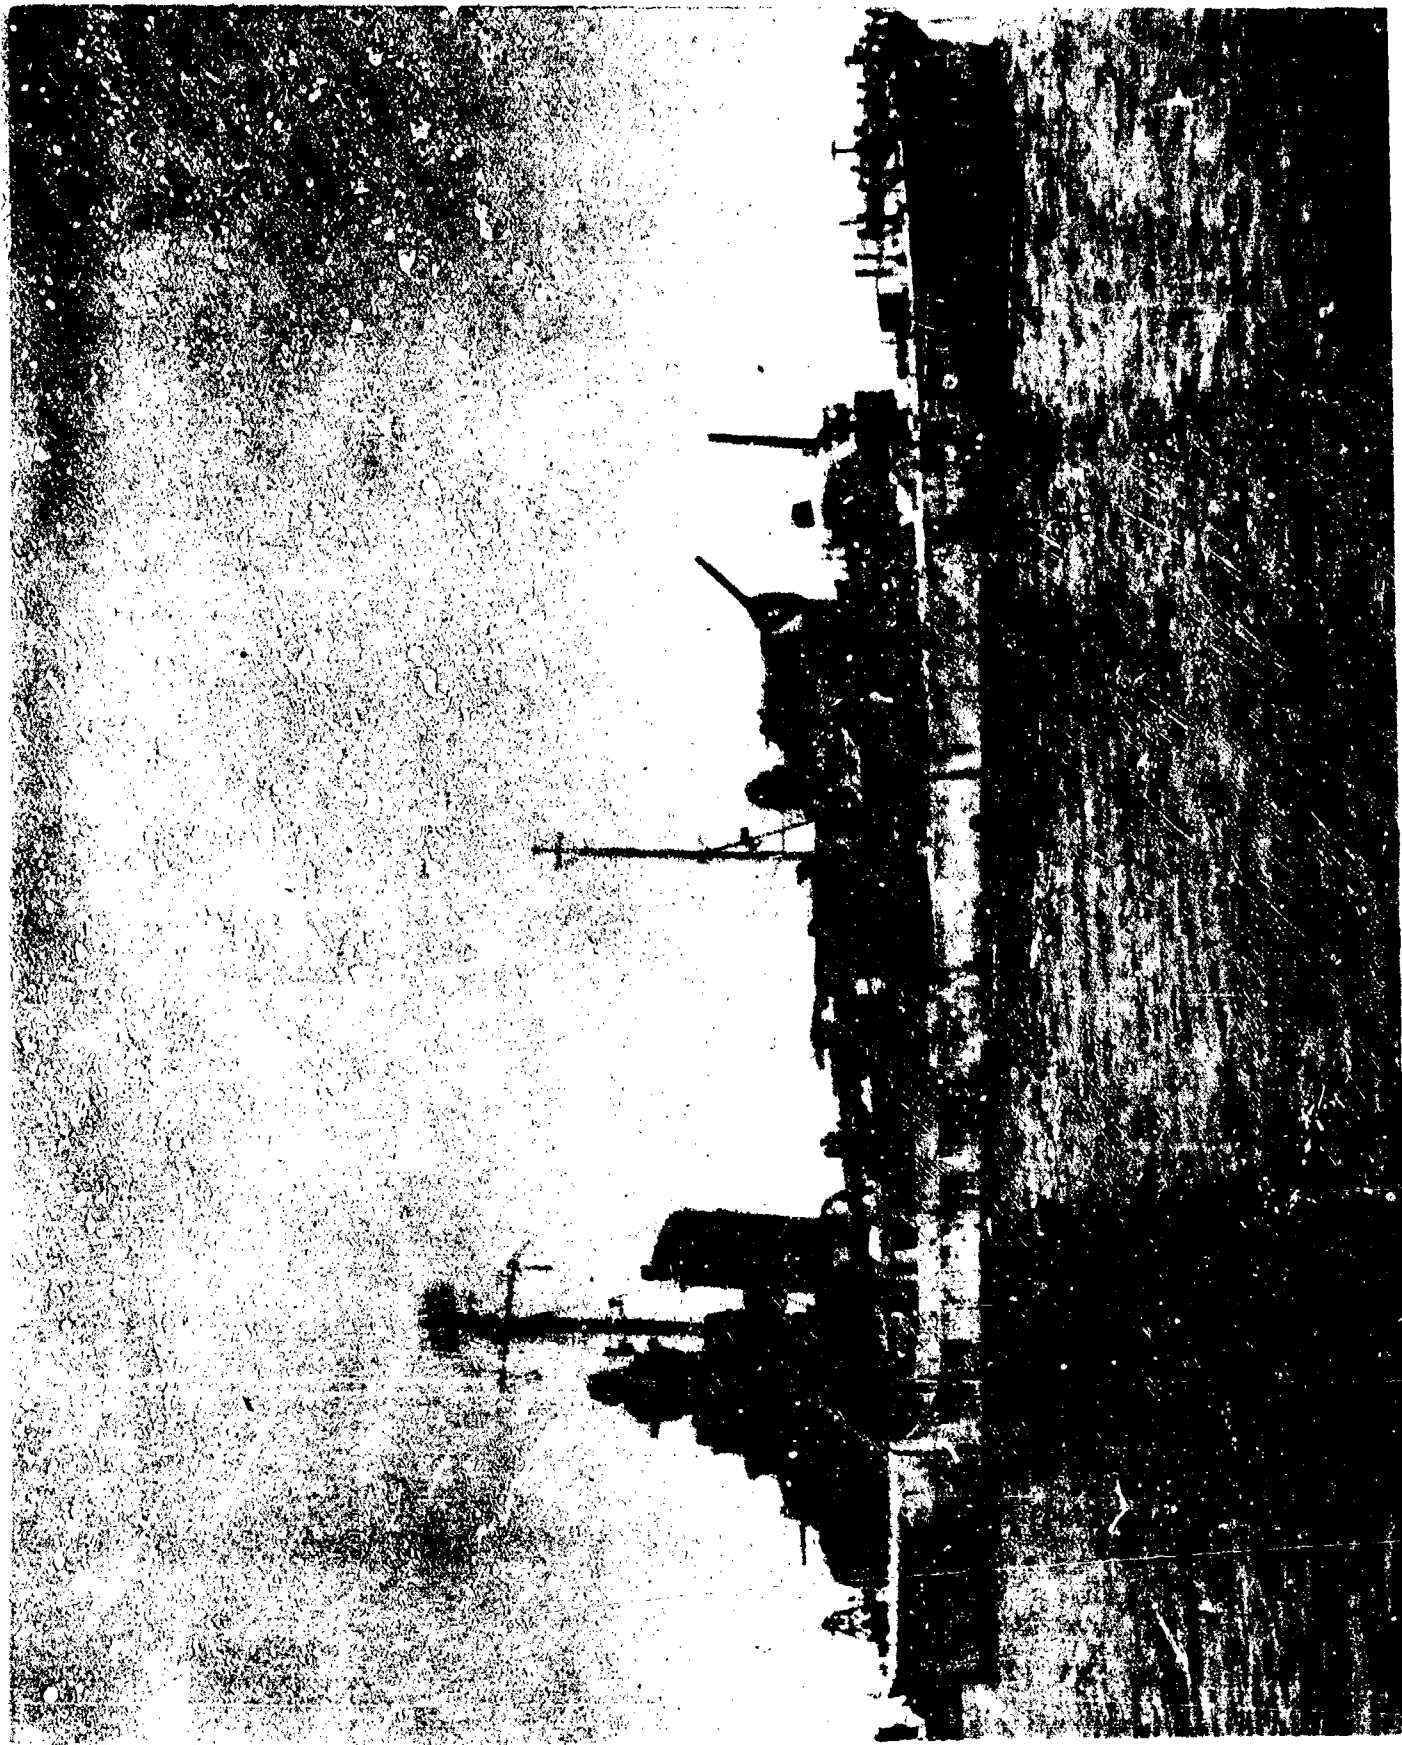
AB-CR-227-283-76. Port quarter after Test B.
