TECHNICAL INSPECTION ~~CONFIDENTIAL~~ REPORT

U.S.S. SEARAVEN (SS196)

TEST BAKER

OPERATION CROSSROADS

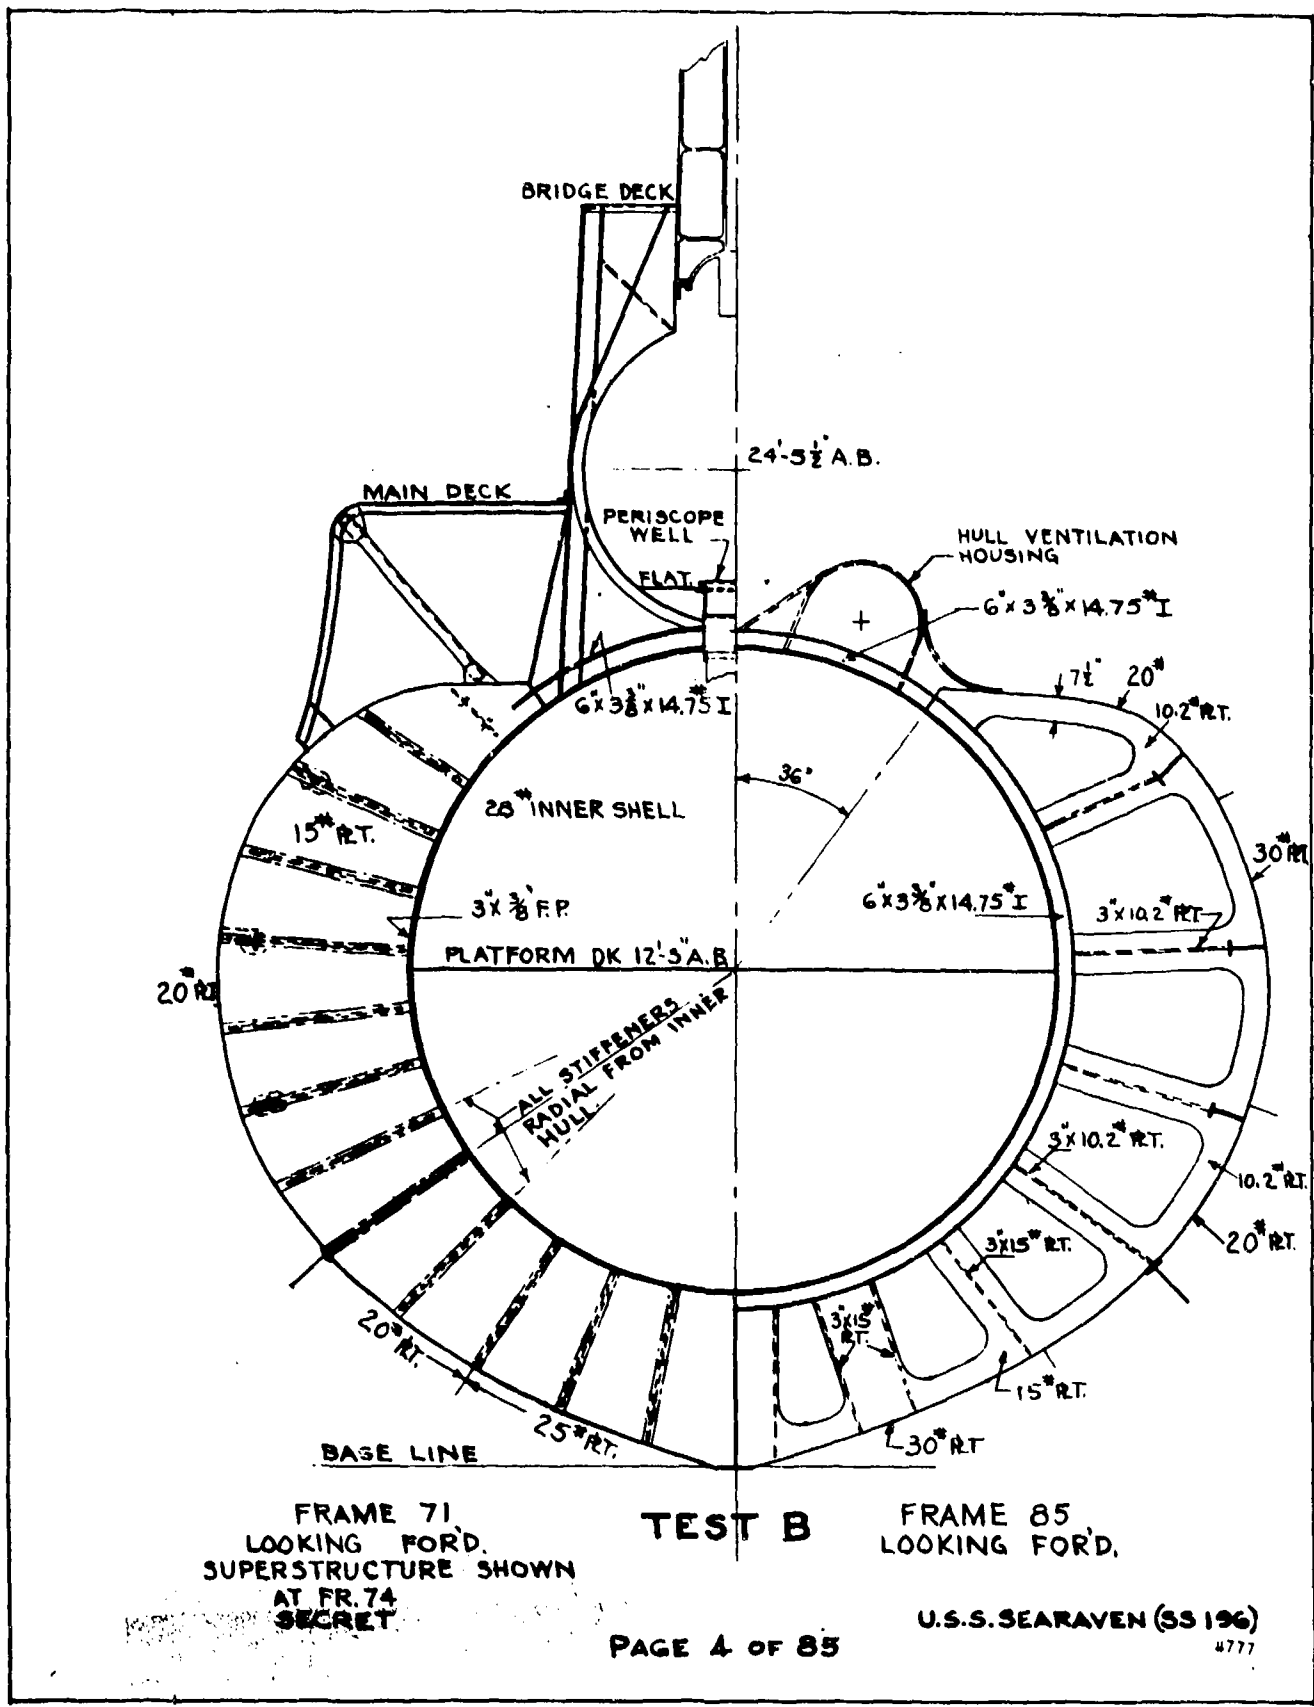
FRAME 71  
 LOOKING FORD.  
 SUPERSTRUCTURE SHOWN  
 AT FR. 74  
 SECRET

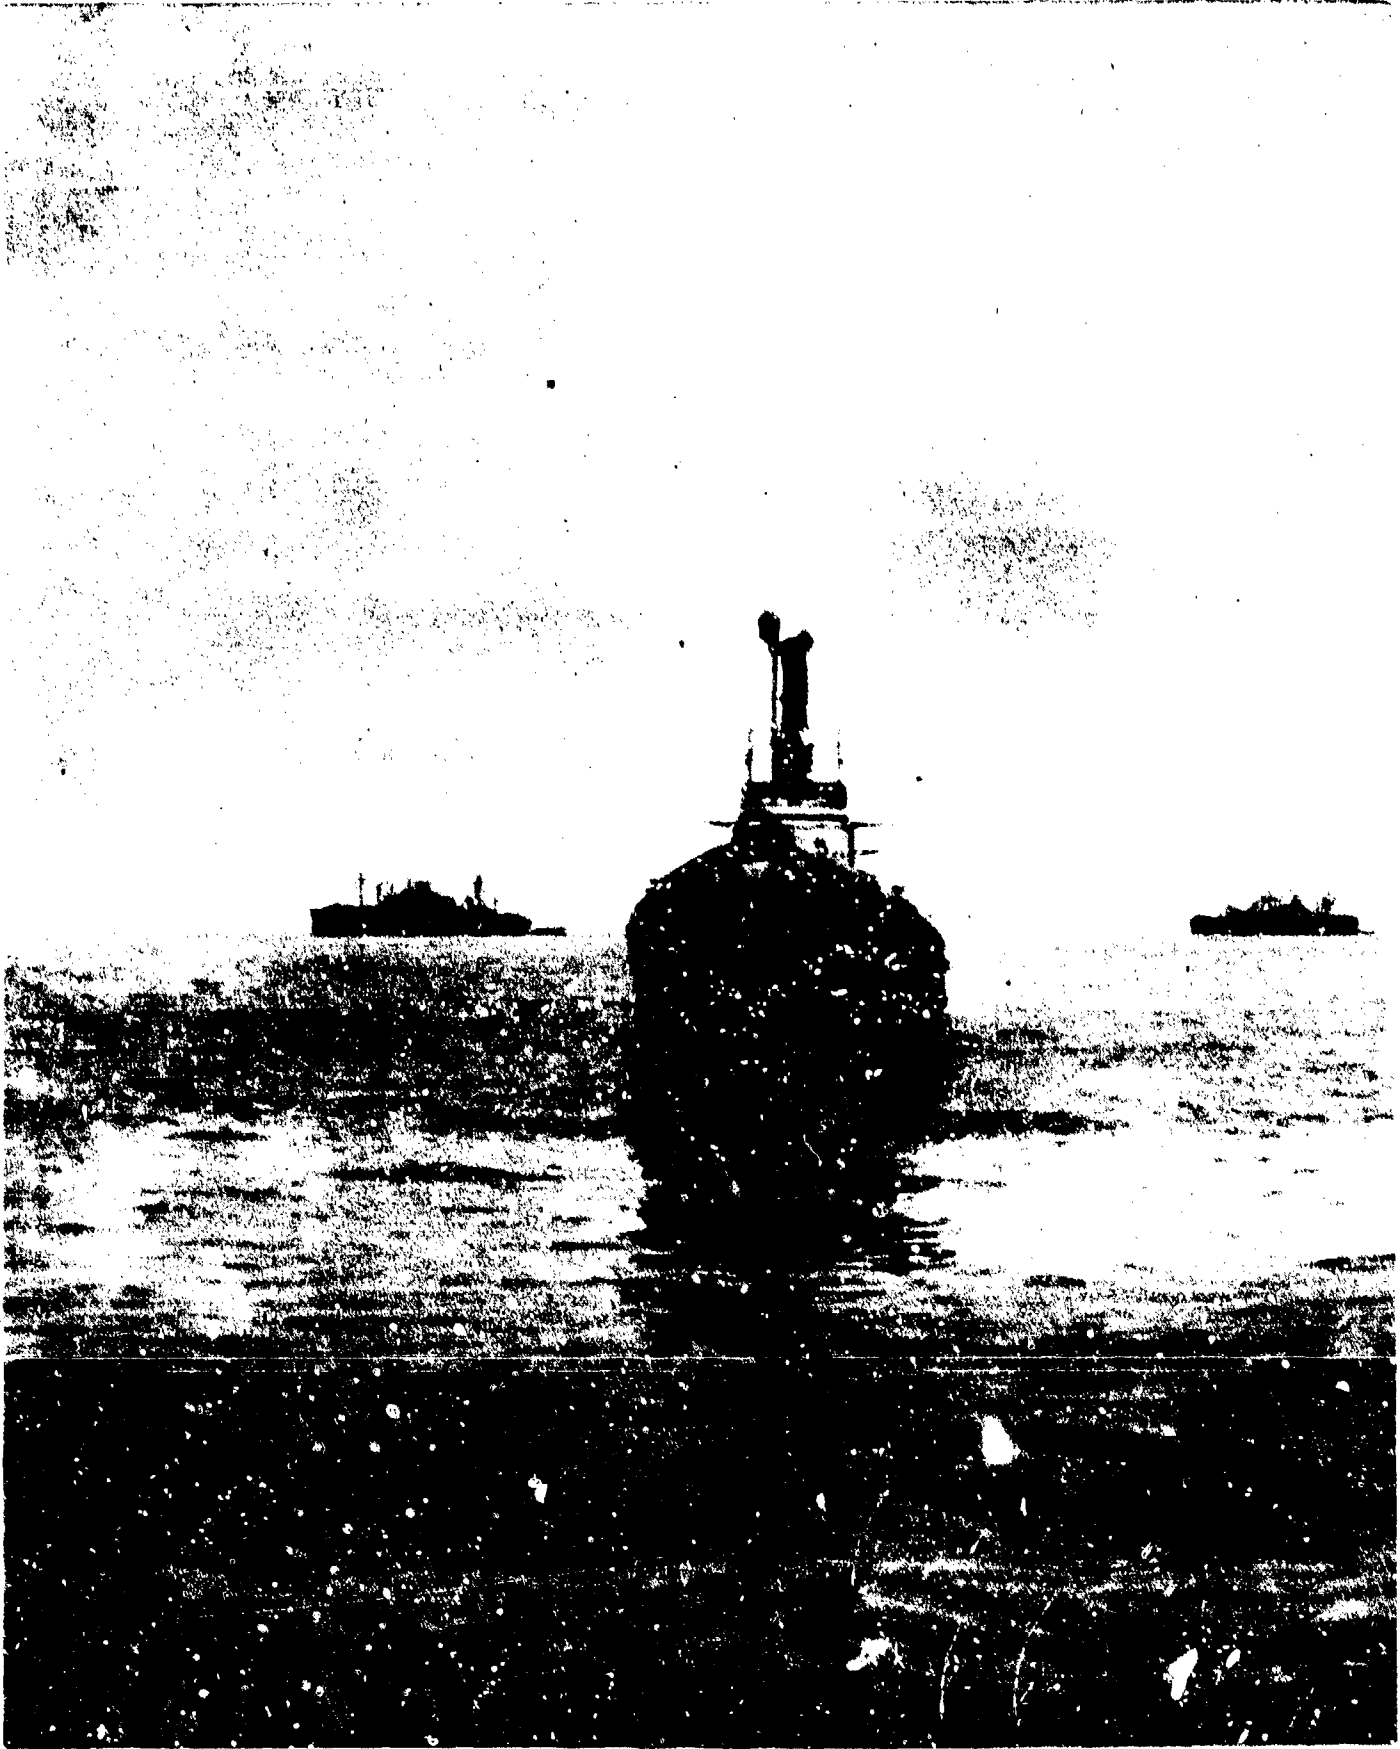
AB-CR-227-283-2: General view from ahead.

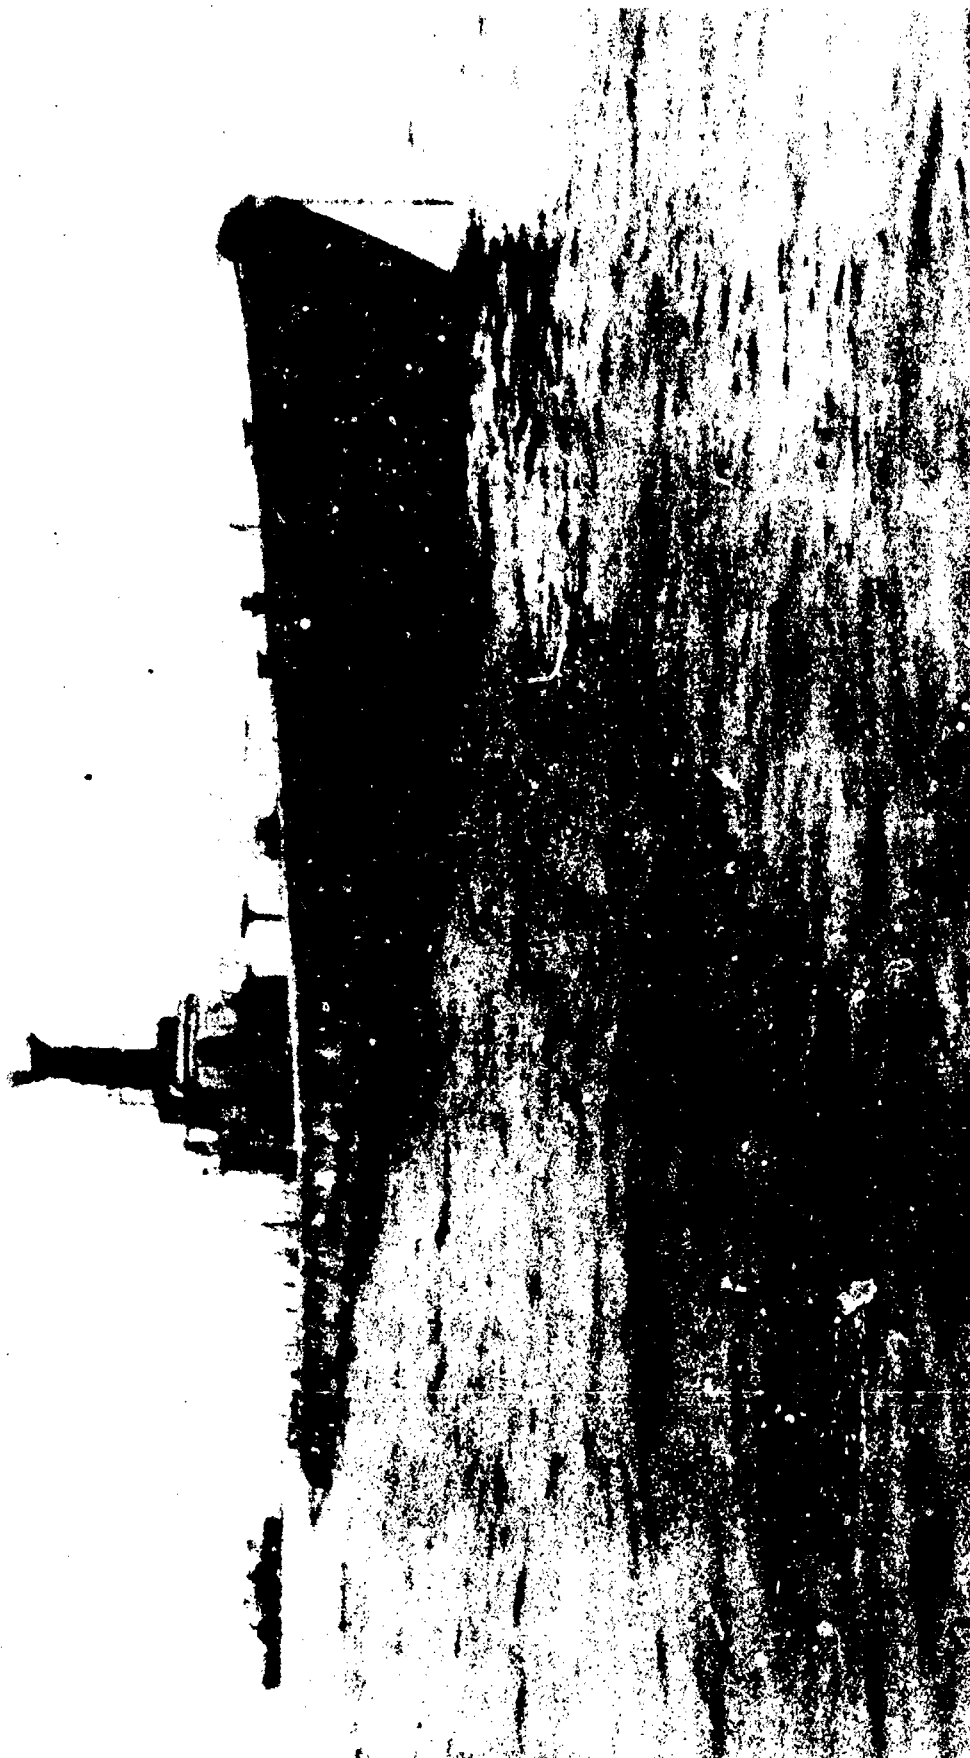
AB-CR-227-283-1: General view from starboard bow.

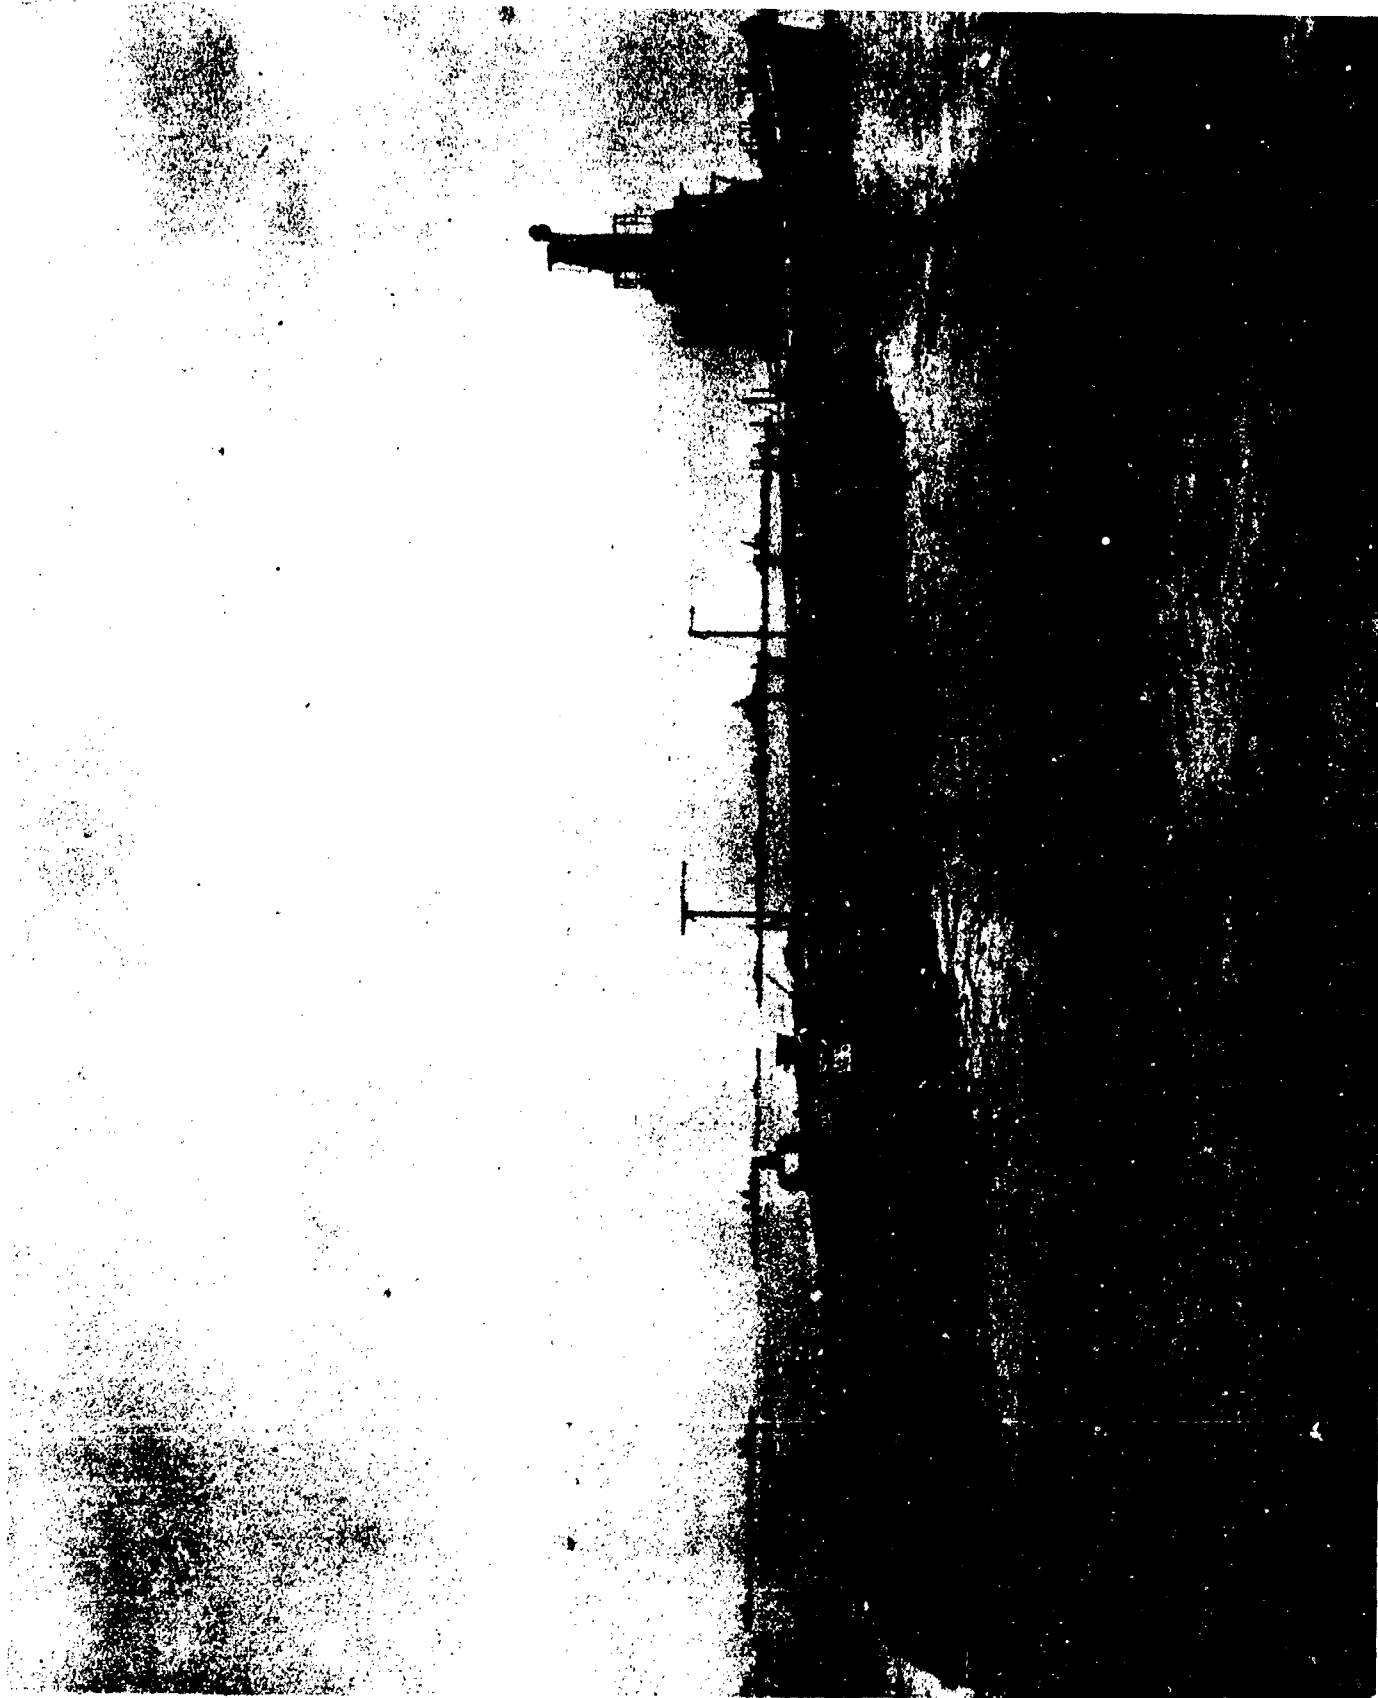
AB-CR-227-283-8: General view from starboard quarter.

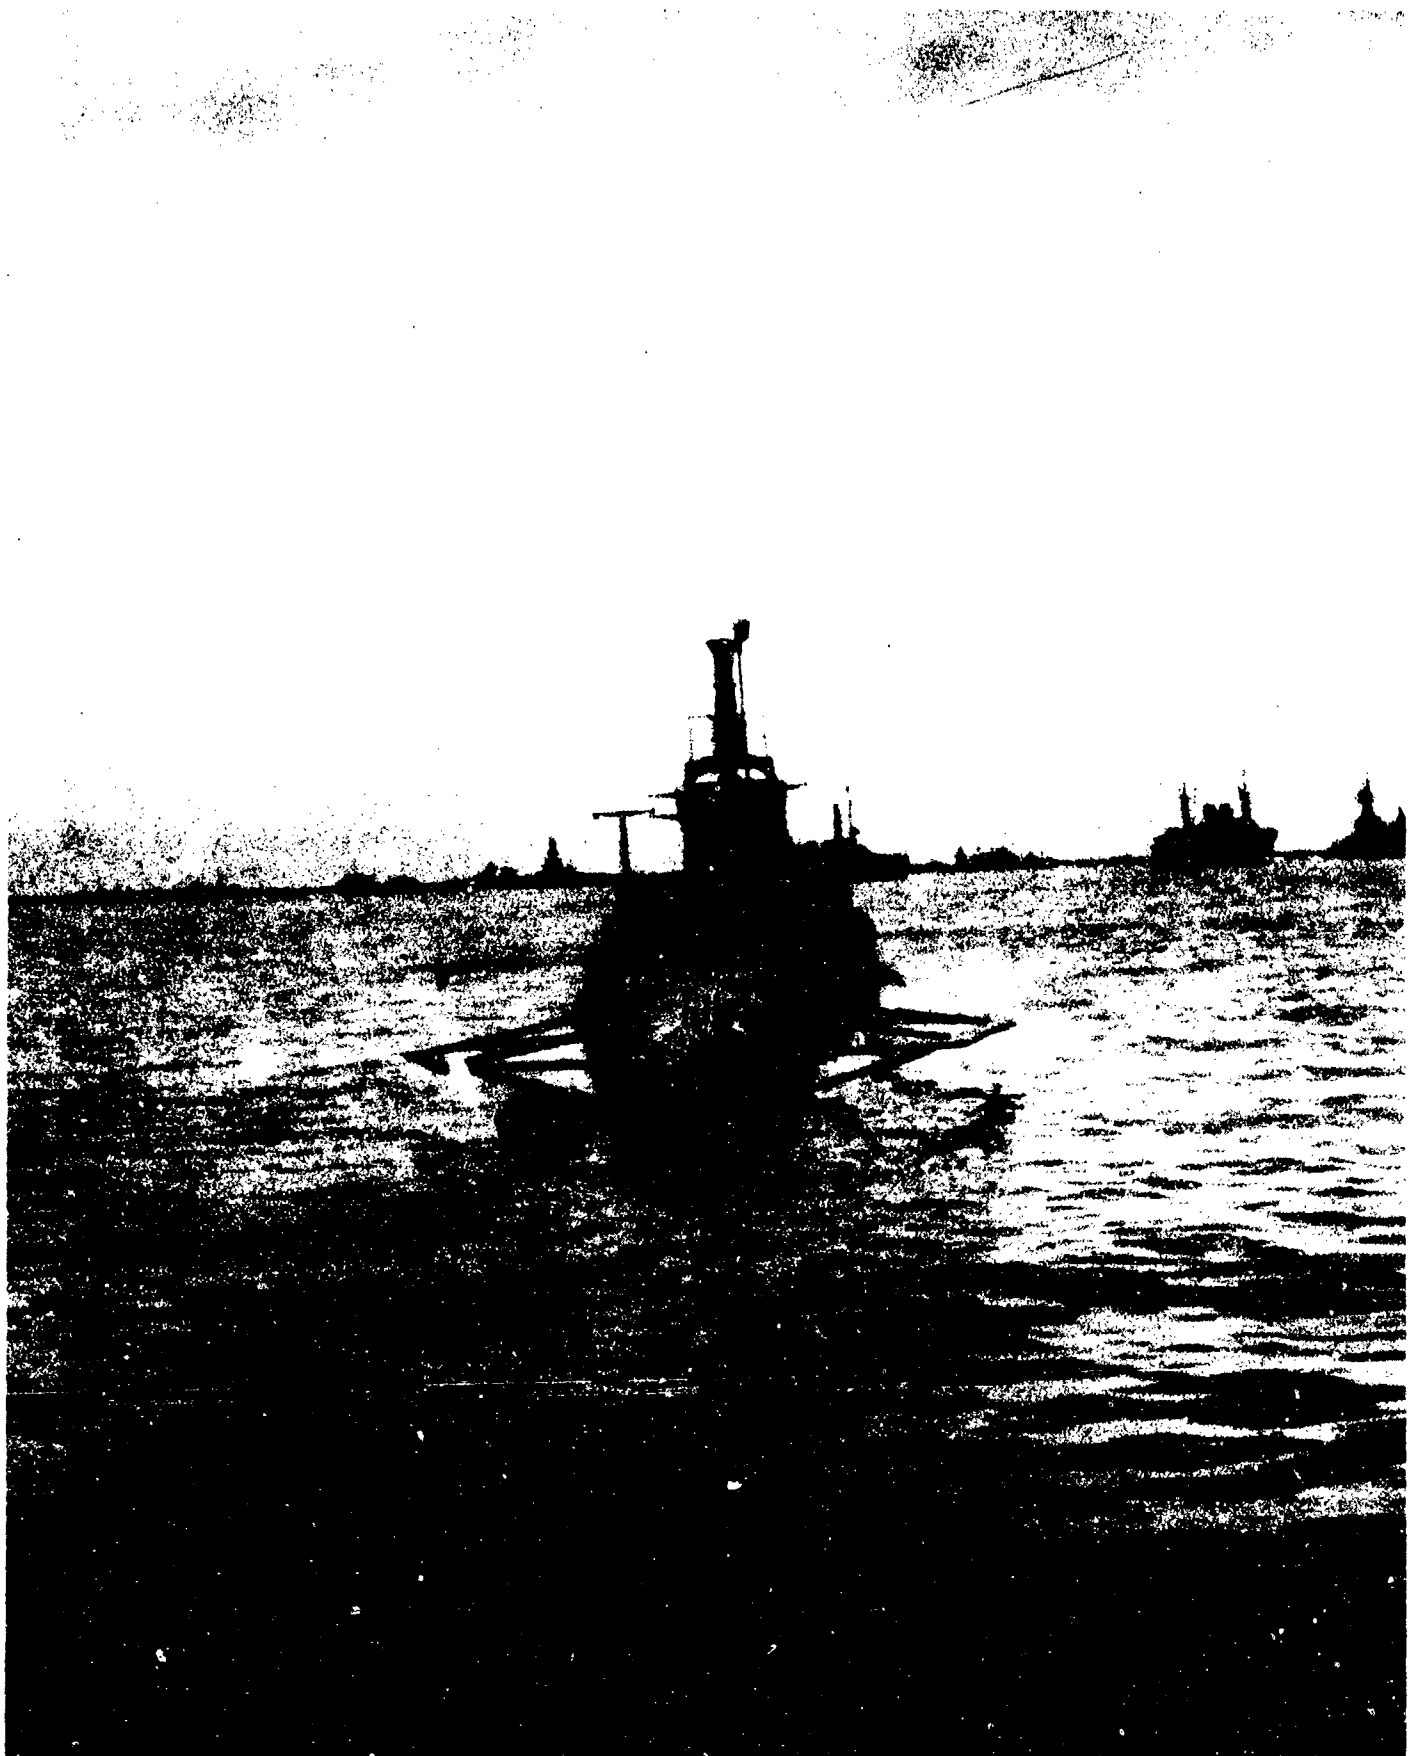
AB-CR-227-283-6; General view from astern.

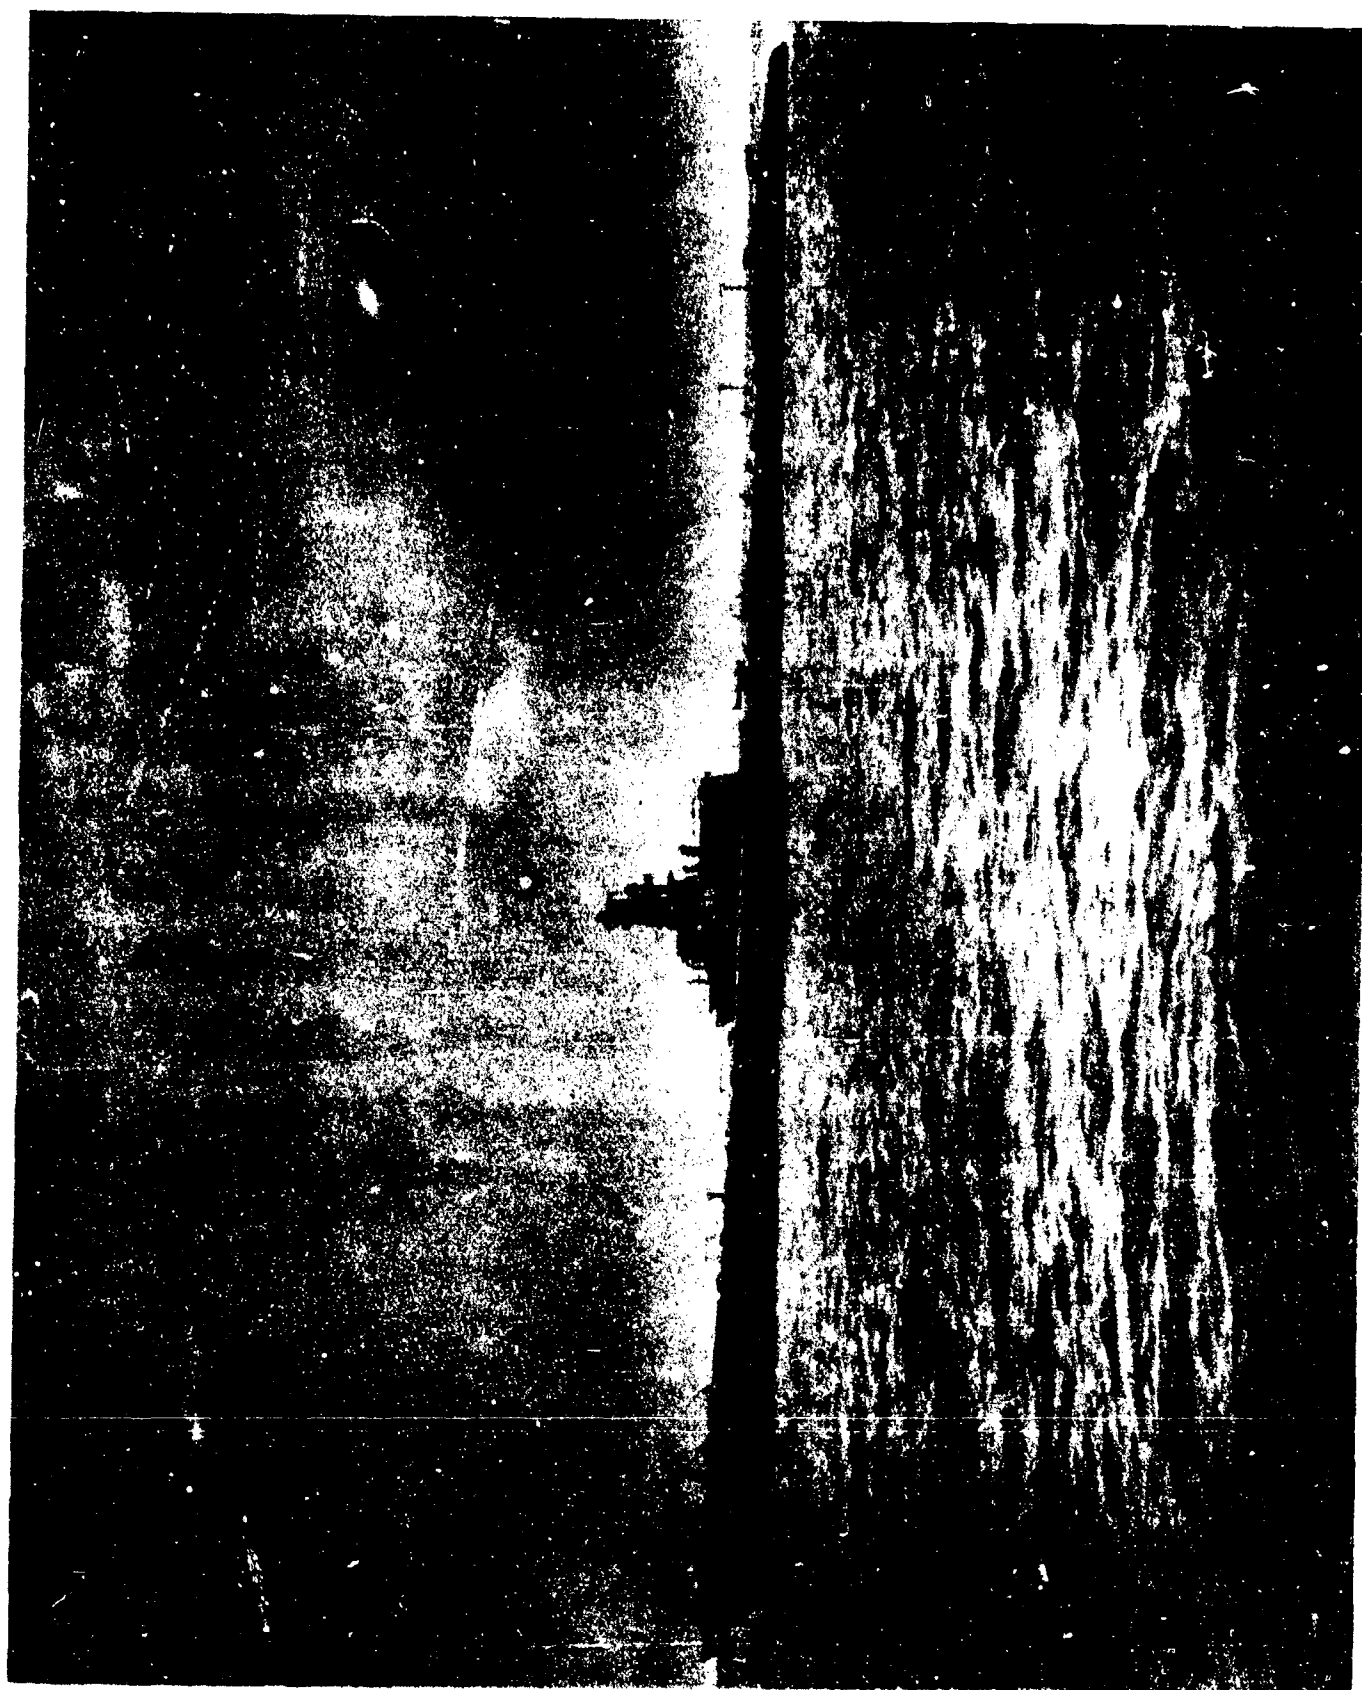
AB-CR-227-283-4: General view from port beam.

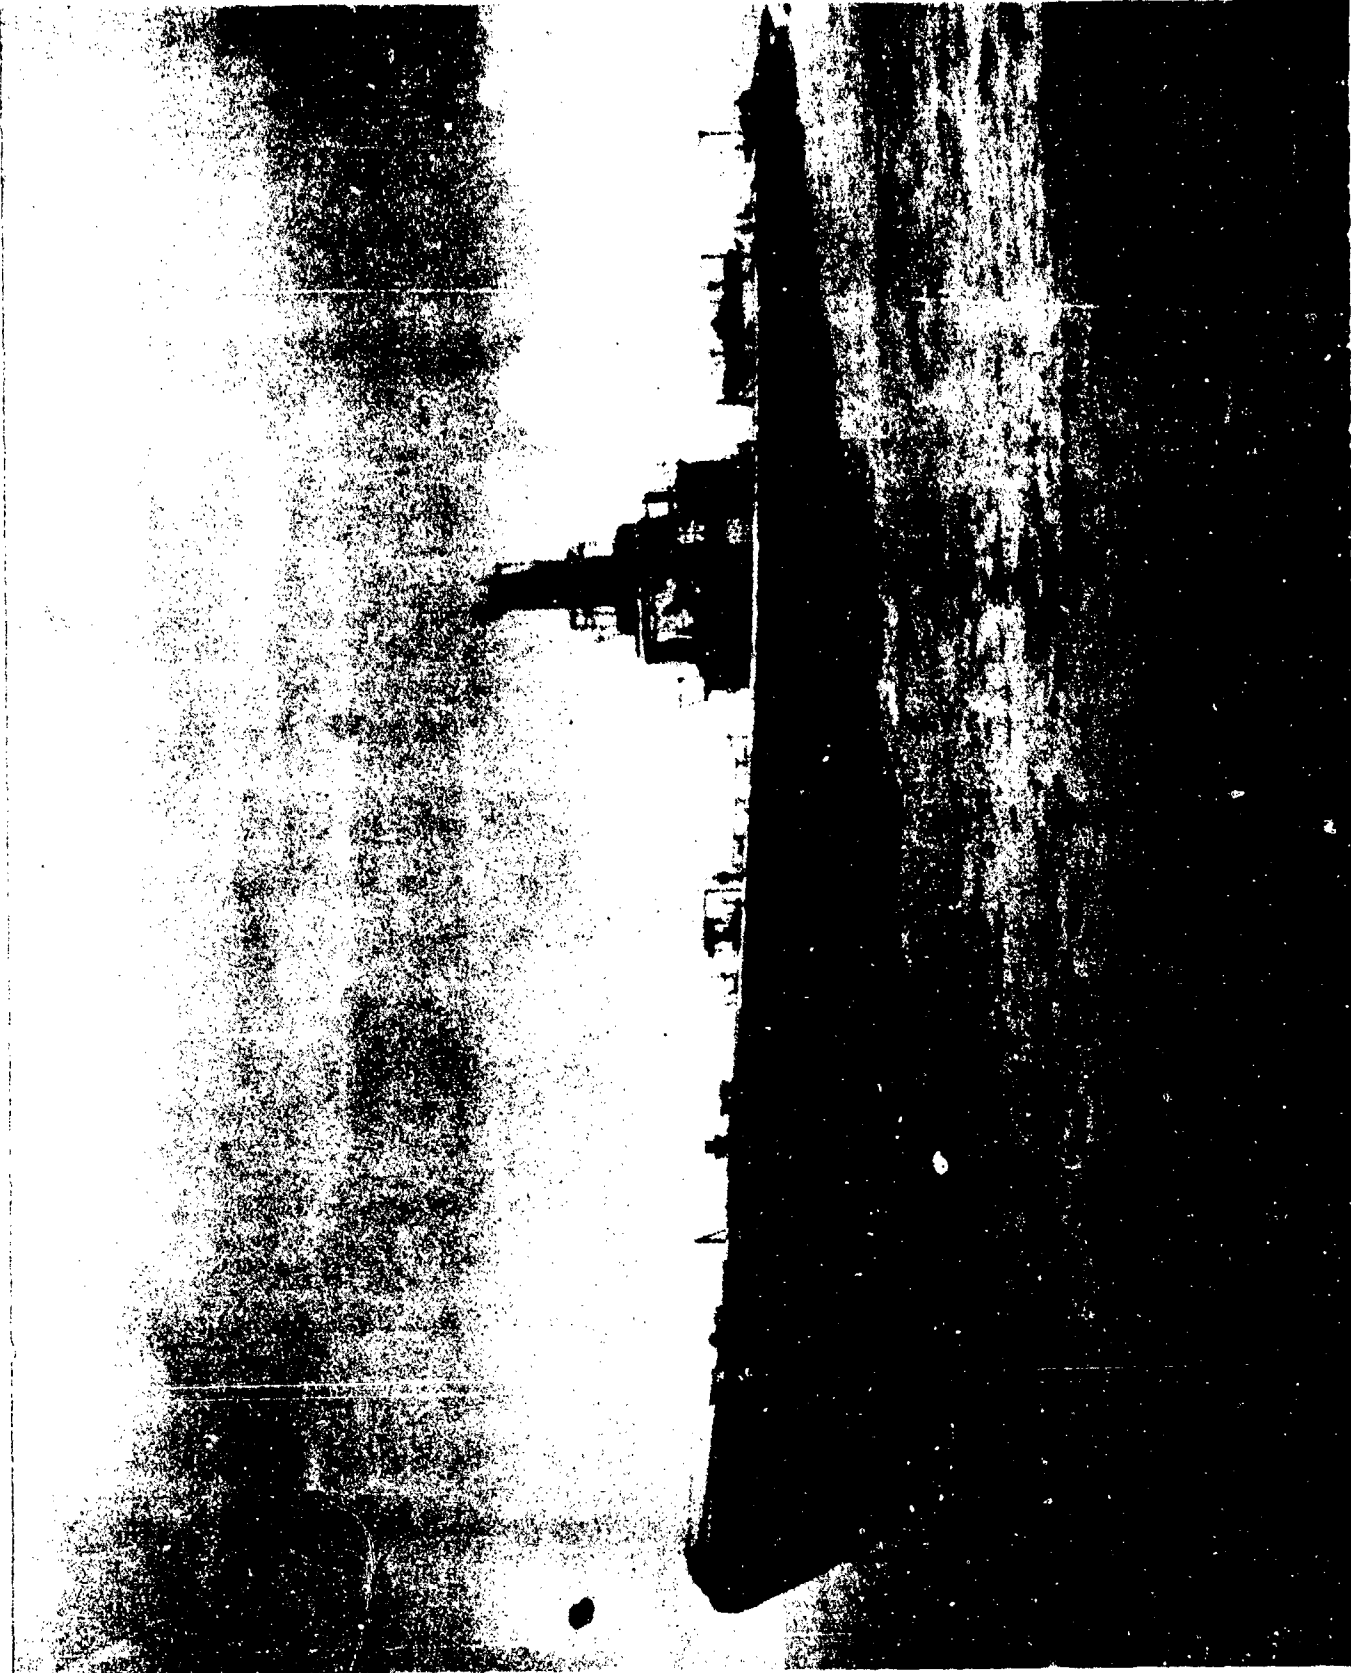
AB-CR-227-283-3: General view from port bow.
