⑨ BUREAU OF SHIPS GROUP
TECHNICAL INSPECTION REPORT

⑥ OPERATION CROSSROADS,
U.S.S. DENTUDA (SS335).

TEST BAKER U.S.

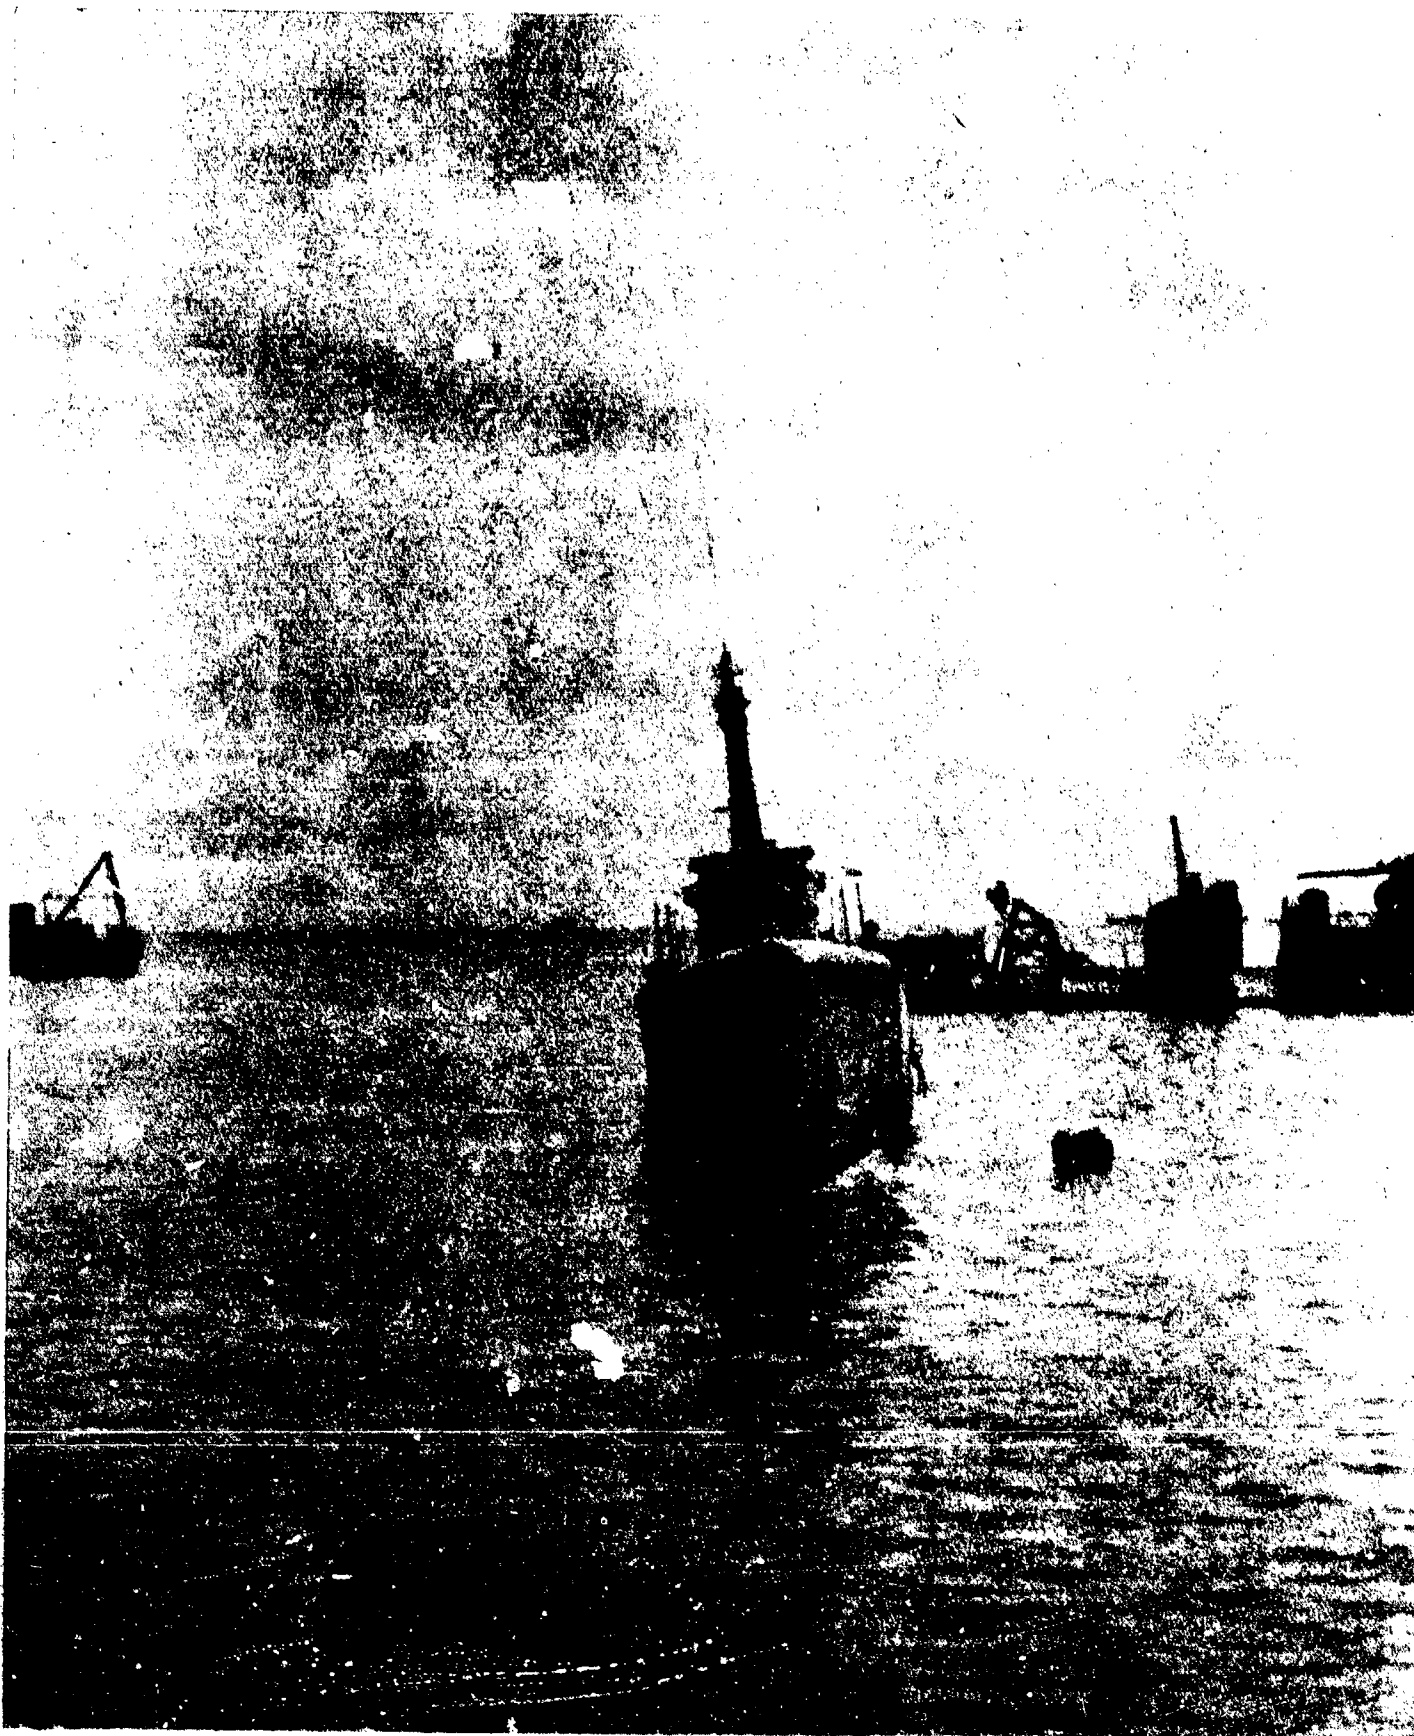
AB-CR-227-290-27. General view from ahead - vessel beached.

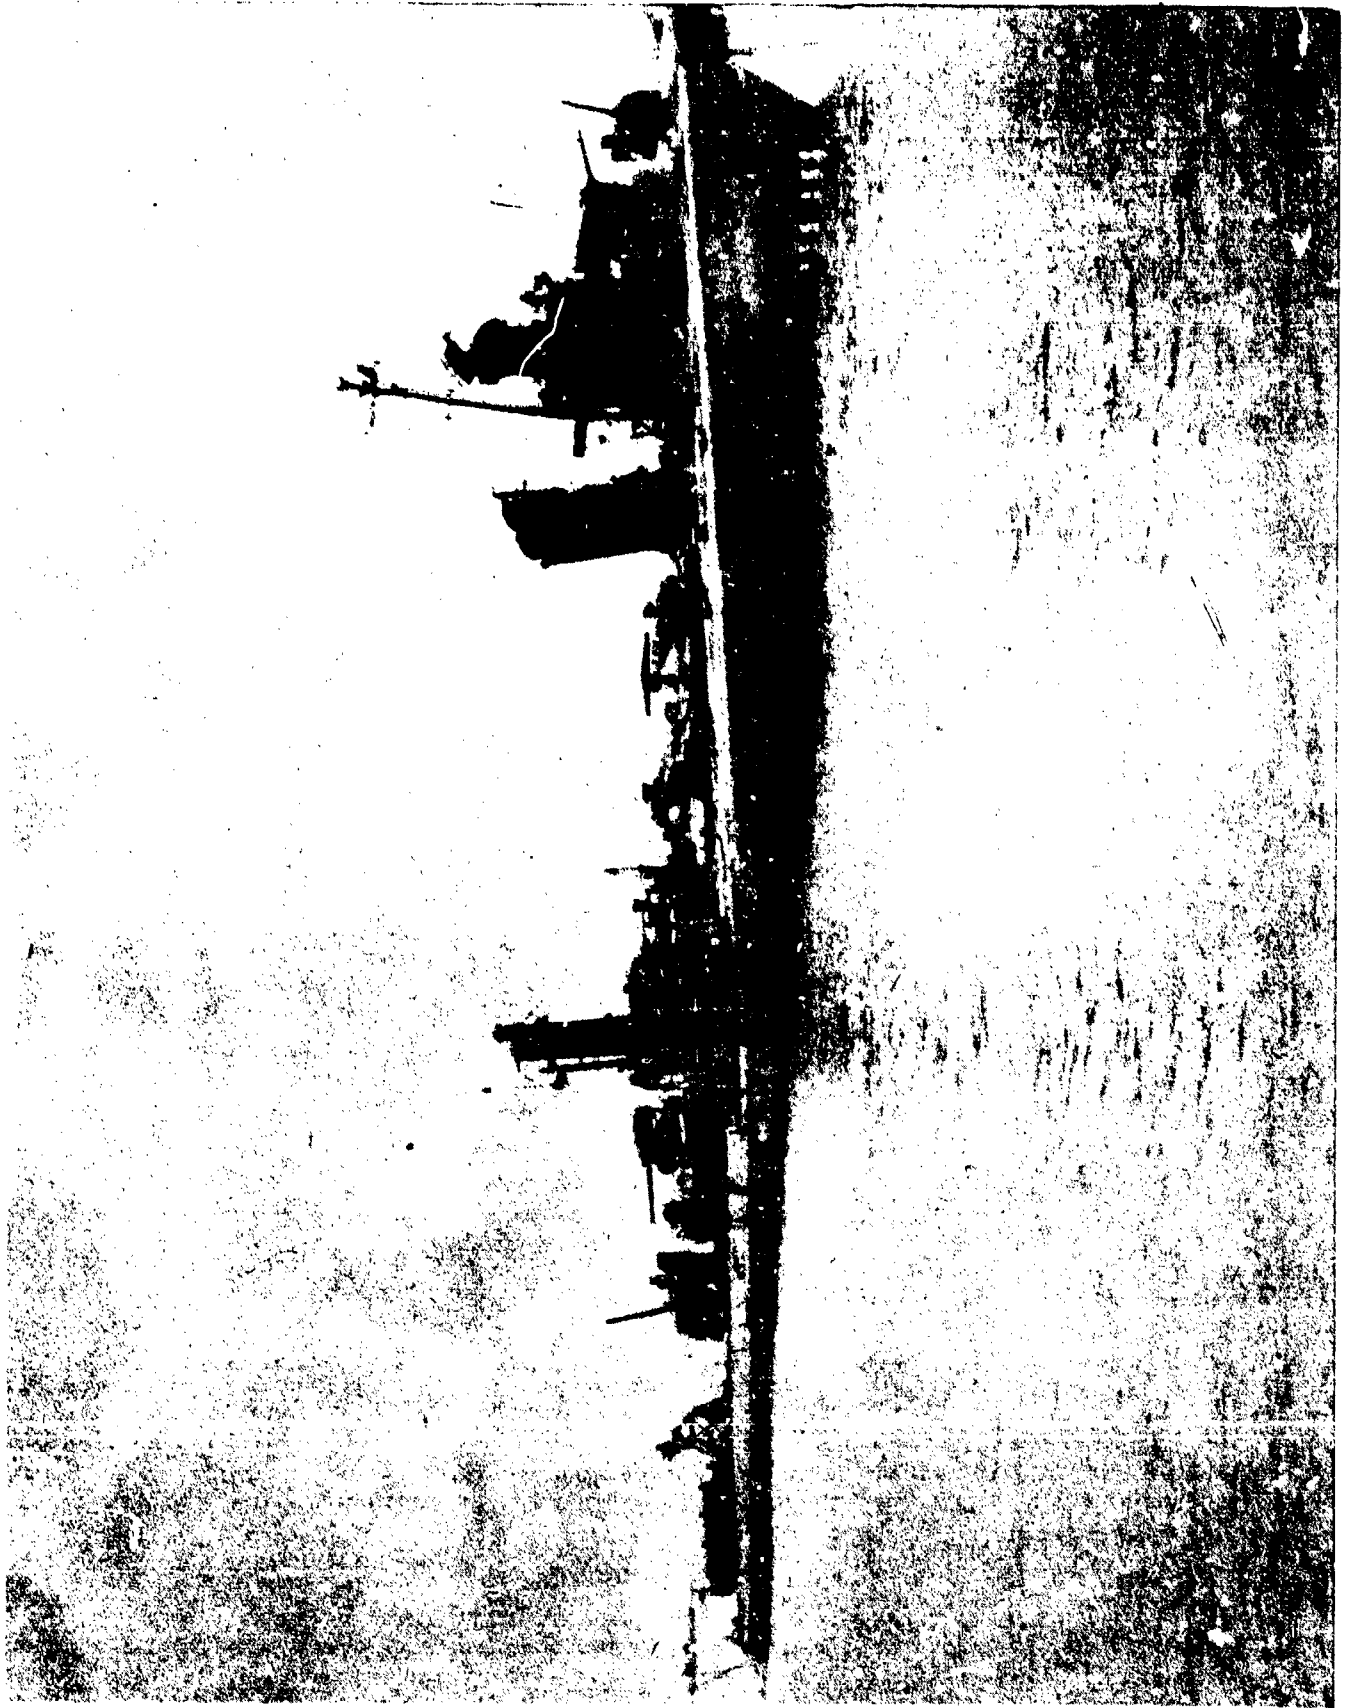
AB-CR-227-290-28. General view from starboard bow - vessel beached.

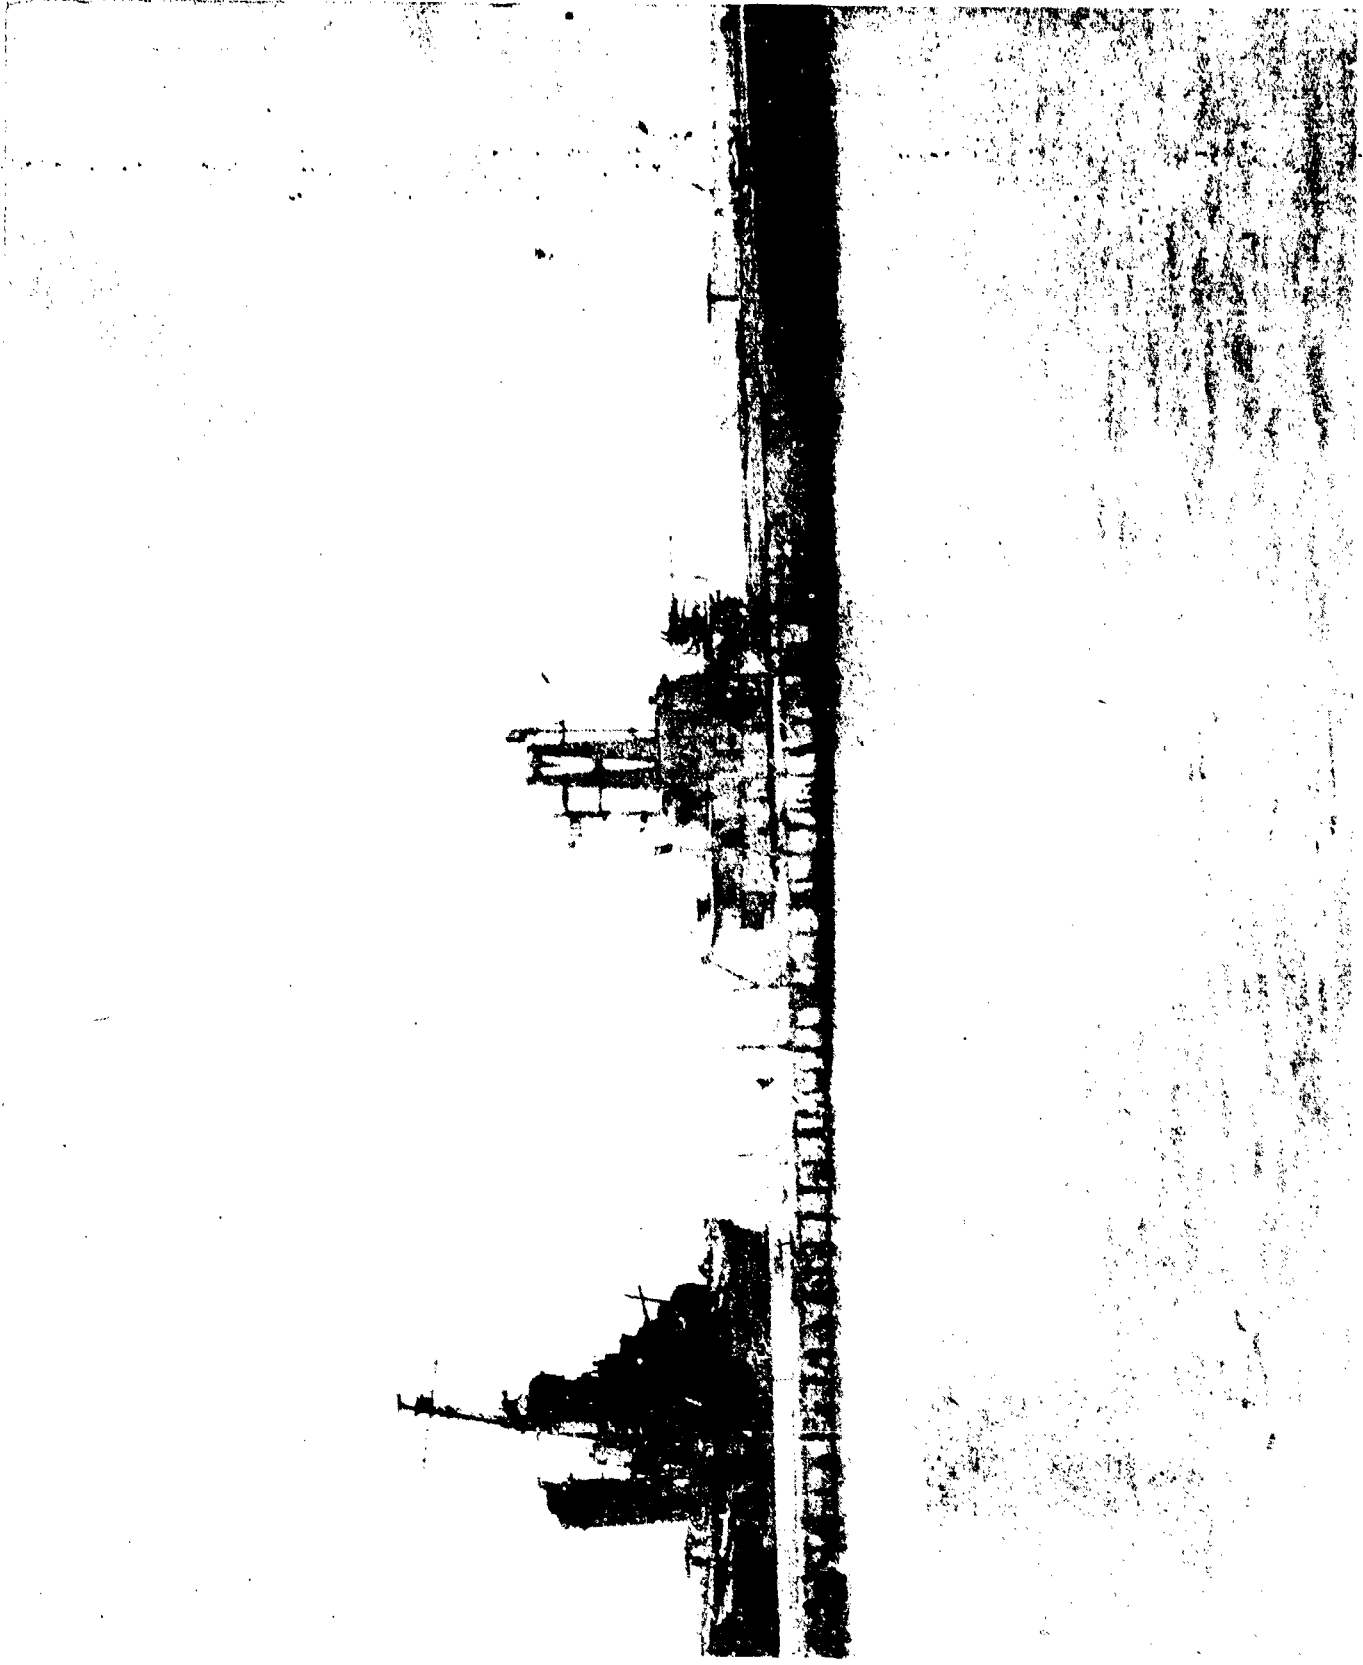
AB-CR-227-290-29. General view from starboard beam - vessel beached.

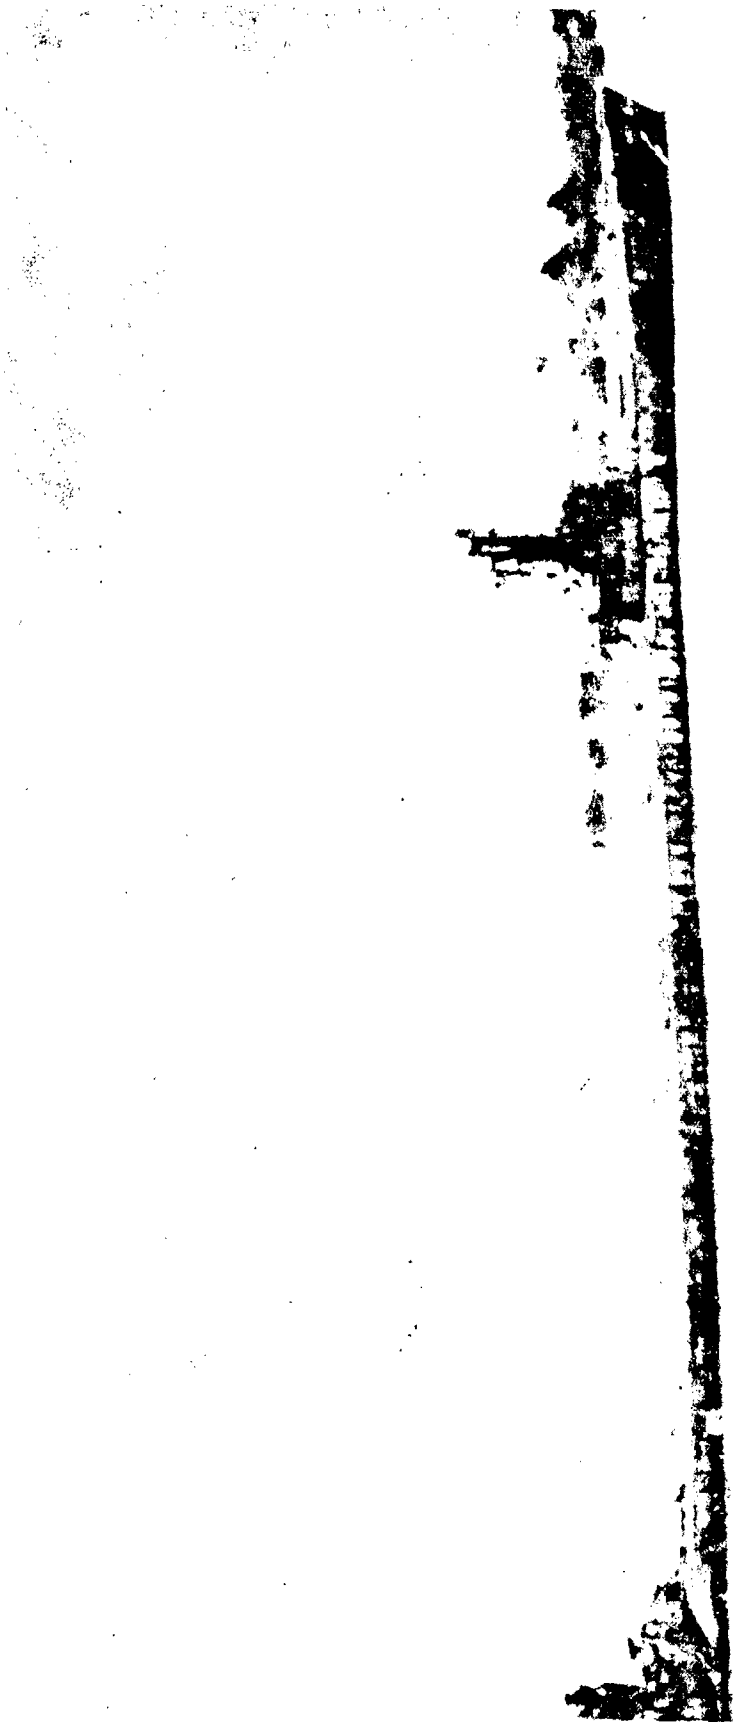
AB-CR-227-290-30. General view from starboard quarter - vessel beached.

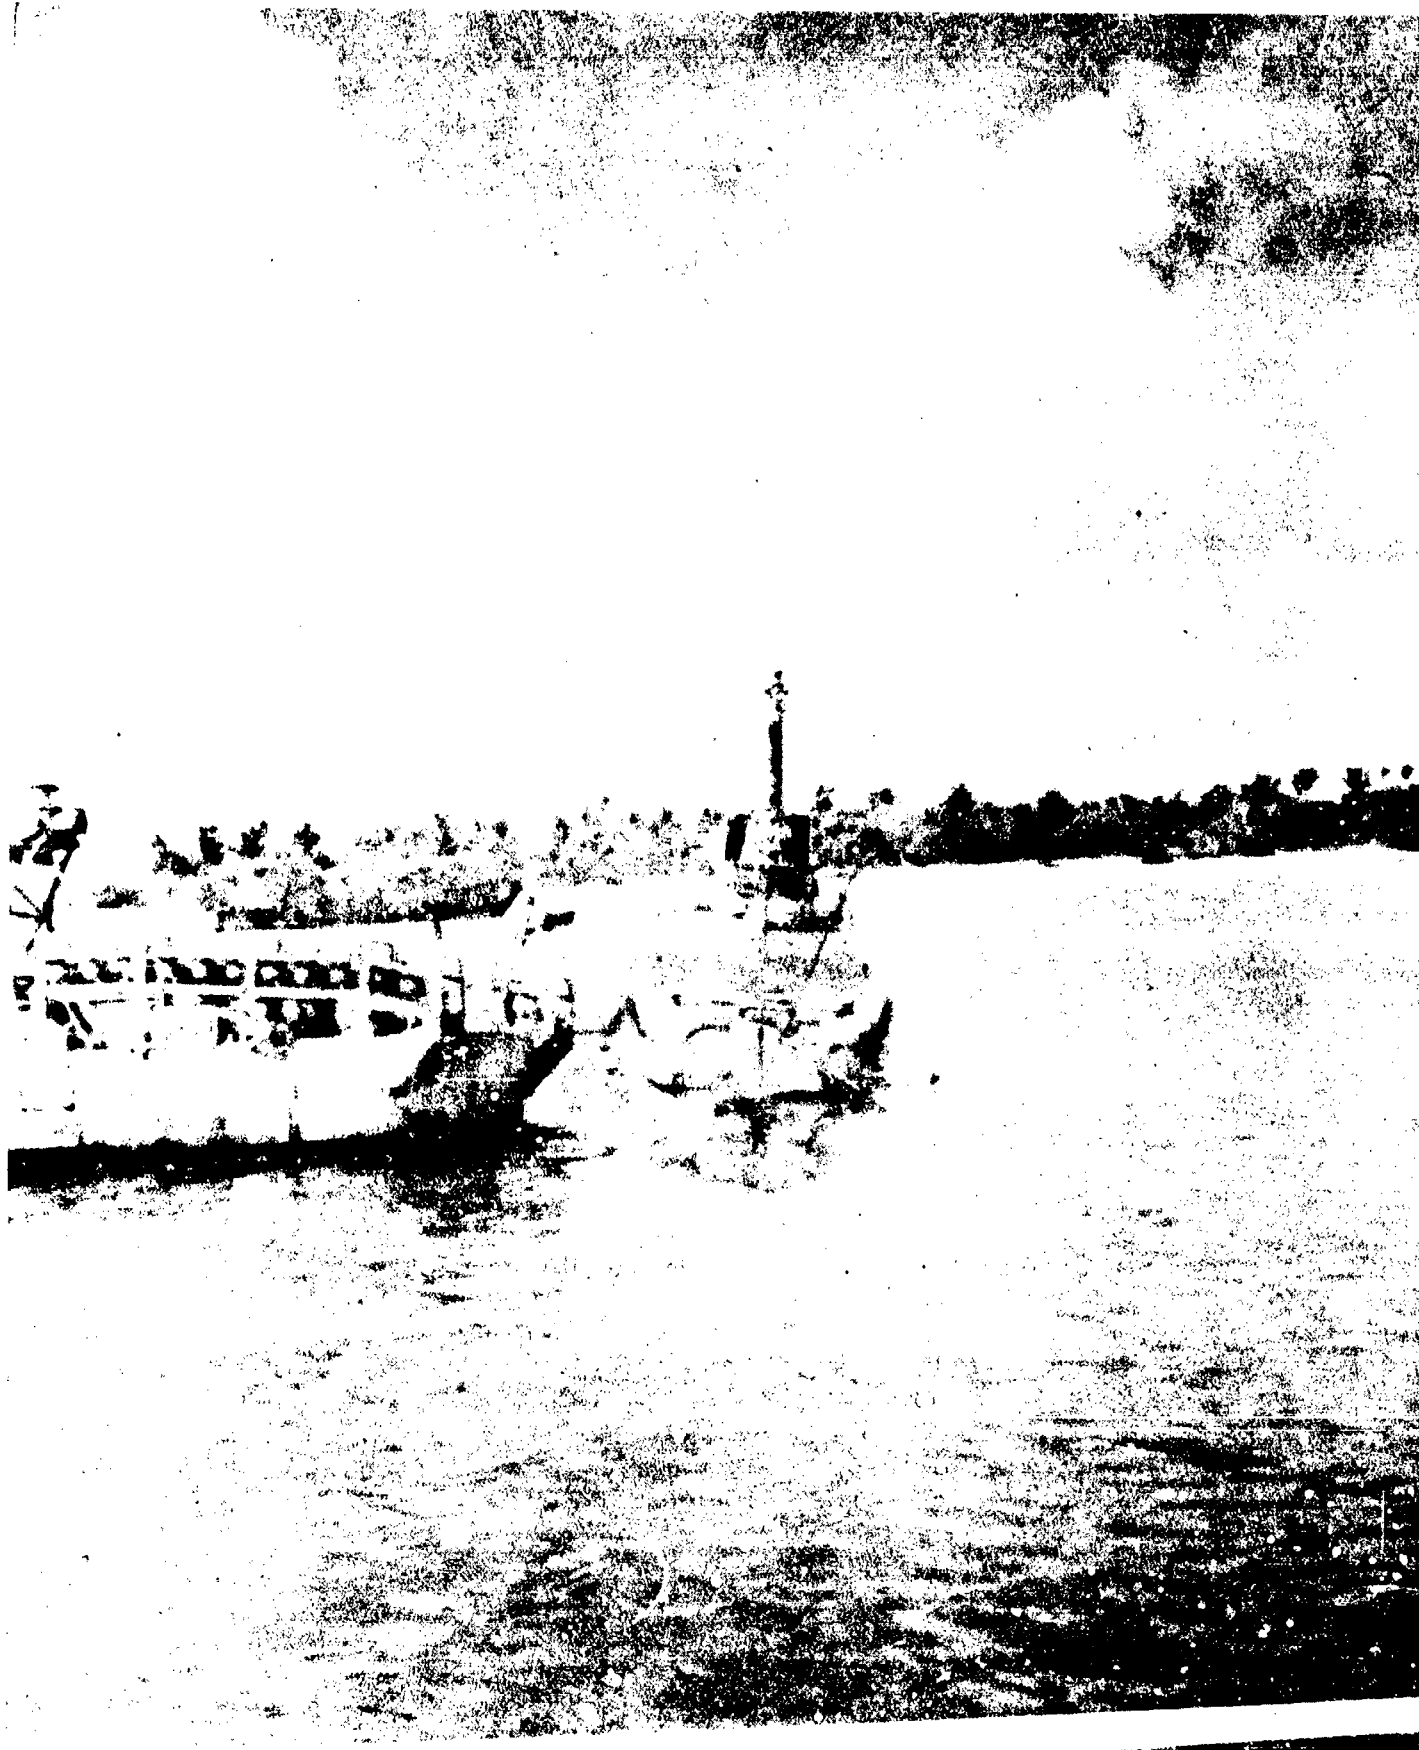
AB-CR-227-290-31. General view from astern - vessel beached.

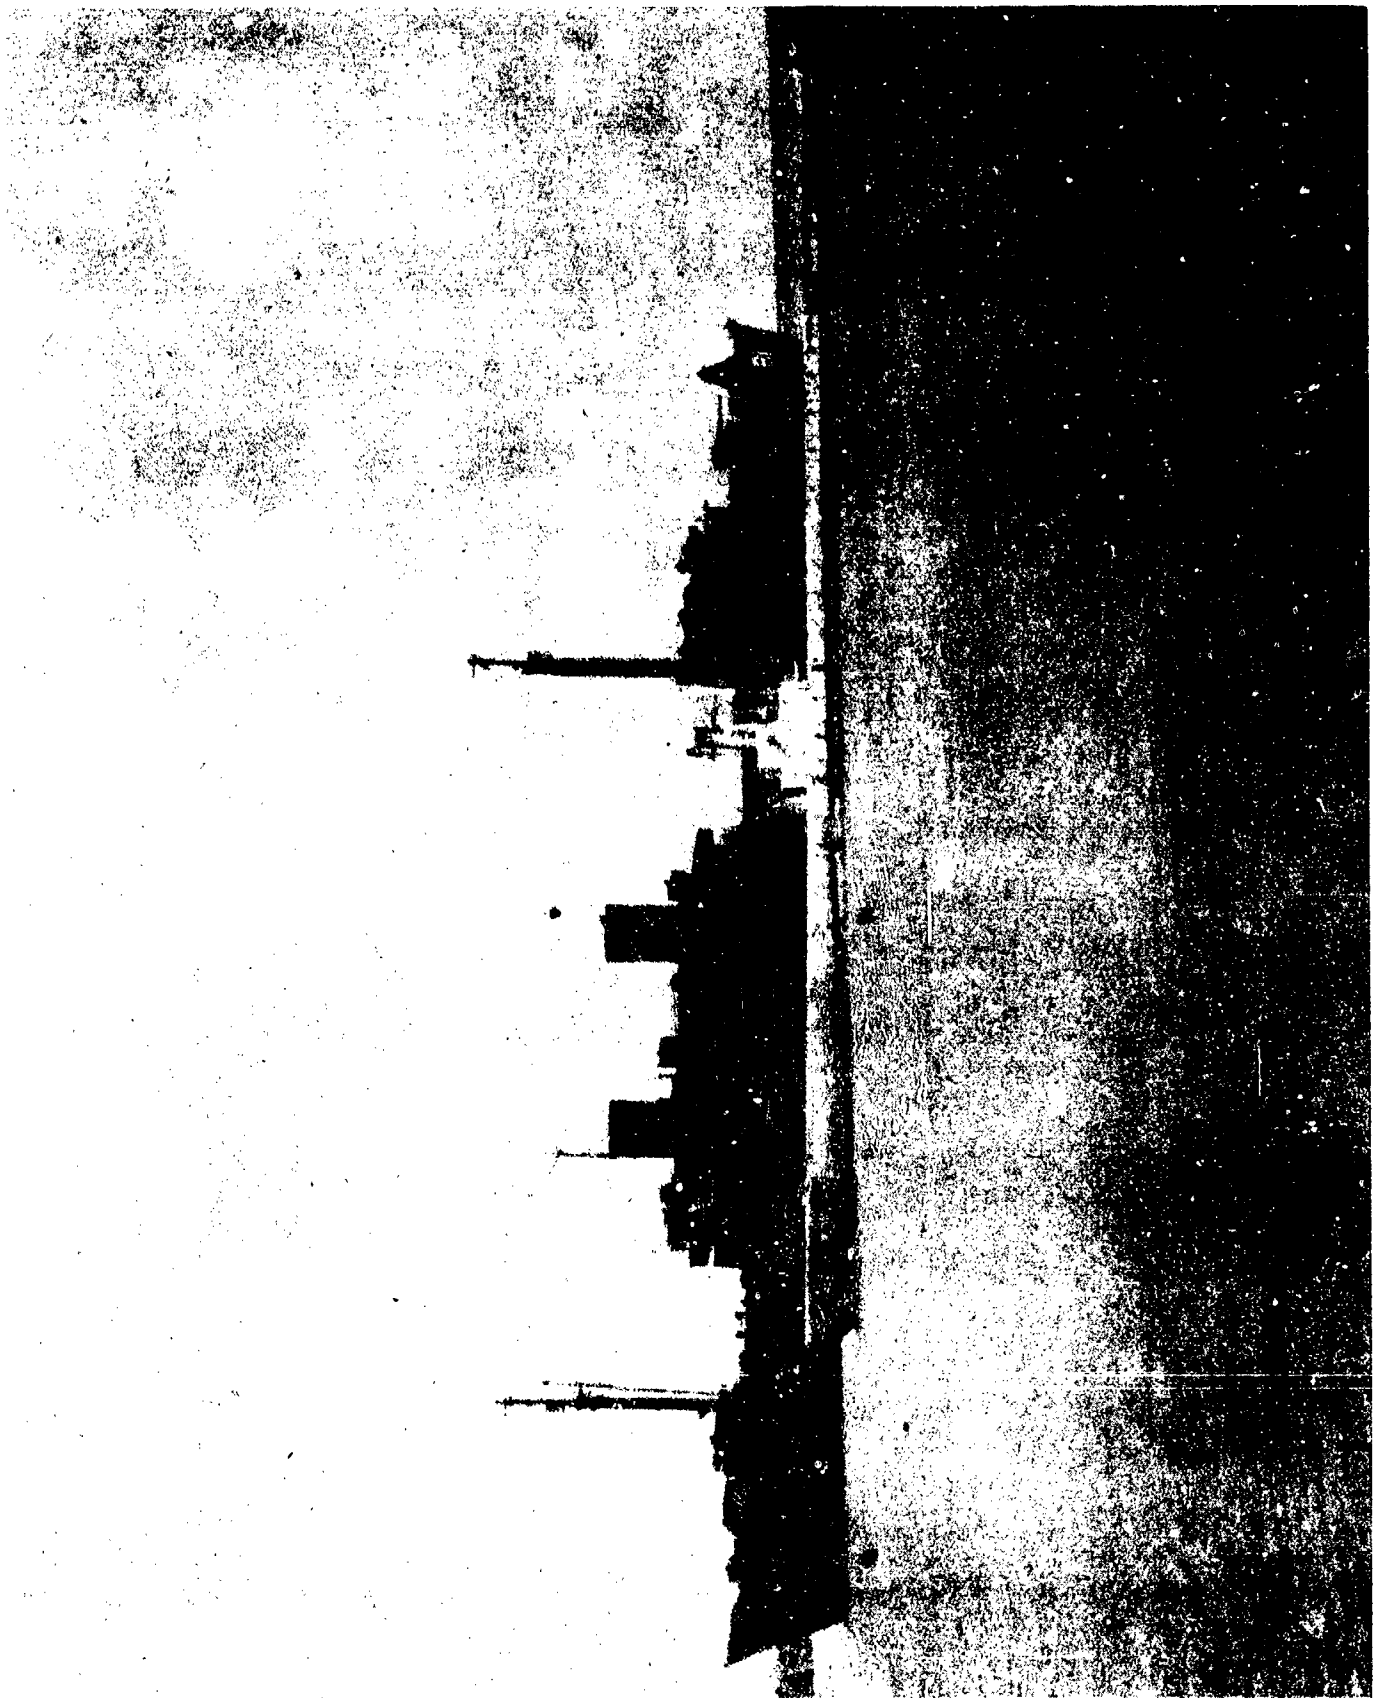
AB-CR-227-290-25. General view from port beam - vessel beached.
