BUREAU OF SHIPS GROUP TECHNICAL INSPECTION REPORT

⑥ OPERATION CROSSROADS,
USS BANNER (APA60).

TEST BAKER [U].

BUREAU OF SHIPS GROUP
TECHNICAL INSPECTION REPORT

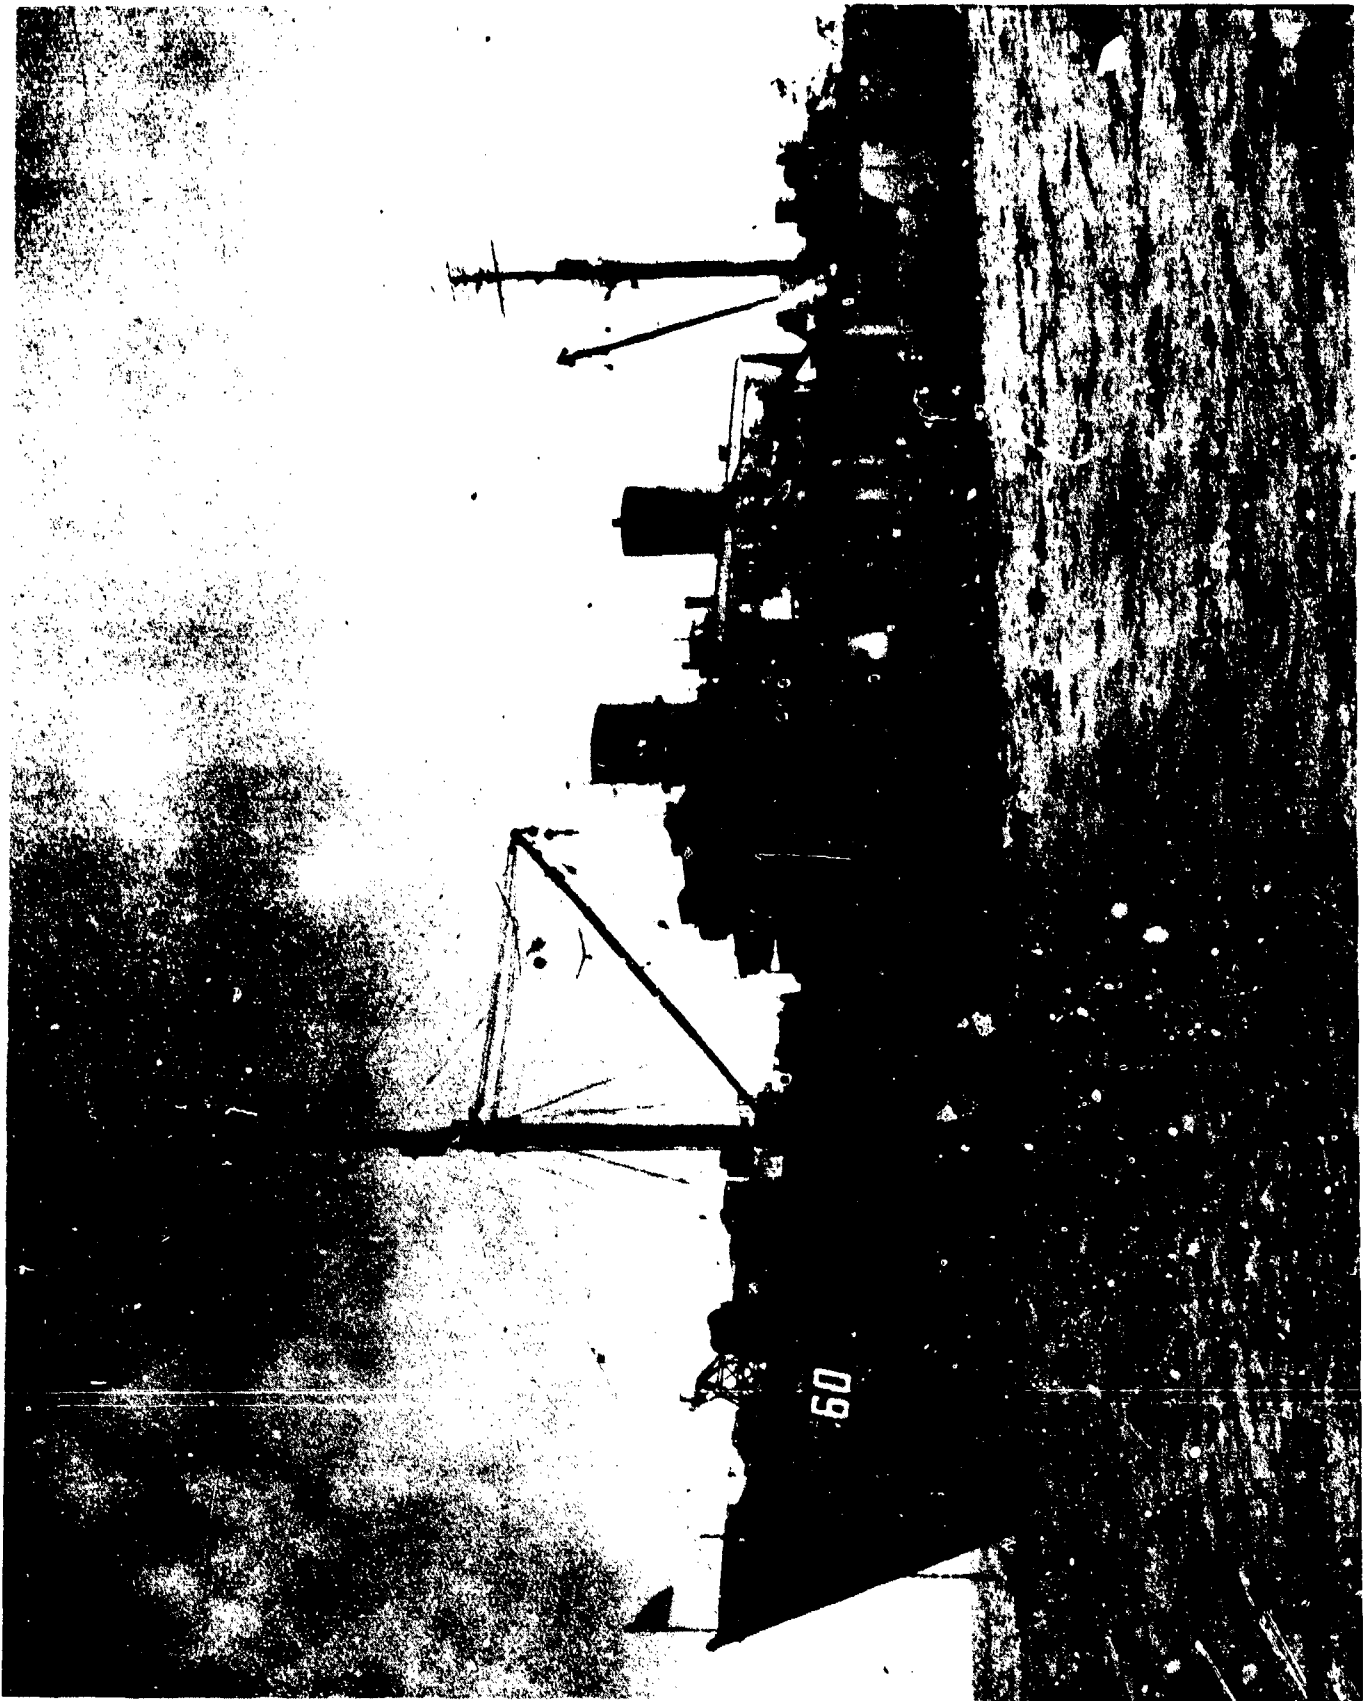
BB-CR-227-513-115. View from off port bow before Test B.

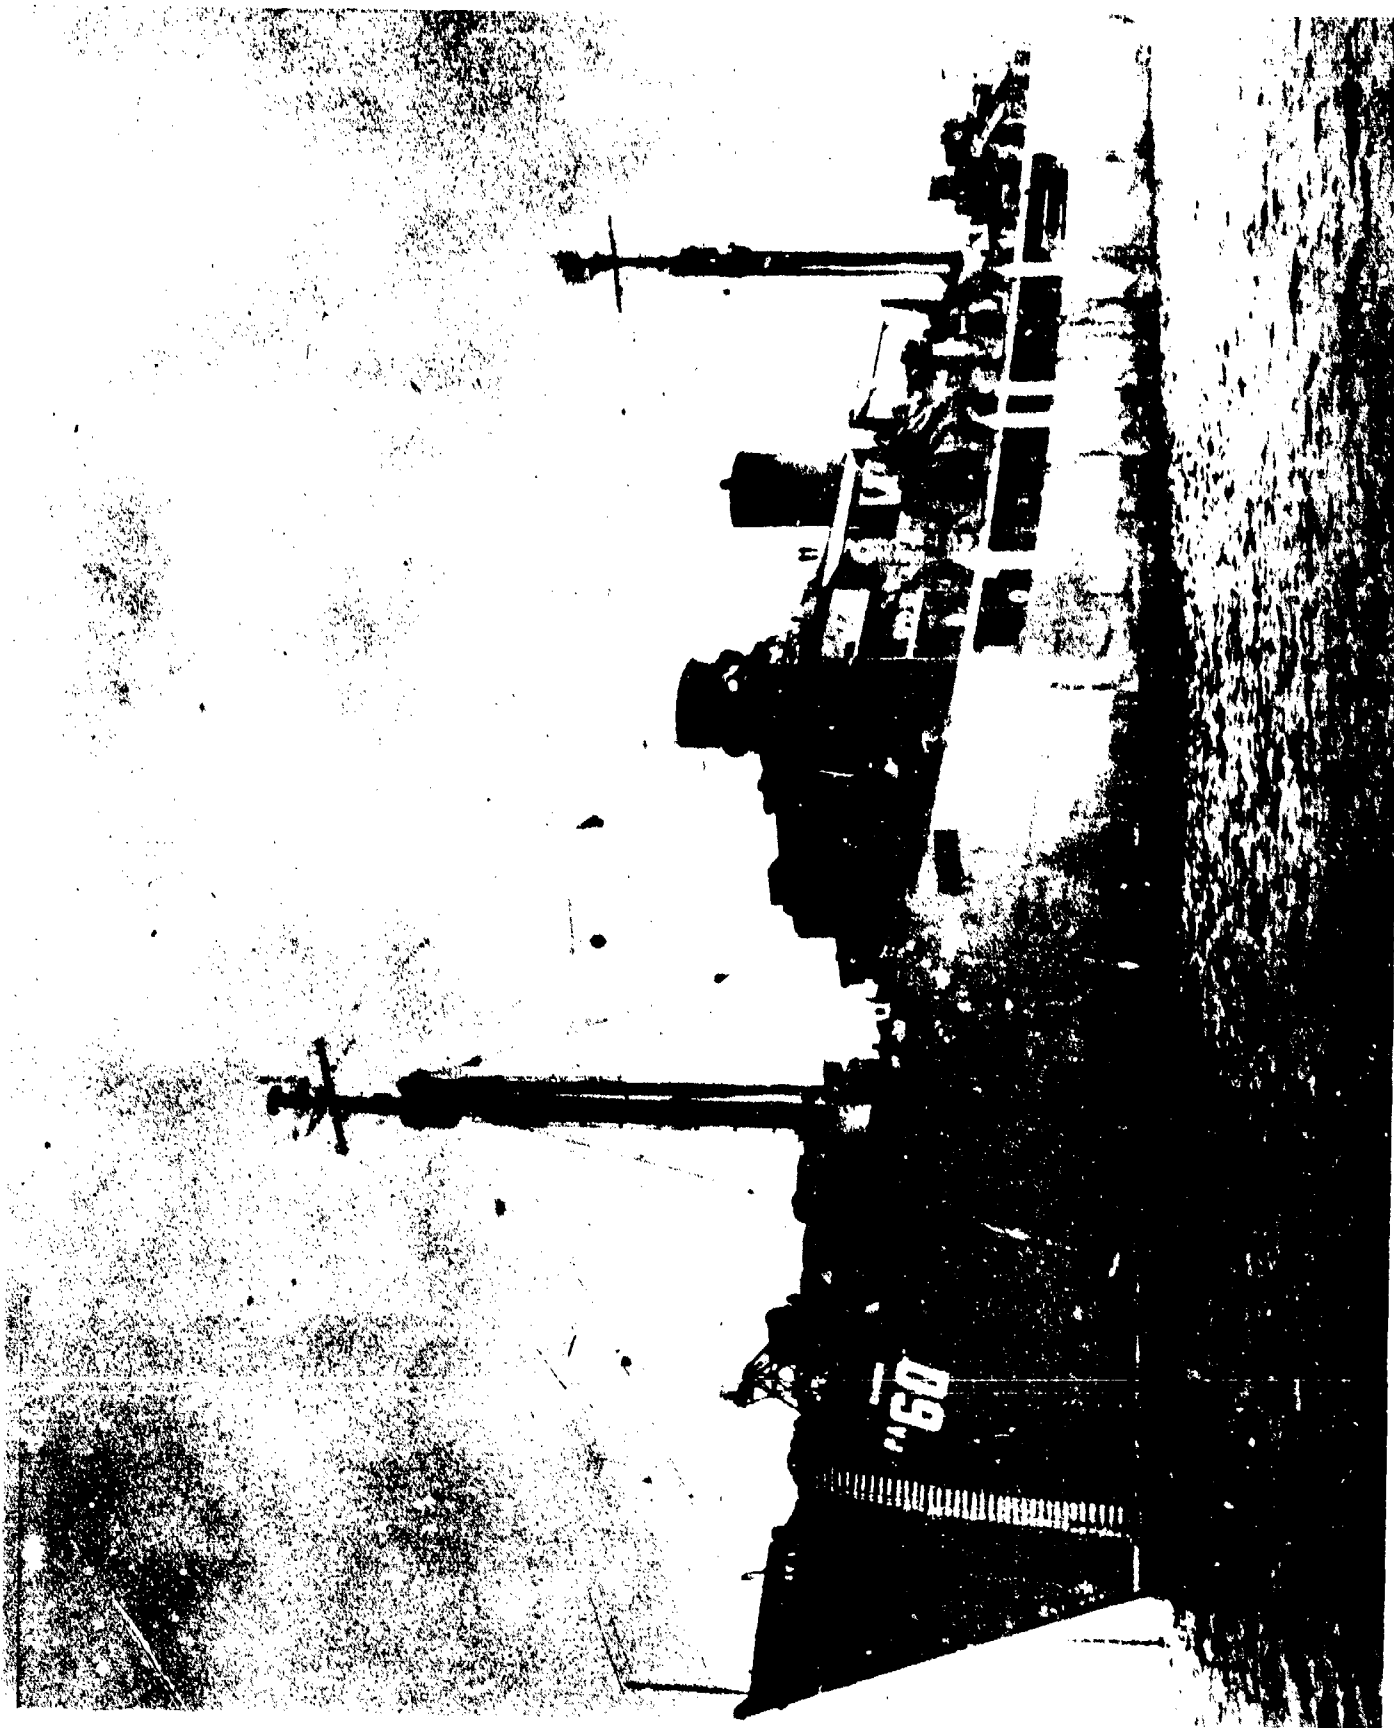
There is no apparent structural damage. A fragment believed to be a part of a bearing cap from the LSM 60, penetrated the superstructure deck at frame 150, starboard. No machinery was operated but there appears to be no reason to expect even secondary damage. Small amounts of water were found in various parts of this vessel. This may have come from normal seepage, rain, or possible from the washing down of the ship during decontamination. General views of the vessel are shown on pages 30 to 37 inclusive.

AB-CR-227-243-4. View from off port bow after Test B.

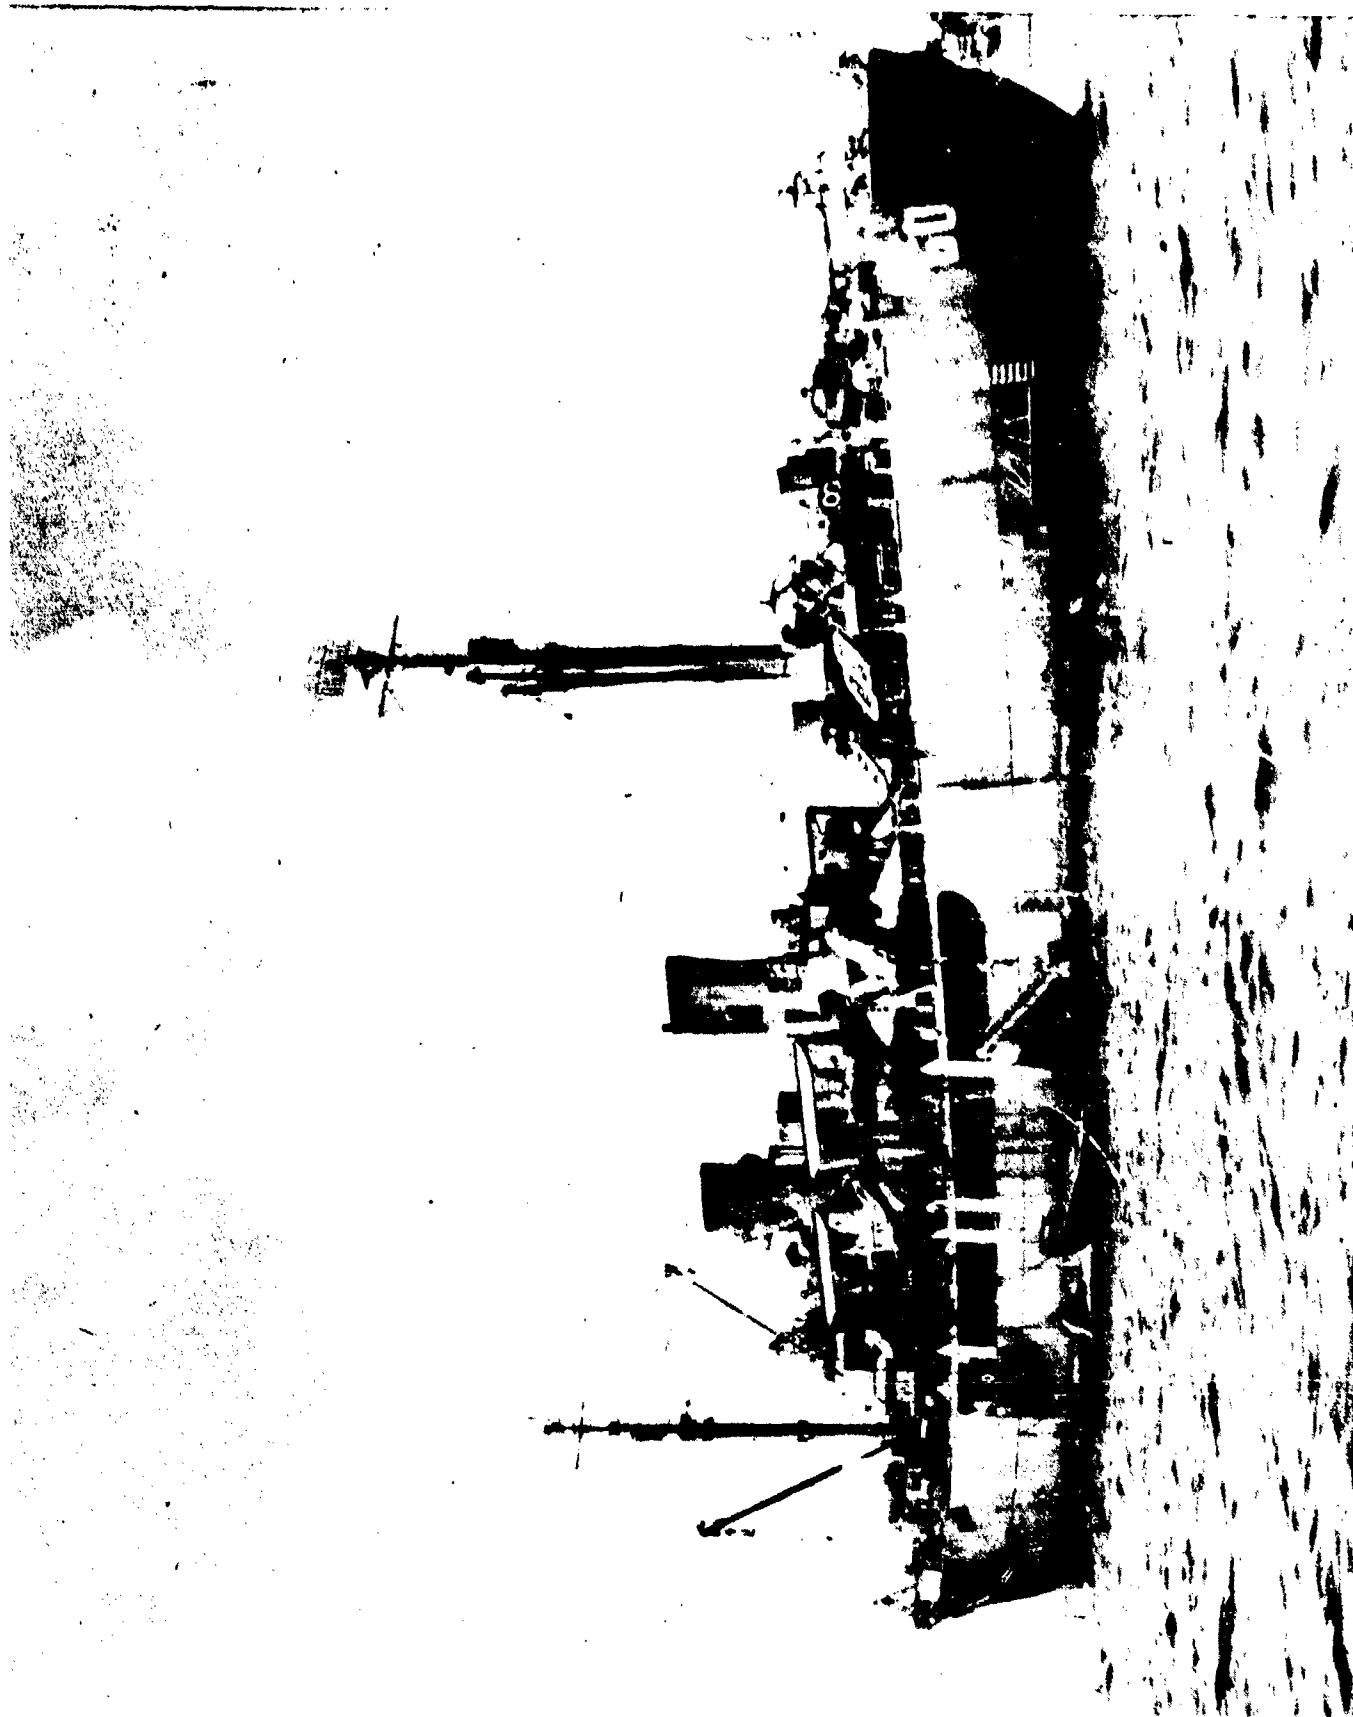
BB-CR-227-513-117. View from off port quarter before Test B.

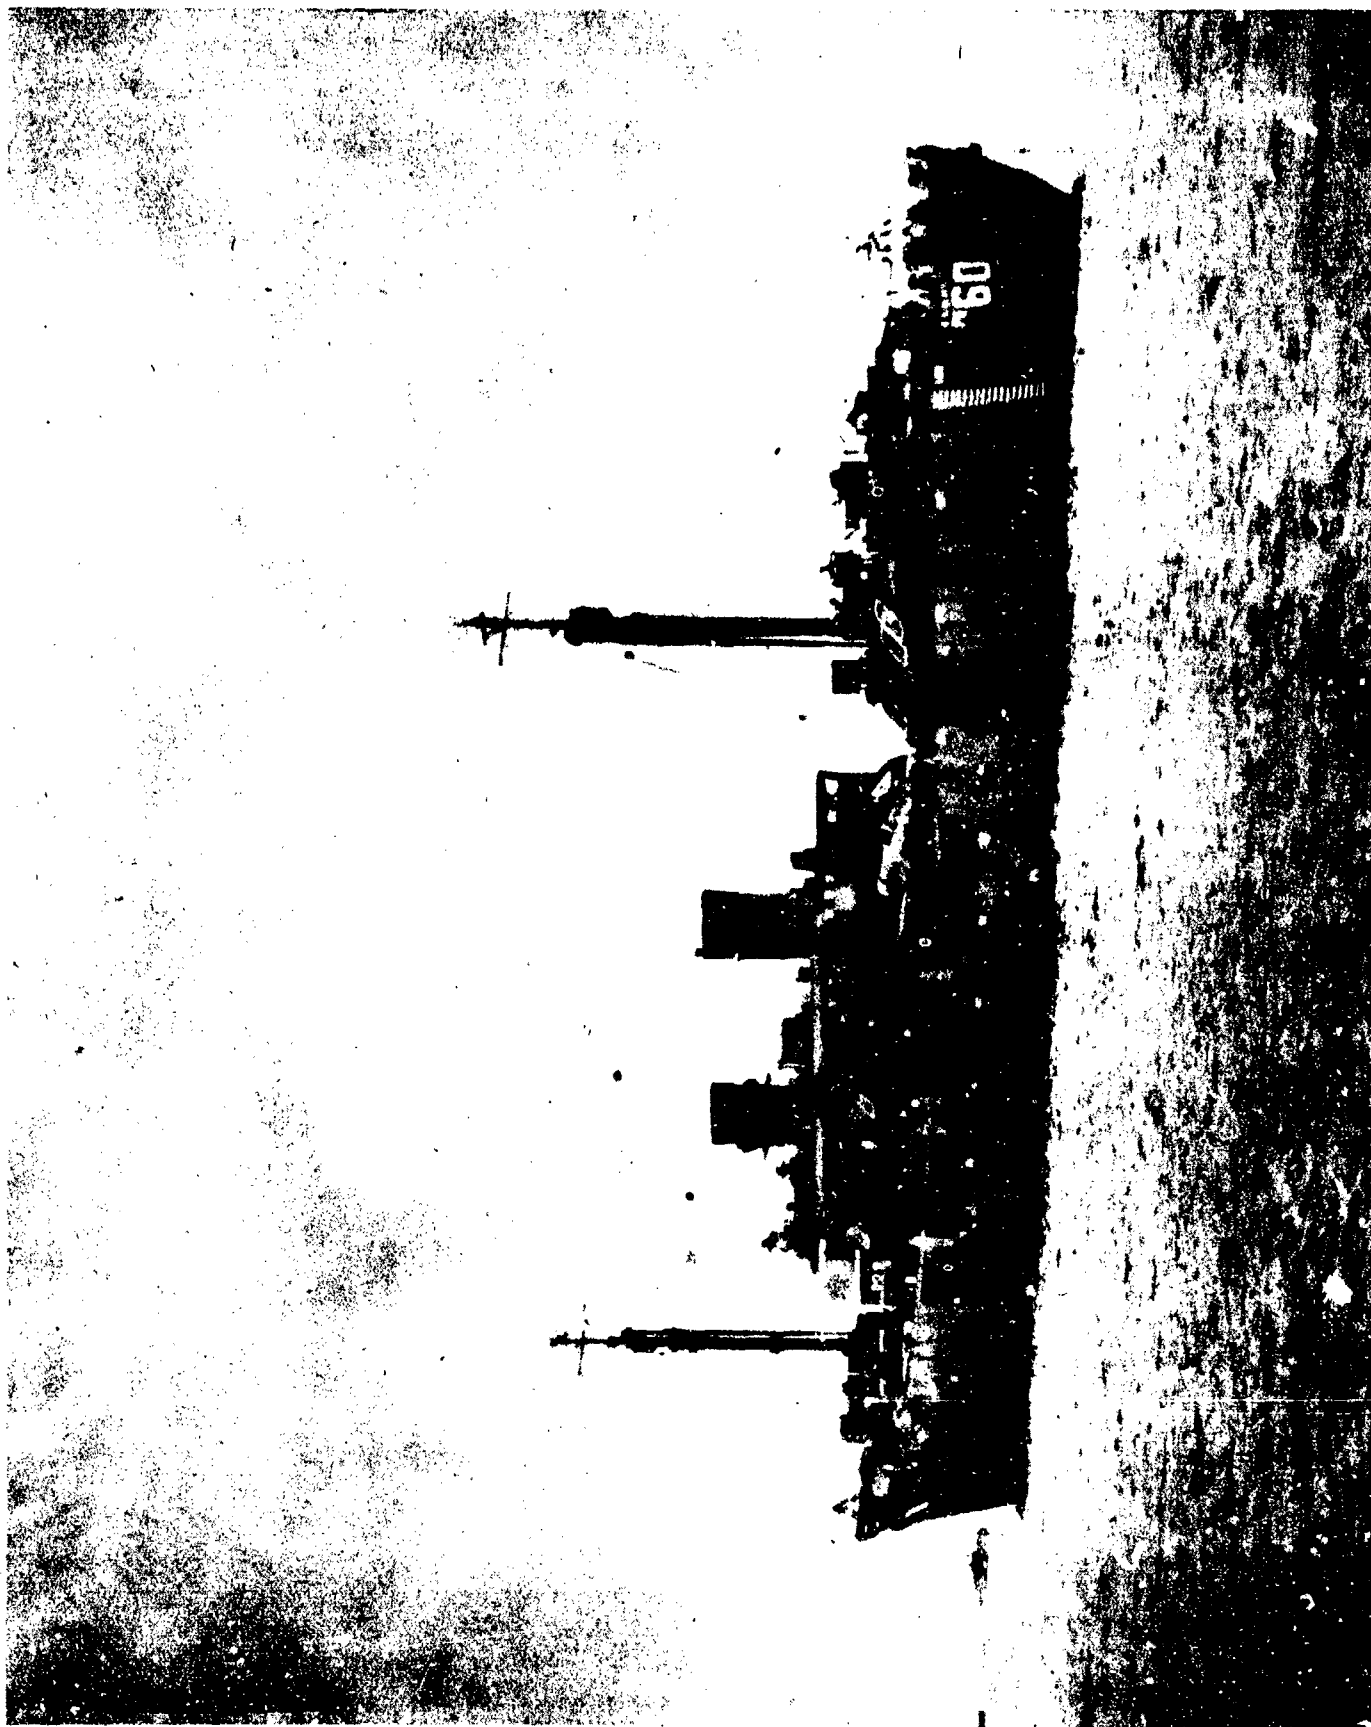
AB-CR-227-243-6. View from off port quarter after Test B.

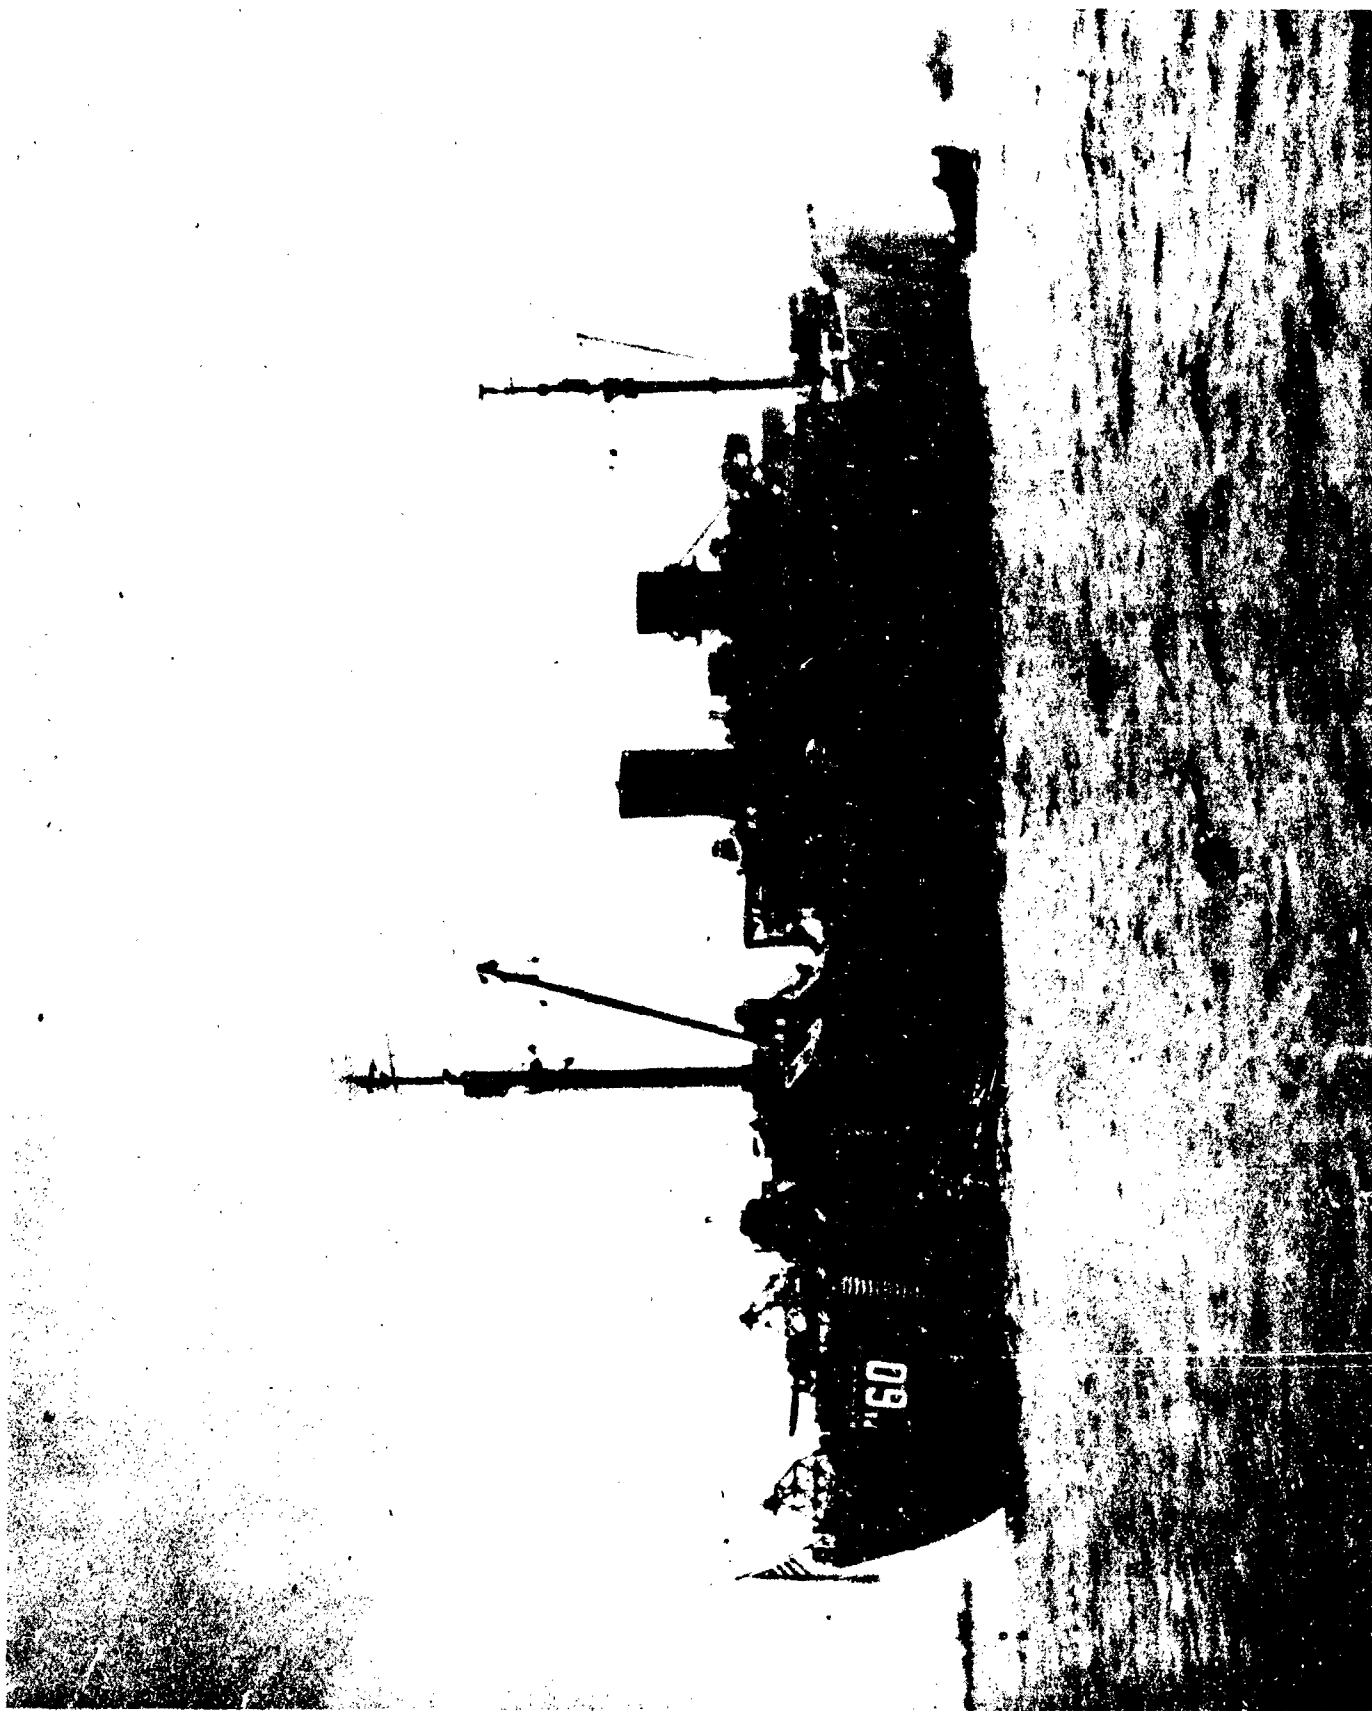
BB-CR-227-513-111. View from off starboard quarter before Test B.

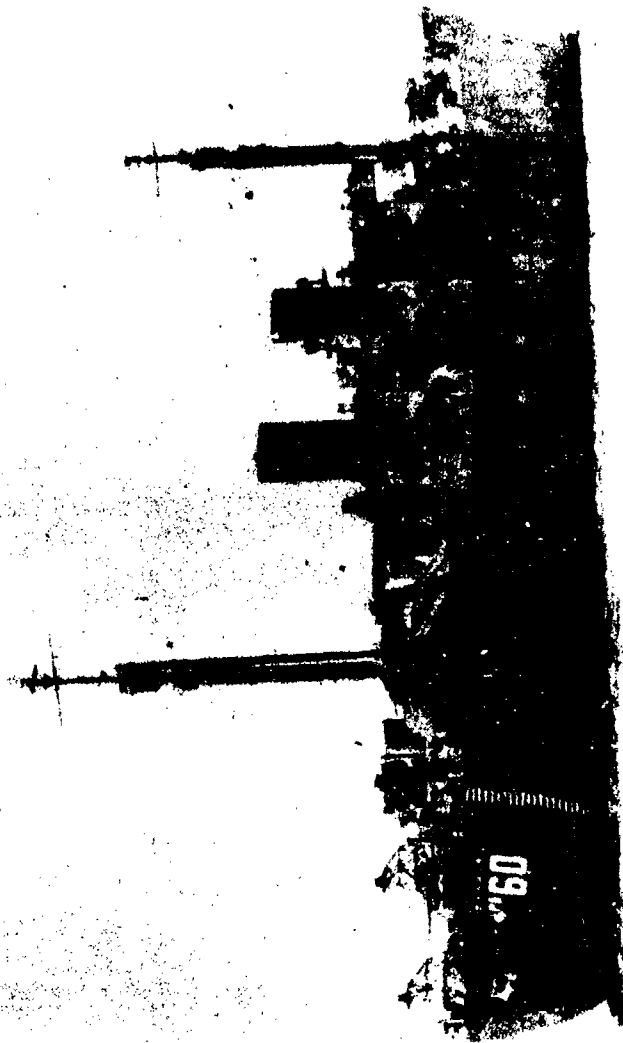
AB-CR-227-243-8. View from off starboard quarter after Test B.

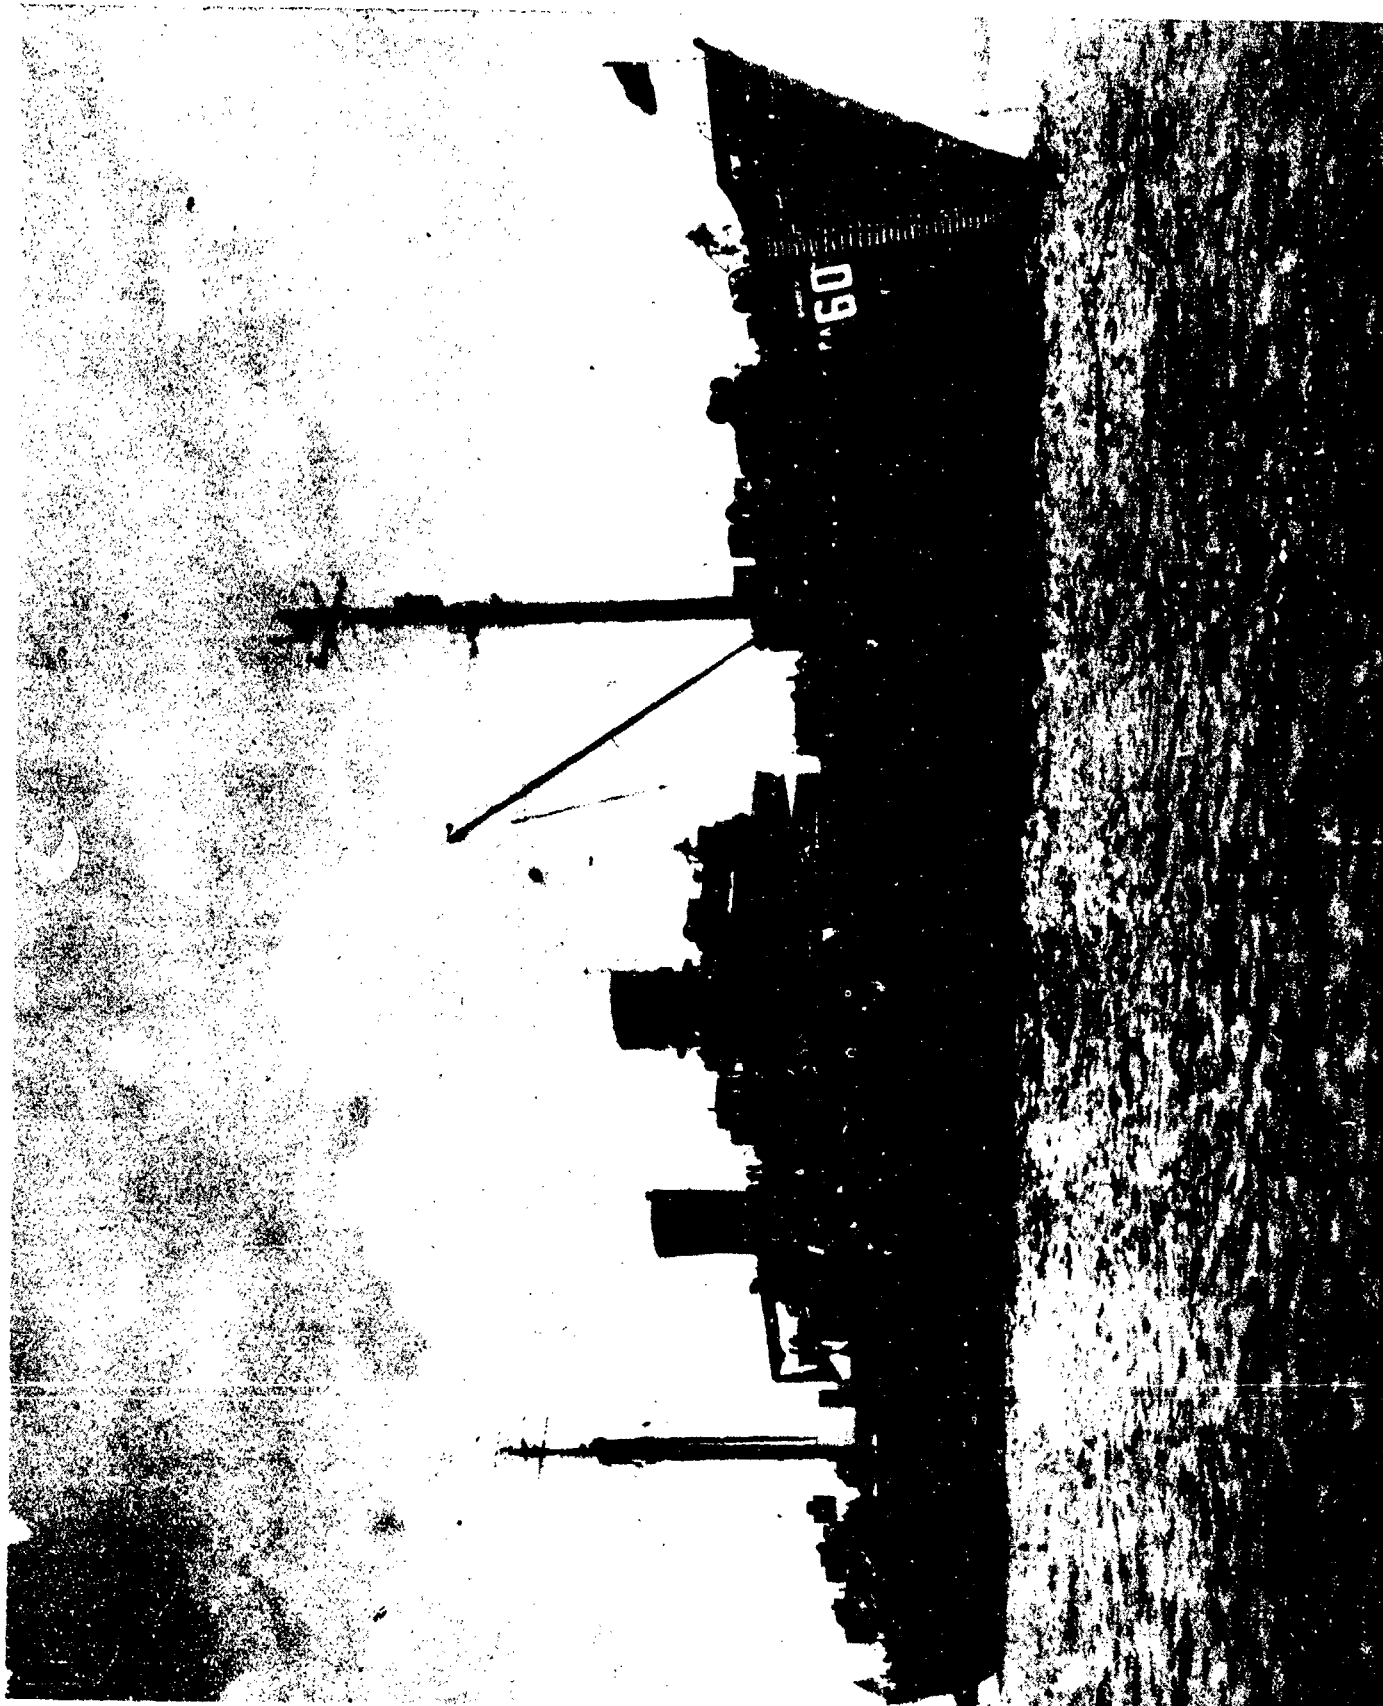
BB-CR-227-513-113. View from off starboard bow before Test B.

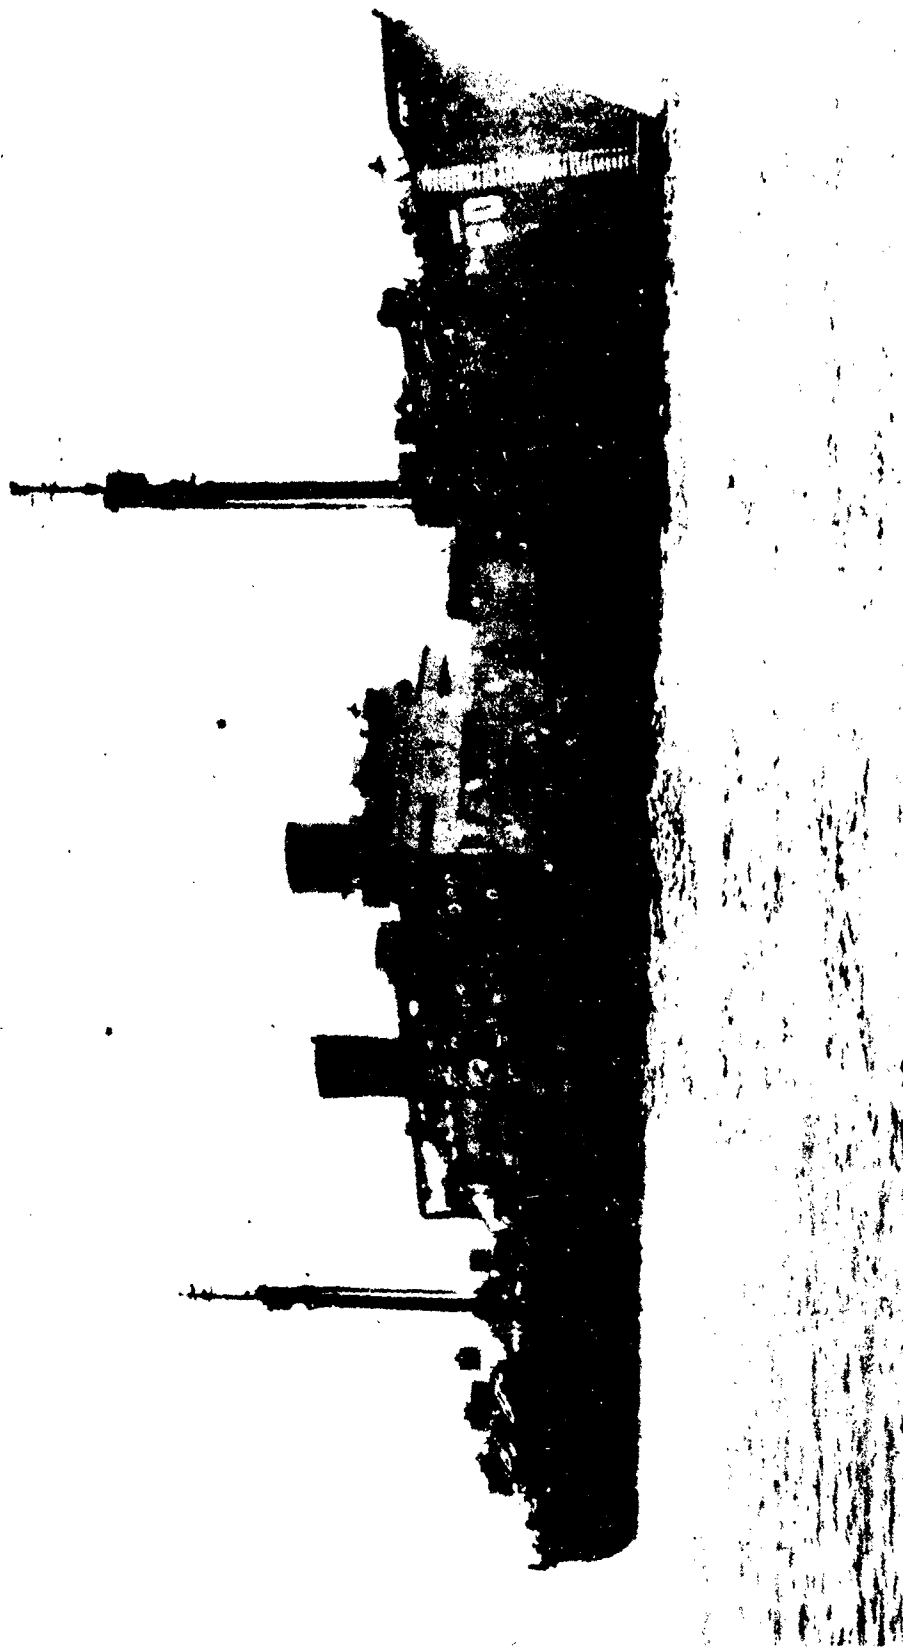
AB-CR-227-243-2. View from off starboard bow after Test B.
