**BUREAU OF SHIPS GROUP
TECHNICAL INSPECTION REPORT**

**OPERATION CROSSROADS.
U.S.S. BLADEN (APA 63).**

TEST BAKER CUT. 8

DIRECTOR OF SHIP MATERIALS
JOINT TASK FORCE ONE

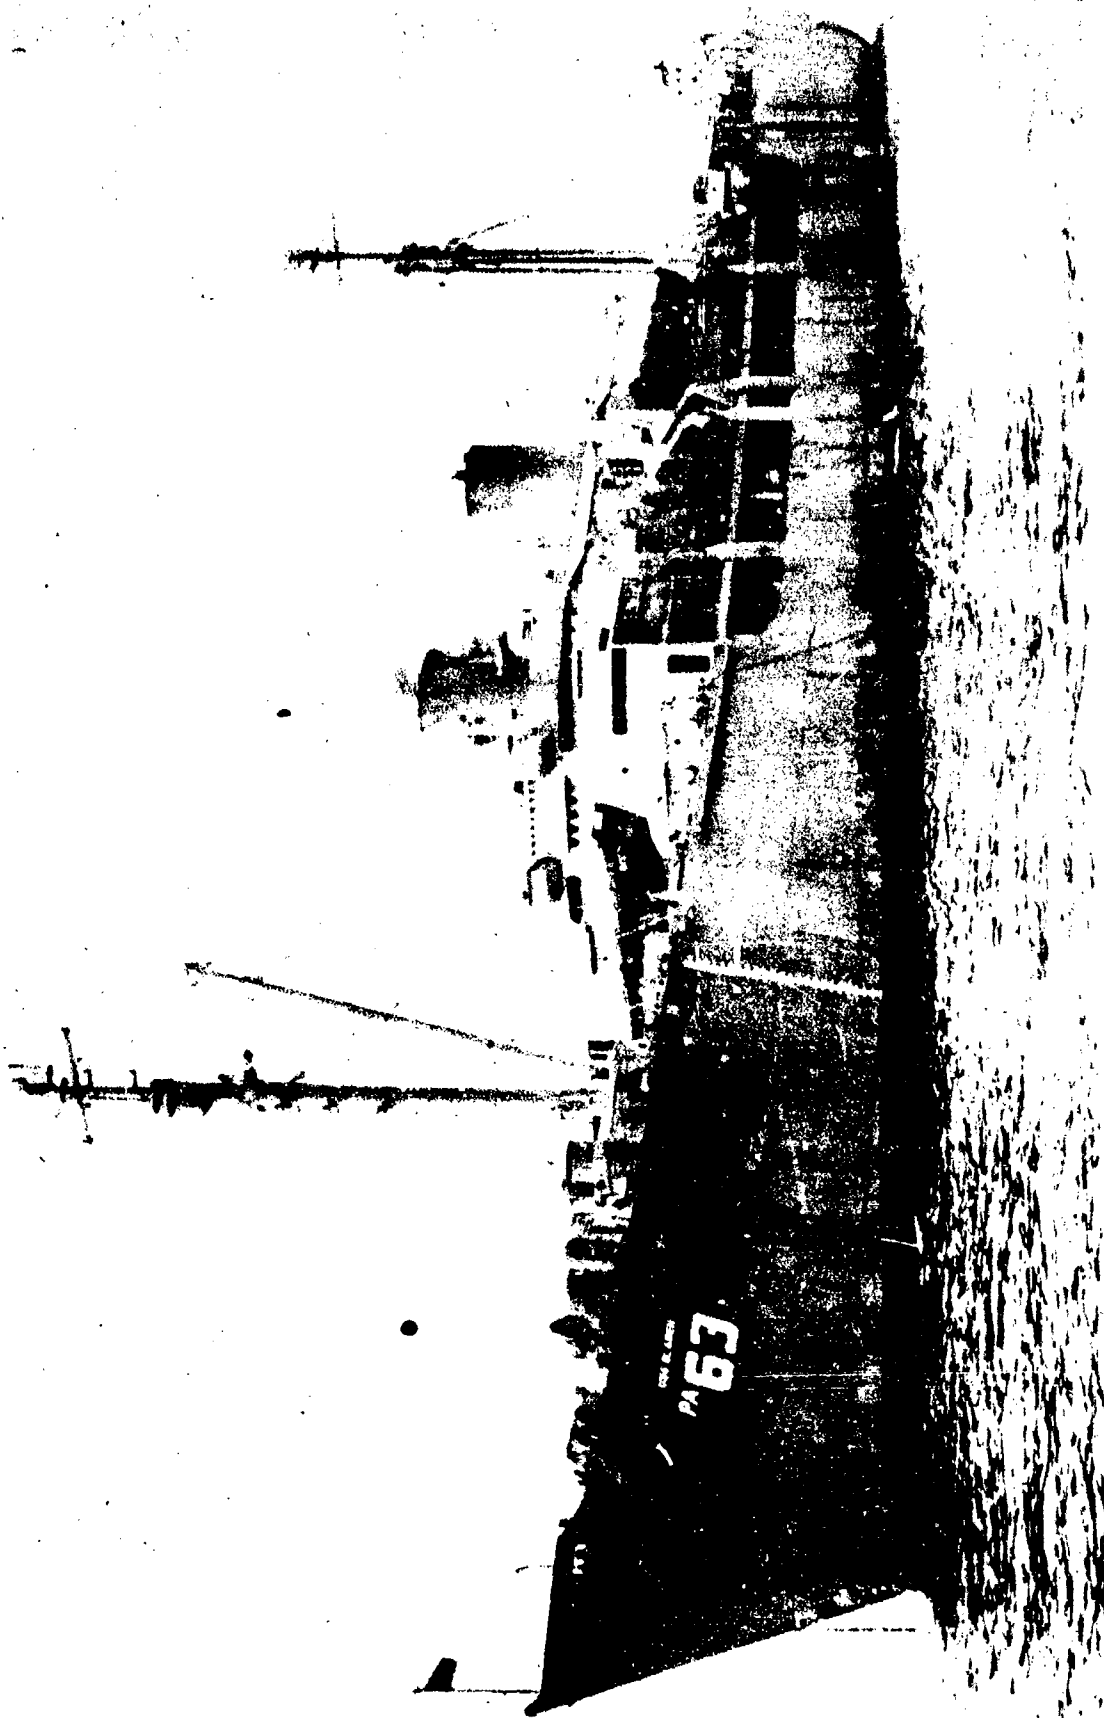
AB-CR-227-289-12. View off the port bow after Test B.

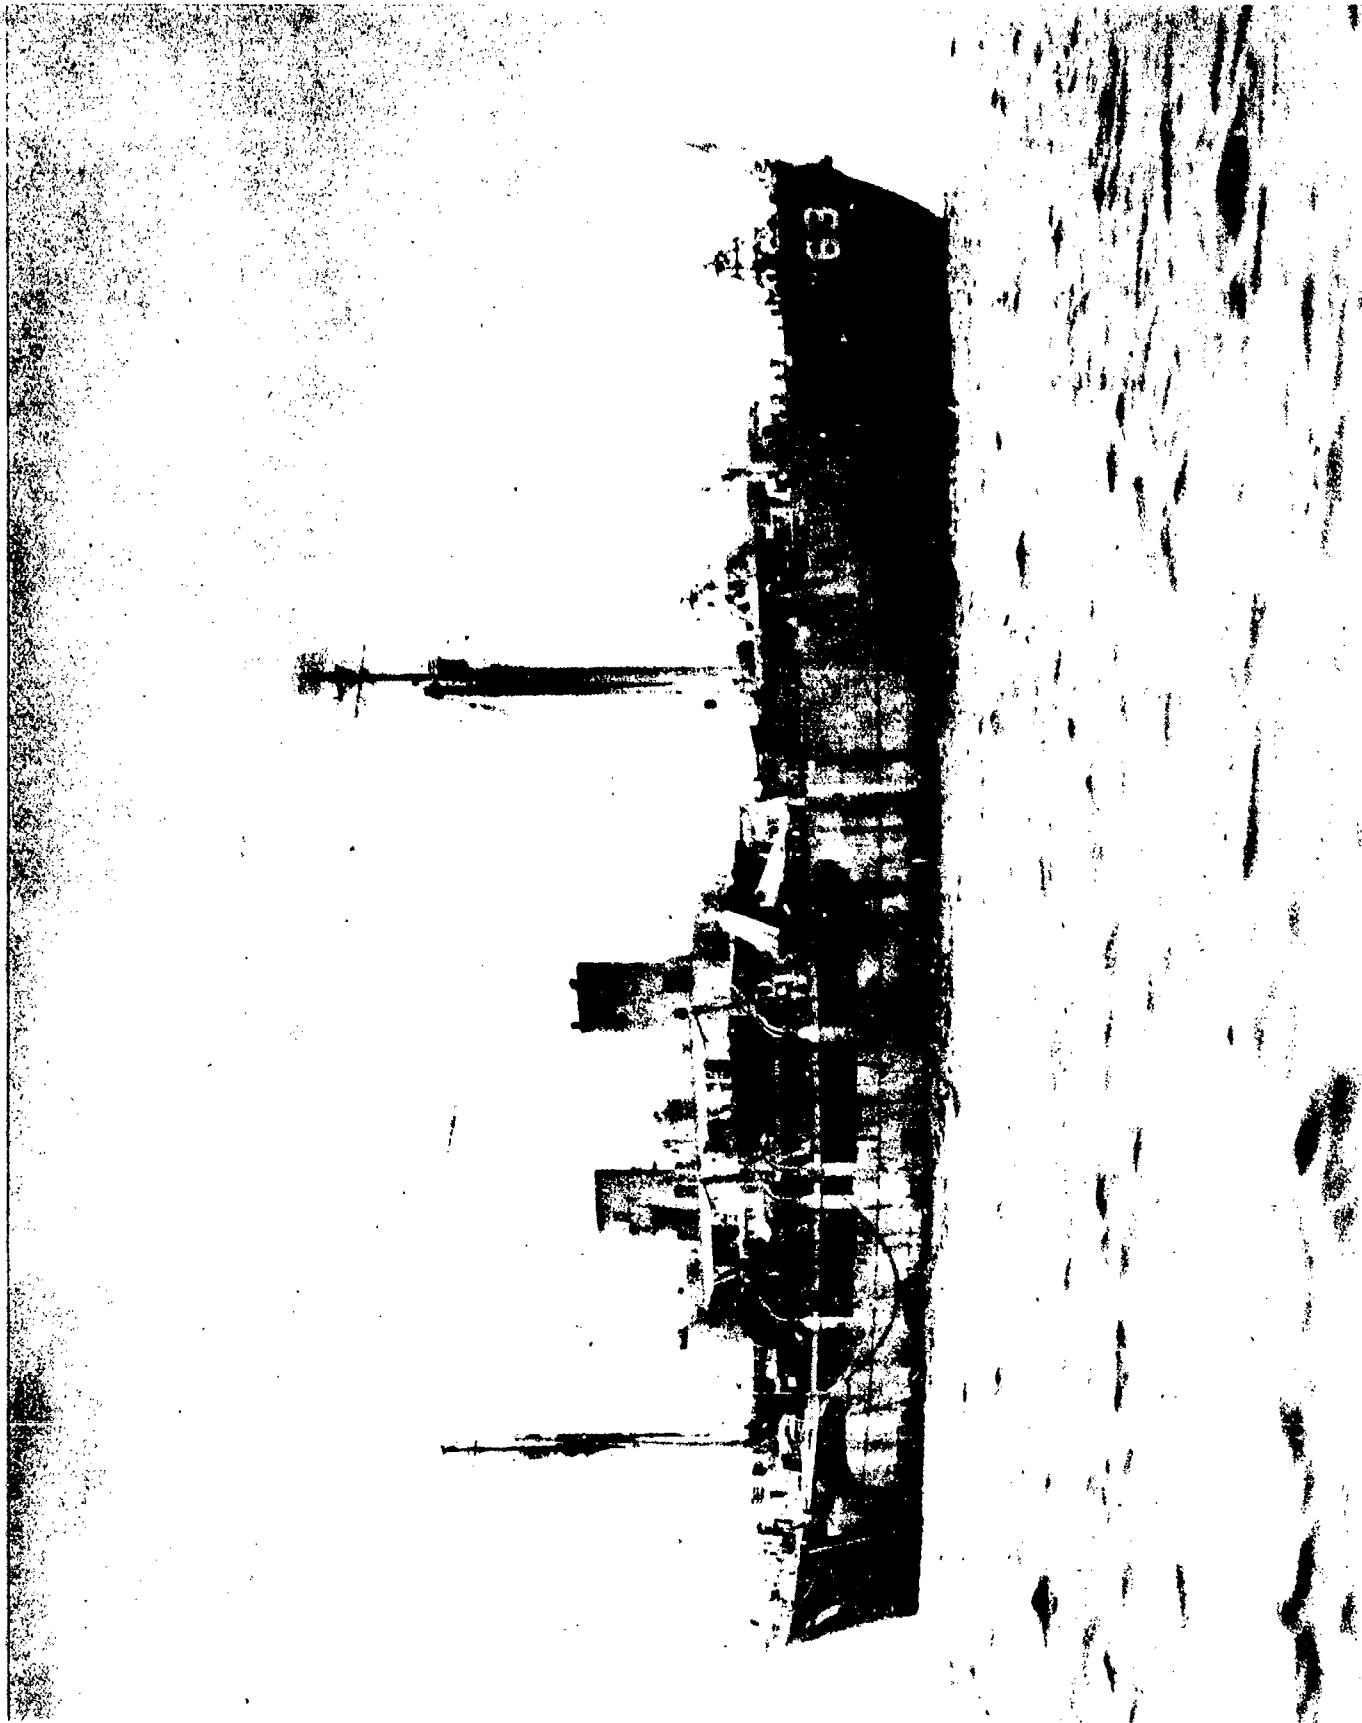
AB-CR-227-289-10. View off the port quarter after 'Test B.

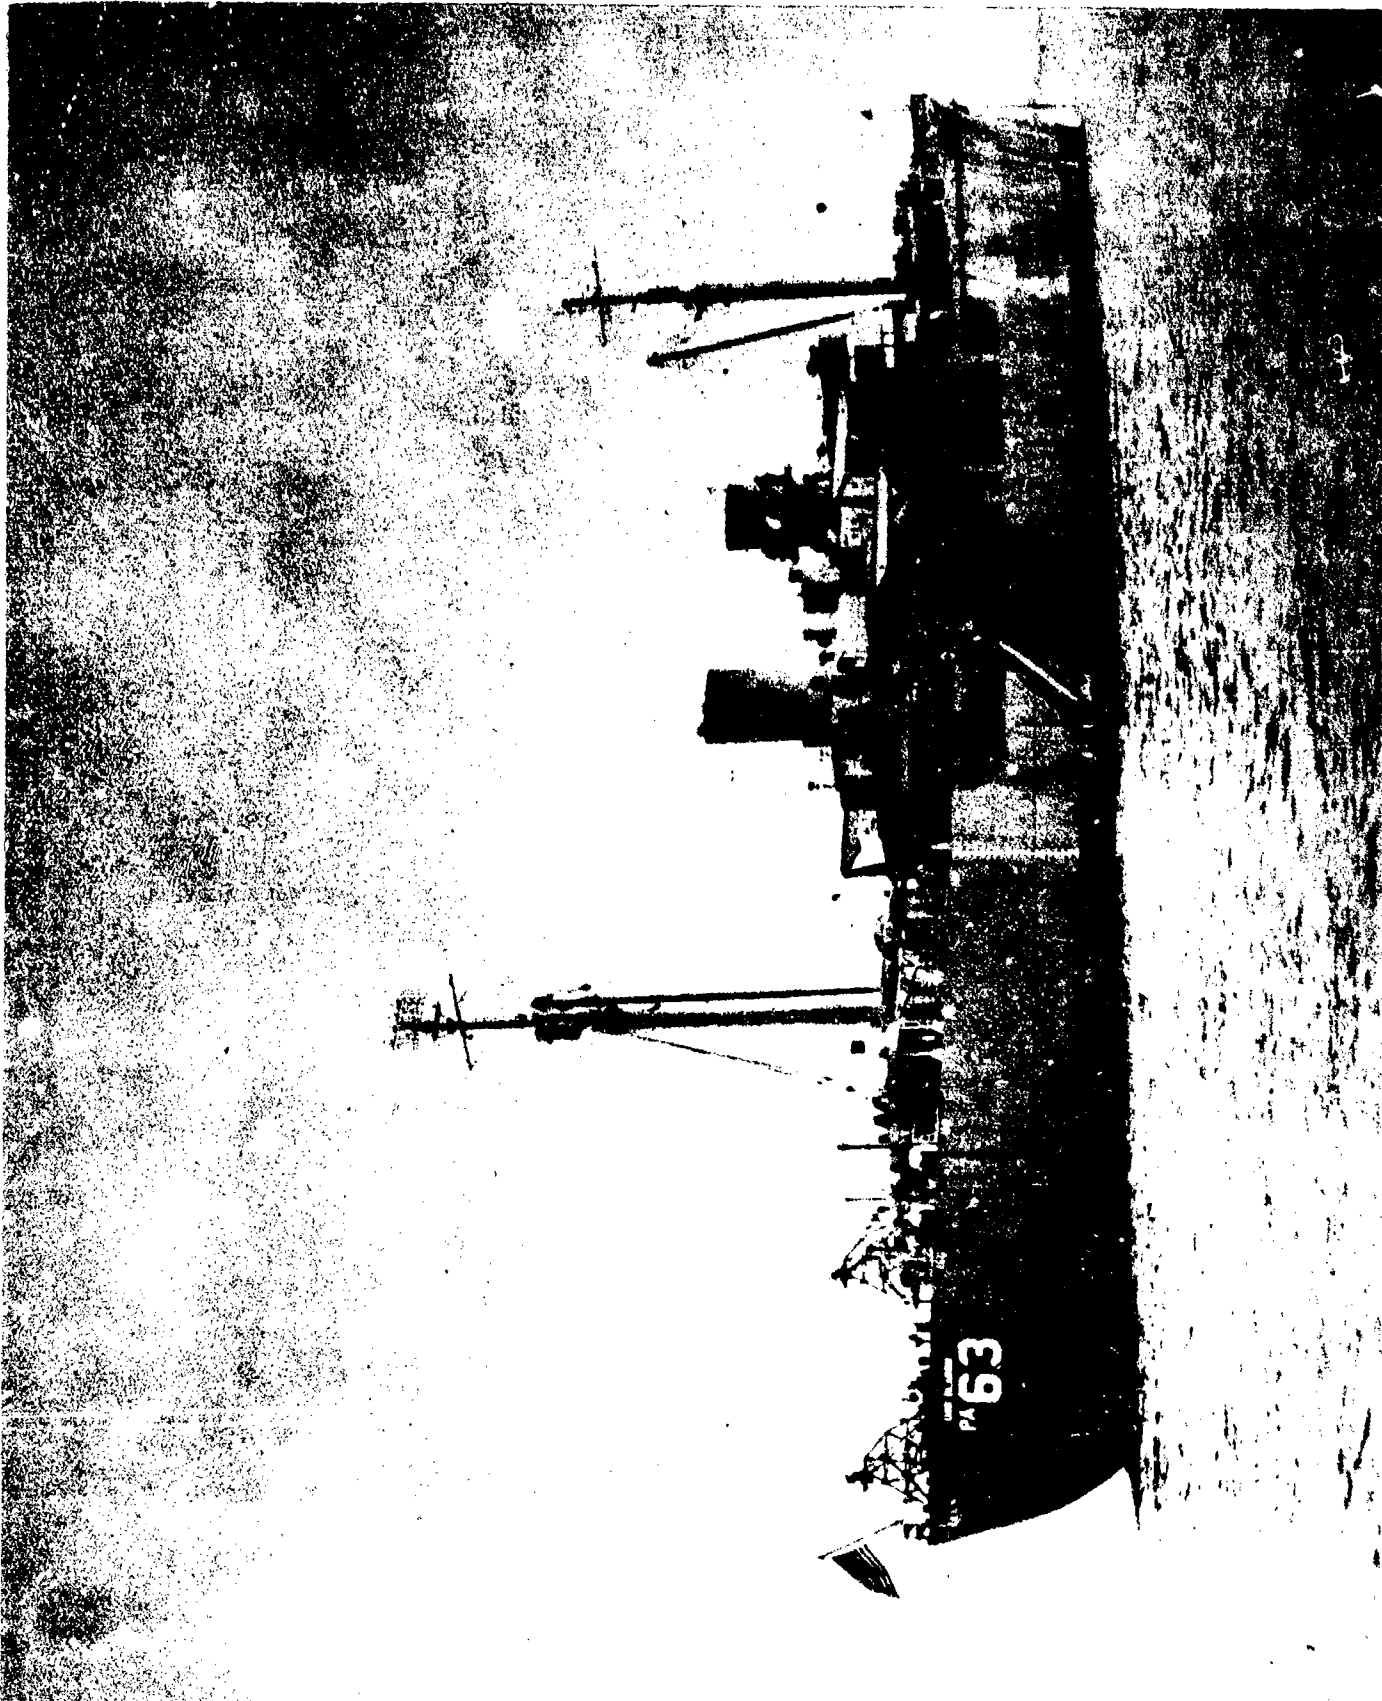
AB-CR-227-289-16. View off the starboard quarter after Test B.

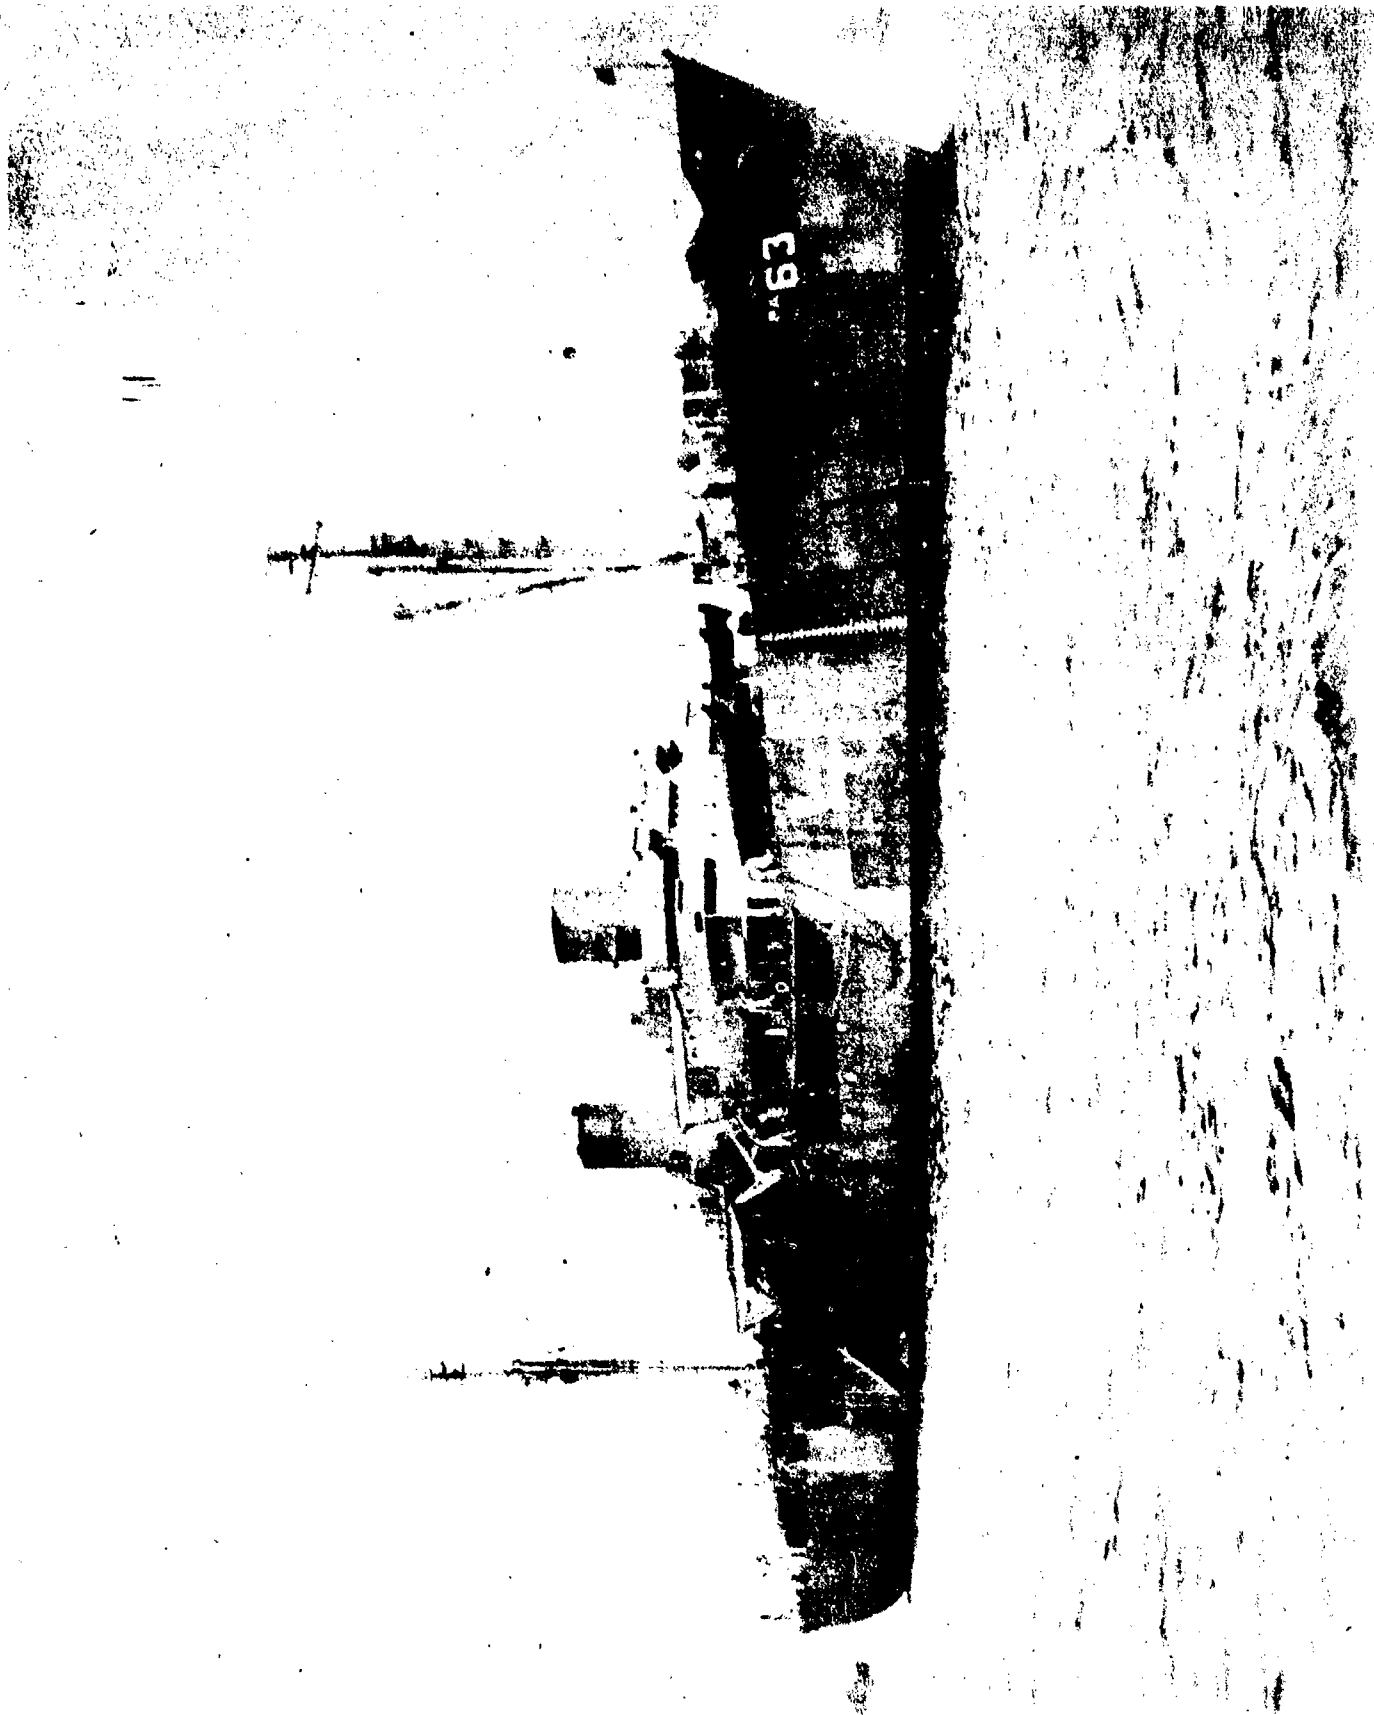
AB-CR-227-289-14. View off the starboard bow after Test B.
