*9*  
**BUREAU OF SHIPS GROUP  
TECHNICAL INSPECTION REPORT**

*6* **OPERATION CROSSROADS.  
U.S.S. BRULE (APA66).**

**TEST BAKER [U].**

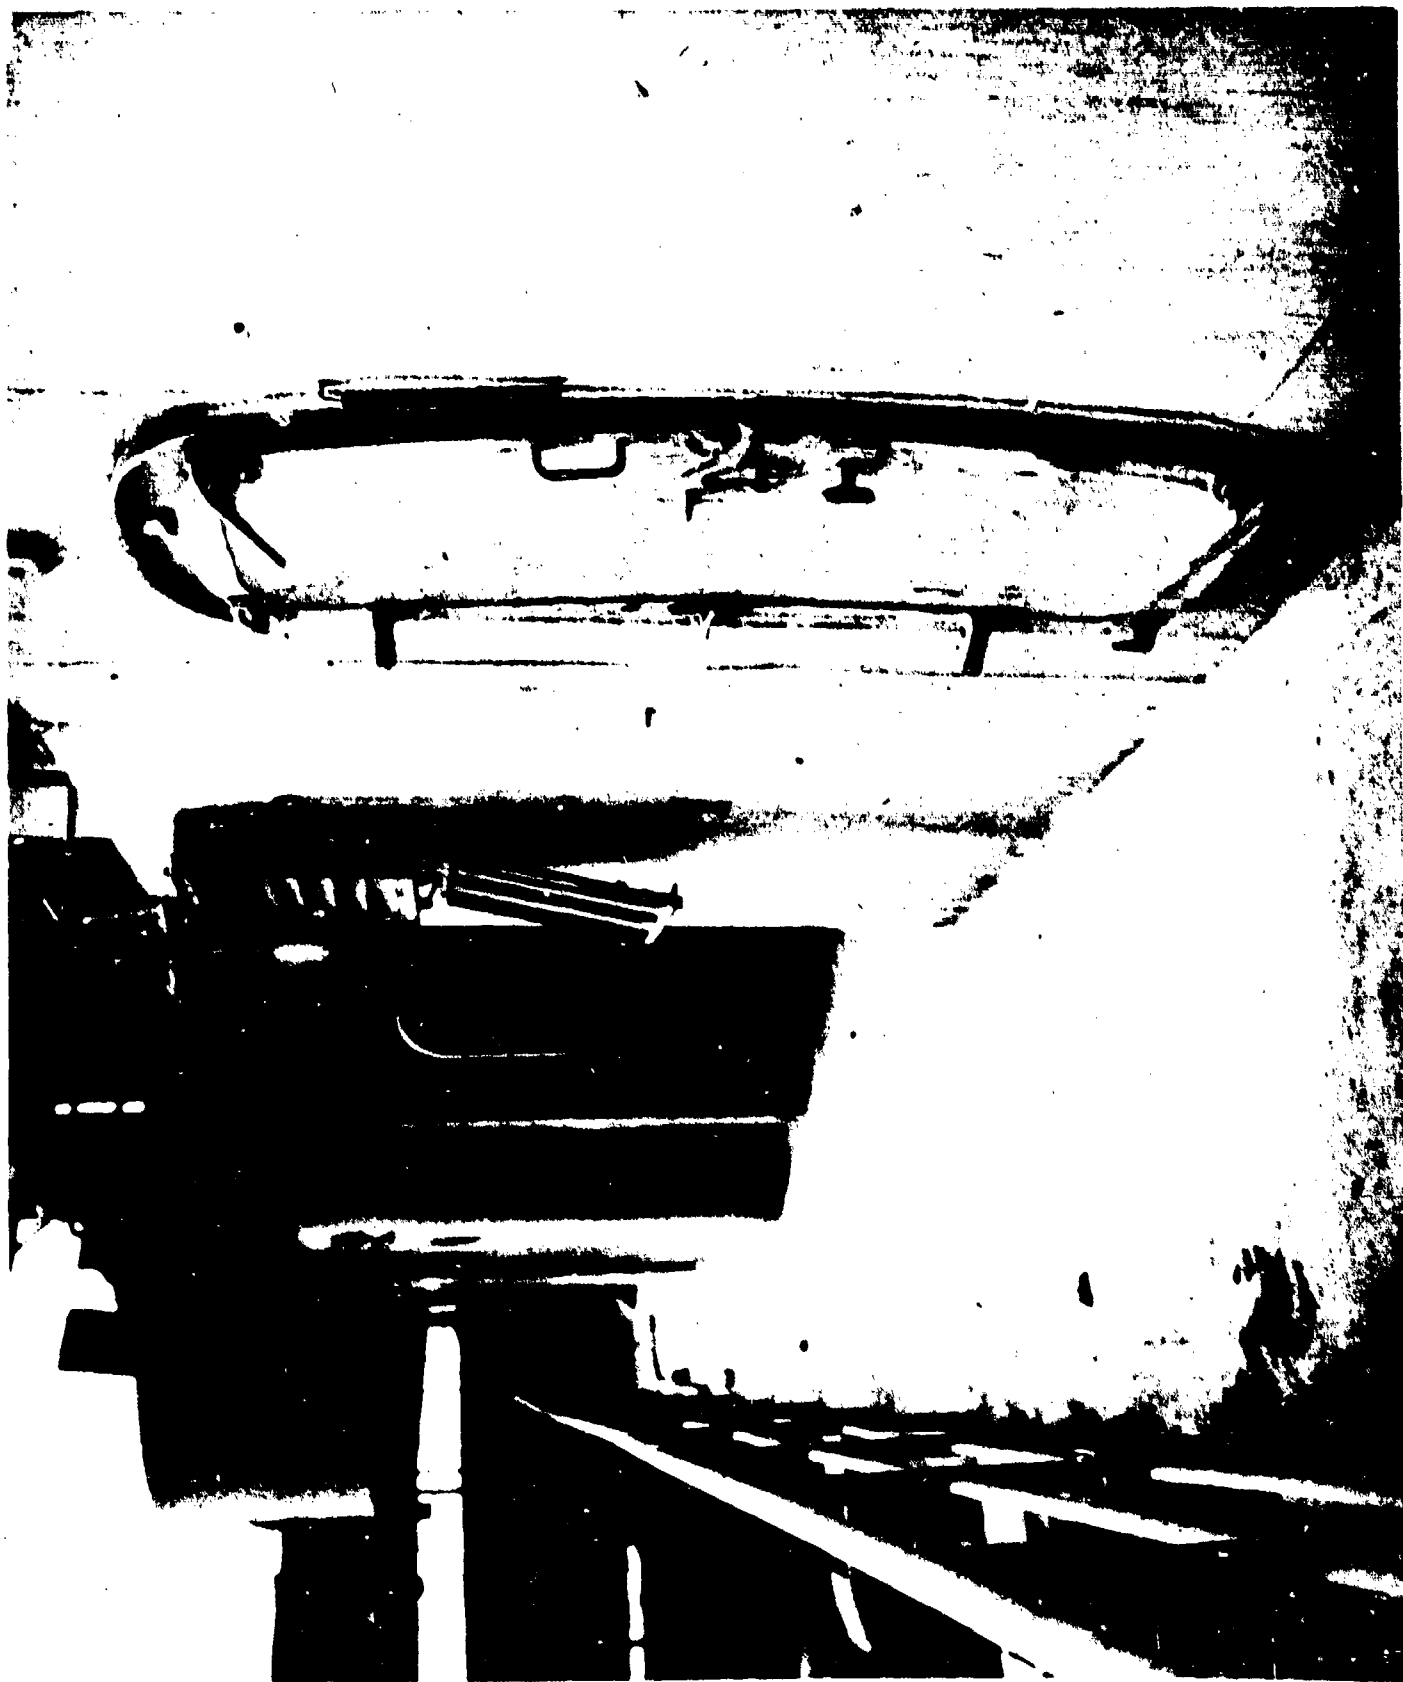
Both stacks are lightly dished on the port side. On the navigating deck, the port longitudinal weather bulkhead is dished a maximum of 1 inch. The door at frame 92, port, is moderately dished (Photo 152-8; page 77 ). A companionway door at frame 68, port, was blown off and fell to the upper deck. Joiner bulkheads in the companionway are damaged.

AB-CR-66-152-8. Navigation deck, port Looking forward on walk-  
way, showing deflected door at frame 92.

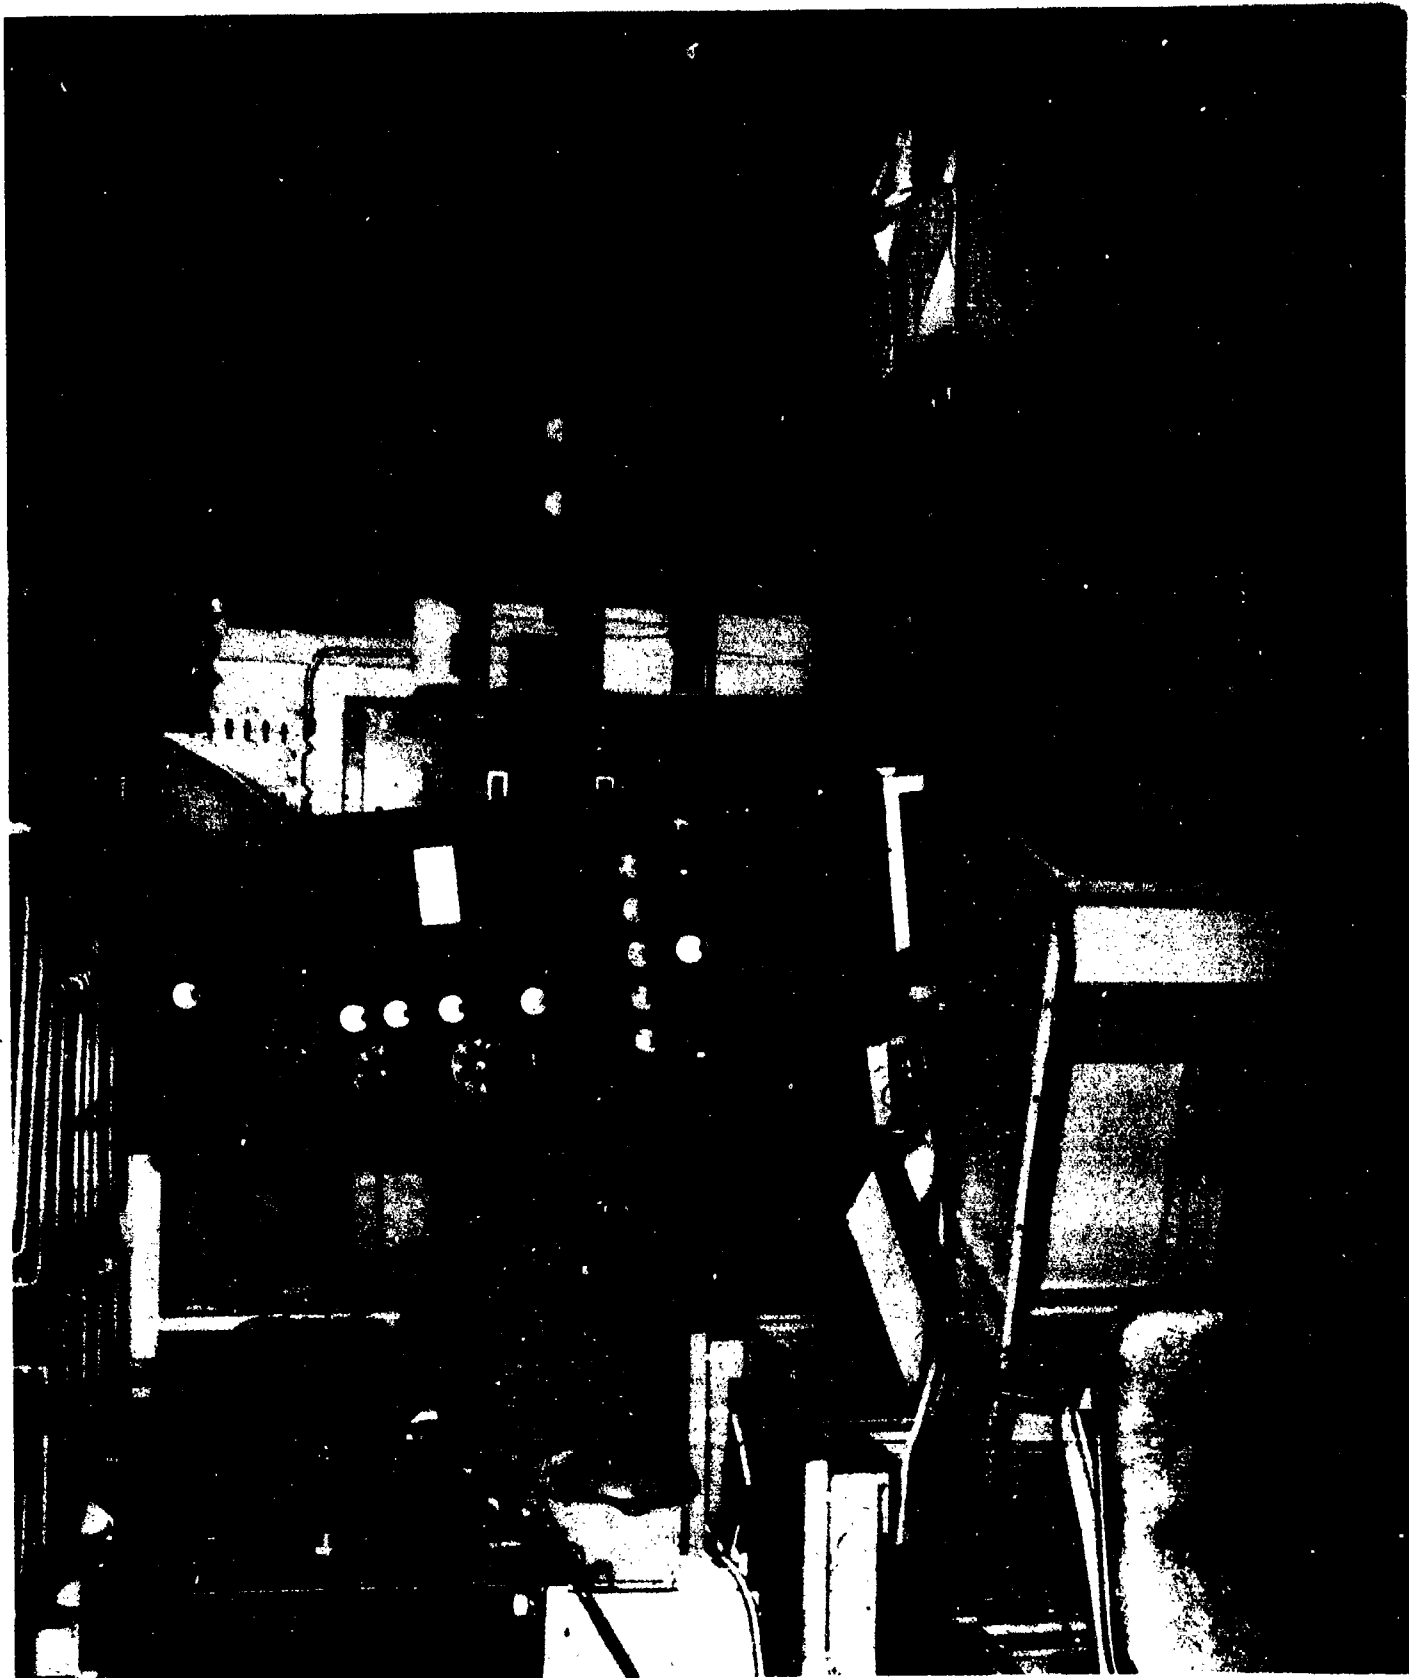
AB-CR-68-152-7. Radio room. Navigation deck, port. Showing displacement of equipment.

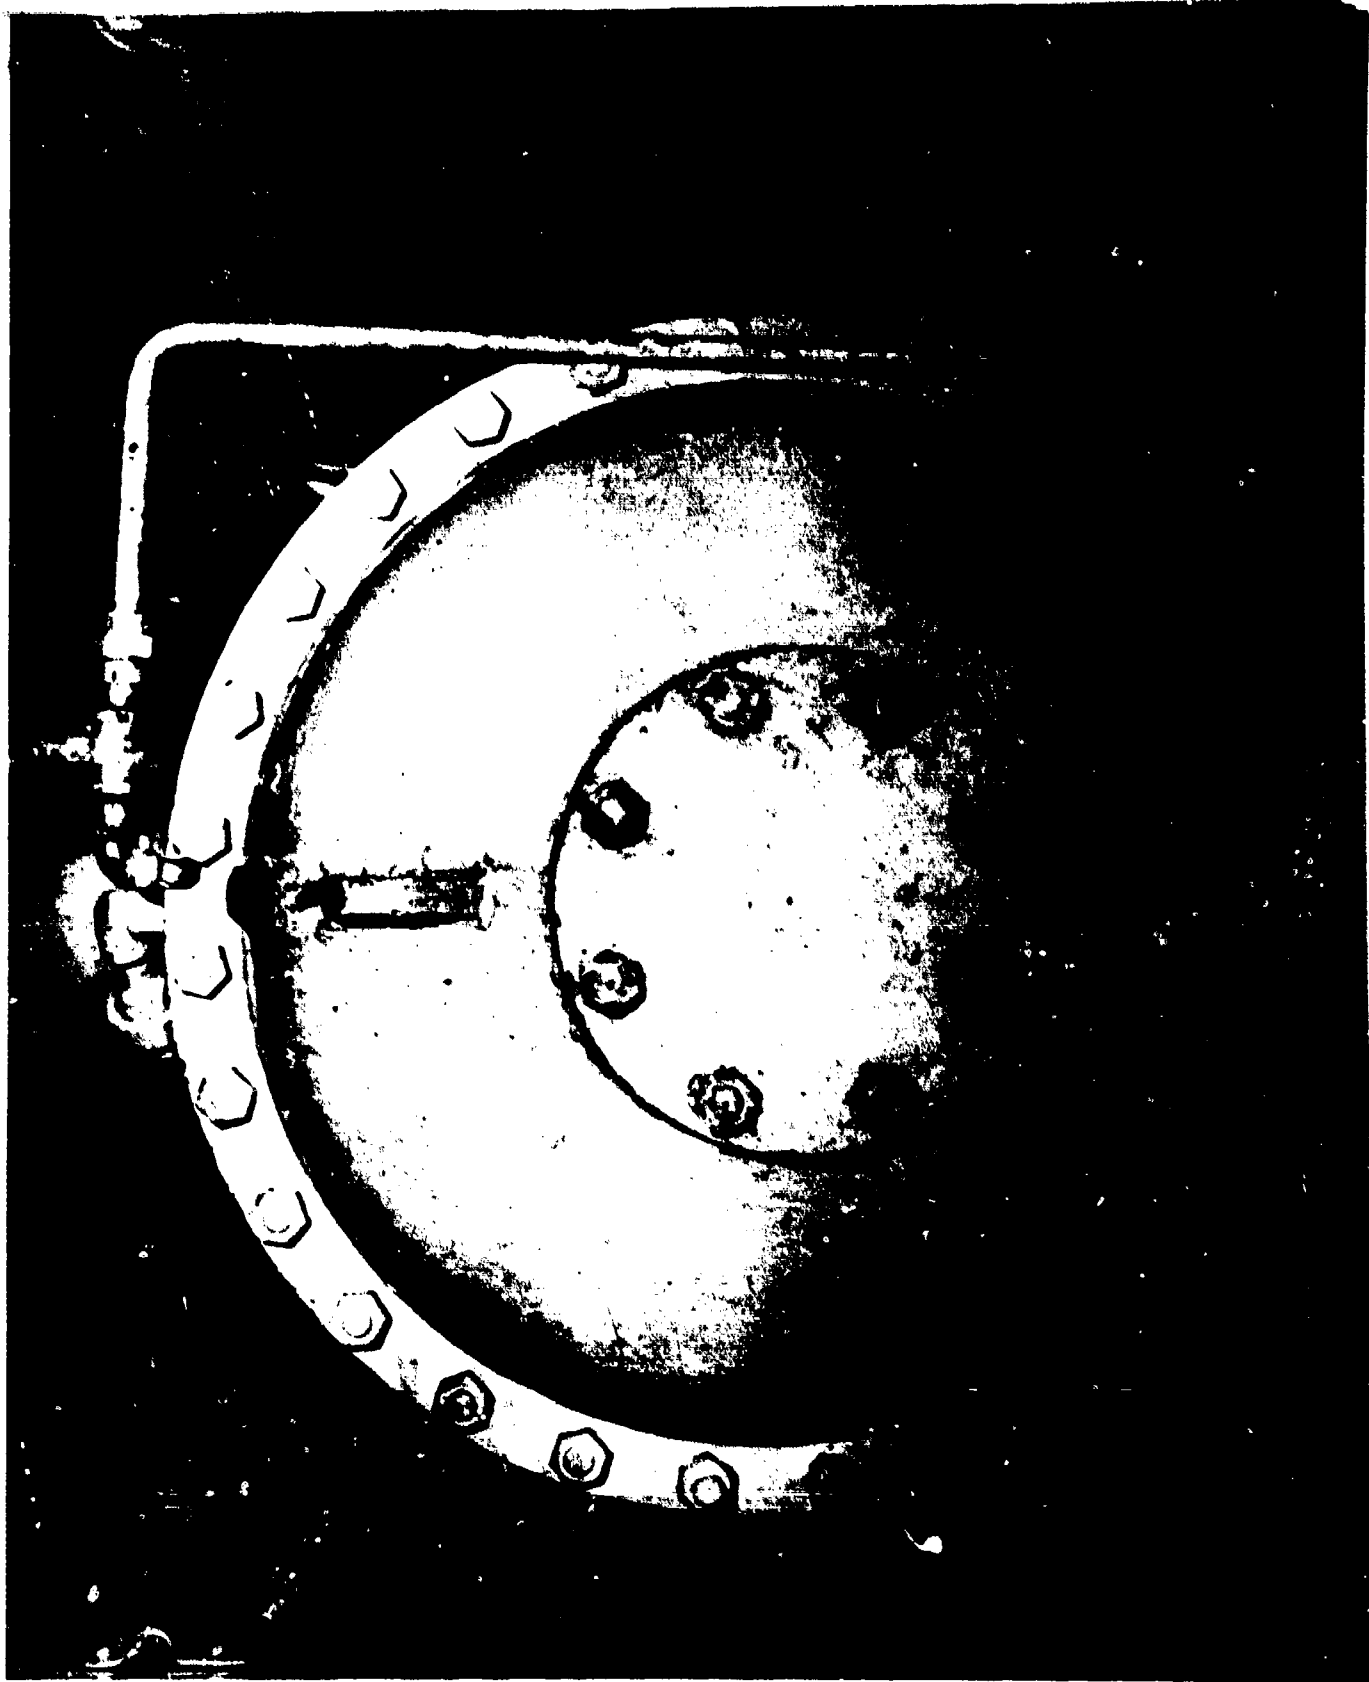
In the forward engine room, a broken 3/4 inch nipple on the salt water side of the auxiliary condenser resulted in flooding of the engine room. Loosening of shaft stern tube glands apparently caused flooding of the shaft alleys.

The forward engine room was flooded to the outside water line. Water entered through a broken vent connection to #1 auxiliary condenser. This injection and overboard valves of this condenser were open during the test. The flooding could have been controlled if the crew had been aboard.

AB-CR-100-2992-2. No. 1 engine room, vent line broken on No. 1 auxiliary condenser.

It is recommended that the design of pipe fittings be studied with a view to making them more resistant to shock. It is also recommended that salt water piping be made more resistant to corrosion perhaps by using coppernickel for this service.
