BUREAU OF SHIPS GROUP TECHNICAL INSPECTION REPORT

USS BUTTE (APA68)

TECHNICAL INSPECTION REPORT

OVERALL SUMMARY

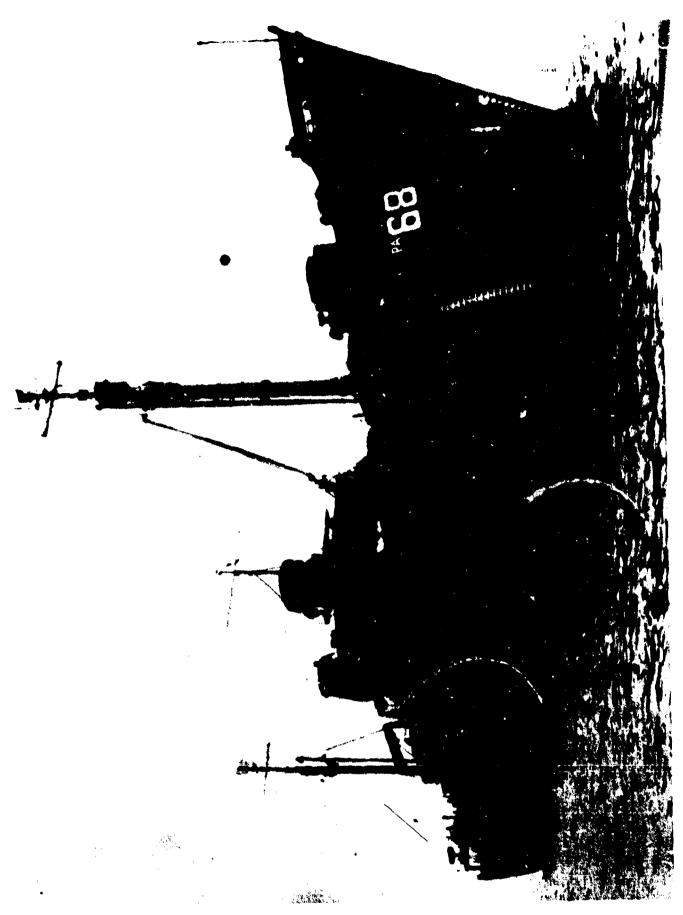
AB-CR-227-283-145. Starboard bow after Test B.

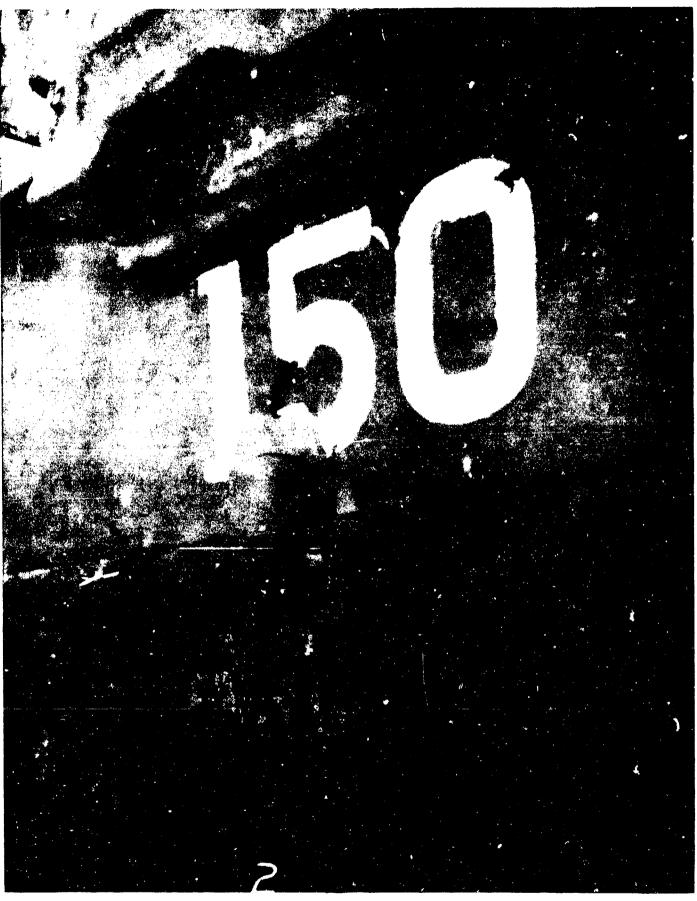
Sixteen hatch boards from the forward cargo hatch and ten hatch boards from the after hatch were dislodged and fell through to the main deck. A fragment pierced the upper deck at frame 150, starboard (Photos. 1674-1 and 2; pages 34 and 35).

AB-CR-81-1674-2. Fragment hole in upper deck.
