**BUREAU OF SHIPS GROUP  
TECHNICAL INSPECTION REPORT**

⑥ OPERATION CROSSROADS  
U.S.S. LCI's 327, 329, 332, 549.  
TEST BAKER [U]

USS LCI's 327, 329, 332, 549

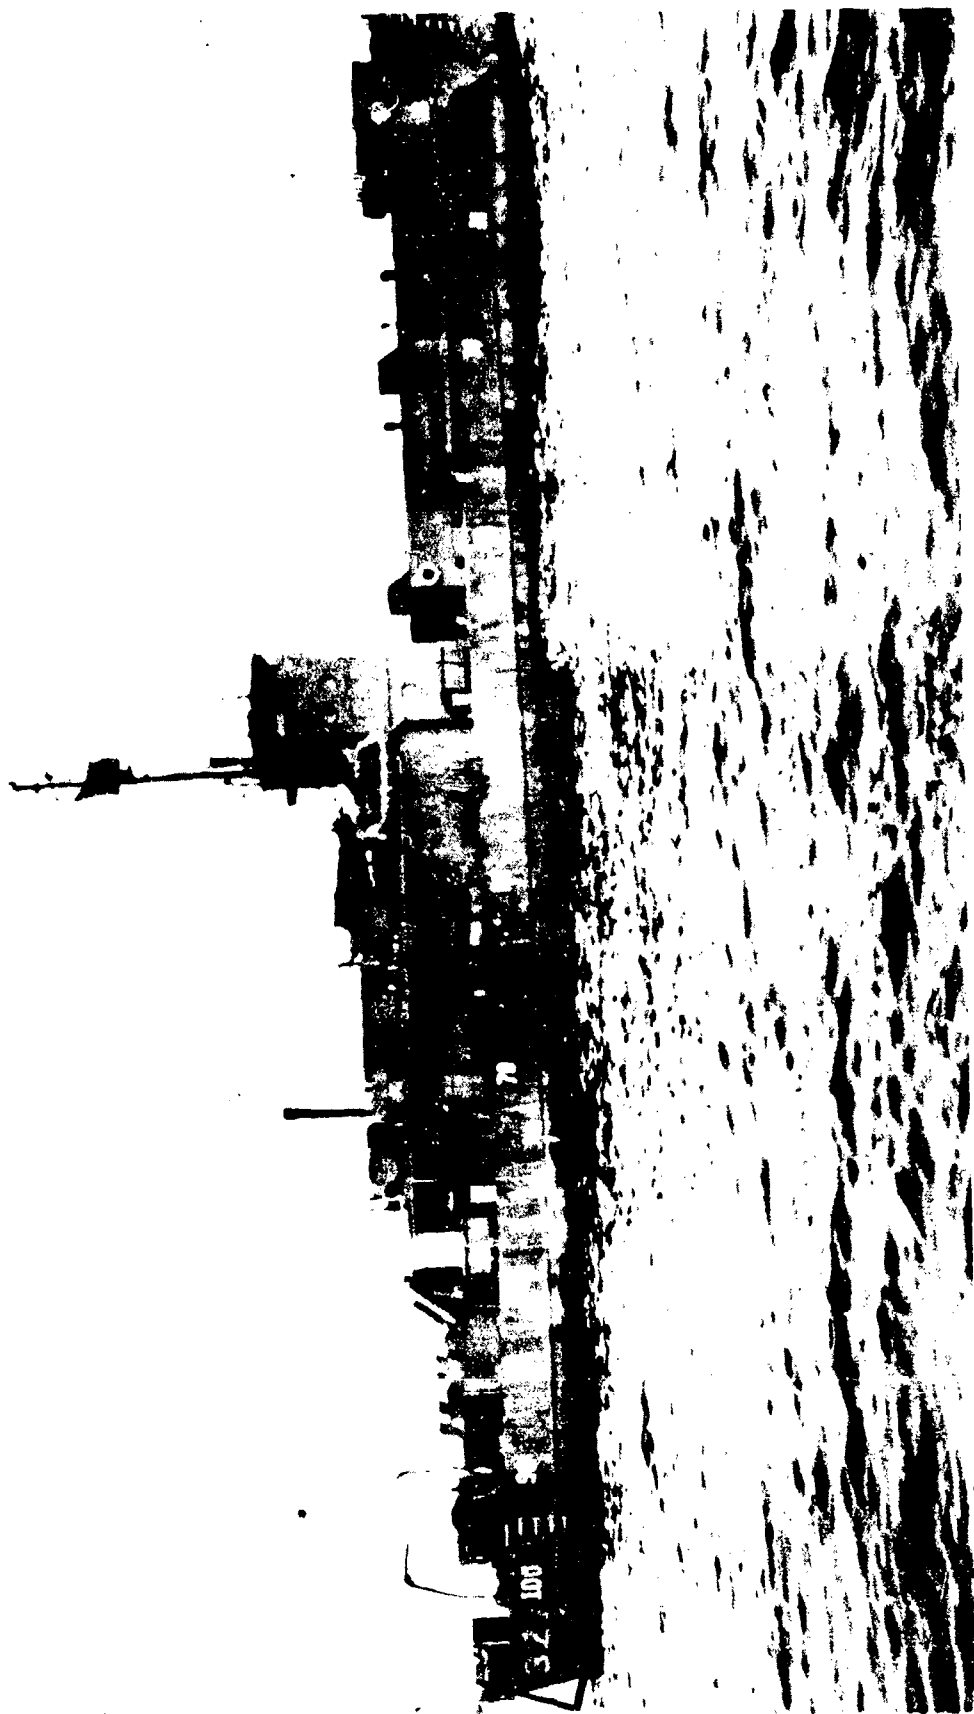
AB-CR-227-290-74. View from starboard beam after Test B.

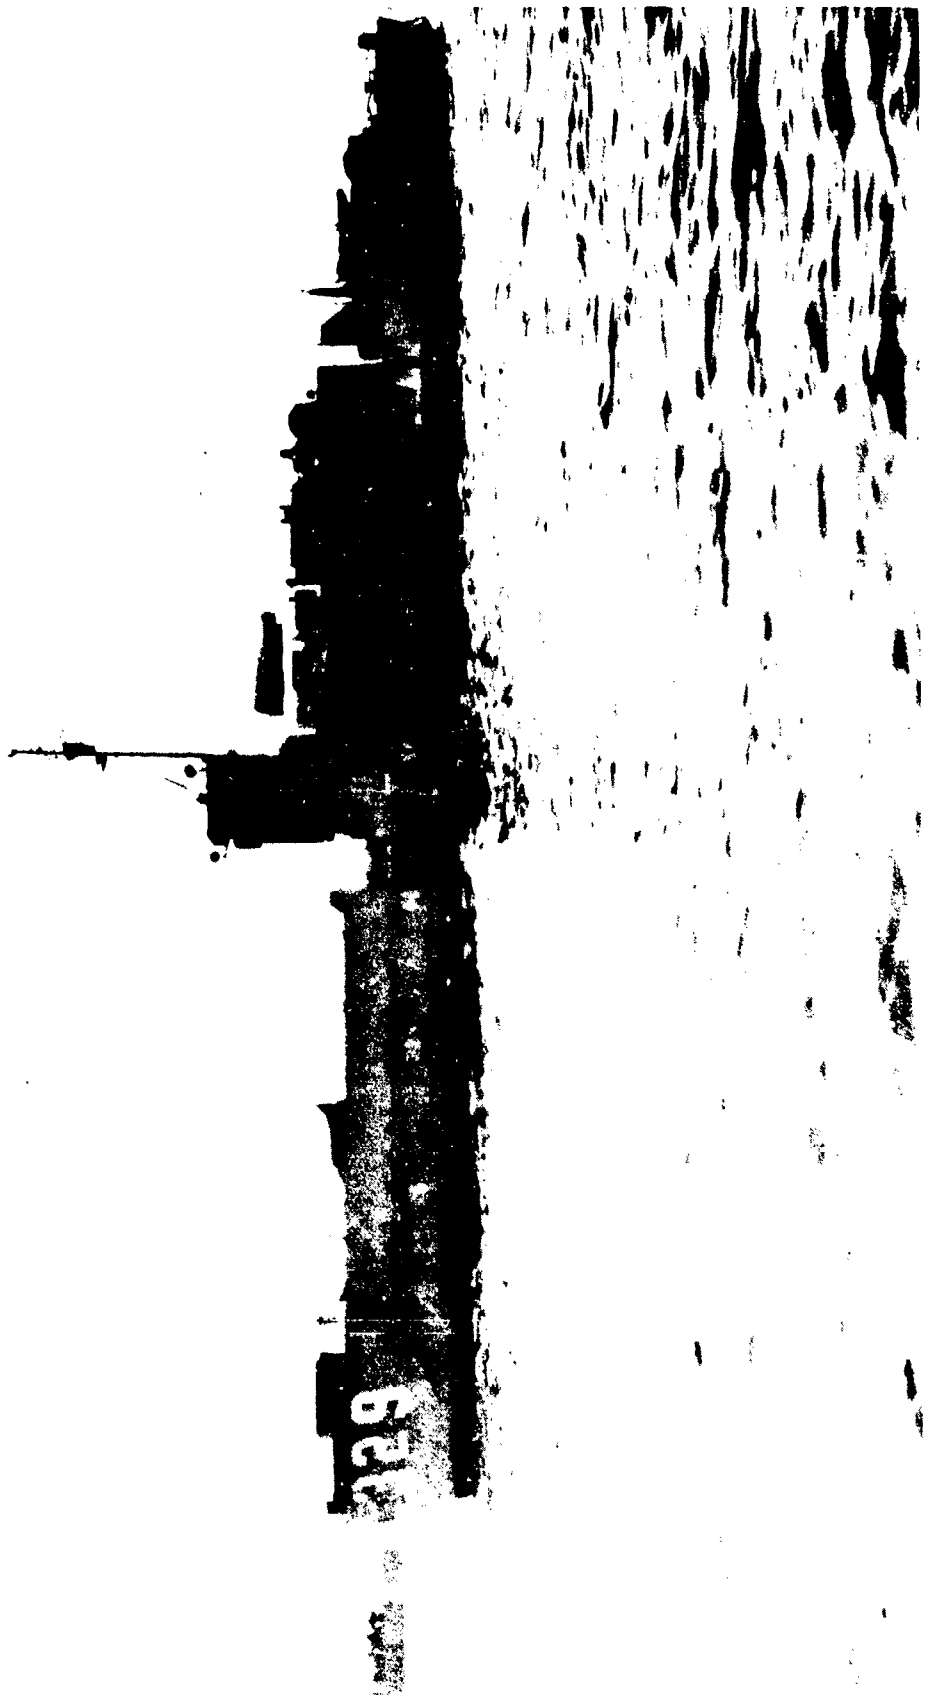
AB-CR-227-290-70. View from port beam after Test B.

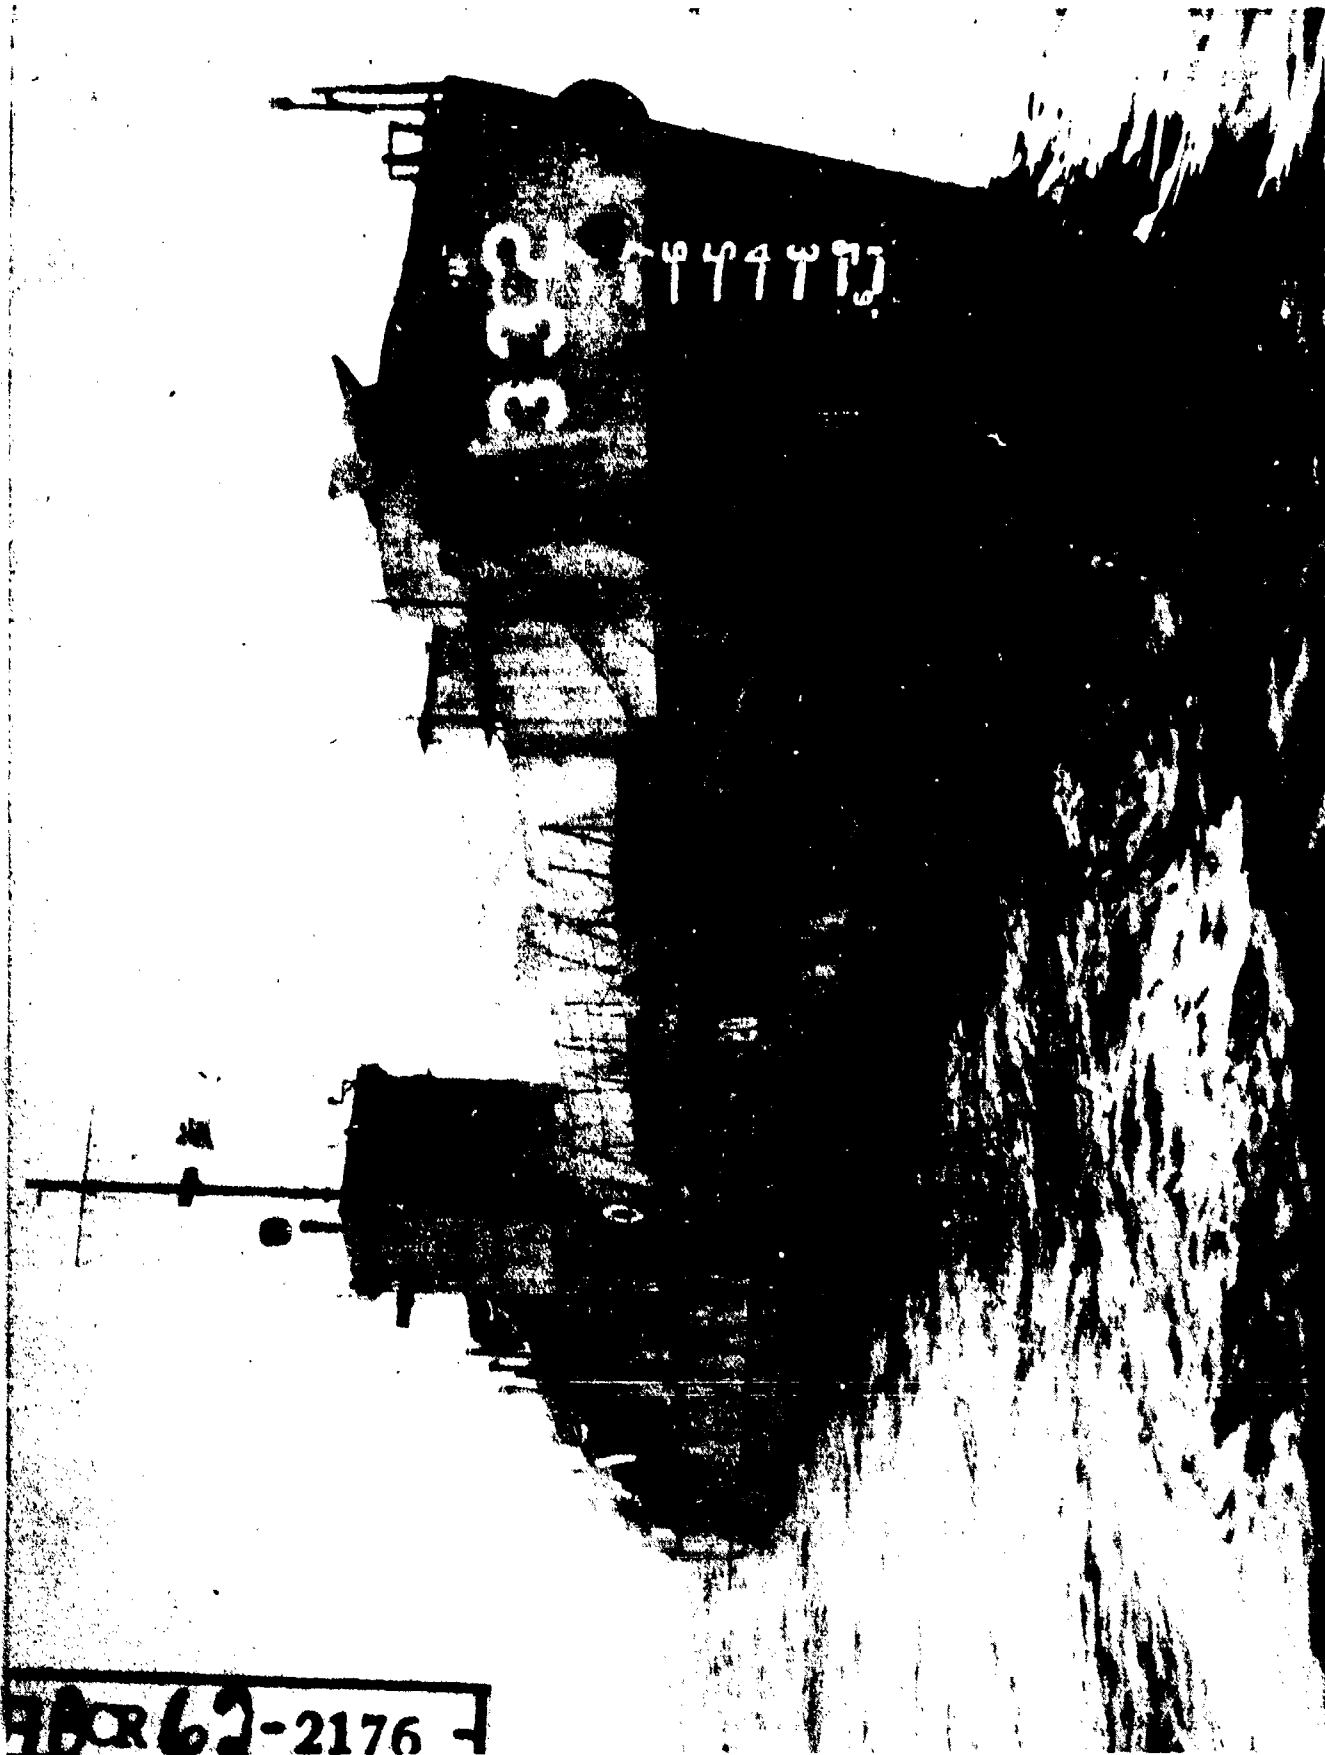
AB-CR-62-2176-1. View from starboard bow after Test B.

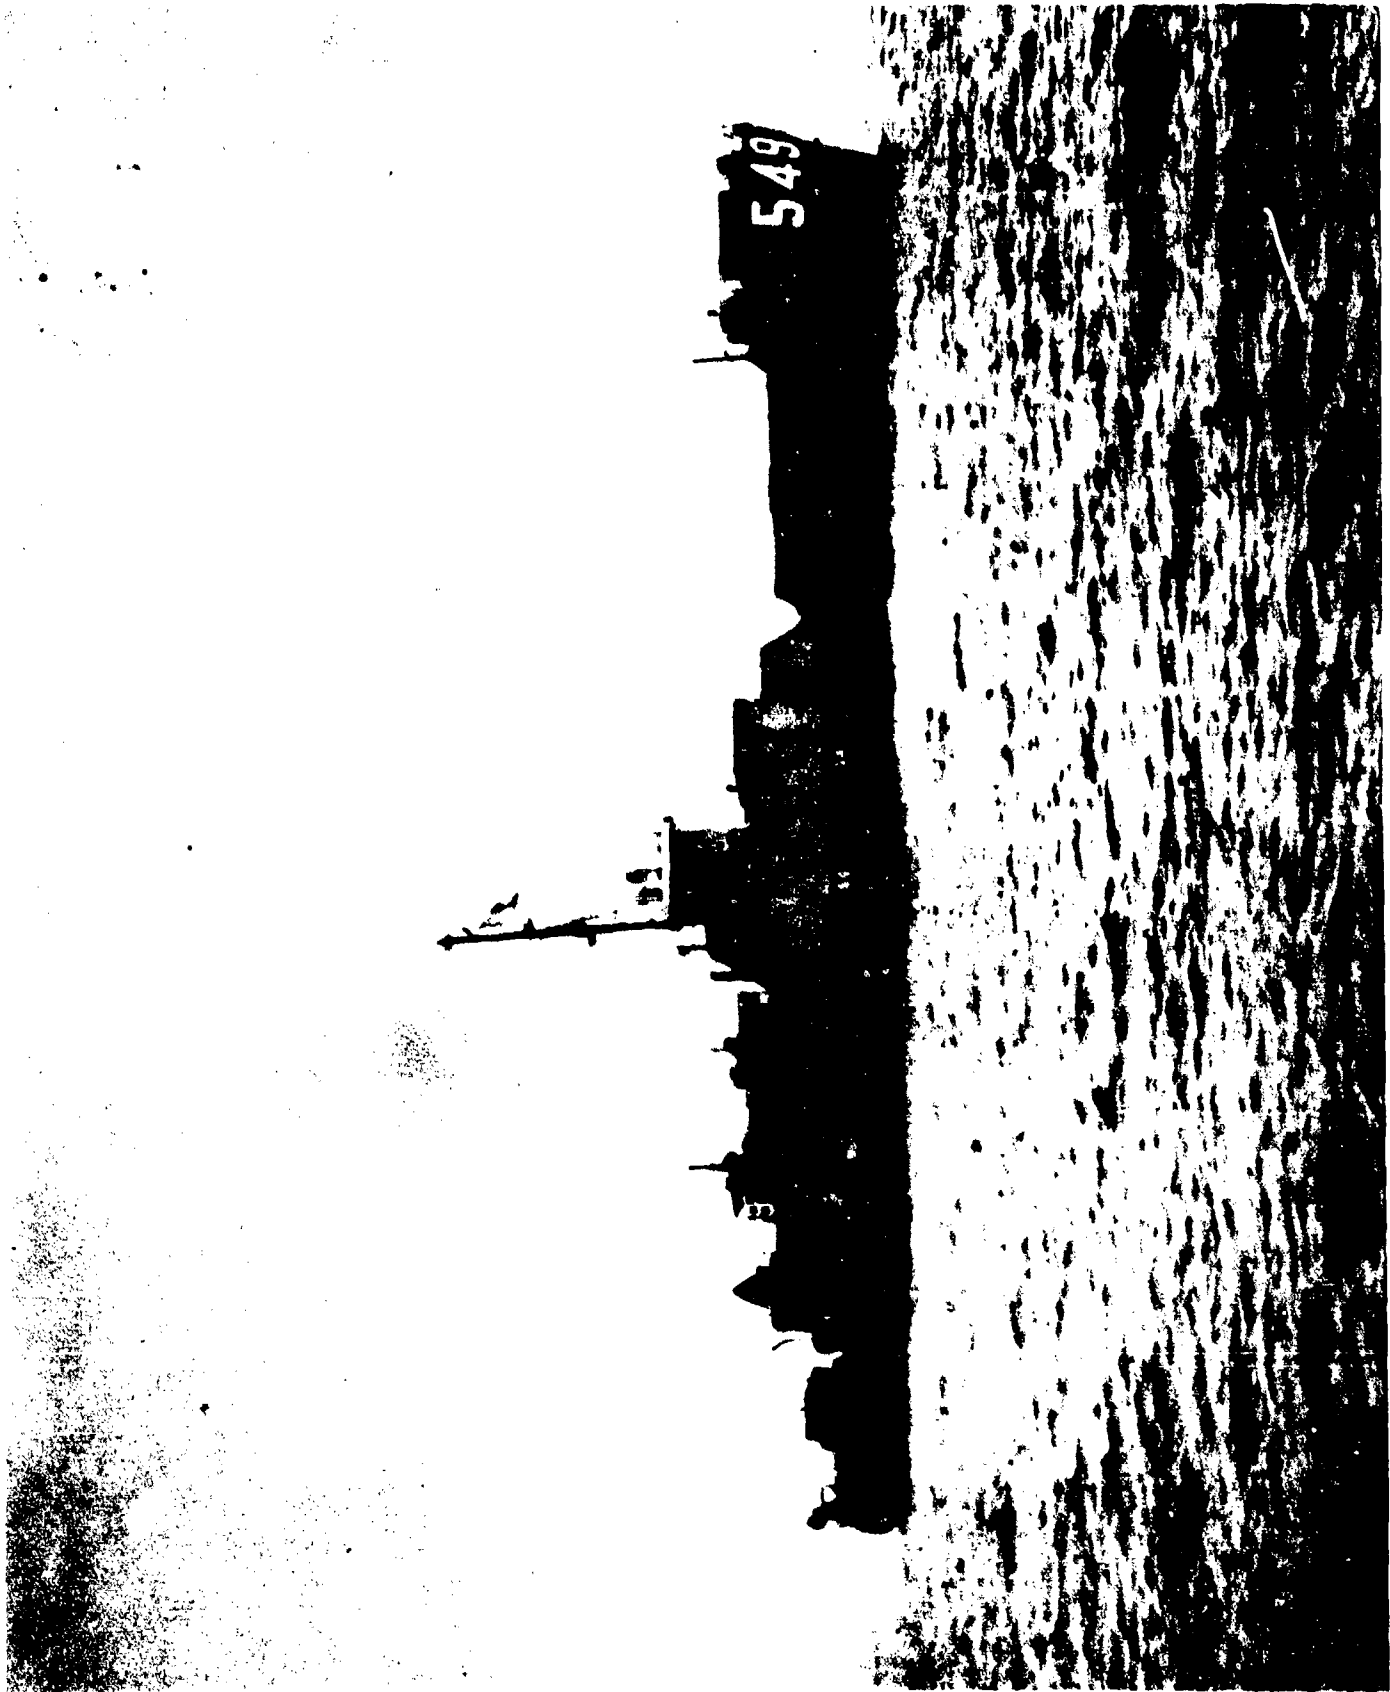
AB-CR-227-290-58. View from starboard beam after Test B.
