ELECTRONICS COORDINATING OF
SHIP PREPARATION
and
TARGET INSPECTION

FINAL REPORT
TESTS ABLE AND BAKER

✓ **VOLUME 2**
PHOTOGRAPHIC RECORD

DIRECTOR OF SHIP MATERIAL
JOINT TASK FORCE ONE
OPERATION CROSSROADS

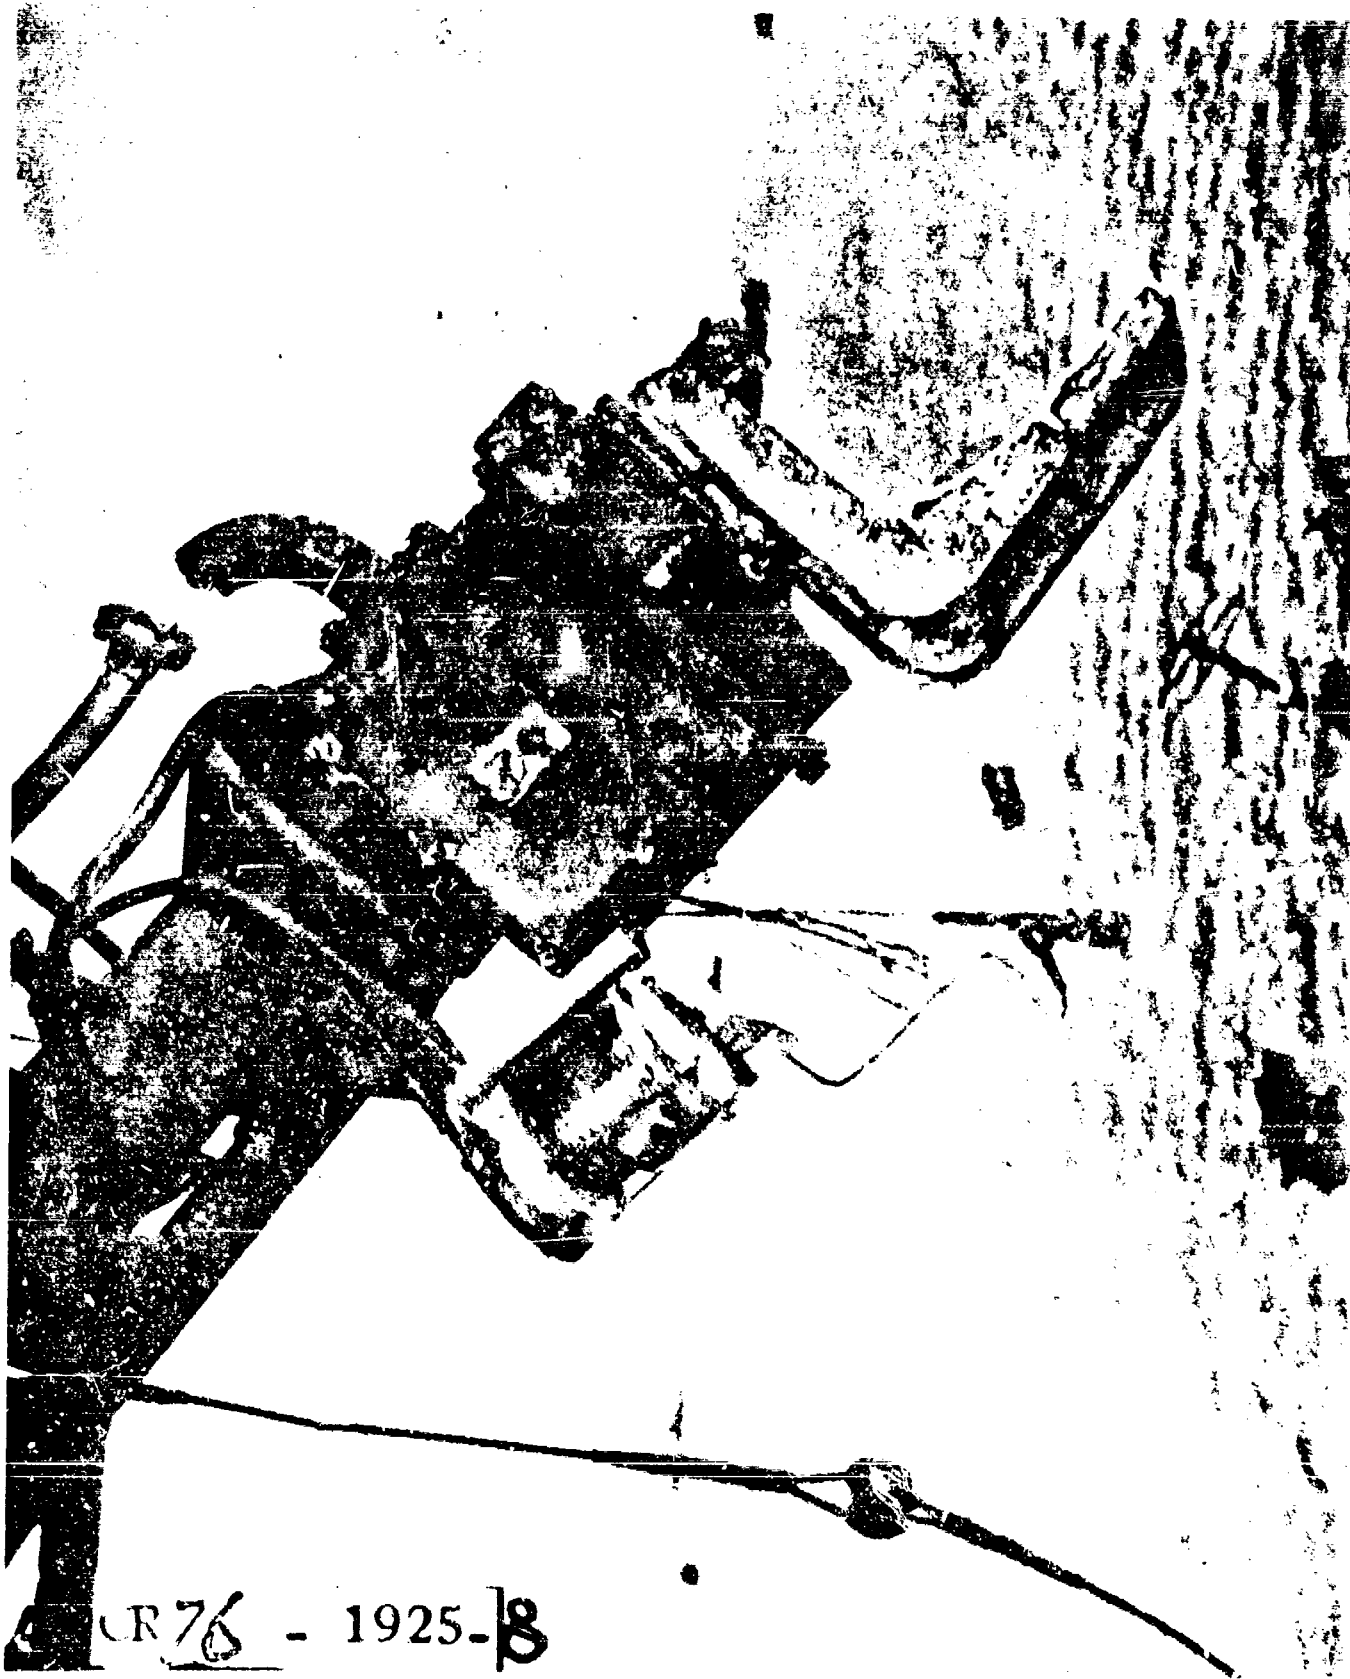
POST ABLE - FORWARD SG ANTENNA. This is one of the few SG antennas which did not survive the direct blast on test. One side of the reflector and the gooseneck nozzle were broken and missing. The waveguide at the entrance to the antenna was also broken.

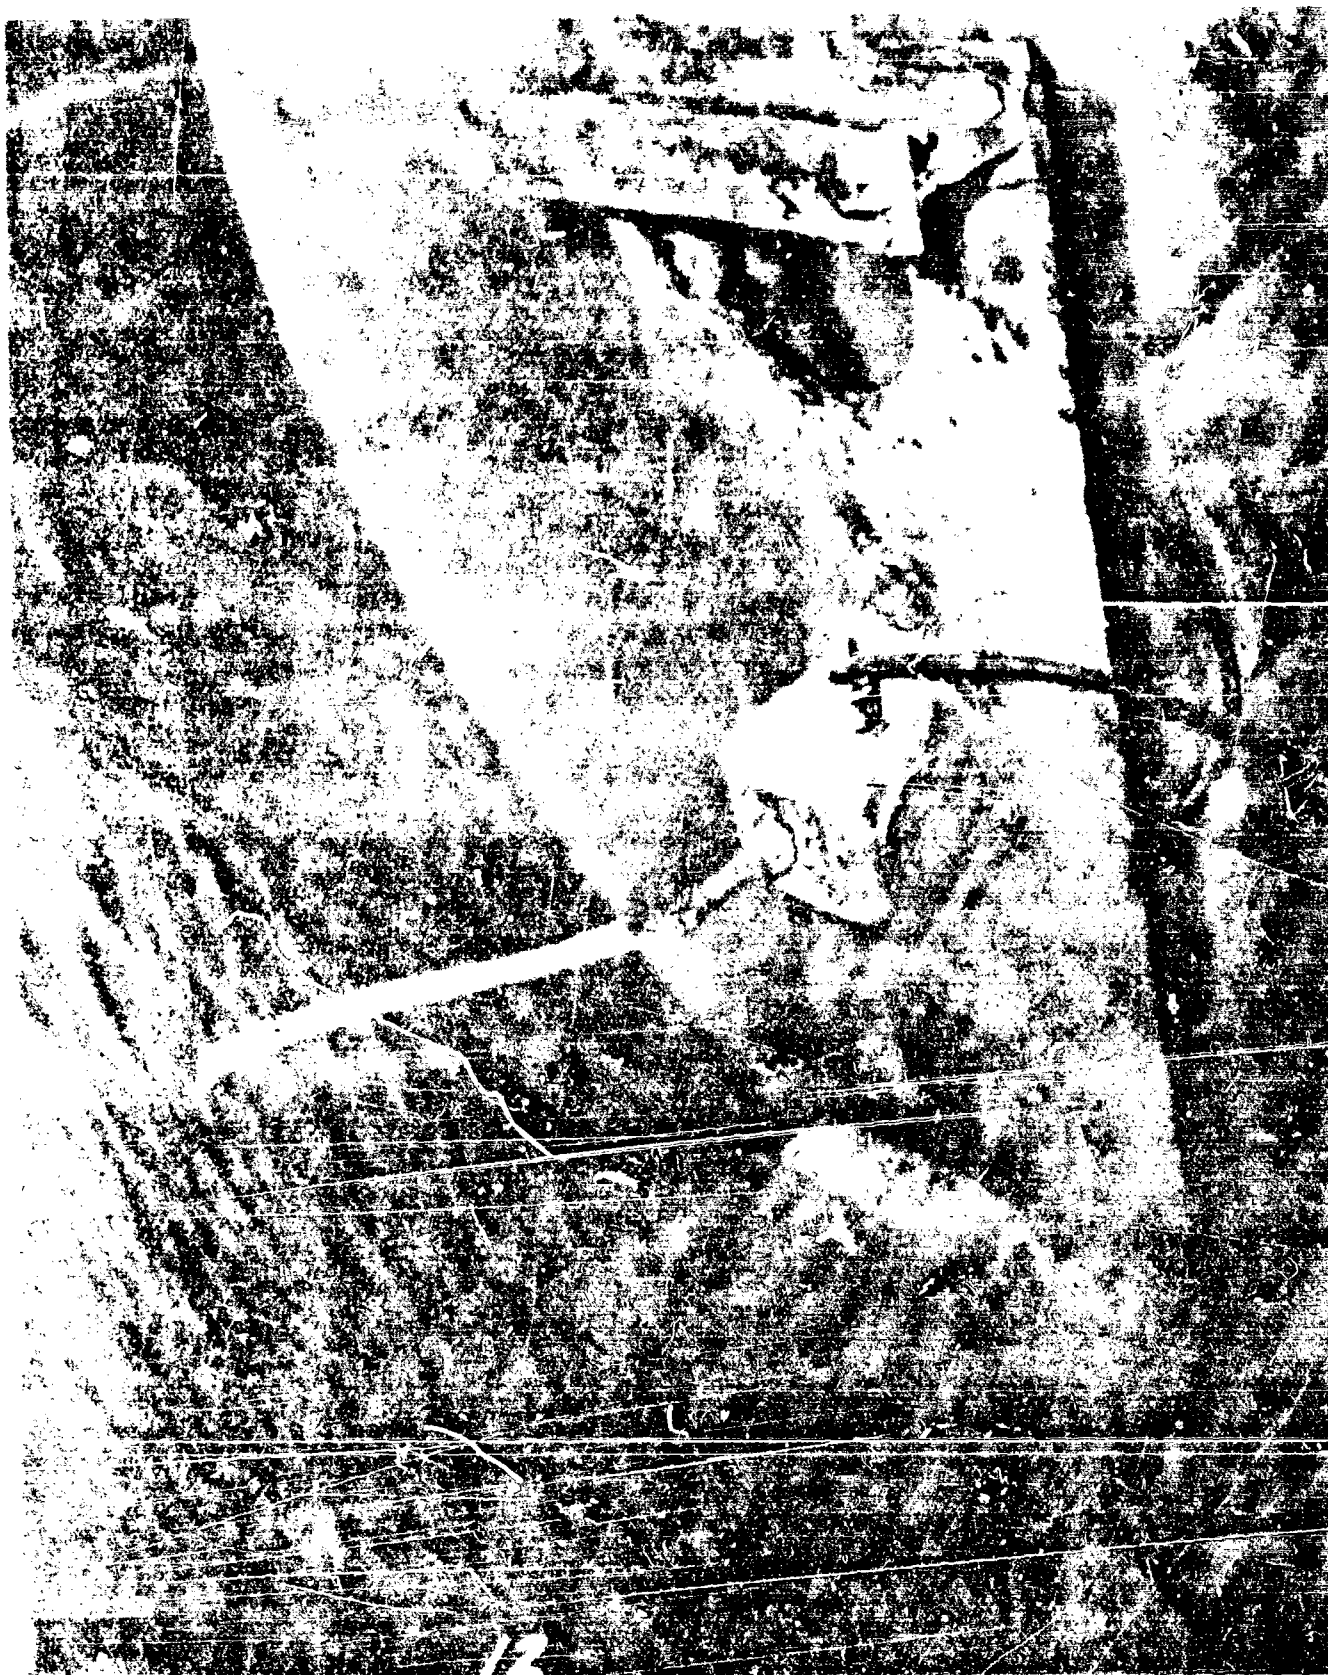
POST BLEN - NK R RADAR ANTENNA. Supporting framework failed completely as blast blew antenna from mount.

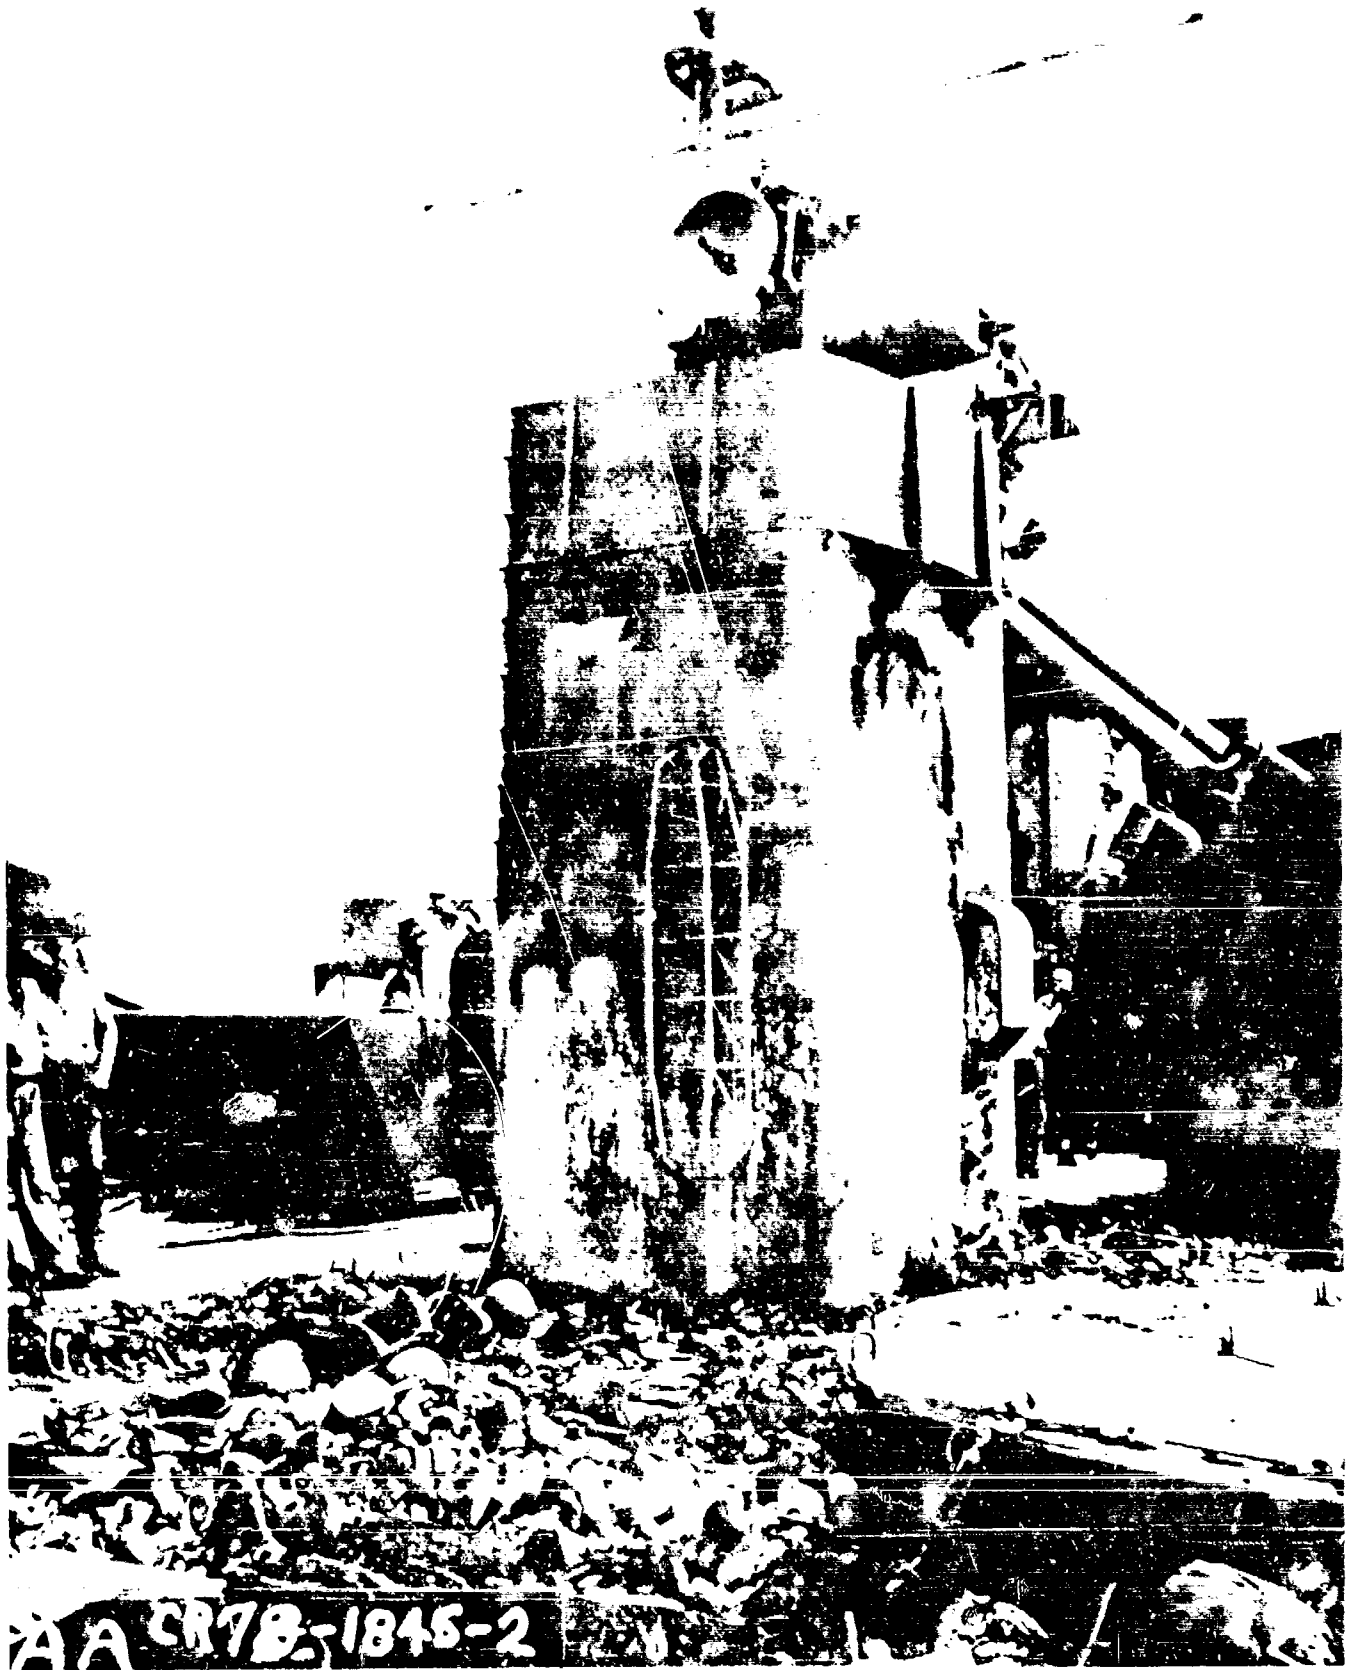
POST ABLE - DECKHOUSE CONTAINING MK 29 FIRE CONTROL RADAR. Radiation from blast set Army equipment on deck afire and burned outside of deckhouse. Heat caused damage to cables, melted tar out of transformers and smoked up equipment inside deckhouse. One meter was damaged. Equipment would probably have operated if cables had not failed.

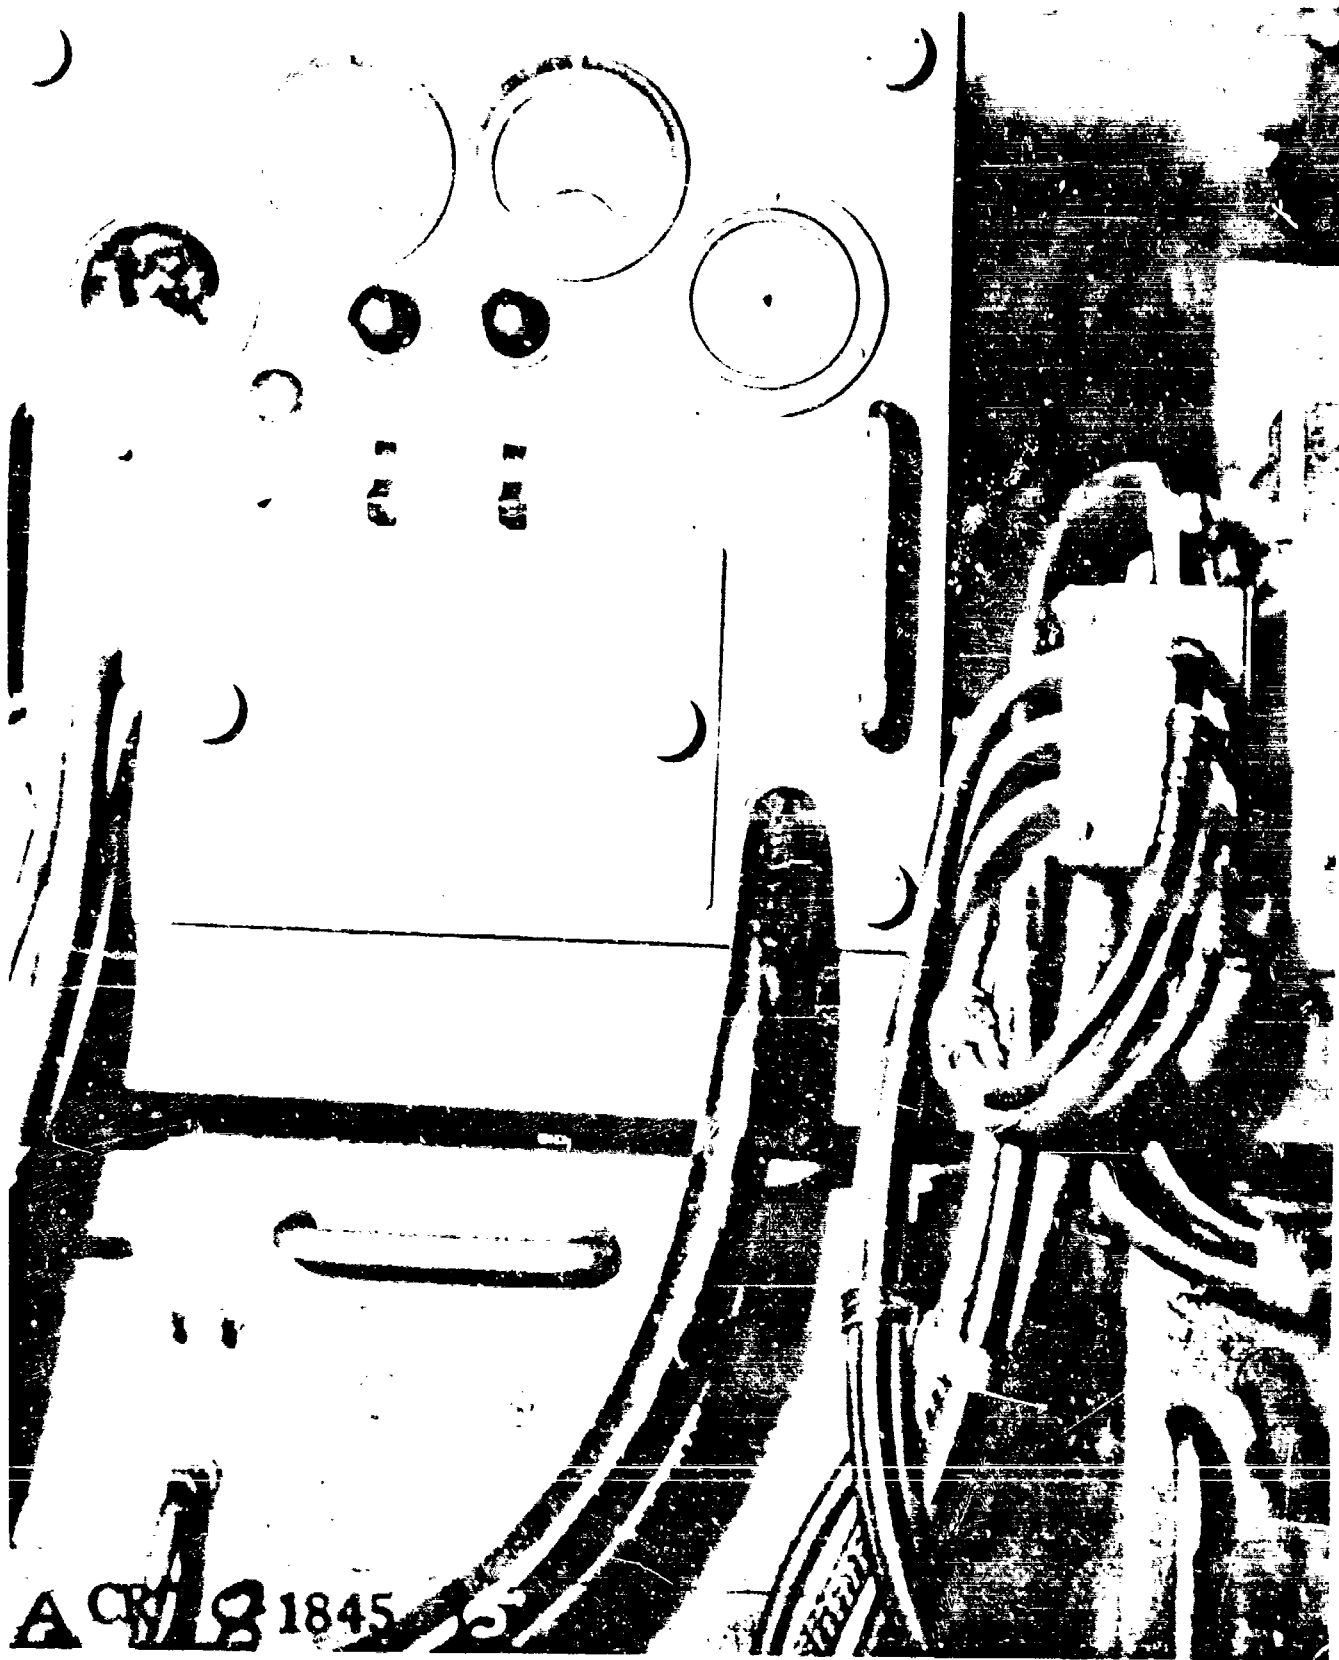
POST ABLE - MK 29 RADAR POWER CONTROL UNIT. Shows the damage done to the meters by the intense heat. Meter needles were against stop pin at zero end of scale, indicating that movements had been damaged. Plastic around zero set screw in center of meter on right was badly burned.

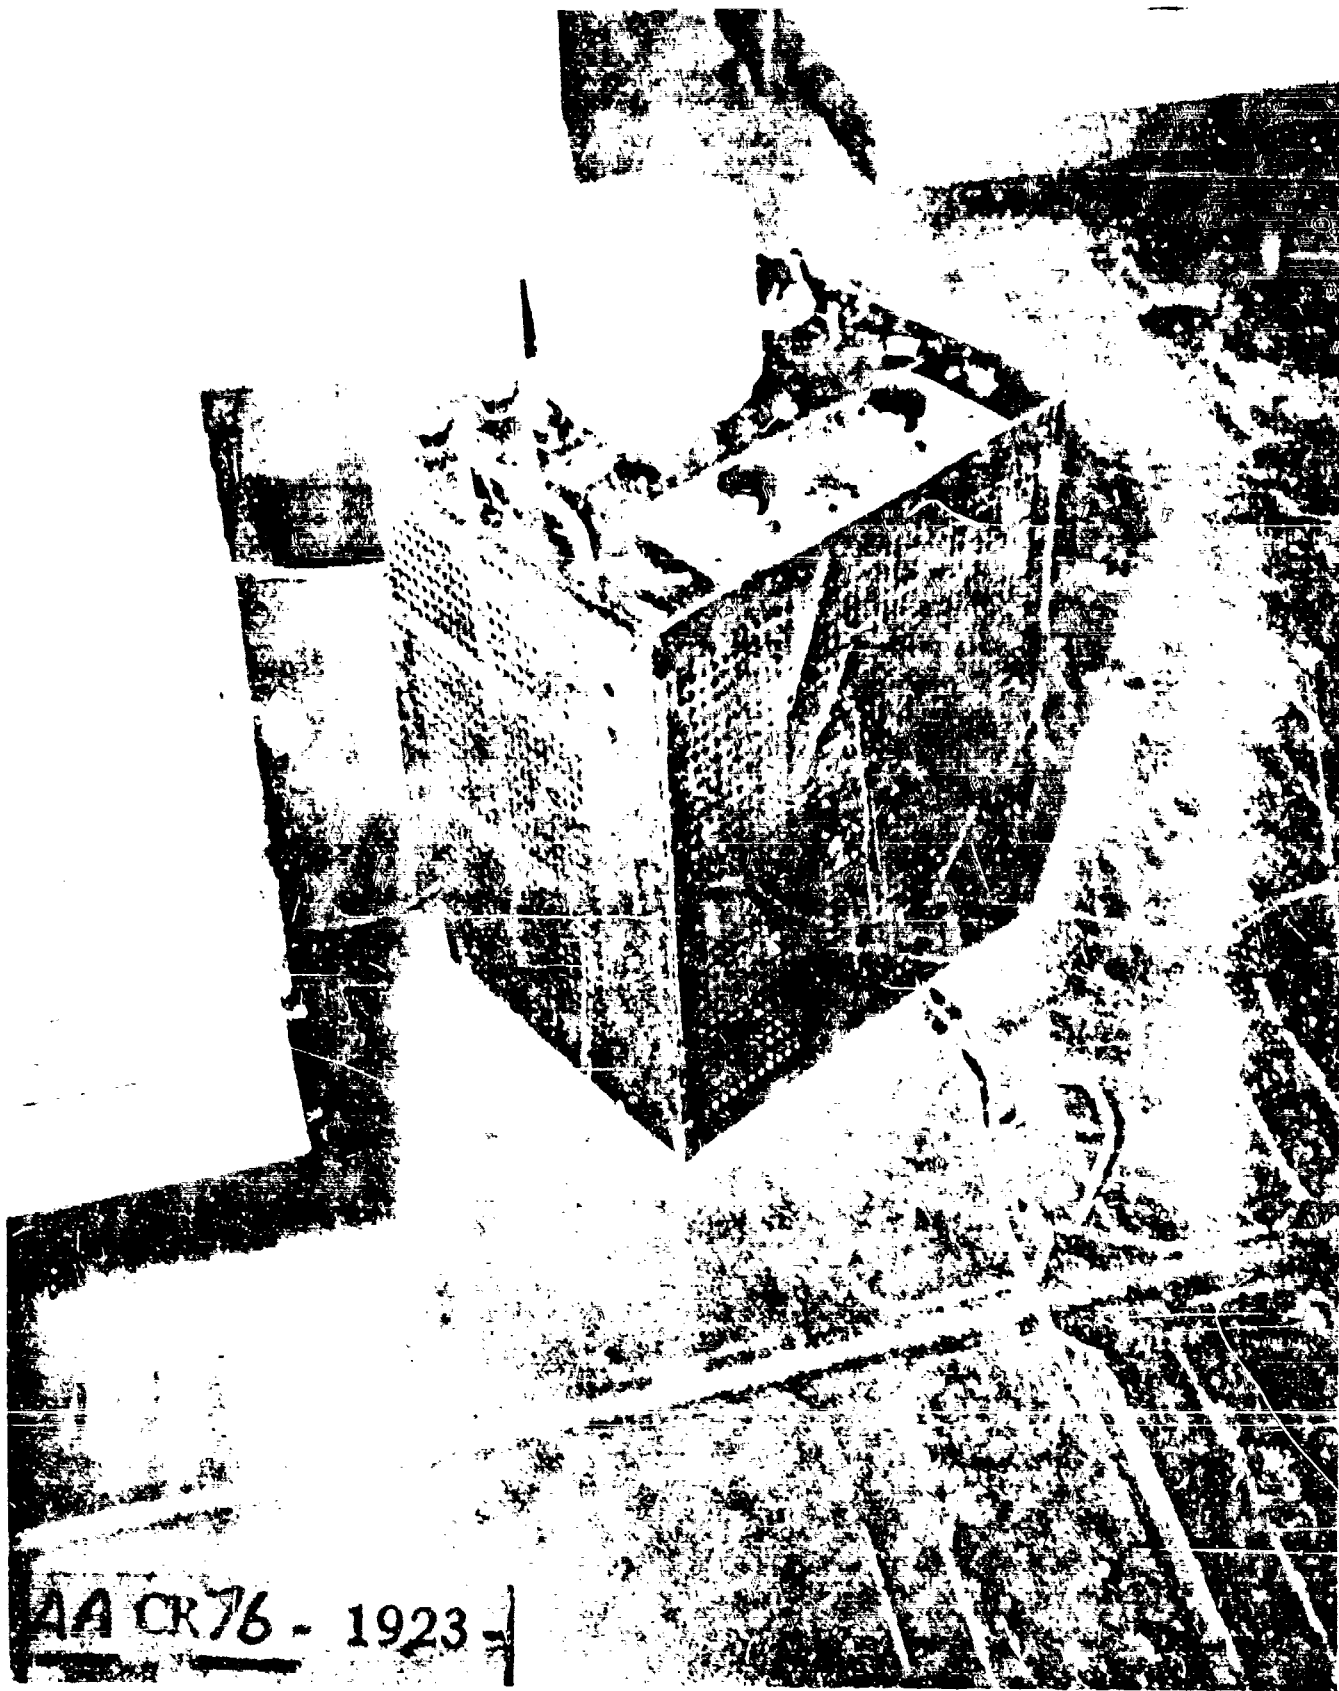
POST ABLE - LORAN. Aircraft type mounting racks are unsuitable for this type equipment. Practically the only damage suffered to loran equipment was the result of equipment being thrown to the deck.

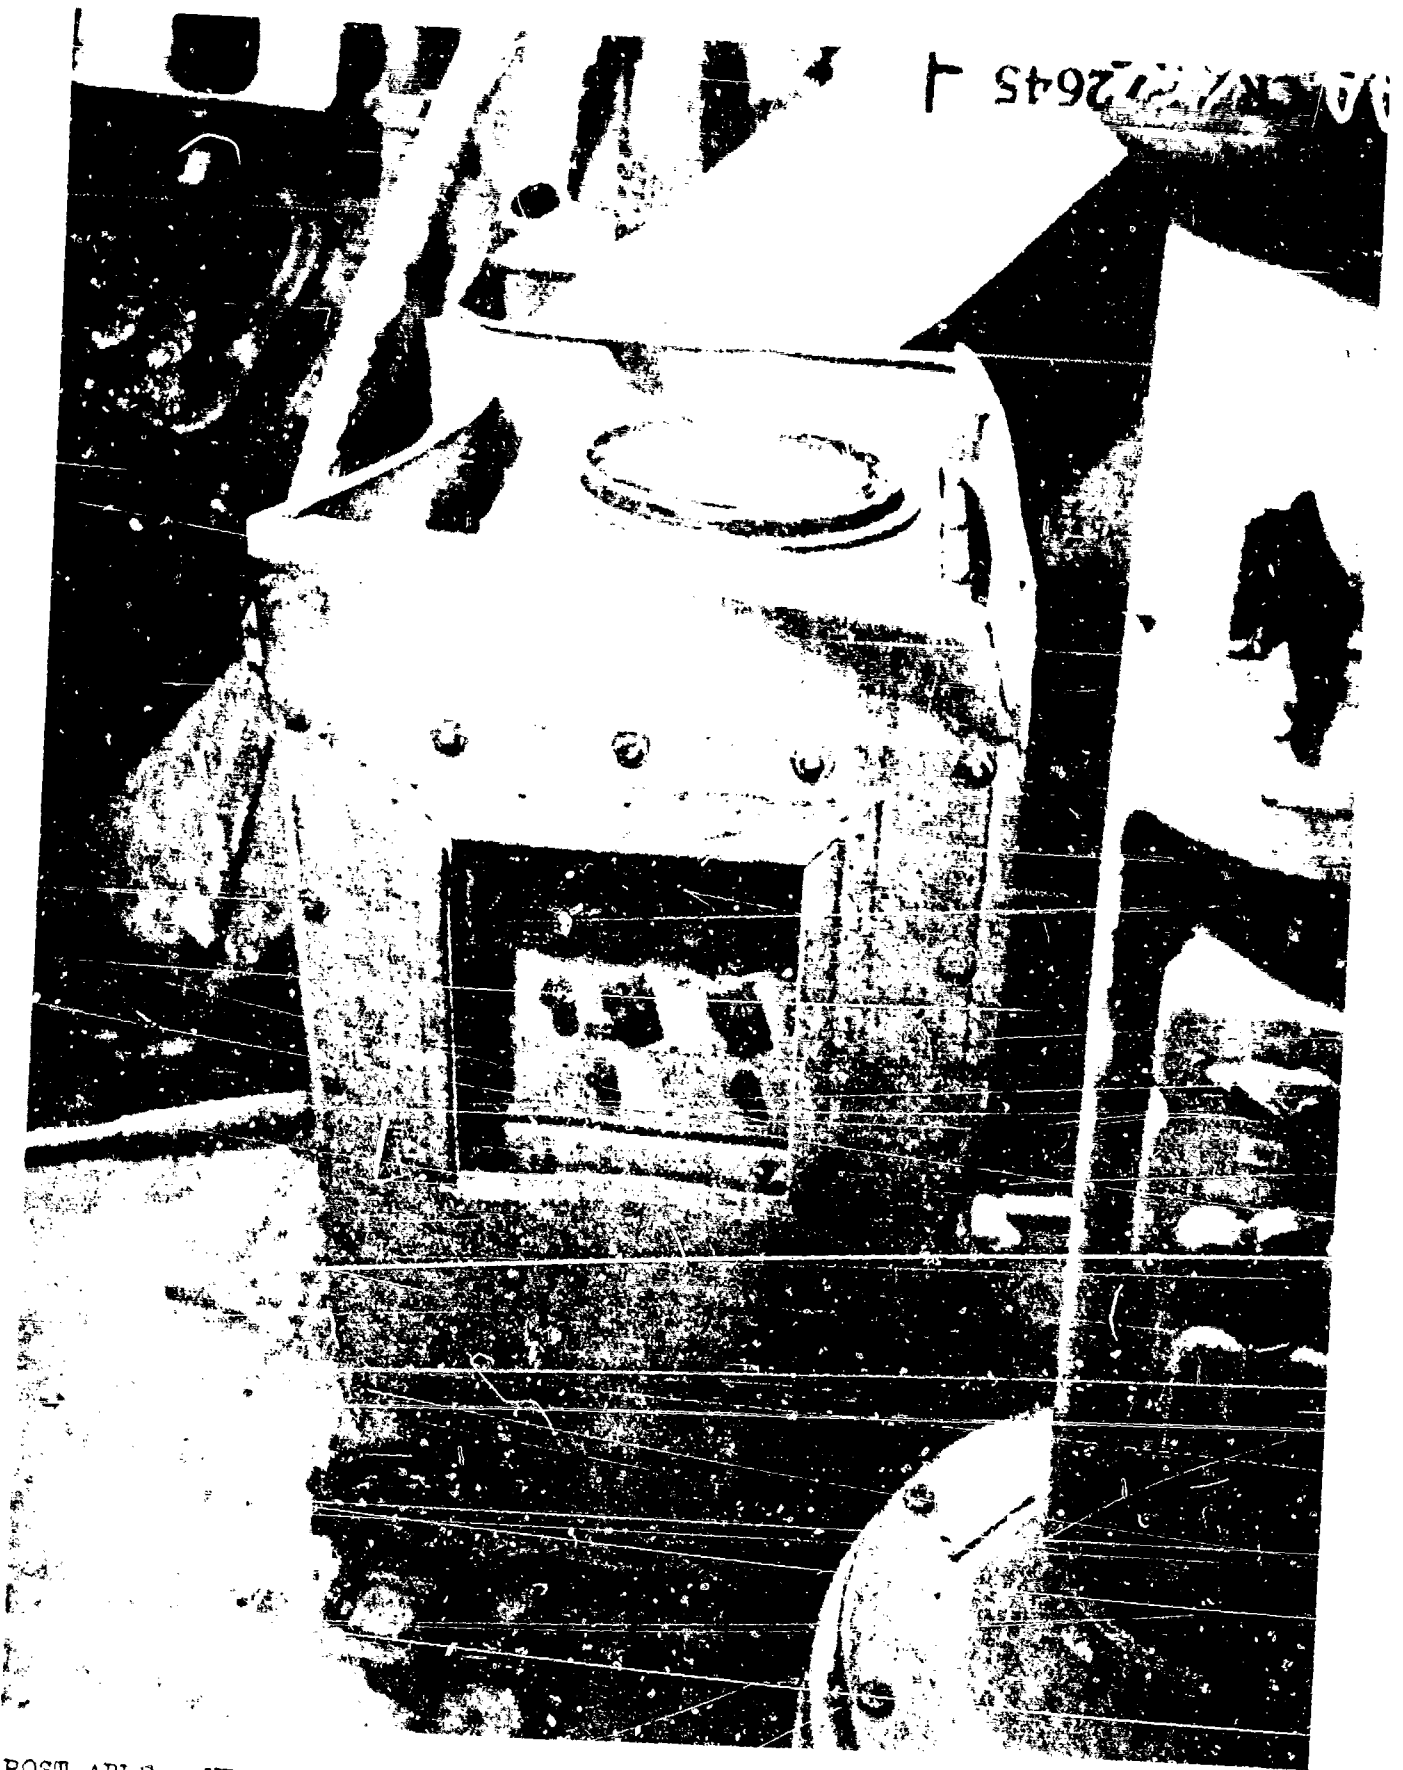
POST ABLE - VD-2 Equipment on open bridge. Welds parted on foundations, and subsequent movement of VD-2 parted cables. Housing sides were warped and top blown off, but VD-2 was apparently undamaged.

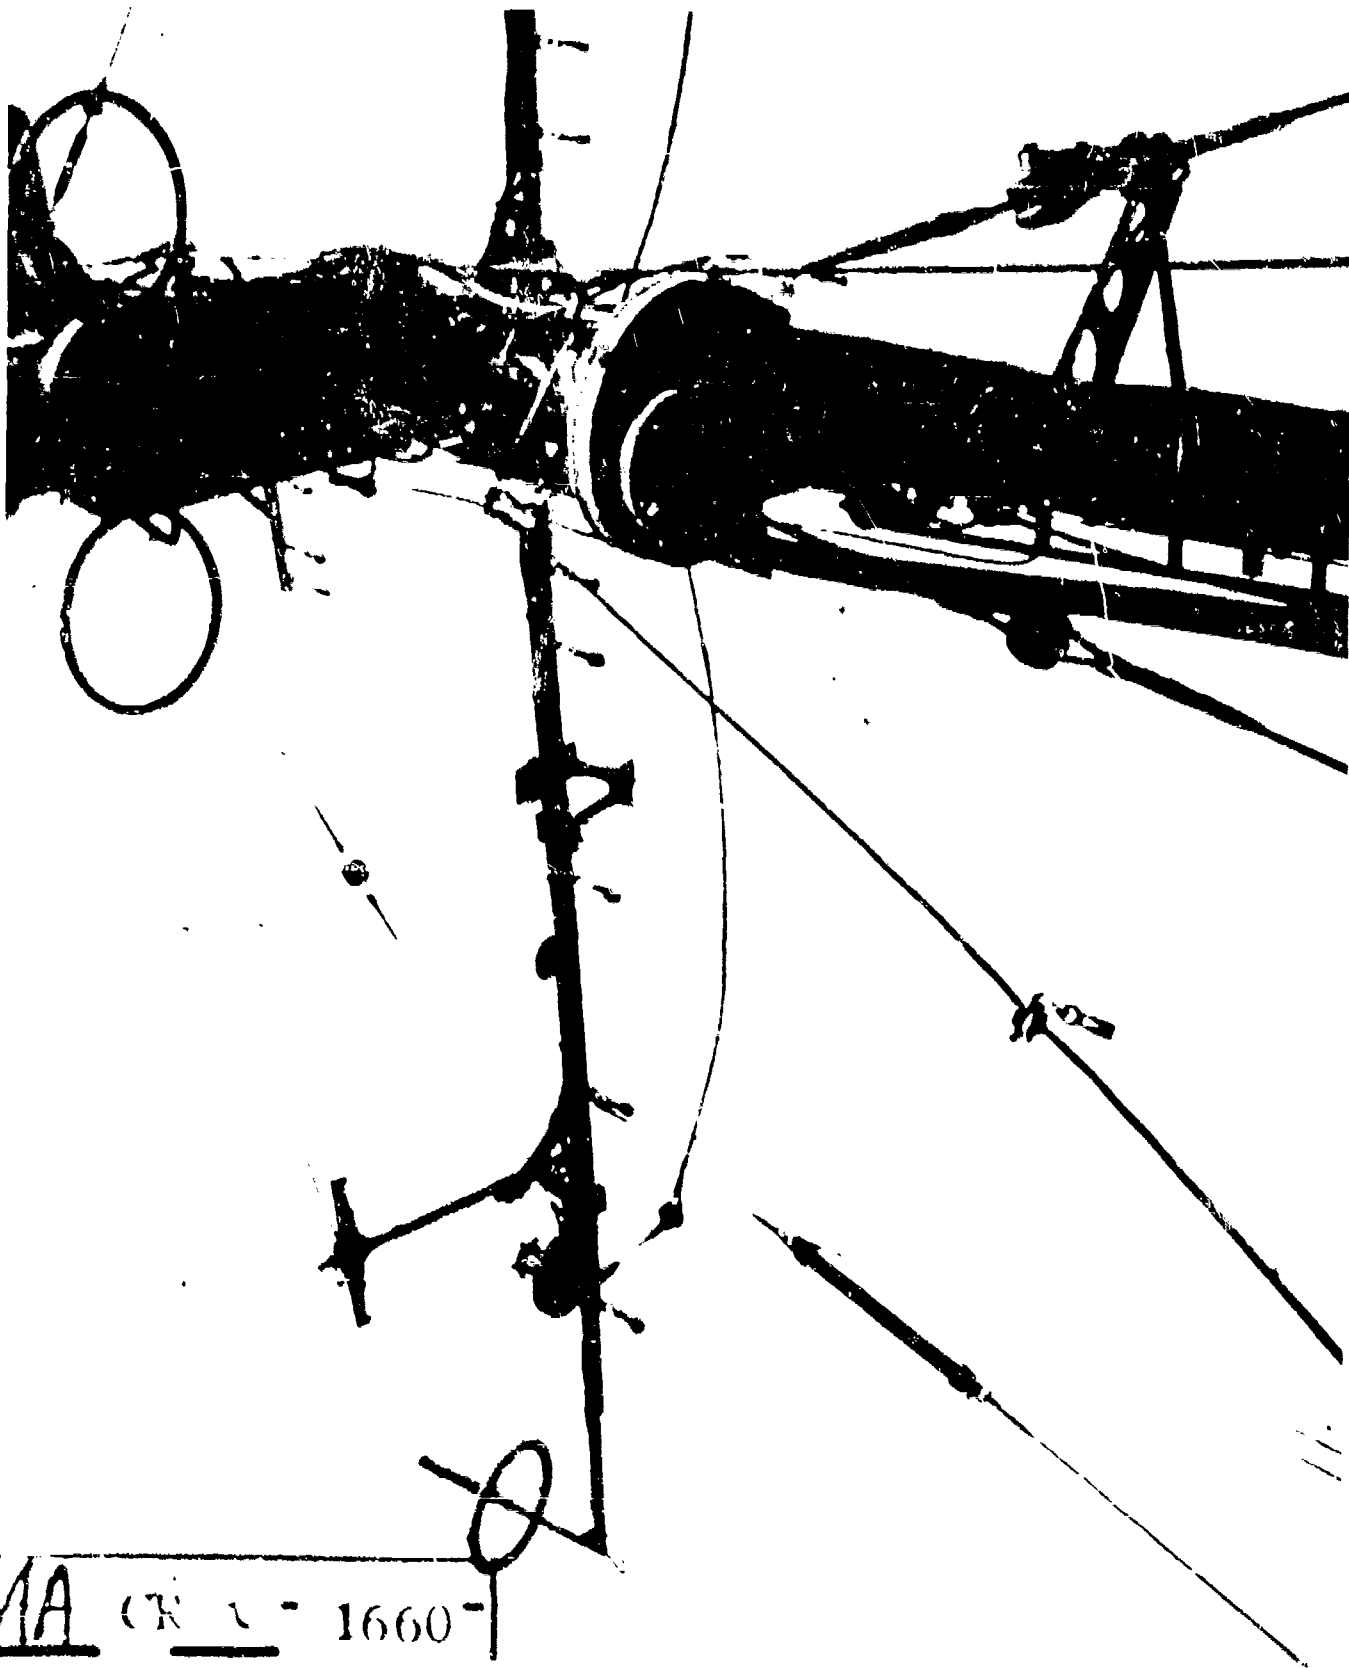
POST ABLE - COMMUNICATION ANTENNAS. The TBS antenna pedestal on starboard yardarm was bent forward about 90° by blast. No elements were damaged and antenna lead was intact. A bent whip antenna can also be seen on yardarm.

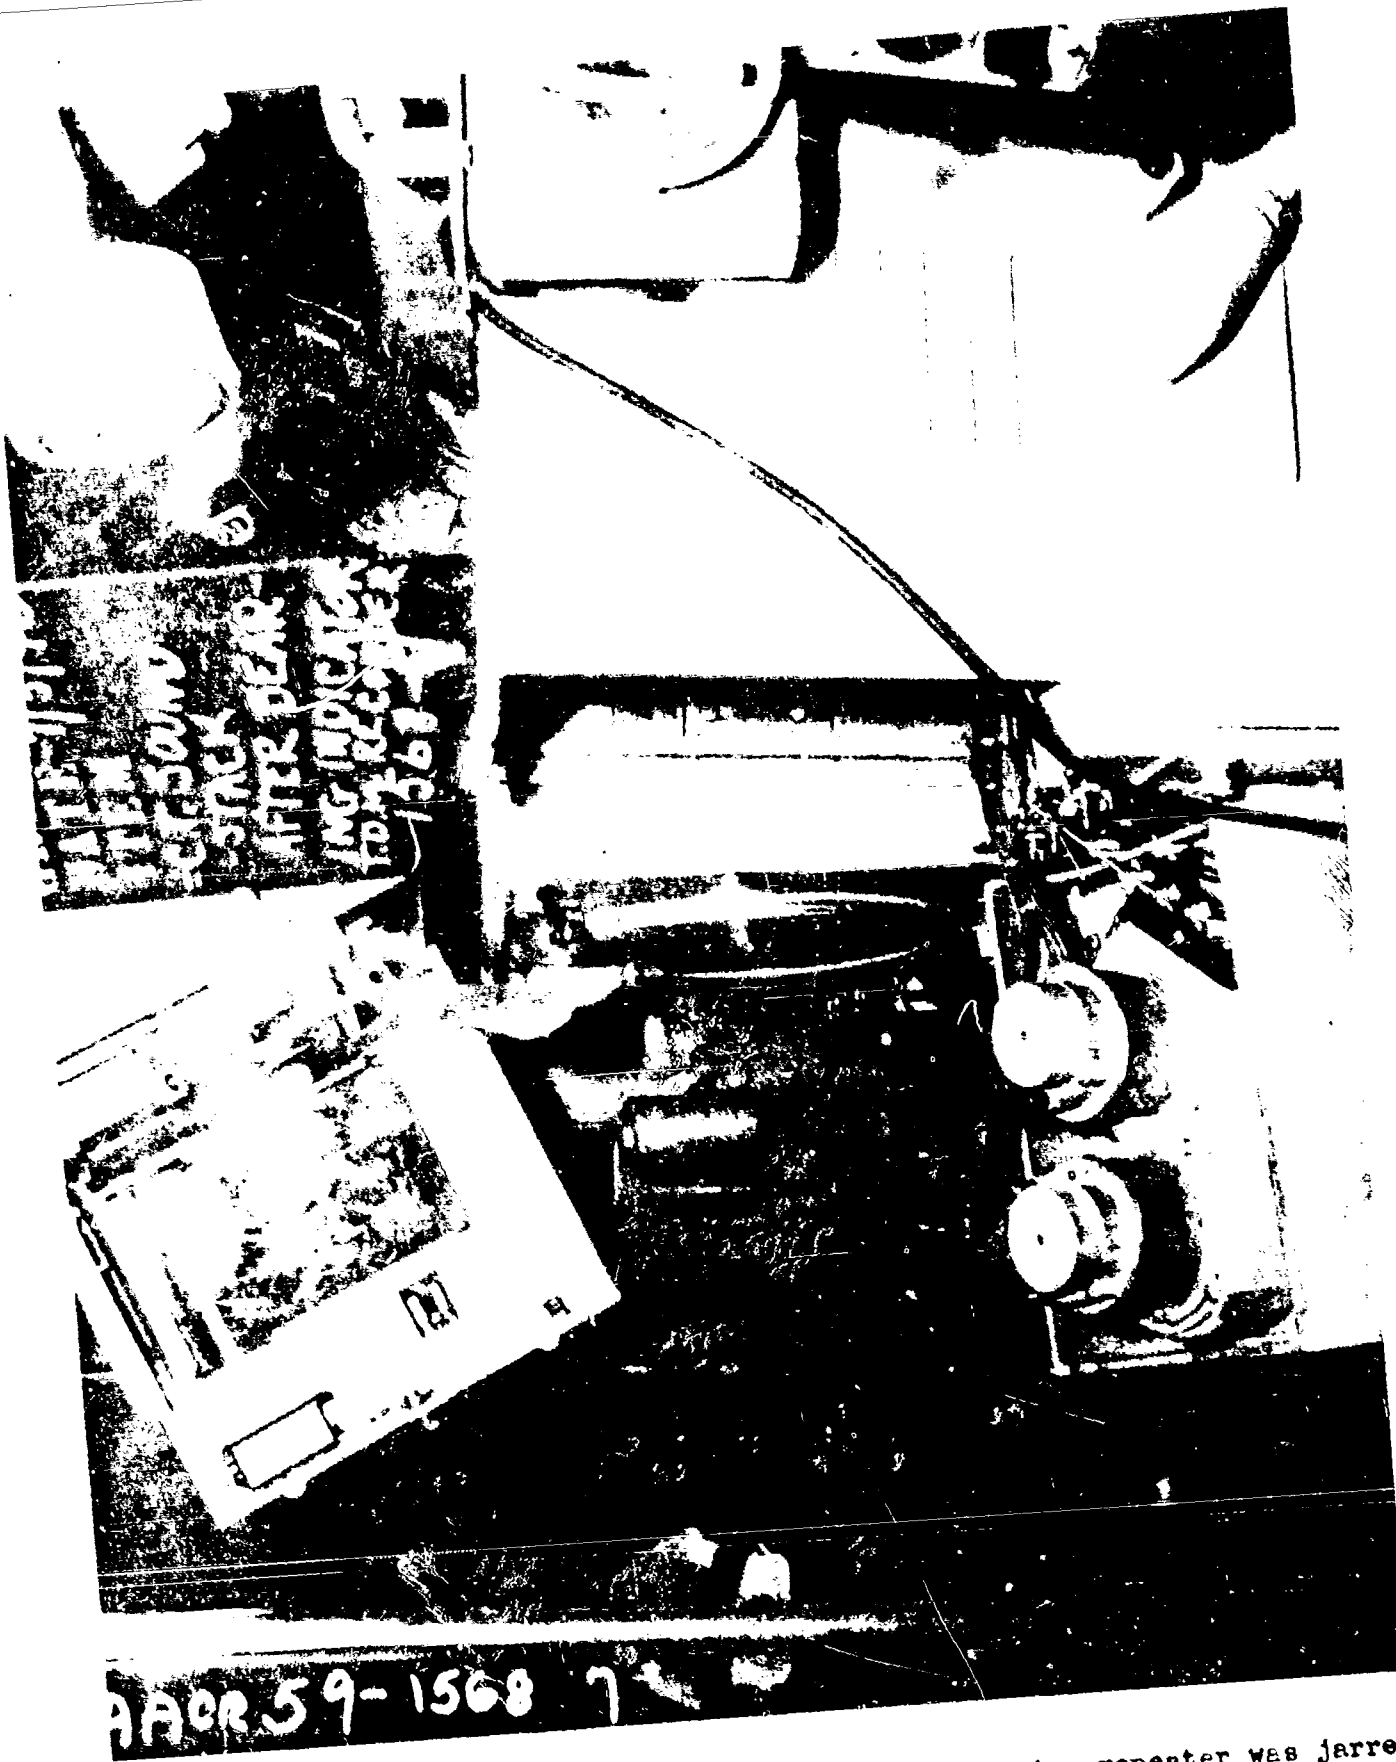
POST ABLE - WCA SOUND STACK. QB head bearing repeater was jarred out of its frame because of a loose pin in the securing brace. Front panel of the TDM recorder dropped open, releasing the roll holding the recording paper. Damage was not serious and operation was found to be satisfactory.

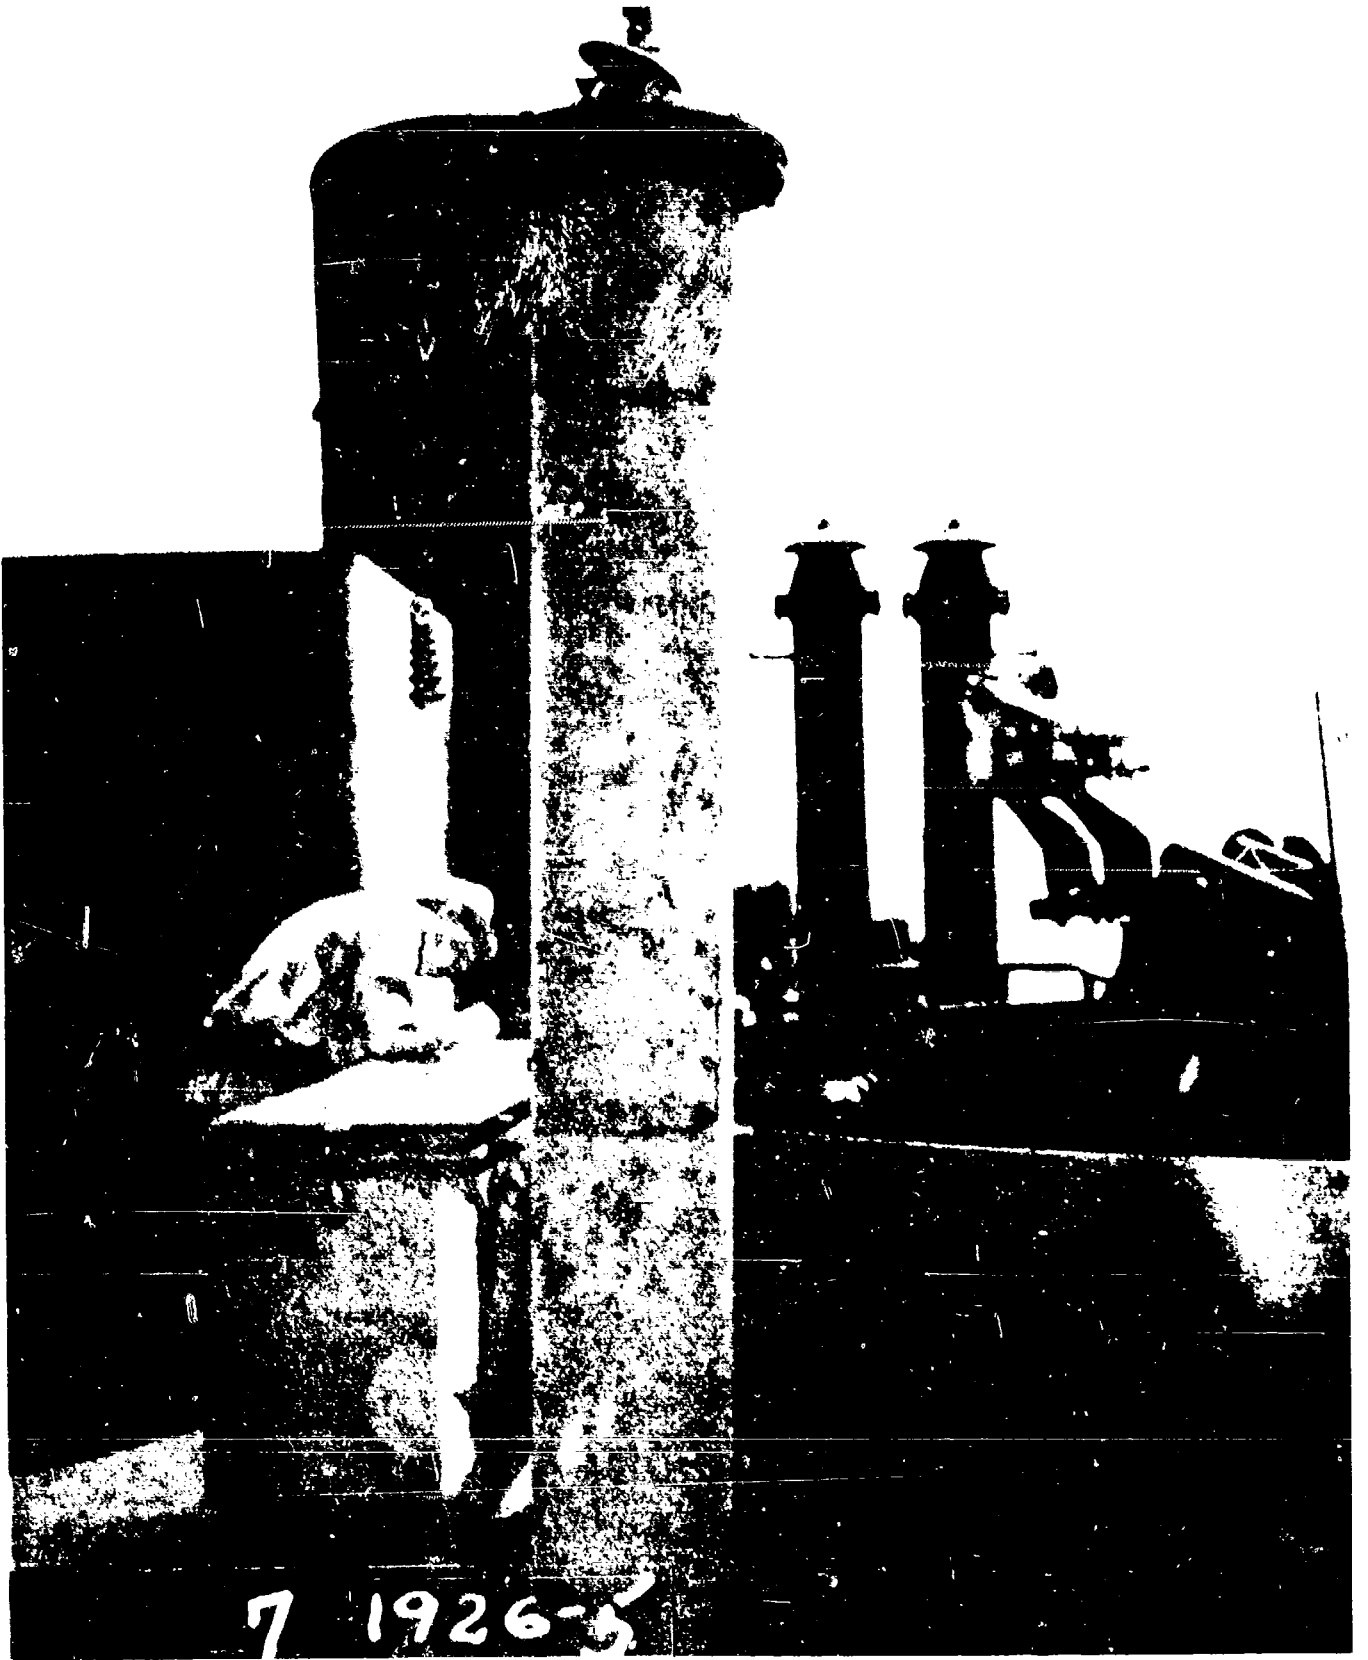
POST ABLE - ANTENNA TRUNK. Entering insulator was damaged and strain insulator broken by the blast.
