ELECTRONICS COORDINATING OF
SHIP PREPARATION
and
TARGET INSPECTION

FINAL REPORT
TESTS ABLE AND BAKER

✓ **VOLUME 2**
PHOTOGRAPHIC RECORD

DIRECTOR OF SHIP MATERIAL
JOINT TASK FORCE ONE
OPERATION CROSSROADS

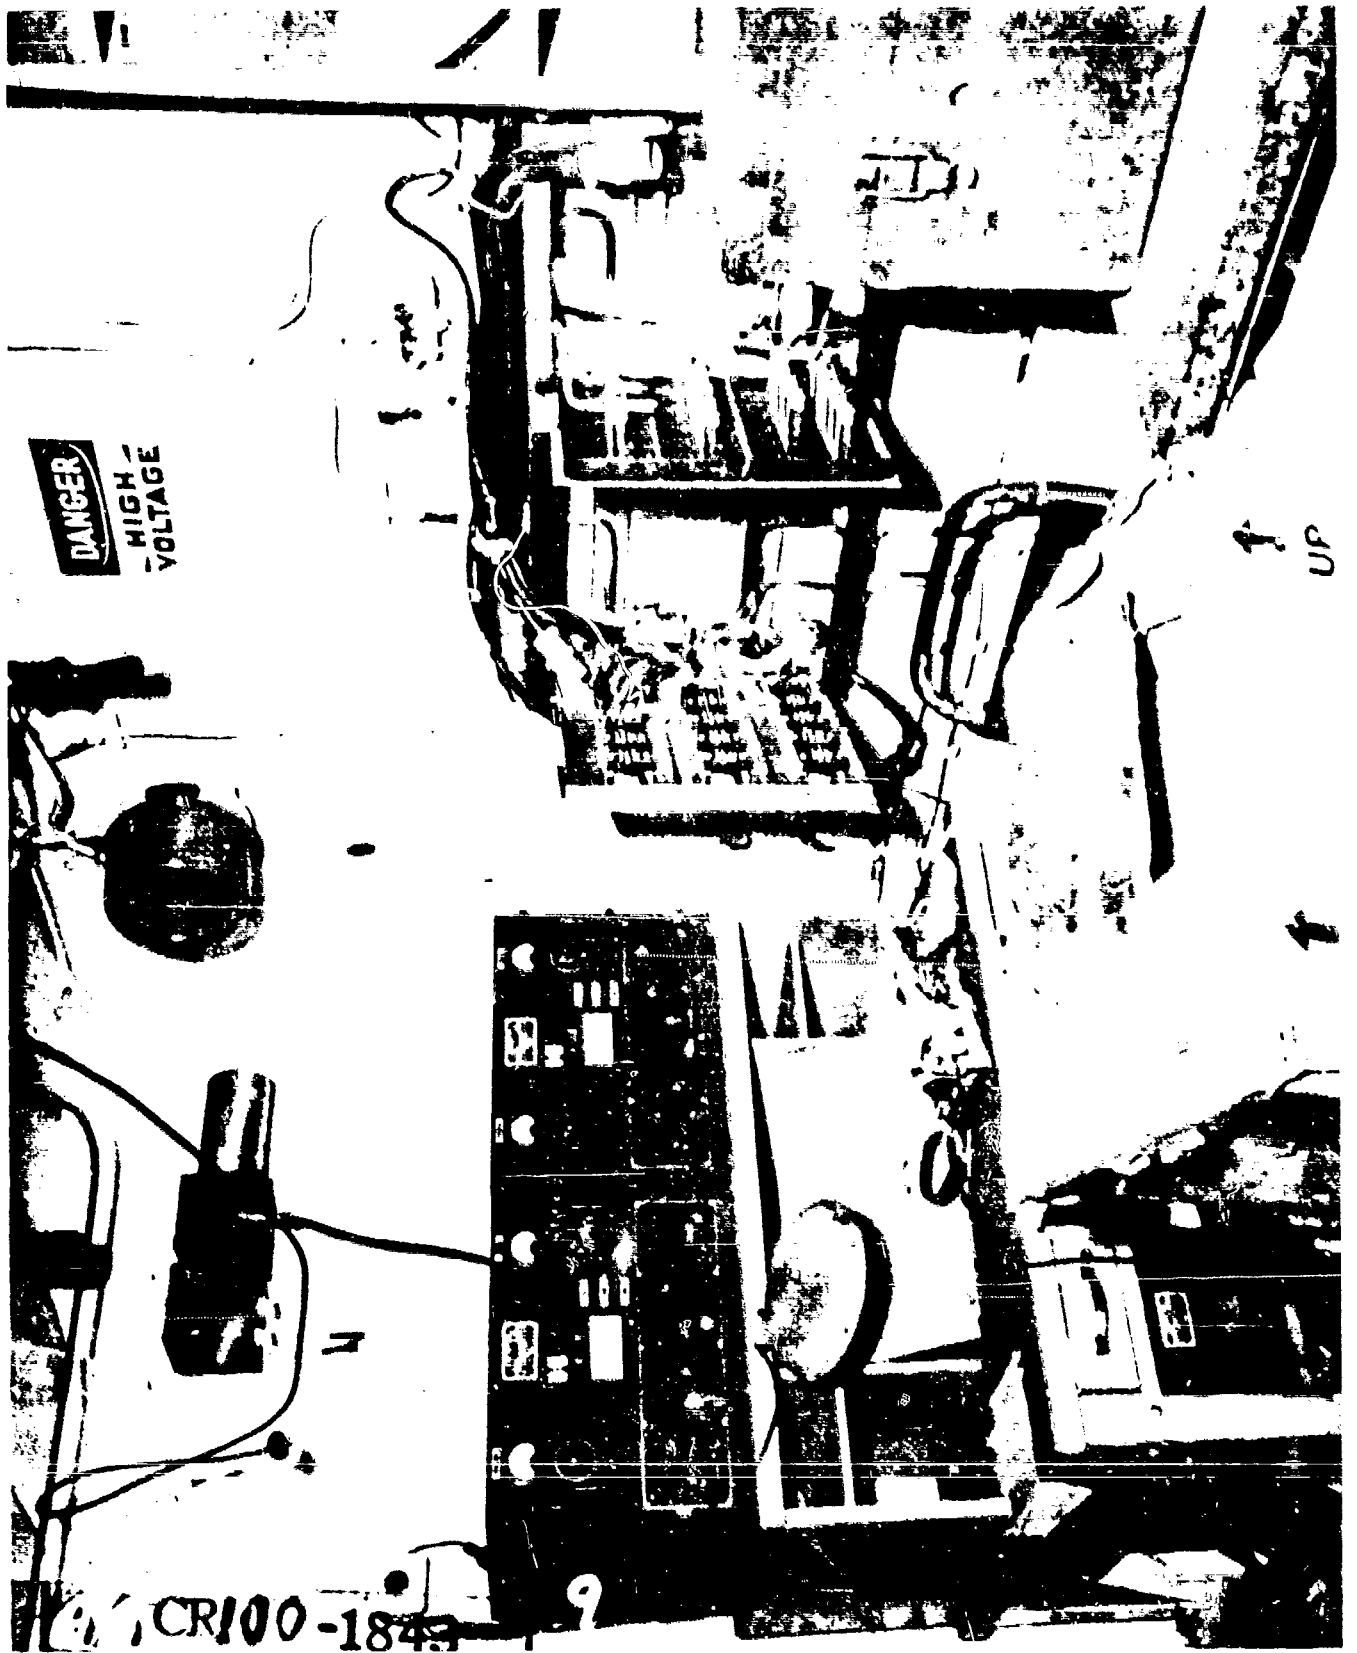
POST ABLE - RADIO III. The patch panel was opened by shock but caused no damage.

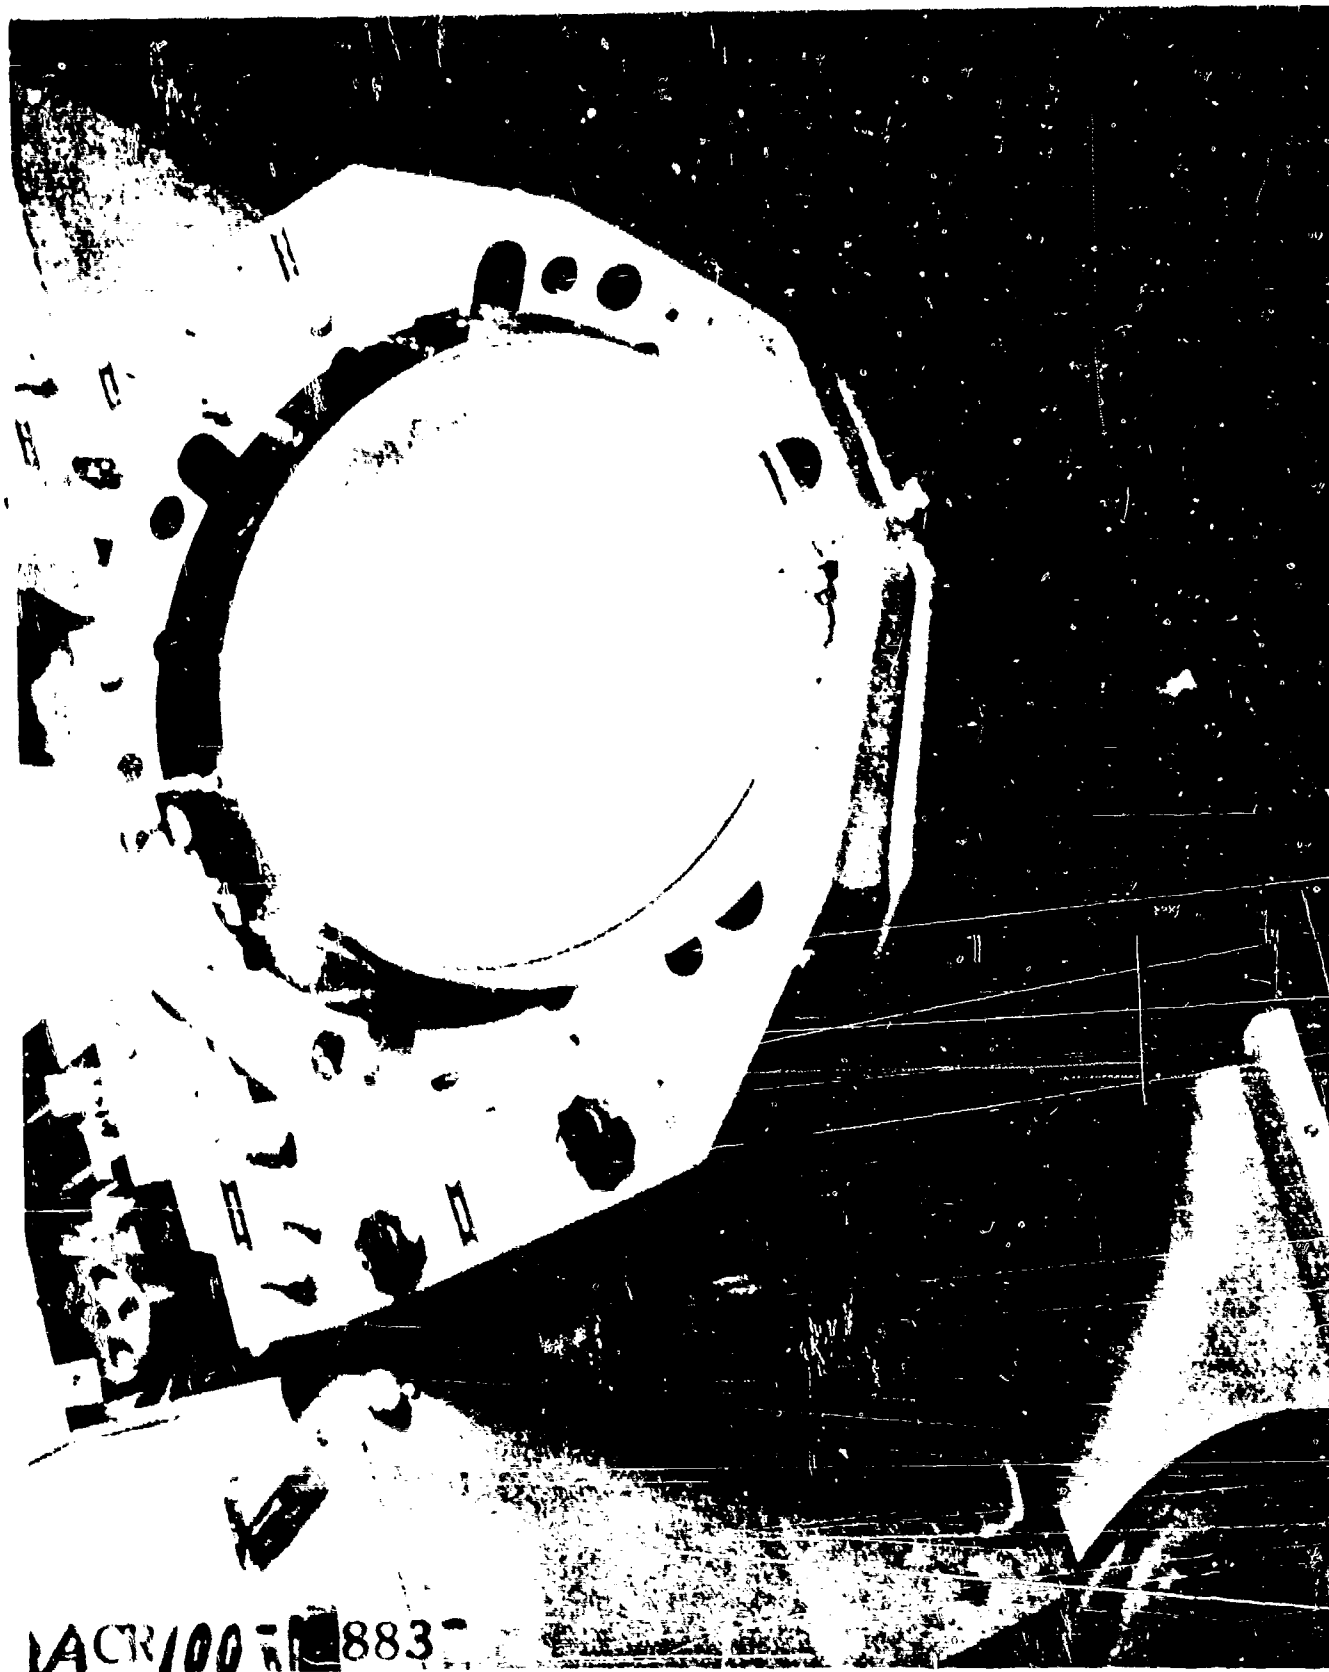
POST ARLE SC-4 INDICATOR. PPI Tube was loosely secured, allowing enough movement of neck of tube to shatter it under shock.

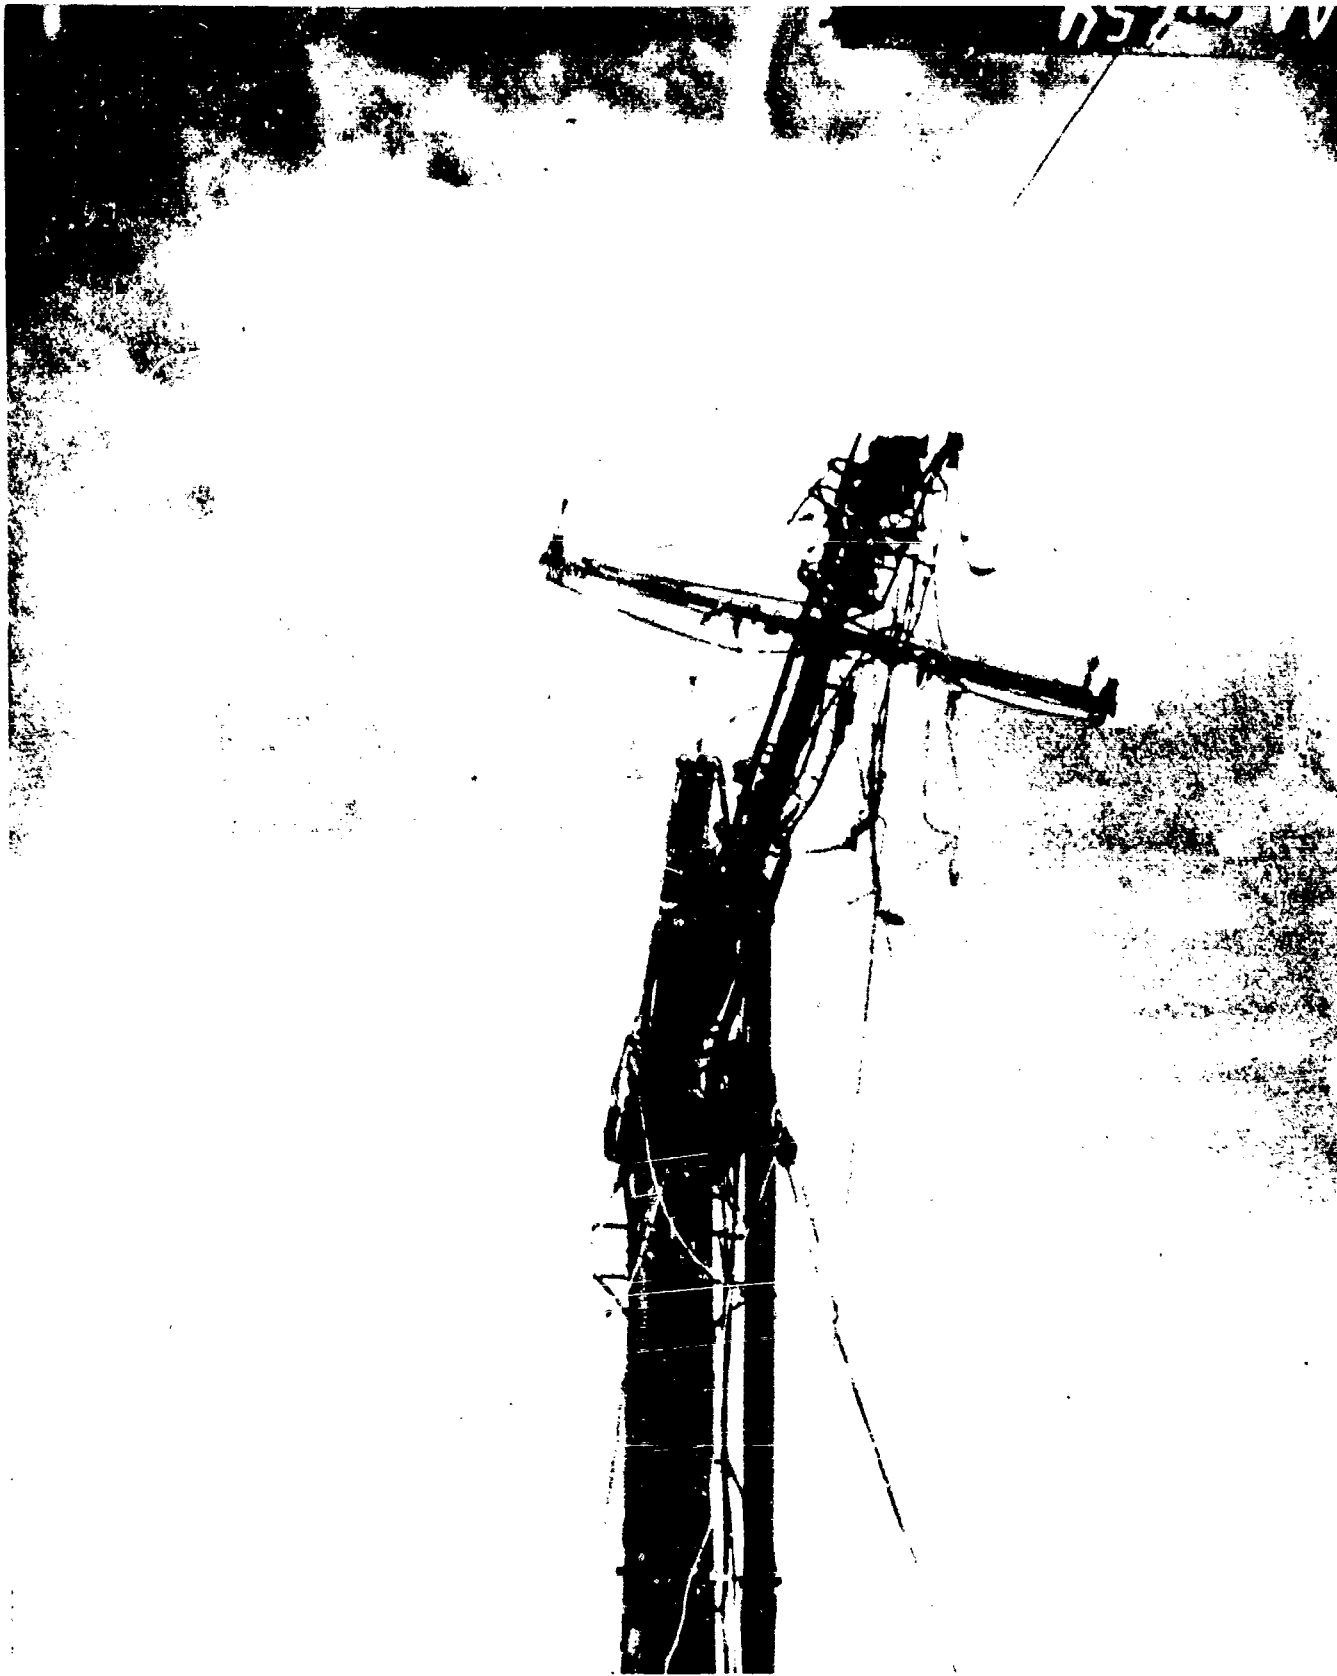
POST ABLE - FOREMAST. Top section blown over. Reflector was broken off of SG-1 antenna and waveguide collapsed.

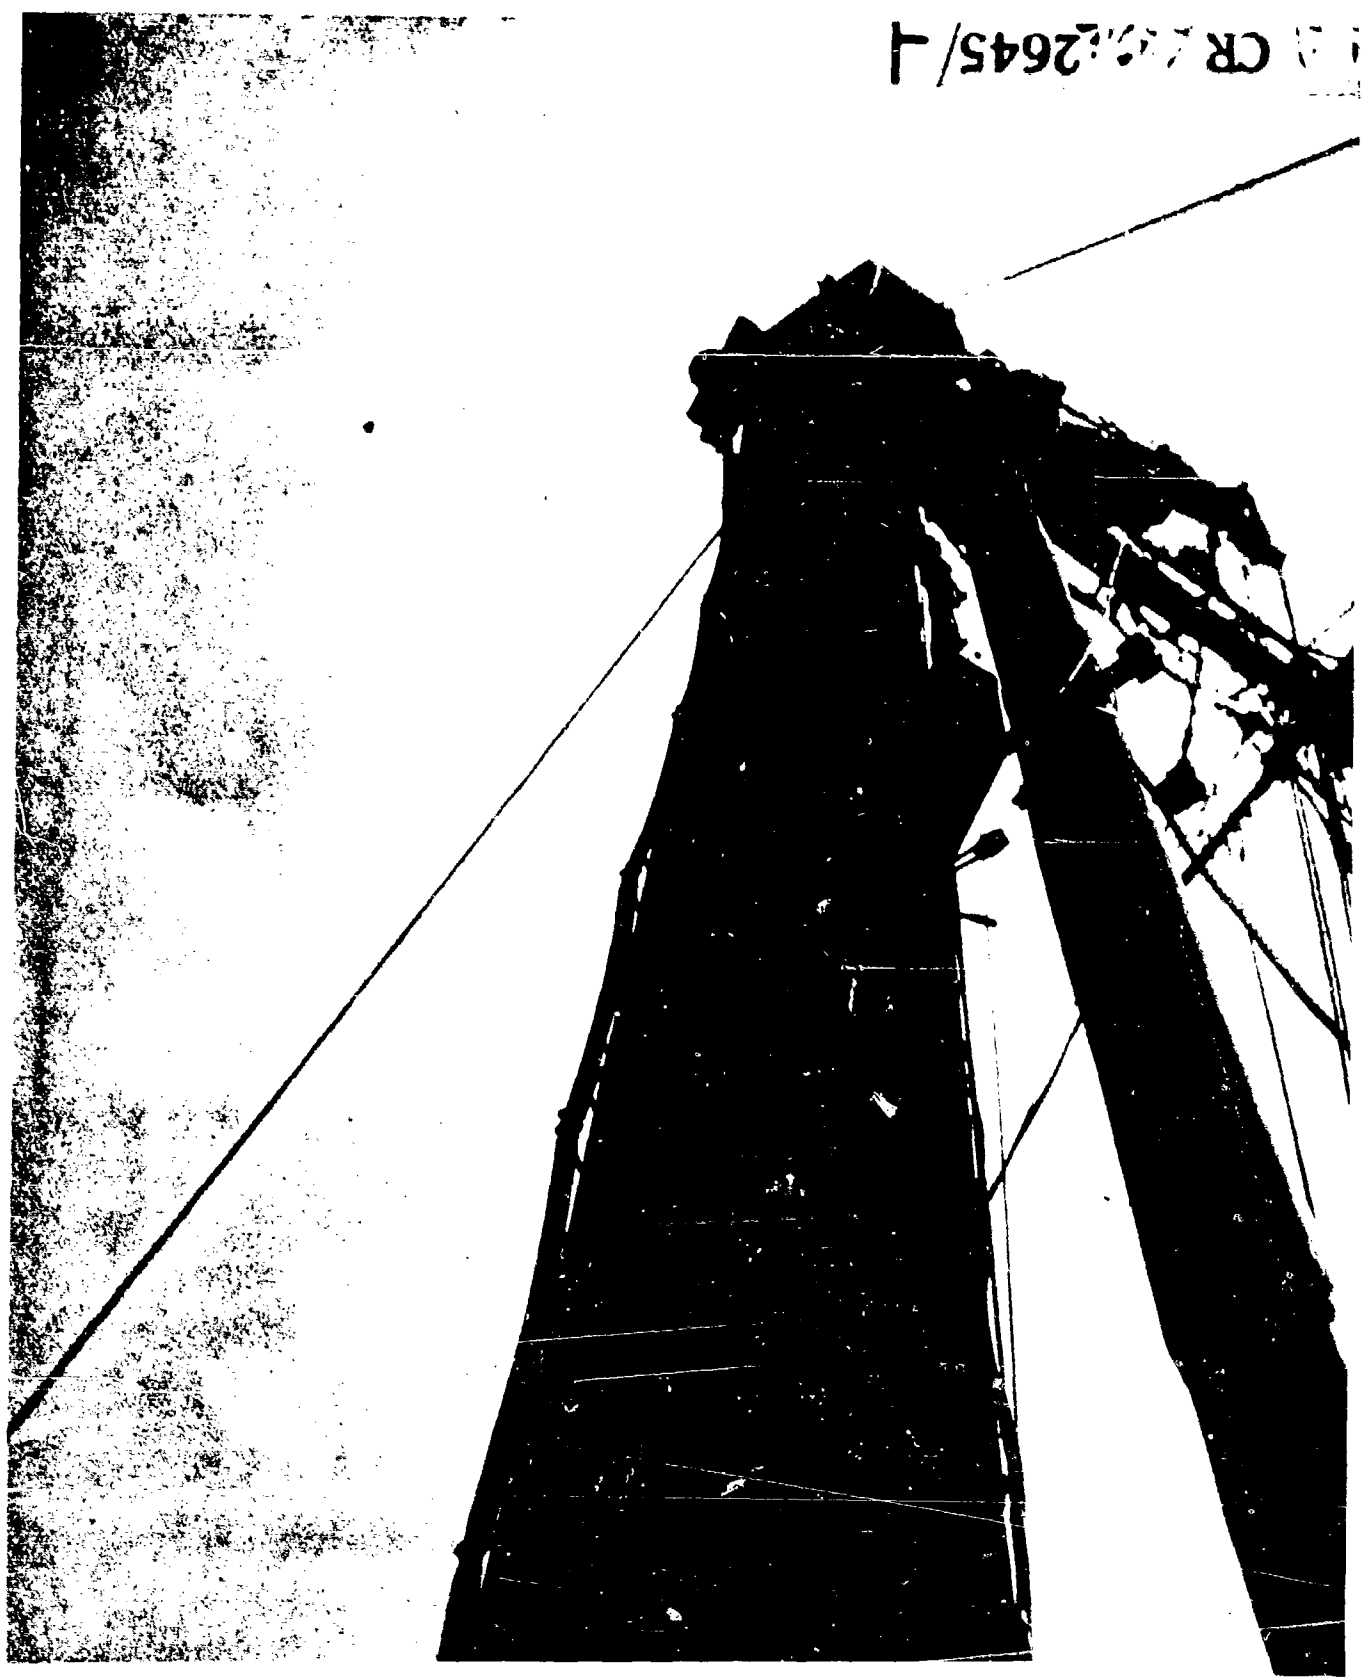
POST ABLE - FOREMAST. Top section blown over. Note condition of waveguide at center of picture, where flange has separated from guide at soldered joint. Waveguide was flattened and next line twisted for full length of exposed run.

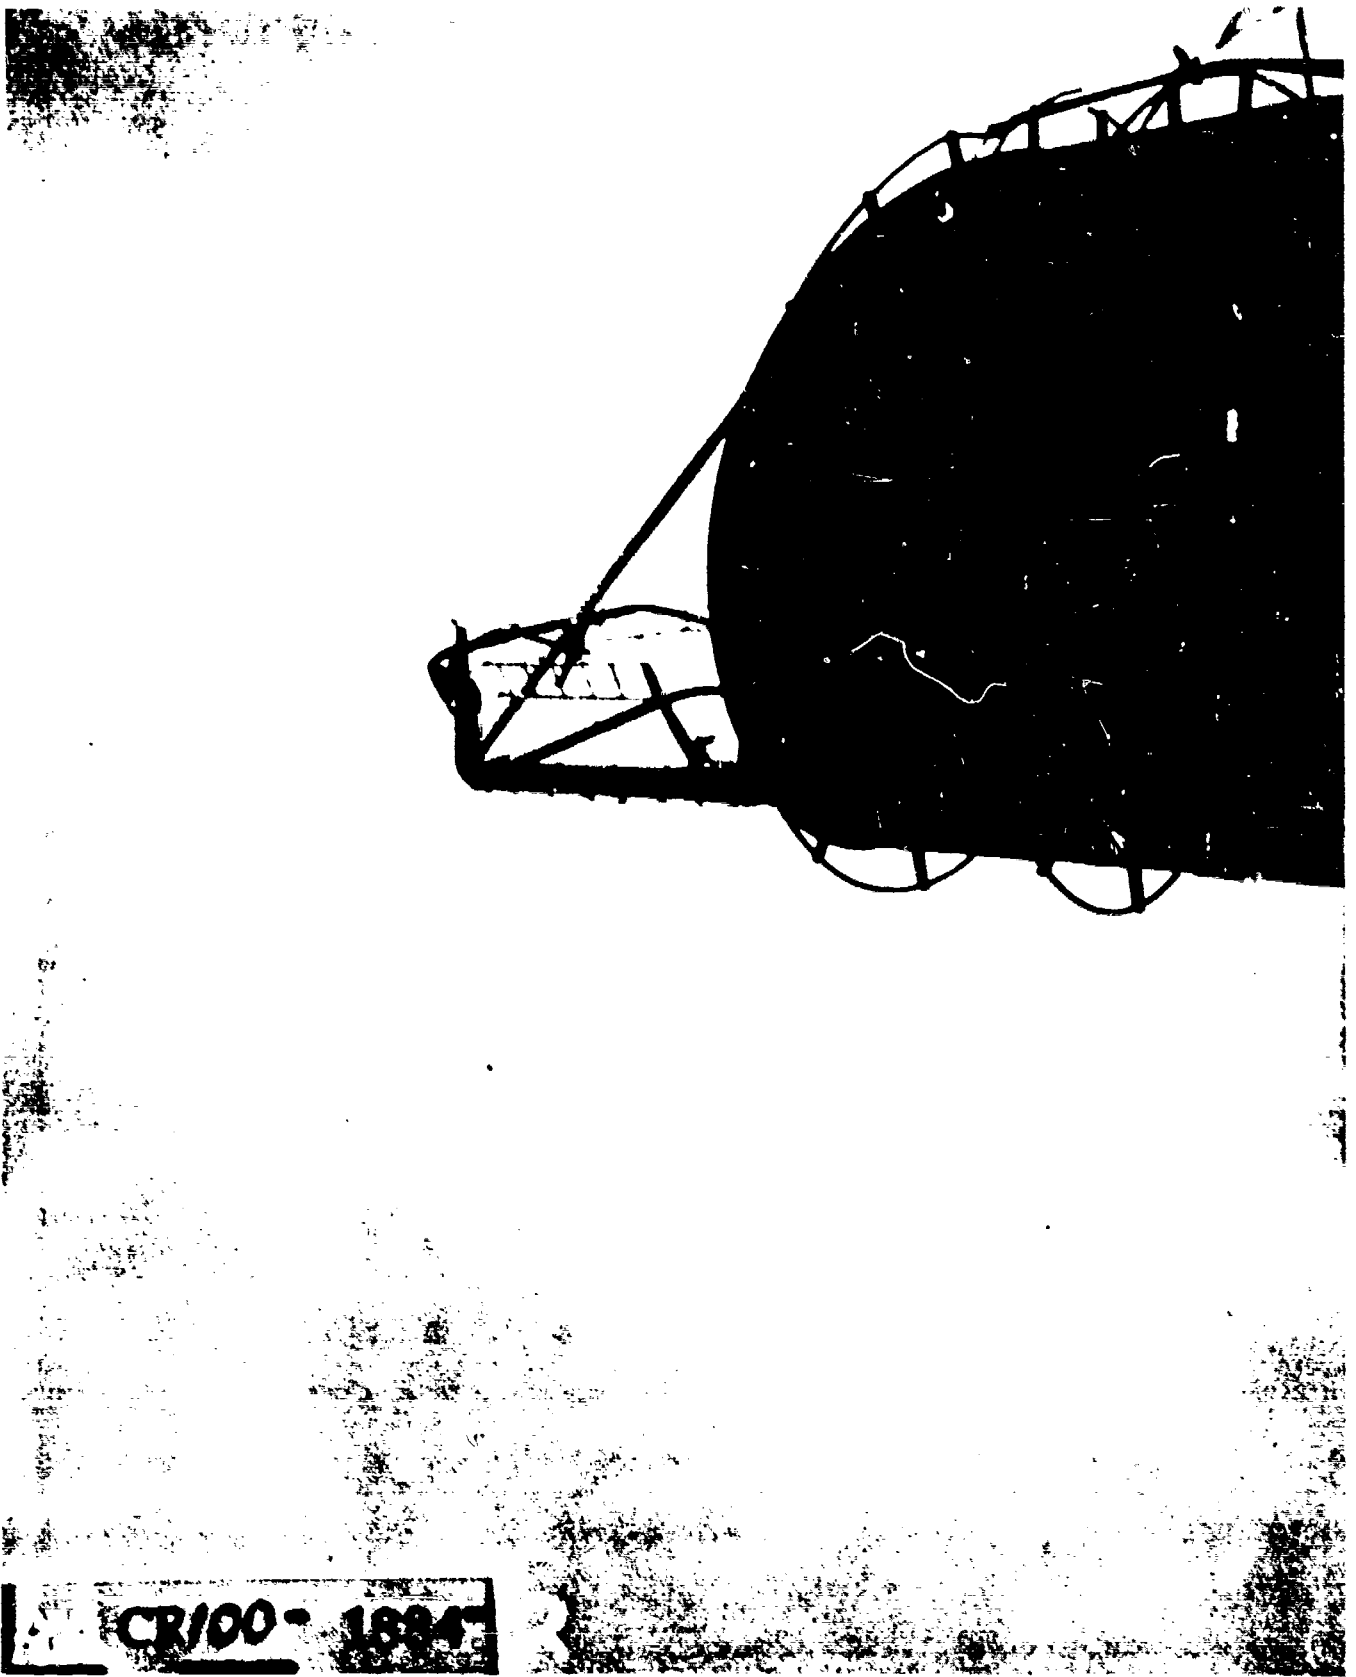
POST ABLE - ANTENNAS. View of damaged stack mounted antennas including TBS antenna.

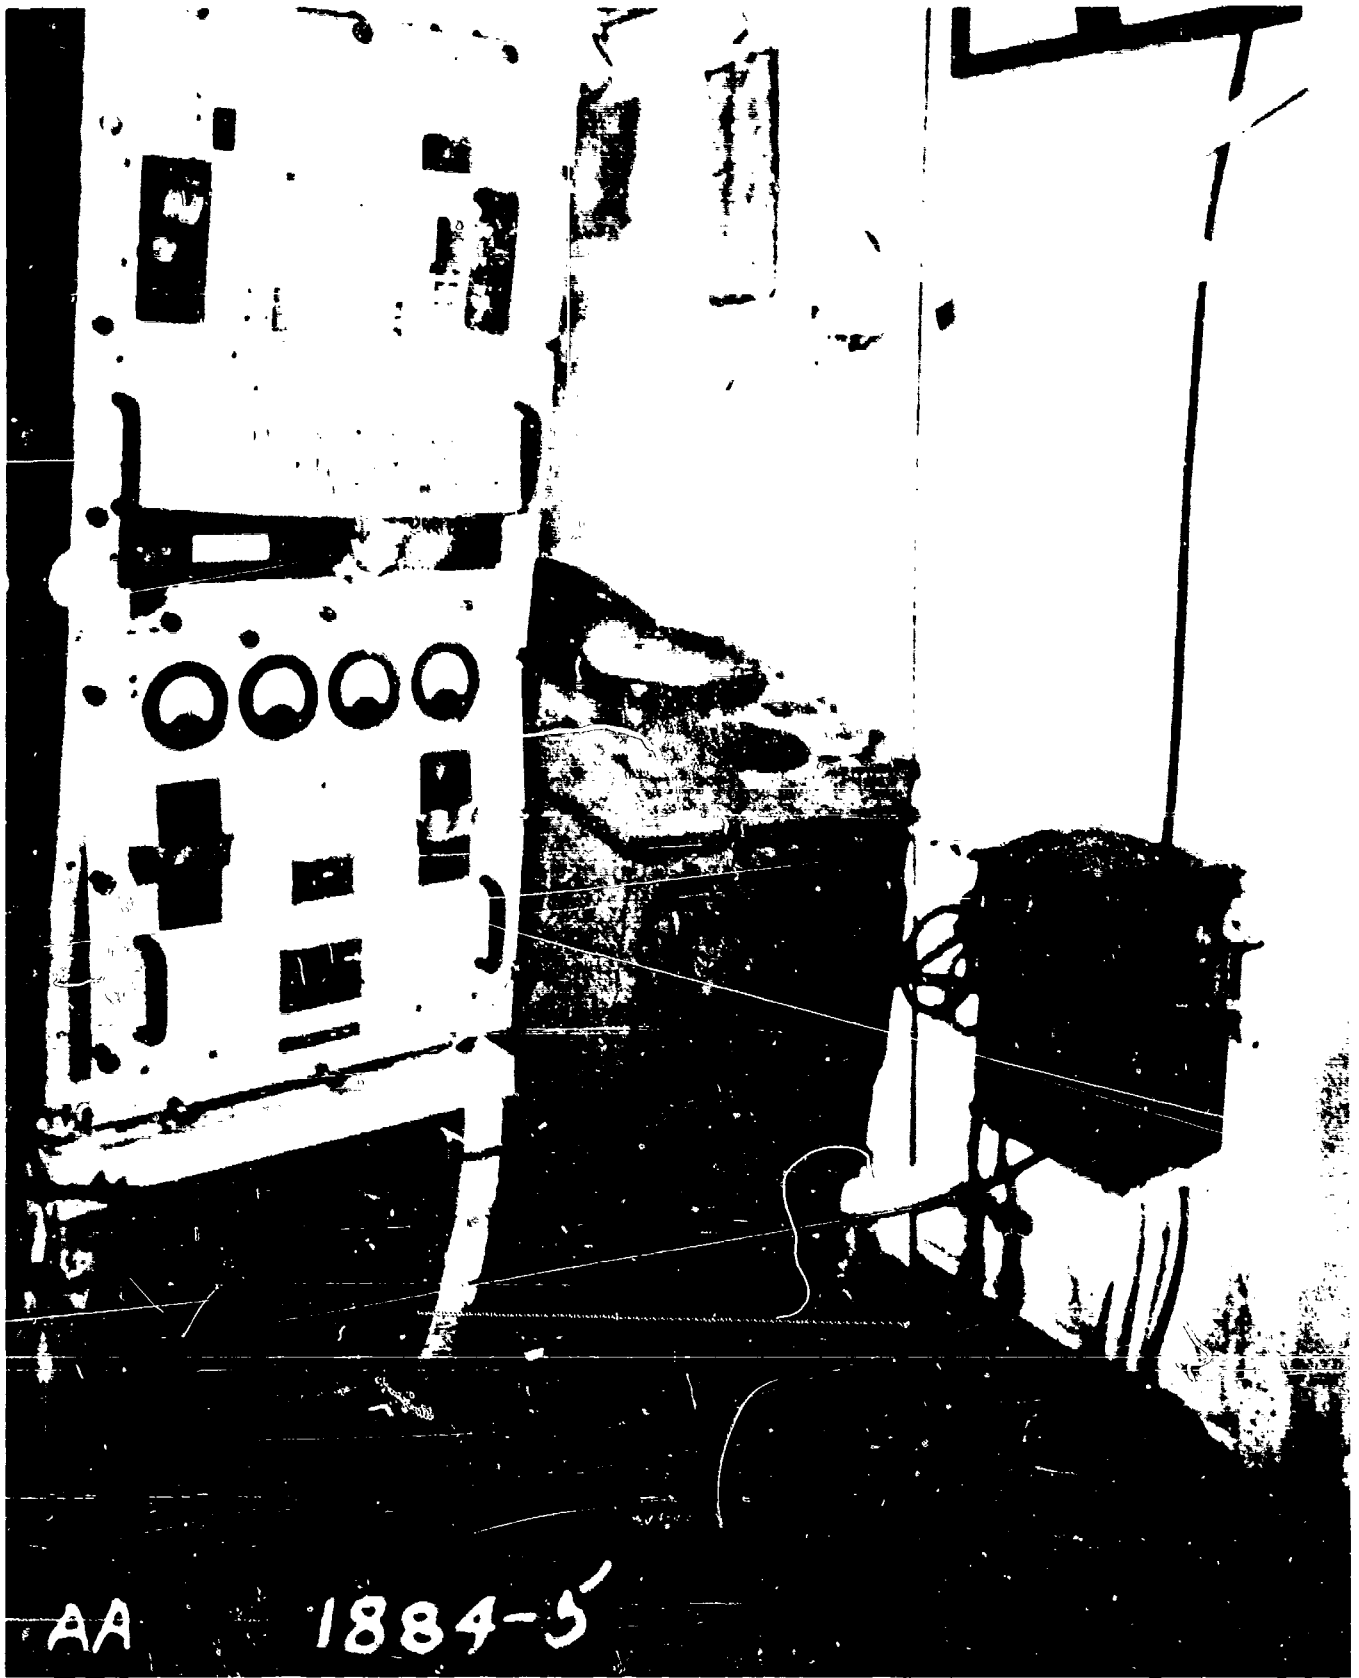
POST ABLE - PILOTHOUSE. Front view of NMC and VD-2. The welds parted on the VD-2 foundation, and the selector switch was torn from its mount. However, the VD-2 was still operable. The NMC was warped and had internal damage.

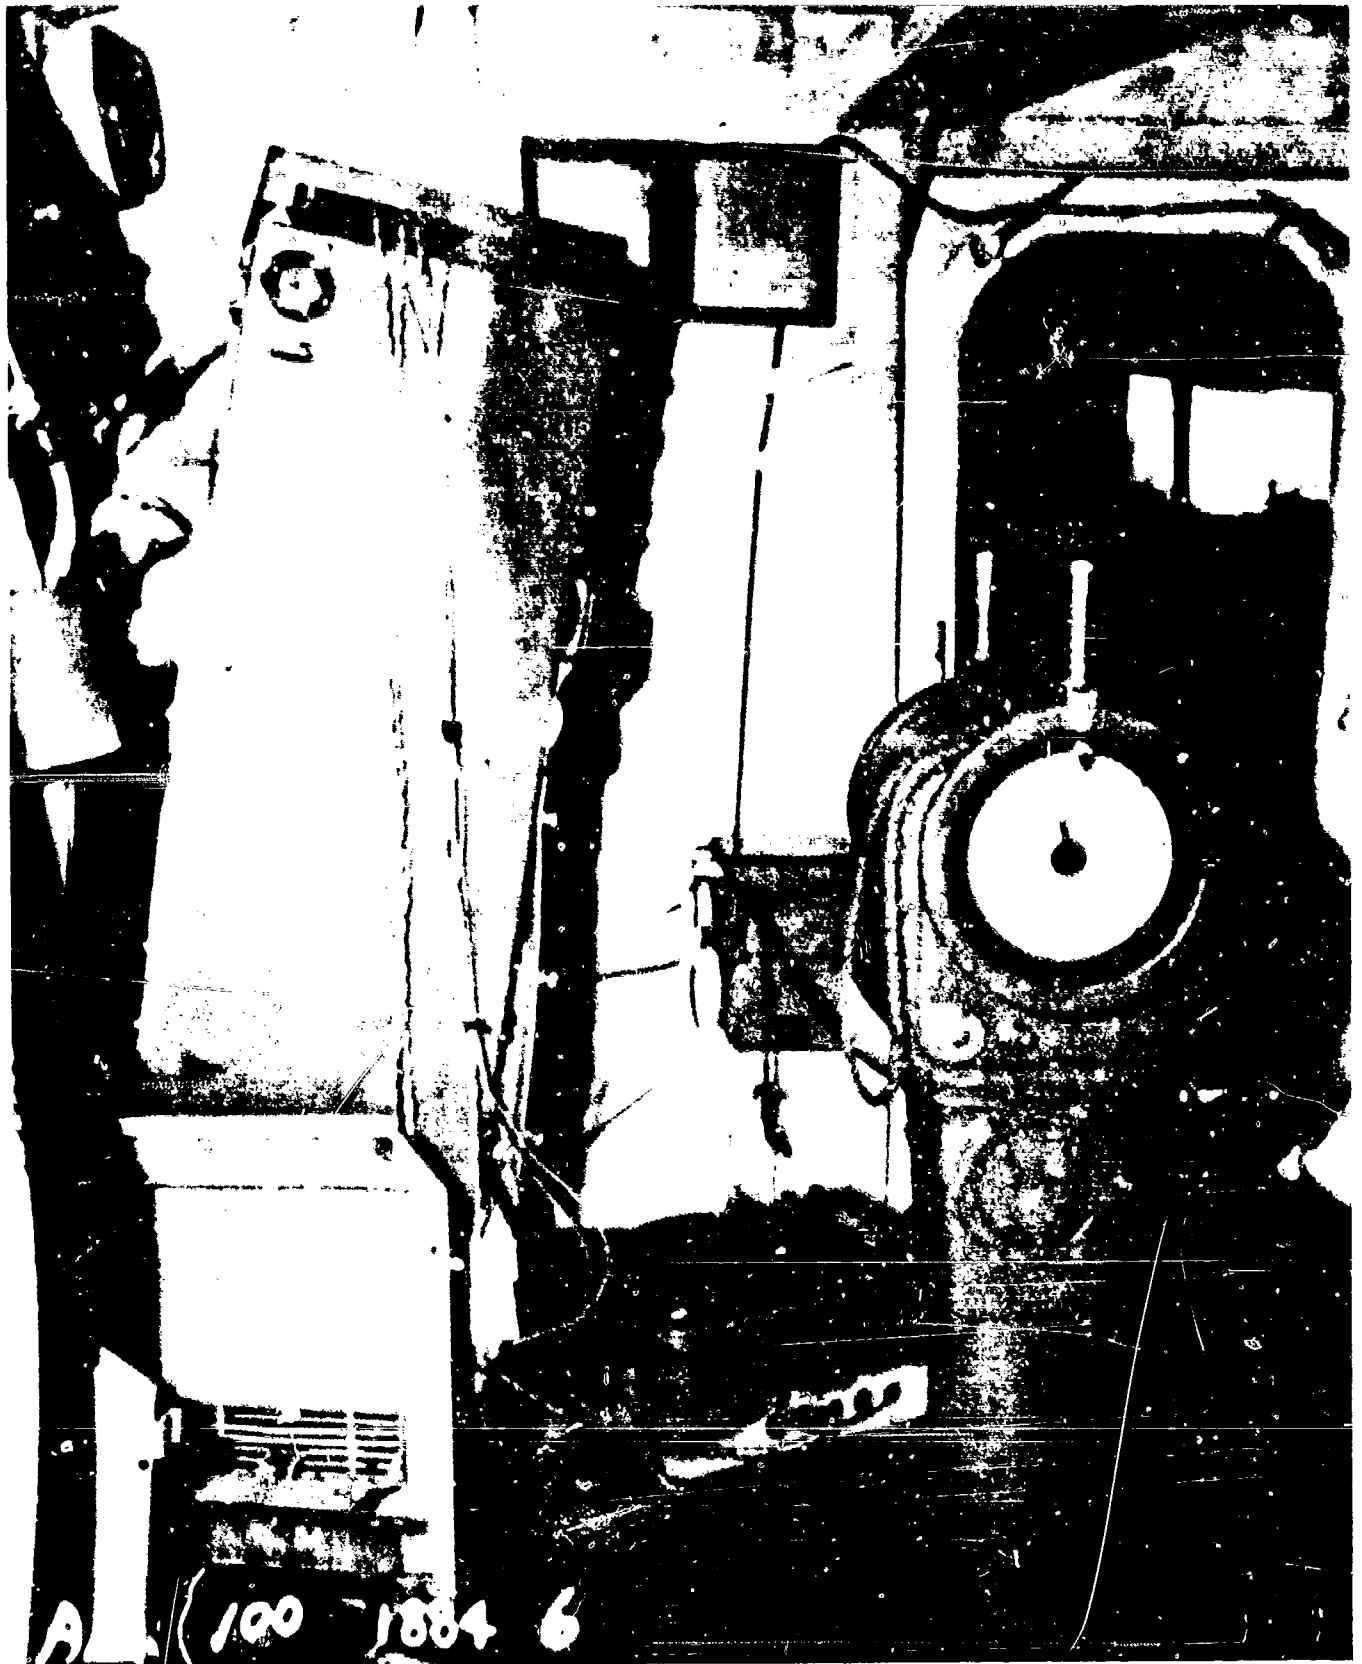
POST ABLE - NMC FATHOMETER. Side view of NMC. Bulkhead to left (forward bulkhead of pilot house) was pushed in, tipping NMC aft and warping its foundation and main frame. Additional fathometer on deck was placed there by instrumentation crew for recording work during test.

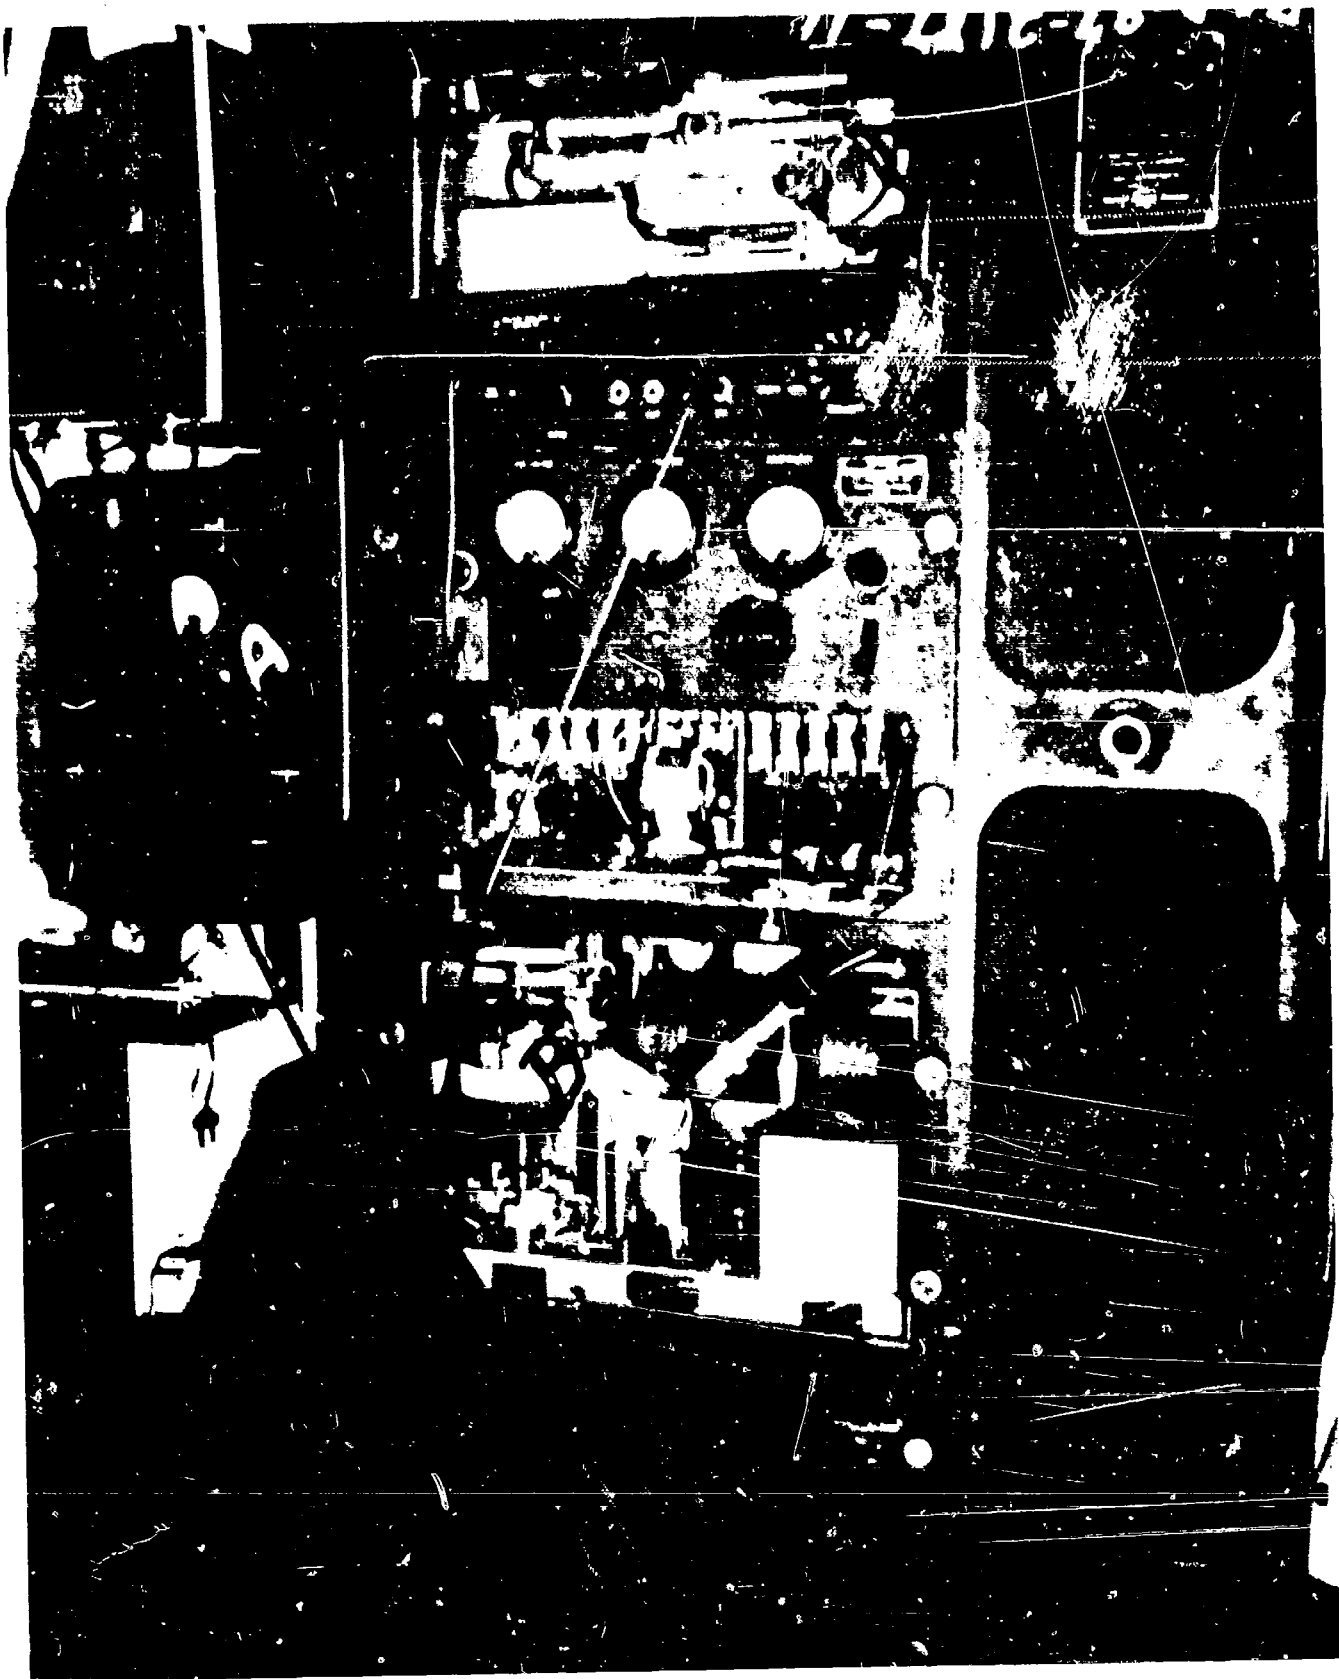
POST BAKER - MK 3 RADAR MAINFRAME. MK 3 Mod 2 main battery forward fire control radar. Regulated power supply "A" was broken loose from its mounts. Keyer tube located behind "B" was broken.

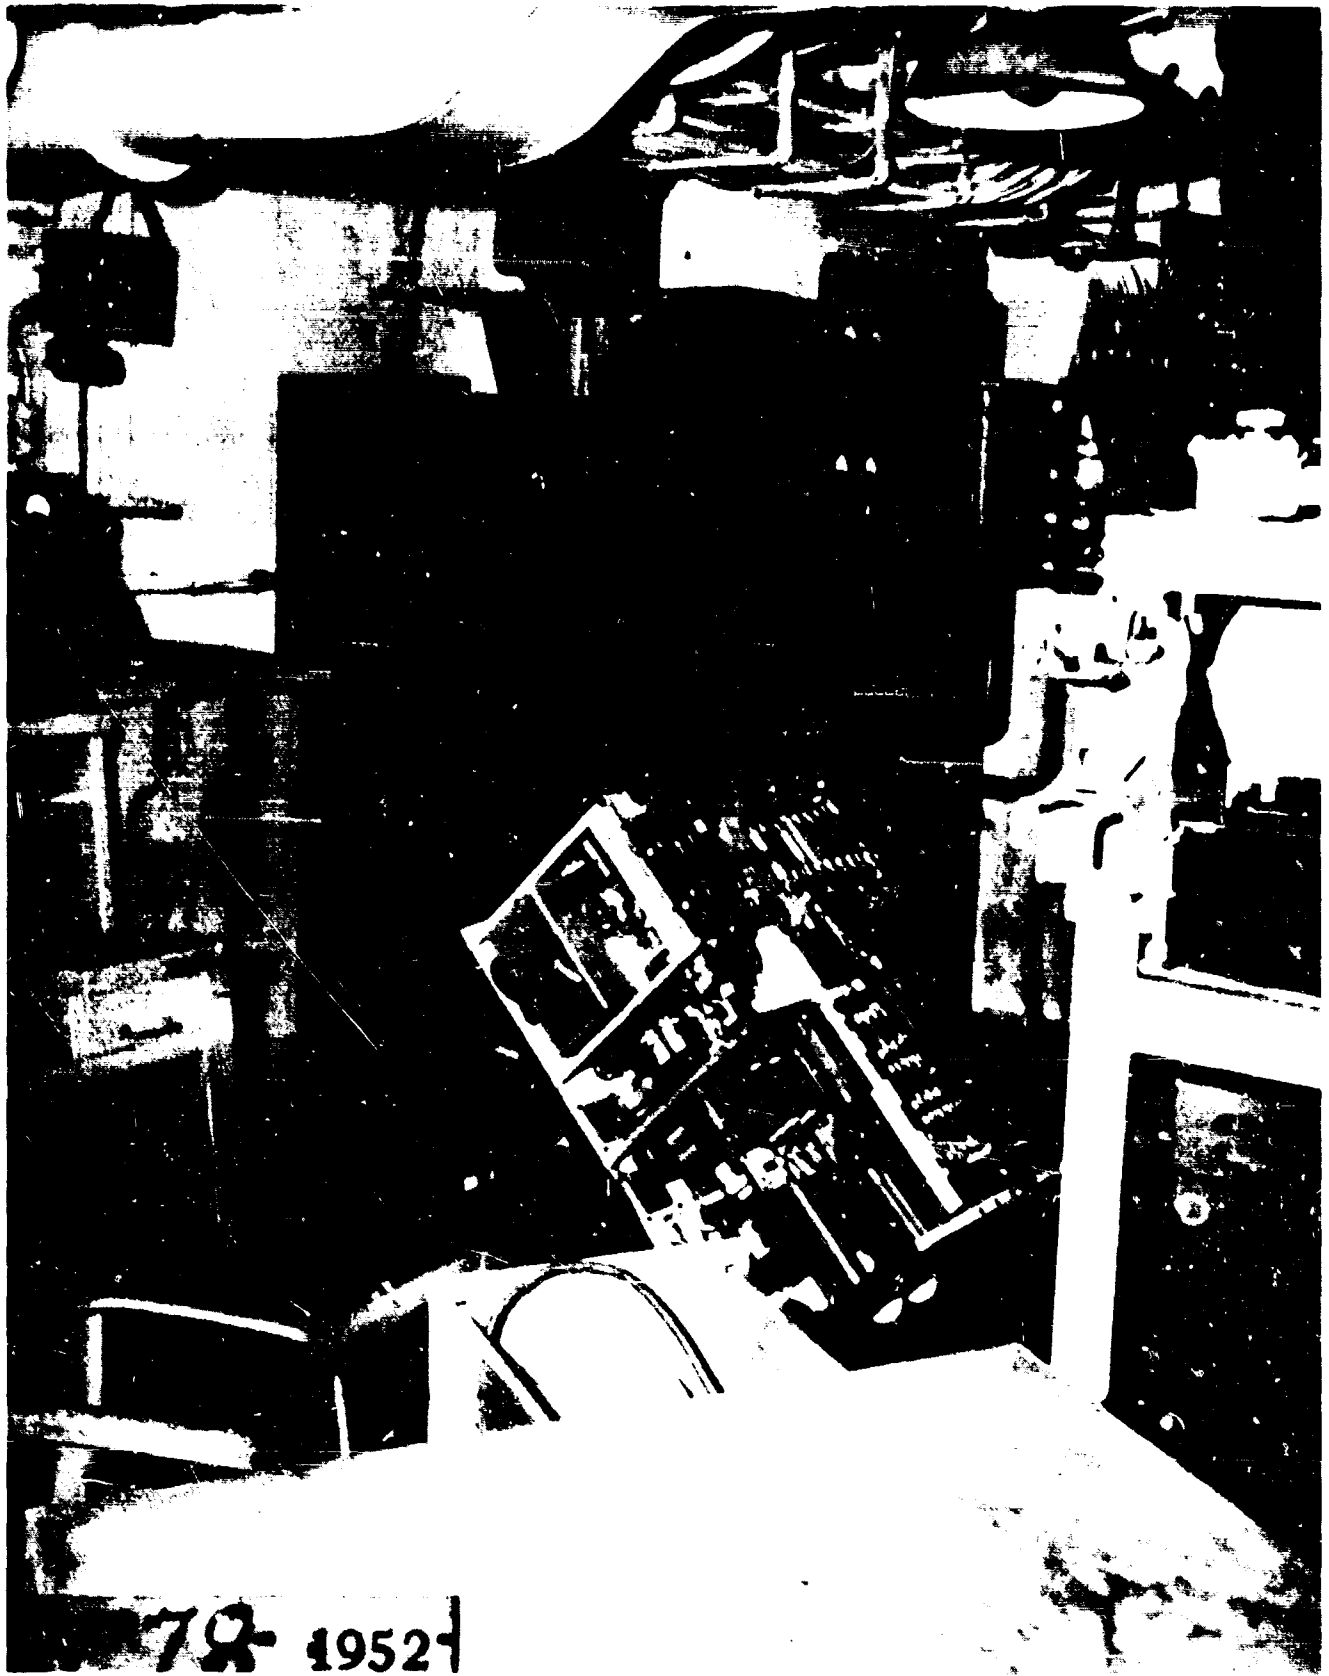
POST BAKER - TDE. TDE was pulled out of its case and fell to the deck. The method of securing this equipment in its case was inadequate to withstand the shock.

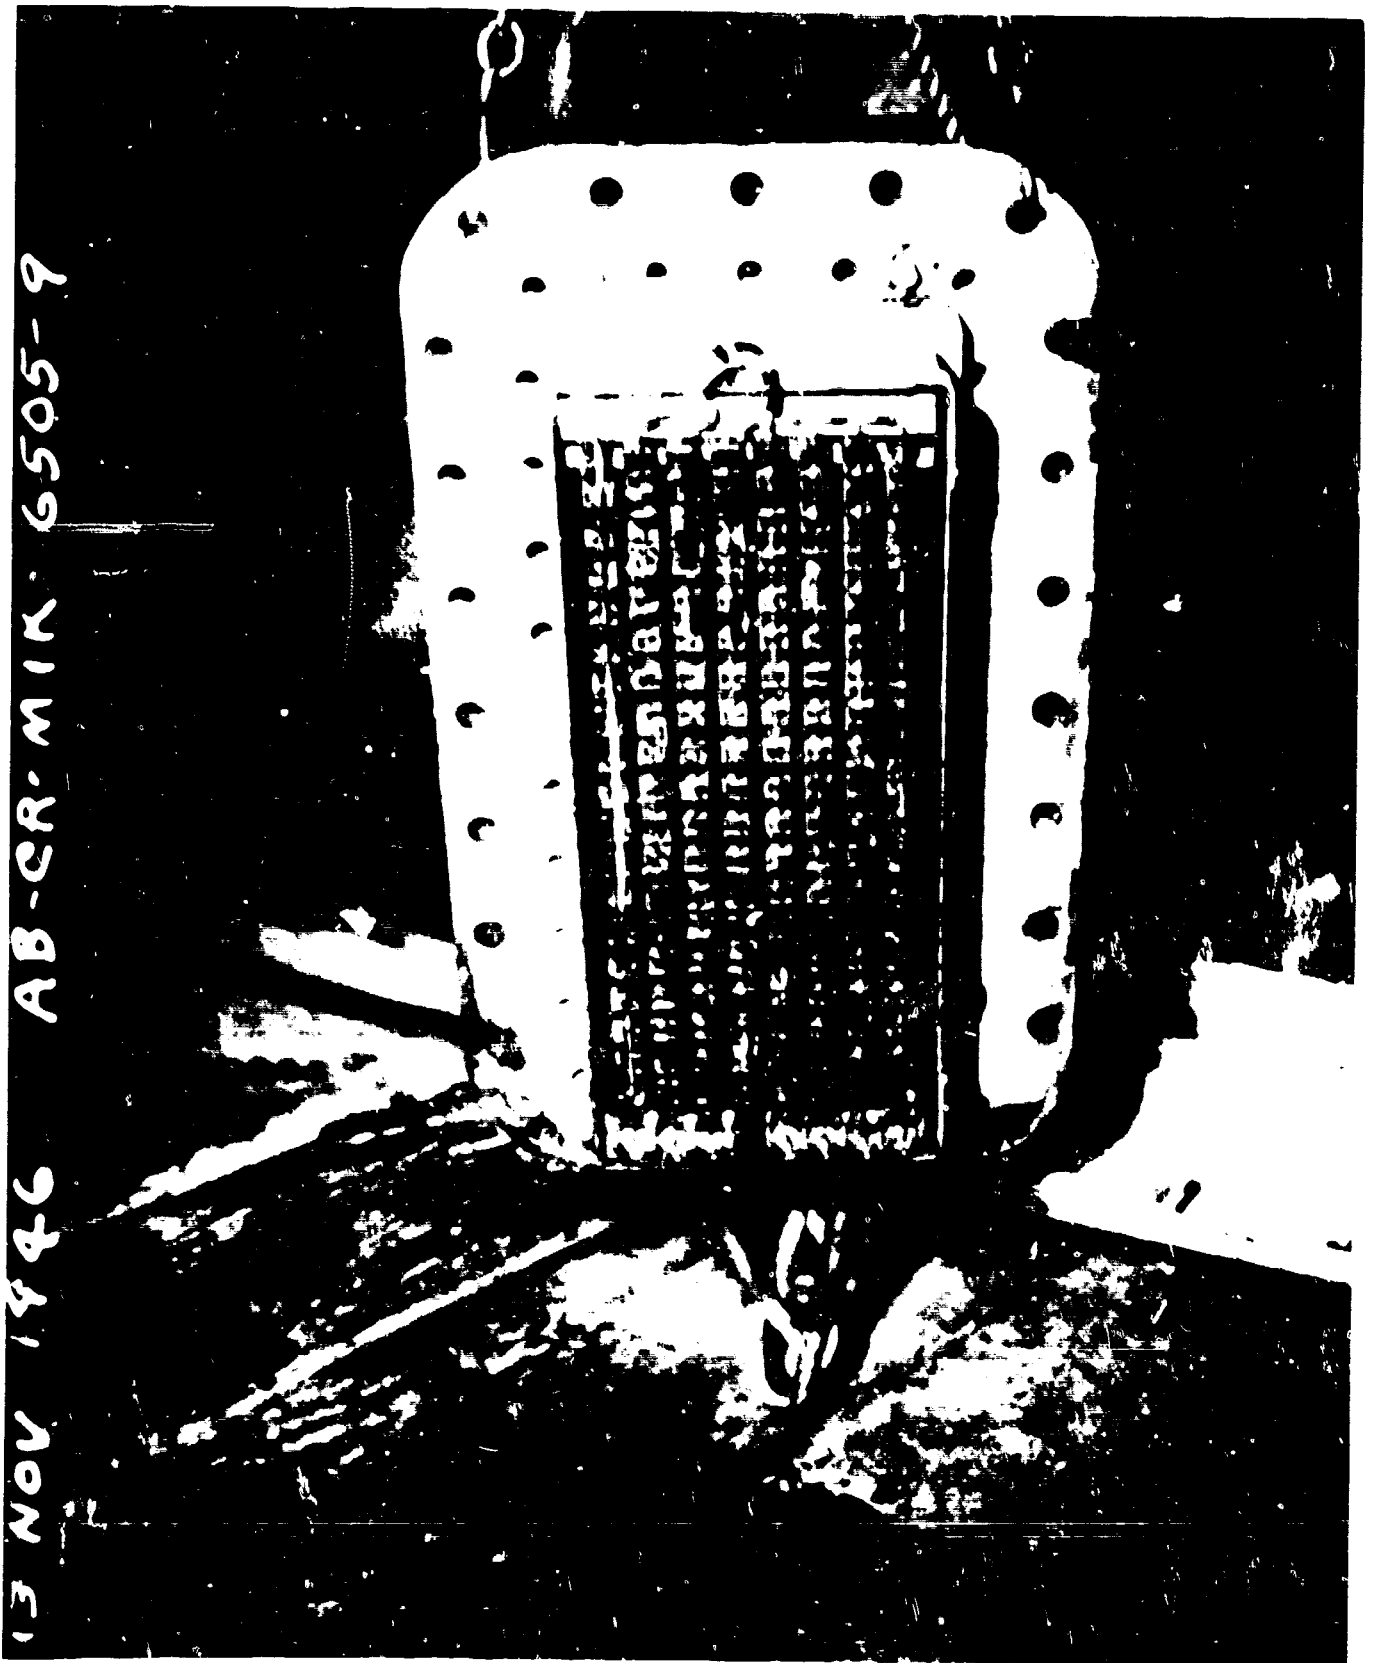
POST BAKER - NGA PROEQUIS. Face view of cover plate and crystal assembly, showing broken and missing crystals.
