ELECTRONICS COORDINATING OF
SHIP PREPARATION
and
TARGET INSPECTION

FINAL REPORT
TESTS ABLE AND BAKER

✓ **VOLUME 2**
PHOTOGRAPHIC RECORD

DIRECTOR OF SHIP MATERIAL
JOINT TASK FORCE ONE
OPERATION CROSSROADS

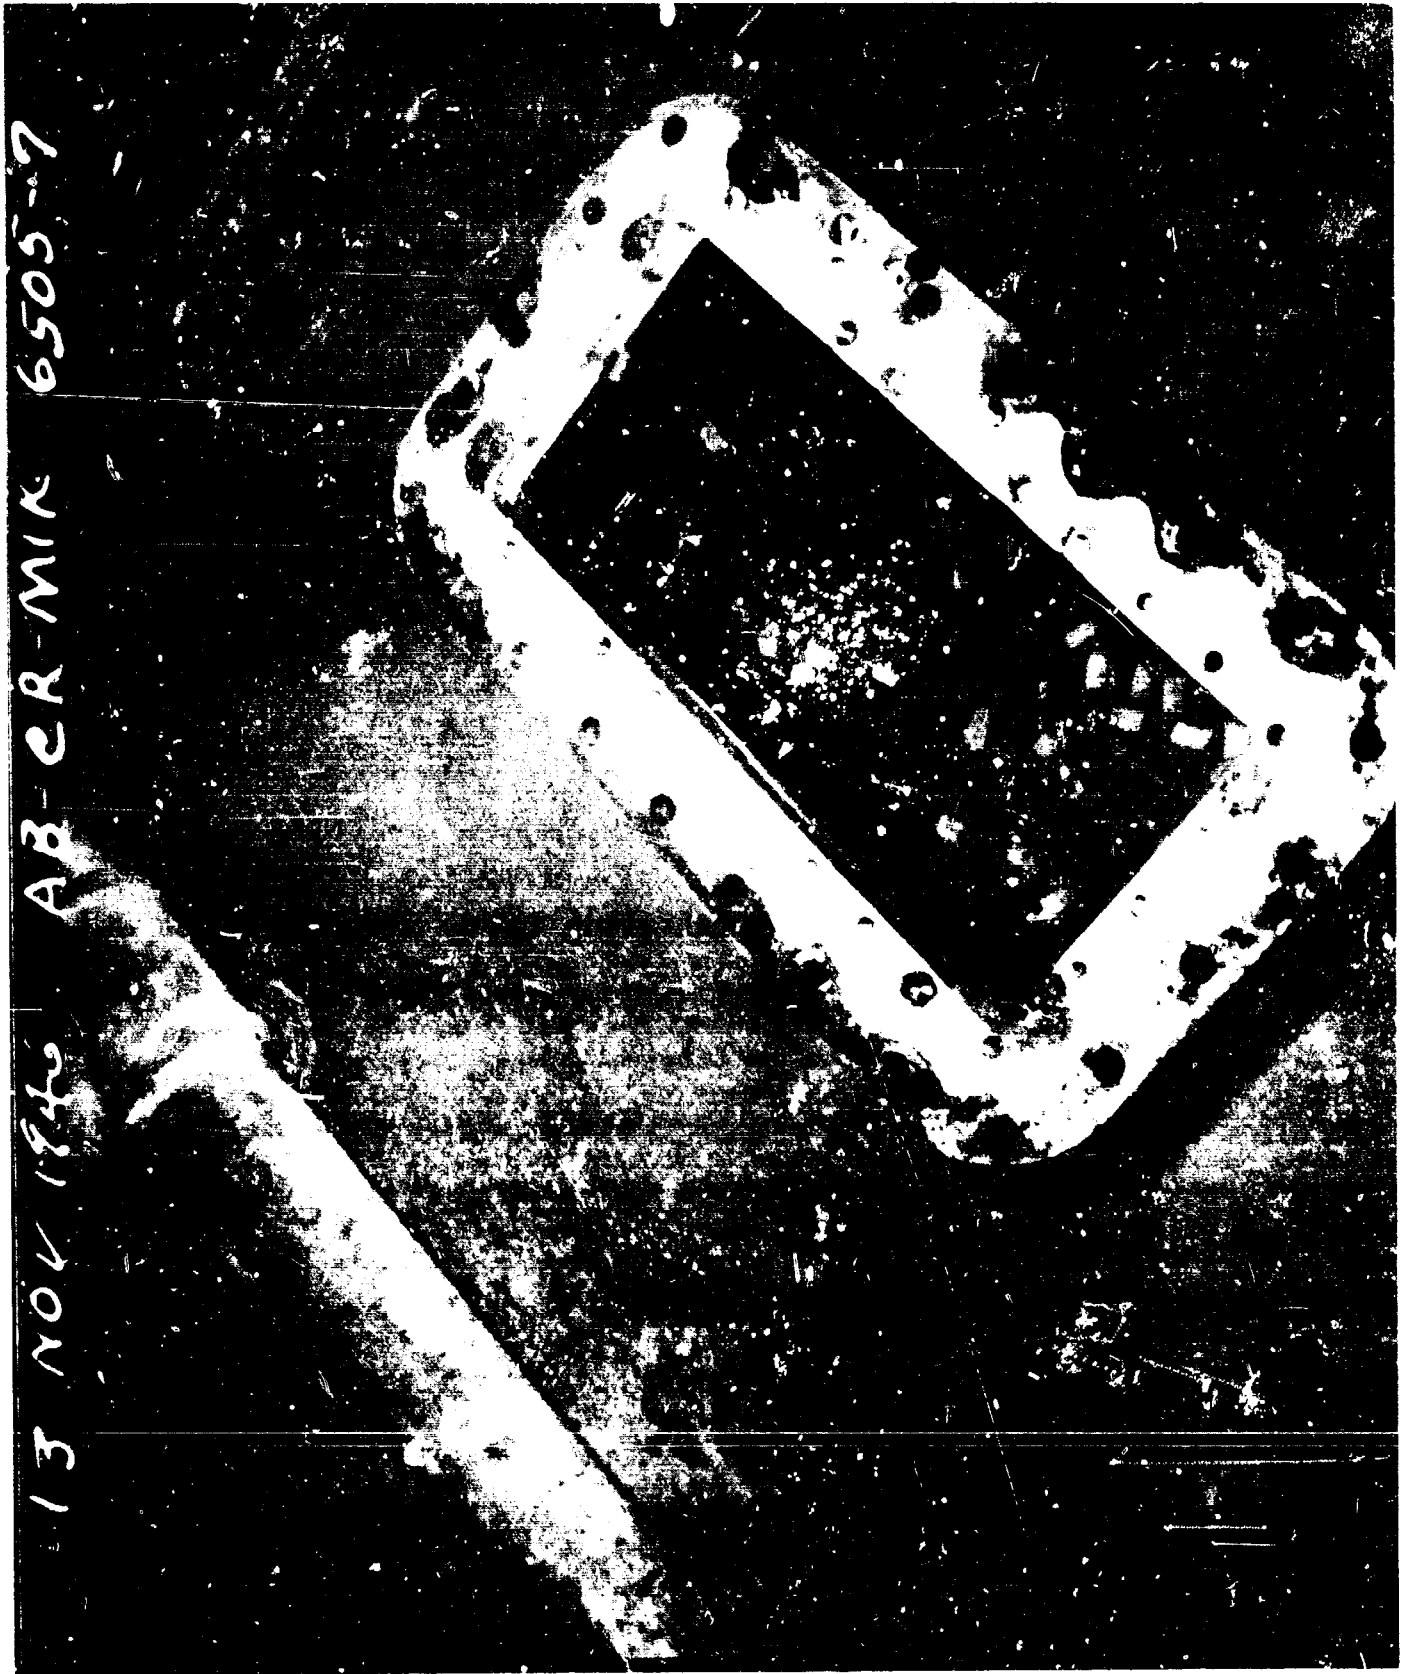
POST BAKER - NGA PROJECTOR. Case with crystal assembly and cover plate removed. Note broken and loose crystals.
