**Technical Inspection Report
Bureau of Ordnance Group**

OPERATION CROSSROADS

**TESTS 'A' AND 'B'
VOLUME II
PART VIII. Fire
Control [8]**

*Bureau of Ordnance group final
technical inspection rept.*

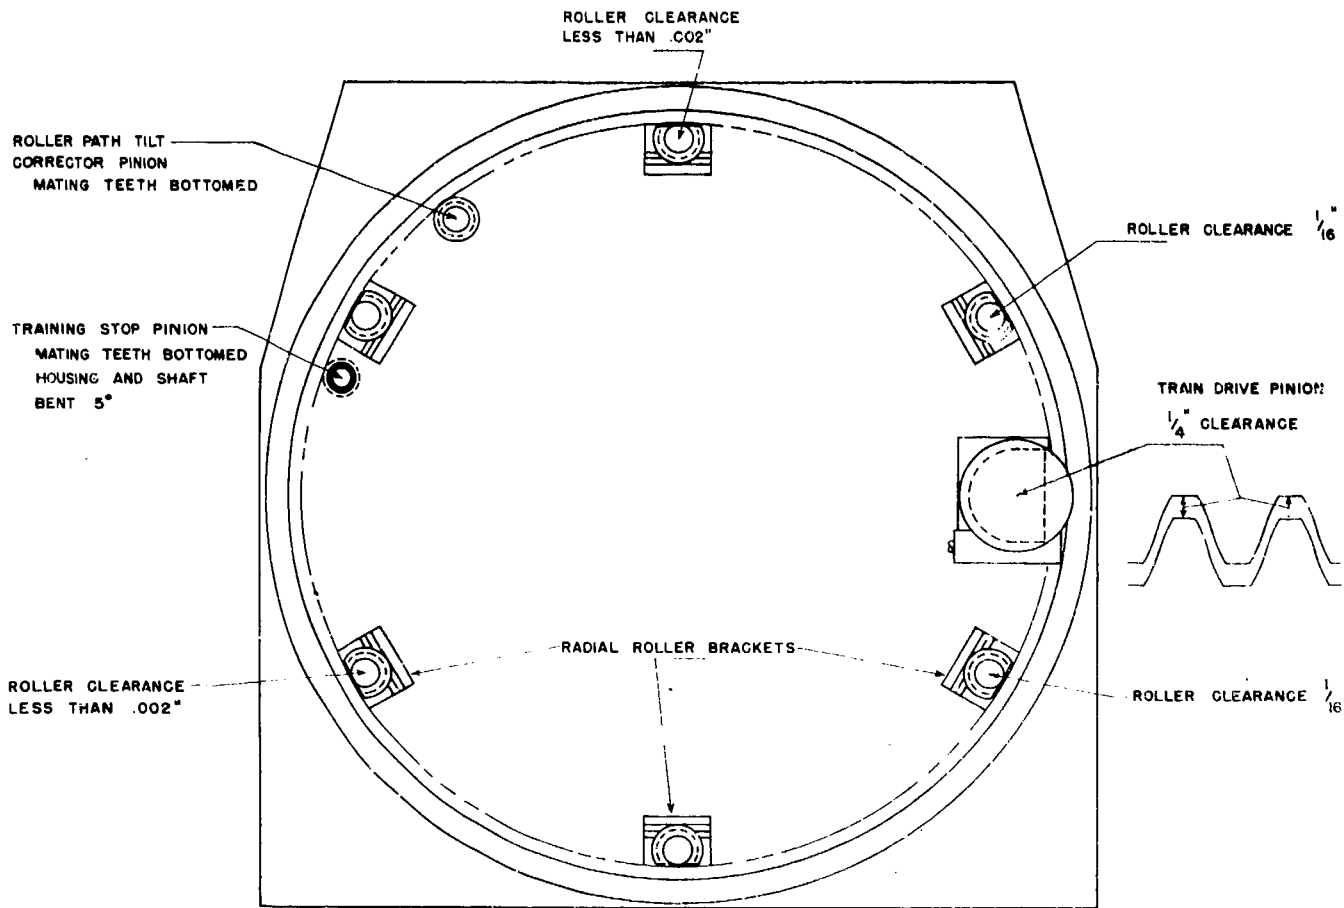
GUN DIRECTOR MK. 37

MOD. 35 SER. NO. 181
