# FINAL REPORT

# TESTS ABLE and BAKER

BUREAU OF AERONAUTICS  
GROUP

DIRECTOR OF SHIP MATERIAL  
JOINT TASK FORCE ONE

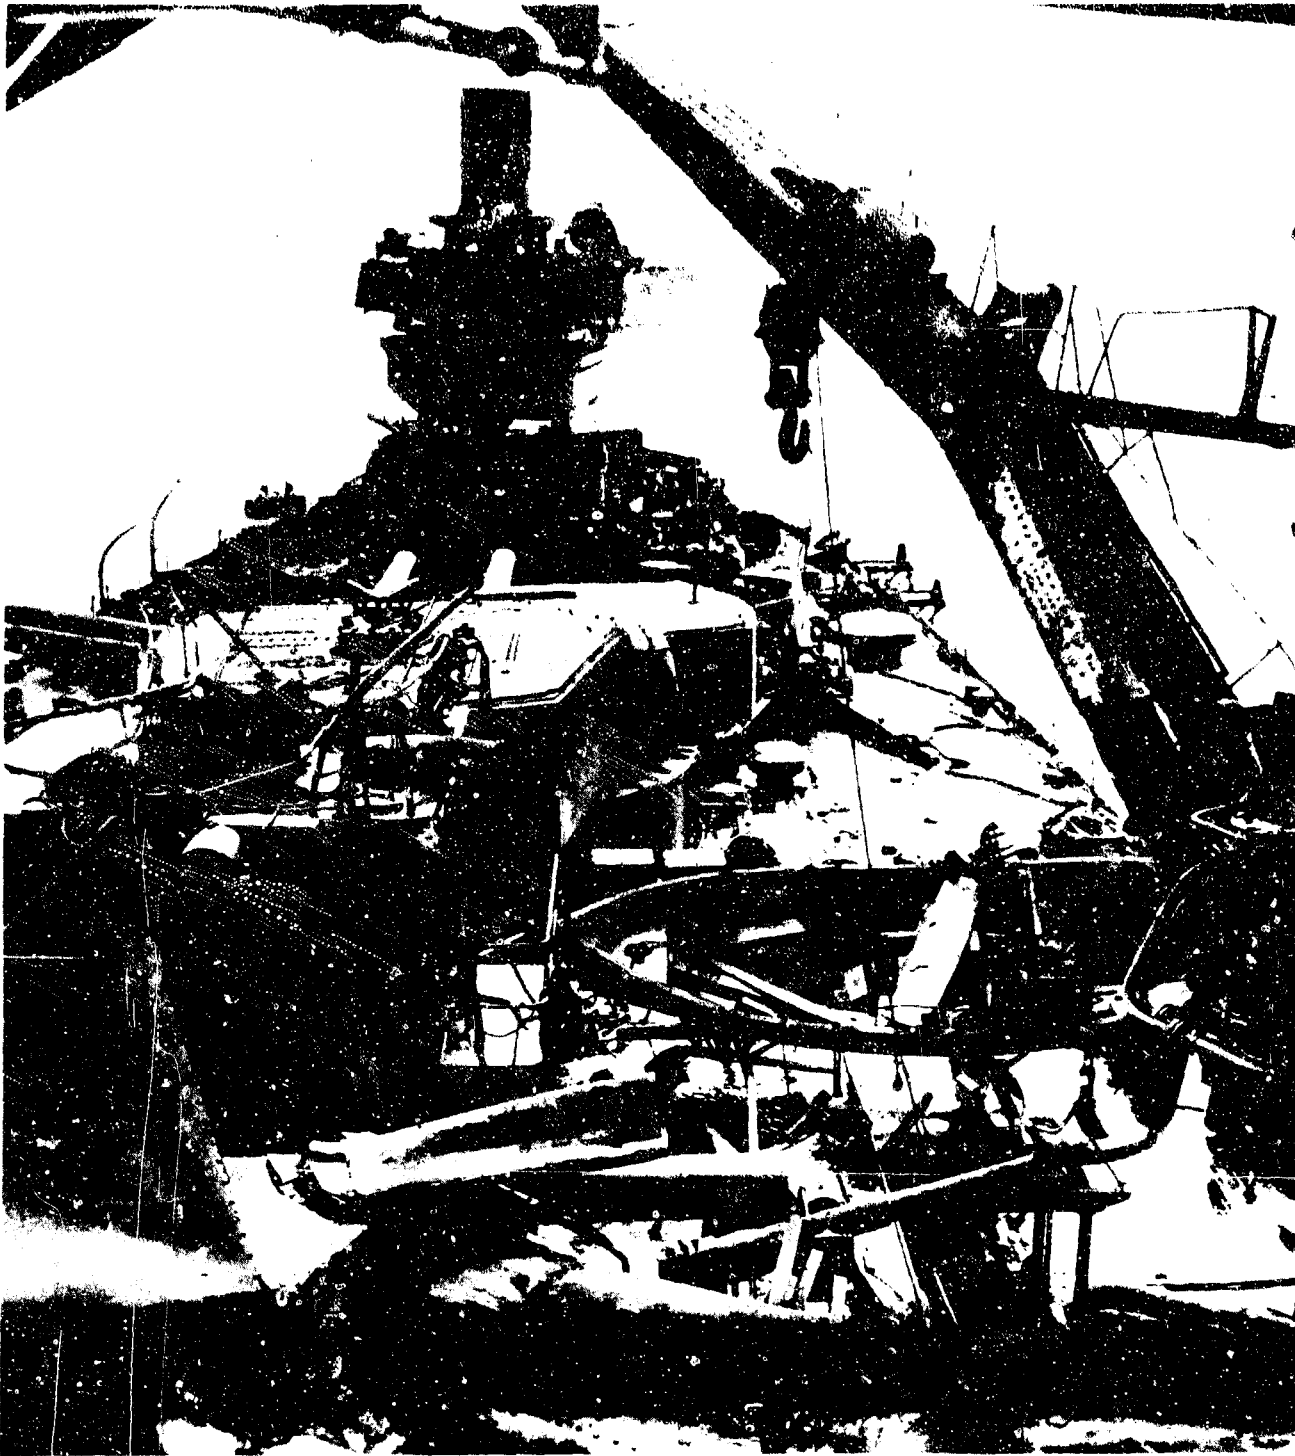
General view of USS ARKANSAS after Test ABLE. OS2U-3 secured to cradle welded atop the turret, visible to the left of center in photograph, was blown over the side with no trace of the airplane remaining.

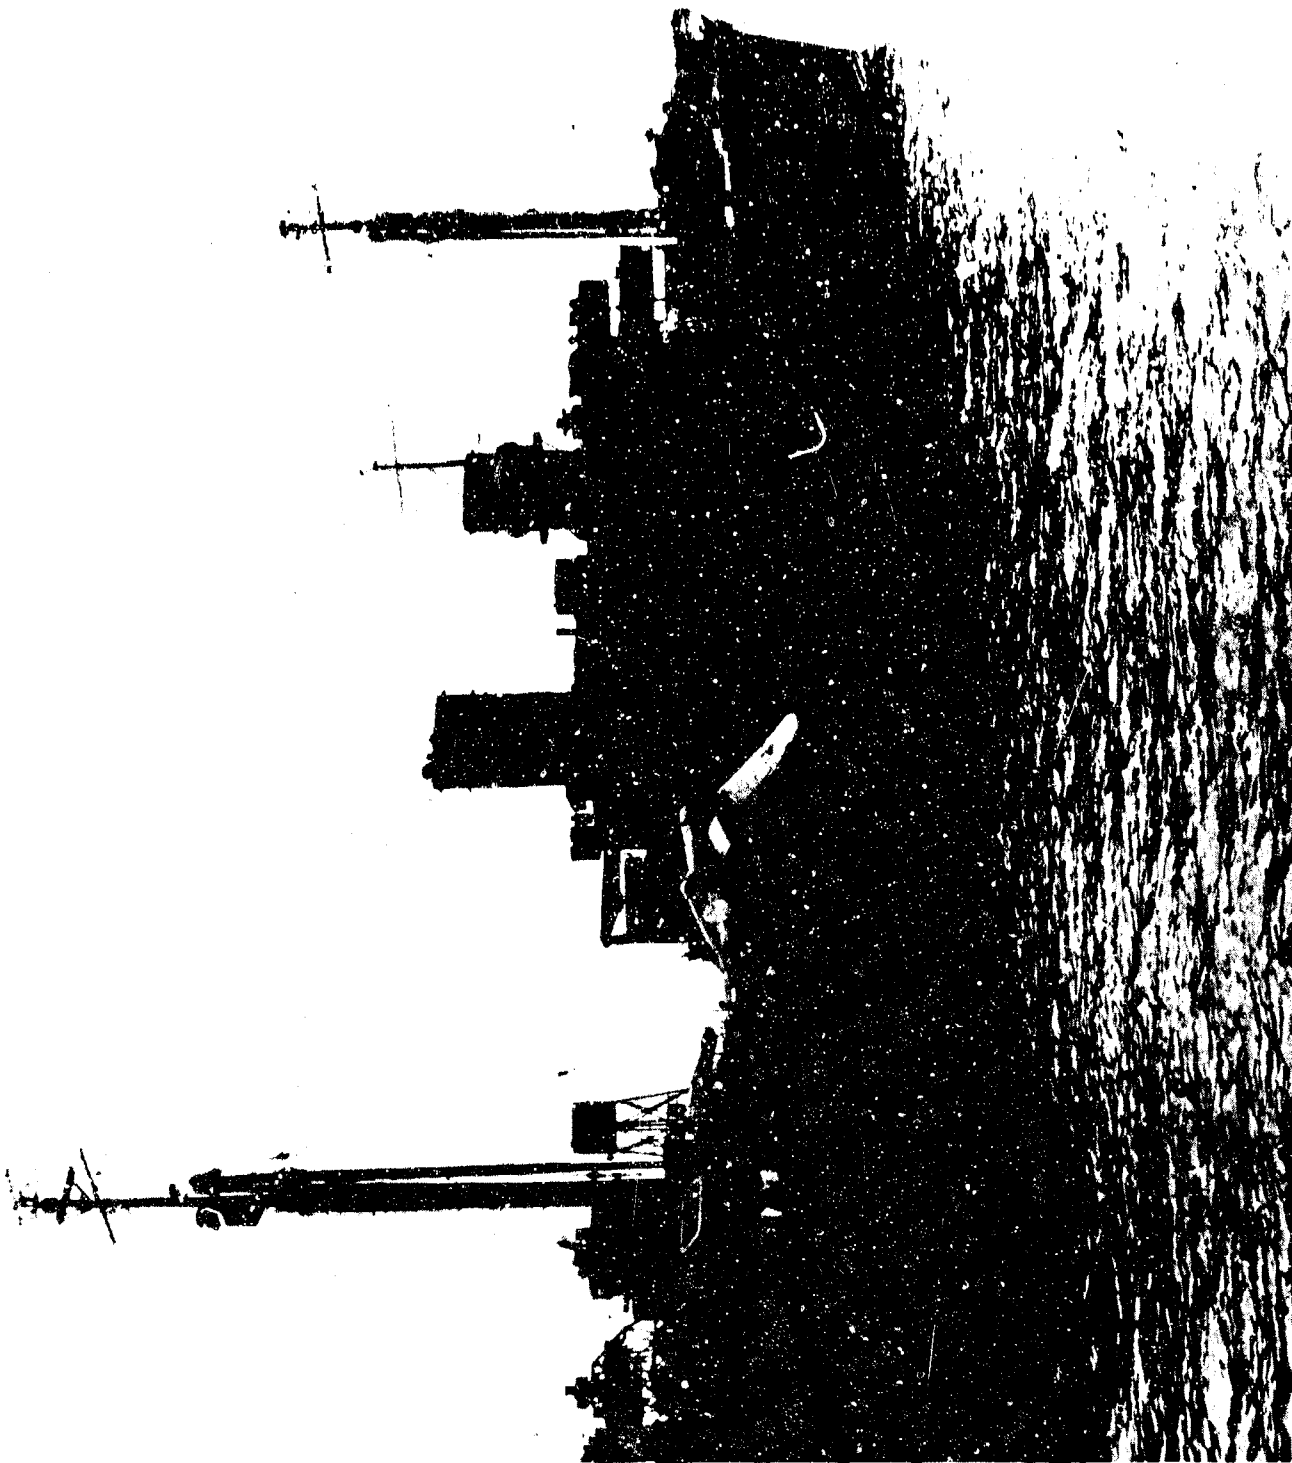
Model FG-1D airplane on main deck of USS CARTERET APA-70, after Test ABLE. The CARTERET was approximately 1600 yards from the blast center in the intermediate zone of damage. Right wing was blown from folded position by the blast.

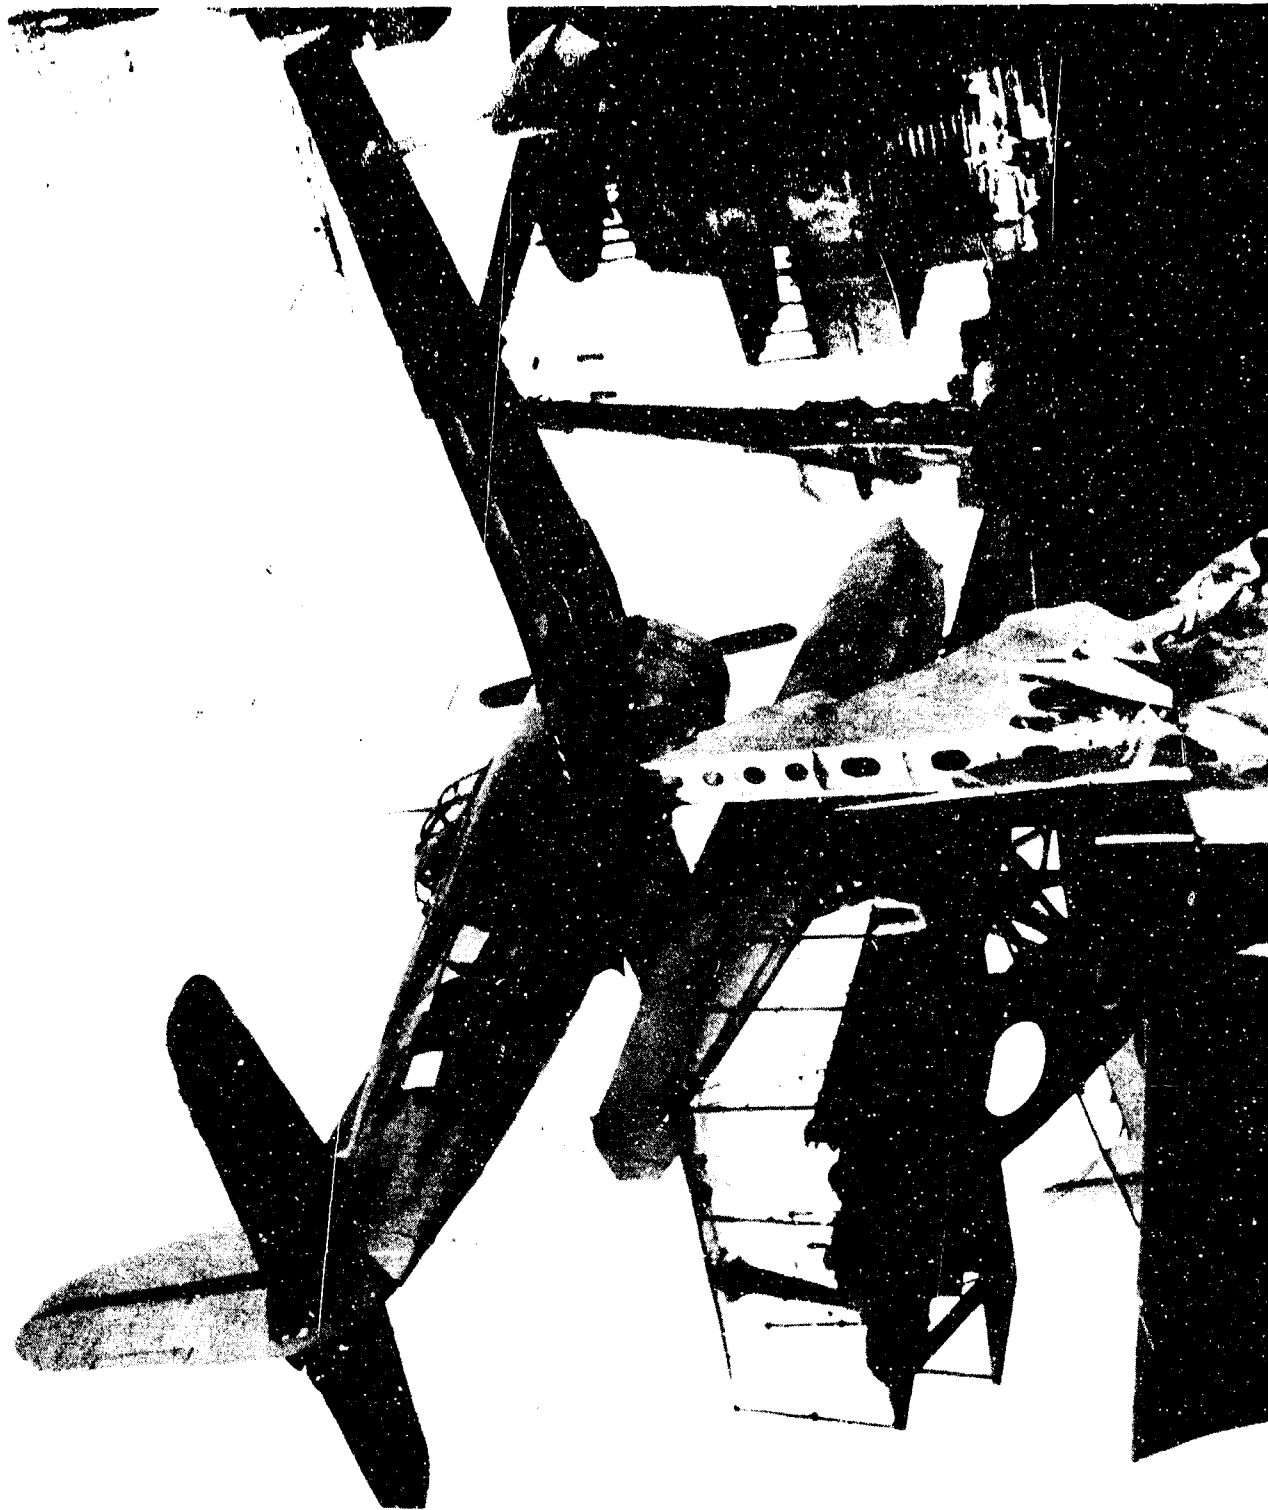
Model XSC-1 Airplane in place on catapult on USS NEW YORK after Test ABLE. This airplane in the intermediate zone shows extreme buckling of fuselage and loss of control surfaces.

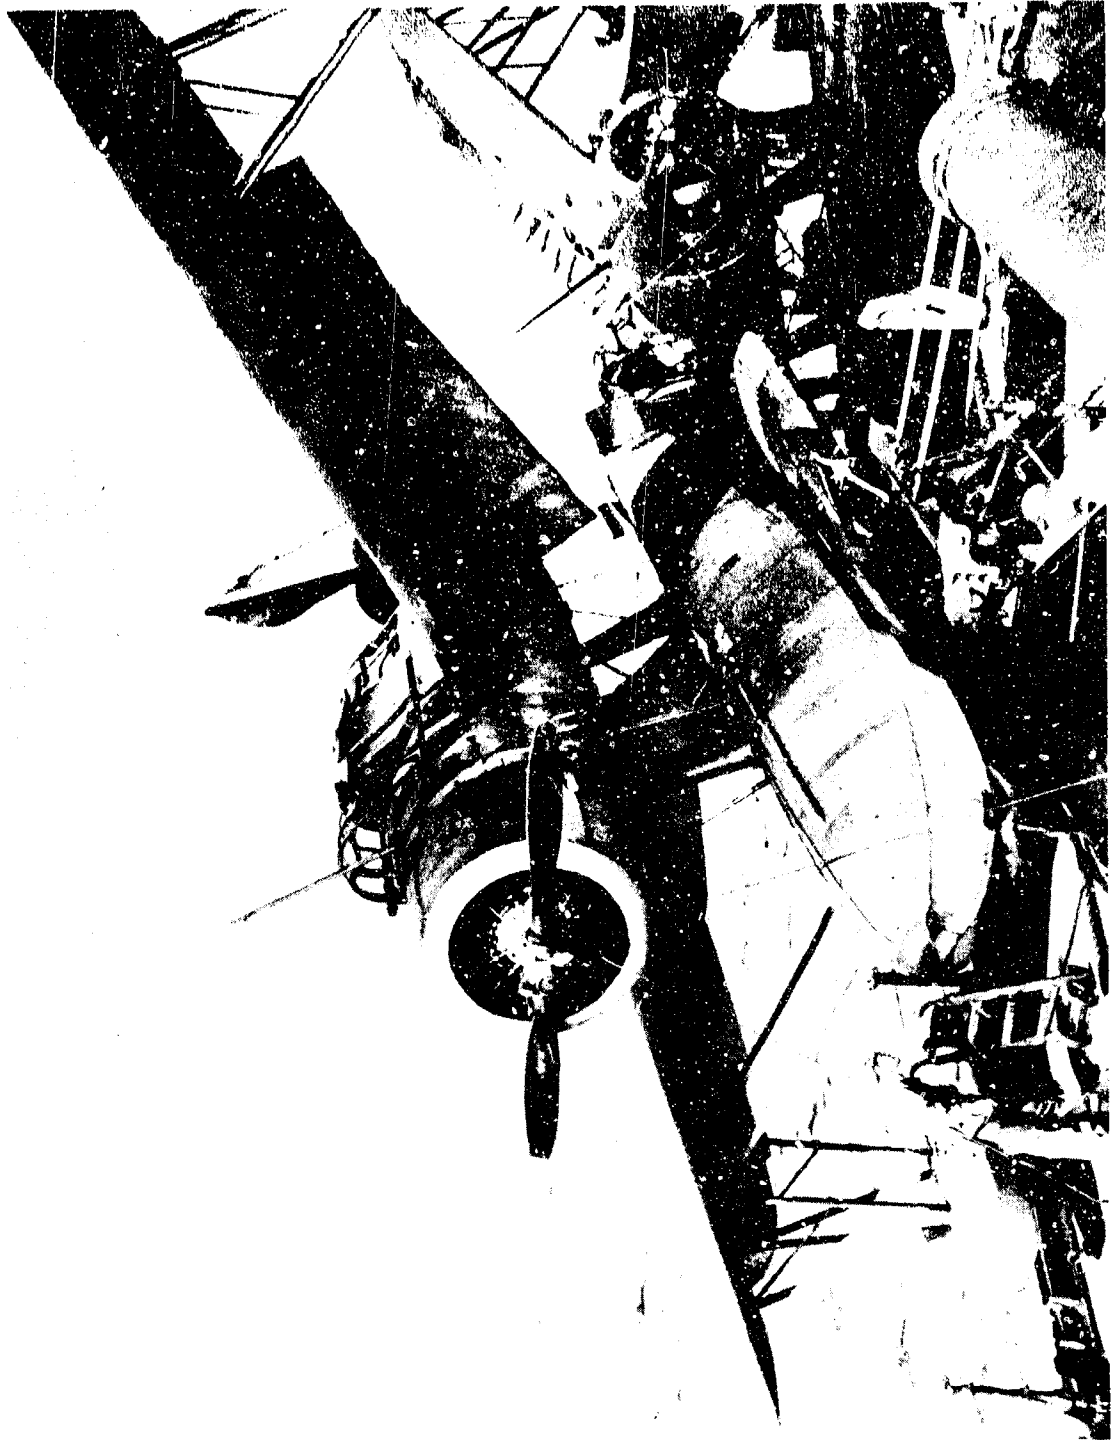
Model OS2U-3 airplane on board USS PENNSYLVANIA after Test ABLE. Float type aircraft exhibited less resistance to overturn as compared to wheel type aircraft, and consequently may be more affected by secondary damage due to falling to deck. Note blast damage to control surfaces and cockpit panels.

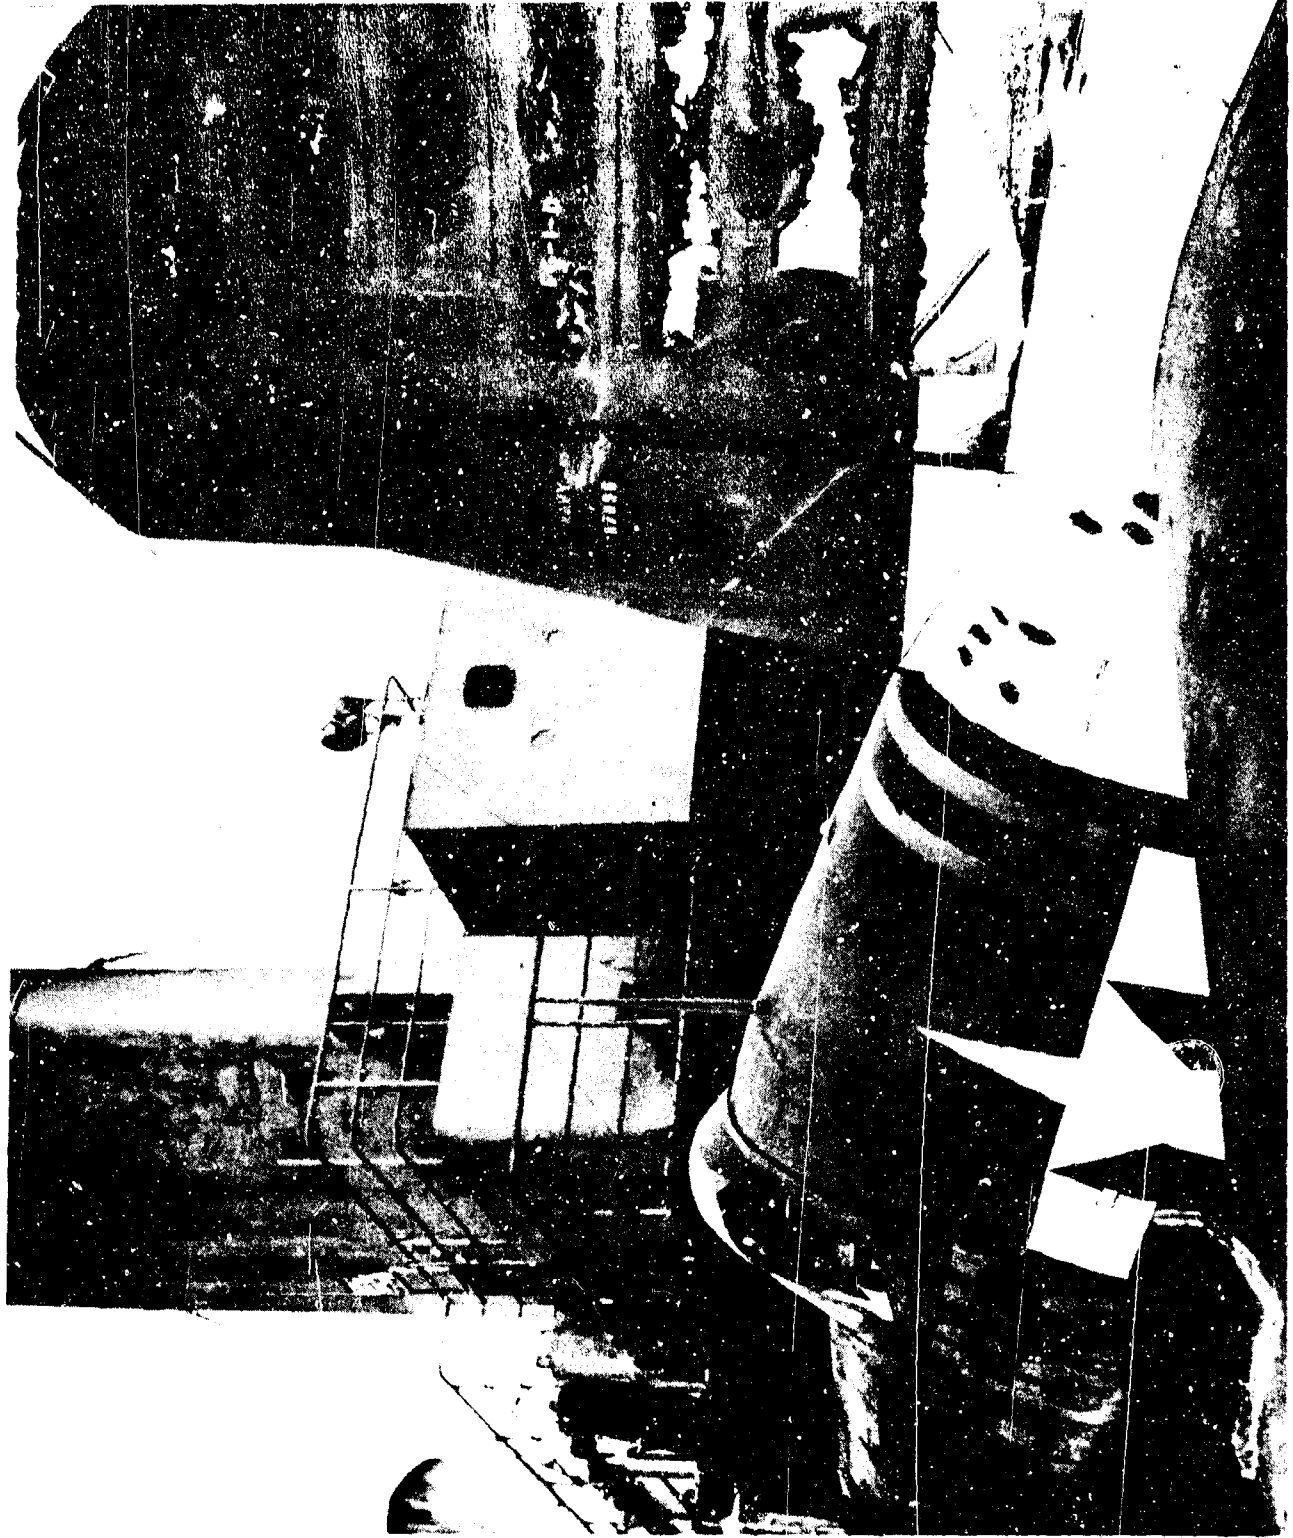
Model FG-1D airplane on main deck of USS BLADEN after Test ABLE. Scorching of fabric and damage to plexiglass is typical of the minor damage sustained by airplanes in the outer zone.

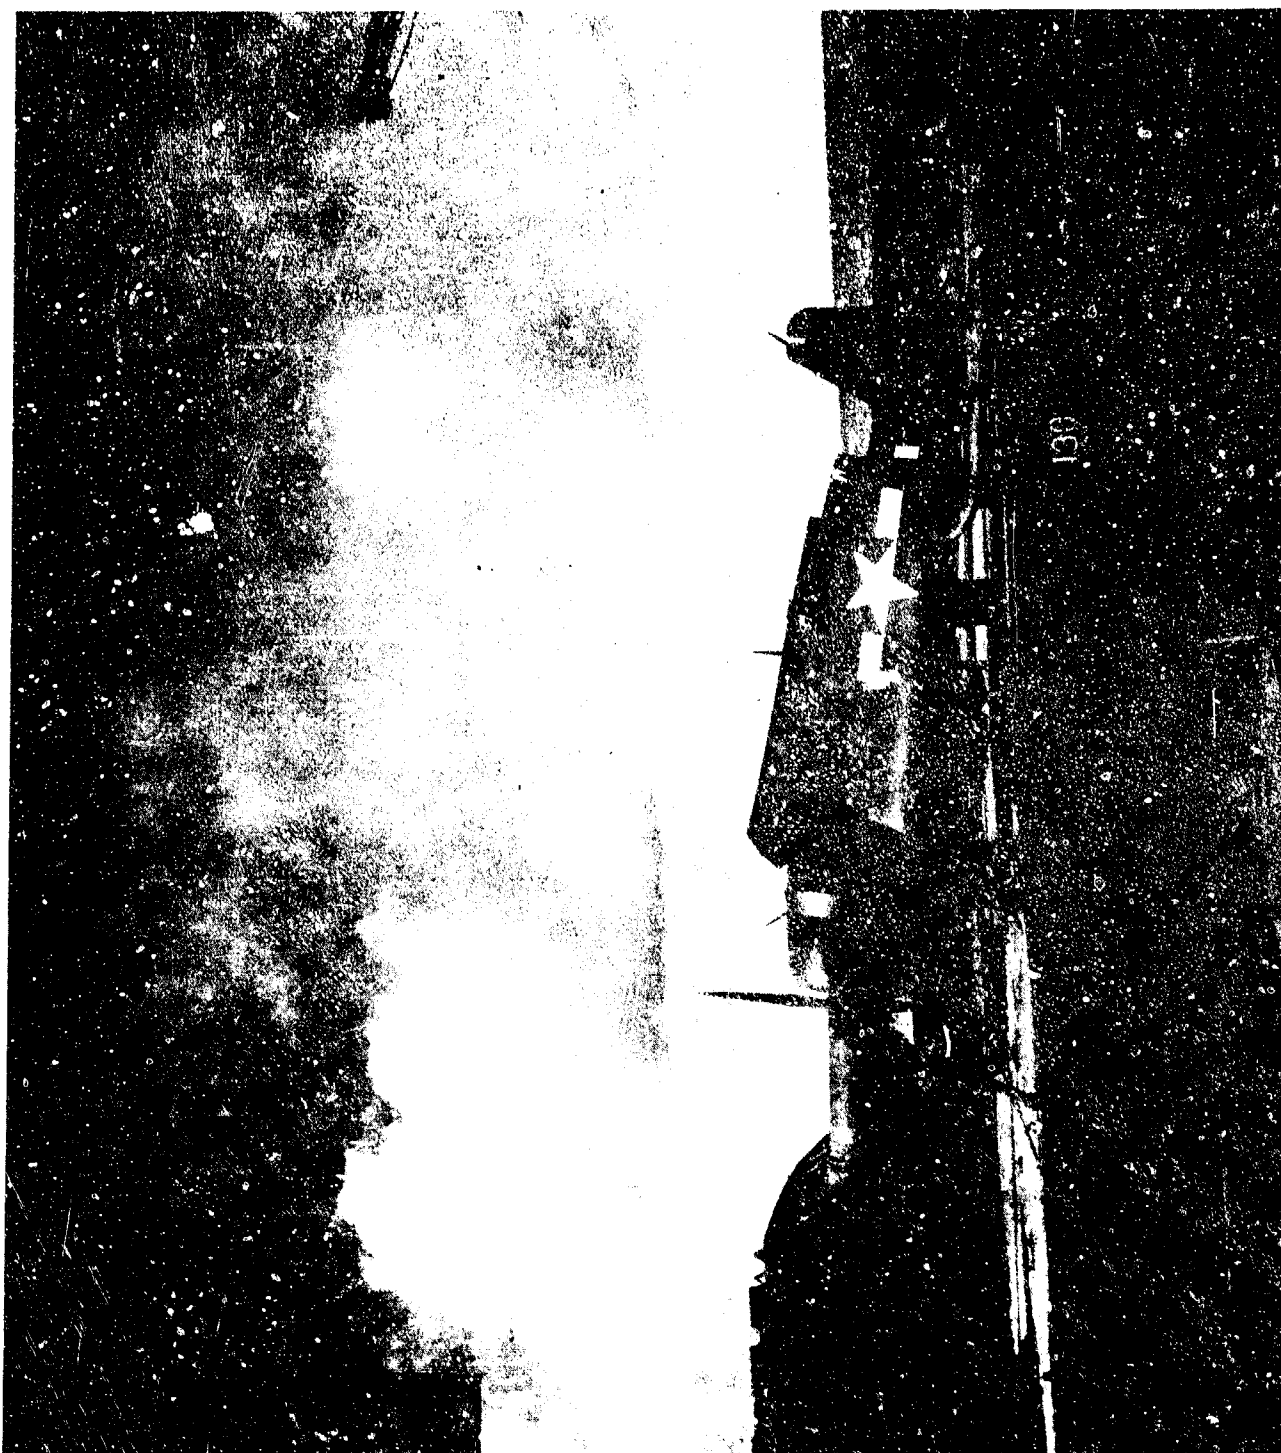
Model F6F-5N airplane aboard PENNSYLVANIA at approximately 1200 yards from burst. This airplane was essentially undamaged by Test BAKER, however extreme radiological contamination would prevent routine maintenance or operation.

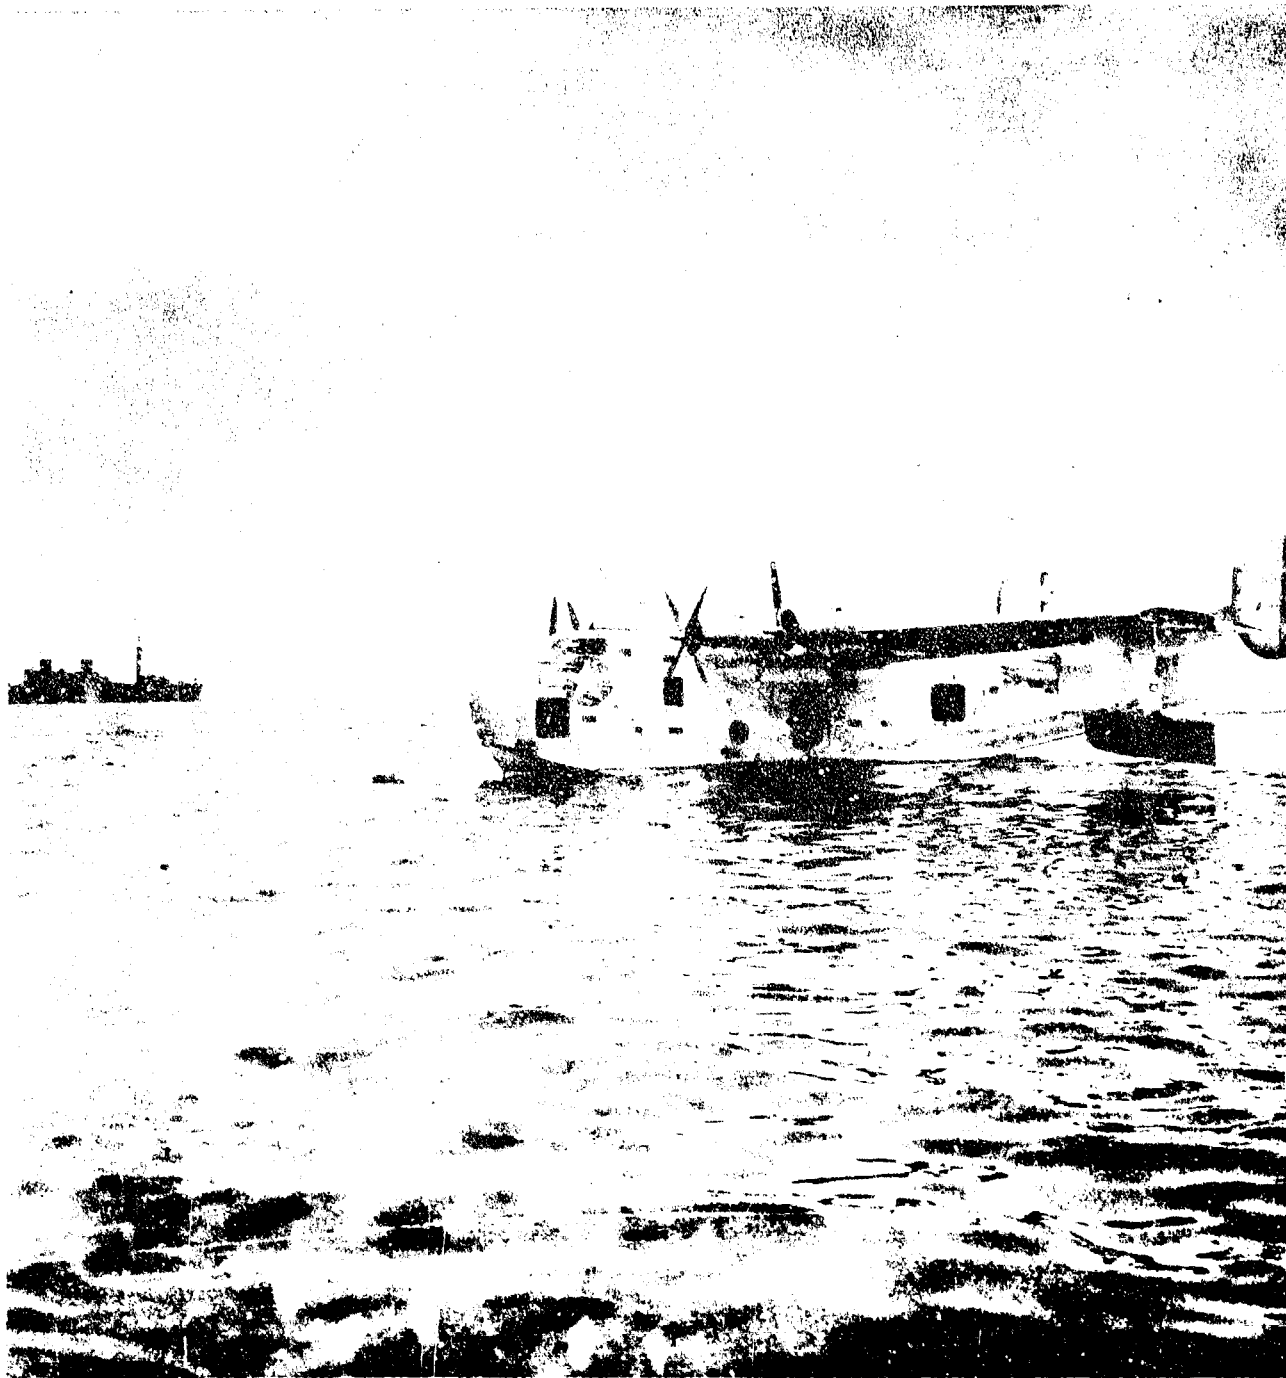
PHOTOGRAPH NUMBER: - AF-615\*97

10.	PB2Y-5H BuNo 7085 moored at Approximately 3000 Yards From Burst. Additional Damage Sustained in Test BAKER	227-283-97	127

Model PB2Y-5H Airplane BuNo 7085 moored at approximately 3000 yards from burst. Additional damage sustained in Test BAKER; namely increase in buckling in nose above insignia, and further damage to after portion of fuselage, was caused by air blast effect. Note that temporary hatch covers installed after Test ABLE have been blown in.
