# ⑨ BUREAU OF SHIPS GROUP TECHNICAL INSPECTION REPORT

## ⑥ OPERATION CROSSROADS, BEACHED LANDING CRAFT,

TEST BAKER

# TECHNICAL INSPECTION REPORT

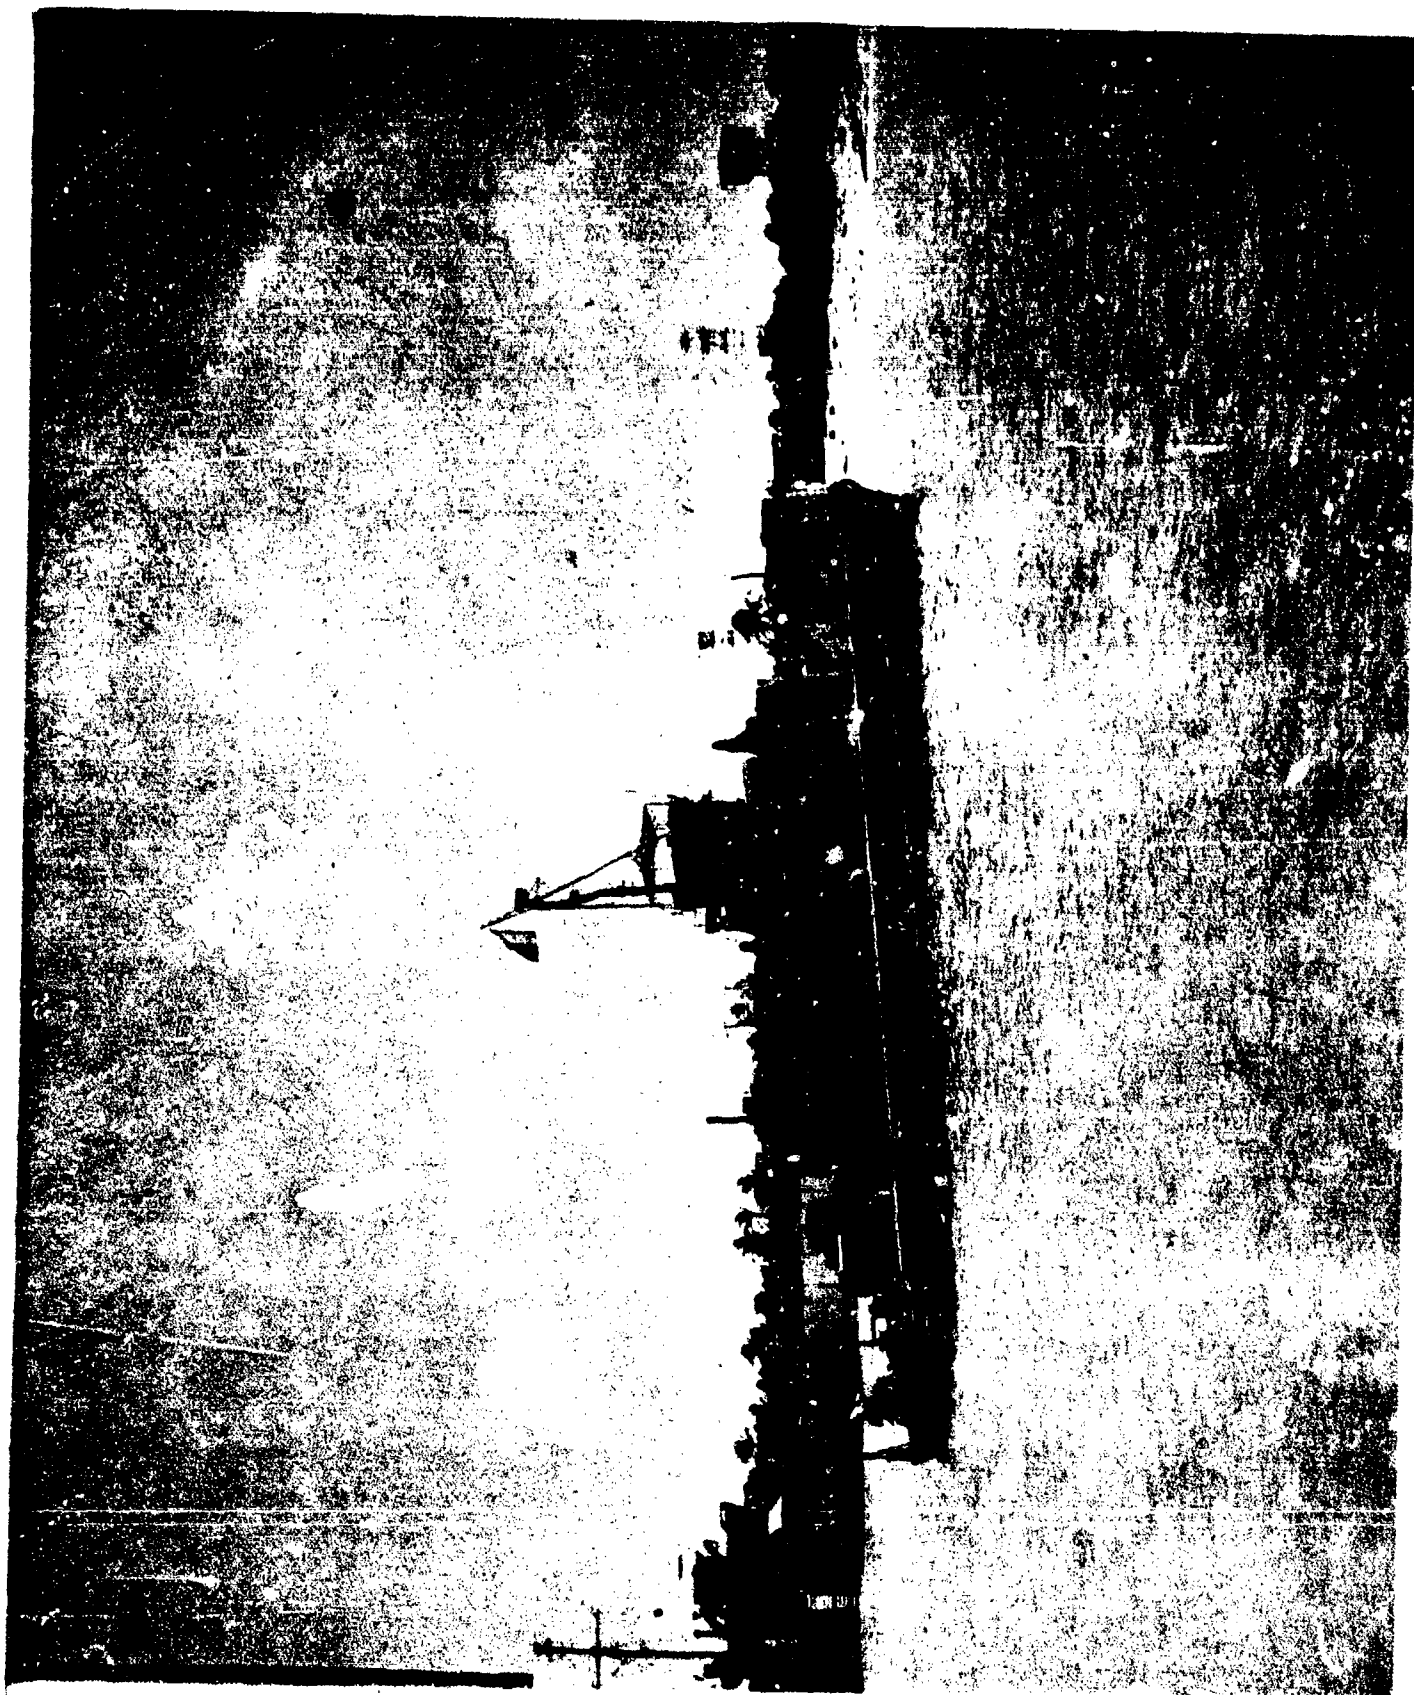
The engine room was flooded to within 4-1/2 feet from the overhead, submerging all engines and generators, and about two-thirds of the switchboards. The steering gear compartment was flooded to a depth of 18 inches. The after troop compartments contained approximately five feet of water.

The starboard ramp was ripped off the ship and all loose gear on the fantail was found piled up against the after end of the deck house.

AB-CR-199-1502-5. LCI-620 after Test B.

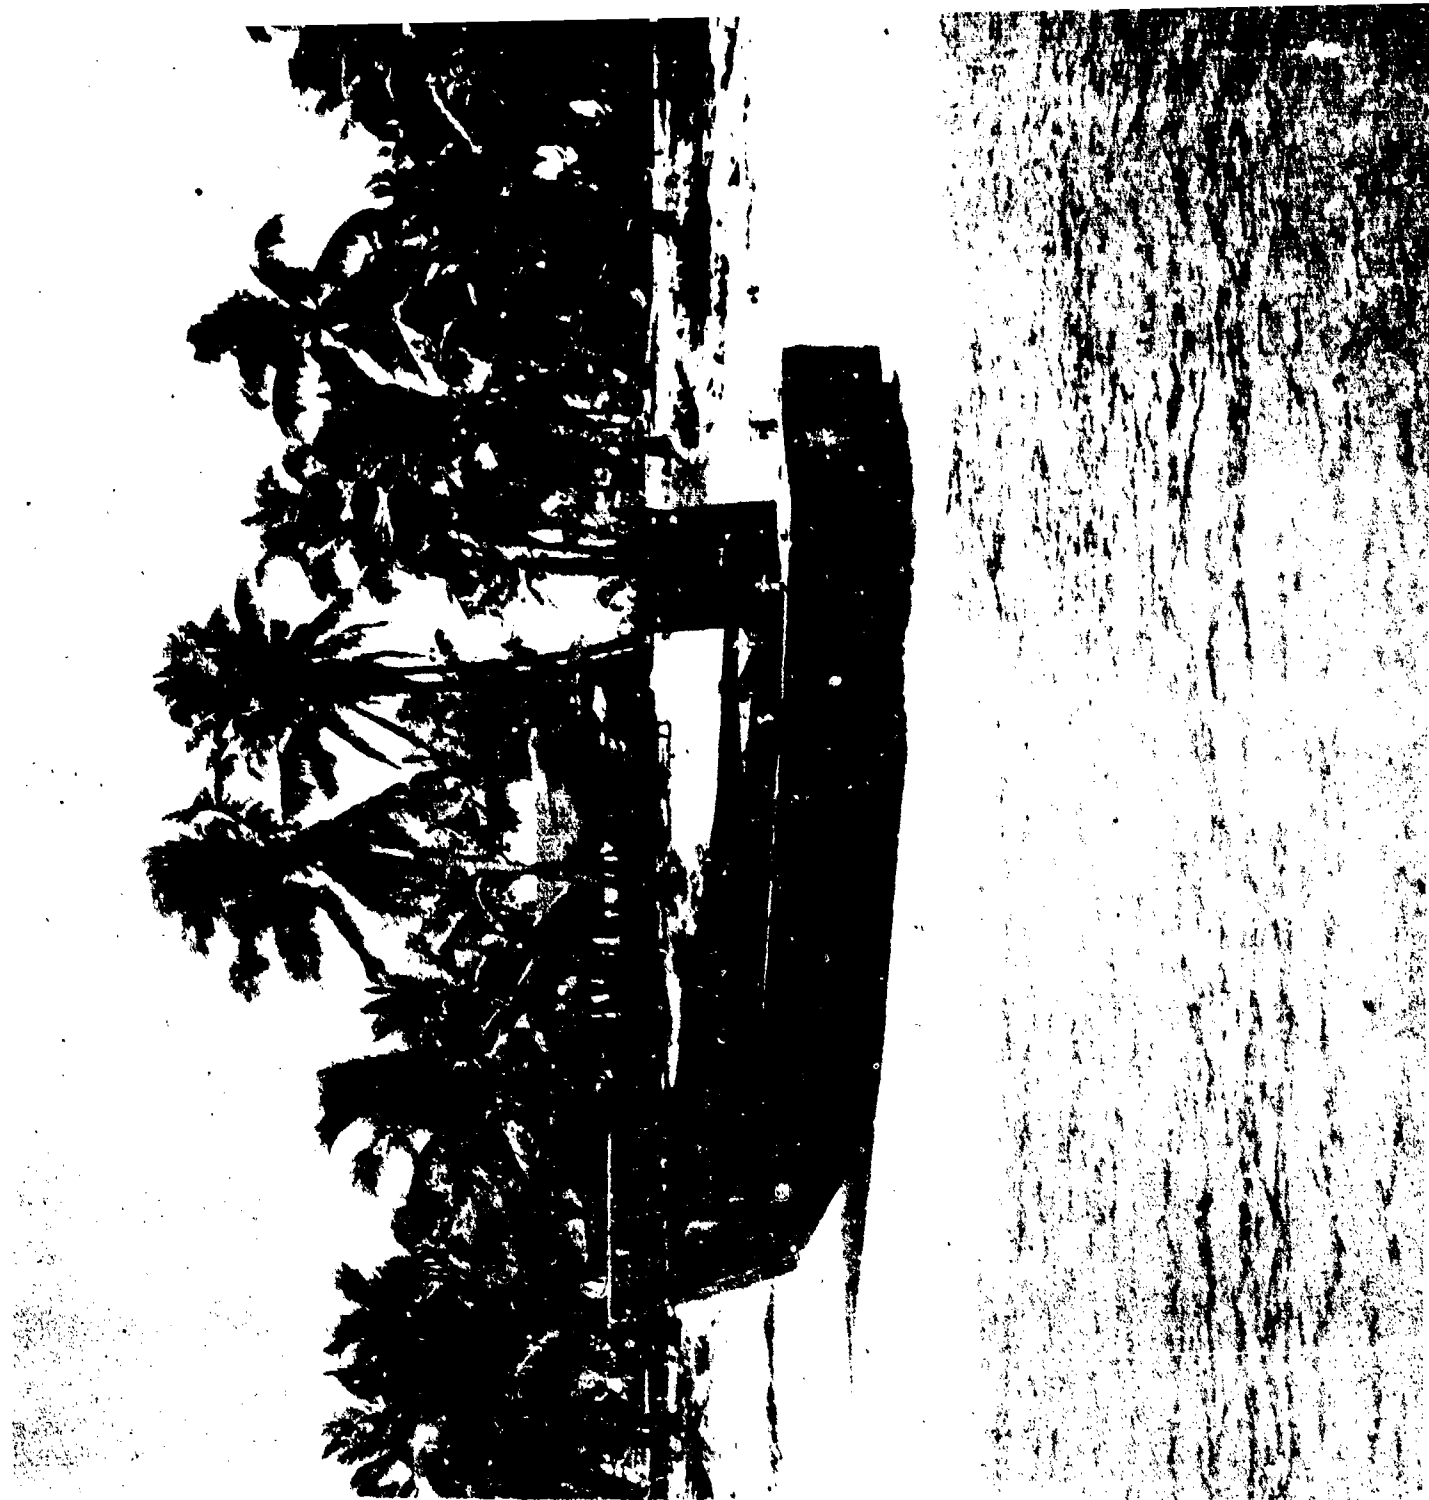
This craft moved about 20 feet along the beach from its location before the test. (Photograph 287-37, page 32 ).

No apparent damage occurred as a result of the test. At the time of inspection, hatches to the engine room and after compartment were open. As a result of wave action and heavy rains, there was two feet of water in the vehicle space, engine room, and after compartments.

AB-CR-227-287-37. LCM-1 after Test B.

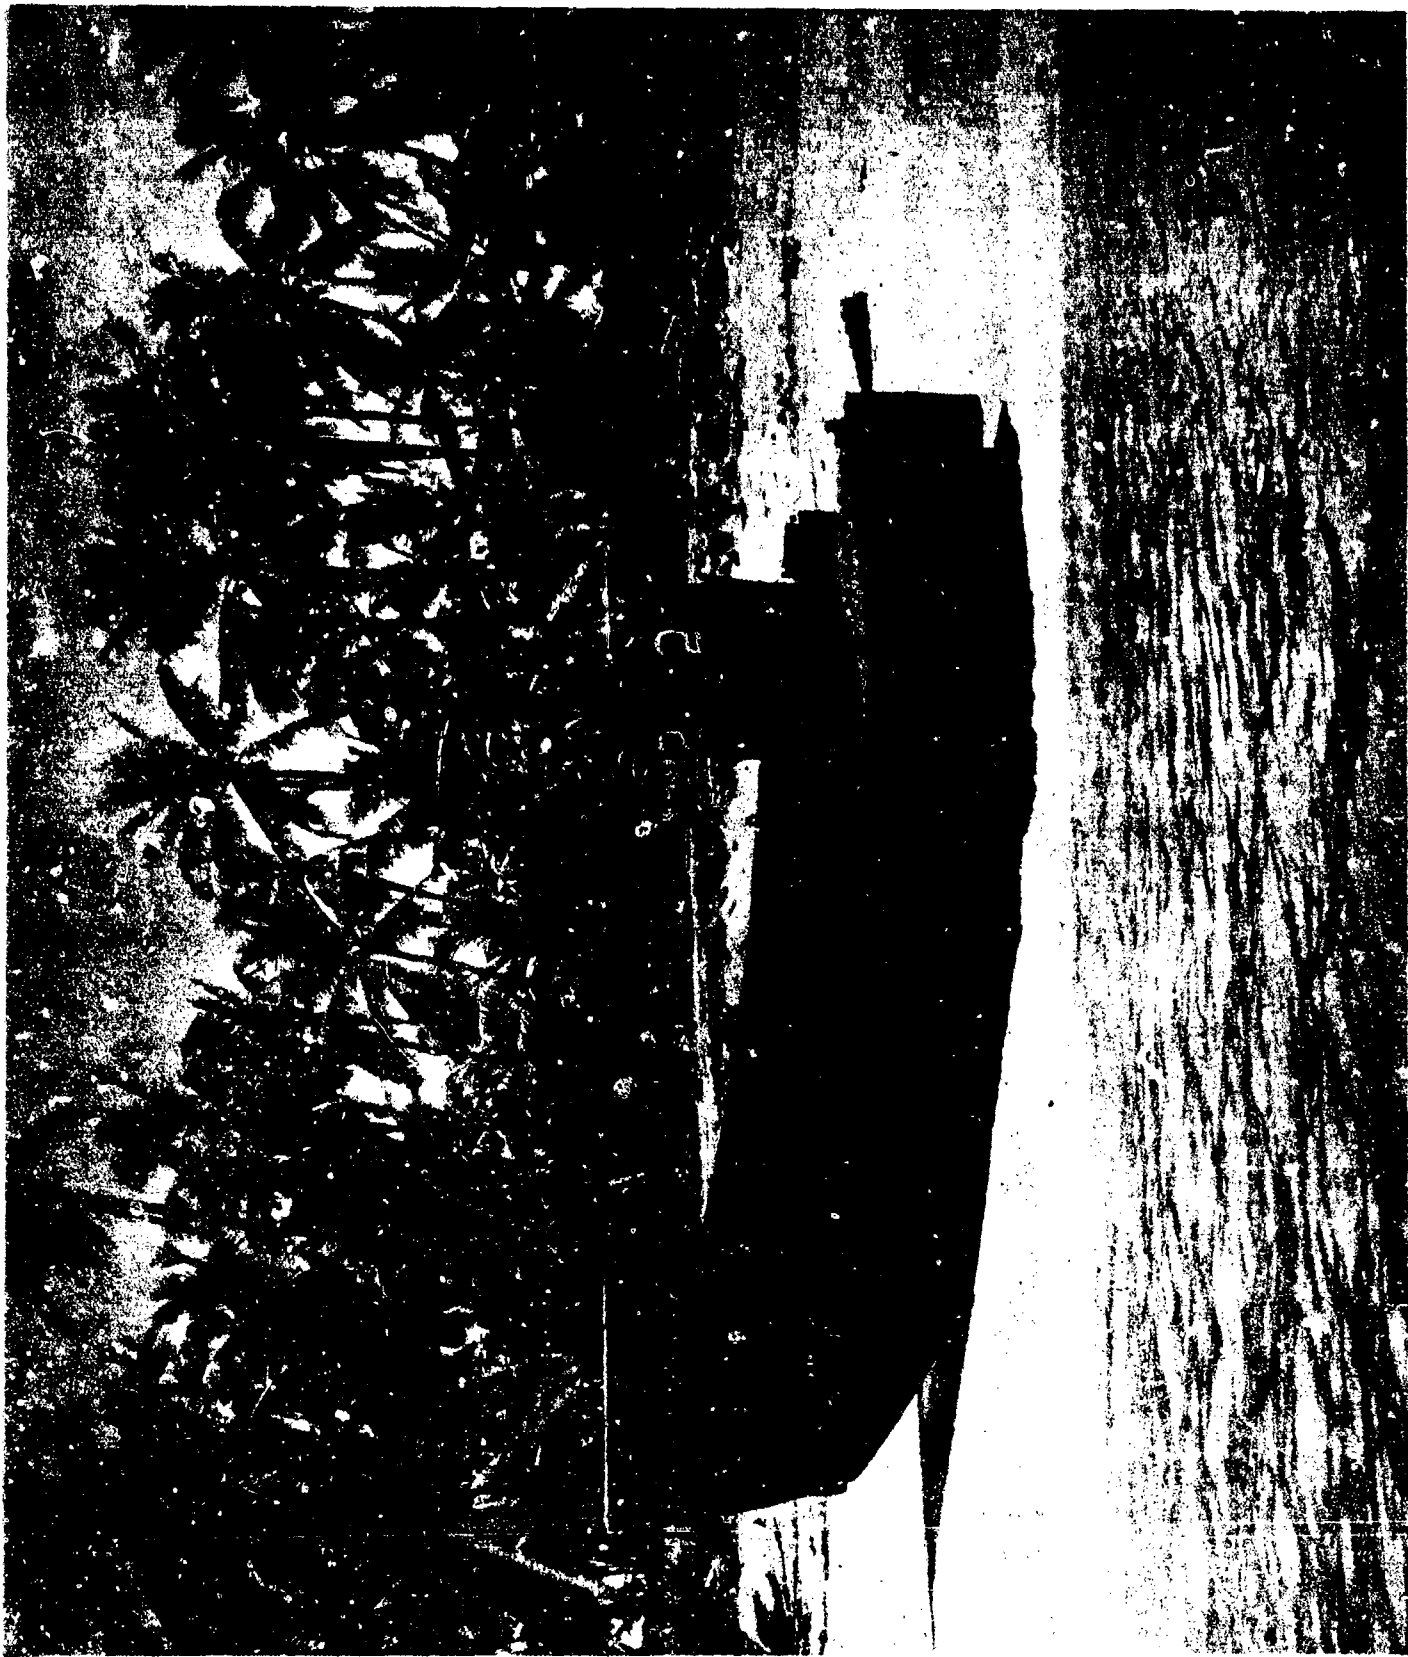
When inspected after the test this craft was on the beach in approximately her original position. (Photograph 287-48, page 33 ). The craft was apparently undamaged as a result of test B.

Hatches to the engine room and after compartment were open. The after part of the vehicle space contained eight inches of water, the engine room, 18 inches, and the after compartment, 12 inches.

A hole 10' x 6' was stove in the starboard side, two feet above the bottom at the after quarter point. A hole 3' x 1-1/2' was punched through the port shell eight inches above the bottom and six feet from the bow. It is believed that these holes existed prior to the test and were caused by contact with coral or with other craft.

AB-CR-227-287-48. LCM-2 after Test B.

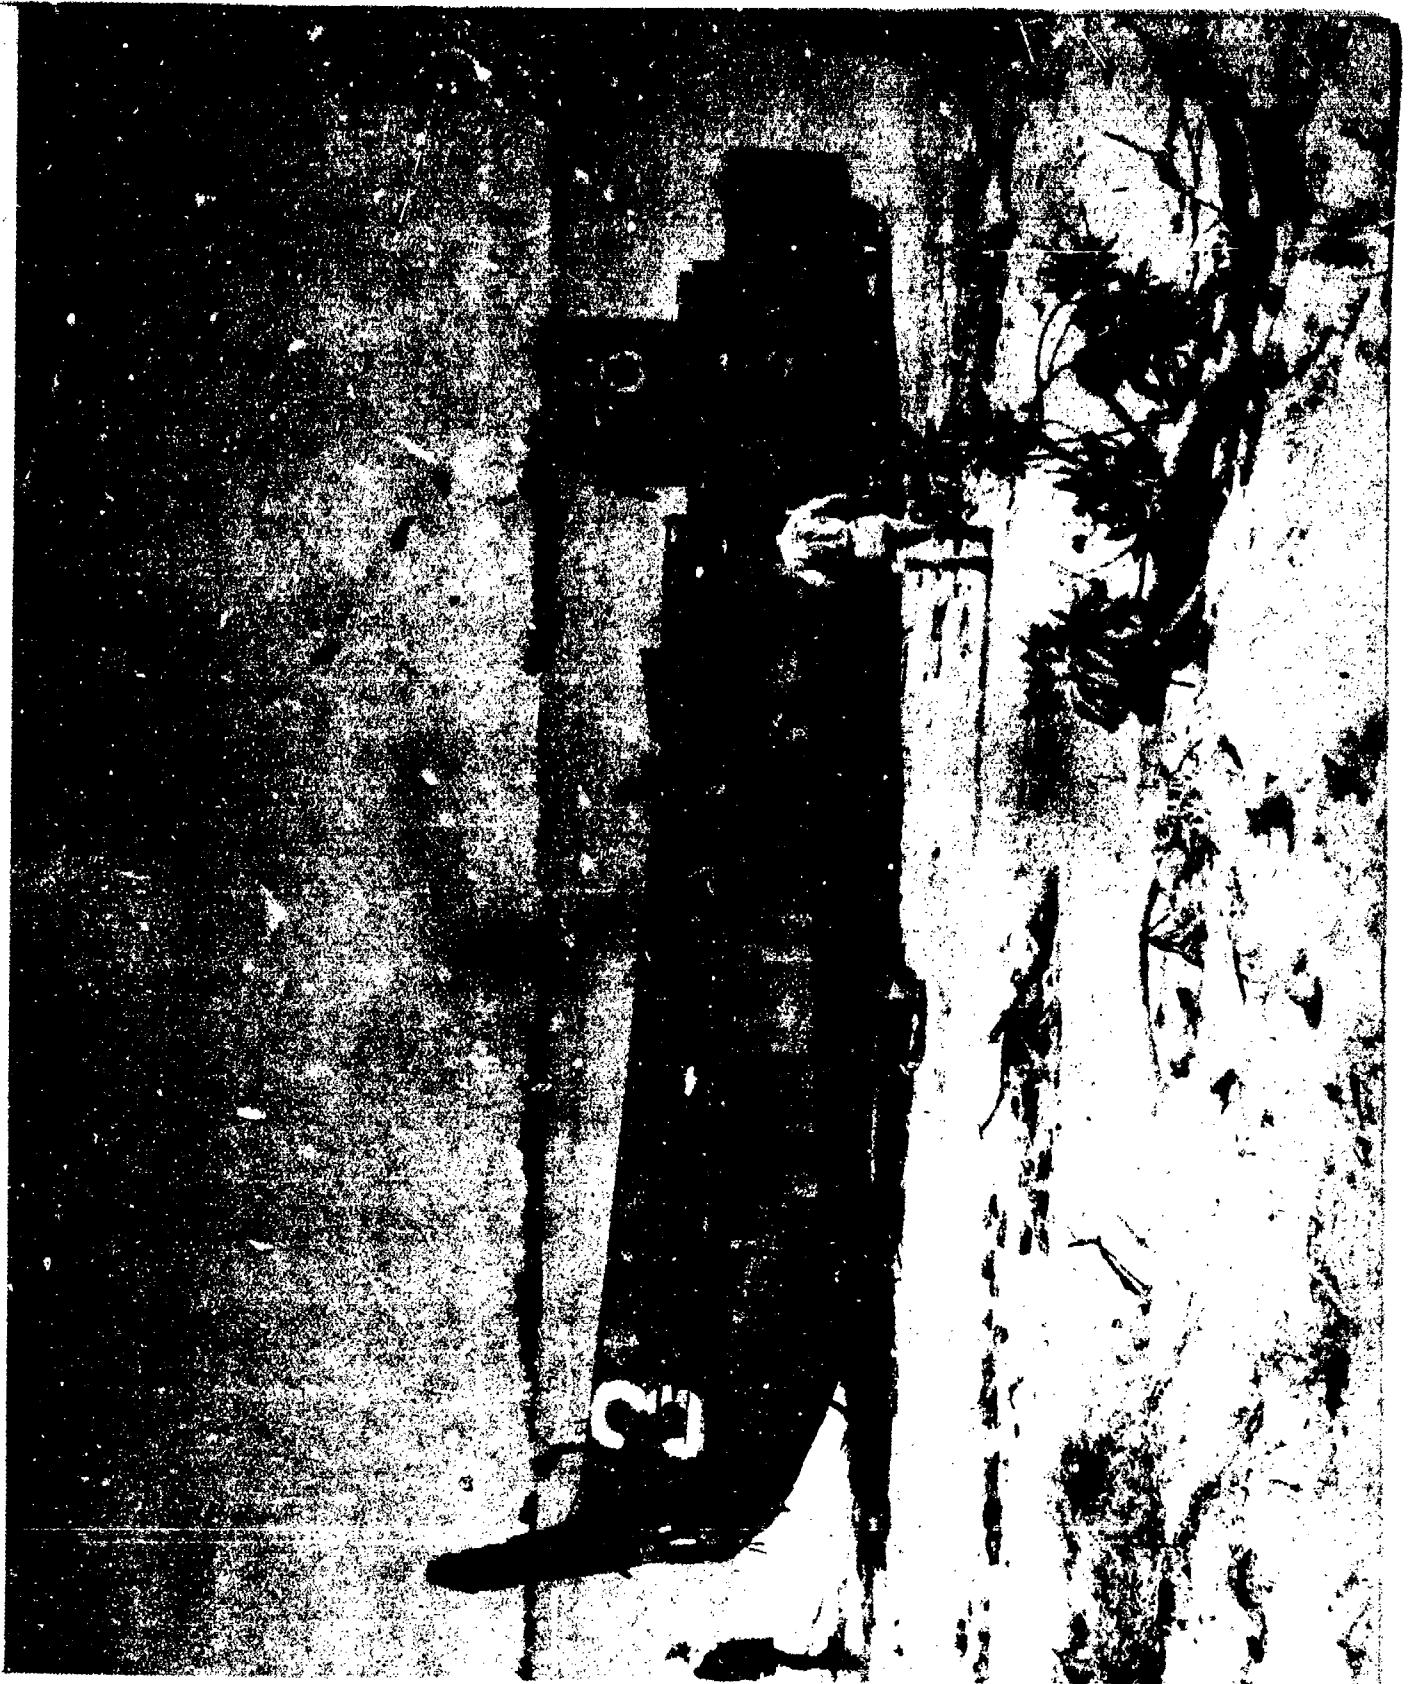
At the time of inspection this craft had been washed about 135 feet along the beach in a southeasterly direction, had moved about 35 feet farther down toward the water's edge, and had broached 45 degrees to port. (Photographs 1718-7, page 34 ).

AB-CR-60-1718-7. LCM 3 after Test B.

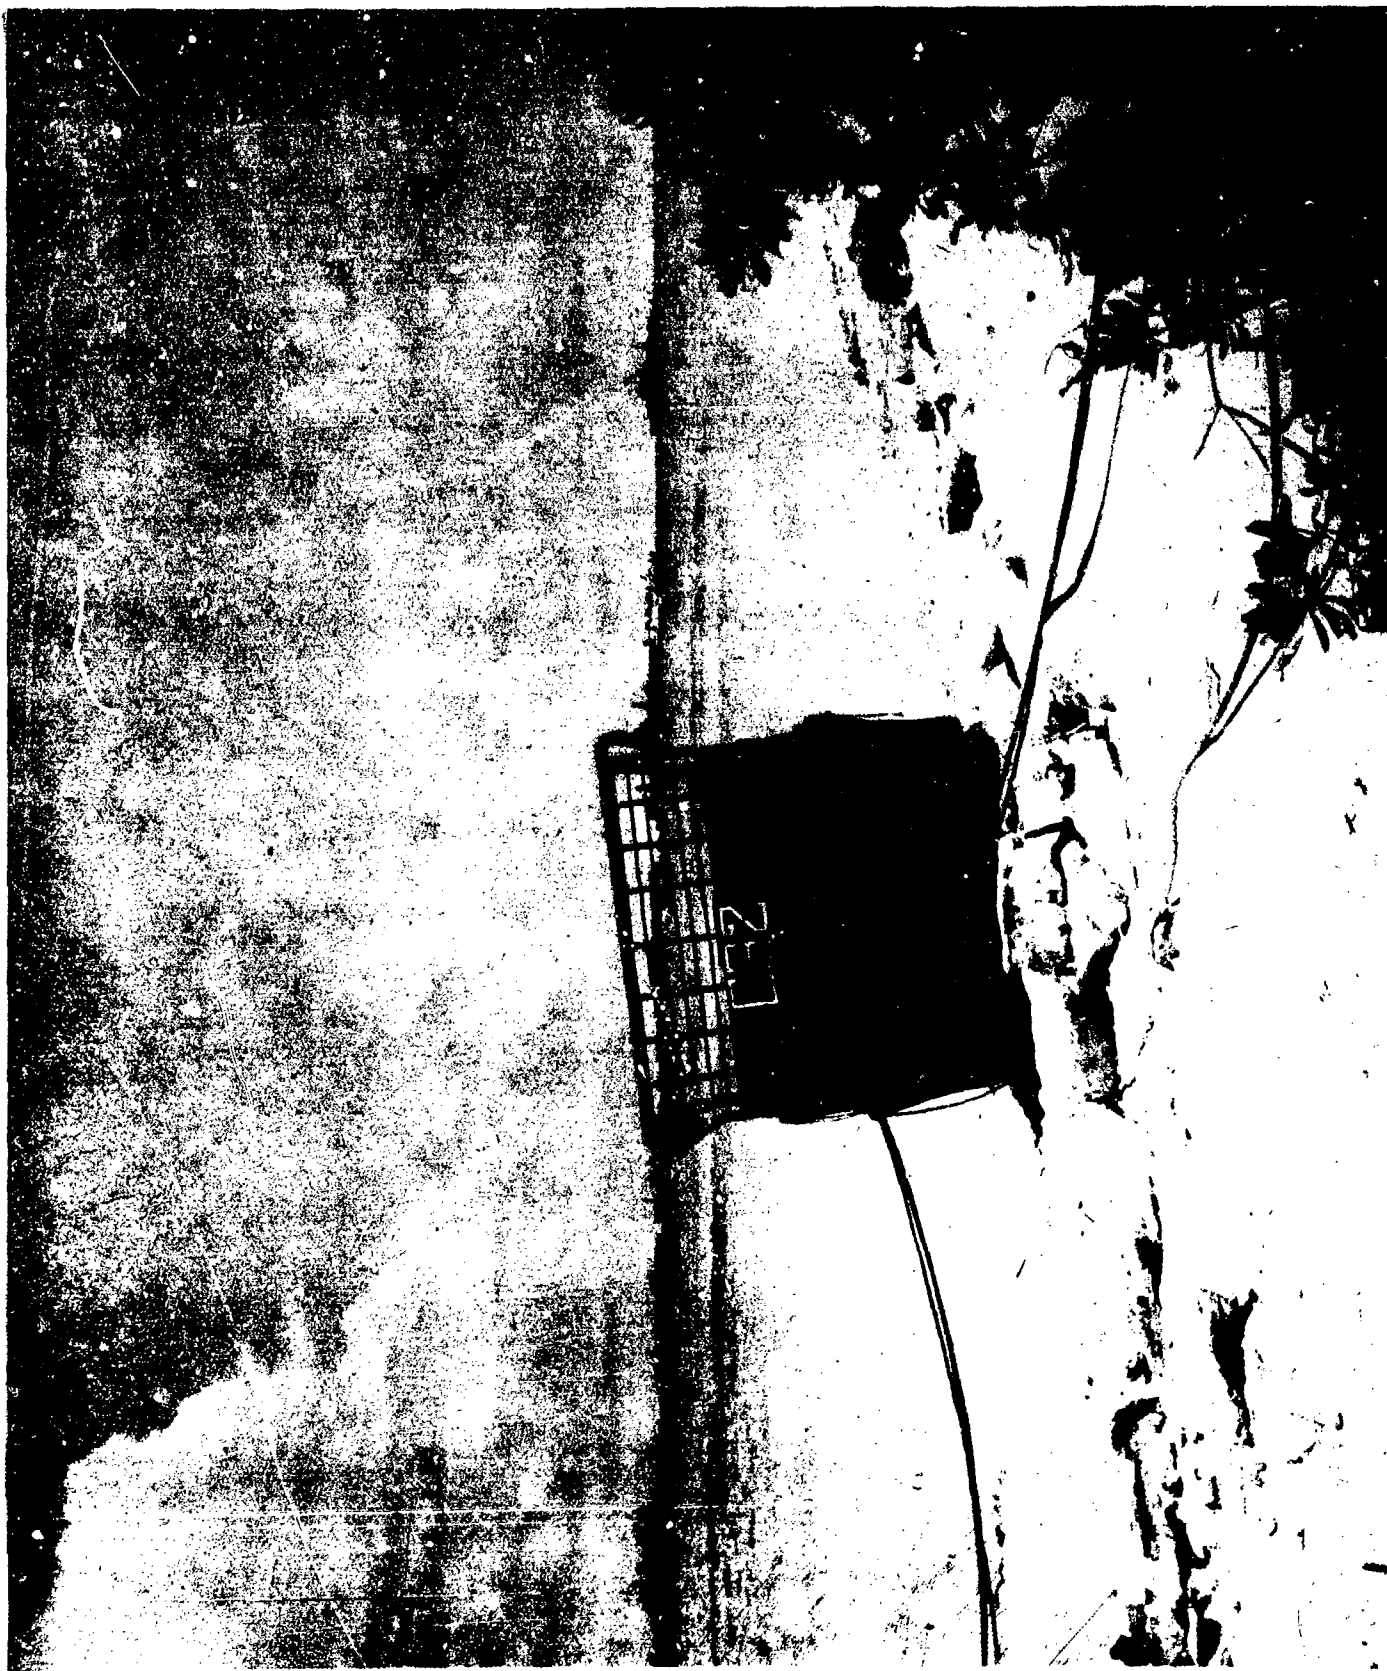
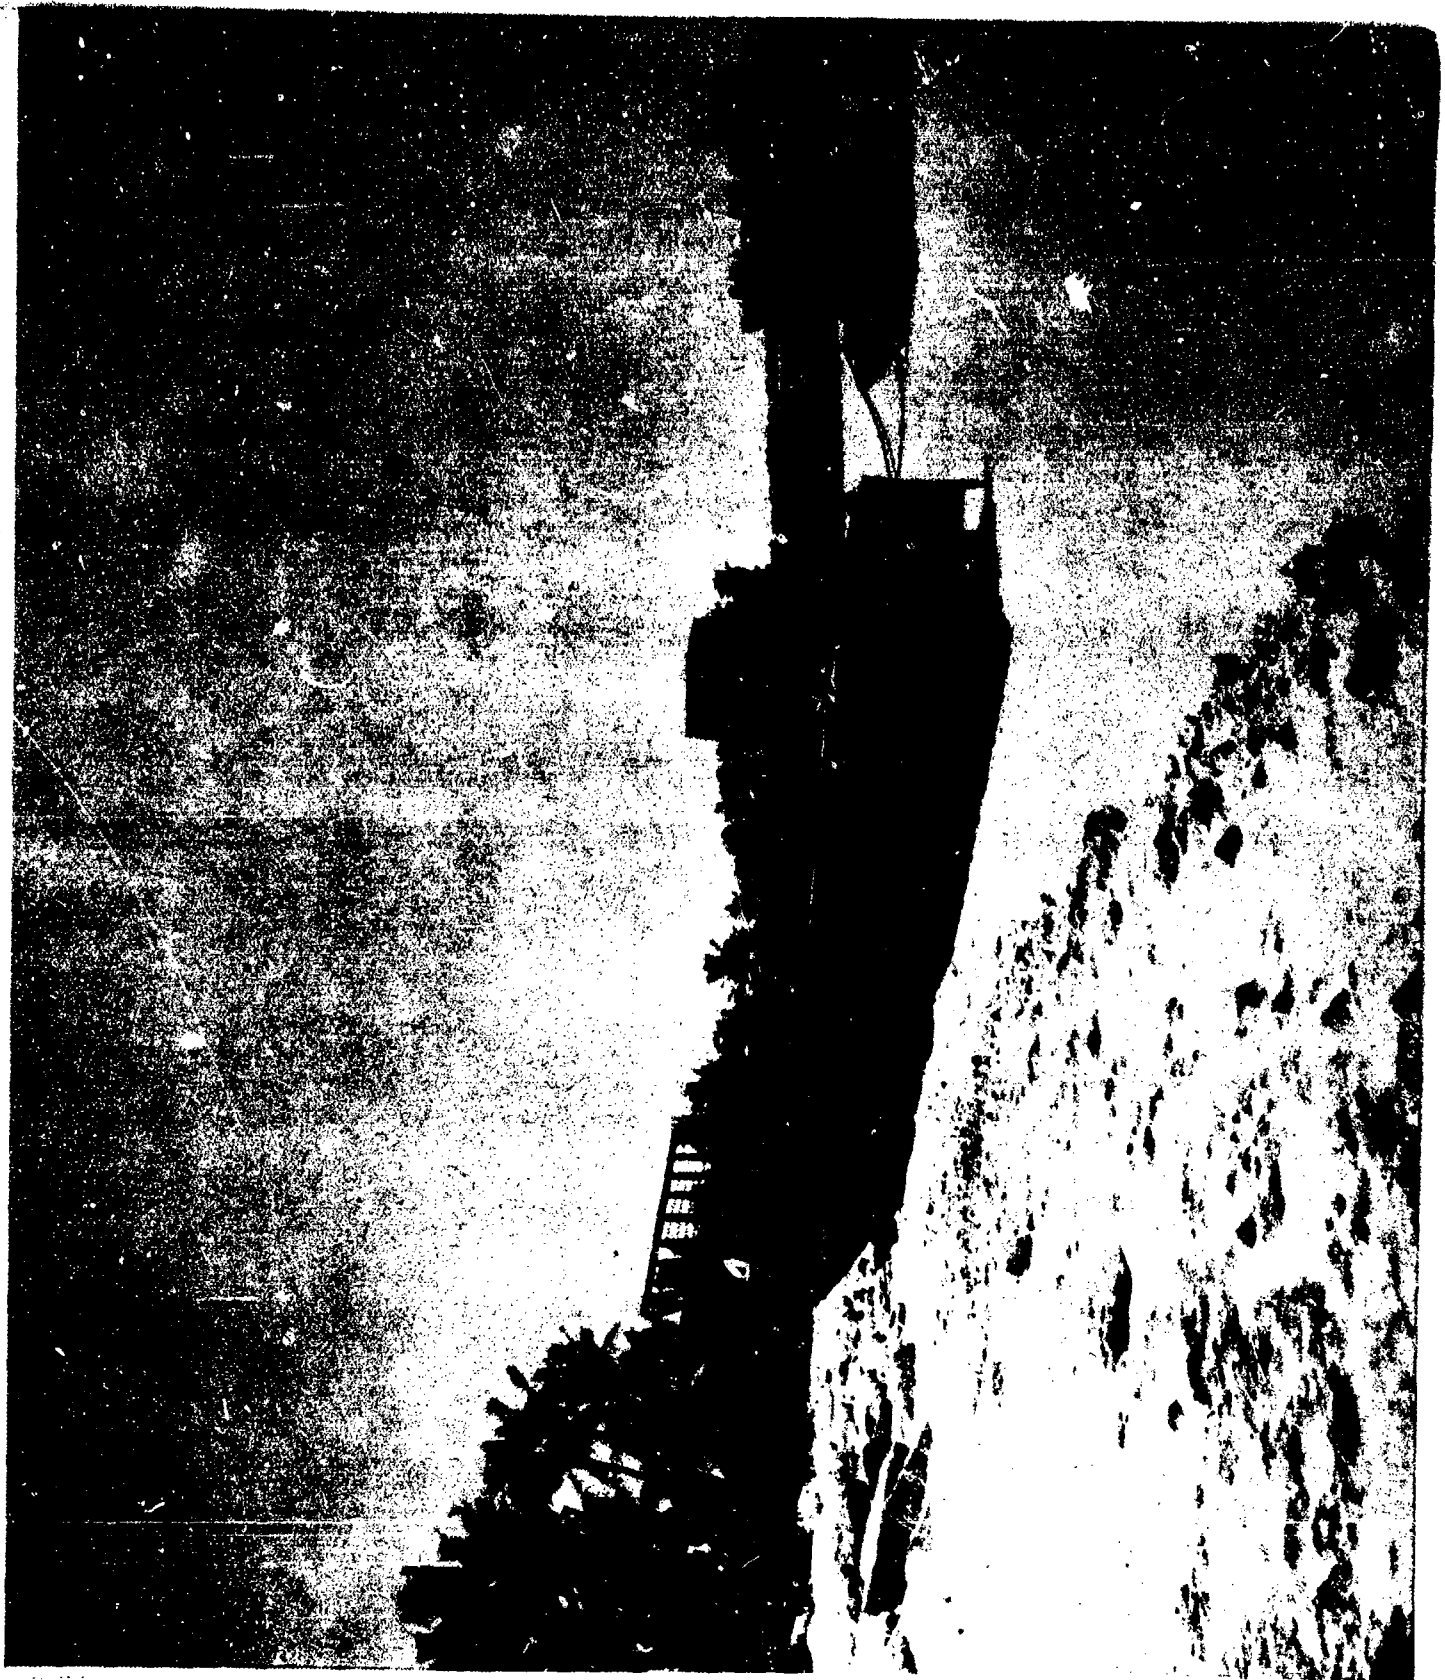
Photographs taken before the test show that the stern of the LCM 4 was used to moor the non-target derelict LCT 1175, (photographs 4295-3, page 35 4294-12, page 36 ). At the time of inspection, the sea was level with the top of the LCM 4's engine compartment and the craft was about 50 feet farther out into the water than when it was inspected prior to test B. (Photographs 292-15, page 22 and 287-10, page 37 ).

BB-CR-199-4295-3. LCM-4 before Test B showing mooring lines to the derelict LCT-1175.

BB-CR-199-4294-12. LCM-4 before Test B showing mooring lines to the derelict LCT-1175.

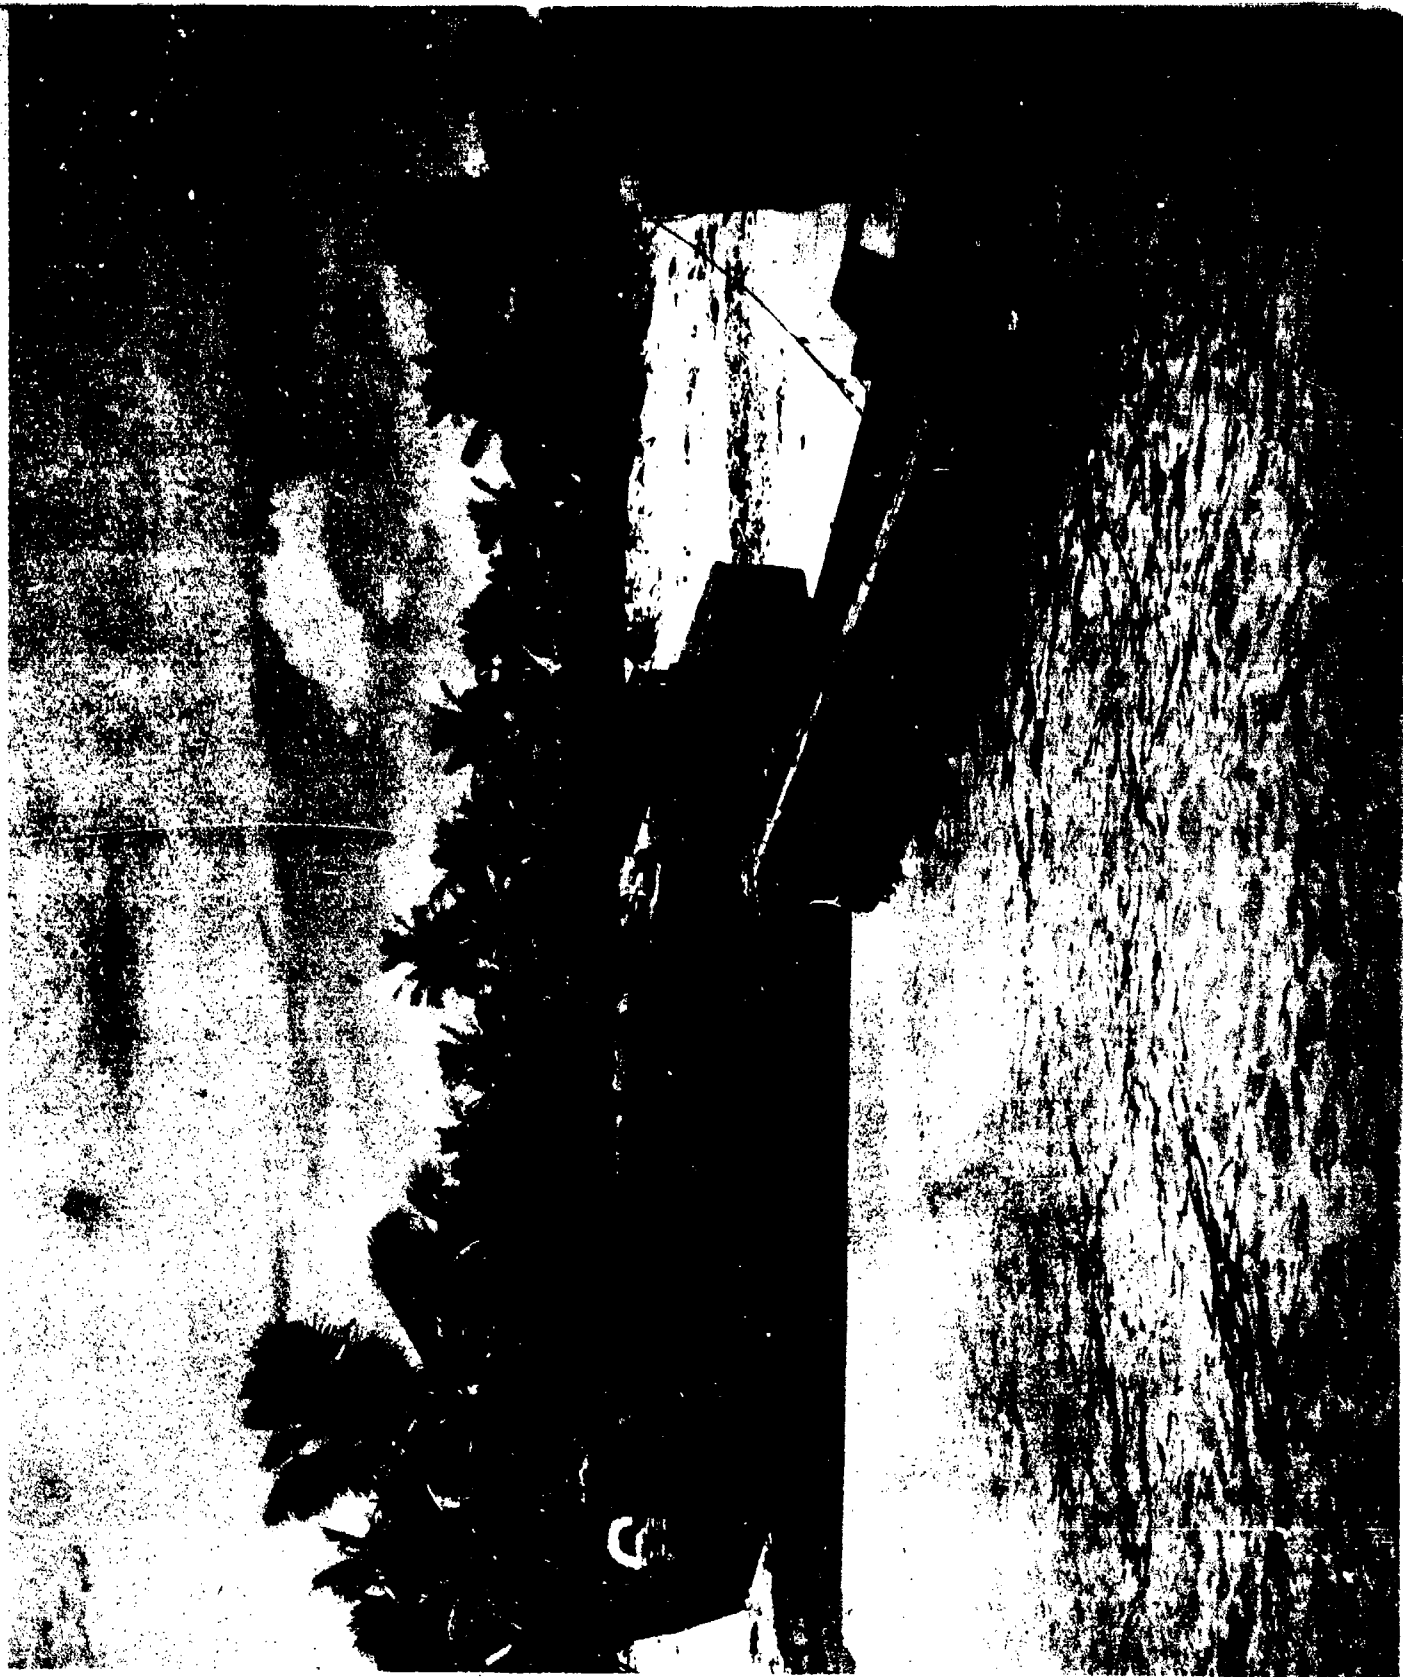
This craft was beached during the test. As a result of the wave phenomena, the craft was moved about 50 feet up the beach in a northwestward direction and about 40 feet closer to the water. (Photographs 292-15, page 22 , 287-28, page 38 , and 258-20, page 39 ).

The craft was unseaworthy and inoperable. (Photographs 292-15, page 22, 287-28, page 38, and 4017-3, page 44).

AB-CR-227-287-28. After Test B general view of LCM-6, LCVP-11,  
and port side of LCT-1137.

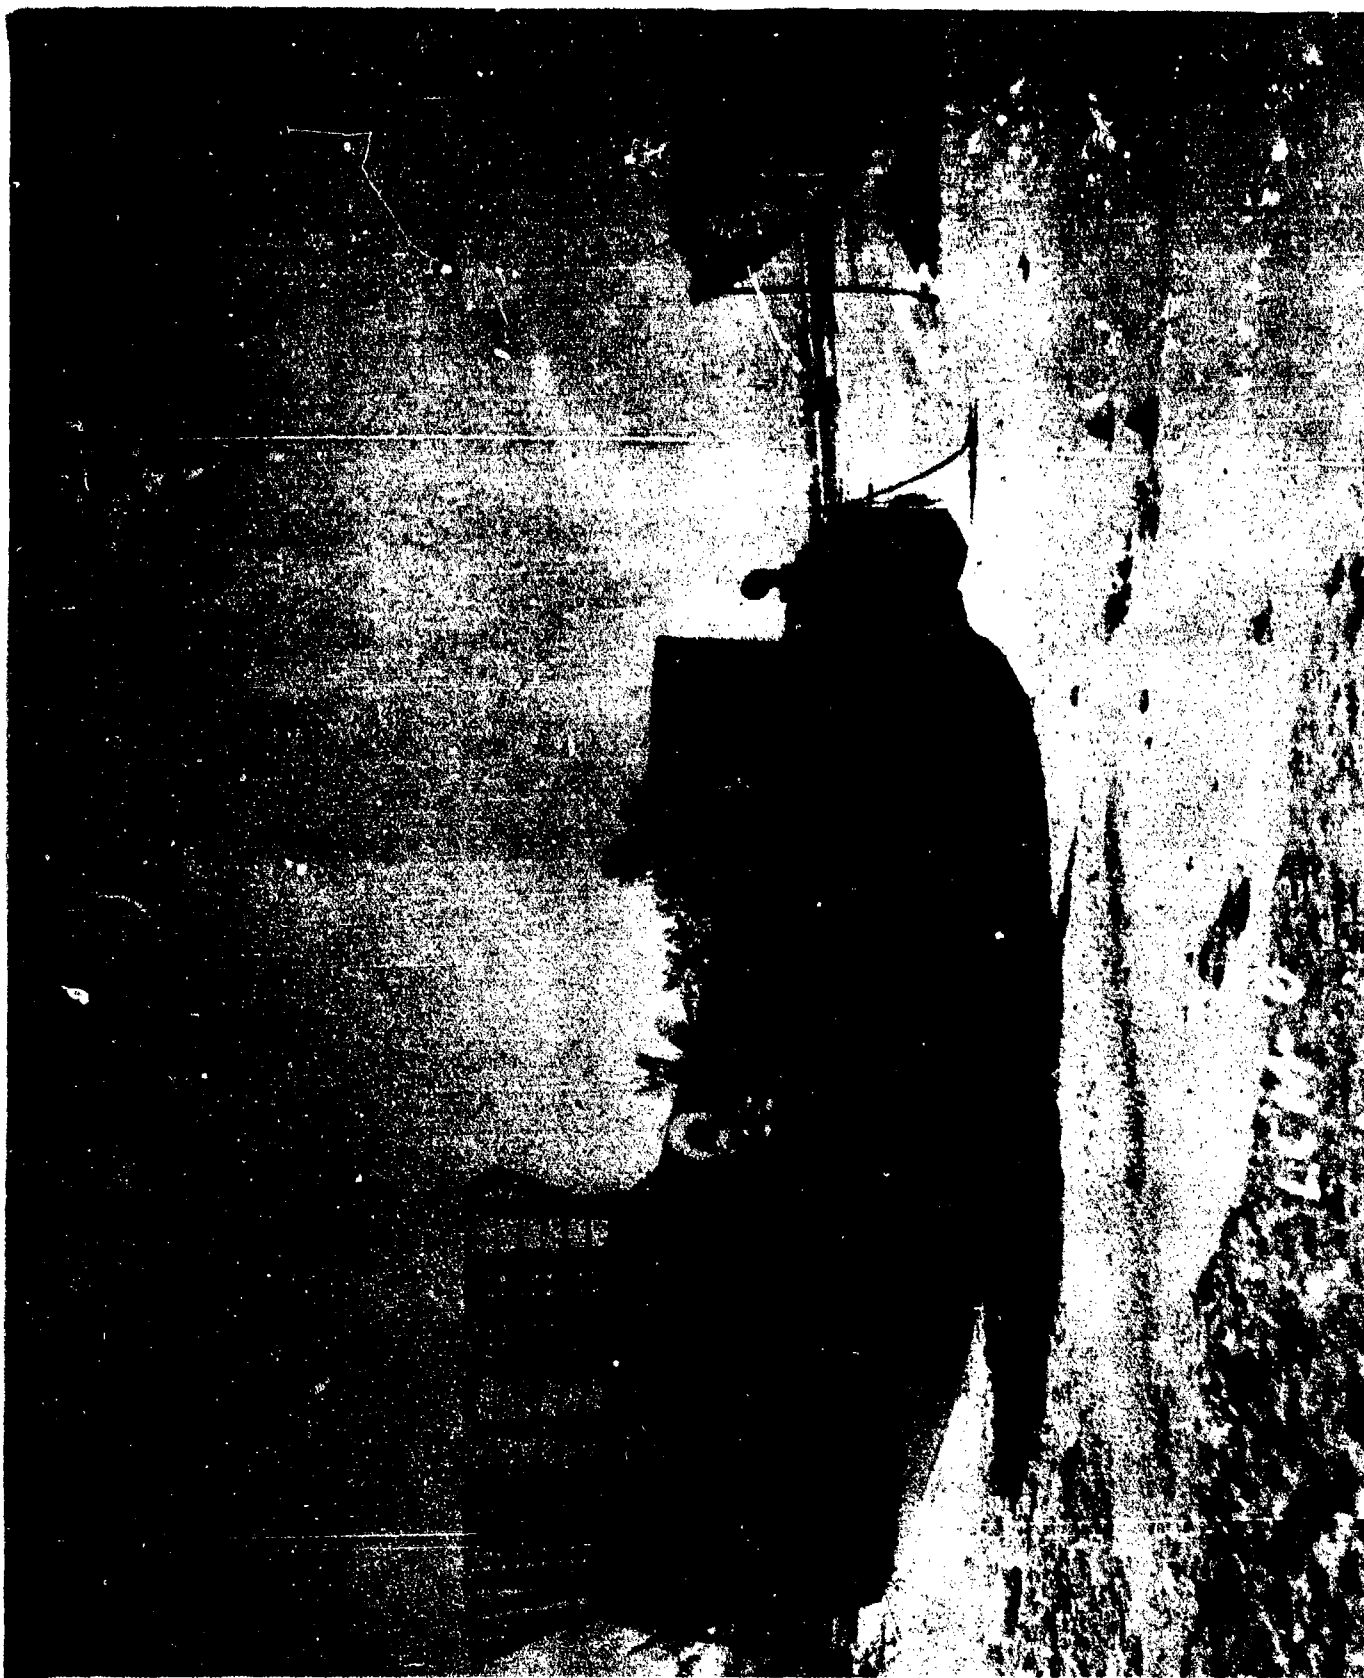
AB-CR-231-358-20. LCM-6 and LCT-1187 after Test B.

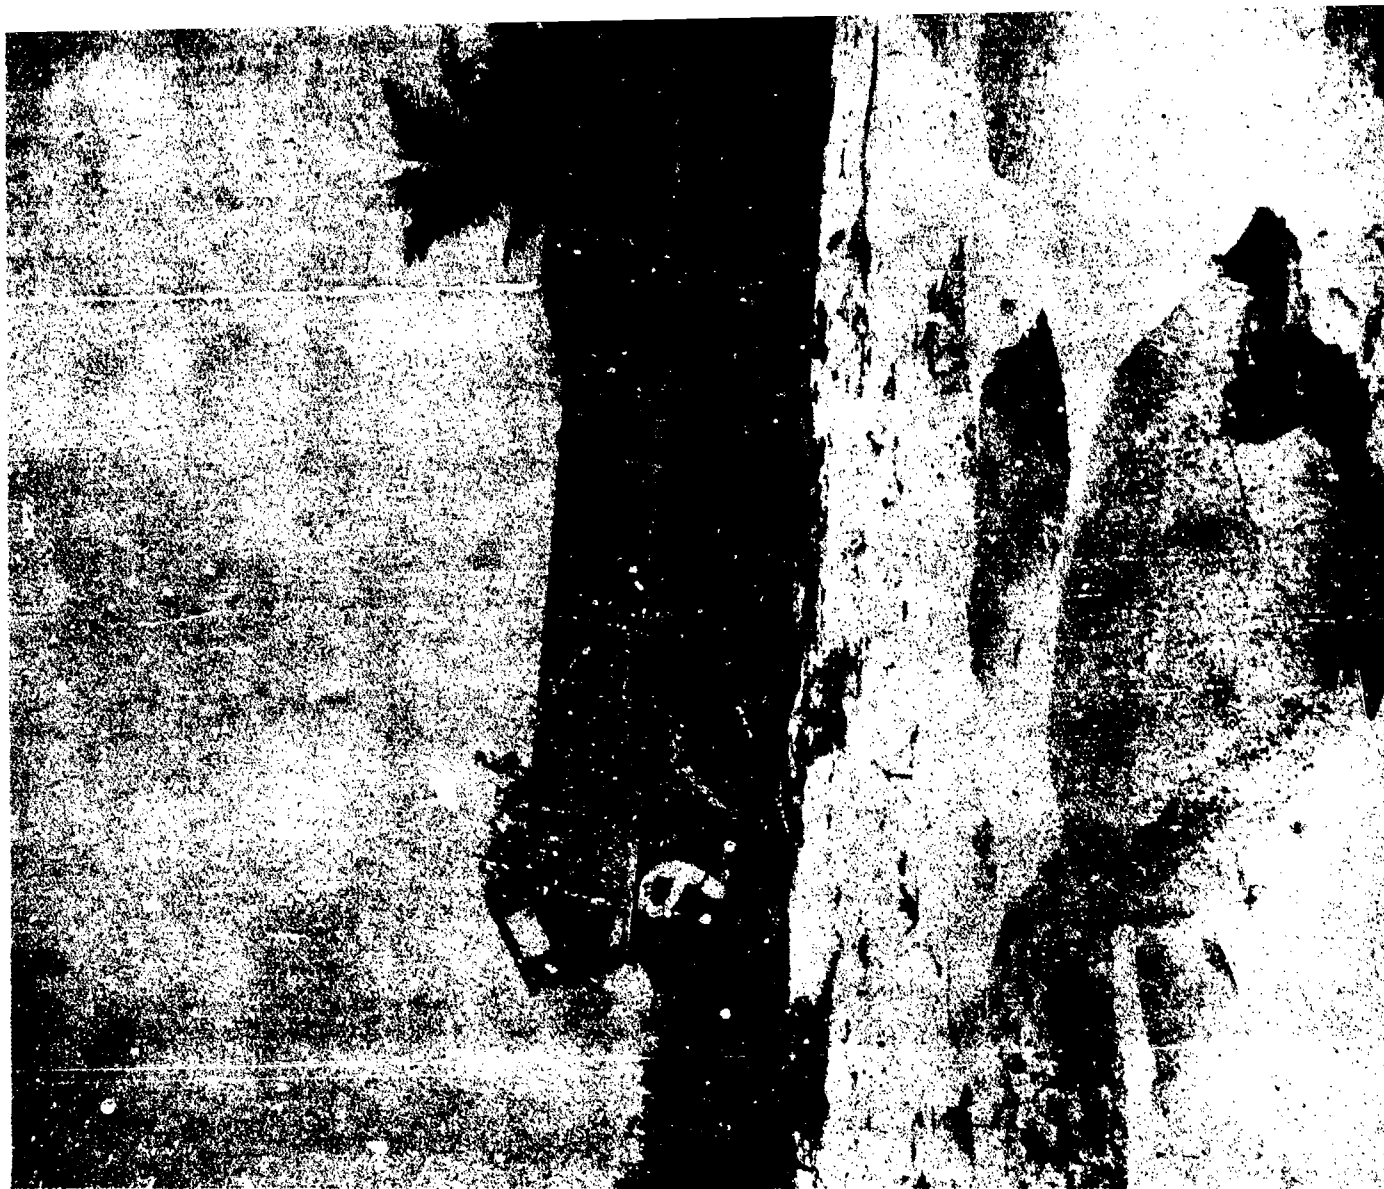
This craft suffered no apparent damage as a result of the test. The stern pivoted to starboard about 45 degrees. (Photograph 1718-8, page 42). A metal strip was torn away from the starboard bilge chine apparently from handling on the beach by tractors.

AB-CR-60-1718-6. LCVP-9 after Test B.
