# ⑨ BUREAU OF SHIPS GROUP TECHNICAL INSPECTION REPORT

## ⑥ OPERATION CROSSROADS, BEACHED LANDING CRAFT,

TEST BAKER

# TECHNICAL INSPECTION REPORT

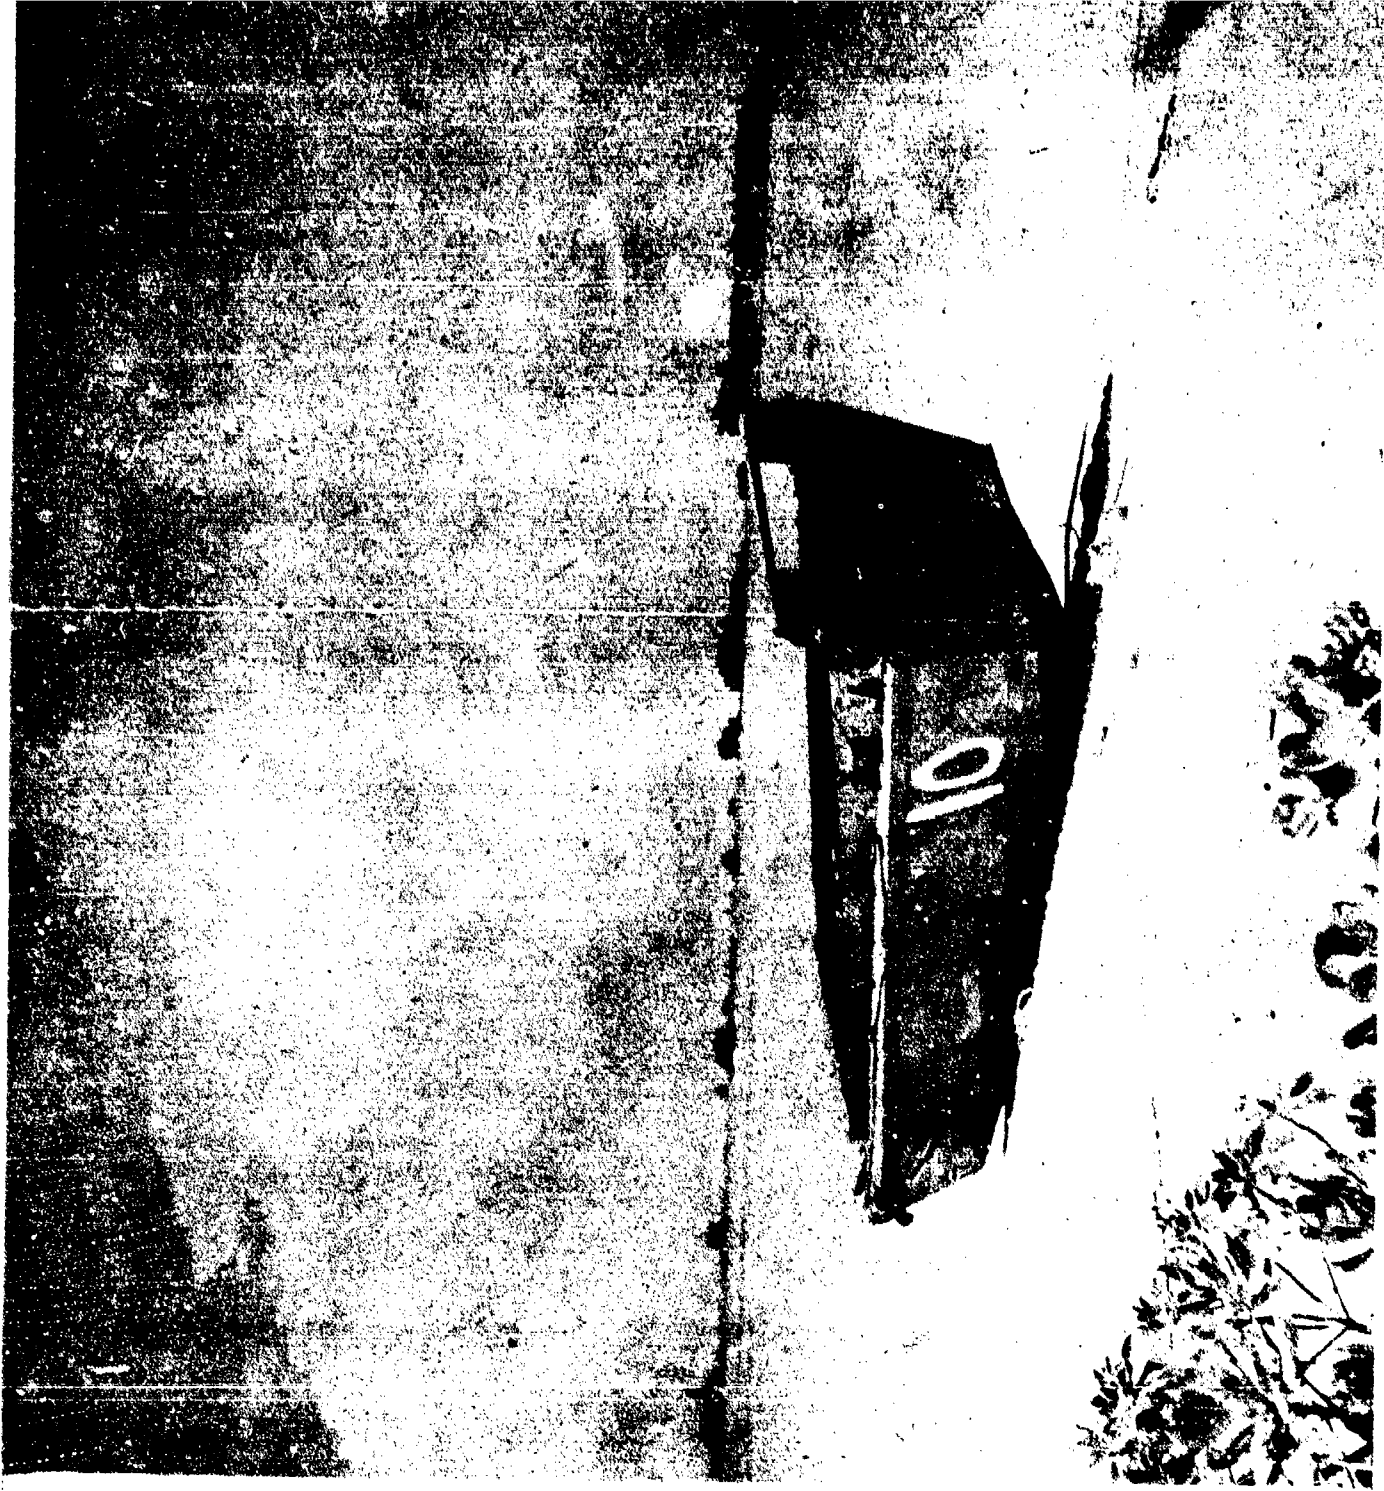
This craft was beached at about the tidal high water mark. (Photograph 4295-11, page 43). It was washed off the beach and was never seen after test B. Probably the craft was punctured from contact with coral ledges and sunk somewhere near the beach.

BB-CR-199-4295-11. LCVP-10 before Test B.
