BUREAU OF SHIPS GROUP TECHNICAL INSPECTION REPORT.

~~OPERATION CROSSROADS.~~
U.S.S. LCT's 705, 816, 818, 874, 1013,
1078, 1112, 1113, 1114, 1115.

TEST BAKER [U] (P)

OPERATION CROSSROADS

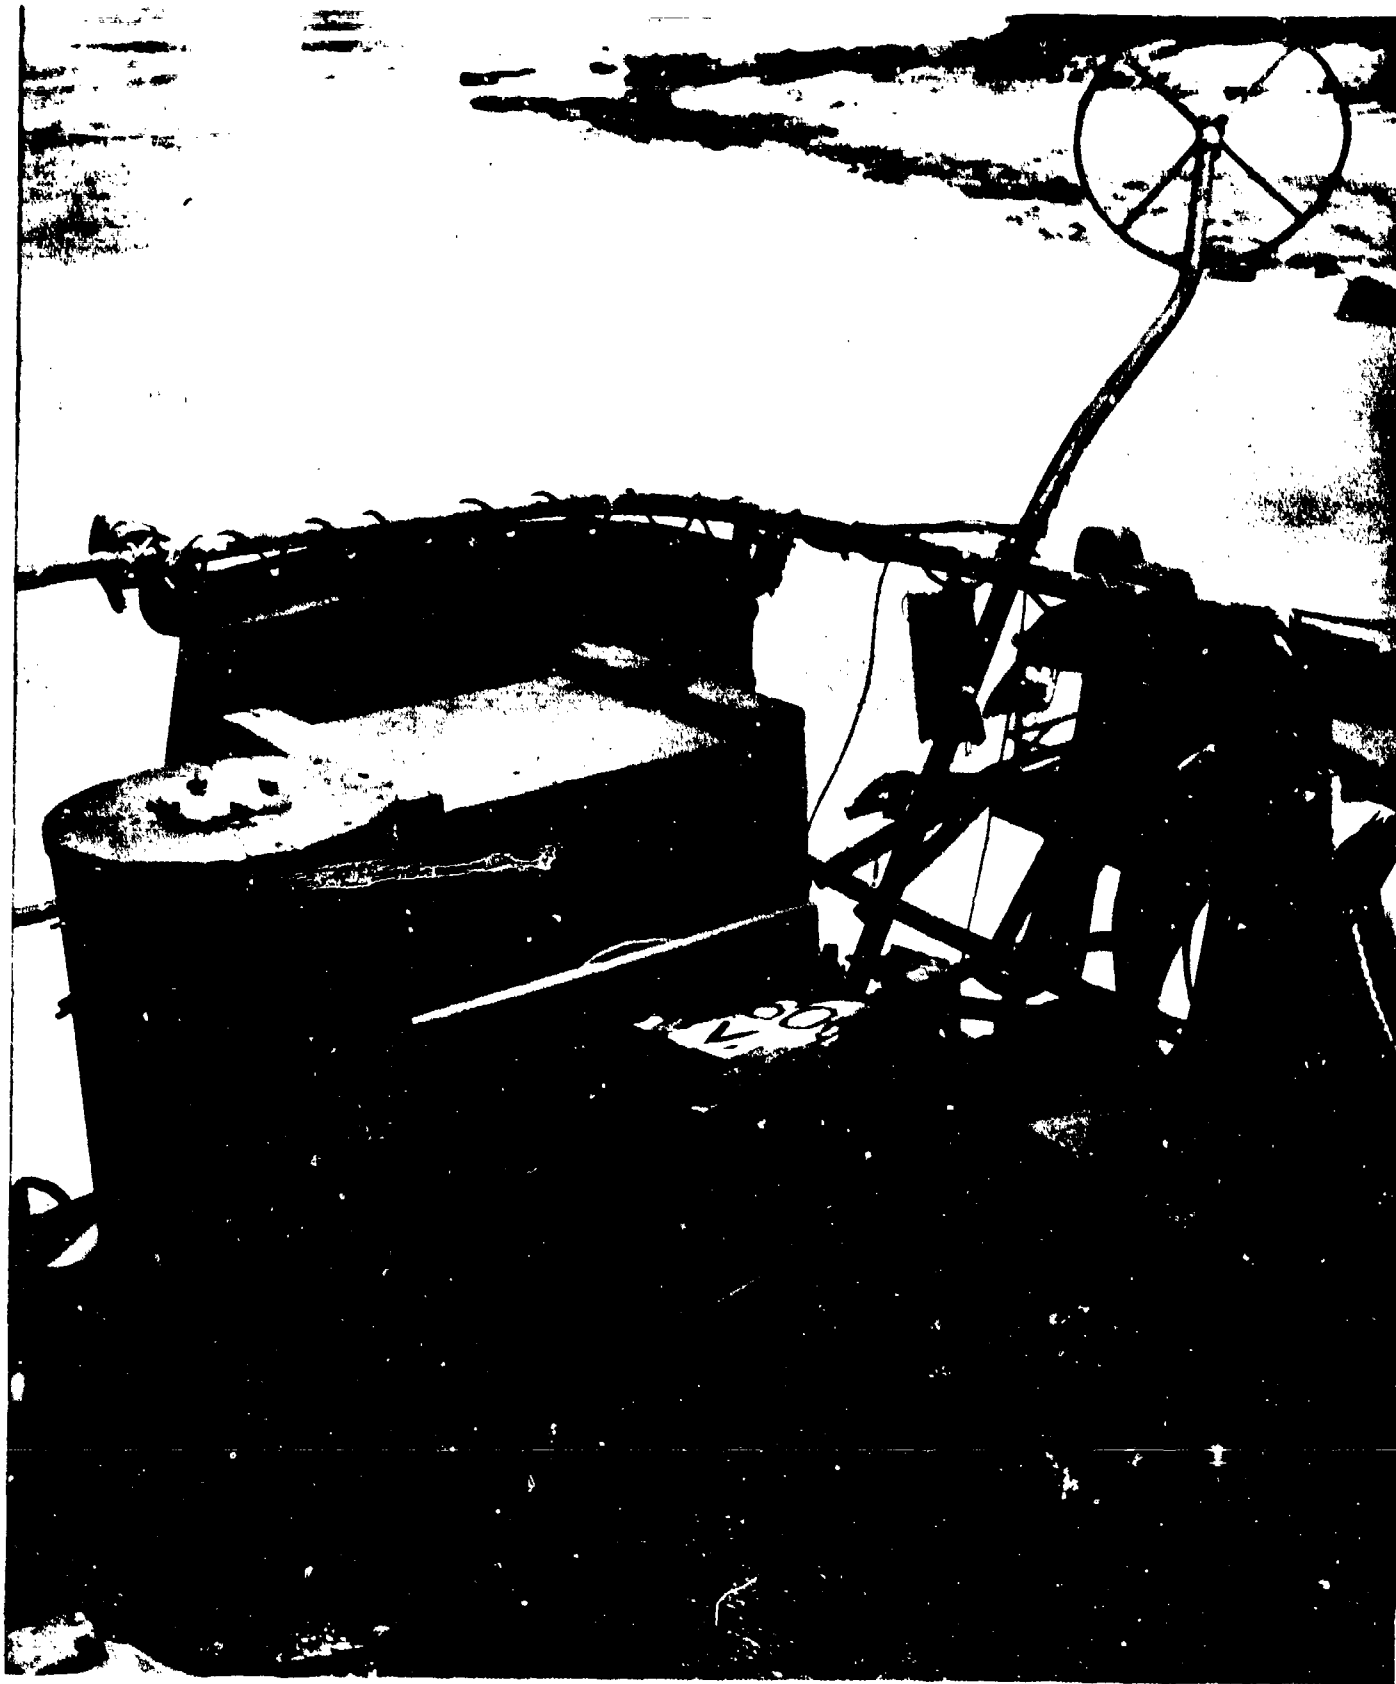
There is a general moderate dishing of the starboard superstructure. Handrails and the IFF antennae are bent. (Photos 4046-9, 10, 11, 12 pages 60, 61, 62, and 63). The port superstructure suffered some mild dishing. The stub of the wood mast broke off and a portion of it was found on the tank deck. (Photo 4045-2, page 64).

AB-CR-97-4046-9. Bent IFF antennae support.

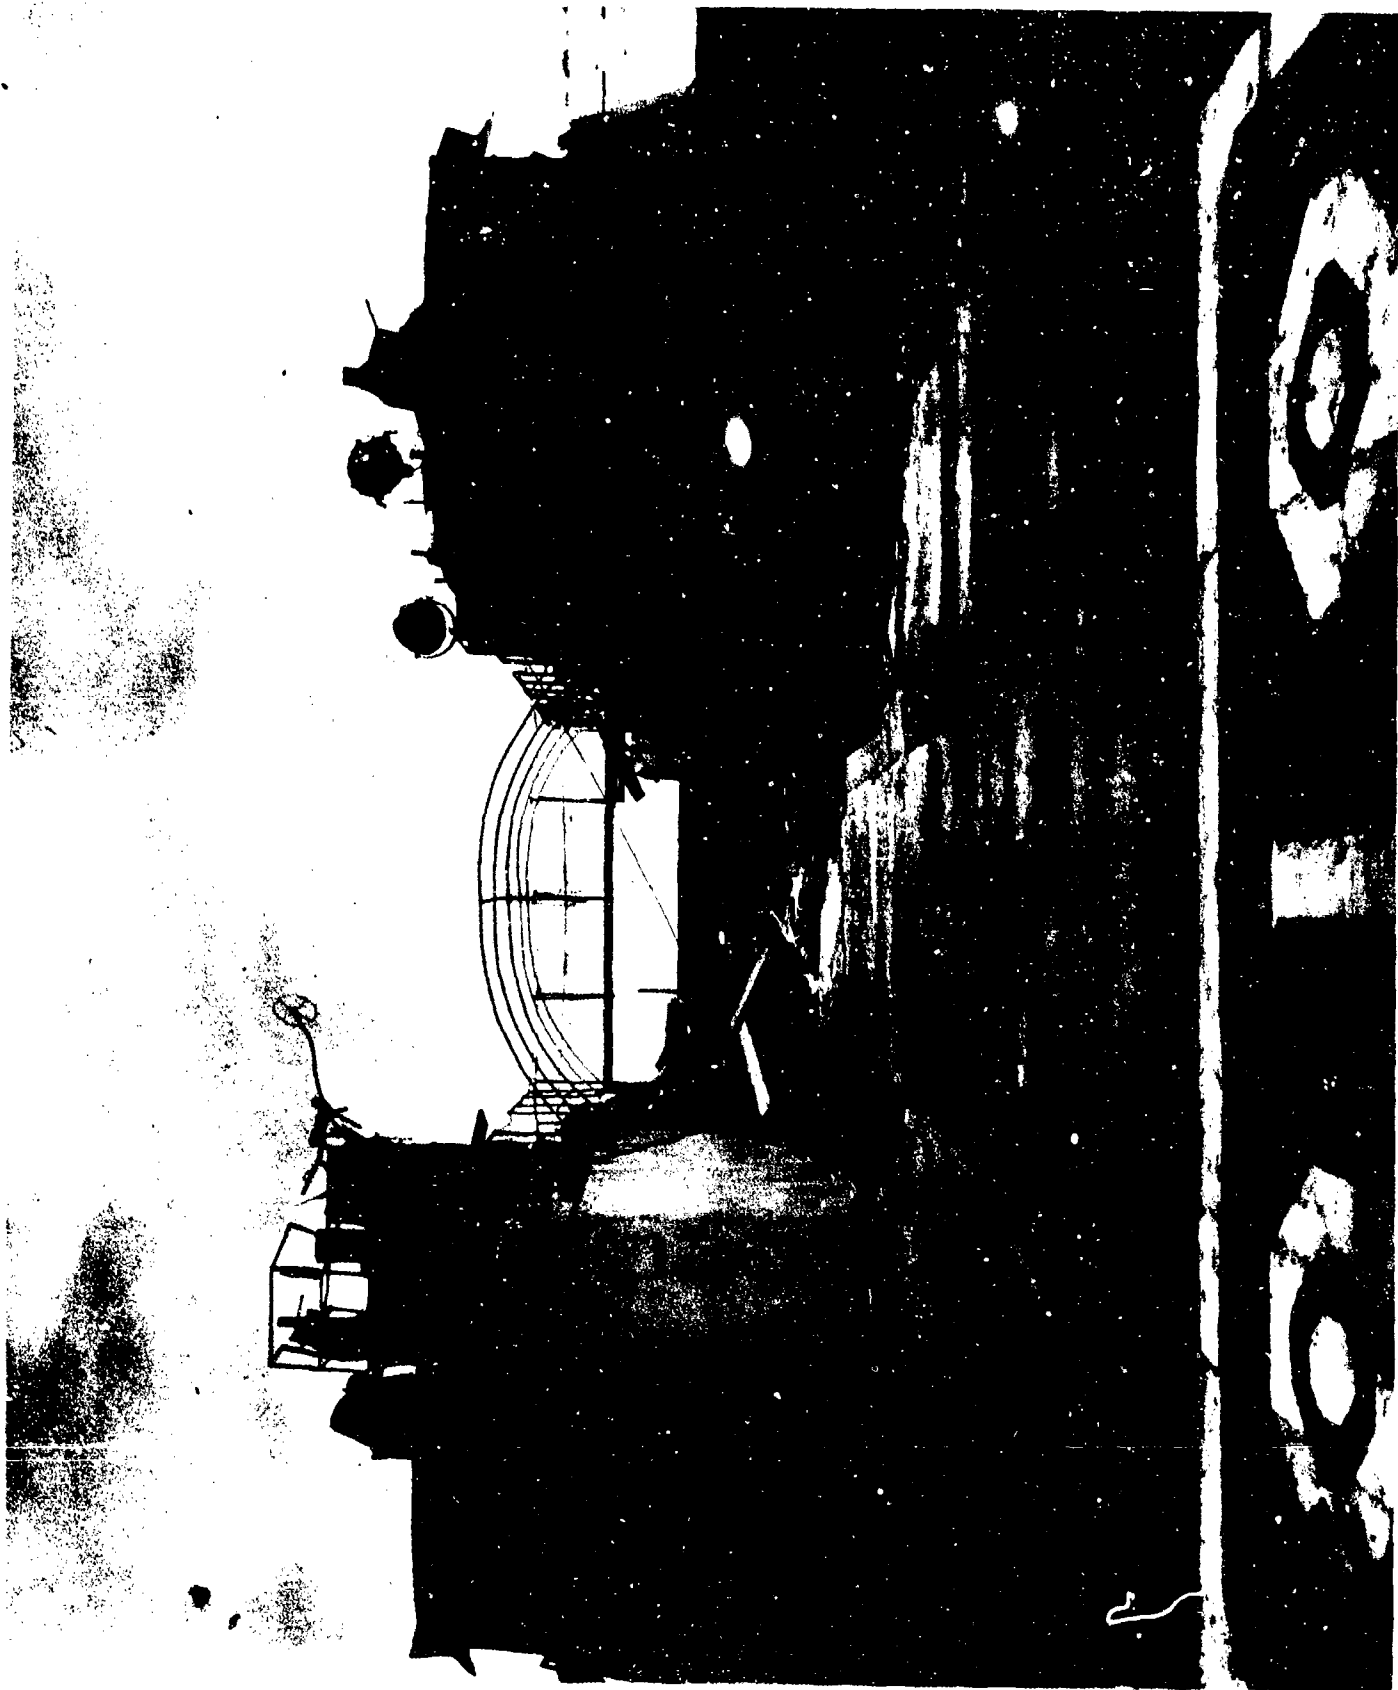
The port and starboard bulwarks are bowed to port about 12 inches. Loose equipment and fittings have been scattered on the tank deck. (Photos 4045-1, 2, 4, and 5, pages 65, 64, 66, and 67).

AB-CR-97-4045-5. Looking aft on tank deck.
