GROSS DAMAGE REPORT

Subject: ⑥ [Director] Ship [Material] [Gross] Damage Report [A-1, (Test  
ABLE re-entry plus five (5) days report.)] [43.60]

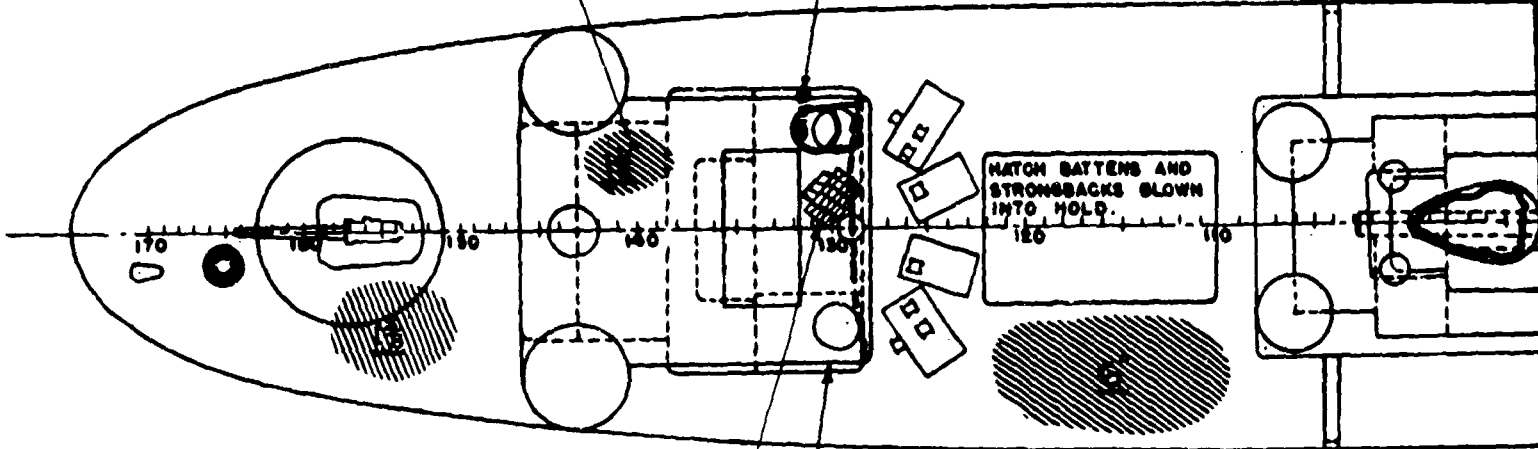
SC 4 RADAR SCREEN

LIFE RAFT SUPPORTS CARRIED AWAY.  
(ONLY 6 RAFTS OUT OF 45 REMAINED  
ON BOARD OR UNDAAGED)

SC 4 RADAR SCREEN FELL TO TOP  
OF AFTER DECK HOUSE

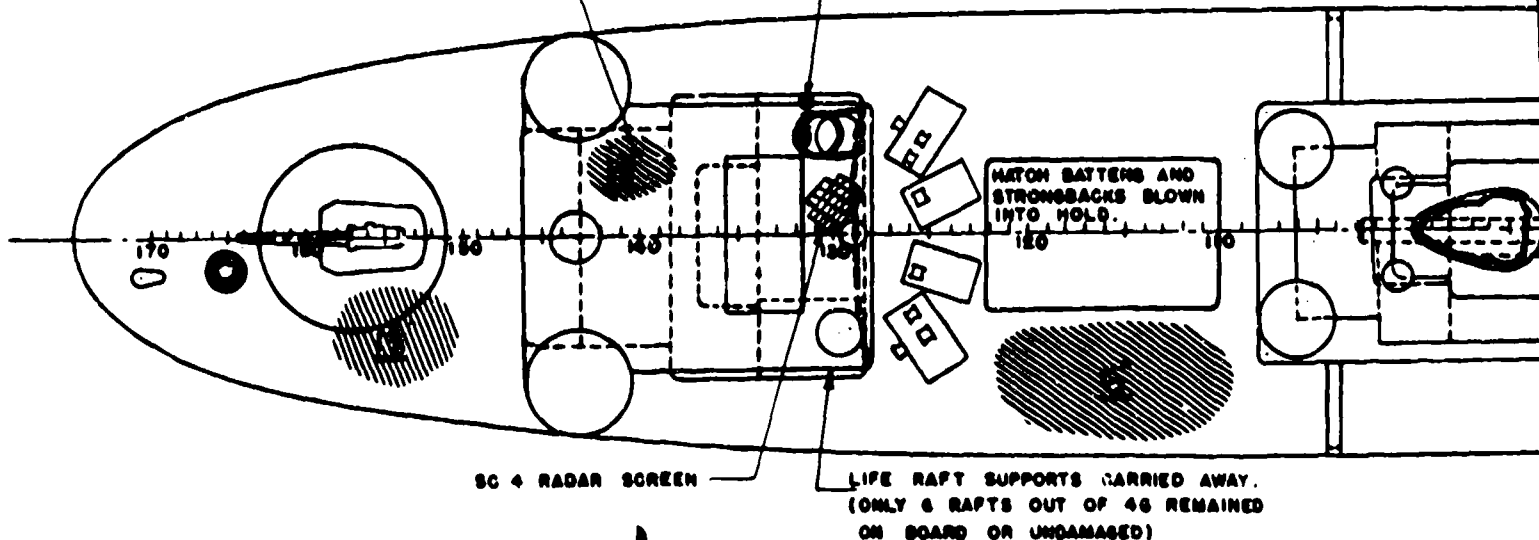
SC 4 RADAR SCREEN

LIFE RAFT SUPPORTS CARRIED AWAY.  
(ONLY 6 RAFTS OUT OF 48 REMAINED  
ON BOARD OR UNDAMAGED)

SIGNAL MAST BENT, YARD ARMS DAMAGED,  
ANTENNAE AND MASTYARDS DOWN.

PORT 24" SEARCHLIGHT BLOWN OFF AND  
STBD. SEARCHLIGHT DEMOLISHED.
