COMPILATION OF  
MATERIALS RESEARCH DATA

27 May 1963

AR-592-1-374

**SUBJECT:** Metallographic Examination of Radiographically Detected Defects in Resistance Spot Welds in 0.010" thick 301 Stainless Steel Centaur Intermediate Bulkheads.

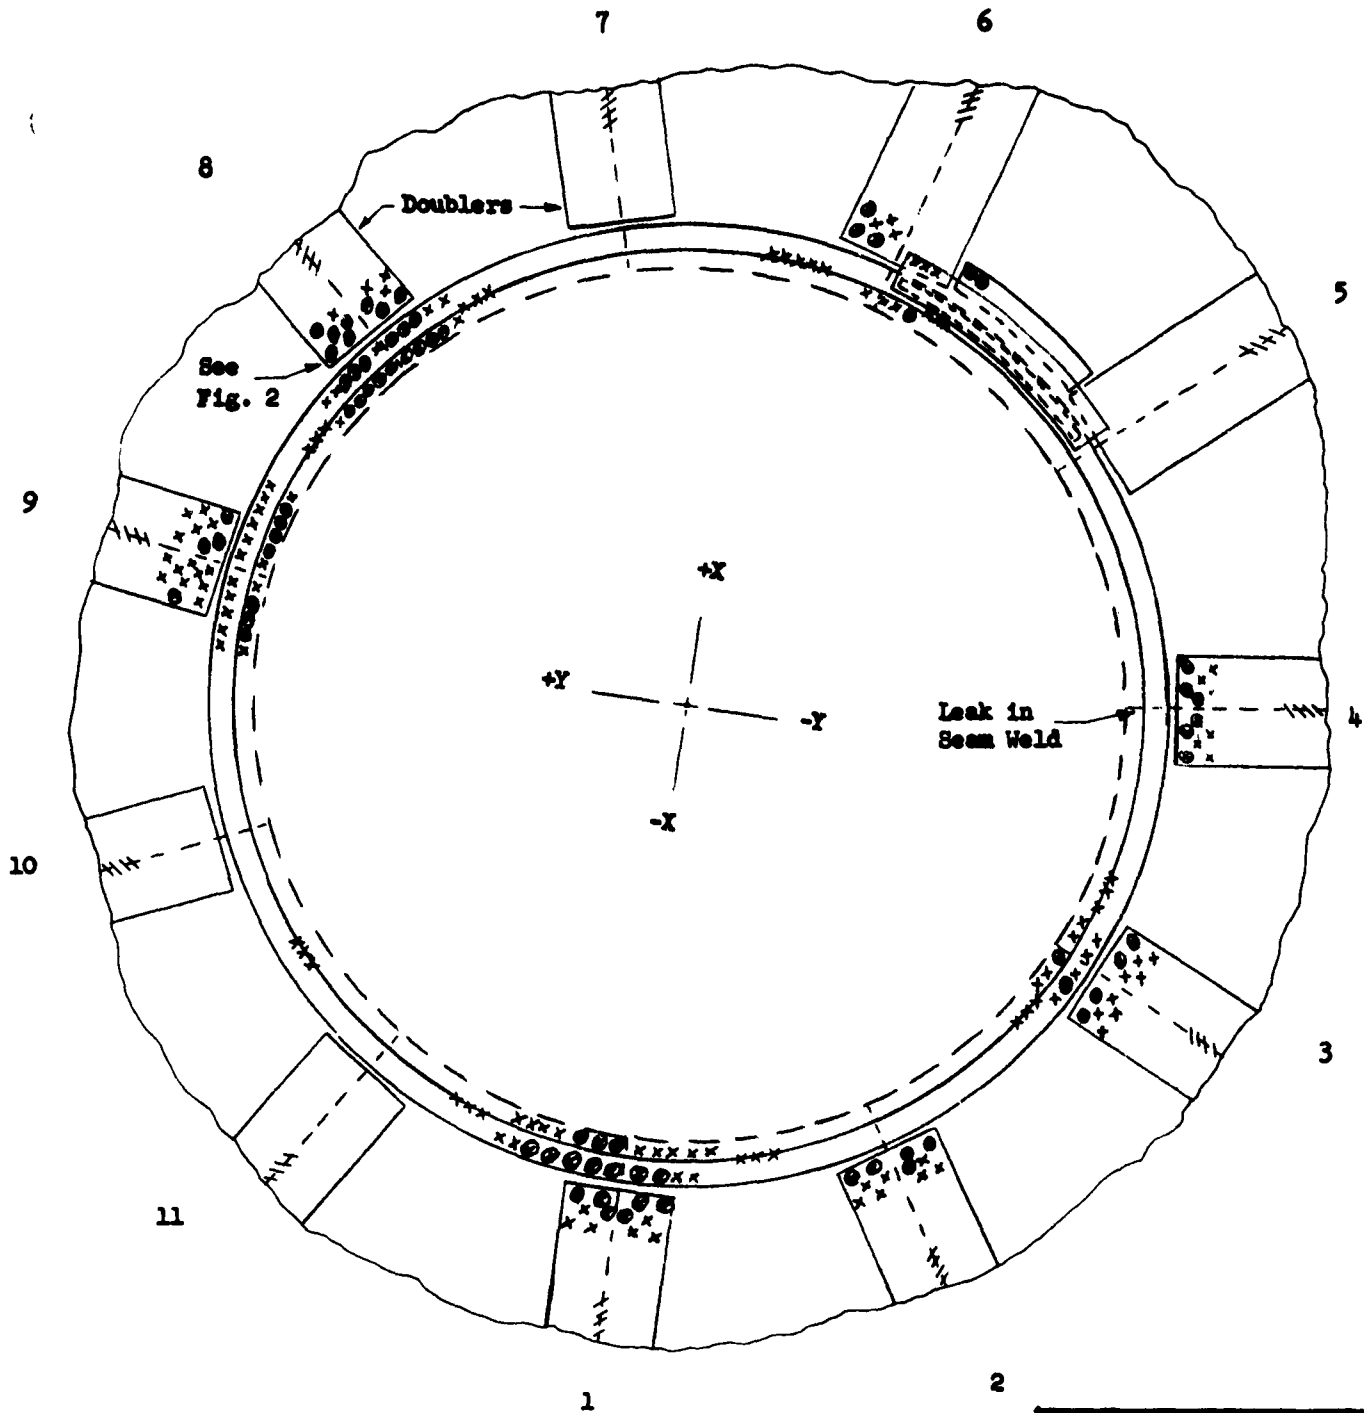
Spot Welds from the Structural Bulkhead. A sketch of the structural bulkhead is included to show the location of two spot welds which were removed from the bulkhead for microscopic examination of the defects, as recorded radiographically (see Fig. 1).

Fig. 1. Cap Area of the Structural Bulkhead from the first Centaur C-2. View looking forward which shows the locations of the resistance spot welds in which radiographic inspection detected defect indications.

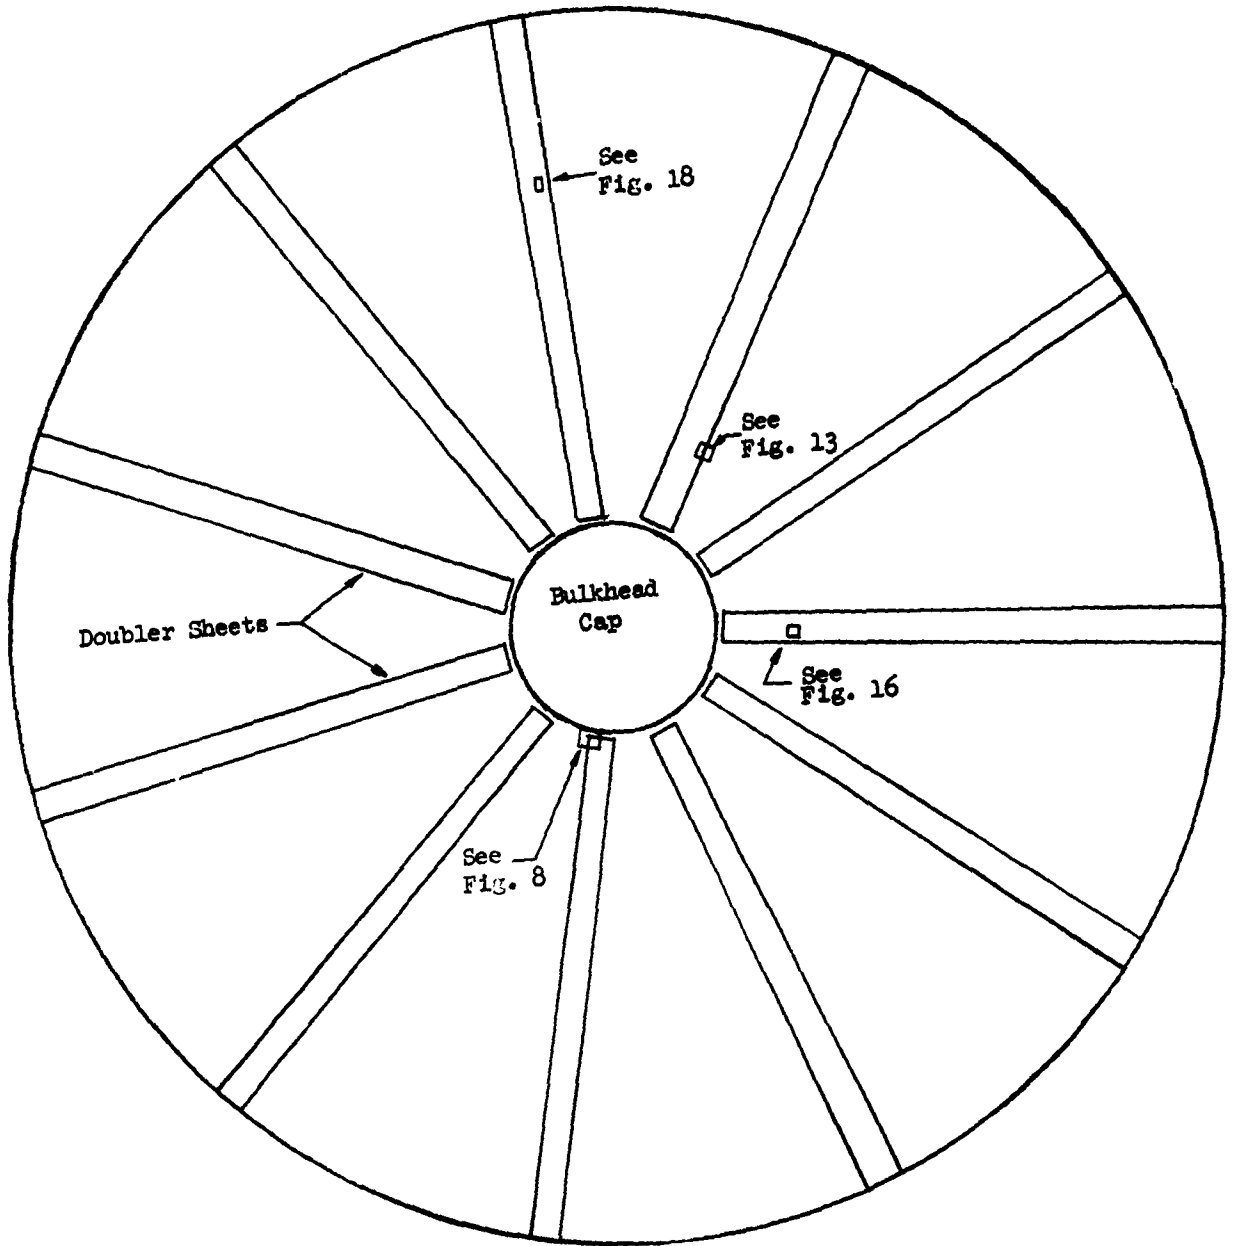
Spot Welds from the Spring Ring Bulkhead. A sketch of the spring ring bulkhead is also included to show the location of the five spot welds which were also removed from the bulkhead for microscopic examination of the defects as recorded radiographically (see Fig. 7).

Figure 7. The above sketch shows the location of the two spot welds shown in Figures 8, 13, 16 and 18. The sketch represents the Spring Ring Bulkhead of the first Centaur C-2.

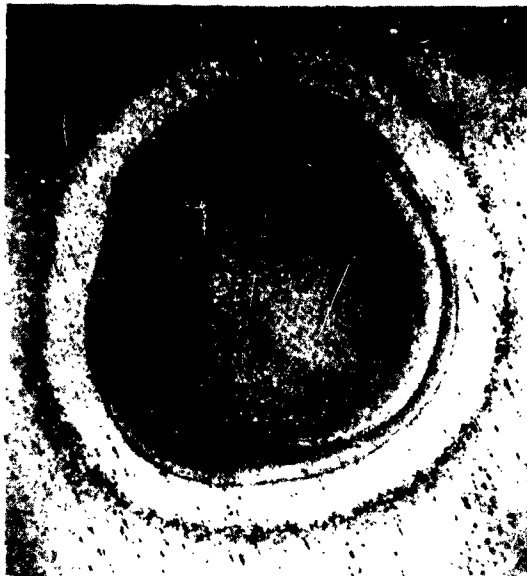
Figure 17. Photomicrograph of a plan view of the spot weld shown above. The grinding and polishing of this mugget was performed on the doubler sheet. This defect was located in the gore skin since 0.011" was removed by grinding and polishing. When compared to the radiograph, it is seen that this photomicrograph shows the mugget in a view which is turned slightly counterclockwise. This defect, like the one in Fig. 15, also appears to be a corrosion pit at the carbide precipitation zone.
