**FIFTH QUARTERLY PROGRESS REPORT
EVALUATION OF HIGH-STRENGTH LIGHTWEIGHT
LAMINATED PRESSURE VESSELS OF
LAP-JOINT CONSTRUCTION**

10 April 1963

Period covered: 1 January to 31 March 1963
Republic Aviation Corporation
Farmingdale, L. I., N. Y.

TECHNICAL REPORT NO. WAL TR 766.2/3-4

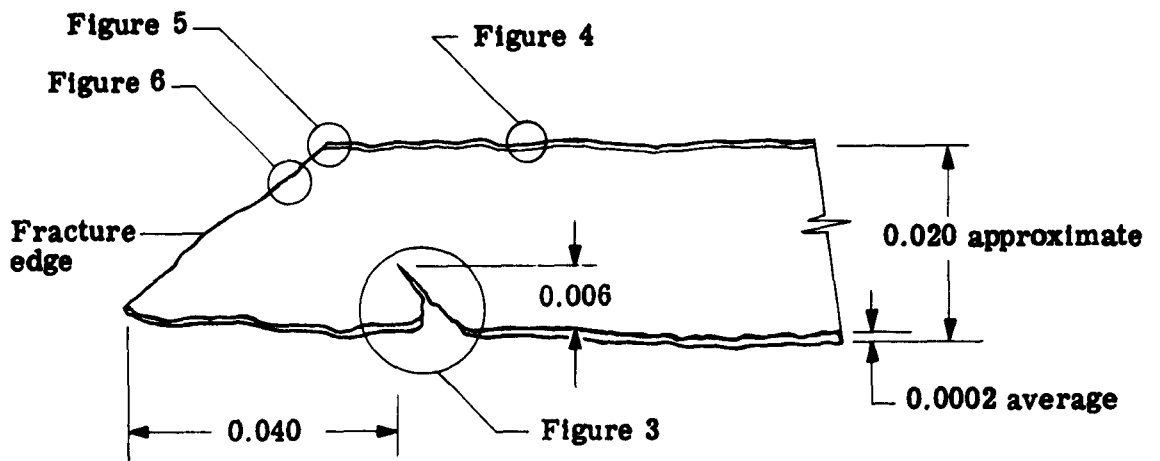
Figure 2. Edge View of Failure Origin and Locations of the Micrographs

Figure 2 shows the location of the fracture origin relative to the secondary fracture as well as the relative location of the photomicrographs. Figure 3 shows the light-etching, hard zone devoid of structure. Evidence of the softer layer previously discussed is presented in Figures 4 and 5. Figure 6 shows the discontinuous nature of this layer.

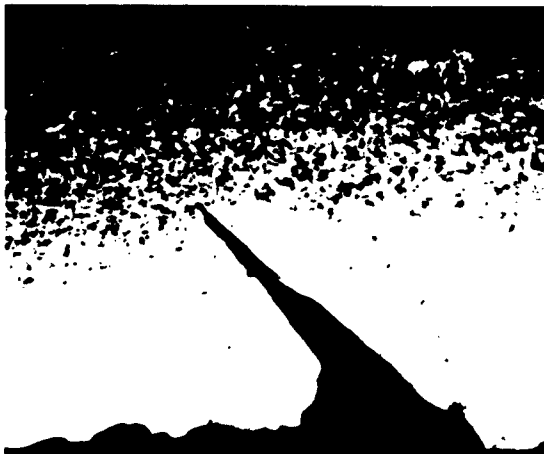
Figure 3. Secondary Fracture in 18-9-5 Mar-aging Steel (about 250X, Schantz Etch)

The appearance of the microstructure in Figure 3 is noteworthy. A microhardness traverse indicated that the lightly etched area contained two zones. The first was an outer soft layer from 0.0001 to 0.0003 inch in depth ranging in hardness from R_b (Rockwell b scale) 84 to R_c (Rockwell c scale) 29. The second area was harder (R_c 60 to 61) and extended to a depth of 0.006 inch. This corresponded to the inner extremity of the fracture zone; the darker etched field originated at this point. Hardness values were found to be R_c 57; these remained constant to the midpoint of the section. Beyond this point, the values decreased to R_c 50 and remained at this level to the opposite surface.

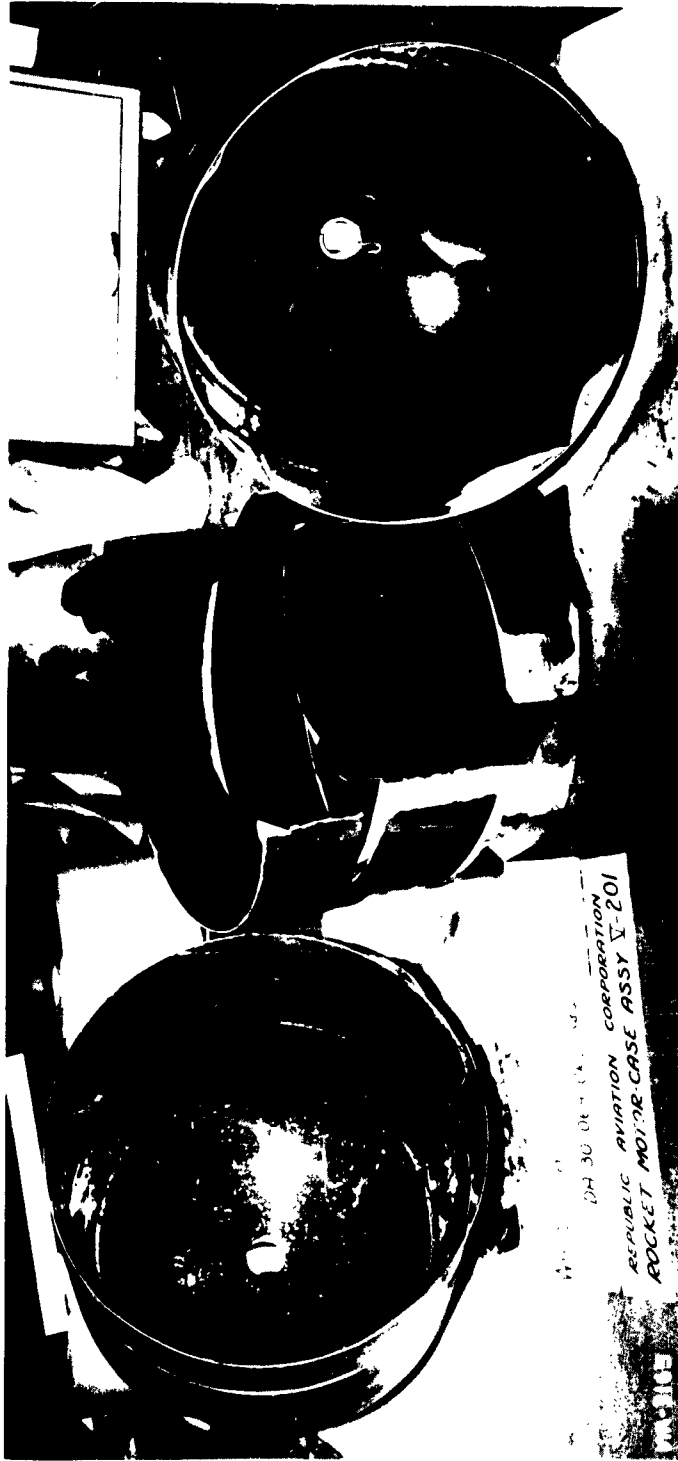
Assembly 4 (V-201) was fabricated using the two headers of the 244-1005-3 (see Figure 16) configuration, FM1000 adhesive, and five 0.038-inch-thick rings. The headers were not permanently deformed from their use in testing assembly V-103. When the vessel was hydrostatically tested, failure occurred at an internal pressure of 2030 psi. Figure 13 shows the pressure trace as it was recorded during this test. The ultimate membrane hoop stress in the metal rings was 320,000 psi based on the average thickness of the mar-aging rings (0.0375-inch average ring thickness). This stress level is approximately 12 percent greater than the uniaxial strength of the parent metal (see Table 6). Figures 22 and 23 show the metal parts just after removal from the test chamber and the original relative position of these parts. Examination of the parts showed that the failure originated in the parent metal and was not associated with any weldment or adhesive joint. A close-up view of the rings containing the failure origin is shown in Figure 24.

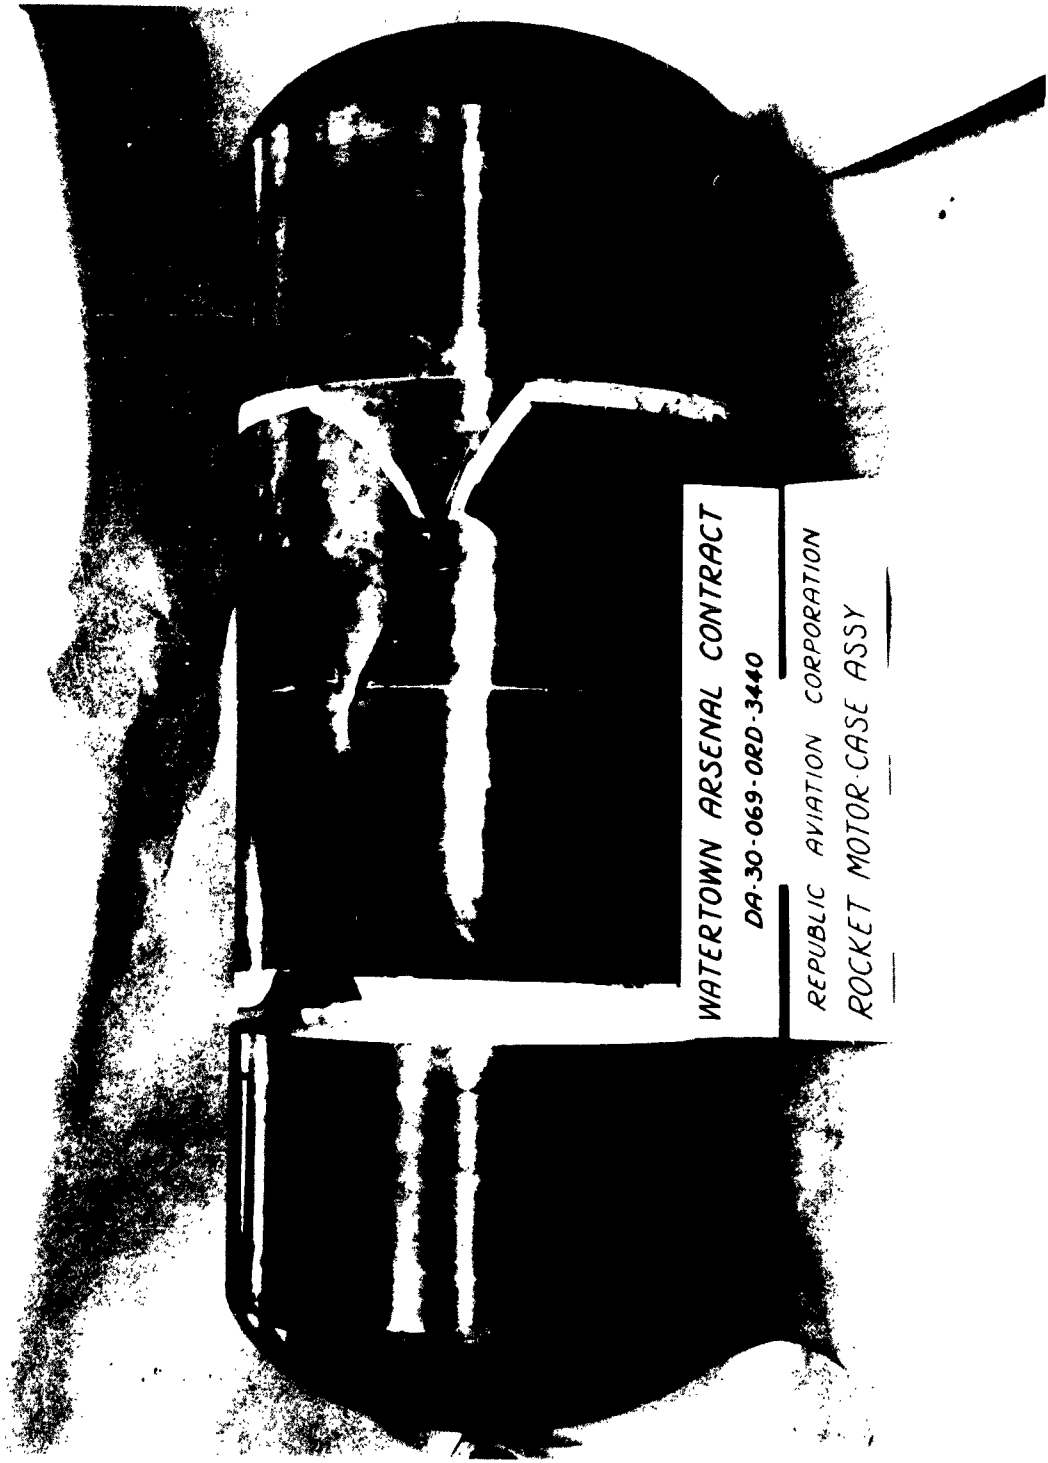
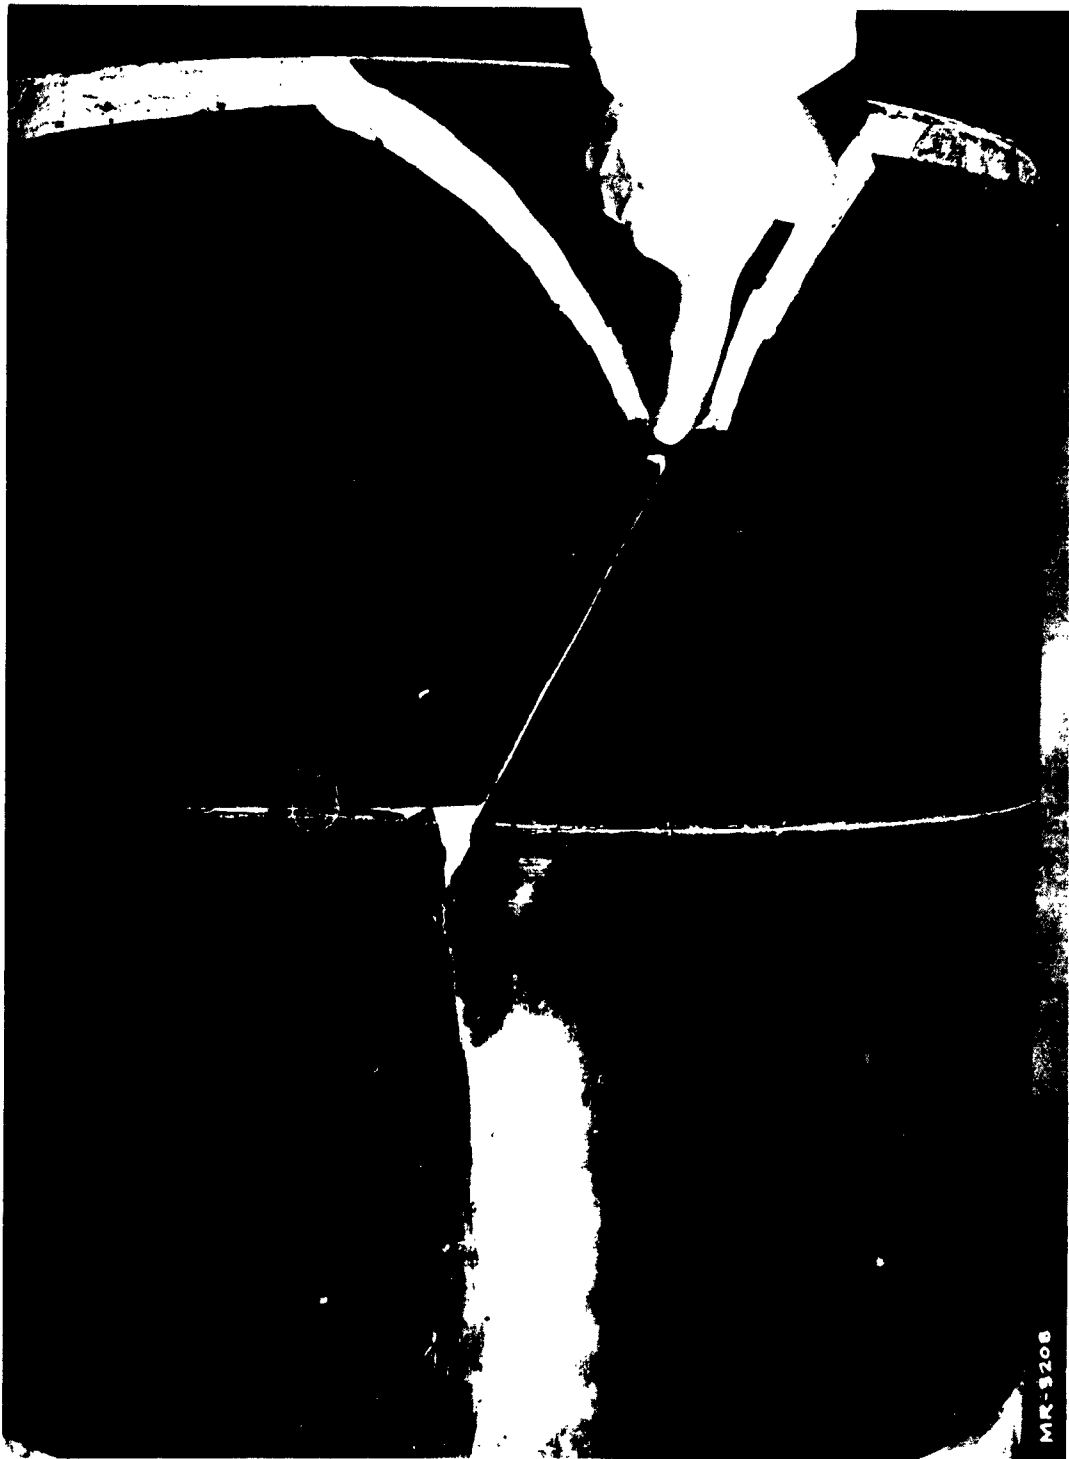
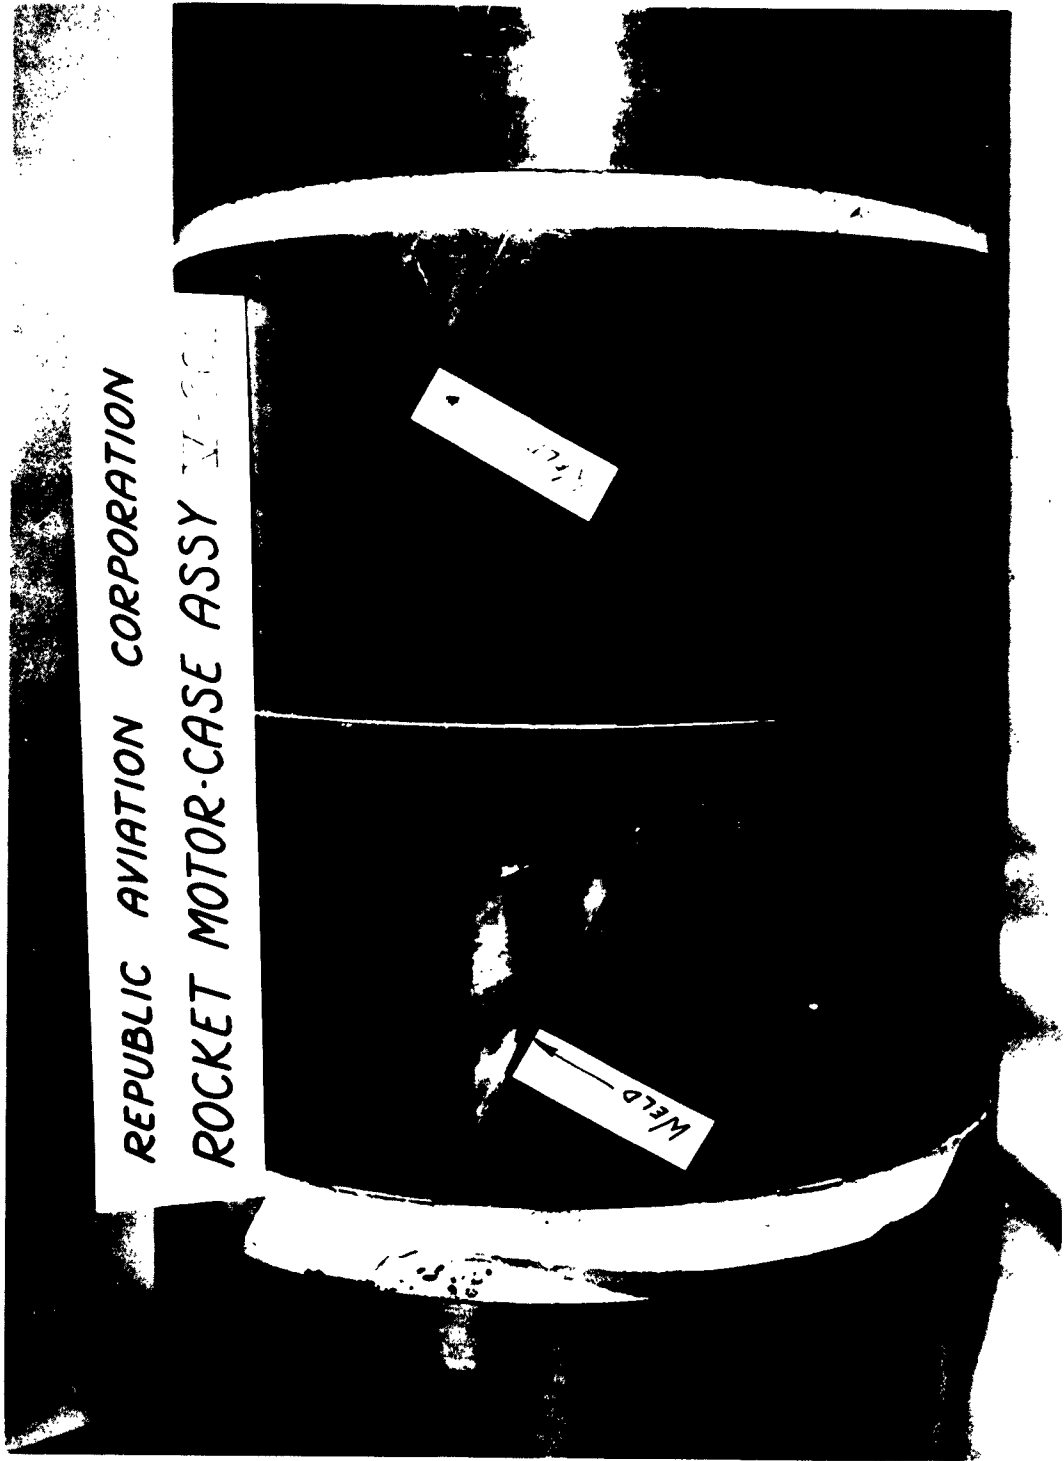
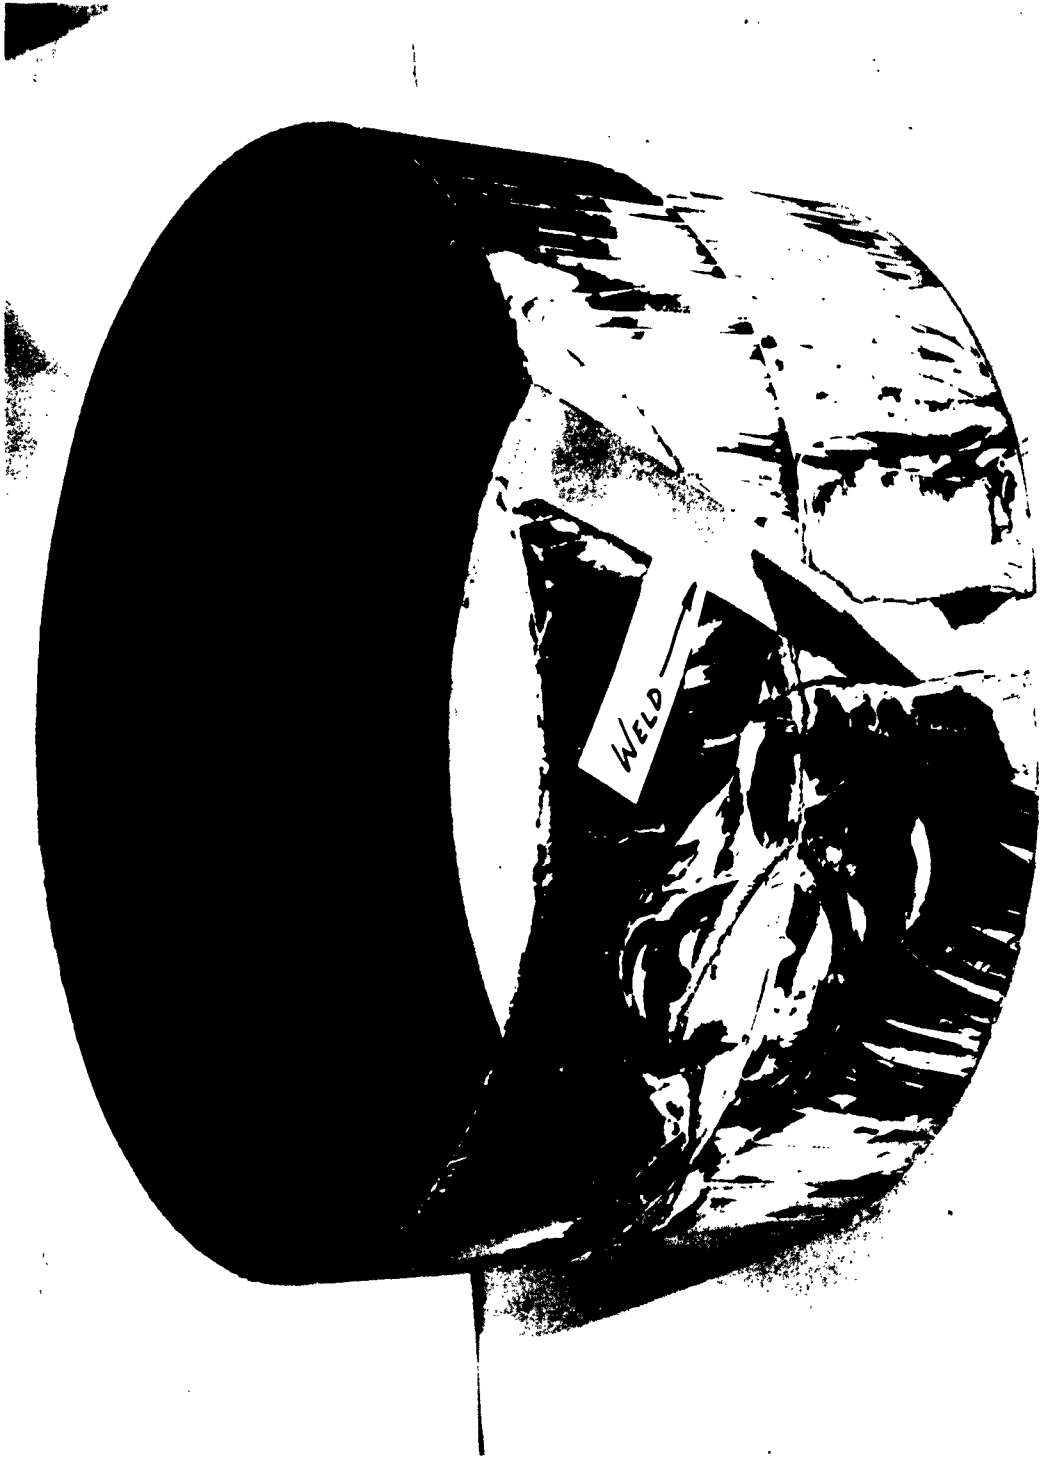
V-202**	5	0.075	FM1000	1520	240,000	Failure originated in a weldment in the central inner ring. Examination showed no unusual conditions in the weld. Uniaxial tensile strengths of weldments tested range from 243,000 to 263,000 psi.
V-301**	6	0.124	FM1000	2290	219,000	Failure due to unbonded area in one header joint (approximately 20 percent of area). Preliminary evaluation attributed this condition to the stiffness of the work-horse header preventing uniform contact pressure during the cure cycle.
<p>* The detailed report on vessel III-101 is in the "Fourth Quarterly Progress Report," RAC 1160. ** See Section III.</p>

revealed no unusual conditions. X-ray photographs of the weldment before and after failure are shown in Figures 26 and 27. Figure 28 shows an over-all view of the assembly after test; a close-up of the primary failure zone is shown in Figure 29. It is noteworthy that this view shows that the edge of the inner ring containing the weld failure remained bonded to the outside ring. Another view (Figure 30) of the reconstructed assembly shows the position of the weldments in the outer rings on the surface opposite the primary failure. The inner ring containing the weld along which the failure originated was delaminated; this ring is shown in Figure 31.

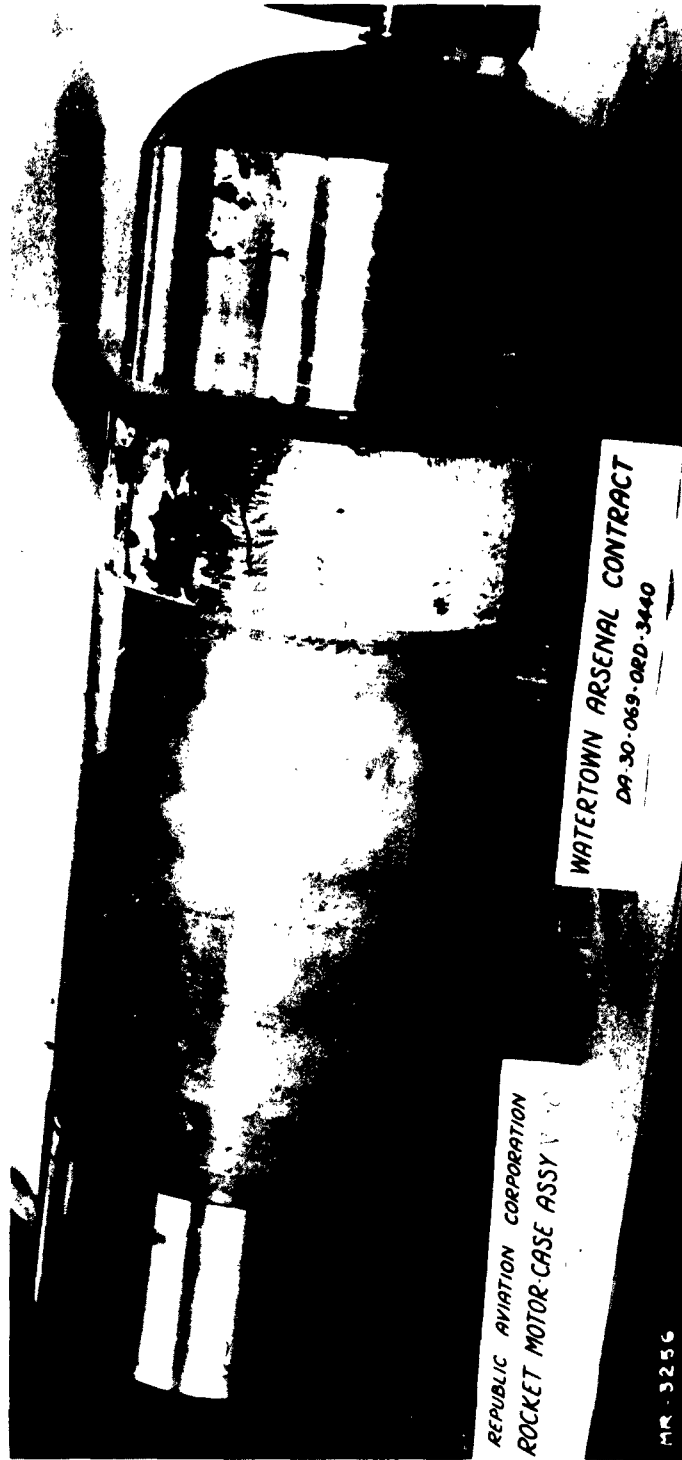
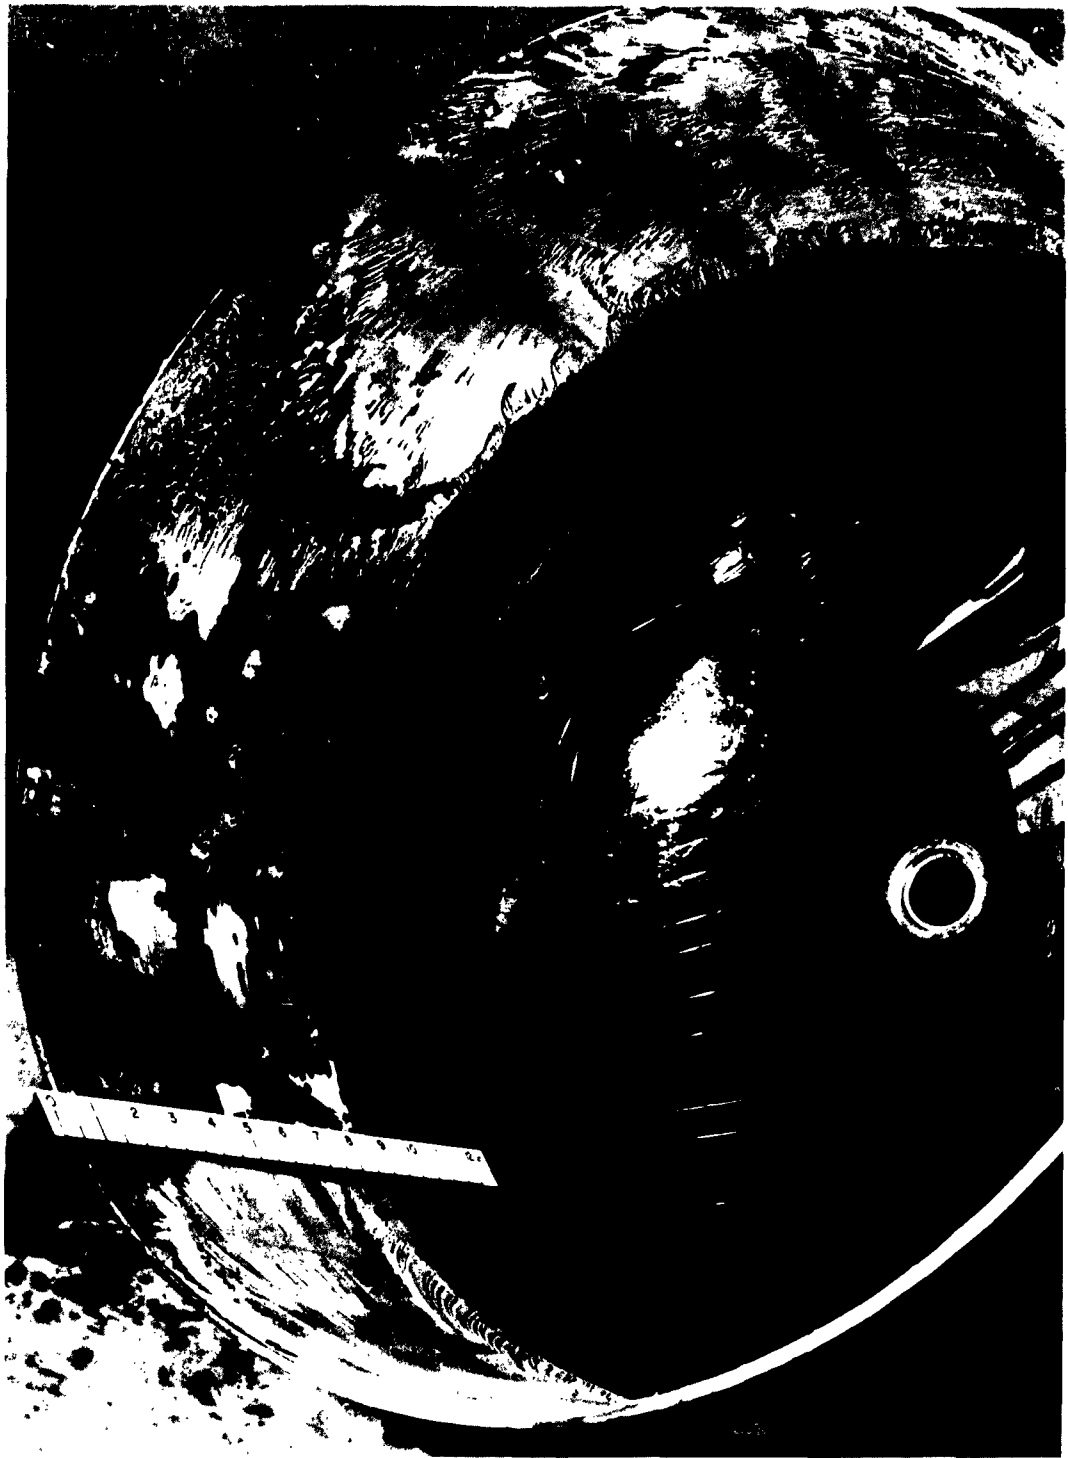
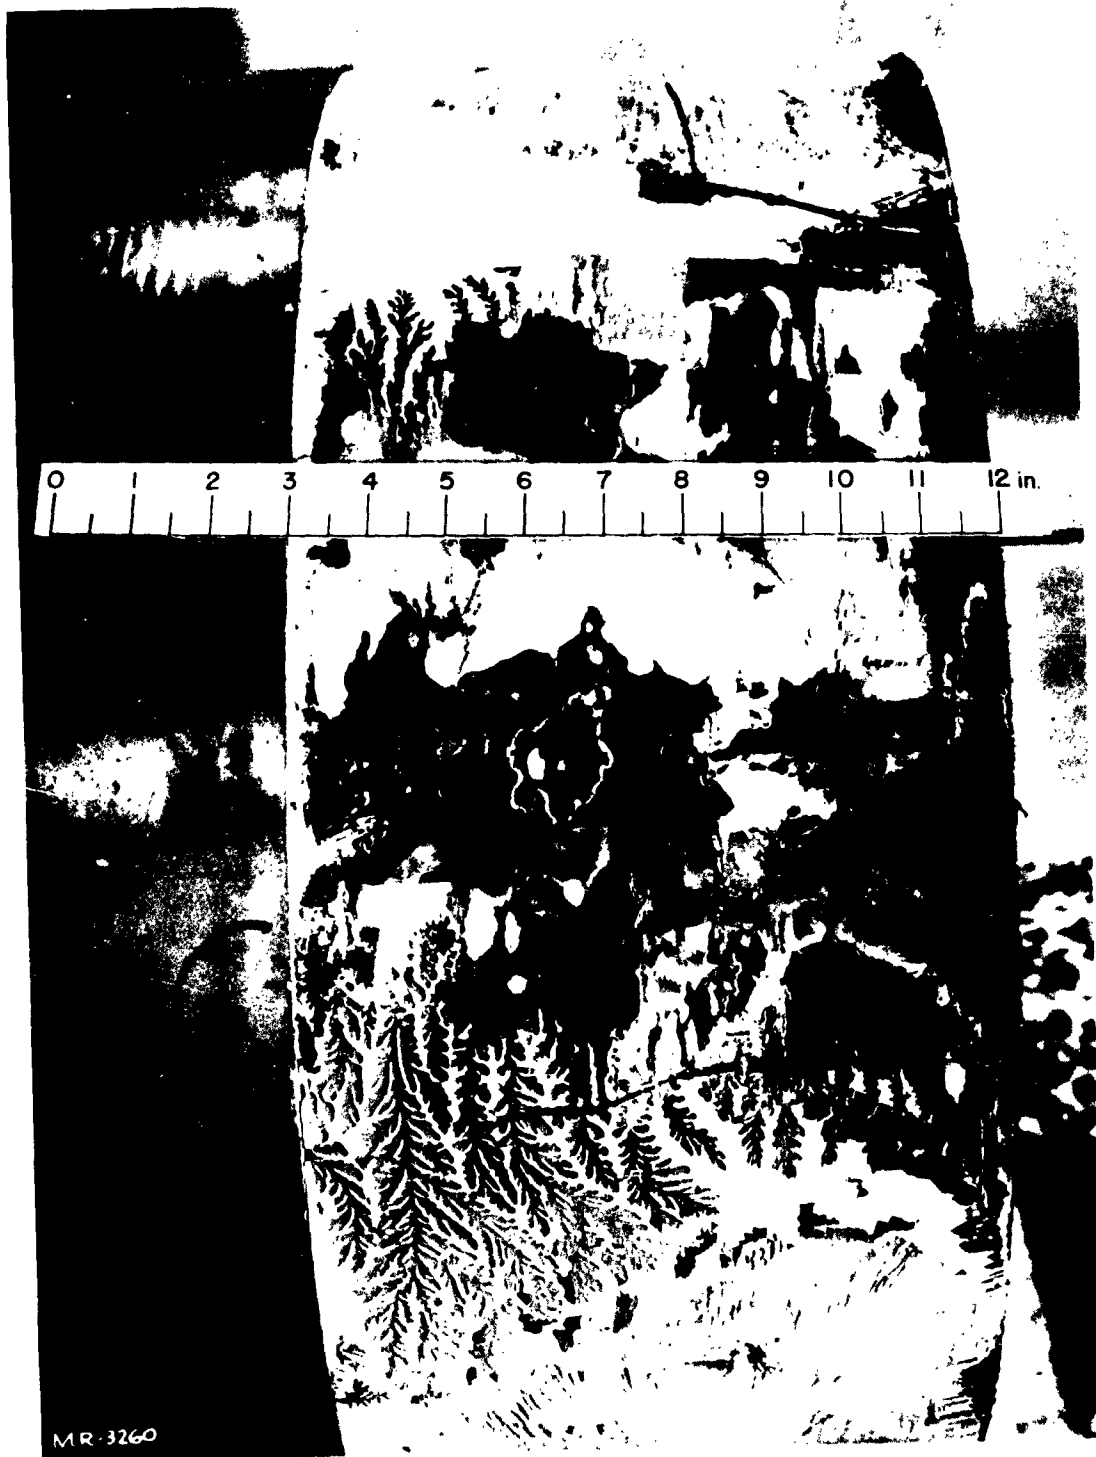
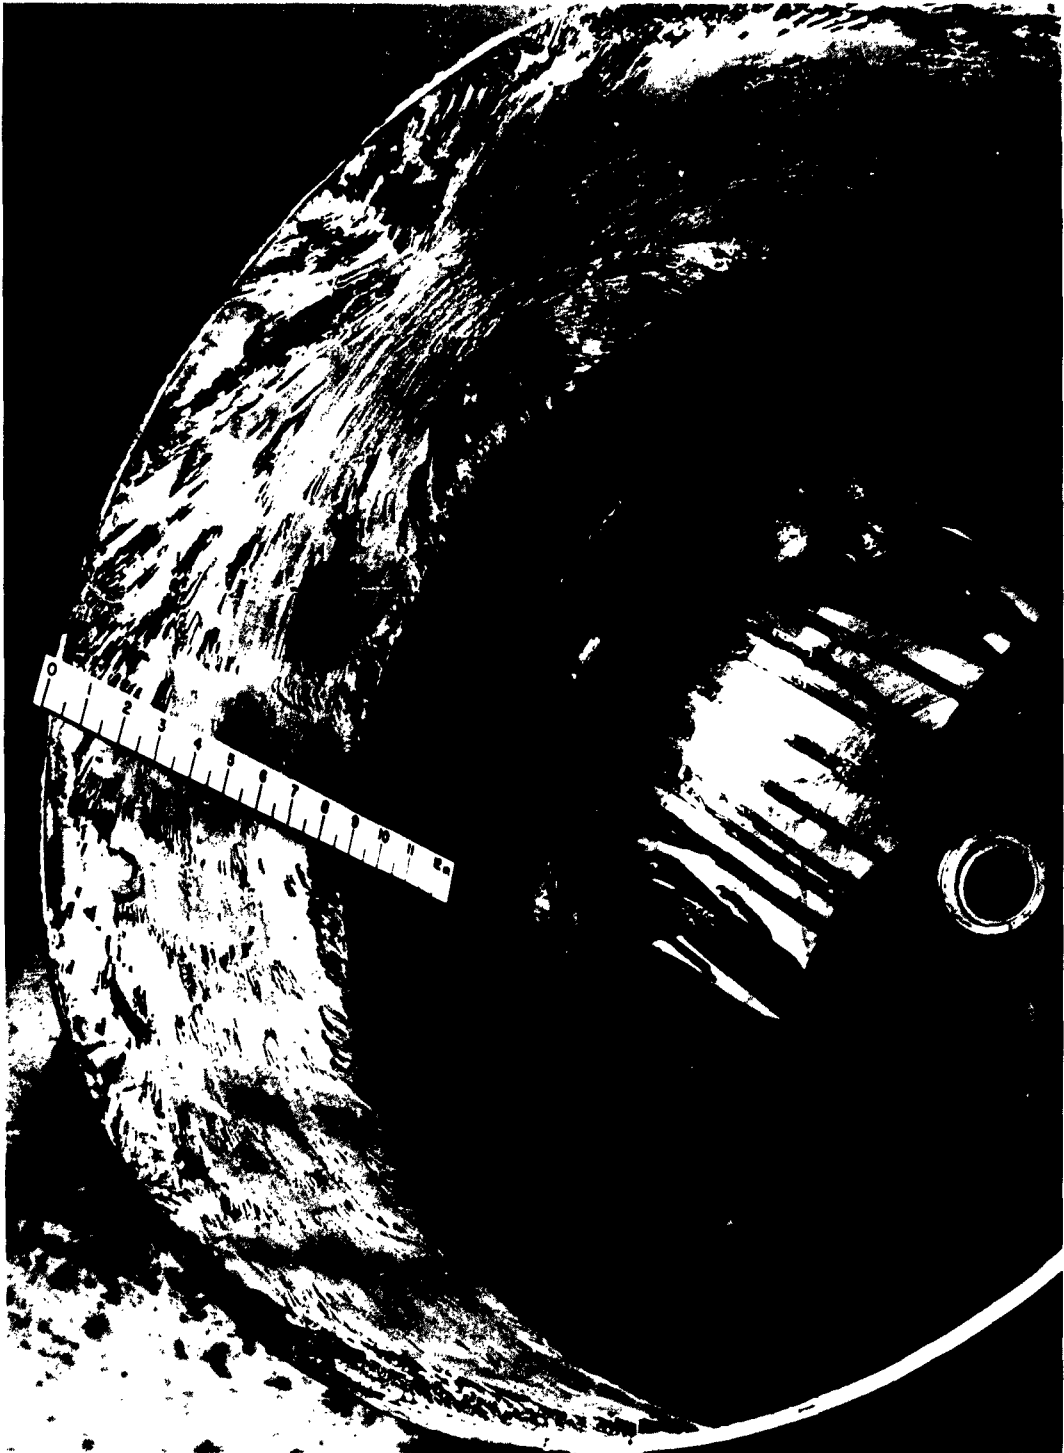
The last vessel tested during this quarter was pressure-vessel-assembly V-301. It was fabricated using the 244-1005-5 (see Figure 16) header configuration, FM1000 adhesive, and five 0.062-inch-thick mar-aging steel rings. Figure 32 shows the assembly being moved into the test chamber before the test. The vessel was hydrostatically tested to failure at an internal pressure of 2290 psi. The failure was caused by the delamination of one of the adhesive-bonded, header-to-mar-aging-steel-ring joints. Examination of the faying surfaces subsequent to failure disclosed an unbonded zone equaling approximately 20 percent of the total joint area. Figure 33 shows the vessel after failure; the dark area at the top of the joint is the unbonded zone. Close-up views of the failure origin on the header and ring faying surfaces are shown in Figures 34 and 35. The longitudinal cracks seen in the steel ring were caused by the pressure exerted on the single thickness of inner ring as the header moved off the cylinder on a skewed angle. Figures 36 and 37 show the areas on the header and steel inner ring that sustained the end load until failure occurred. The strain striations on the adhesive are typical of adhesive failures where the adhesive has performed its function of load transfer.

Preliminary evaluation of this failure indicates that the lack of bond over this large area was caused by the stiffness of the work-horse header skirt. This situation was the result of attempting to use two ideas in one design. The strength requirement for the D6-A steel headers (244-1005-5) made it necessary that the skirt section (0.188 inch thick) be nine times stiffer than the mar-aging steel ring to which it is bonded. The flexural and natural arch rigidity of the thick-walled, cylindrical skirt of the header prevented the proper mating with the lighter, more flexible, 0.062-inch-thick rings during the adhesive cure cycle. For optimum

design, a header fabricated especially for use with each assembly would have the same thickness and rigidity as the ring section to which it is bonded. If this were done, the poor contact pressure in the local area during cure would not occur under the fit-up conditions that are imposed (line-to-line diametric fit with the tolerance on the side of interference) during assembly.
