Technical Report

PROTECTION OF MOORING BUOYS -  
PART I. INITIATION OF FIELD TESTING

30 June 1963

U. S. NAVAL CIVIL ENGINEERING LABORATORY

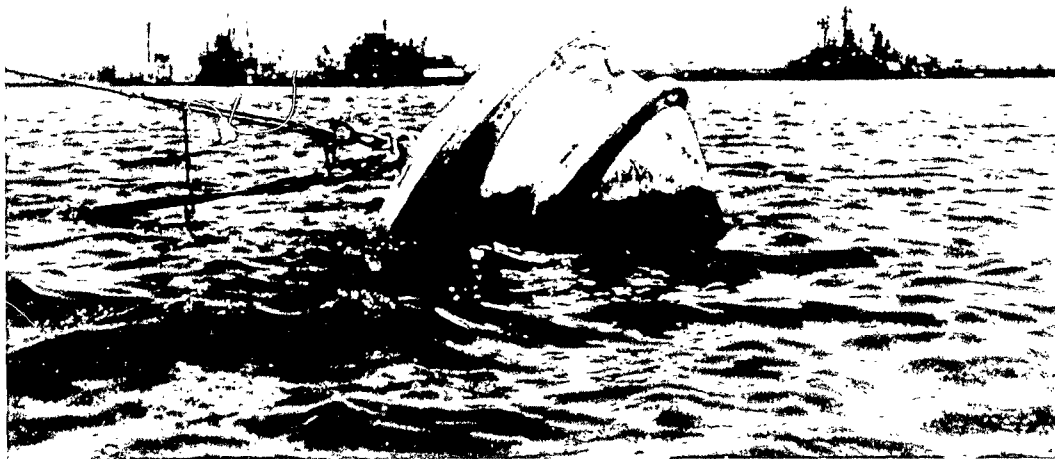
Figure 1. Mark I peg-top riser-chain buoy tilted by mooring lines.

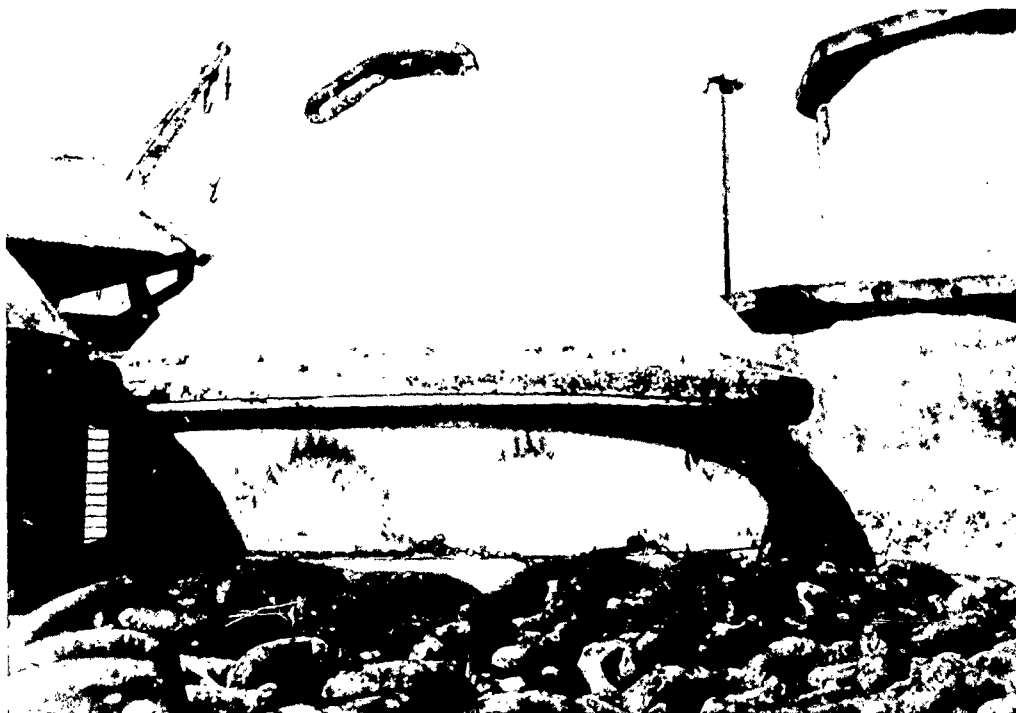
Figure 2. Buoy with coating on sides abraded by side-hanging chains.

1. Side-hanging chains and other non-functional appendages should be removed from mooring buoys.
2. Pads should be used to protect the coated surfaces of buoys to prevent abrasion during handling.
3. Coated bolts should be used for securing wooden fenders to buoys.
4. Sandblasting and coating application procedures recommended by specification or suppliers should be standard practice.
5. Buoys should be coated as soon as possible on the same day after sandblasting.
6. Coatings should not be applied when the humidity is greater than 85 percent or when the temperature is below the minimum set for the particular coating.
7. Initial inspection of test buoys should occur shortly after the first buoys have been 6 months in service.

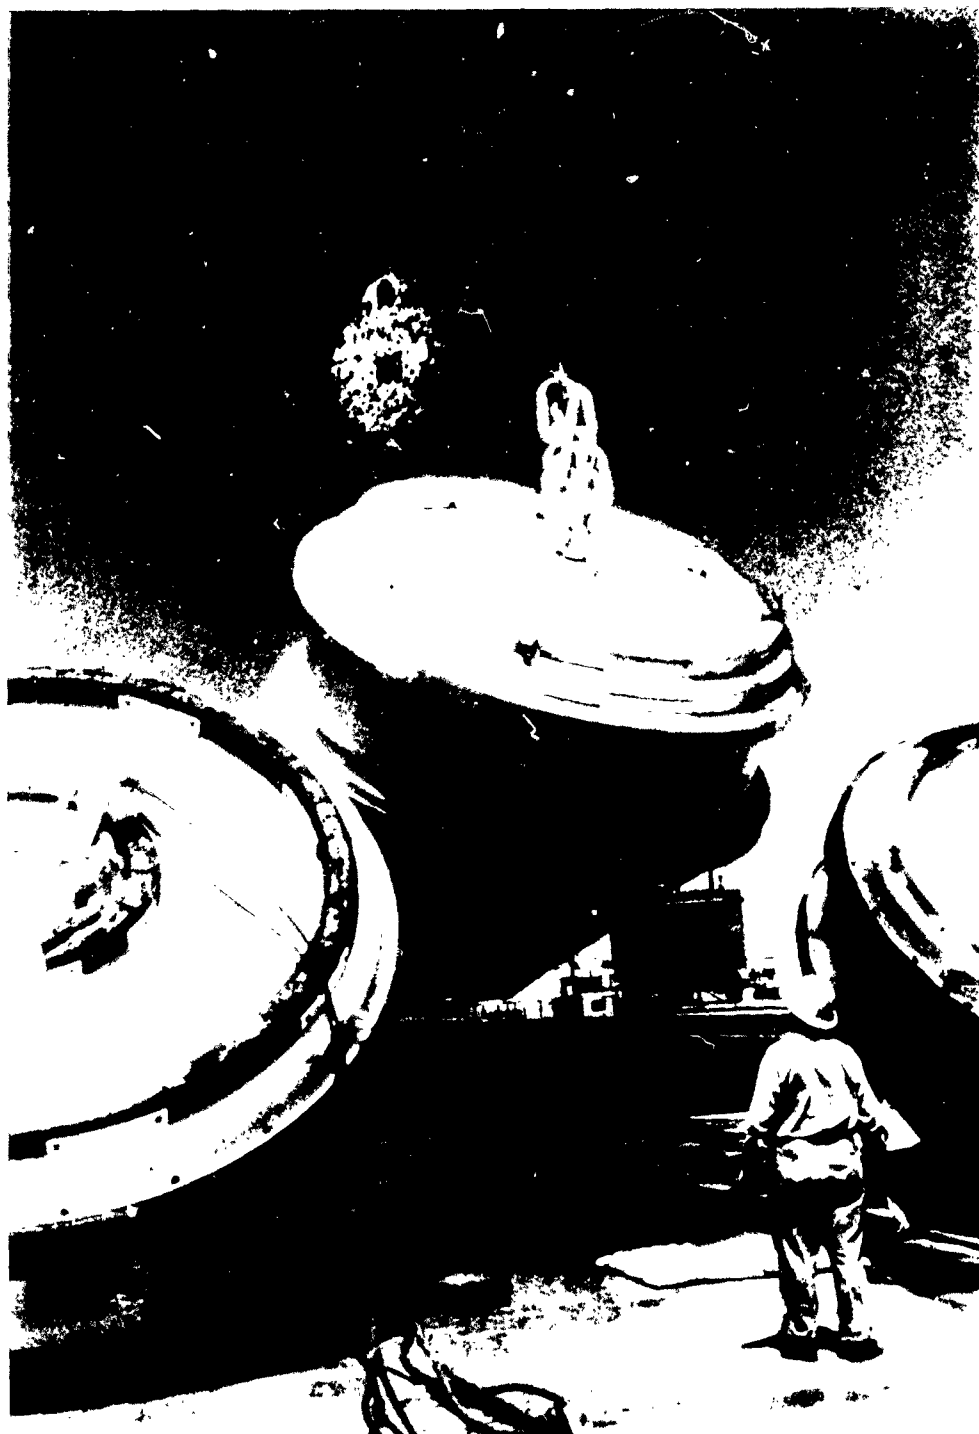
Figure 5. Buoy being lowered onto protective pads.

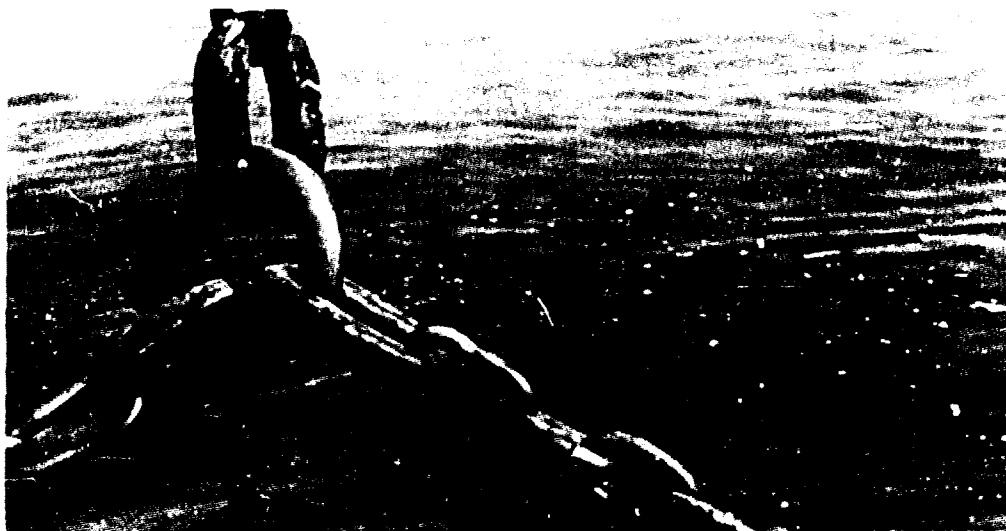
The protection of mooring chains presents a special problem in itself. The BuDocks-recommended coating, asphalt varnish TT-V-51c, protects the chain well in storage but is rapidly lost when the chain is placed into service. PW personnel at San Diego Naval Station have found it advantageous to coat anchor chain with cold-applied coal tar coating conforming to MIL-C-18480A. This can be accomplished conveniently and economically by dipping the chain in a tank of this coating. Riser-chain moorings show great deterioration on links in the area adjacent to the ground ring (Figure 6). Chain that remains in the mud has very little corrosion damage. Periodically reversing anchor chain end for end may distribute the wear and extend service life.

Figure 6. Heavy deterioration of chain in vicinity of ground ring.

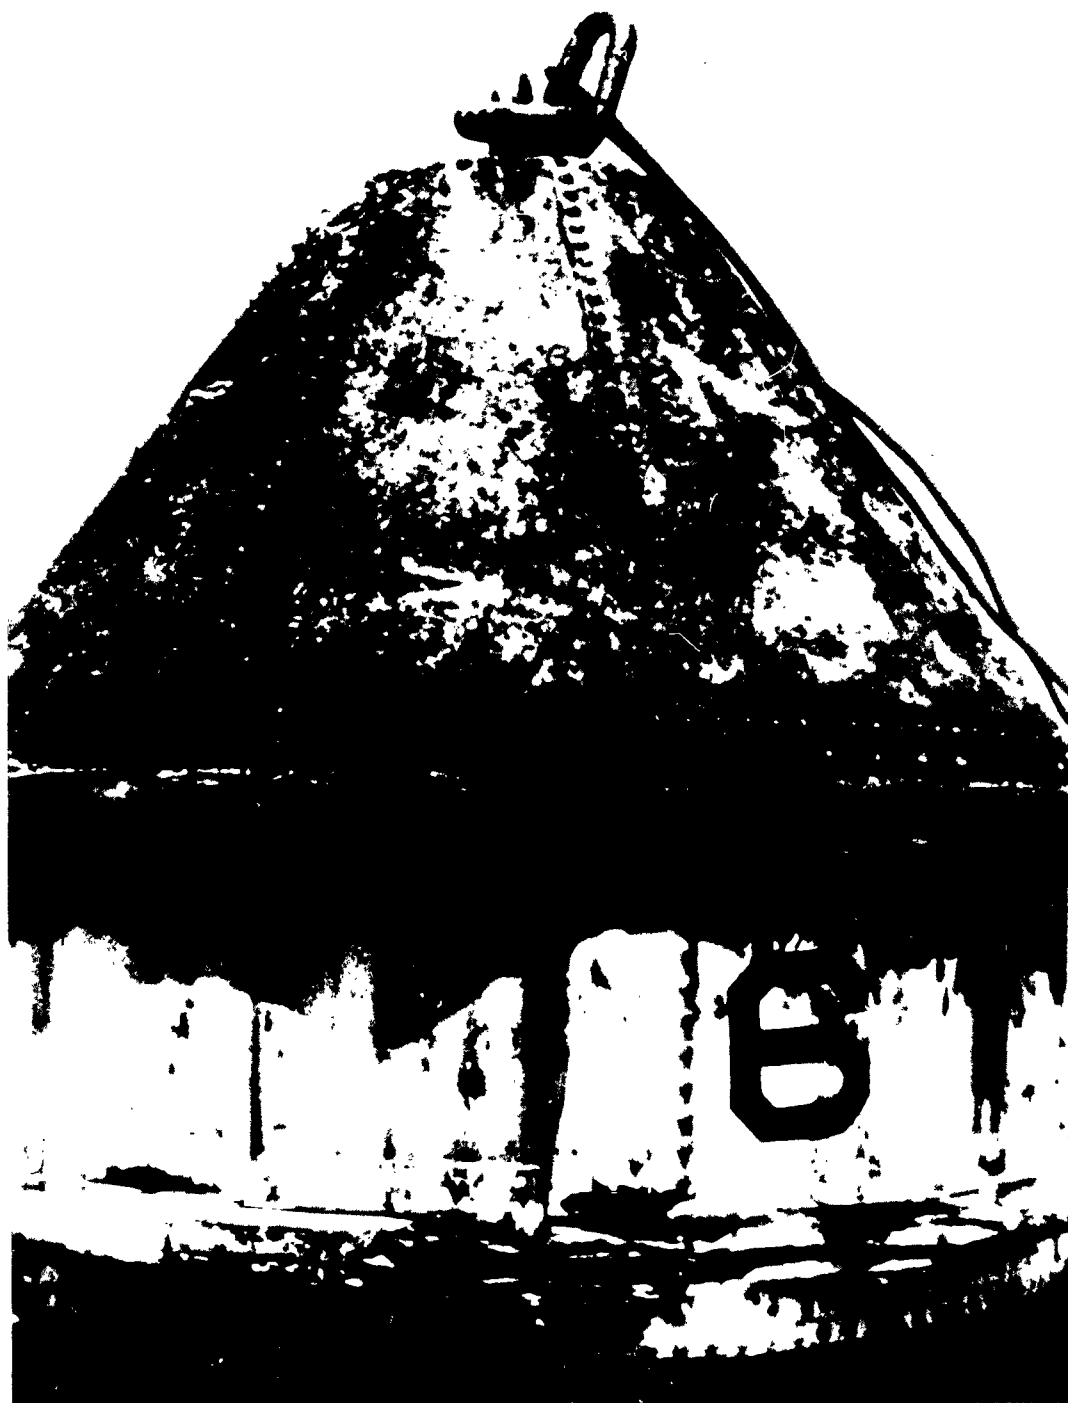
Figure 7. Buoy damaged by overriding vessel.

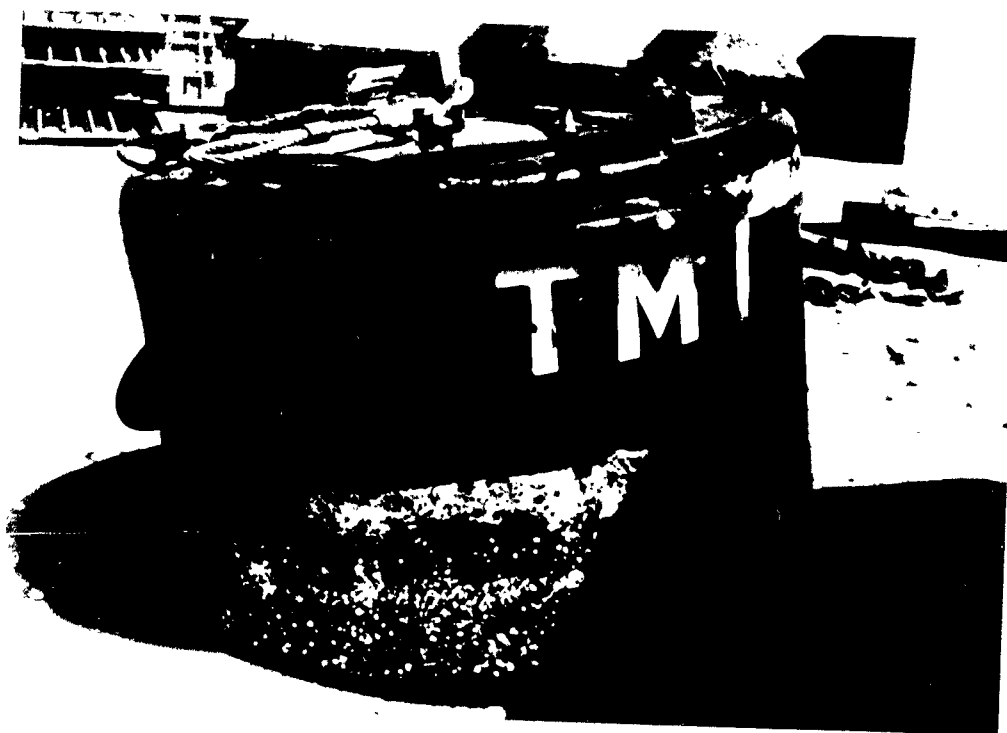
Figure 8. Damaged, plastic, test, mooring buoy.
