NRL Memorandum Report 1427

FRACTOGRAPHY

PART XI

7075 T-6 ALUMINUM ALLOY FORGING FRACTURE

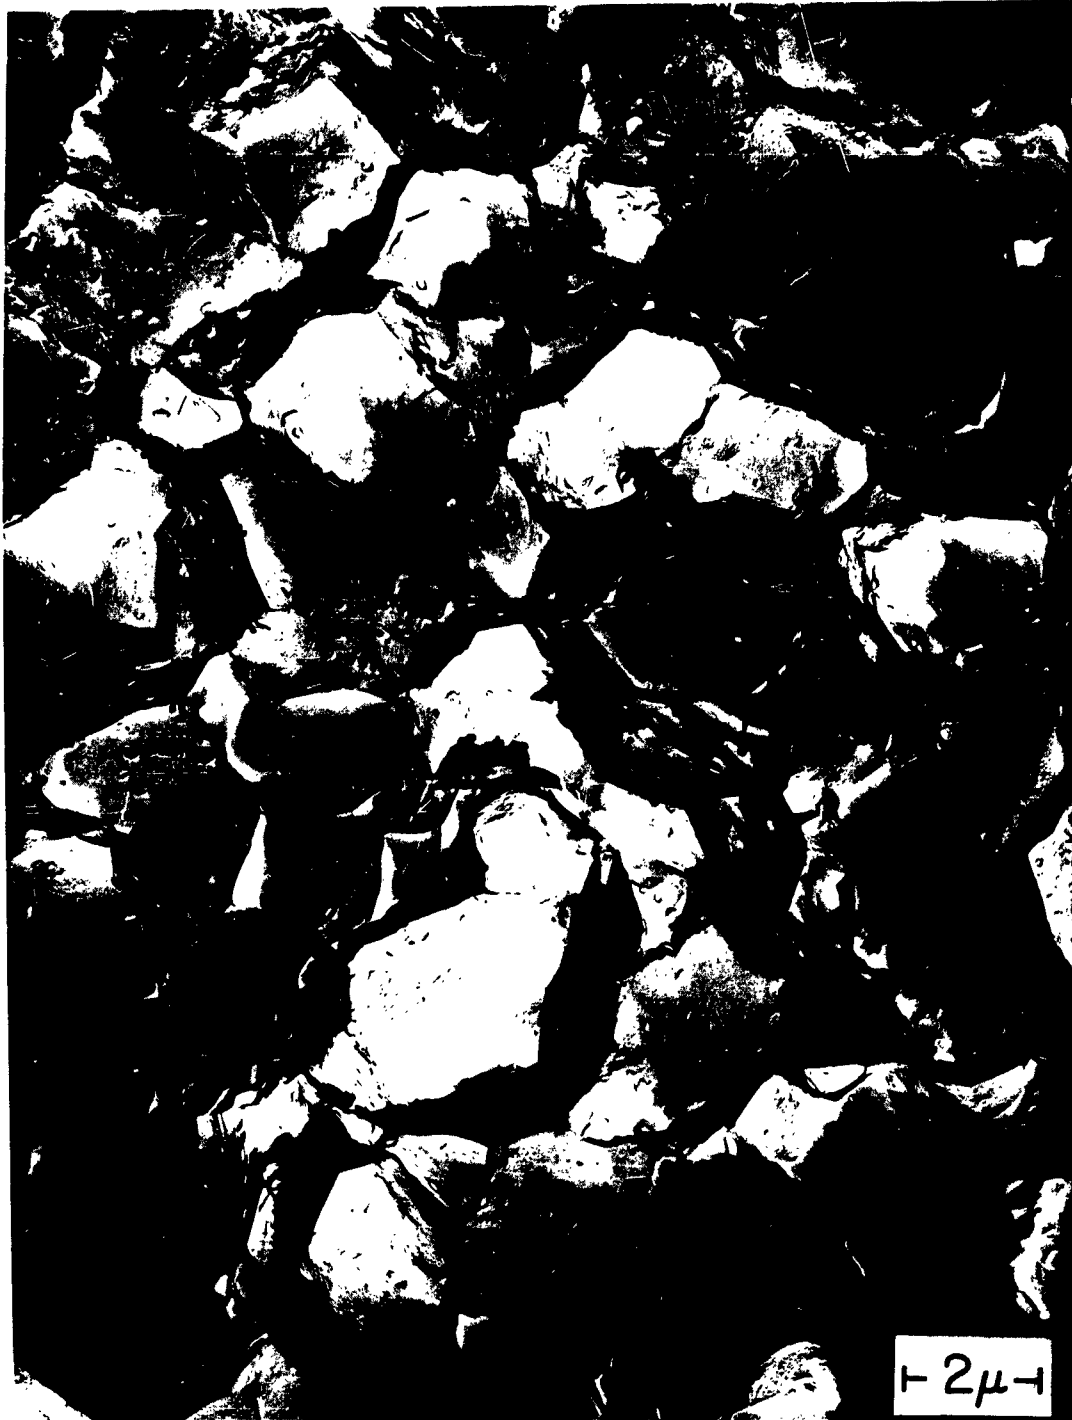
A representative area from the fracture initiation region is shown in Figure 2. The faceted or "rock candy" appearance indicates that the crack propagated along grain or sub-grain boundaries in an intergranular fracture mode. Figure 3 shows the micro-appearance of a representative region in the fast fracture area. The network of small dimples is typical of overload fracture in this aluminum alloy. The dimples result from small voids which tear open in the fracture plane and are thought to be associated with small precipitate particles. No evidence of mechanical fatigue crack propagation was observed

The intergranular fracture mode, the stepped appearance of the fracture profile, and the absence of evidence of mechanical fatigue in the fracture initiation area indicates that the failure in this region resulted from a stress corrosion cracking mechanism. Final fracture of the forging took place when the stress corrosion crack penetrated to a sufficient depth to cause the remaining material to fail through mechanical overload.

Fig. 2 - Intergranular fracture in the crack initiation region.
Magnification 6,000X.

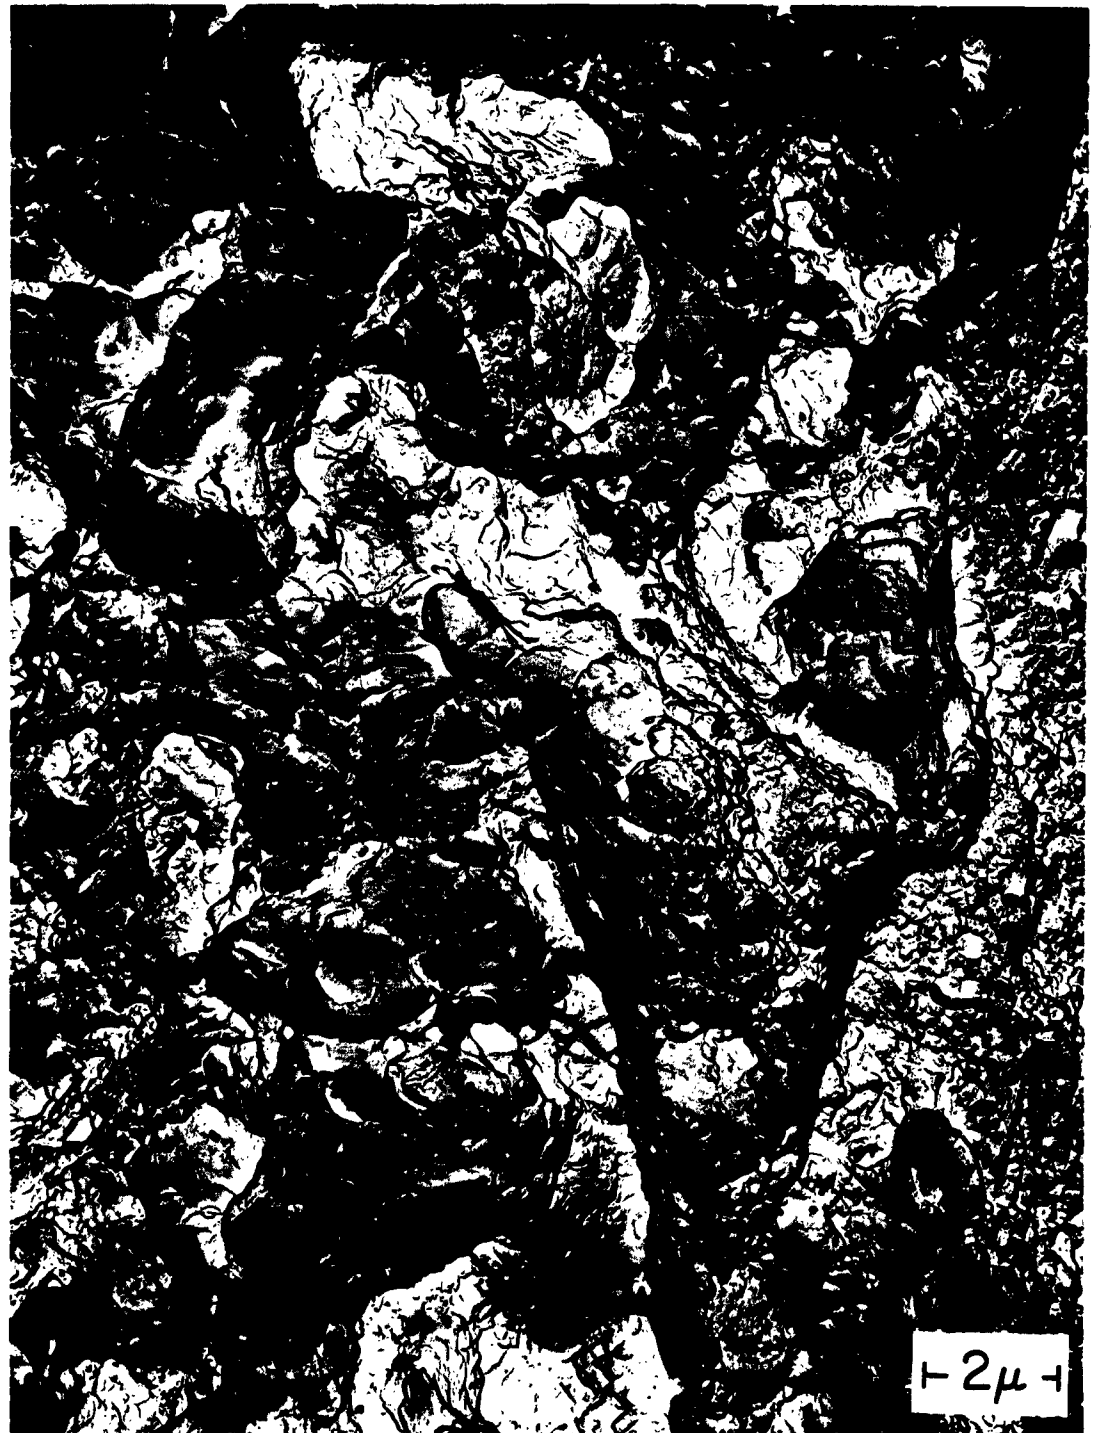
Fig. 3 - Dimpled rupture surface in the fast fracture region.
Magnification 6,000X.

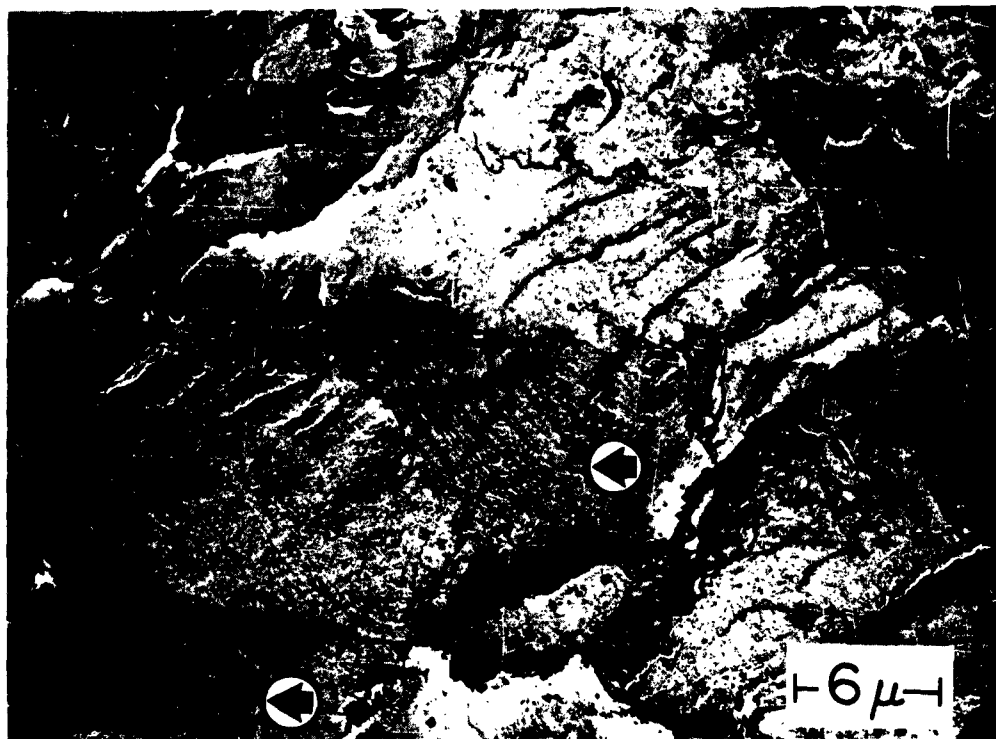
in either area. Such fatigue markings, having been observed on fractures of 7075 T-6 alloys (1) (see Figure 4) subjected to severe conditions of "after the fact" handling and corrosion, would presumably have been observable if the subject failure had resulted from mechanical fatigue.

Fig. 4 - Fatigue fracture markings (arrows) on a 7075 T-6 aluminum alloy dive brake skin. Magnification 2,000X.

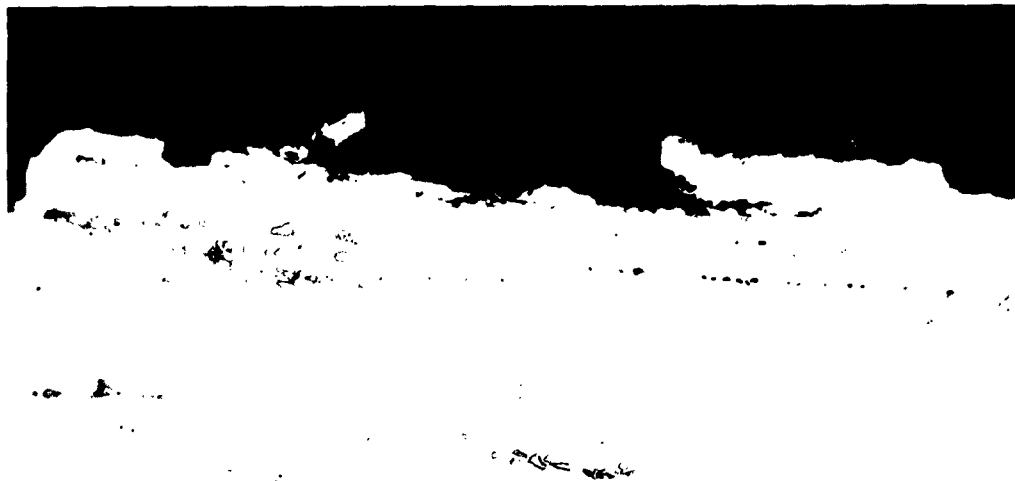
Figure 5 shows a mounted and polished cross-section of a portion of the fracture in the crack initiation region. The stepped fracture profile was generally parallel to the elongated grains and secondary cracks were observed near second phase particles strung out in this direction by the forging operation

Fig. 5 - Cross section of the subject failure showing the fracture profile in the crack initiation region. Magnification 200X.
