TRECOM TECHNICAL REPORT 63-10

Automatic Light Aircraft Readiness Monitor  
Project ALARM

VOLUME I

York Division of The Bendix Corporation  
York, Pennsylvania

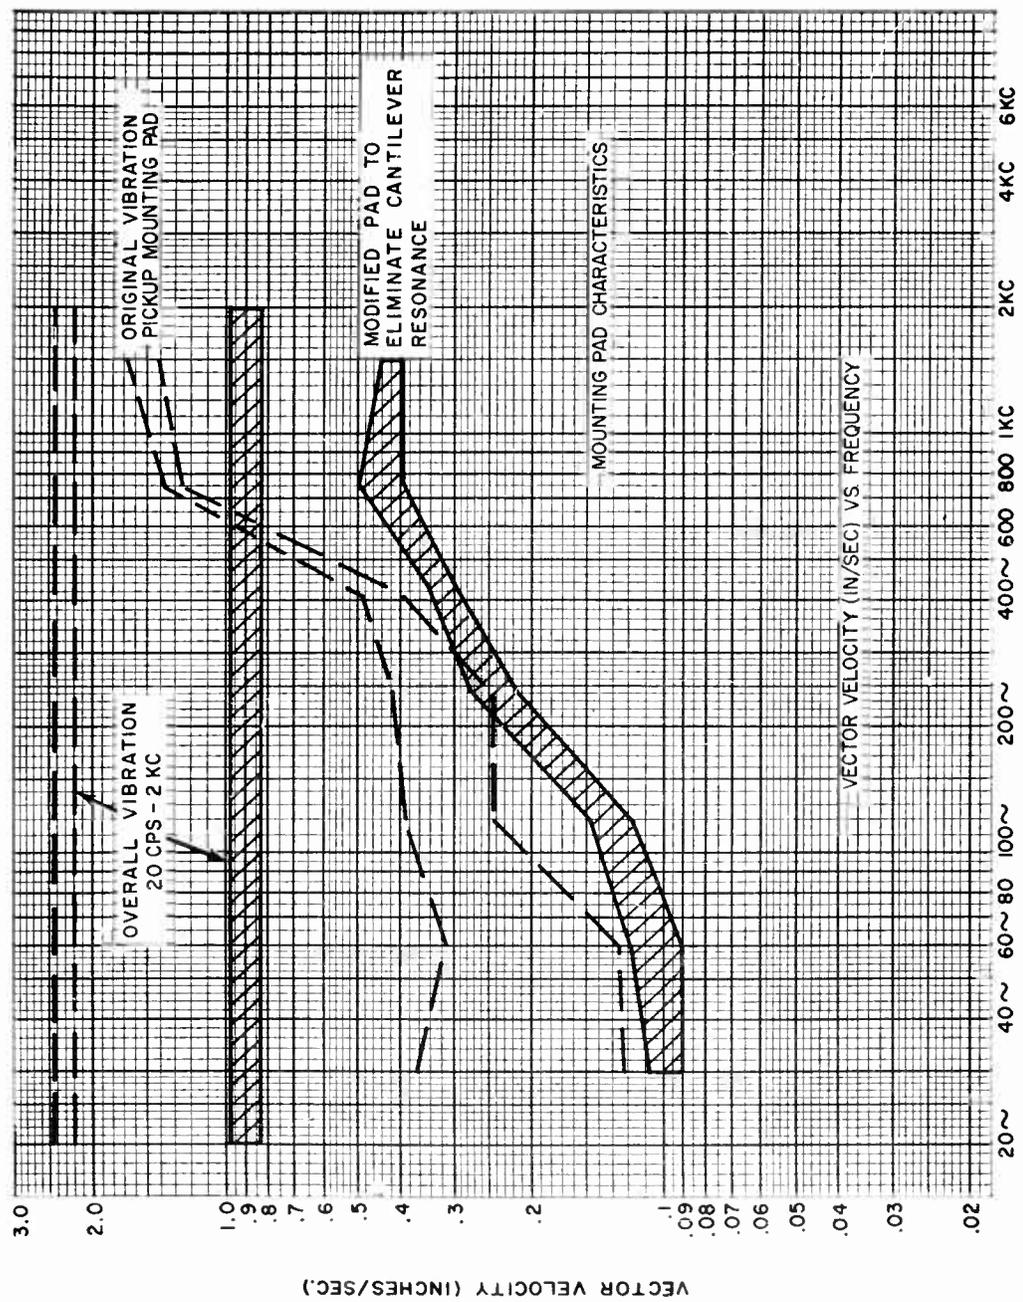
Prior to actually commencing the malfunction test sequences on the turbine engine, an investigation of the forward engine vibration pick-up was made as a result of an analysis of previous data recorded from that channel. It was suspected that the pick-up mounting pad arrangement was creating some resonances which were masking actual vibrations. A modified pad was manufactured and the results are shown in Figure 25. This modification will alter the actual vibration levels as recorded during Operational Tests of this channel, but it is felt that the relative amplitude differences at the various flight attitudes are still valid. The modified pad was used throughout the Malfunction Tests.

FIGURE 25. COMPARISON OF ORIGINAL AND MODIFIED FWD ENGINE PICKUP

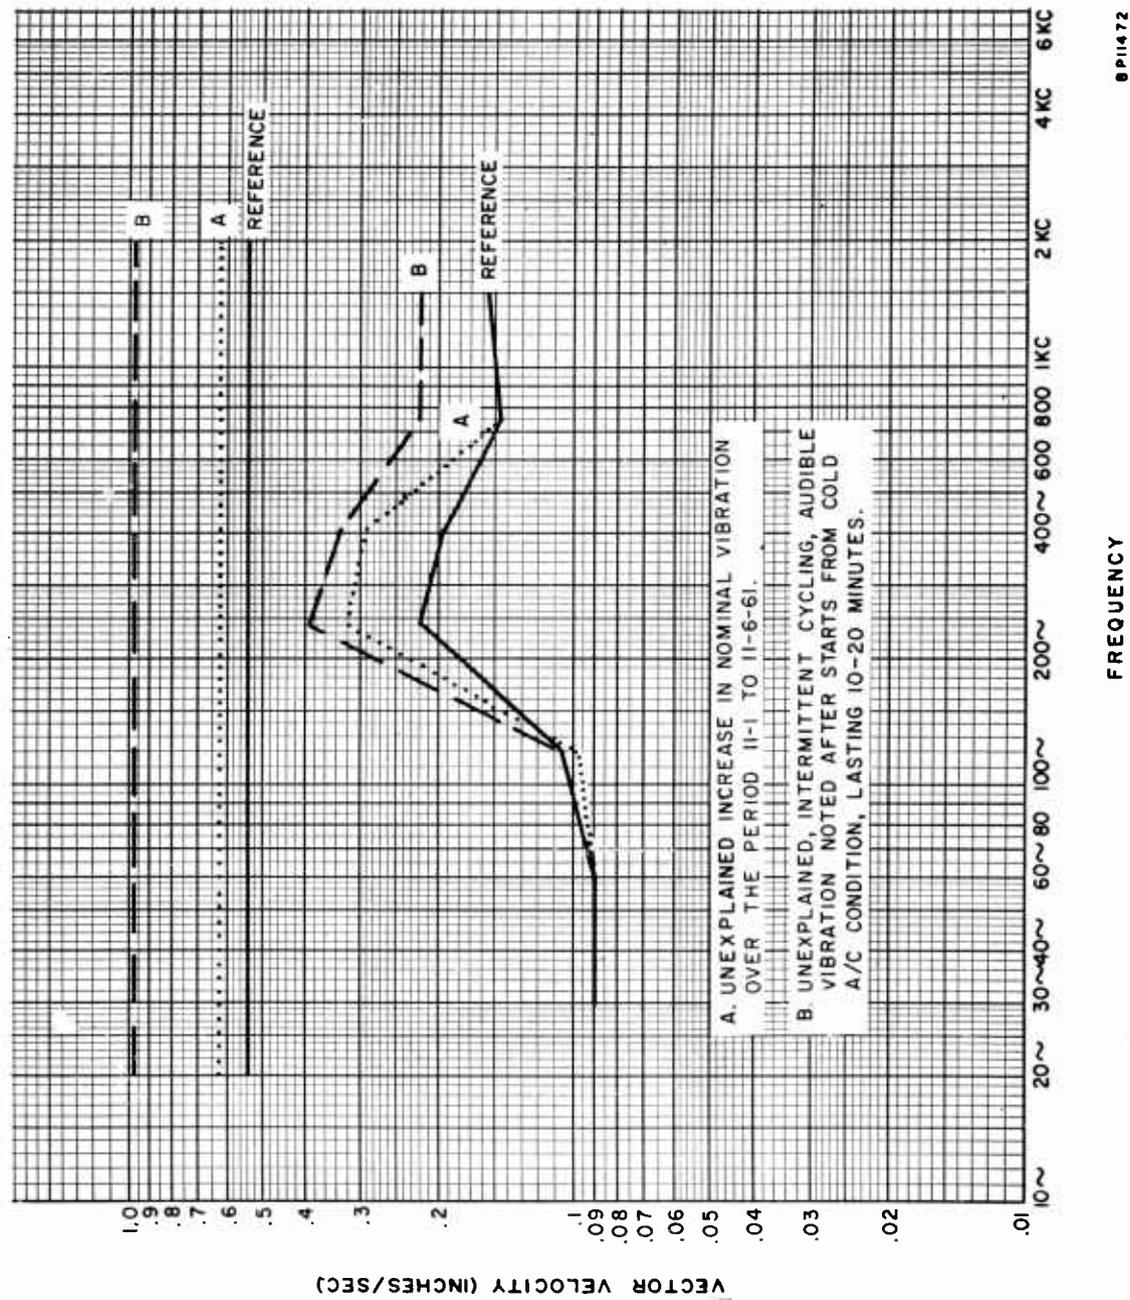
FIGURE 36. PLOT, UNEXPLAINED INCREASE IN NOMINAL VIBRATION AND INTERMITTENT CYCLING, AUDIBLE VIBRATION

able to accumulate complete data on this condition, which is presented in Figure 36. Also illustrated on this graph is another unresolved condition which occurred; specifically, an increase in the nominal or reference vibration levels just prior to the end of the test program. This also was indicated by the ALARM System. Both of these conditions (Figure 36 A and B) may be directly related, and the overhaul report should provide valuable information to resolve this phenomenon.

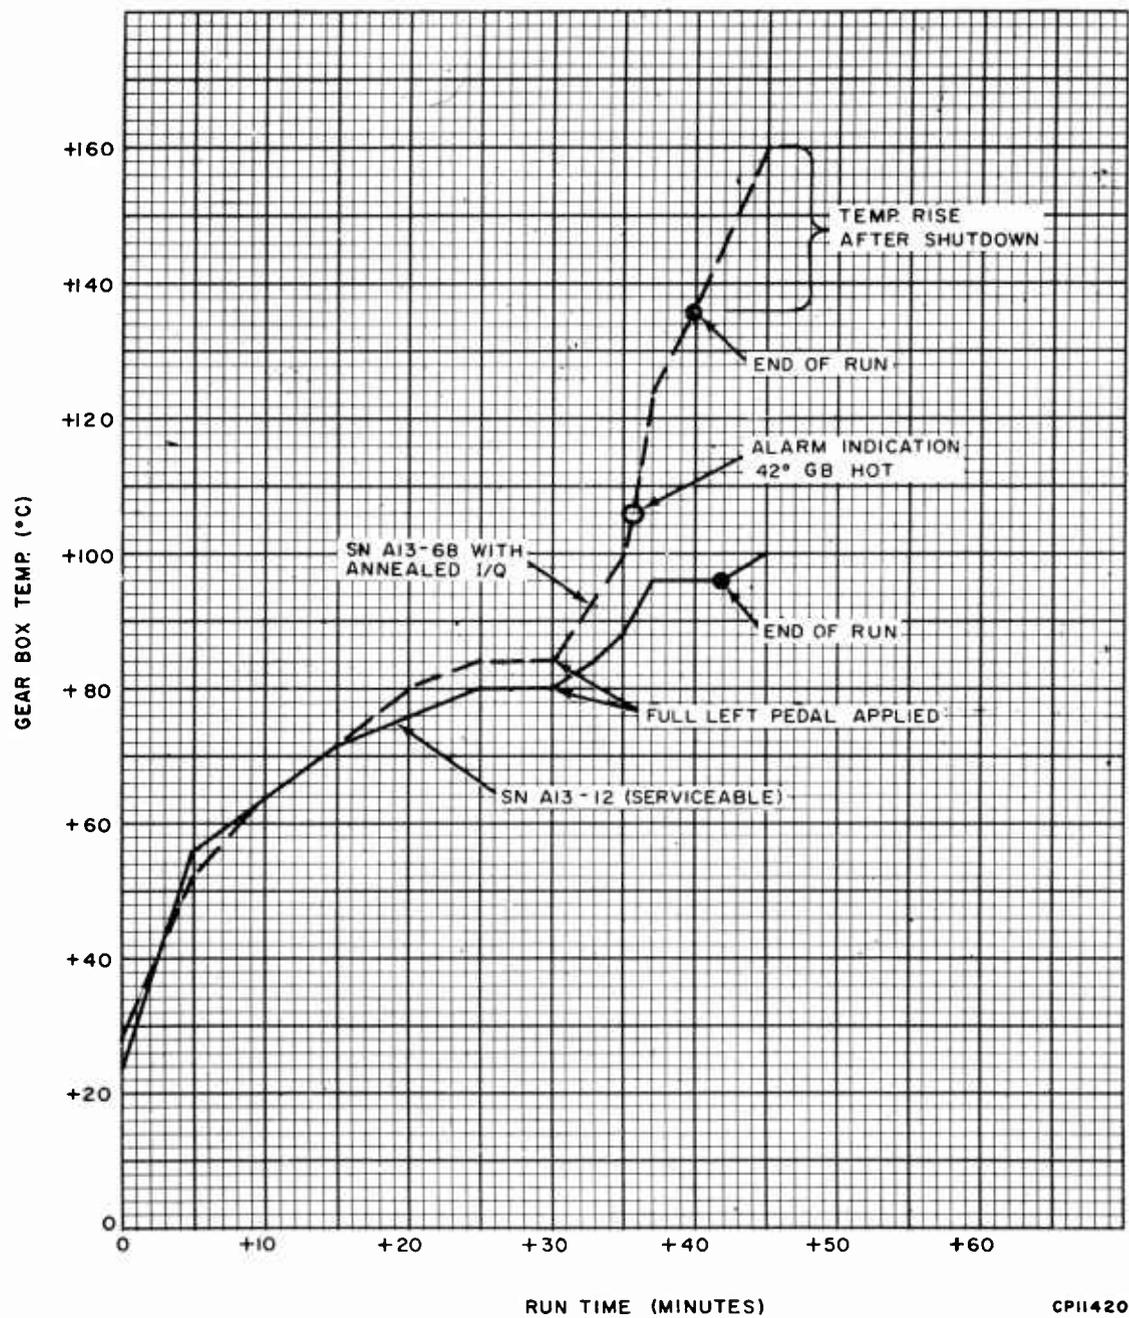
In approximately 5 hours running time, tail vibration began to increase and the

FIGURE 37. MALFUNCTION TEST #8, ANNEALED INPUT QUILL (42° 6B)

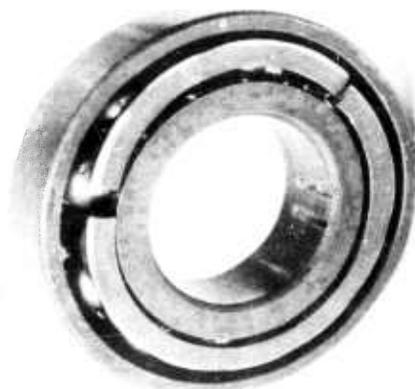
Figure 39. 42° Gear Box Input Quill Bearing Retainer Failure.

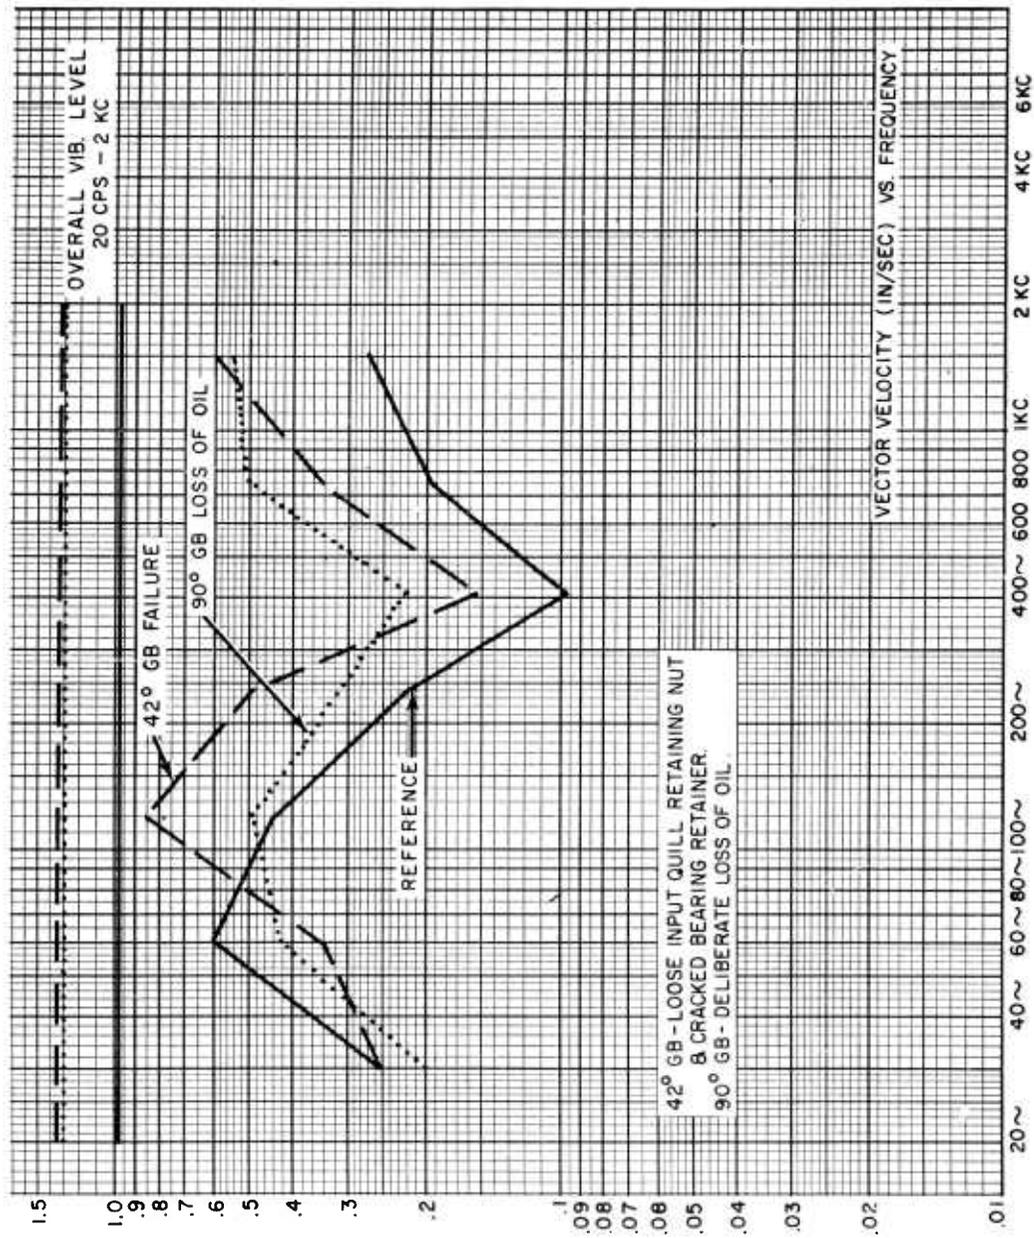
VECTOR VELOCITY (INCHES/SEC)  
FIGURE 41. TAIL VIBRATION, INDICATED FAILURES

ALARM Tail Vibration channel indicated "NO GO". Other tests were in progress when this first occurred, resulting in about 2 more hours of running time during which recorded vibration levels continued to increase. At this time, an abnormal grinding noise was audible from the gear box, particularly on coast-down. Subsequent disassembly and inspection revealed both a loose bearing retaining nut and a failure of the inner bearing retainer, as shown in Figure 39. It is difficult to conclude when complete failure occurred. Apparently it took place after 5 hours, and the continued increases in vibration were caused by progressive deterioration of the bearings. The data associated with this test are shown in Figure 41. It is not certain whether the heat-treating process (to accelerate wear) caused this failure directly or indirectly by causing the retaining nut to become loose. Of more significance is the effect this condition had on tail vibration, particularly on increasing higher frequencies while actually decreasing levels at the lower frequencies. No indication was noted in chip detection during this sequence, probably because of its location (see discussions under Test #15).

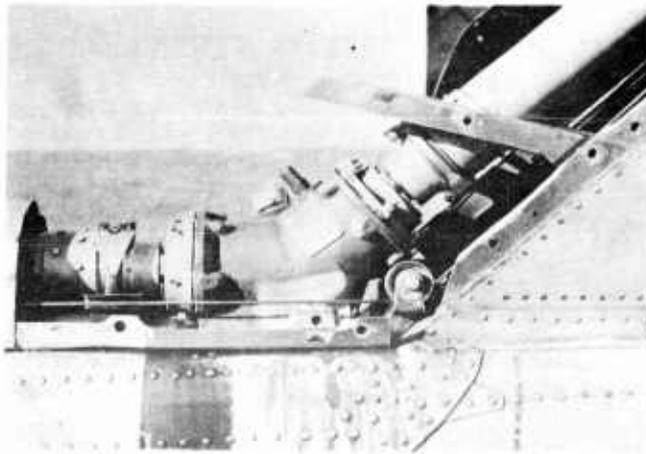
Figure 60. 42<sup>o</sup> Gear Box  
Showing Relocated Chip  
Detector Provision.

It is also recommended that the magnetic chip detectors for the main transmission and the 42<sup>o</sup> gear box of the HU-1A aircraft, be relocated in accordance with the finding of this report. In addition, it is recommended that the filter bypass setting be changed from the present 50% bypass flow to indicate bypass valve opening.

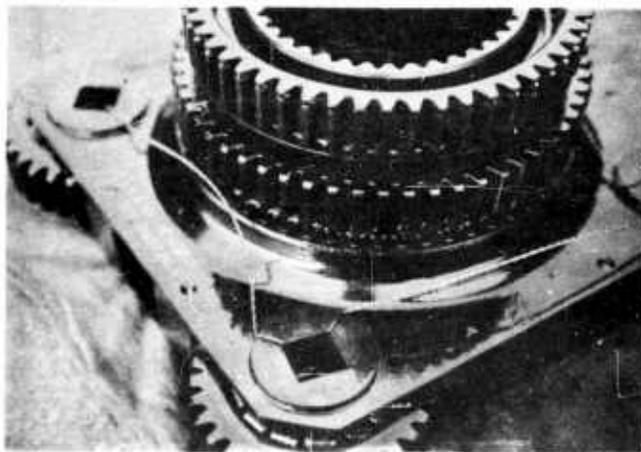
Figure 67. Upper Planetary Bearing Retainer Failure.

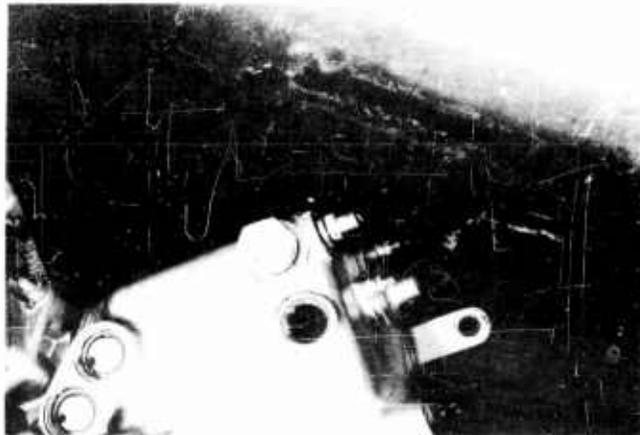
Figure 71. Relocated Main  
Transmission Chip Detector.
