NOTS TP 3170, NO. 8 30 AUGUST 1963

# AIR WEAPONS BULLETIN

## SIDEWINDER 1A MK 15 AND MK 17 ROCKET MOTORS-- INSPECTION AND MAINTENANCE,

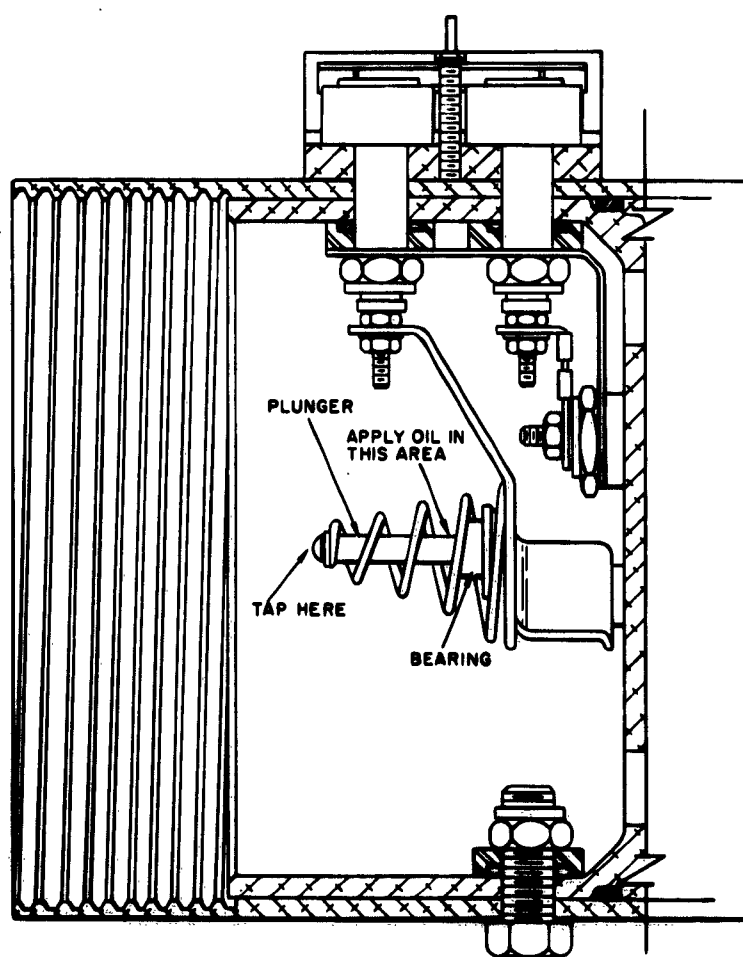
Some lot numbers of the Sidewinder 1A Mk 15 and Mk 17 rocket motors are susceptible to corrosion of the fuze contact subassembly. In some extreme cases, the fuze contact plunger becomes so severely corroded that it will not operate.

In case of an emergency need for the motors, the following field fix can be attempted (see figure). Place a drop of rust-inhibiting oil on the plunger adjacent to the bearing. Allow the oil to penetrate for several

minutes. Wipe off the excess oil and products of corrosion. Gently tap the end of the plunger with a wooden mallet or other nonsparking tool until the plunger moves freely. If the plunger remains bound or is bent, reject the motor. If the plunger moves freely, apply a thin coat of bearing grease (MIL-G-16908, or equivalent) to the plunger shaft adjacent to the bearing.
