# **CRASH INJURY EVALUATION**

## **DYNAMIC TEST OF A COMMERCIAL-TYPE PASSENGER SEAT INSTALLATION IN AN H-21 HELICOPTER**

**One of a Series of Reports  
Pertaining to the Dynamic Crash Test of a U. S. Army H-21 Helicopter**

TRECOM Technical Report 63-24

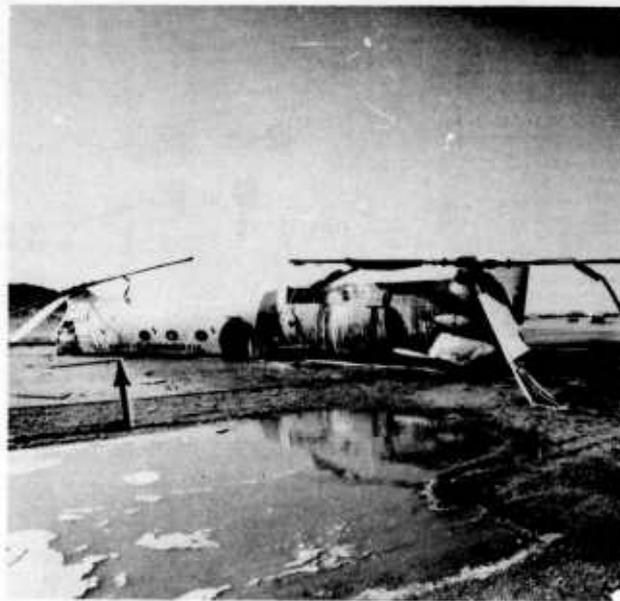
Figure 7. View of H-21 Test Vehicle, Postcrash. The general location of the commercial passenger seat is shown by arrow.

The entire lower structure of the forward fuselage section, including fuselage skin, floor support structure, and lower section of body frames, was crushed by impact of the helicopter on the runway. The left side of this lower structure was crushed more severely than the right side, due to impact with approximately 4 degrees left roll. Interior views showing the extent of buckling of the floor panels throughout the cabin area are given in Figures 8 and 9.

Generally, the fuselage structure above the normal troop seat attachment points, approximately 17 inches above the floor line, remained intact on both sides of the aircraft, while structure below this line was crushed extensively.

Although this impact was sufficiently severe to cause irreparable damage to almost every component of the aircraft, the crash is classified as potentially survivable because the occupiable areas of the fuselage remained essentially intact.

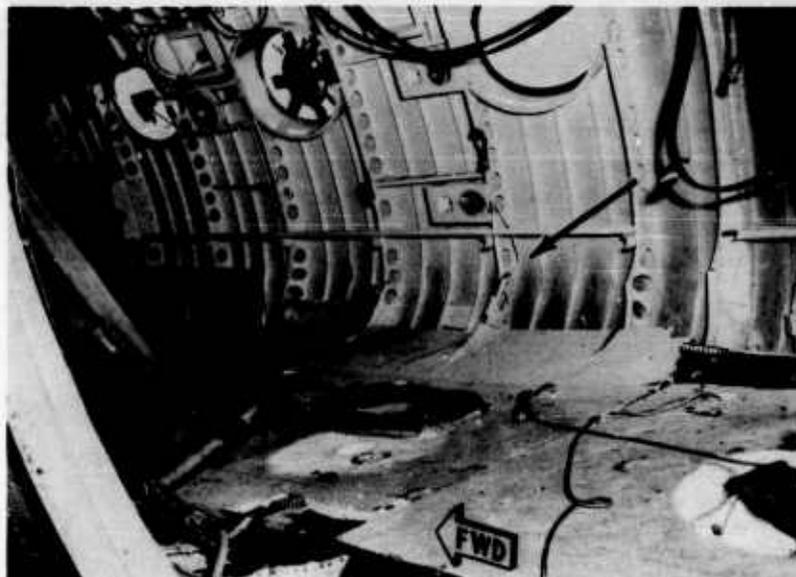
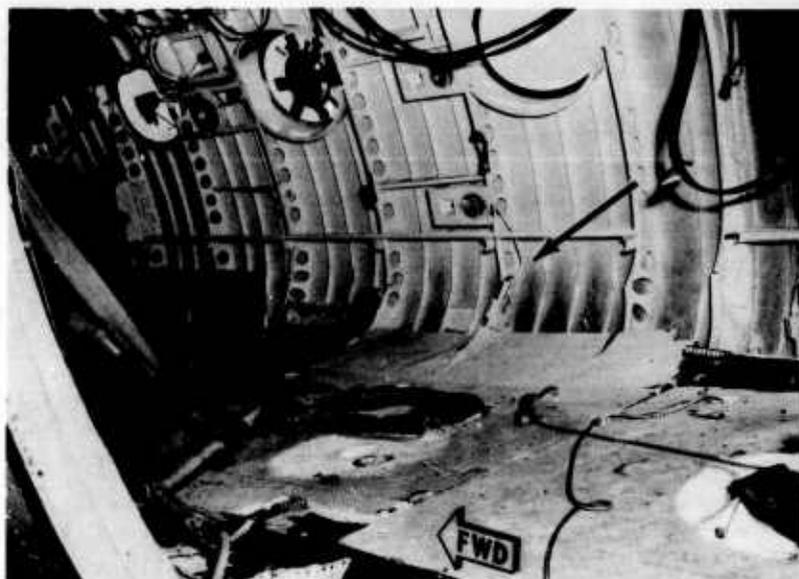
Figure 8. Passenger Compartment, Rear.  
Arrow shows the buckling of fuselage frames.

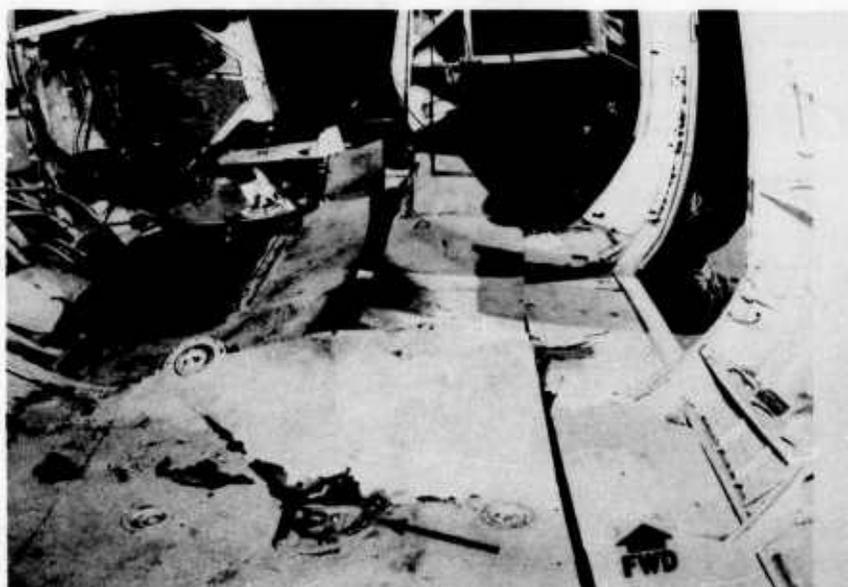
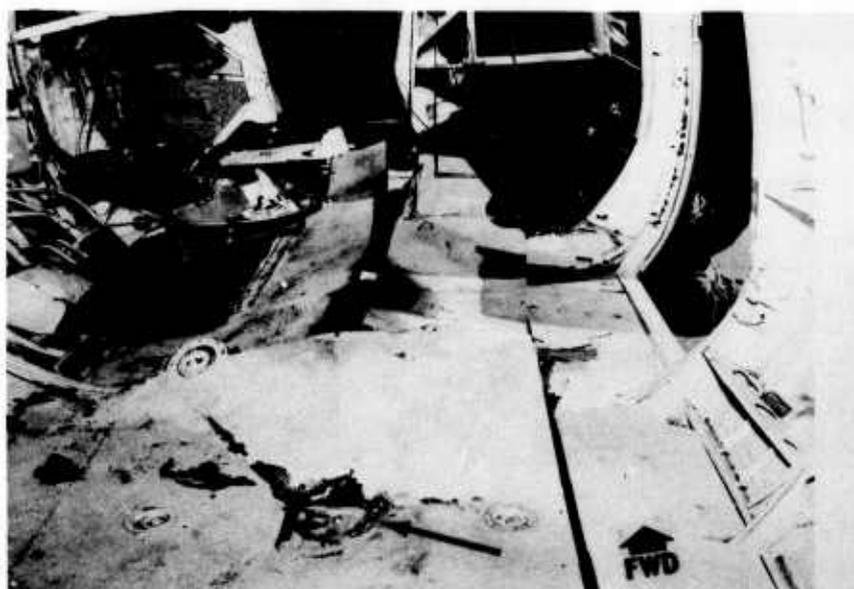
Figure 9. Passenger Compartment, Front, With Commercial  
Passenger Seat Removed.  
Arrow shows floor attachment plate for seat.

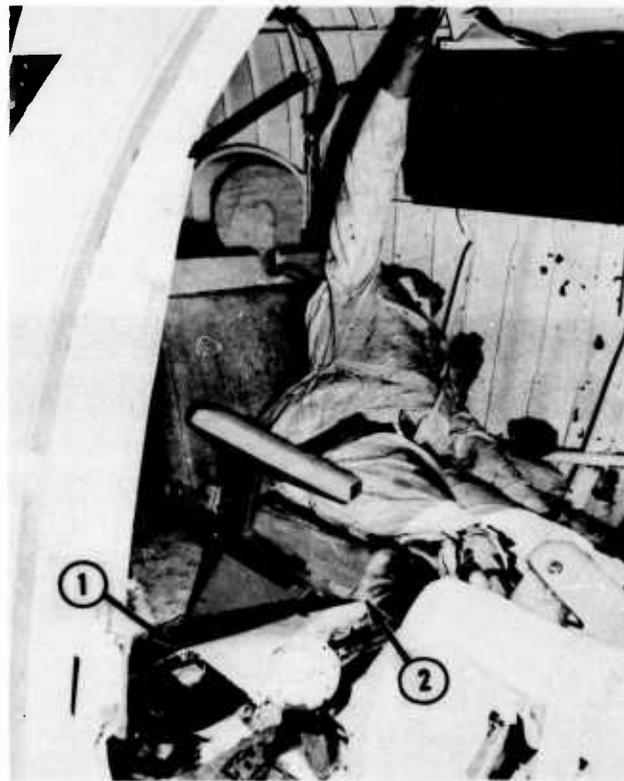
Figures 10 and 11 show postcrash views of the seat and dummy. The seat was basically intact; however, there was considerable deformation in most elements of the seat, as shown in Figure 11. Partial separation of several parts of the seat occurred, although no complete failures of any component of the seat were observed.

Figure 10. Postcrash View of Commercial Passenger Seat and Dummy.

Arrow 1 shows floor and supporting structure upset in front of seat by nose wheel and nose gear. Arrow 2 shows contact of seat with buckled floor structure.

It is possible, and even probable, that the contact of seat and floor structure as seen in Figures 10 and 11 may have provided some longitudinal support to the seat, yet the performance of the seat must be considered as excellent in view of the existing specifications to which the seat is designed.

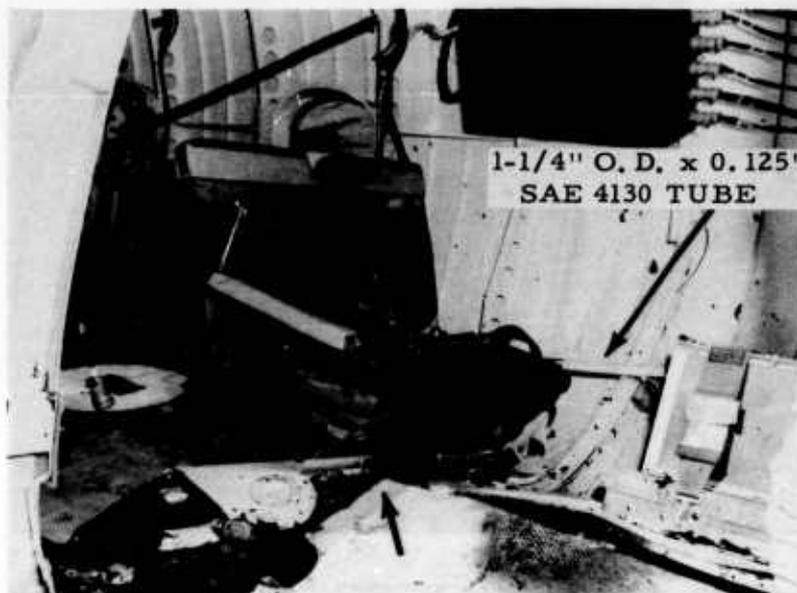
Figure 11. Postcrash View of Commercial Passenger Seat,  
With Dummy and Sandbags Removed.  
Arrow shows contact of forward edge of seat with buckled  
floor structure.

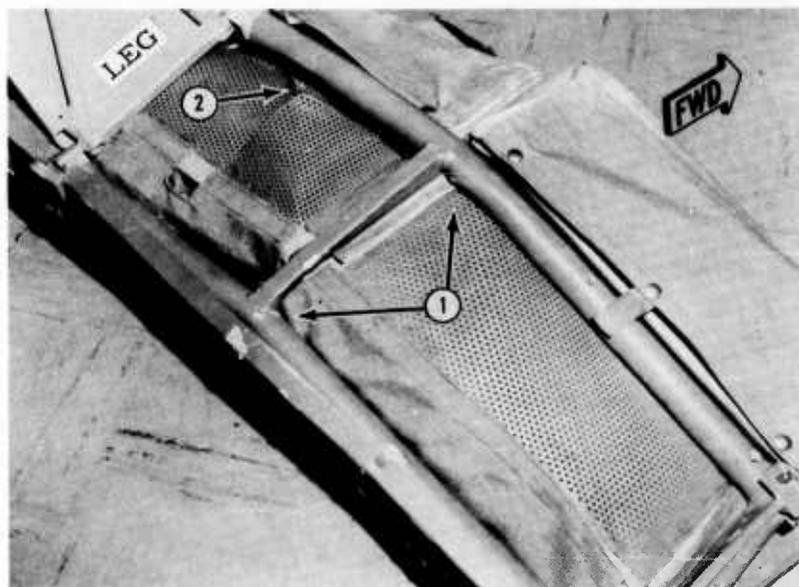
Figure 12. Bottom Structure of Seat, Postcrash.

Figure 12 shows a postcrash view of the bottom of the seat, illustrating the deformation in the main structure. There was a fracture of the rear tube at the wall end.

Both the front and the rear tubes were bent at the center (arrow 1). In addition, the front tube was further bent near the leg of the seat. This bend occurred directly beneath the dummy. Note that the seat pan is fractured in the same area (arrow 2). The front tube has a larger permanent vertical deflection than the rear tube, as would be expected in accidents having forward and downward velocity components at primary impact; i. e., the forward tube can be expected to carry a major portion of the vertical inertia load.

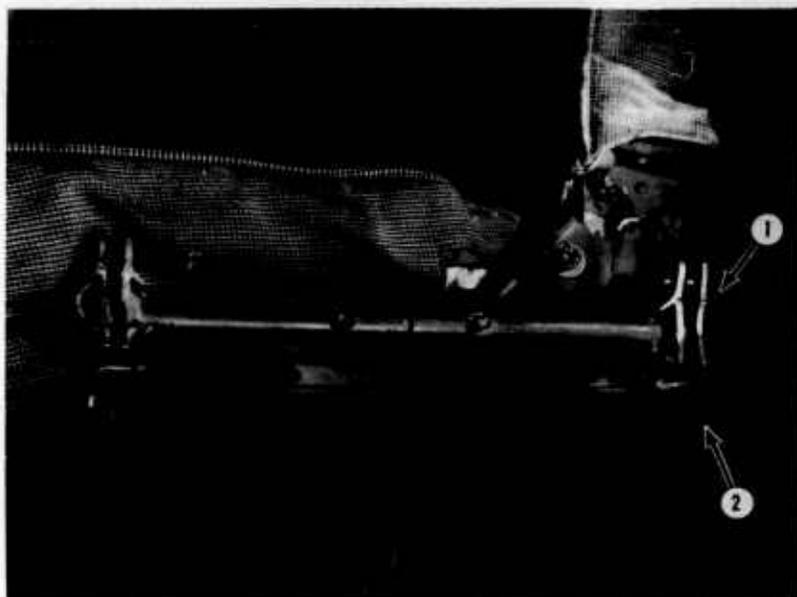
Figure 13. Wall Attachment, End of Seat, Postcrash.

Figure 13 shows the condition of the wall attachment portion of the seat. Arrow 1 shows the fracture of the rear tube. The bent flange (arrow 2) was a support for a locking bar used in folding the seat. This bar was removed prior to the test to allow modification of the test seat (an early model) to conform strengthwise to the proposed

service model. The 4130 tube to which the seat was attached at the wall of the aircraft remained in place, with slight (5 degrees or less) bends in the vertical and horizontal planes containing the axis of the bar.

It should be recalled that the wall support of this seat was quite rugged (1/8-inch wall x 1.25-inch O. D. SAE 4130 tube), yet it was permanently deformed with approximately 5 degrees of bend in each of two planes. Failure of the normal H-21 aluminum support would have undoubtedly occurred as has been shown by previous experience with troop seats.\*

1. The folding leg of the commercial passenger seat be redesigned to incorporate energy absorption capability to reduce peak vertical accelerations.
2. The attachment of the seat to the wall of service aircraft be capable of developing the full potential of the seat. The standard troop seat attachments in the H-21 are inadequate from this standpoint.
3. Additional restraints in the form of shoulder harnesses be installed.
4. Provision be made for reducing injury through contact of the lower extremities with the rear main beam of the seat in all installations involving tandem seating.

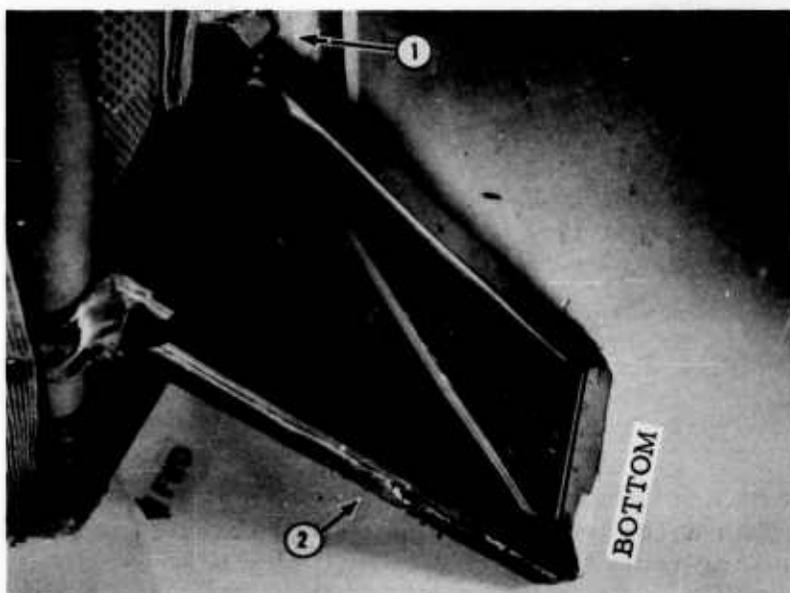
4. The aisle leg of the seat is quite rigid and may constitute a hazard to the occupant under high vertical decelerations due to its inability to deform or to absorb energy.

Figure 14 shows the folding leg of the commercial passenger seat. Arrow 1 shows the deformation and fracture of the aft leg fitting beneath the seat. Arrow 2 indicates the area of contact of the forward edge of the leg with the buckled floor panel. (See also Figures 9, 10, and 11.)

Figure 14. Folding Leg of Commercial Passenger Seat.  
Arrow 1 shows a partial failure of the fitting. Arrow  
2 shows region of contact of leg with buckled floor.

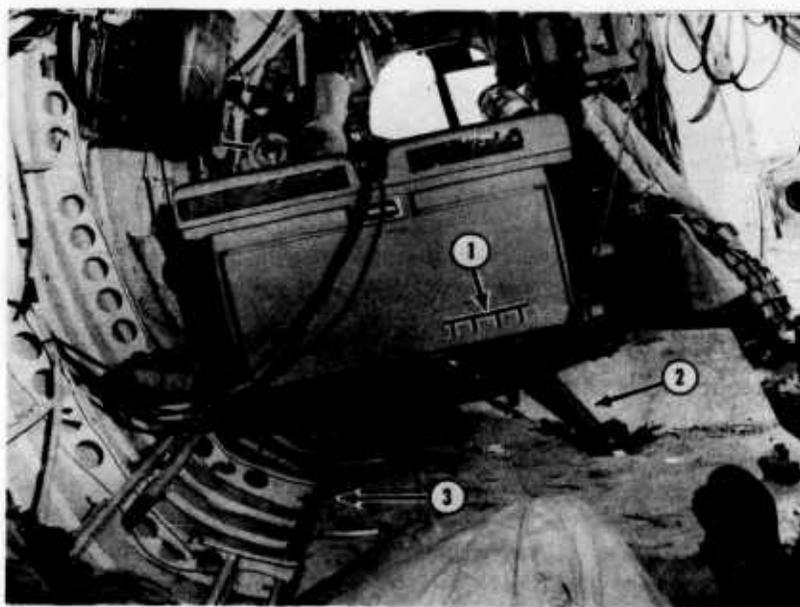
Figure 15. Rear View of Seat, Postcrash.

Figure 15 gives an overall rear view of the orientation and condition of the seat immediately after the crash. Arrow 1 shows the region of application of vertical inertia load due to the passenger in the aisle position. The position of the seat leg provides an almost direct load path to the floor. Thus, had the 200-pound dummy and the 120-pound sandbags been reversed in position, it is probable that a more extensive deformation of the forward main tubular structure would have resulted. Initially, the leg of this seat was vertical, as shown in Figures 2 and 3. The apparent rightward shifting of the floor attachment for the leg at arrow 2 in Figure 15 was actually due to the displacement of the left wall of the aircraft to the left with respect to the centerline of the floor. This movement was due to extensive buckling of the fuselage frames along the entire left side of the cabin, as shown at arrow 3.

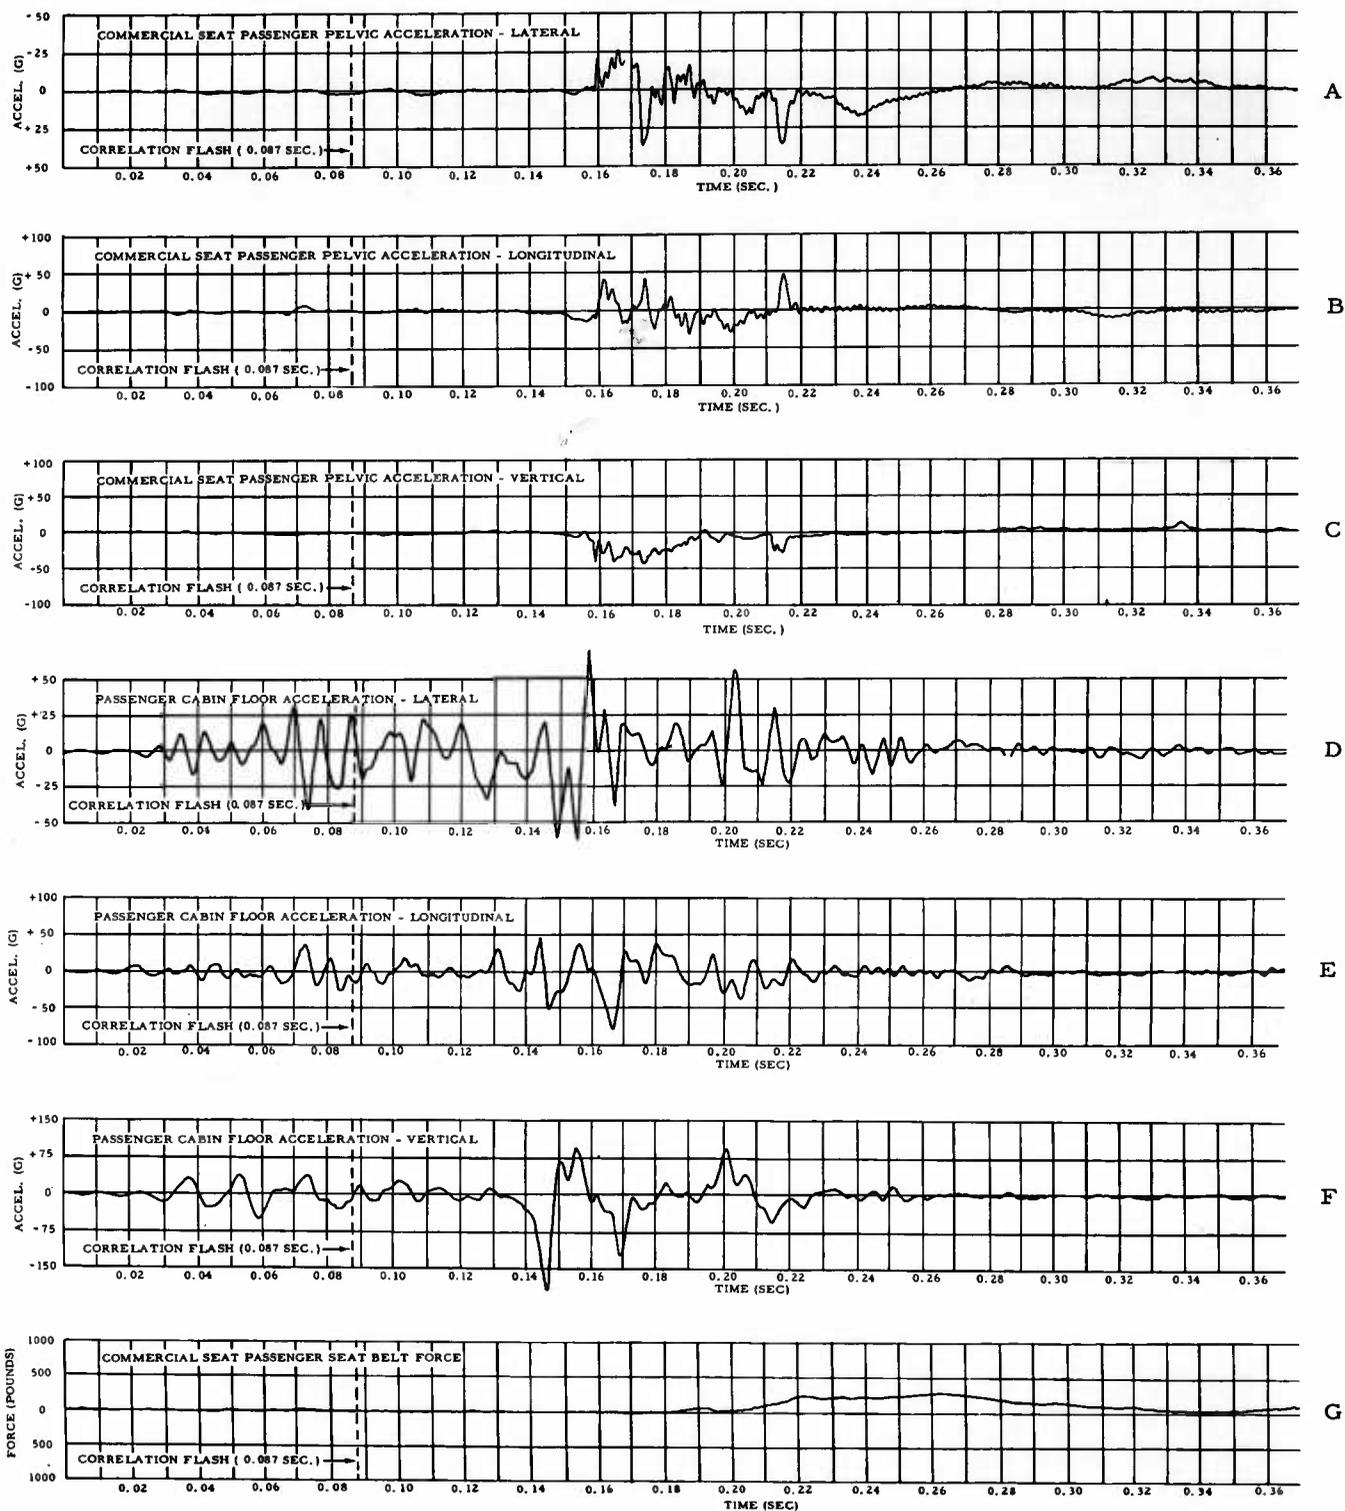
Figure 16. Accelerometer-Time and Force-Time Histories.

The accelerometer traces applicable to analysis of the commercial passenger seat described in this report are presented in Figure 16, including (a) the records of lateral, longitudinal, and vertical acceleration in both the pelvic region of the dummy and at the passenger cabin floor level and (b) the passenger seat belt force. In these records, time zero corresponds to first contact of the aircraft as noted on Figure 16C. The primary seat deformation and the buckling of the floor reached maximums at about 0.215 second.

The seat belt loads, Figure 16G, did not exceed 300 pounds. This is in agreement with results obtained in other tests\*\*in which the longitudinal deceleration occurs only in conjunction with a simultaneous and relatively large vertical deceleration.

Figures 16A, B, and C show the acceleration environment in the crash as recorded by three accelerometers mounted in the dummy pelvic region. It should be noted that the acceleration in a given direction (vertical, lateral, or longitudinal) refers to the direction measured with respect to the dummy pelvis, not to the airframe on the ground. Considerable movement of the dummy (including flailing of arms and legs) occurred with respect to the airframe, and thus the "vertical" alignment of the vertical accelerometer at impact was not maintained during the progress of even the primary pulse. Figure 17 has been presented for the convenience of the reader in visualizing this motion of the dummy. Such displacements gave rise to interactions between the lateral, vertical, and longitudinal inputs as picked up by the respective accelerometers.

Reference to Figure 16C shows that the primary "vertical" acceleration in the dummy occurred in the interval from 0.14 second to 0.22 second immediately following the impact of the fuselage proper with the runway.

The acceleration pulse occurring at 0.215 second and recorded on all three accelerometers was probably associated with the contact of the seat with the buckled floor structure as shown in Figures 10, 11, and 14. Although no definite proof of this fact exists at this time, it is reasonably certain as observed in the high-speed films. Sign conventions are in accordance with those recommended by C. F. Gell, M. D., D. Sc., in December 1961, Issue of Aerospace Medicine, Vol. 32, No. 12, i. e., Eyeballs Right (lateral), Eyeballs In (horizontal), and Eyeballs Down (vertical).
