ROCKETDYNE

R-5316

FINAL REPORT, DEVELOPMENT OF DOWNRATED
ATLAS YLR101-NA-15 VERNIER ENGINE

Contract AF04(695)-306

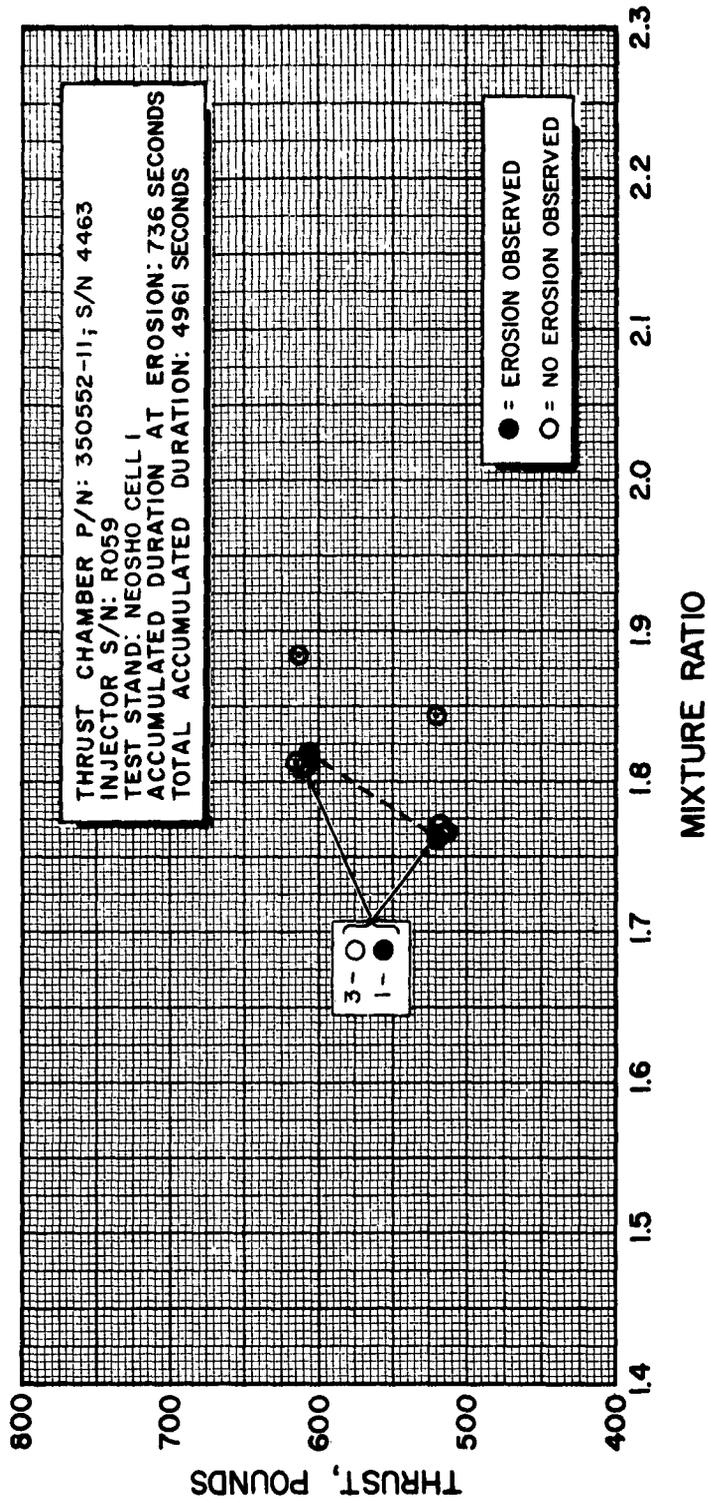
Figure 11. Operating Regime of Standard Injector P/N 350604 Tested With Engine S/N 0003-5

The erosion spots (Fig. 11) apparently were caused by LOX fans that impinged on the chamber wall. This problem had previously occurred at thrust levels from 830 to 1000 pounds, and was eliminated during development of the P/N 350604 injector by adding 12 fuel showerhead holes around the periphery of the injector. This formed a fuel screen between the LOX fans and the chamber wall. At thrust levels between 525 and 600 pounds, the velocity of the fuel through the injector was reduced by more than half. A subsequent loss in fuel screen momentum also occurred, and apparently allowed the LOX fans to break through to the wall, resulting in hot spots similar to those experienced prior to the last injector modification.

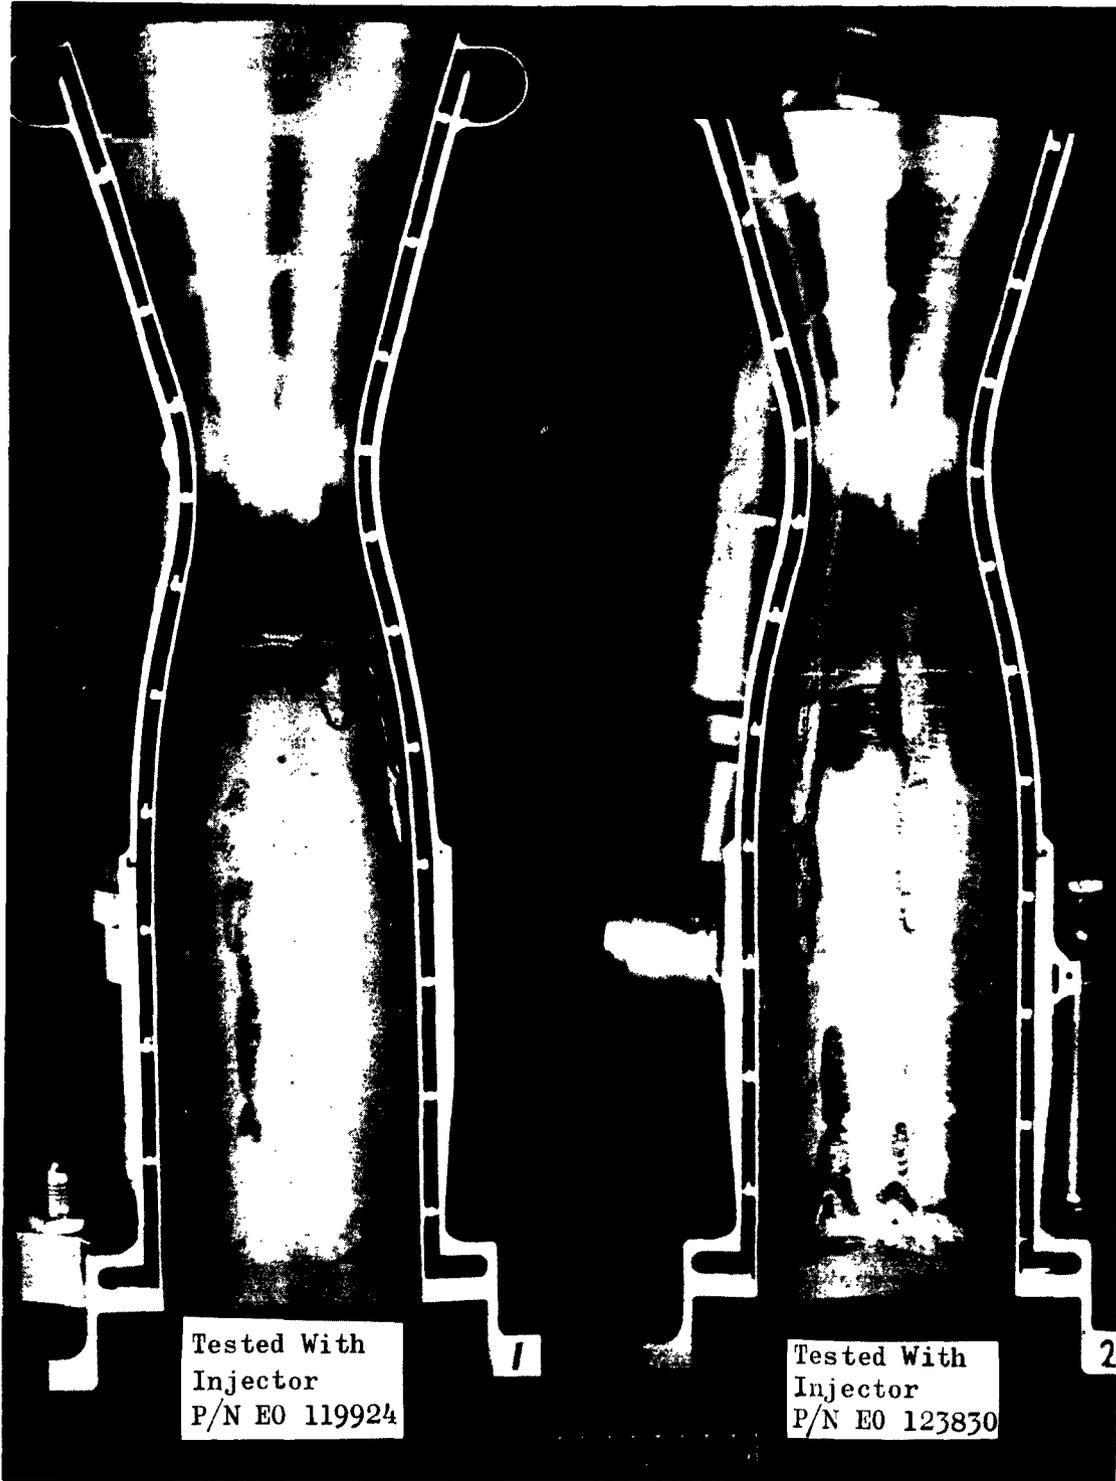
Figure 26. Sectioned Vernier Engine Showing Thrust Chamber Erosion Resulting After Tests With Injectors P/N EO 119924 and P/N EO 123830

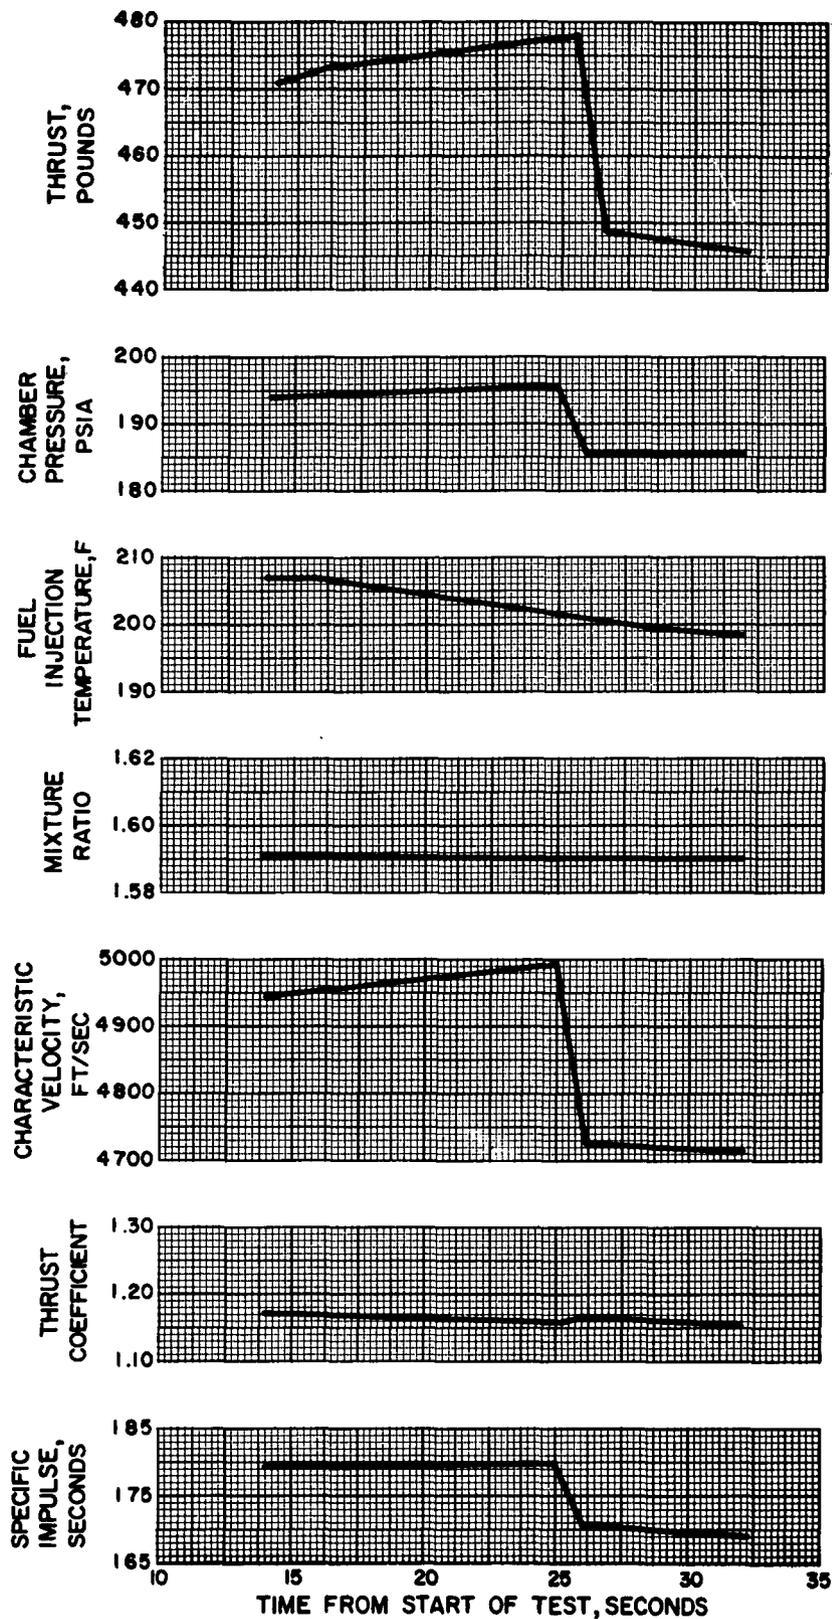
Figure 50. Engine S/N 3401 Performance Shift Caused by Buzzing During Run No. 8954 Using Injector P/N E0 123829, S/N 6320891

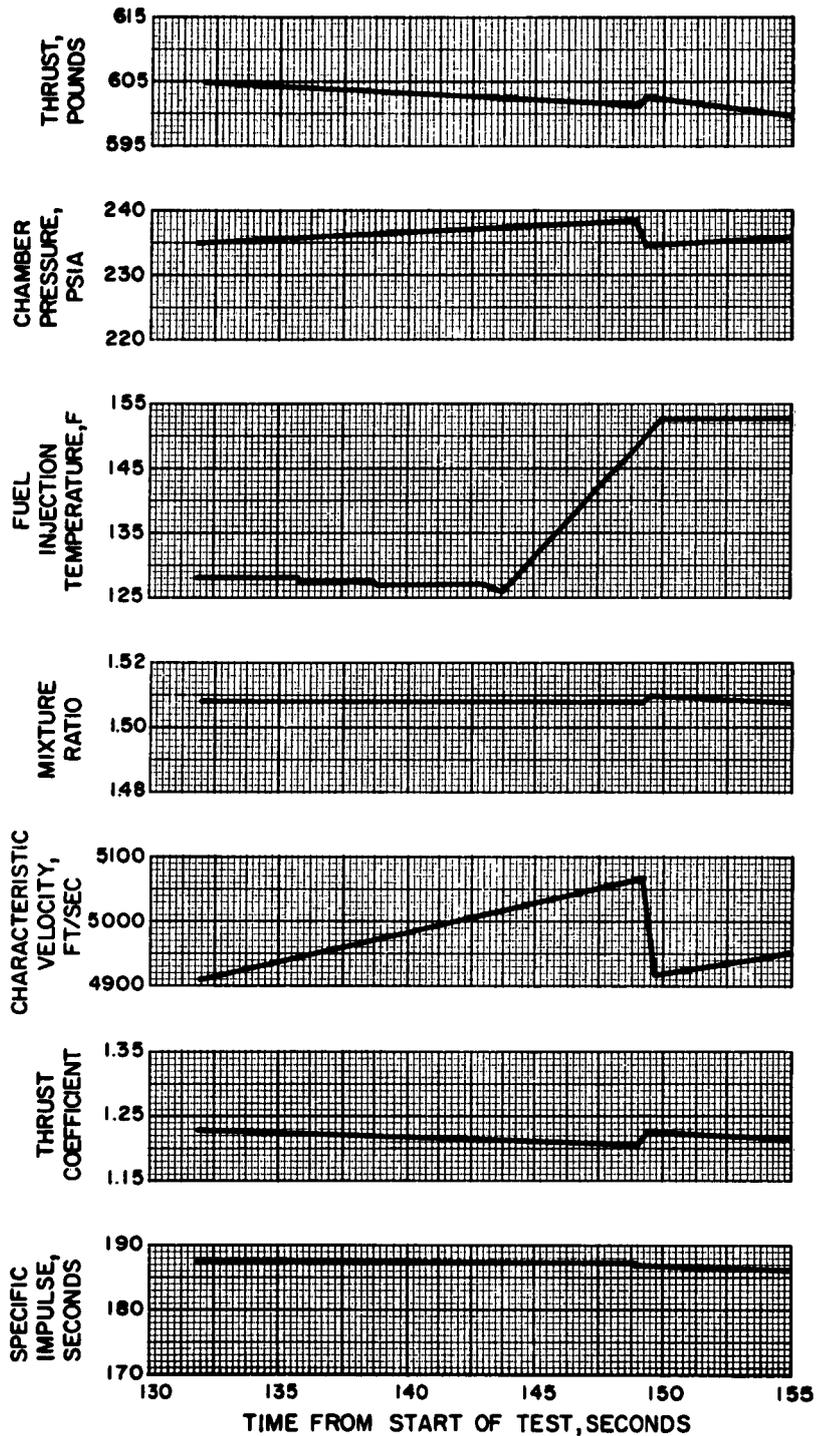
Figure 51. Engine 3402 Performance Shift Caused by Carbon Buildup in Thrust Chamber Throat During Run No. 8987 Using Splash-Plate Injector S/N 6321992

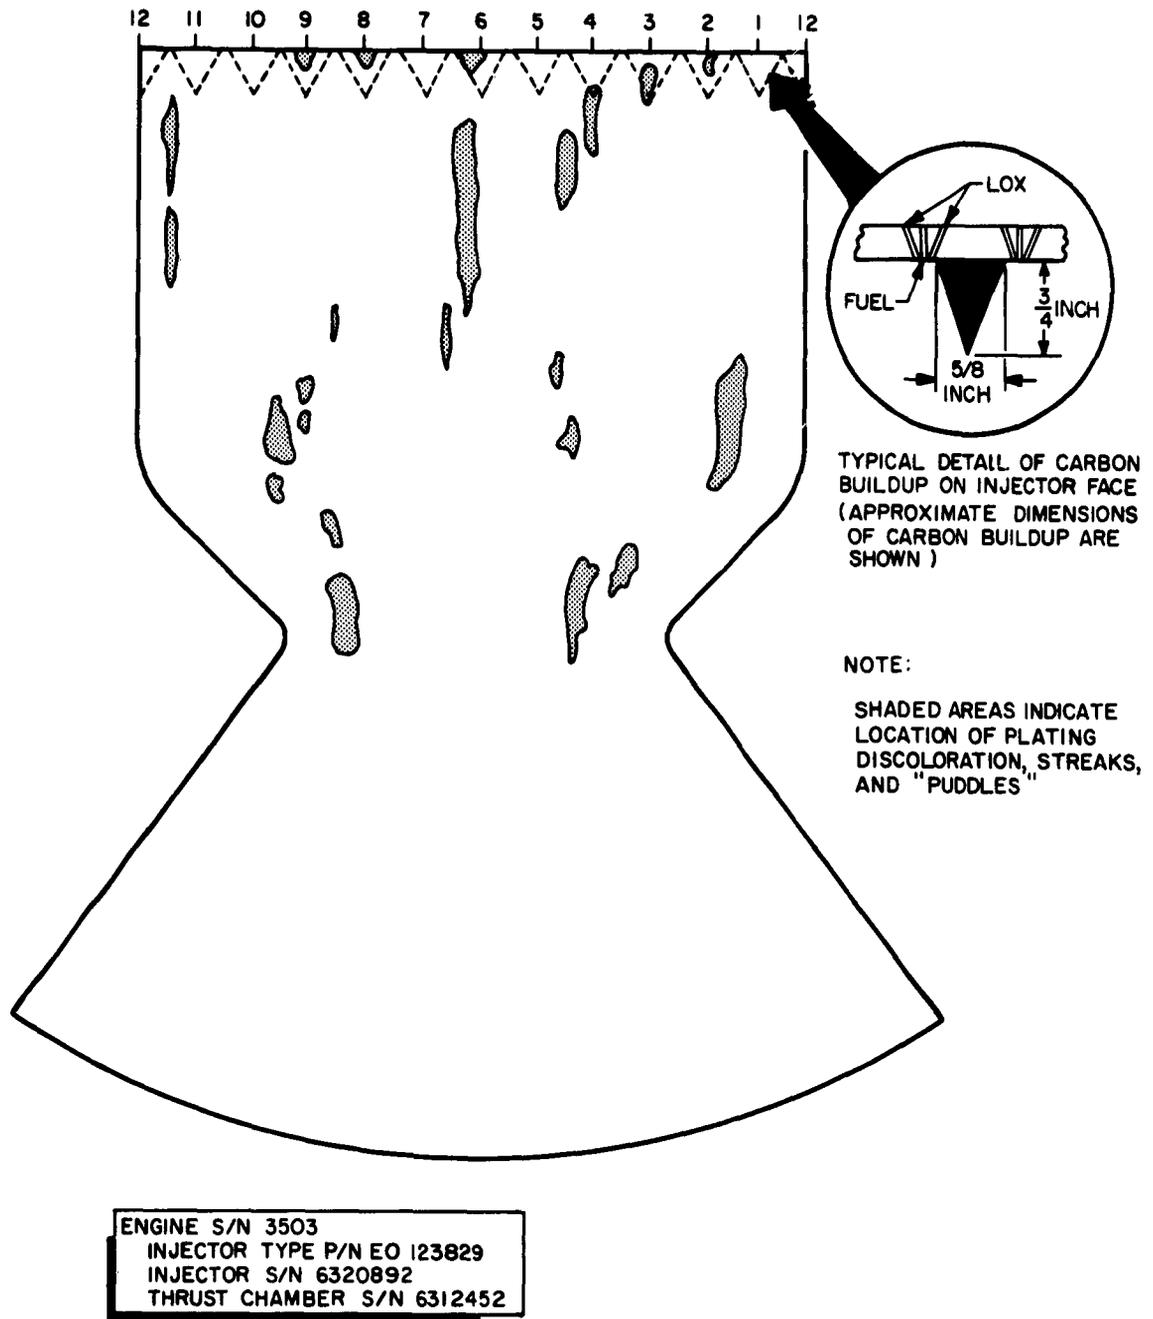
Although the wall of the first thrust chamber tested (engine S/N 3401) was only lightly coated with carbon, erosion was not detected until the thrust chamber was removed and cleaned. A subsequent test of the eroded area using an acid solution of copper sulphate showed that the erosion was into the parent metal. This solution turns exposed parent metal (type 4130 steel) to a copper color. As testing progressed, various means of detecting plating streaks and erosions were employed. These included wiping the carbon from the thrust chamber after every test, removing the injector periodically, and using the copper sulphate solution to check the spots that might be into the parent metal.

Figure 54. Typical Vernier Engine Thrust Chamber Inner Wall Following Testing
