Report 63-136

**AN ACCIDENTAL EXPLOSION  
INVOLVING THE USE OF OXYGEN  
DIFLUORIDE**

Contract AF33(657)-9162  
Project No. 62-2899-7381, Task No. 783103  
November 1963

**ASTROPOWER, INC.**

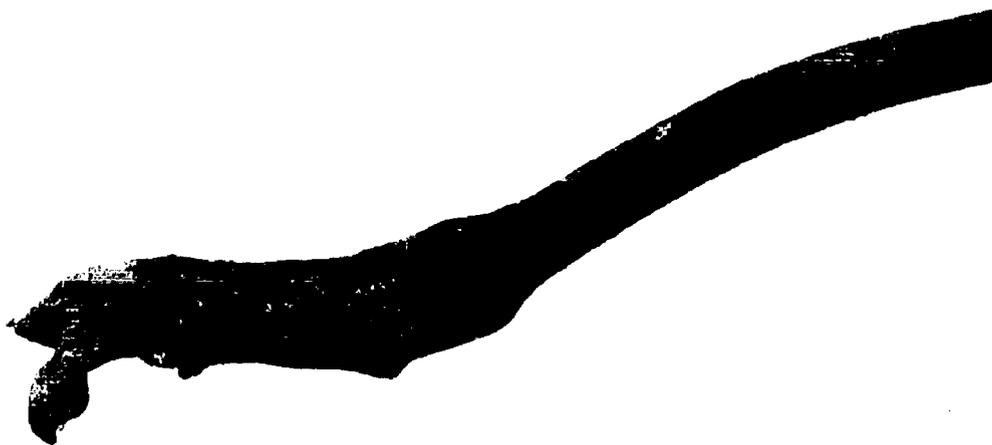
The possibility of shock wave or detonation propagation through 1/8 in. tubing connecting the test bombs appears unlikely, as evidenced in the appearance of connecting tubes and the manner in which they were plumbed. It is extremely difficult to propagate a shock or detonation wave through such small diameter tubing because of the pronounced boundary layer effects and large heat waves to the tubing wall. In only one instance did a piece of tubing show a "banana peel" failure, indicating the passage of a shock or detonation. In this case, heat discoloration in the fracture area indicated either a detonation or the presence of hot combustion gases forced into the tube from the bursting bomb (see Figure 8).

Figure 8. Stainless Steel Tubing Showing "Banana Peel" Failure

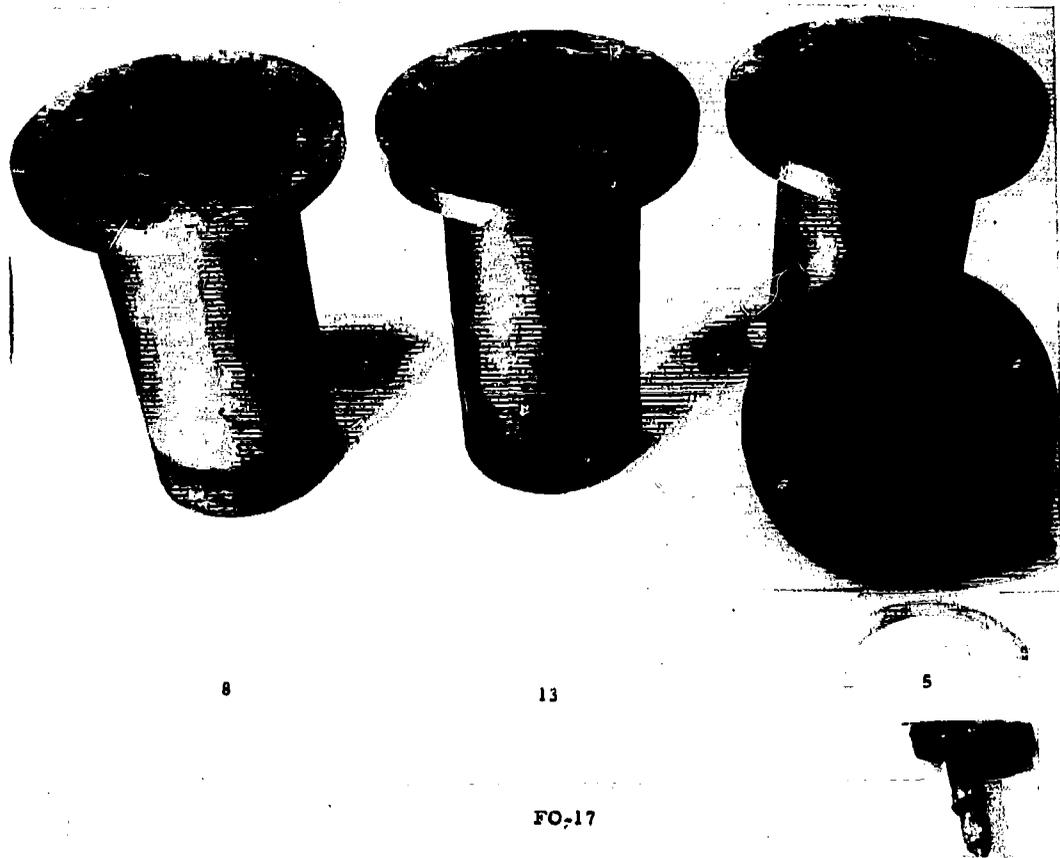
The appearance of the six test bombs and bomb lids is shown in Figures 9 and 10. The bombs were not distorted appreciably, but the lids were cupped 0.010 to 0.020 in. Lid No. 1 was distorted 0.090-0.095 in. on the arc. The bolts were tension sheared and strewn over a wide area. All three bombs from Test FO-17 showed severe erosion in the area of the gasket sealing surfaces between the main body and the lid. Erosion was also noted on the bolt flange. Only one bomb (No. 1) from Test FO-10 showed any erosion. The lid from bomb No. 3 showed rapid separation with slight erosion.

The erosion of the bombs was associated with the outrush of gaseous  $\text{OF}_2$  at high temperature. It is inferred that the pressure inside the bomb increased rapidly due to some exothermic reaction. The observations previously made with uncooled flame deflectors by Mr. Pickford<sup>(4)</sup> appear to indicate that the type of erosion in such a short duration, as noted above, would indicate temperatures well in excess of 6000°F. The heat transfer coefficient for expanding gases in general shows a marked increase at Mach 1, and the kinetic forces exerted against the metal surface have a marked peak in the range of Mach 1 to 1.5. This range of sonic flow would take place near the gasket surfaces and both flanges, causing erosion to occur in these areas.

Figure 9. Photomicrograph Showing Appearance of Bombs from Test FO-17. Two of the lids were not found.

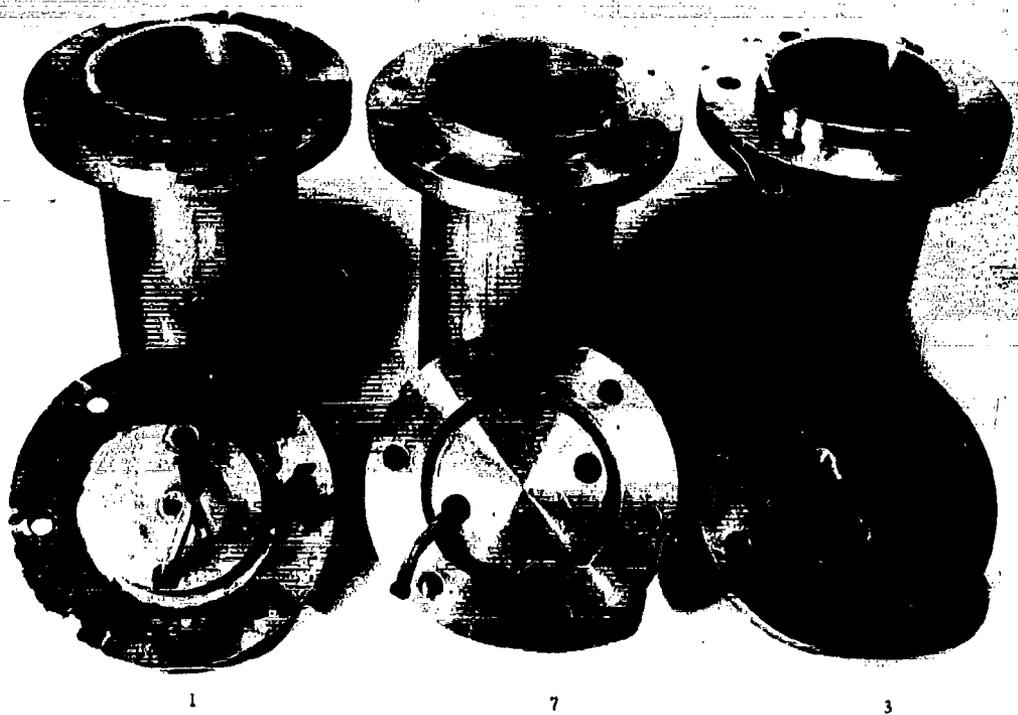
Figure 10. Photomicrograph Showing Appearance of Bombs from Test FO-10

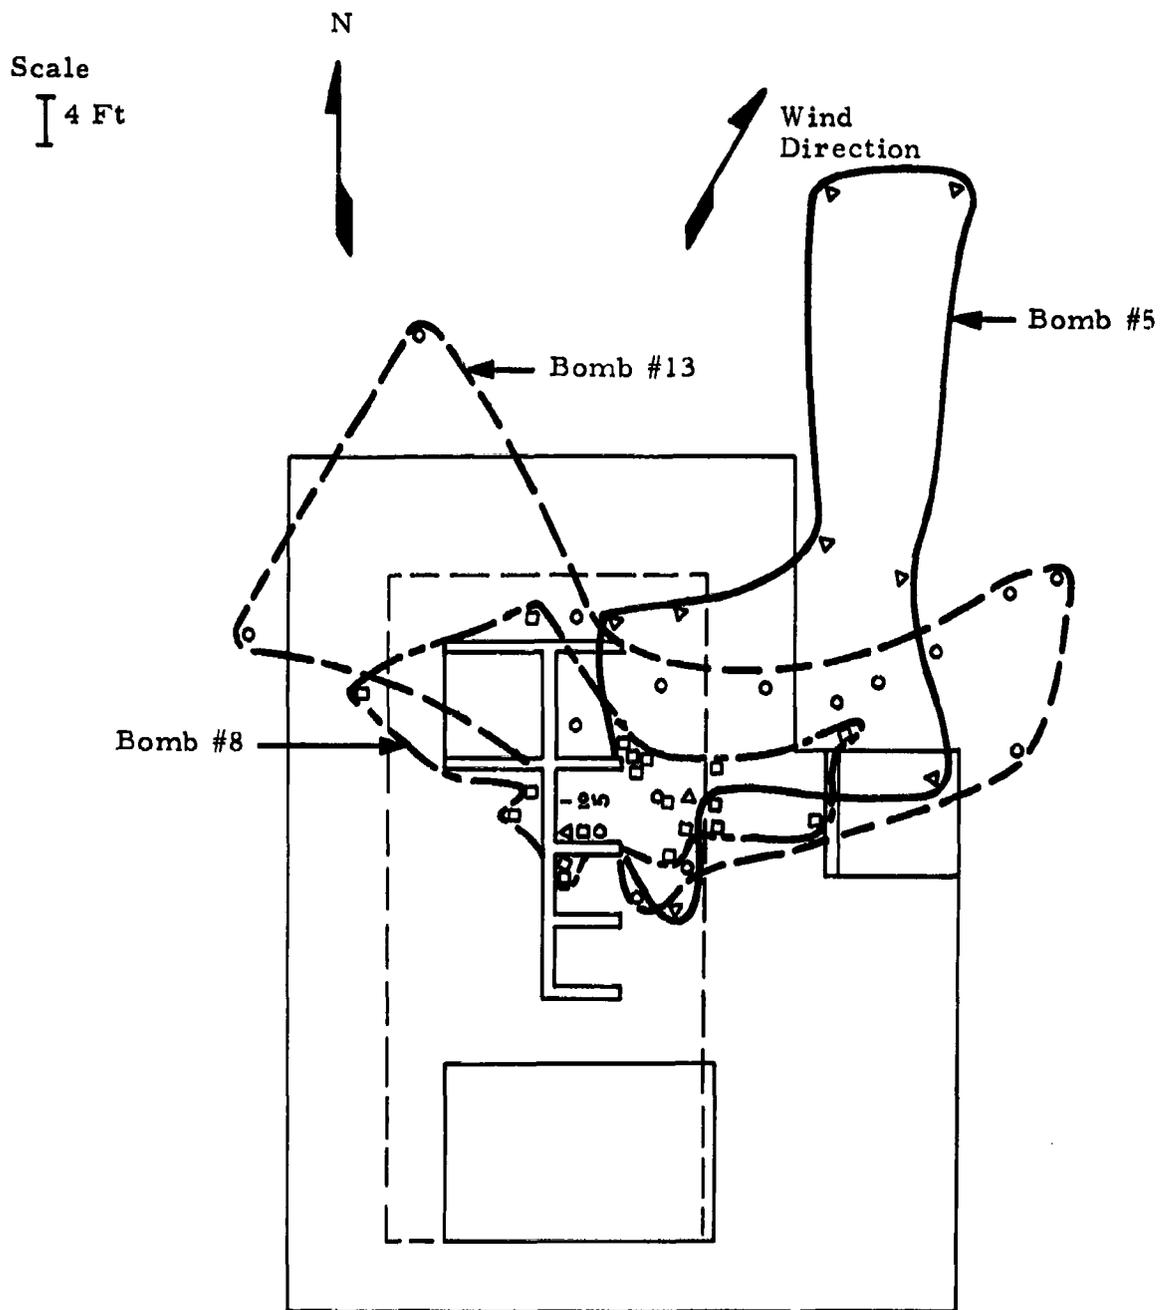
An evaluation was made of the scattering of test specimens and bomb parts, and of the appearance of specimens recovered, in order to clarify the manner in which the explosion occurred and determine its intensity (see Figures 11 and 12, and Tables I and II). Lid No. 5 of Test FO-17 was found 7 ft east of the bay; the other two lids were blown out through the roof to a considerable distance from the facility and could not be found. Lid No. 3 of Test FO-10 was found on the roof, and lids No. 1 and No. 7 were in the bay.

The test specimens from bomb No. 5 (Test FO-17), which were basically Al alloy and Teflon, were found 10% in the bay and 90% scattered in the wind direction (see Figure 11). The Teflon showed reaction and considerable deterioration. Some Al-5456 and Al-6061 specimens showed considerable distortion of a mechanical nature; other specimens from the same alloys (D, F) were reasonably straight (Figure 13).

Figure 11. Scattering Pattern of Specimens from Test FO-17

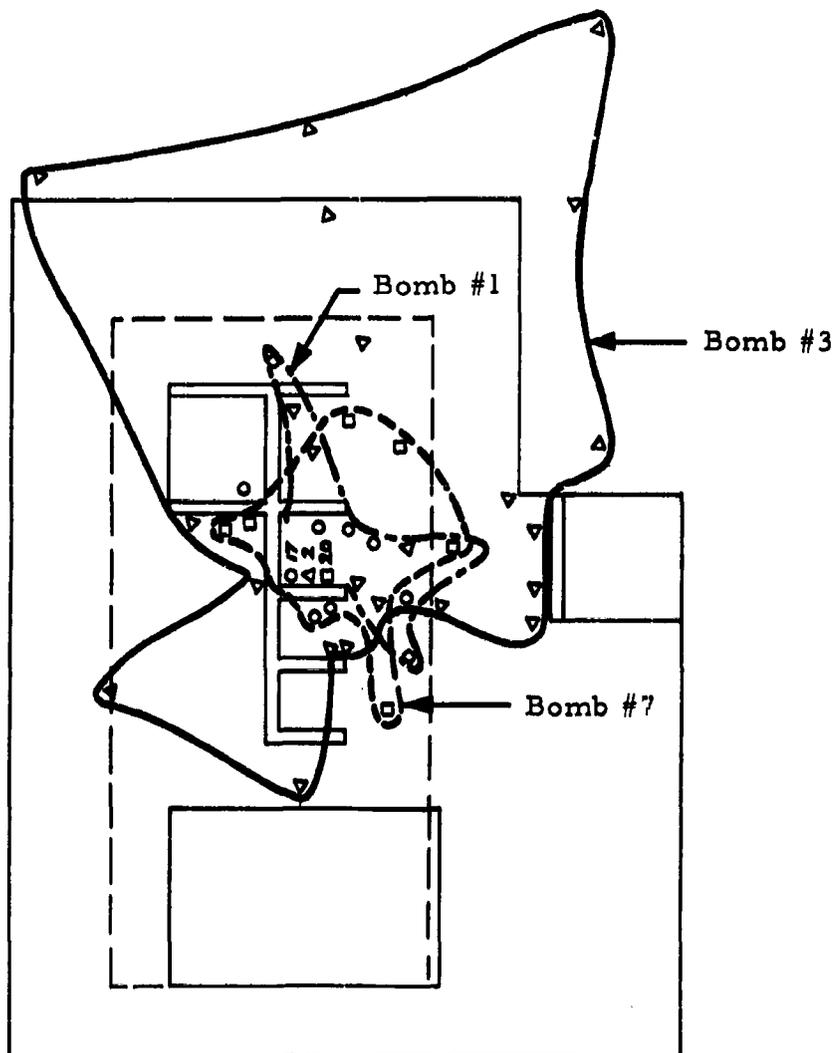
The scattering of specimens from Test FO-10 is shown in Figure 12, and the appearance of test specimens from three bombs in Figures 16 to 18. The scattering of aluminum alloy samples from bomb No. 3 was very extensive. Al-1100 samples showed excessive mechanical damage, particularly in the gas phase. This bomb also contained columbium samples (Y) which exhibited severe distortion and heating on the edges.

Figure 12. Scattering Pattern of Specimens from Test FO-10

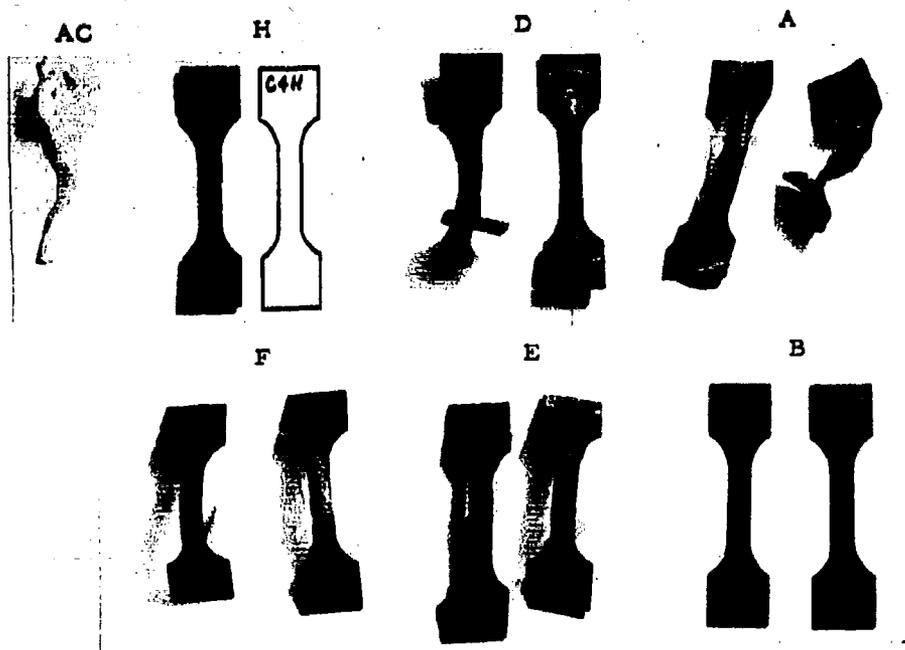
**FO-17 BOMB 5**

**Figure 13. Appearance of Specimens from Bomb No. 5, Test FO-17.  
All Specimens immersed in gaseous phase.**

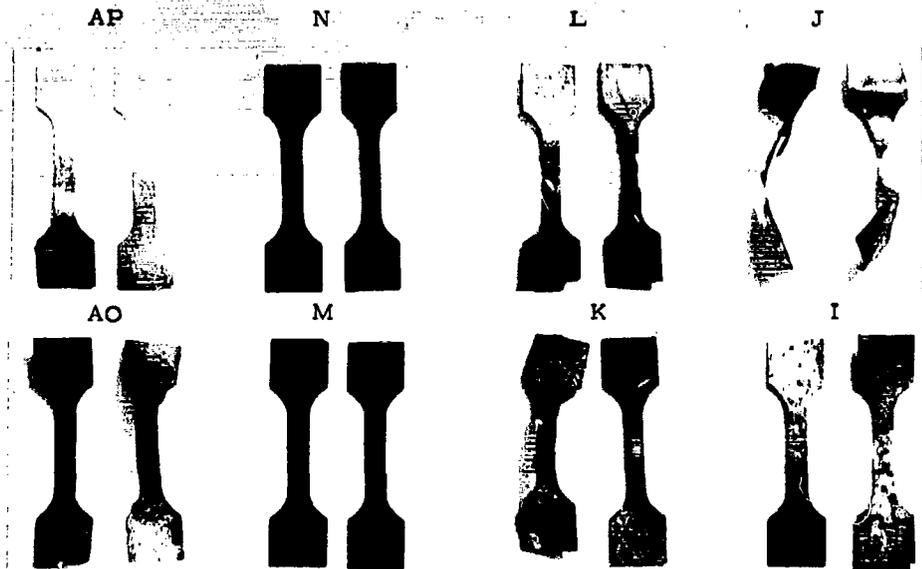
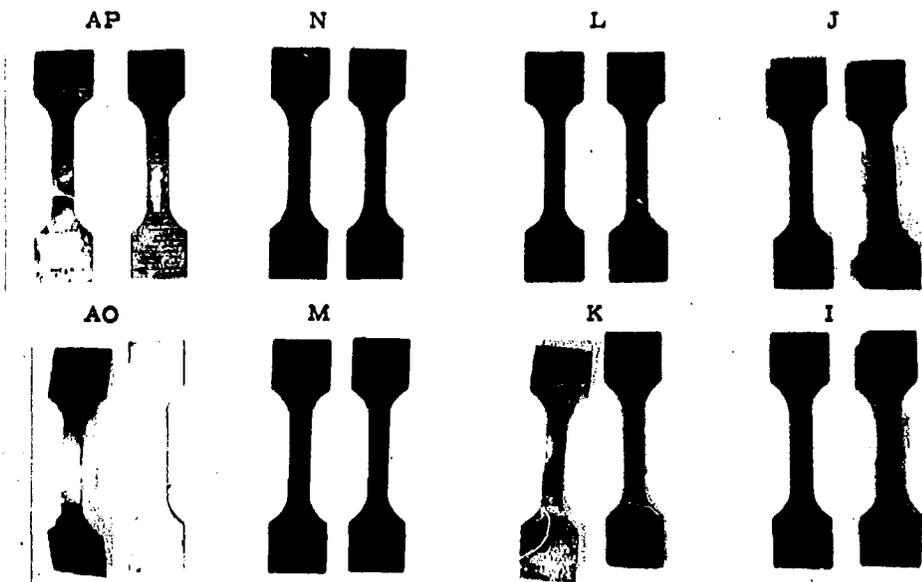
FO-17 BOMB 8

The test specimens from bomb No. 8 (Test FO-17), which were basically stainless steel, were recovered 31% in the bay and 69% at nearby locations. The specimens were reasonably unaffected, except those of stainless steel Type 316 (J), which showed mechanical distortion. The test specimens from bomb No. 13 (Test FO-17) were recovered 17% in the bay and 83% at considerable distances, the majority being found on the roof. The nickel-base alloy specimens did not show any damage. Titanium alloy Al10AT (T) exhibited self-sustained burning on the edges. Columbium and tantalum were badly distorted and exhibited excessive heating on the edge surfaces (Y, AA). Of the four specimens of graphite A, G, K, S, P, only three small pieces were recovered in the bay. They crumbled easily under pressure, as compared to the "as-received" specimens. X-ray diffraction analysis of the basal (0002) planes of "as-received" material had a  $2\theta$  angle of 26.30 radians (3.386 Å), and immersion test material had a  $2\theta$  angle of 26.40-26.42 radians (3.371-3.369 Å). The slight contraction of the d-spacings noted might be attributed to the formation of fluoride bonds in the basal planes.

Figure 14. Appearance of Specimens from Bomb No. 8, Test FO-17

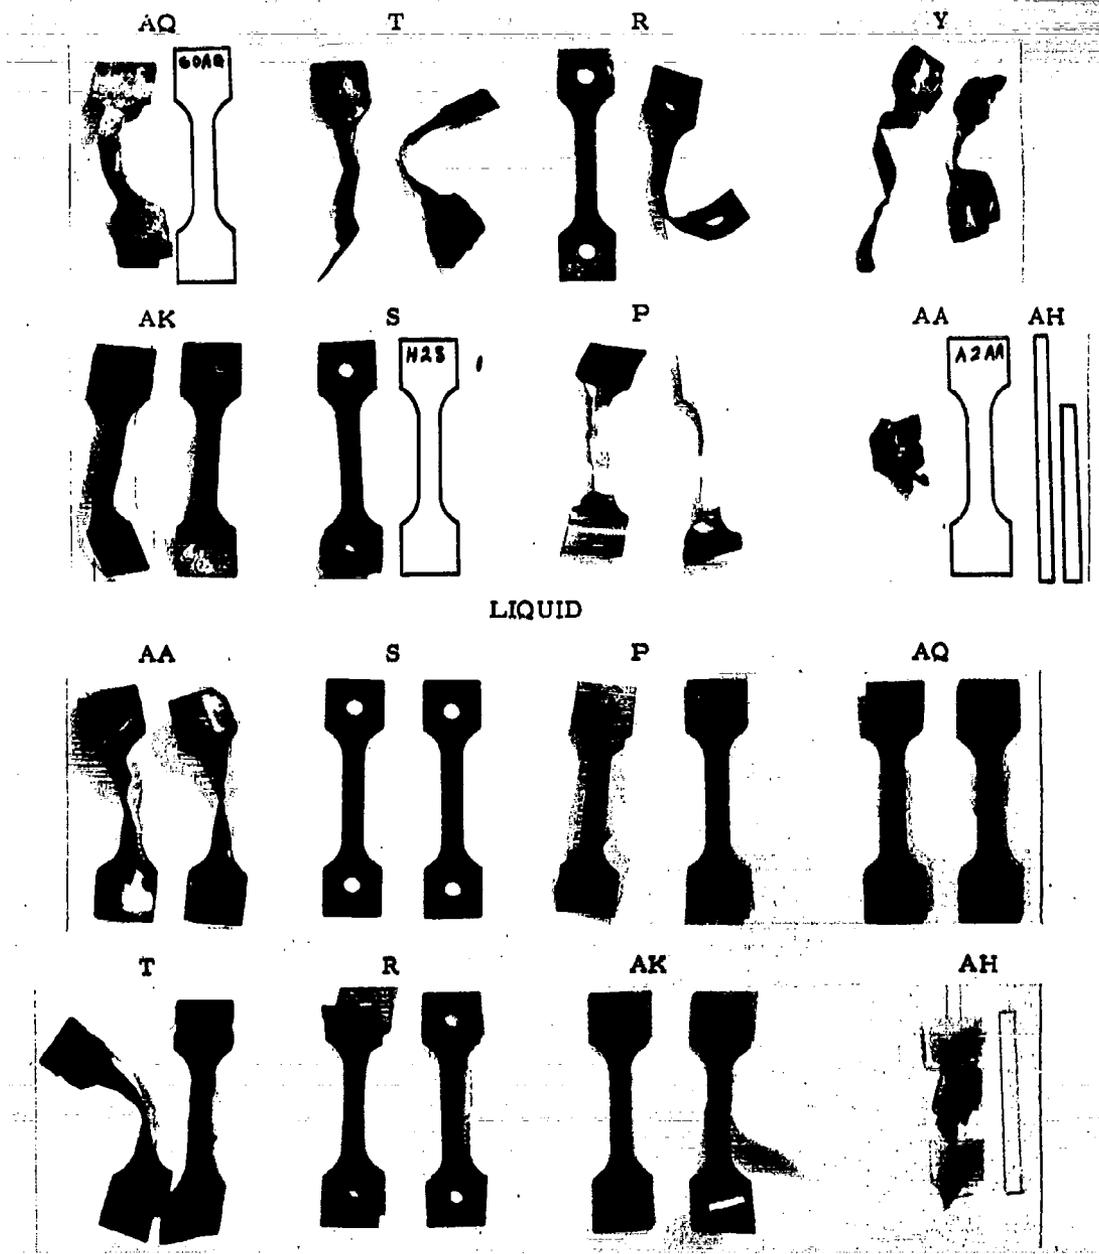
FO-17 BOMB 13

Figure 15. Appearance of Specimens from Bomb No. 13, Test FO-17

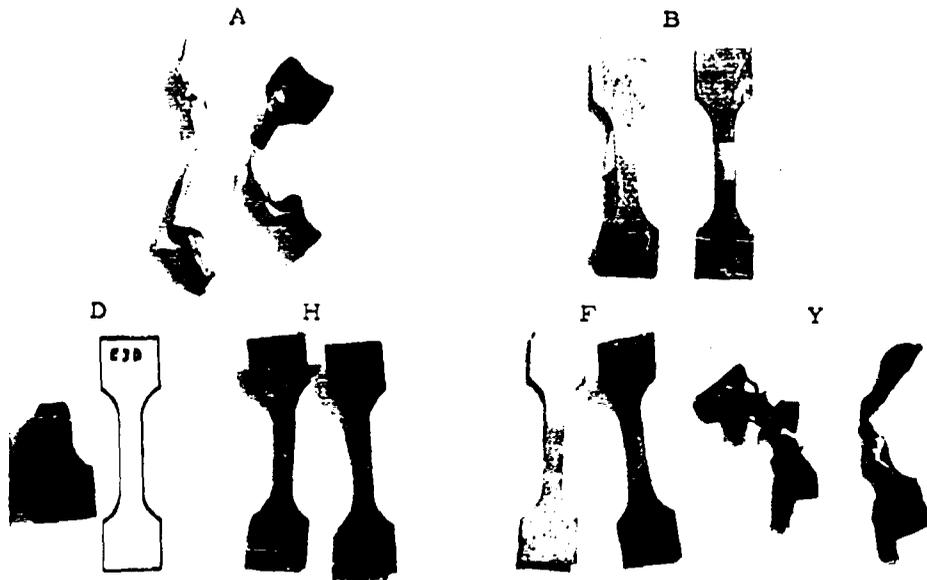
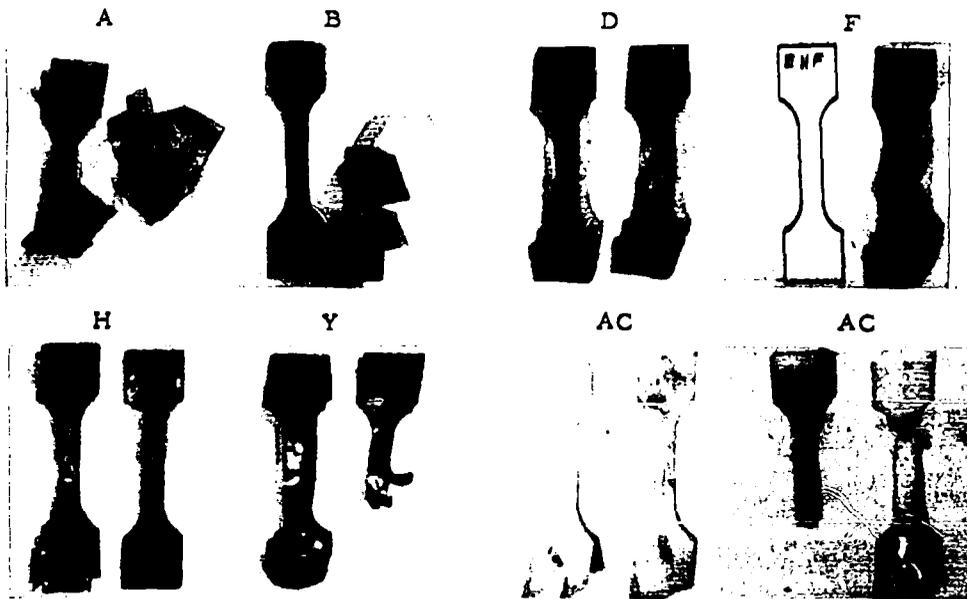
FO-10 BOMB 3

Figure 16. Appearance of Specimens from Bomb No. 3, Test FO-10

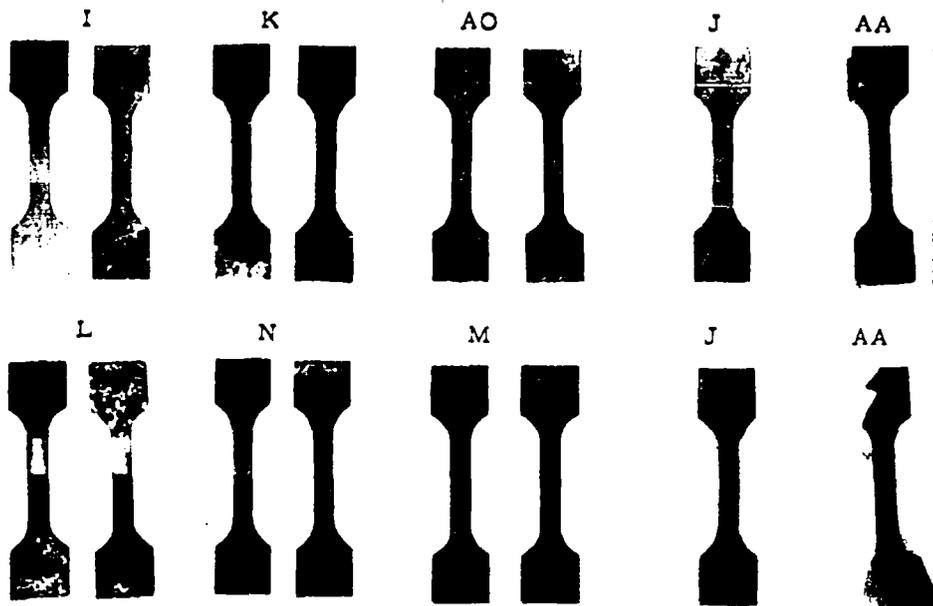
FO-10 BOMB 1

Most specimens from bomb No. 1 and bomb No. 7 were found in the bay; scattering was restricted to short distances. Stainless steel Type 410 specimens (AA, Figure 17) exhibited low temperature brittle fracture (by impact), which indicates that the specimen was cold when failure of the bomb occurred. Tantalum specimens (AA) in the gas phase exhibited excessive

Figure 17. Appearance of Specimens from Bomb No. 1, Test FO-10

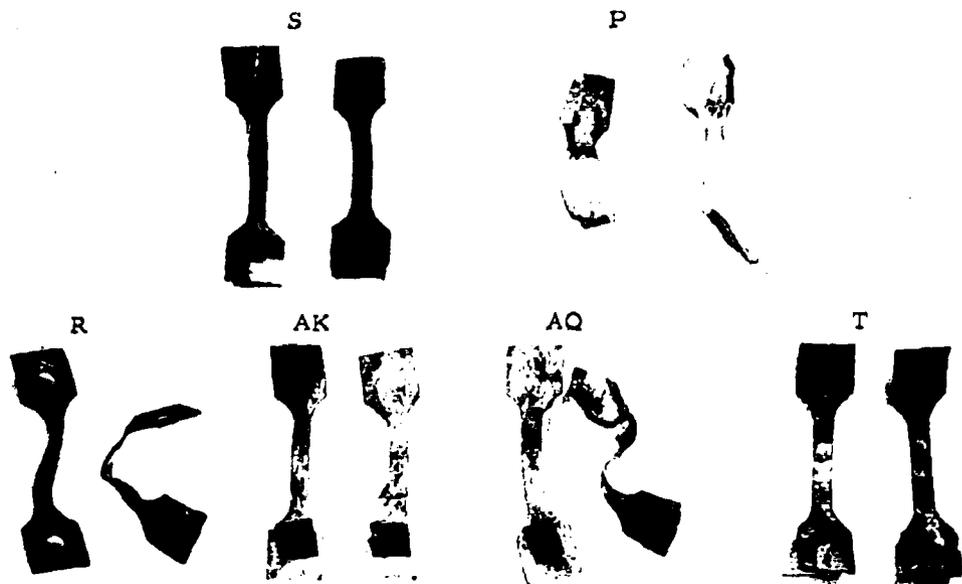
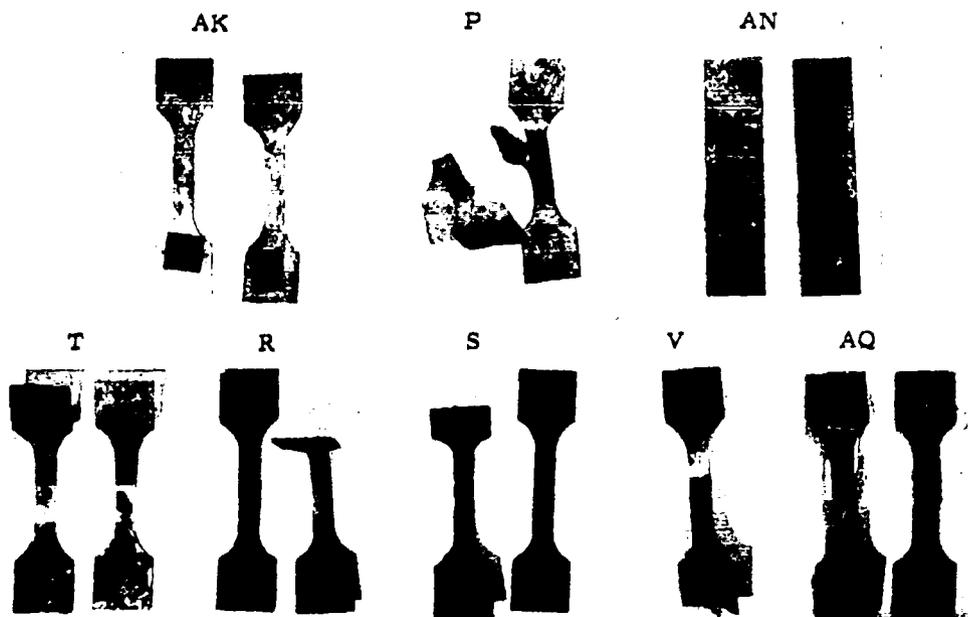
FO-10 BOMB 7

distortion and edge burning, but those in the liquid phase were not severely distorted. Titanium All0AT specimens exhibited sustained burning, particularly in the gas phase (T, Figure 18).

Figure 18. Appearance of Specimens from Bomb No. 7, Test FO-10

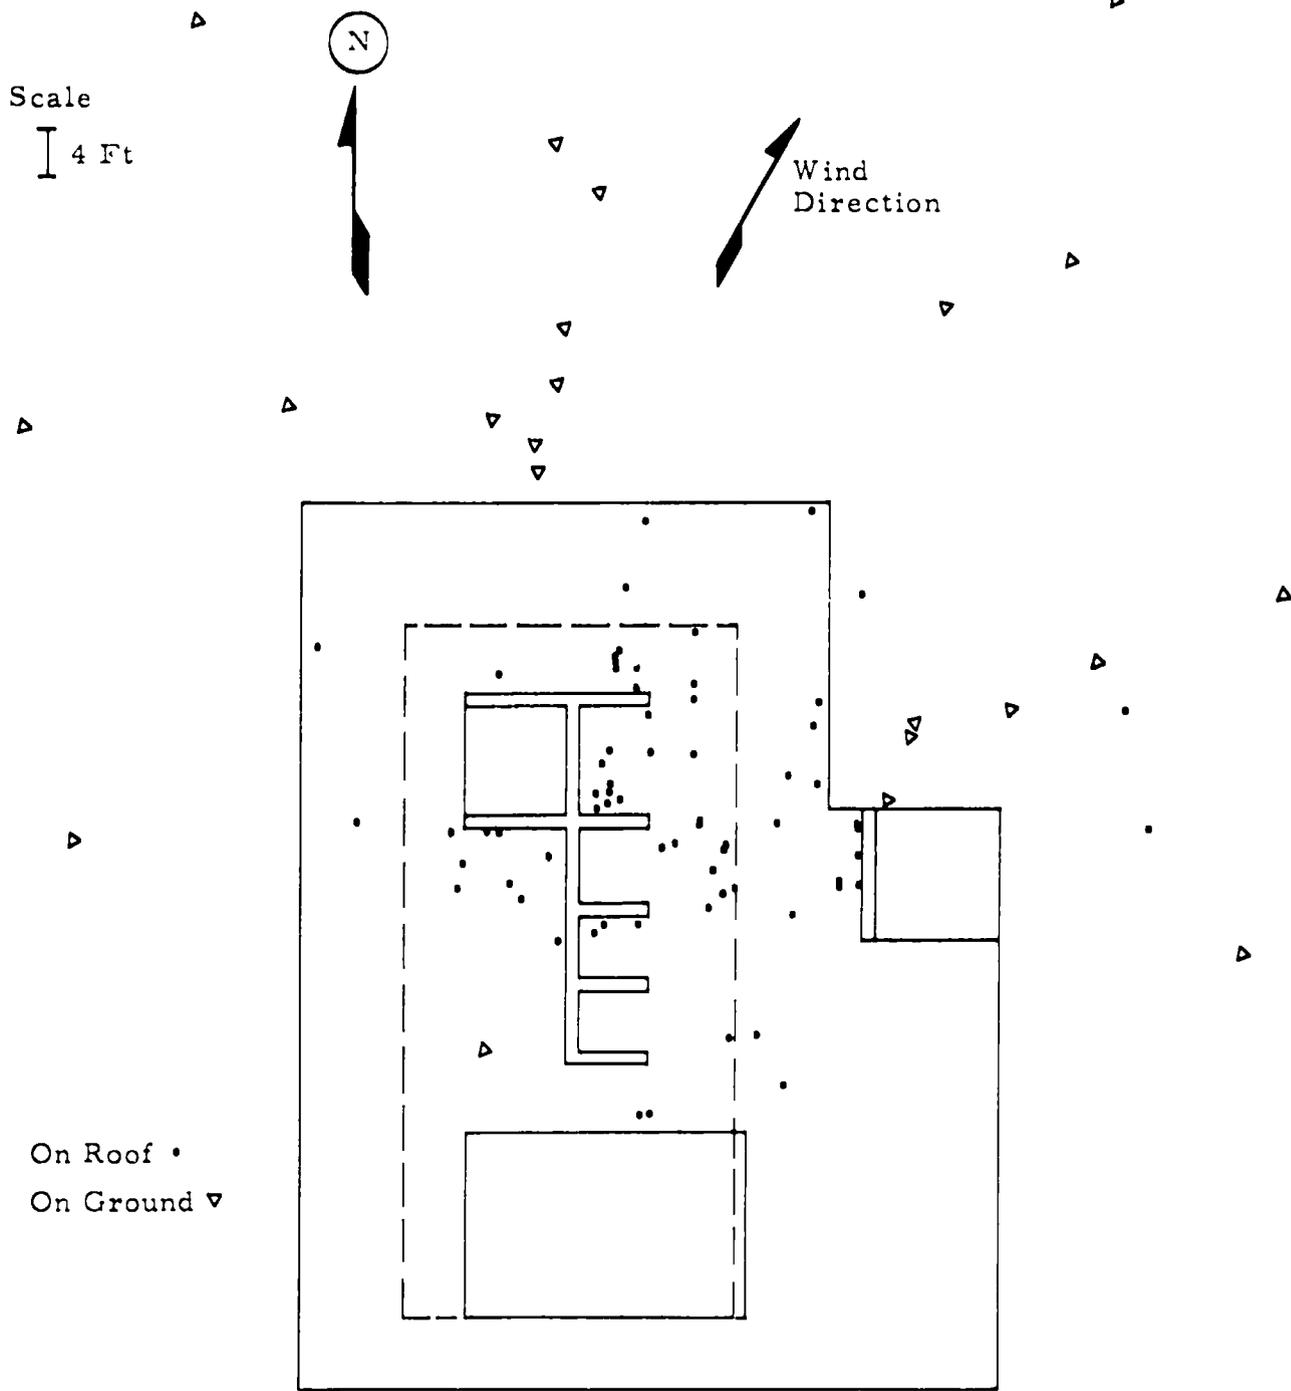
The test specimens were press-fitted into V-grooves 1/4 in. apart in Teflon rack assemblies (Figure 19) for support in the stainless steel bombs. The racks were machined from LOX grade Teflon TFE. Approximately 300 g of this material was present in each bomb. Pieces of the racks were scattered over a wide area, in general in the northerly direction of the wind (see Figure 20). The pieces recovered almost completely account for the 15 racks used in the tests. Most of the pieces were filled with bubbles and blow holes which did not previously exist (see Figure 21).

Figure 20. Scattering Pattern of the Pieces of Teflon Racks

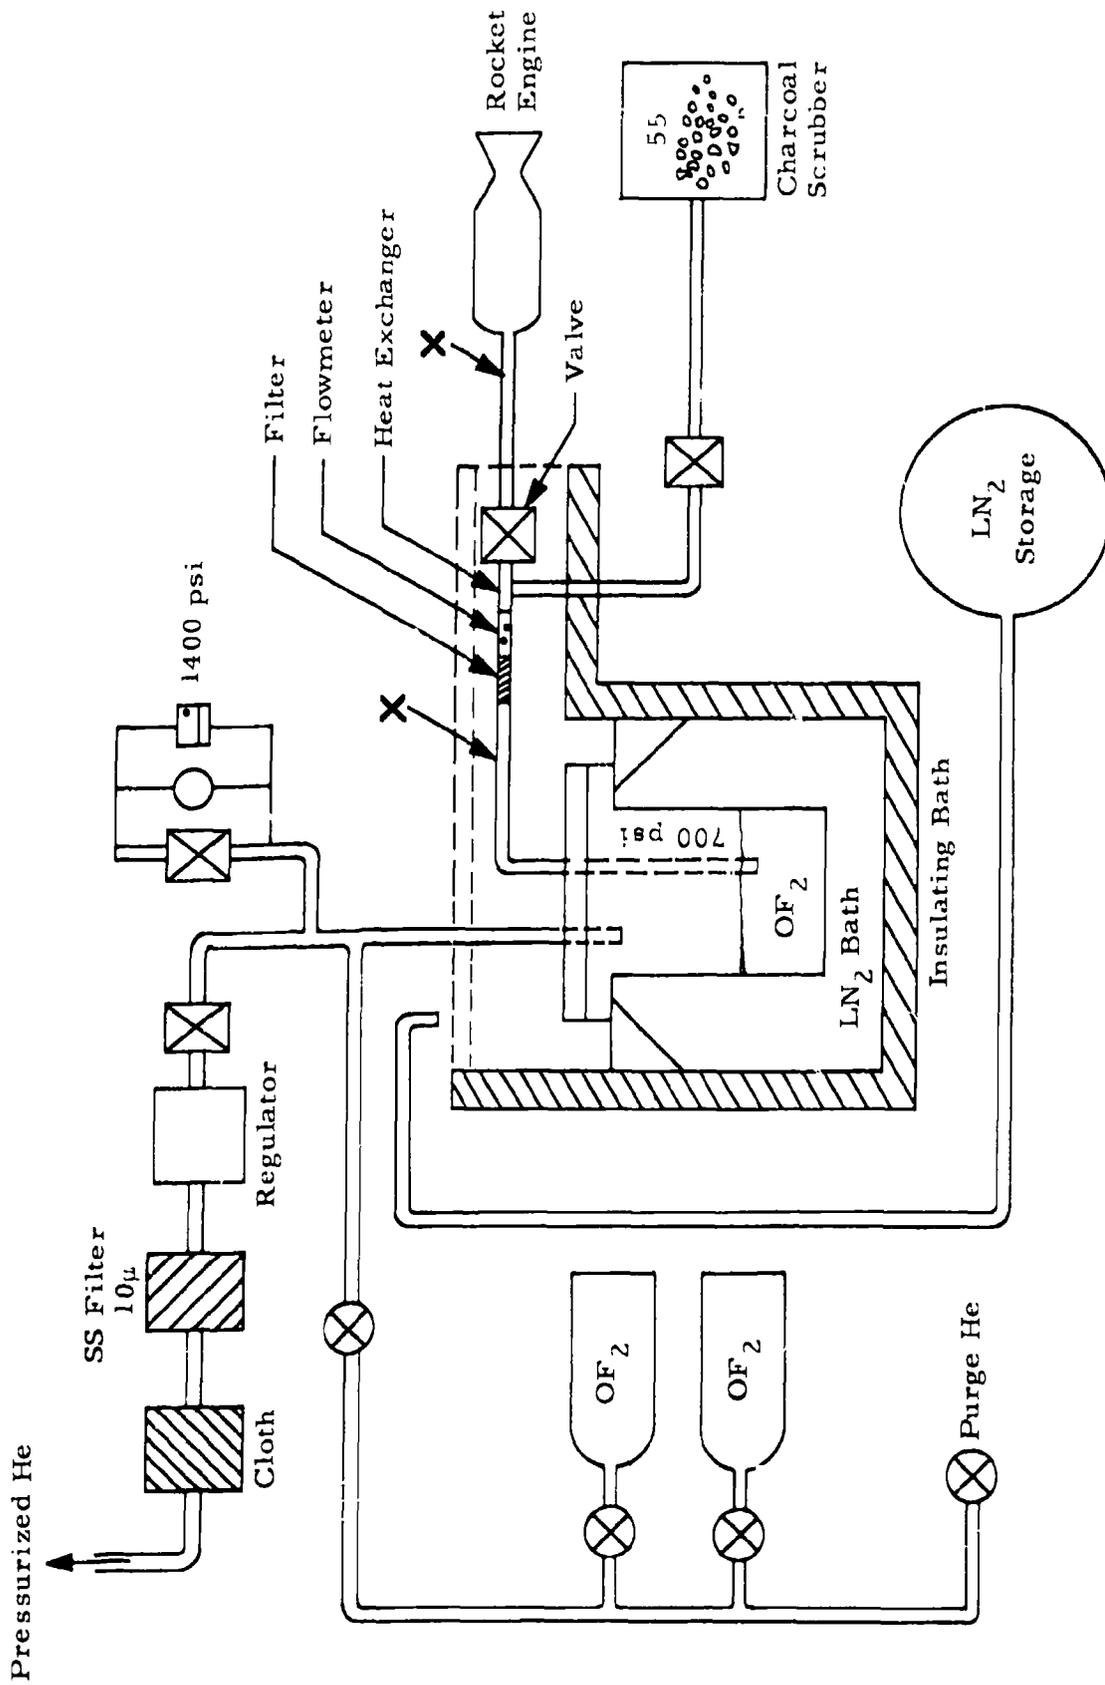
It should be pointed out that 3 lb of  $\text{OF}_2$  were shipped to Aerojet General Corp. as replacement of some oxidizer previously loaned to us. It was reported<sup>(5)</sup> that the stainless steel injector tube manifold (and one day later, the transfer line) of the rocket engine firing stand burned through and caused fire (in locations marked by arrows in Figure 22) while using the oxidizer received from cylinder R-4145.

Figure 22. Simplified Schematic Diagram of Rocket Engine Firing Test Stand Illustrating Burning of Stainless Steel Tubing (Courtesy of Aerojet-General Corp.)
