DESIGN, FABRICATION AND HYDROTESTING  
OF A 120-INCH DIAMETER PRESSURE VESSEL  
USING 18 PERCENT NICKEL  
MARAGING STEEL

Research Contract Status Report No. 8

METALLURGICAL ANALYSIS OF FRACTURED CLOSURE PLATE  
OF THE 120-INCH MARAGING STEEL PROTOTYPE VESSEL

Final Report

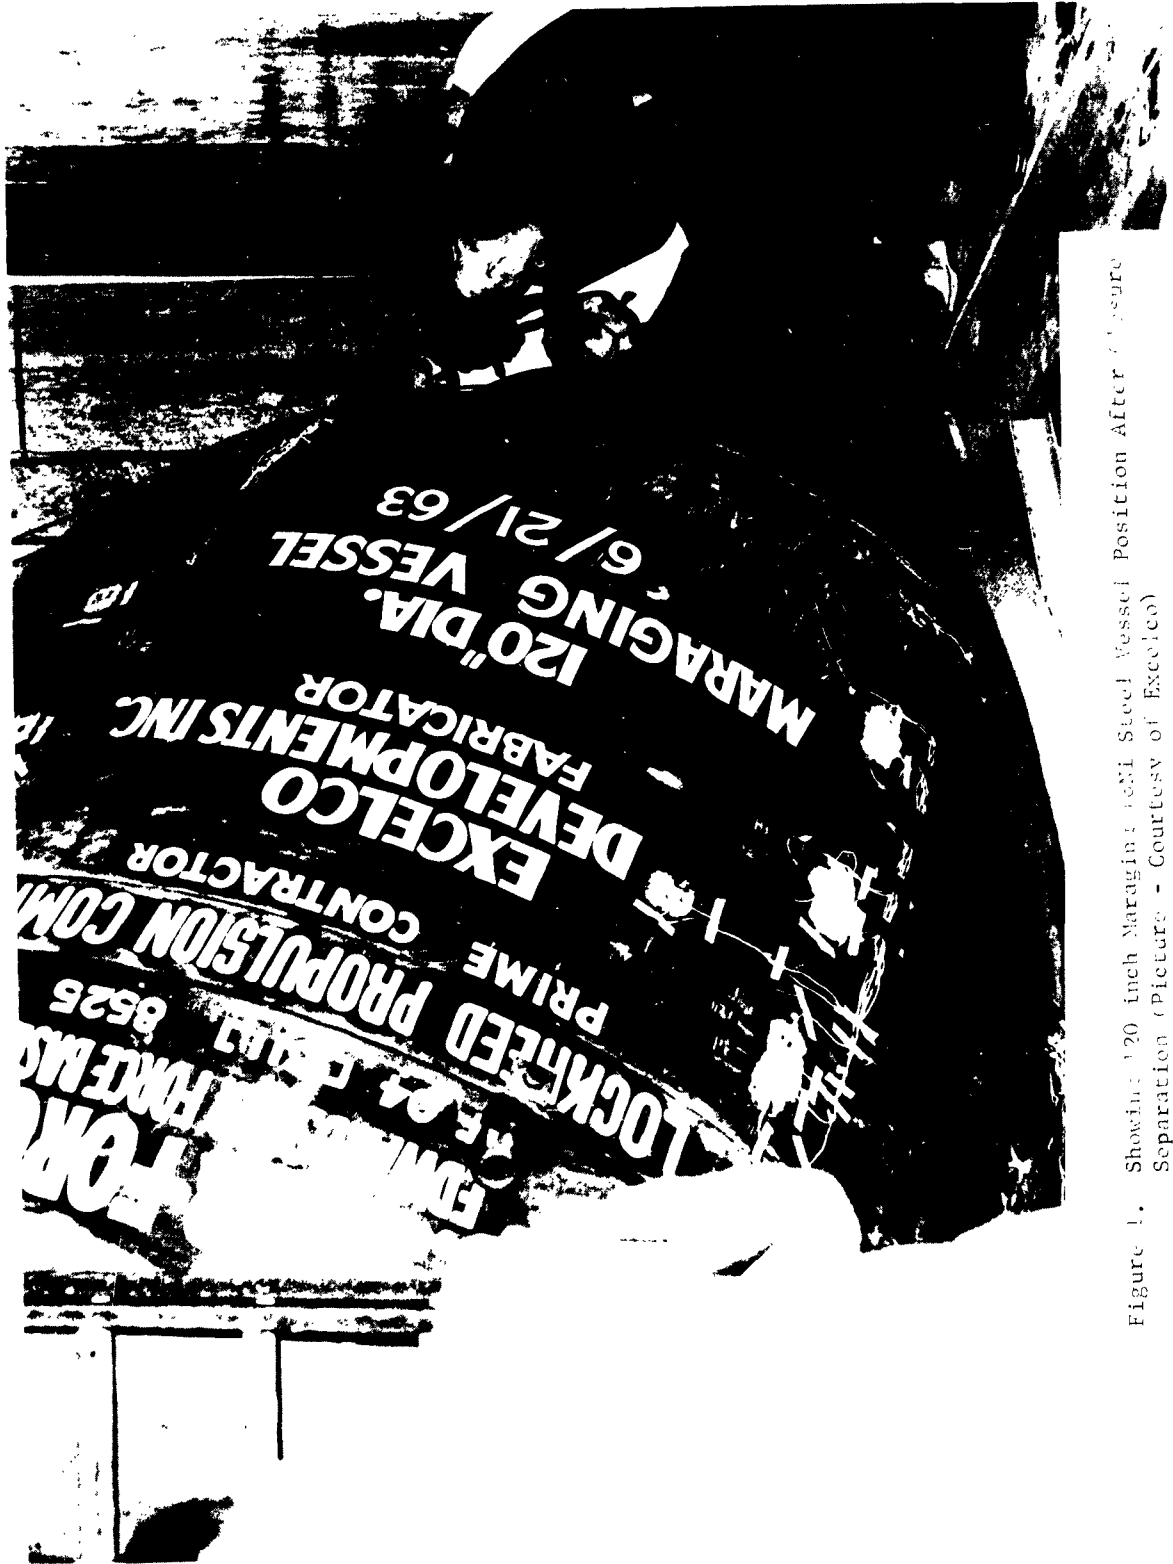
At burst, the closure had been forced down through the steel grating which then hit the concrete pit four feet below. The chamber itself was lying inclined at an angle as shown in Figure 1. The test stand which was supported on steel girders had been driven down with such force that the two 26" beams were badly twisted. The closure plate had broken into several pieces approximately 65 per cent of the main fracture was through the thicker forging. The 5/8" plate welded on to the forging had also fractured and delaminated.

Figure 1. Showing 120 inch Maraging steel Vessel Position After Pressure Separation (Picture - Courtesy of Excelco)

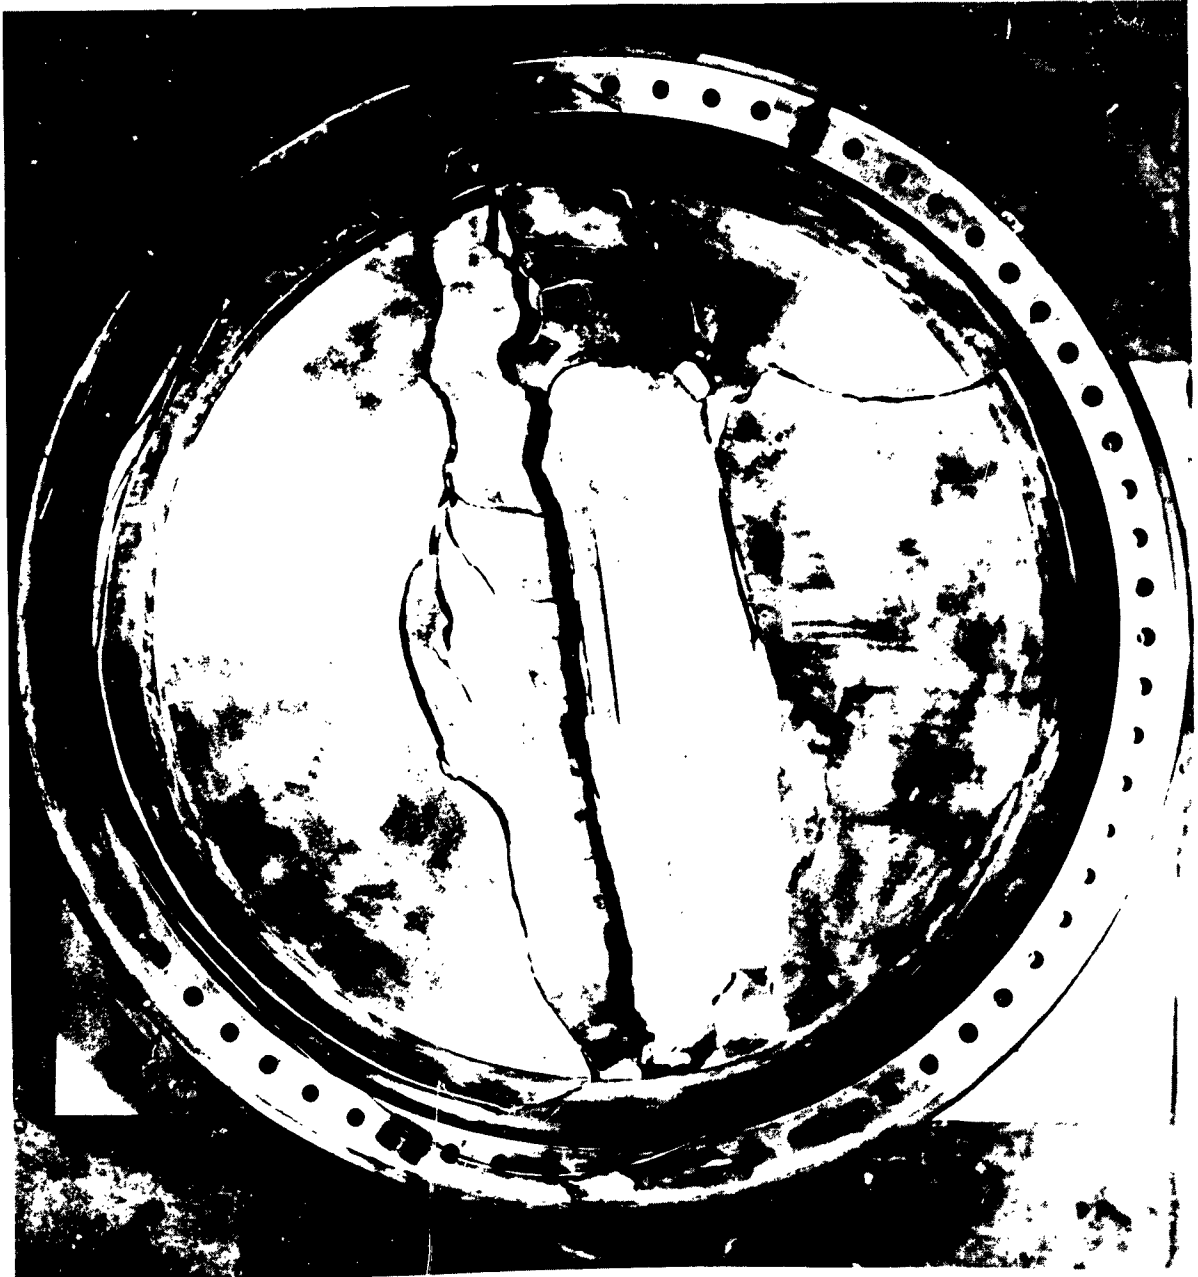
The top and bottom view of the fractured closure plate are as depicted in Figures 2 and 3, respectively. Close up views of the various textures seen in the fractured surfaces in the closure plate, forging and the forging-to-plate weld are shown in Figures 4, 5, and 6. The nature and extent of delamination observed in the 5/8" thick plate is as shown in Figure 7.

Figure 3. Bottom View of Fracture Travel Paths in the 120 inch Maraging 18Ni Steel Vessel Closure Plate

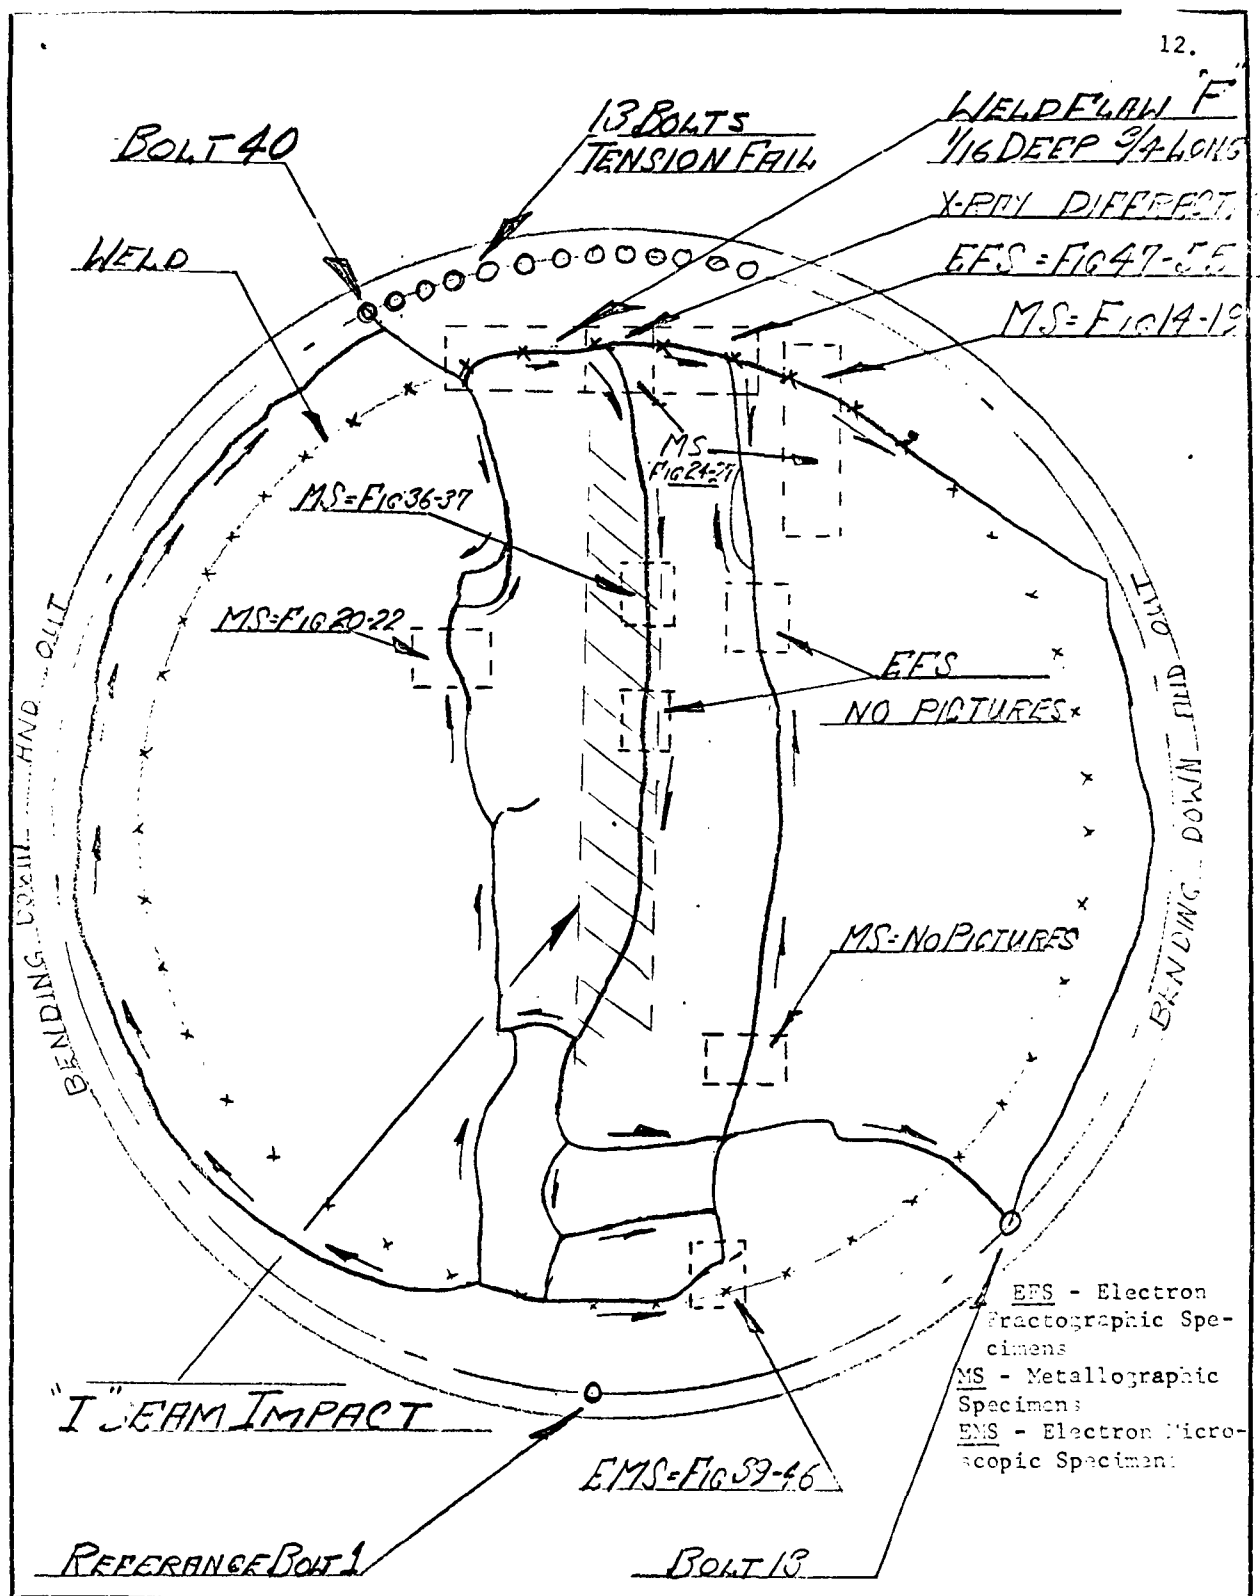
Figure 8		MELLON INSTITUTE, PITTSBURGH, PA.	
REVISION		FRACTURE DELINEATION - CLOSURE 120"	
REF. DWGS.		DATE 10/22/63	DRAWN
DWG. NO.		SCALE NONE	CHECKED F. LITSCHE
		CHARGE NO.	APPROVED

Figure 8 shows the various fracture travel paths and the direction of fracture travel in the closure plate. The fracture paths have cut through the 13th and 40th bolt hole from the reference bolt hole numbered 1. There were no visible defects in the forging although the fracture path had been mostly in the forging. The locations from which the metallographic and fractographic examination specimens were extracted have also been indicated in this figure. The I beam impact area markings on the closure plate have also been traced in Figure 8. Fractures close to this area undoubtedly could have resulted from the impact of the closure plate on the I beam.
