WT-1423

OPERATION PLUMBBOB

Armour Research Foundation
Chicago 16, Illinois

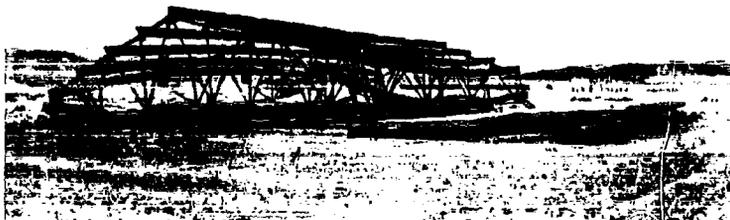
Figure 2.7 Posttest, TP 3.7 b-1 structure, front side view, facing northwest.

The TP 3.7b-1 structure collapsed in a direction away from ground zero (Figure 2.7). The end bents of the structure failed on the lee side by plastic buckling of the columns. All the truss-to-column connections on the ground zero side pulled away from the columns; the failure occurred in the truss-chord portion of the connection. In the interior bents the upper chord-to-column connections on the lee side failed by a combination of angle tearing and bolt failure. The lower chord-to-column connections on the lee side failed by buckling of the column flanges and tearing of the truss chord at the ends of the gusset plates. The lower chord-to-column connections on the ground zero side failed either in the connecting angle or in the bolts. The hinged column bases on the ground zero side appeared to be on the verge of failure. All these connections on the interior columns on the lee side failed because the anchor bolts for the restraining angles pulled out of the foundation. Both the end footings on the lee side of the structure were pulled out of the ground (Figure 2.8). There was pronounced bowing of the roof pur-

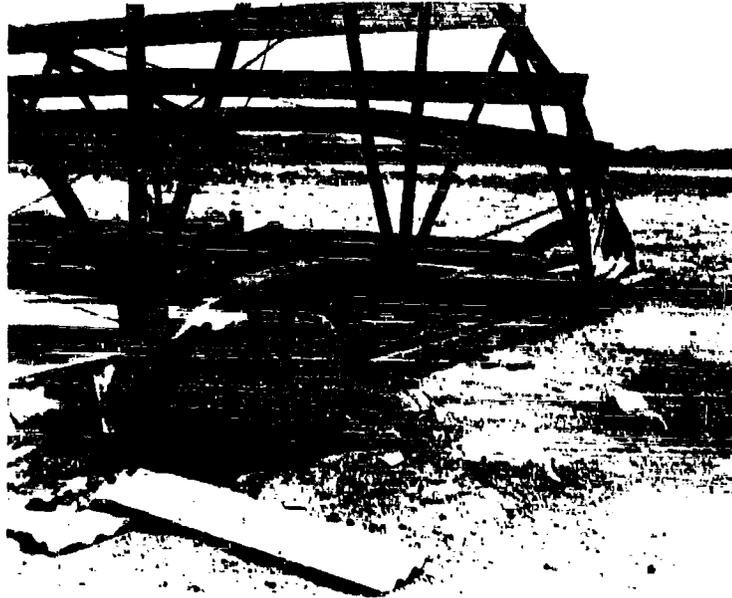
Figure 2.8 Posttest, TP 3.7 b-1 structure, view of north end column footing, facing southwest.

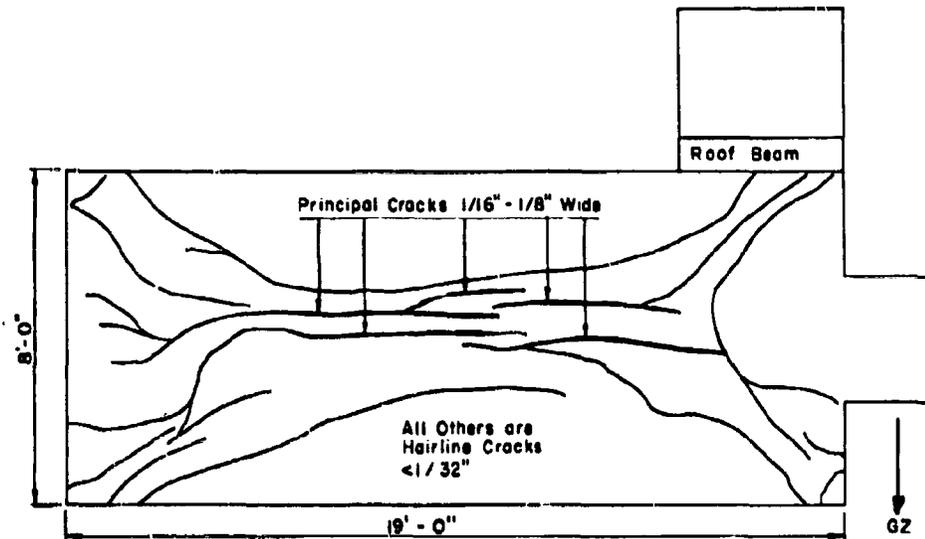
Figure 5.6 Crack pattern on roof of UK 3.7 structure.

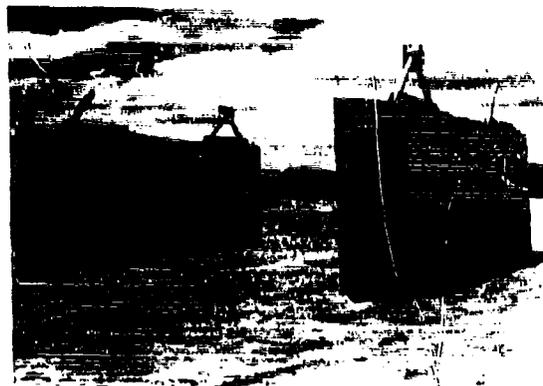
Figure 9.3 Posttest, UK 3.4b foundation, front side view, facing southwest.

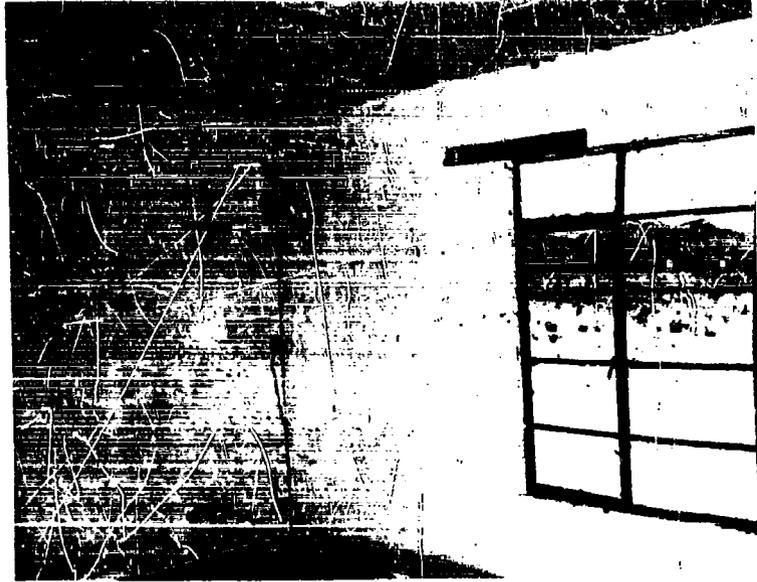
Figure 9.57 Posttest, TP 31.1 e-1, interior of living room, facing northwest.
