TECHNICAL EVALUATION OF THE ZUNI  
ROCKET BASE FUZE MK 191 MOD I

4 DECEMBER 1961

UNITED STATES NAVAL ORDNANCE LABORATORY, WHITE OAK, MARYLAND

NOLTR 61-174

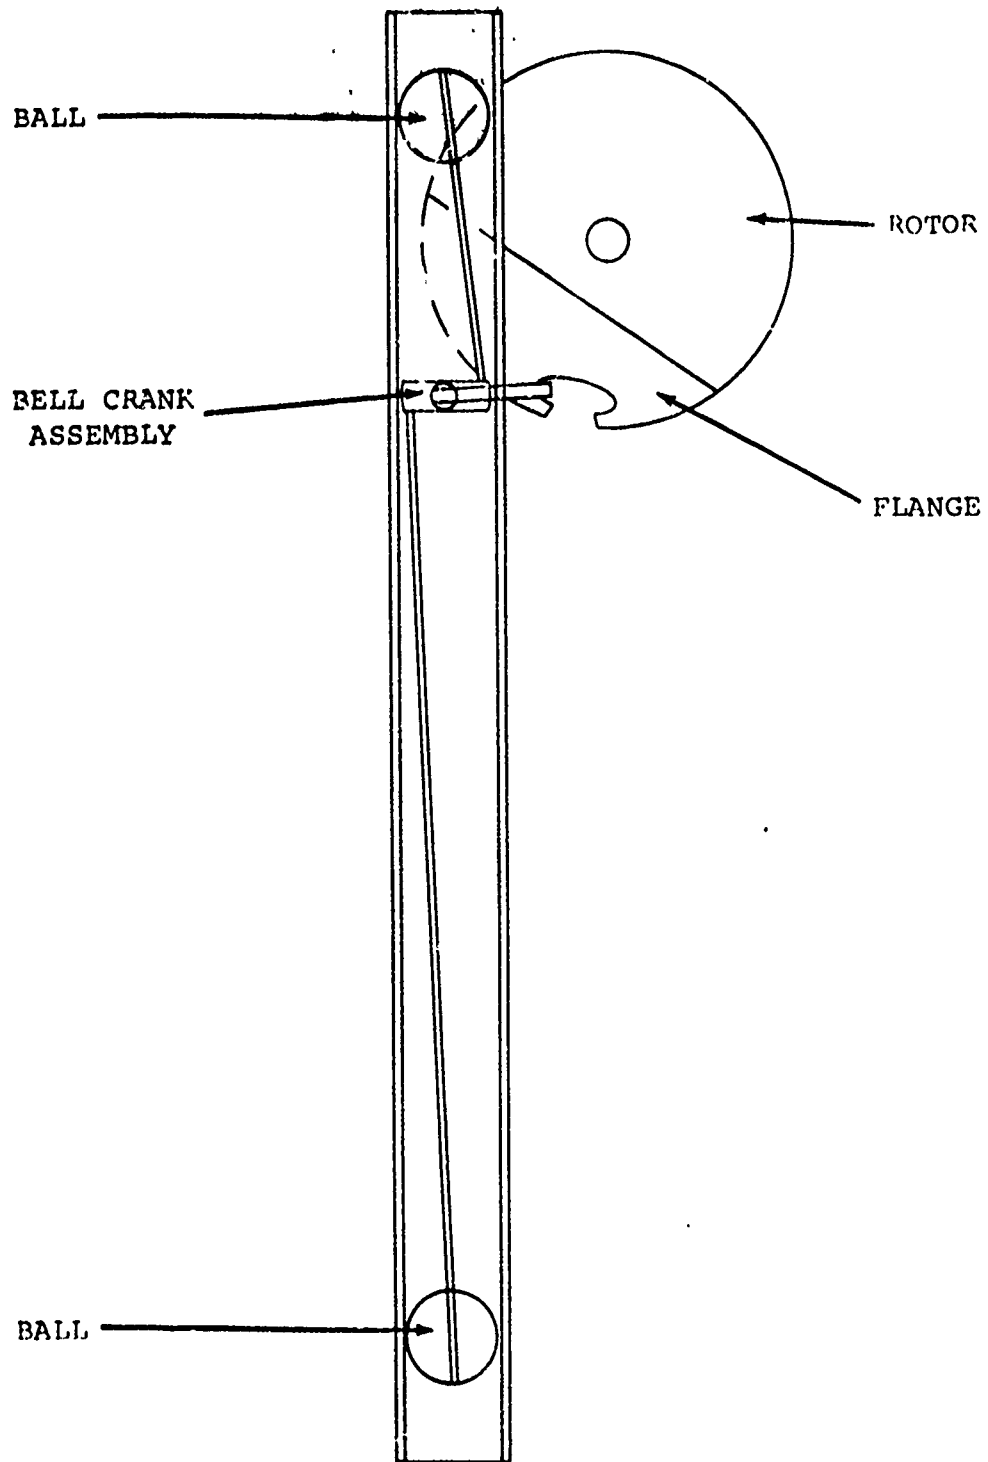
FIG. 3 SAFETY MECHANISM ASSEMBLY

5. The safety mechanism assembly (Figure 3) consists of two balls linked to a bell crank assembly. This assembly is held in position inside a tube attached to the bottom of the forward arming mechanism. The bell crank arm is engaged in a notch in the rotor flange of the forward mechanism. The two balls are positioned at two specific distances from the center of gravity of the rocket head. Since the centrifugal acceleration of a mass is directly proportional to its distance from the center of rotation, the acceleration forces exerted on the two balls are unequal when the head is caused to tumble. In the accidental release situation, where the head separates from the rocket motor and tumbles about its center of gravity, the forces exerted on the two balls and the bell crank arm act to prevent the arm from disengaging from the rotor flange notch, and the rotor is locked in the safe position. Under linear rocket acceleration, the forces exerted on the two balls and the bell crank arm allow the arm to disengage from the rotor flange notch as the rotor moves to the armed position.

samples the fit of the safety mechanism assembly arm in the rotor slot was such that, if the rotor slack is taken up in the armed direction, the arm could easily be moved in and out of the rotor slot. Such a mechanism could become unlinked by a light impact. These tests did not check the effectiveness of the safety mechanism assembly and additional tests were made.

18. Five fuzes, the rear mechanisms of which had previously been lubricated with Lubricating Oil MIL-L-11734A, were subjected to the vibration tests described in 4.7.12 of MIL-E-272C (ASC). The fuzes were X-rayed after the test. The post test examination disclosed that one rear mechanism was inoperable. Two safety mechanism assemblies became unlinked from the forward mechanisms. In three fuzes, some powdered bakelite was present caused by wear of the bakelite primer housing by the brass tube of the safety mechanism assembly. In four cases, the bell crank assembly had an excessive amount of movement in the safety mechanism assembly due to wear of the brass tube by the steel shaft. Some brass dust was present in three fuzes, caused by wear of the brass setback weights against the steel mechanism frames. Because of the wear in the setback weights, the rotors of three forward mechanisms could be turned several degrees toward the armed position, so that the arm of the bell crank assembly could be moved at will in and out of the rotor slot. Since one mechanism was inoperable and two safety mechanism assemblies became unlinked, it is judged that the fuze failed this test.
